# **Middle Truckee River Tributaries Sediment Source Assessment Prescription Plan**

**Truckee River Watershed Council  
USDA Forest Service, Tahoe National Forest, Truckee Ranger District  
August 2016**

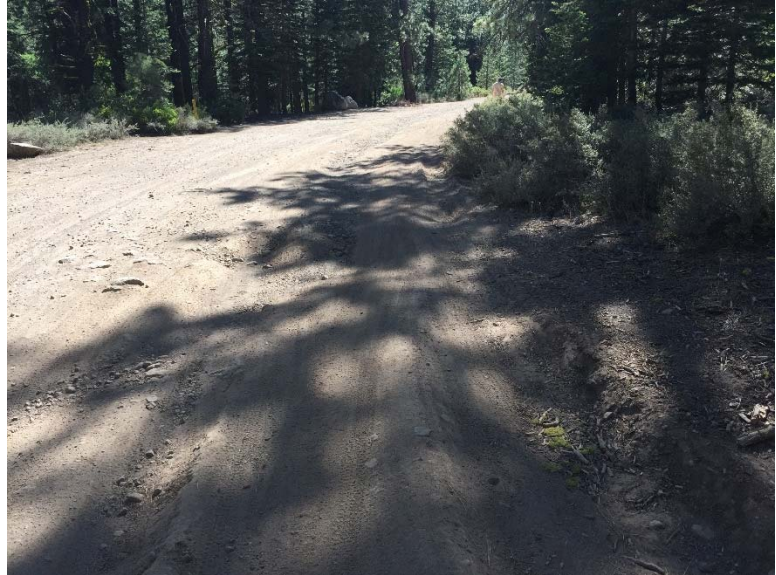
J6. Accumulated surface runoff forming rills and ruts.

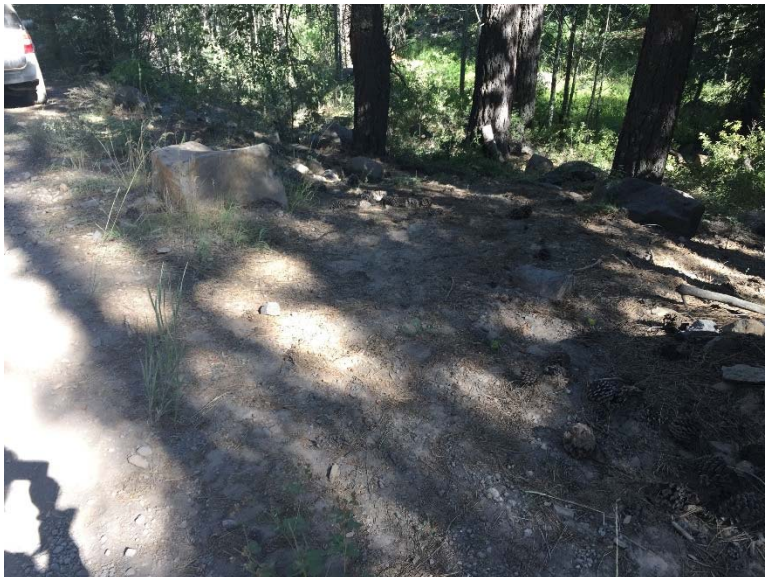
J9: Road segment of Jackass Point road. Road surface runoff carries large amounts of sediment. Waterbars are installed approximately 200 ft apart on a 10% gradient. Leadouts are filled with sediment. Sediment is transported directly to Jackass Creek.

J9. Road surface runoff transports large amounts of sediment into leadouts. Runoff is large enough to transport sediment to Jackass Creek.

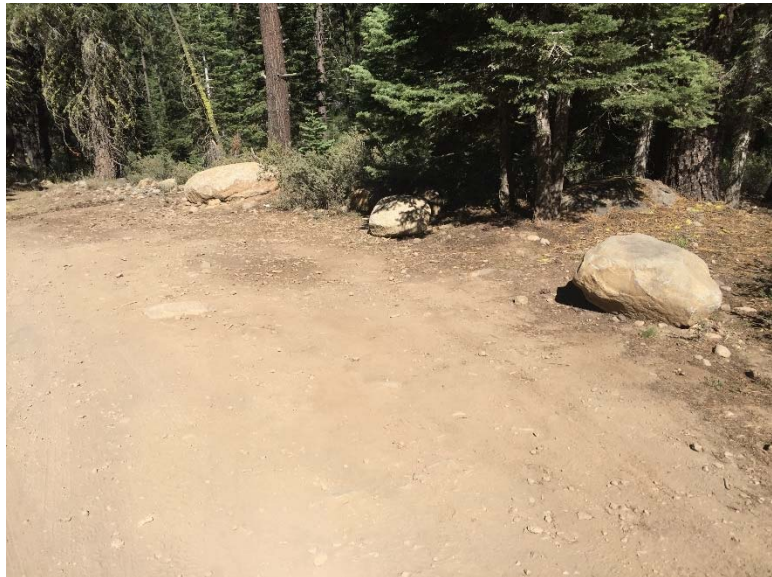
J15. Pullout/landing pooling sediment captured from J6.

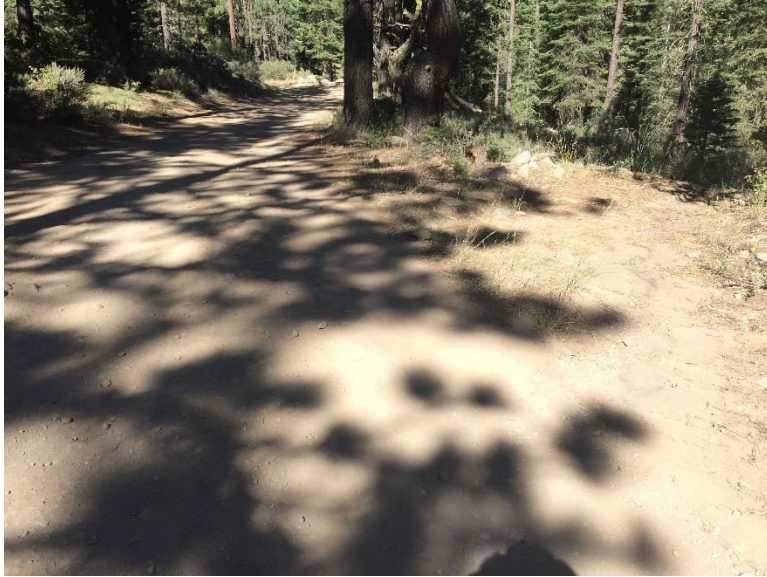
J16: Failed waterbars here allow for runoff from J6 to continue down to road and accumulate more surface runoff. The leadout here still captures some runoff of J6 and is filled with sediment. Sediment continues into Jackass Creek.

J16. Failed water bar while leadout still captures runoff from J6. Leadout is filled with sediment.

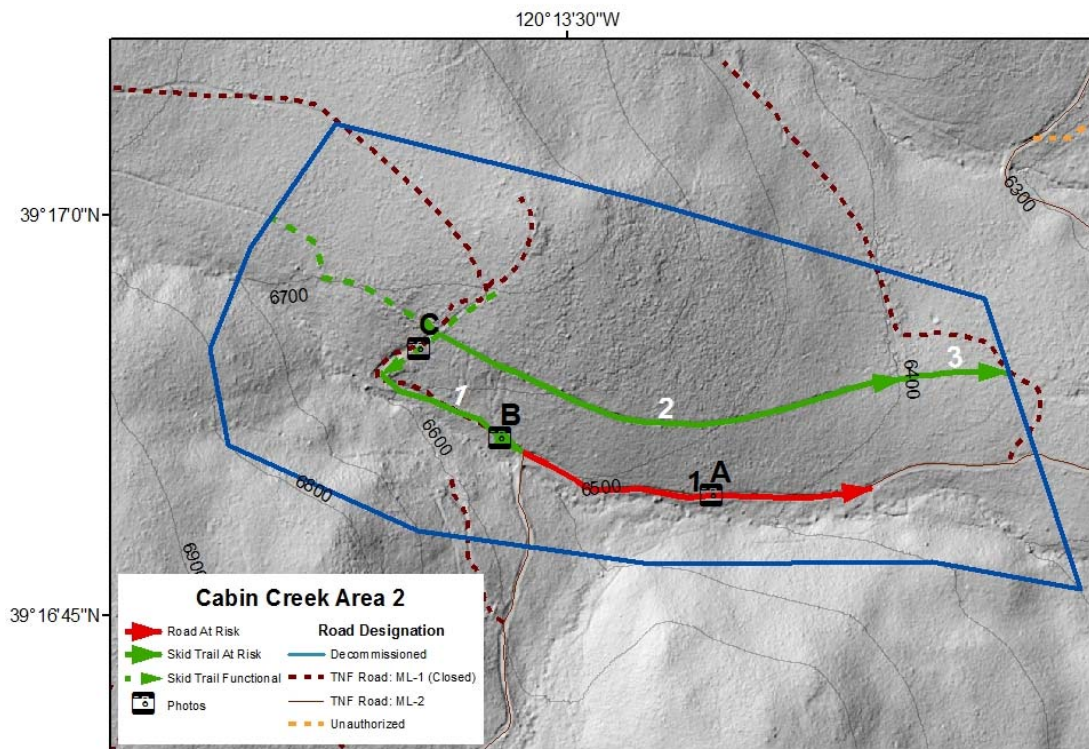
<p><b>Photo A</b> Heading: 180</p> <p>Leadout from road contains abundance of silt which can be traced to stream &lt;40ft downslope.</p>	<p><b>Photo B</b> Heading: 135</p> <p>Leadout from road has significant boulder sized clasts that are not present further down road. This outlet is &lt;30ft above channel.</p>	<p><b>Photo C</b> Heading: 225</p> <p>Leadout from road diverts flow from road, but flow remains channeled and is captured by skid road 1 further downslope.</p>

**Proposed Action** - Ultimately the preferred remediation would be to obliterate both E-W trending roads in this section. Sheetflow is being channeled along both, increasing velocity and turbidity of the stream once both drain into the channel, and rilling and scouring of the road and trail adds to sediment influx into Cabin Creek. Because Skid Trail 2 is no longer in use, we recommend full obliteration; however proper drainage structures will probably alleviate most of the problem provided action is taken on the downslope ML-2 road, Road 1. While full obliteration of the ML-2 road would be ideal, the road can be left in its present location provided it is ripped and proper drainage structures such as waterbars are emplaced along this section. The N-S skid trail at the southwest of this area catches drainage and should also be removed.

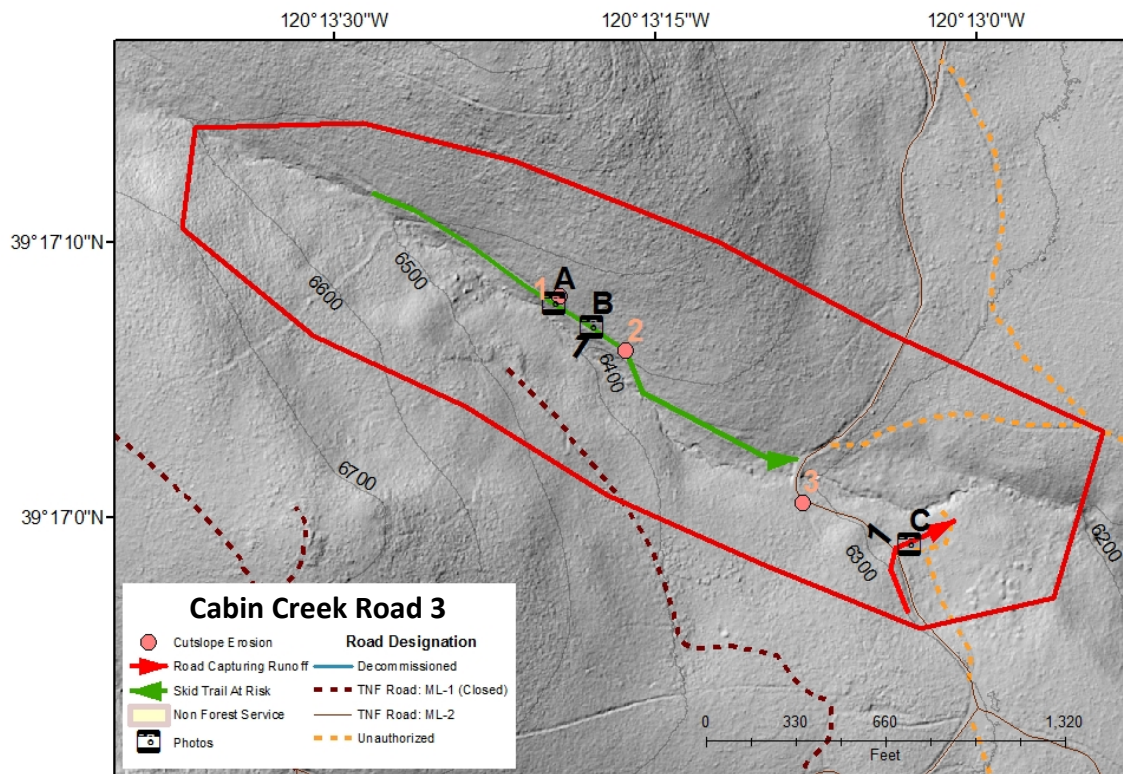
<p><b>Photo A</b> Heading: 330</p> <p>Cutslope erosion along Skid Trail 1.</p>	<p><b>Photo B</b> Heading: 120</p> <p>Sheet erosion over bare soil above Skid Trail 1 that is caught and channeled for ~150 ft. before depositing into creek.</p>	<p><b>Photo C</b> Heading: 250</p> <p>Drainage captured by road is diverted onto landing and remains channeled until it reaches creek.</p>

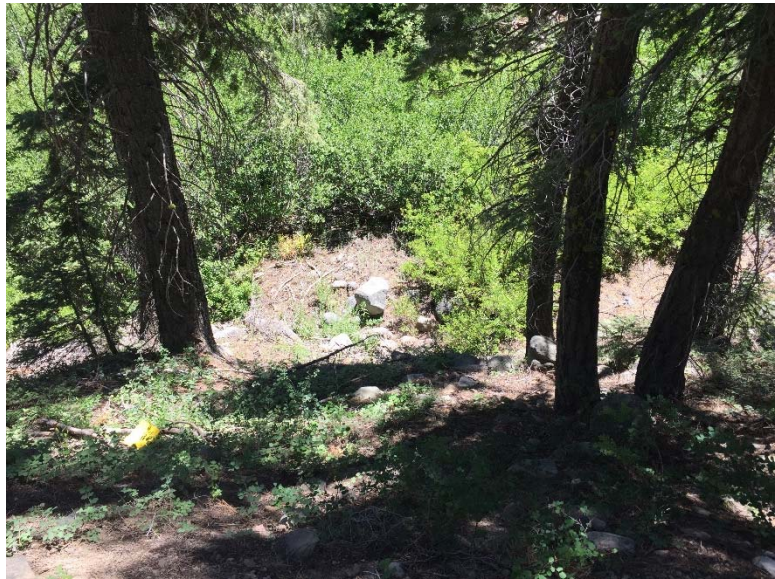
2.7-2.10: Leadout catching excessive amounts of runoff from road. Incision at the outlet and fillslope occurs. Fillslope is failing.

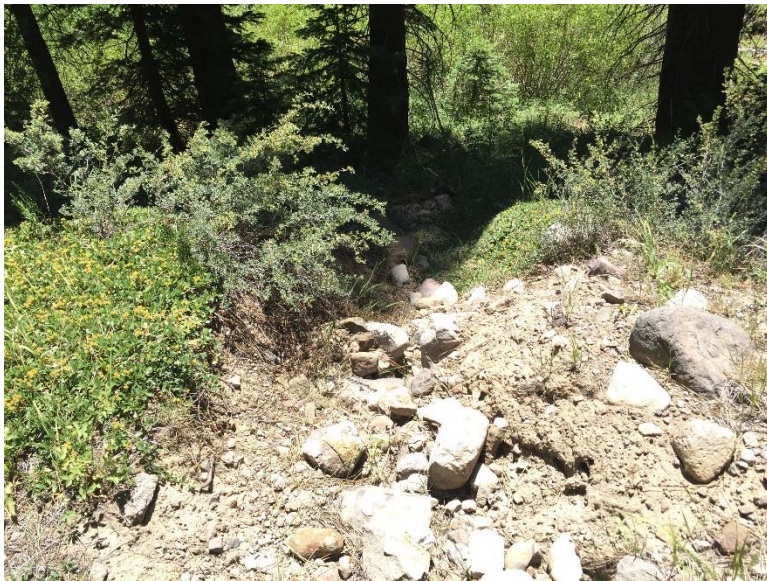
Example of leadout and fillslope incision.

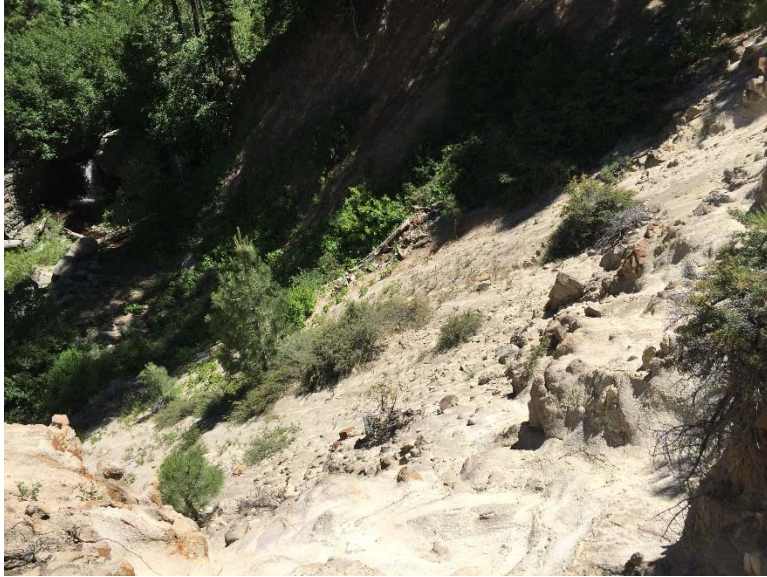
2.11: Segment of road built on toe of a landslide. A washout event may have allowed mass failure of the fillslope. Mass amounts of fillslope is no longer present and has left the remaining fillslope with low vegetation and bare soils.

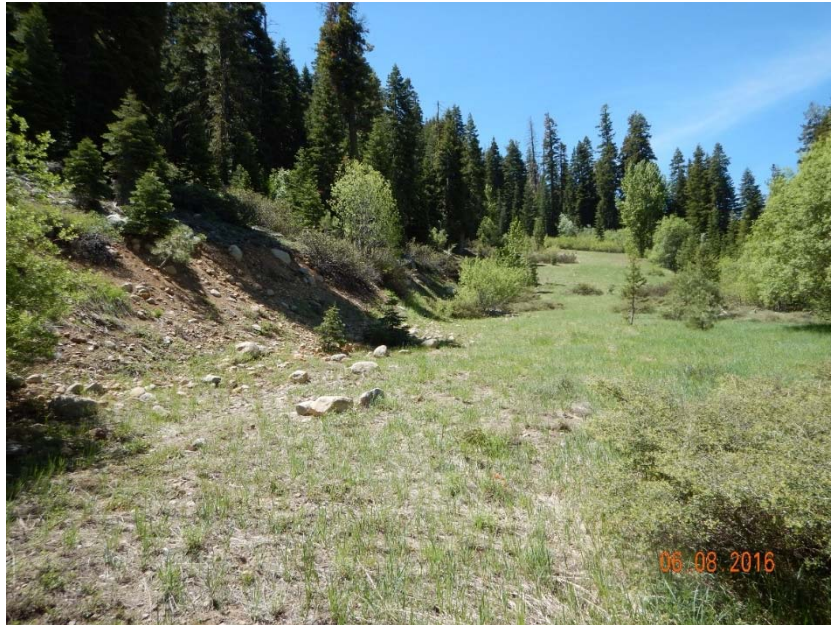
Figure 4. Looking upslope (south) at feature C1.

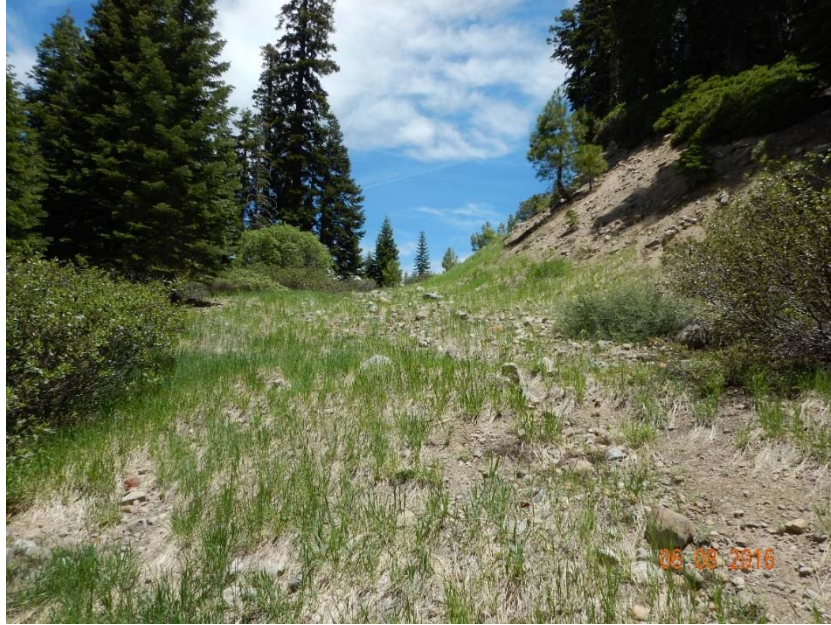
Figure 5. Looking upslope (northeast) at the base of feature C2. Rilling can be seen at center of the photo and moving to the bottom right. Cutslope has exposed surface.

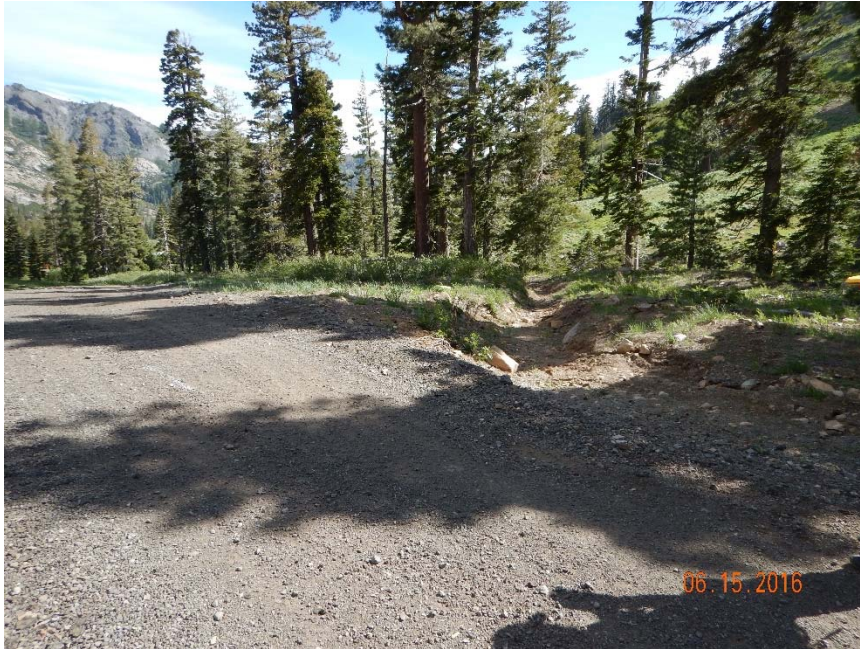
Figure 1. Leadout incision from large amounts of discharge flowing onto road from adjacent hillslope. Discharge is large enough that it flows out of the leadout and into the nearby stream.

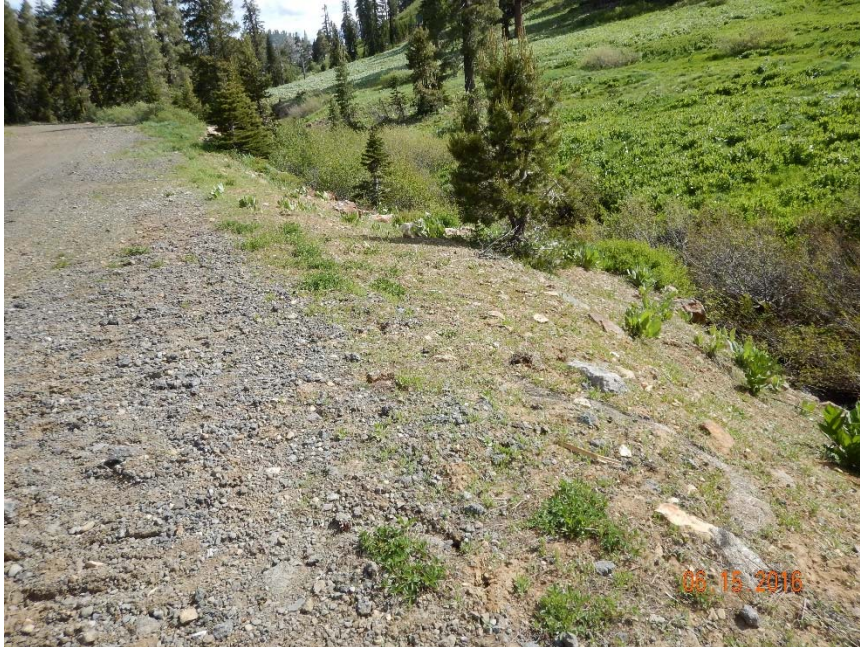
Figure 4. Fillslope of road placed directly into channel.

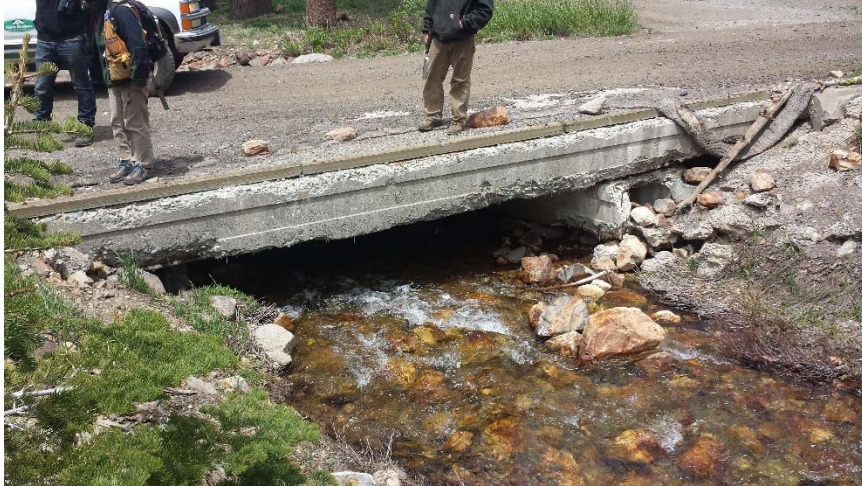
Figure 6. Bridge crossing over perennial channel. Straw waddles installed to prevent water from flowing over the top of the bridge and into the channel have failed.

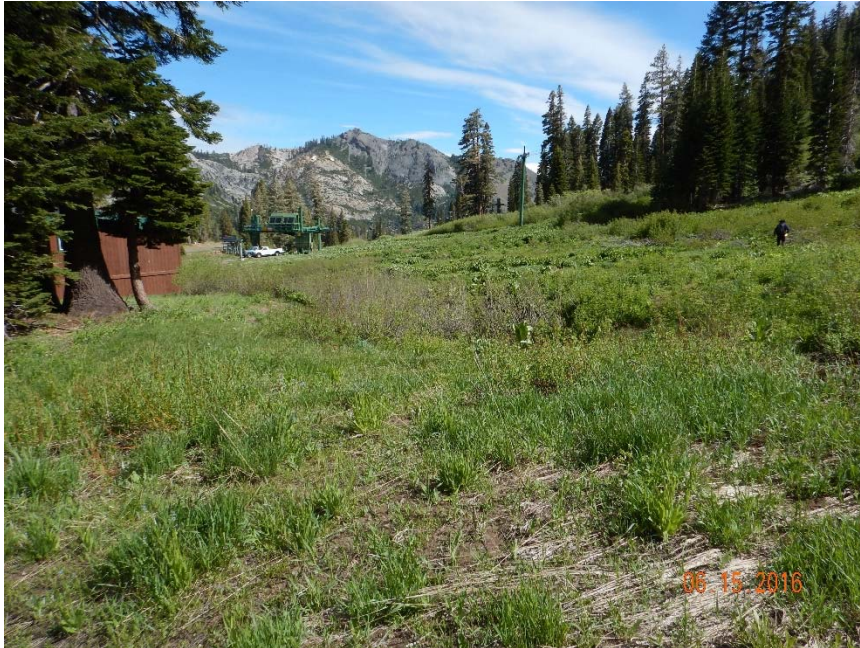
Figure 8. Berm southeast of the Chalet restaurant. Pushing flow to the north, creating meandering channels to form in small meadow.

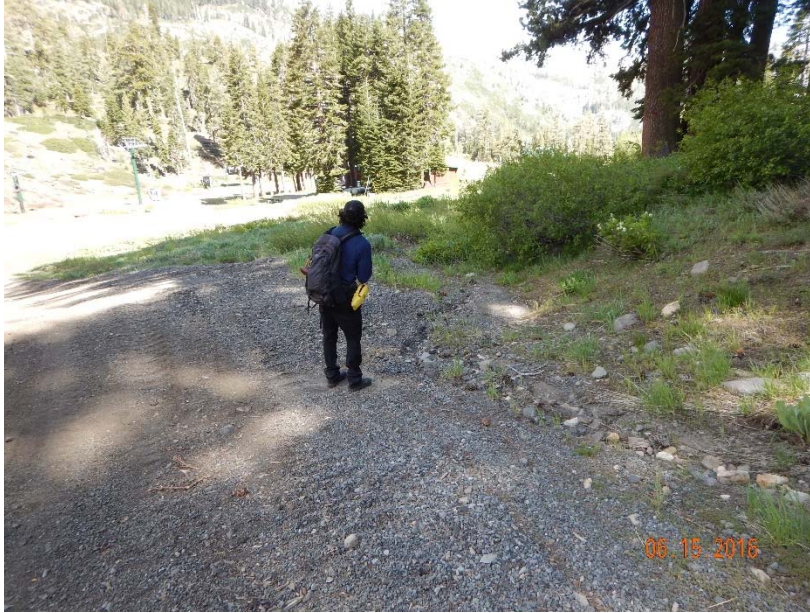
Figure 9. Inside ditch of inslope road shows scouring and rilling. Rilling continues past leadout.

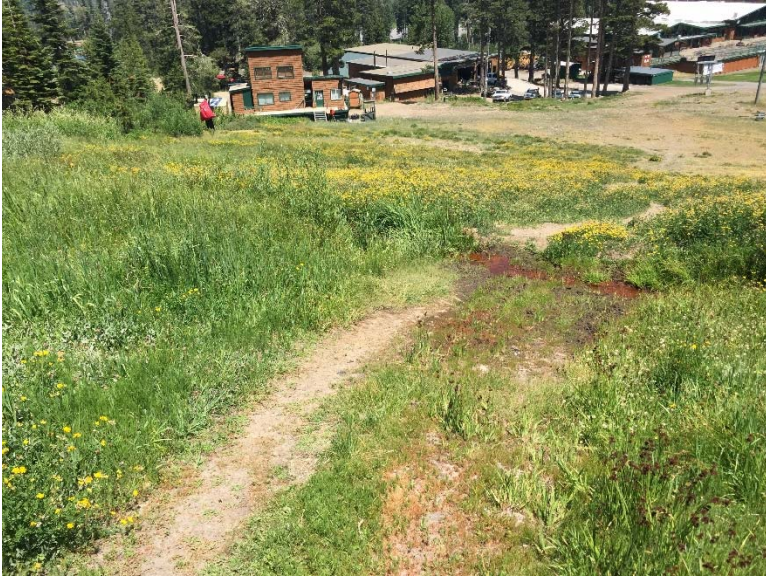
Figure 1. Northern most waterbar capturing water from water tower.

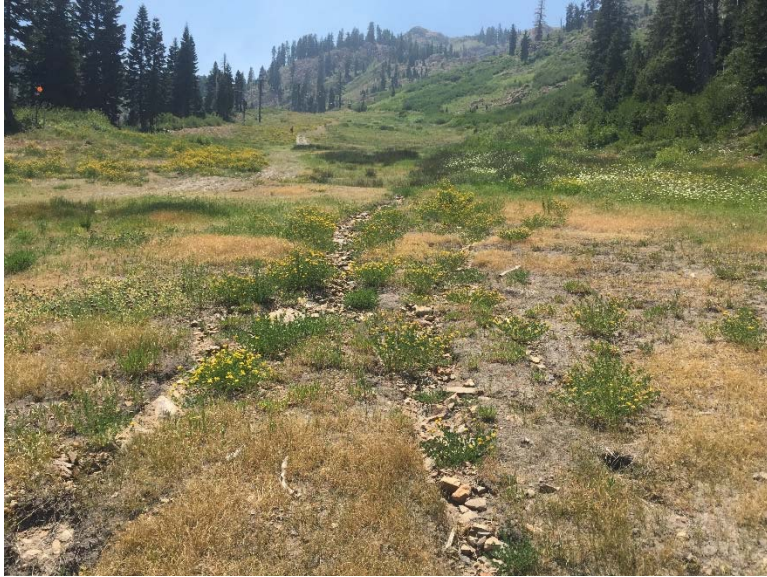
Figure 3. Another photo of rillings that are removing top soil exposing rocky substrate.

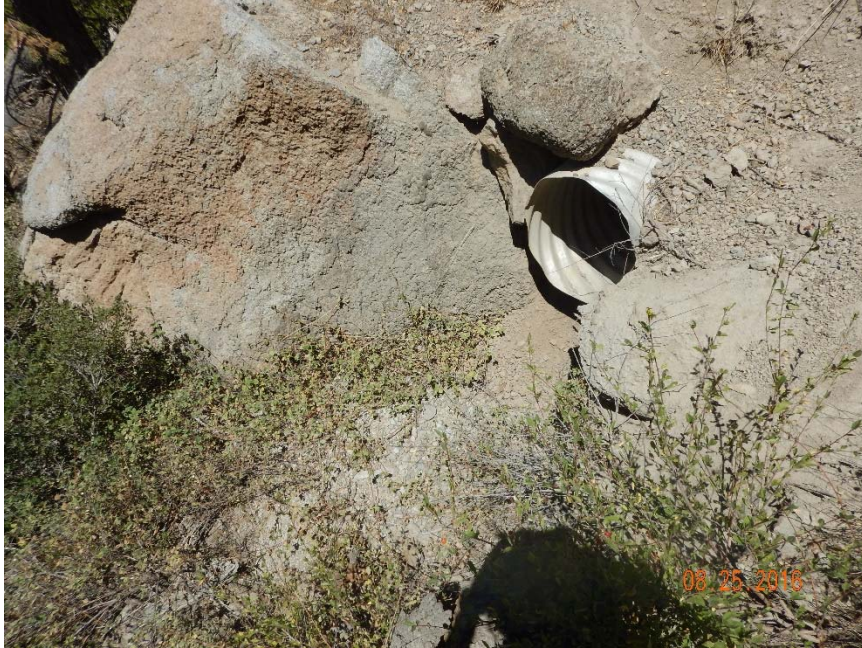
Culvert for ephemeral channel crossing and inside ditch relief. Scouring at outlet due to large amounts of runoff entering culvert. Consider a larger culvert replacement.

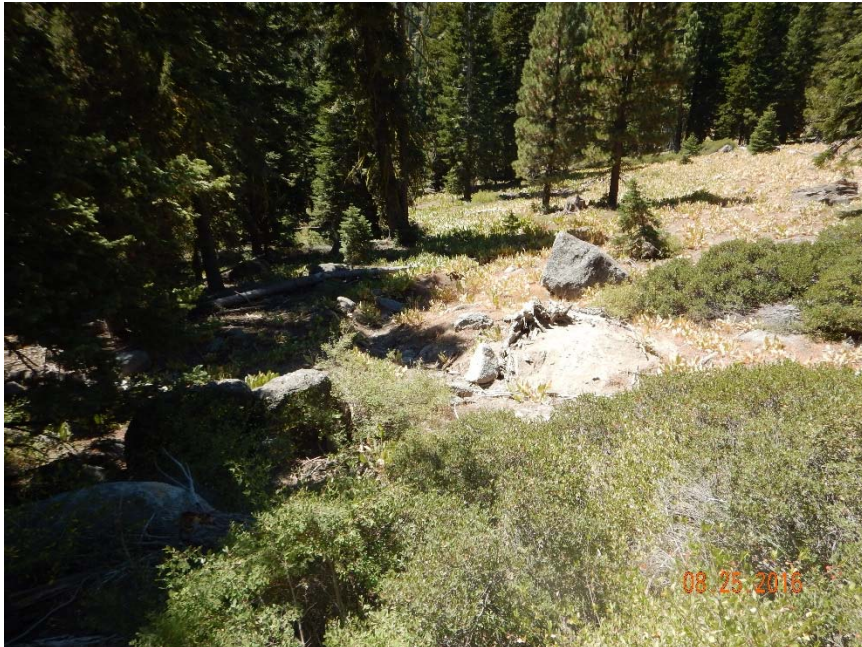
Channel formed from excess runoff from culvert in above photo. Consider additional water drainage.
