Johnson Canyon West Watershed Assessment

Truckee River Watershed Council
PO Box 8568
Truckee, CA 96161

Wildscape Engineering, Inc.
3079 Harrison Ave., Suite 5
South Lake Tahoe, CA 96150

January 30, 2017

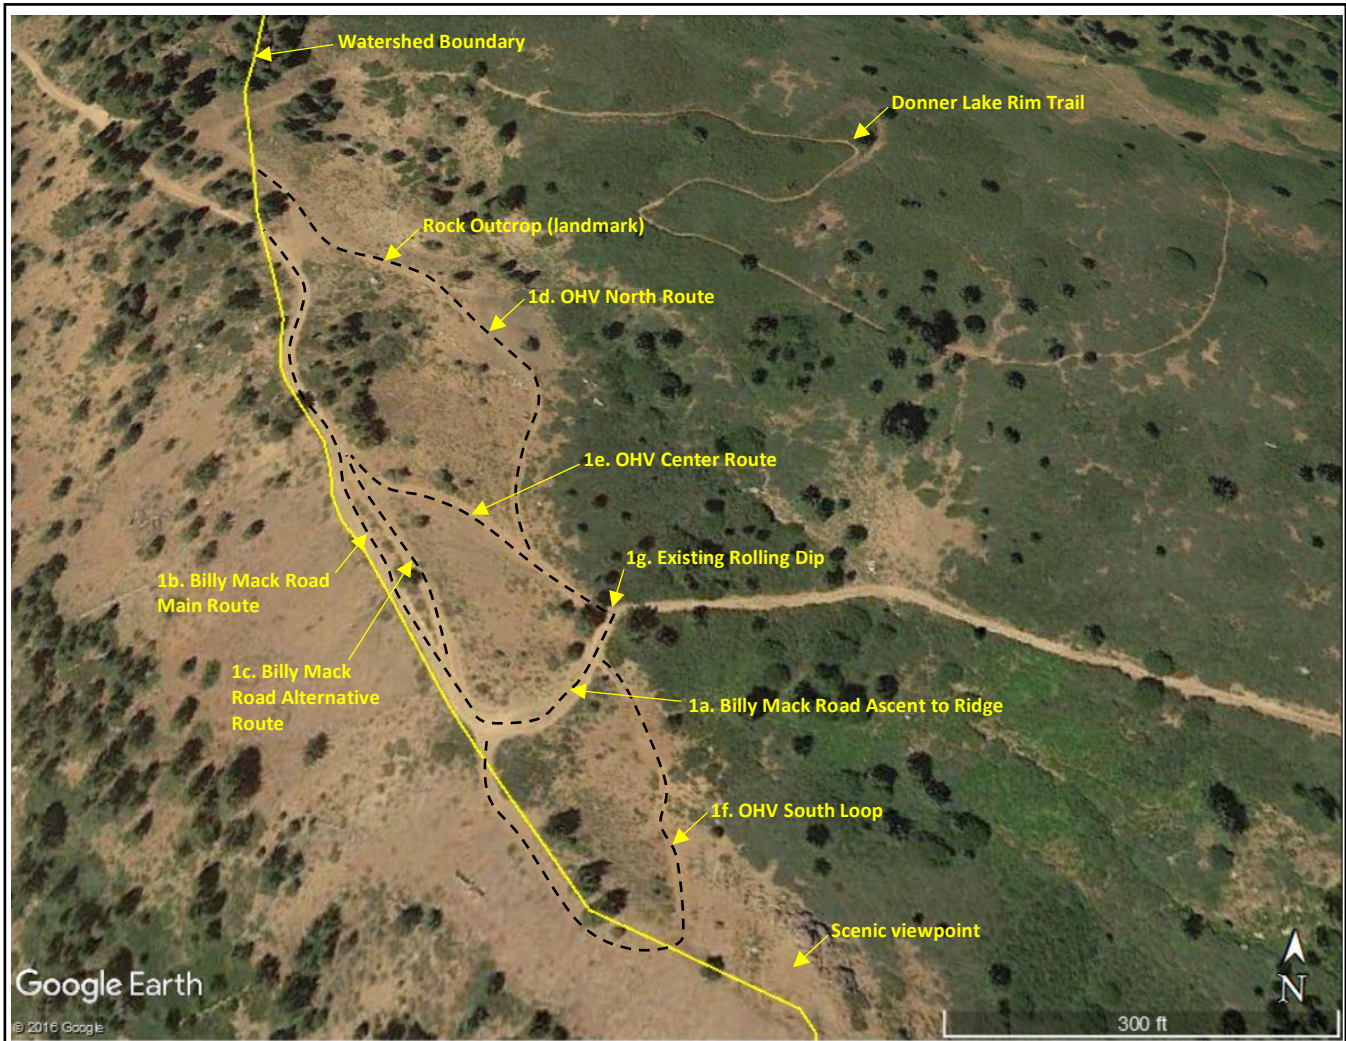
Figure 4. Aerial View of Project Area L: "Four Corners" (#1).
 (Source: Google Earth, 2016)

At the location where Billy Mack Road (USFS Rd West) gains the ridge that defines the western watershed boundary, the slope is steep, vegetation is sparse, and numerous OHV trails have been developed. Figure 4 of Appendix A shows an aerial view of the site. Photos B1-B12 of Appendix B display field photos of the location. Signs of erosion vary among OHV routes and along Billy Mack Road, ranging from mild to severe. This site is broken into several sub-sites for more detailed description and assessment, which is included in Appendix C – Field Log.

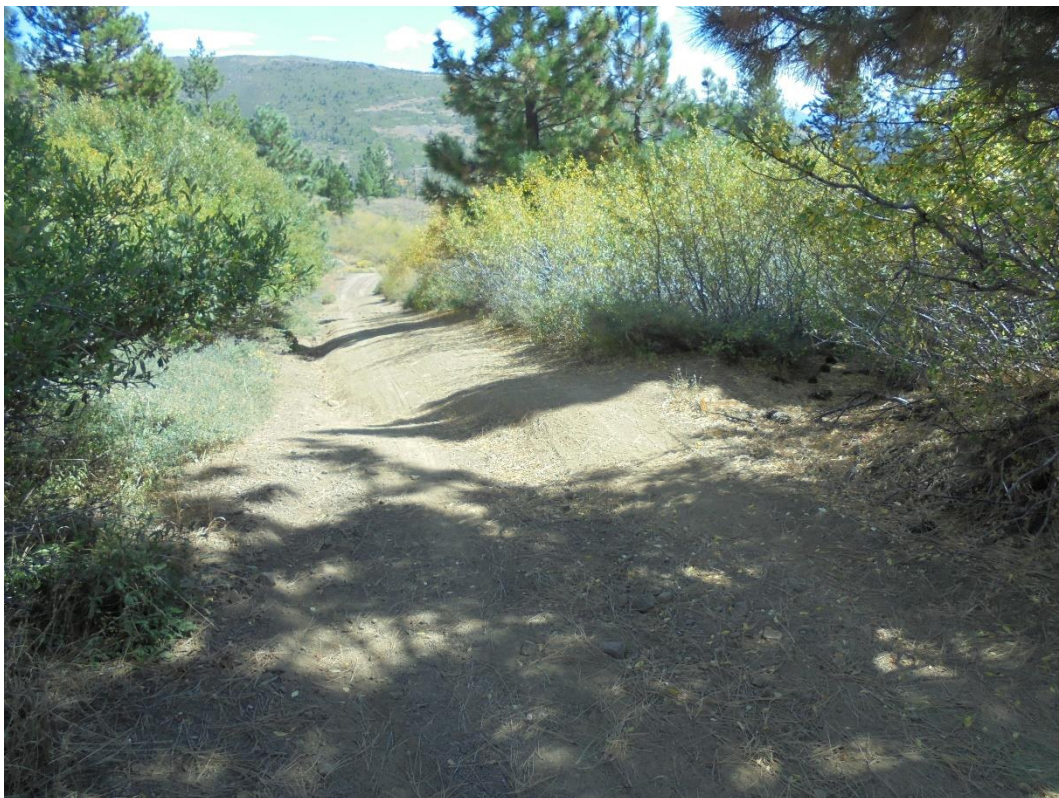
#1g	12	Existing Rolling Dip	Failed rolling dip at bottom of Four Corners drainage area.	N/A	N/A	N/A	High	Reconstruct rolling dip; construct new rolling dip up road and rock-lined outlets.	\$

Photo 12. #1g – Rolling Dip at bottom of Four Corners drainage area (looking east from location where OHV Center/North Route fork from Billy Mack Road).

The existing rolling dip at the bottom of the Four Corners drainage area is appropriately placed to divert runoff, but has been compacted and eroded through the center and is no longer functional. Runoff currently bypasses the rolling dip and flows along the north edge of Billy Mack Road for approximately 100 feet until reaching the next rolling dip, which effectively diverts the flow to the south off of the roadway. Moderate gullying has developed along this stretch of road as a result of the rolling dip failure.

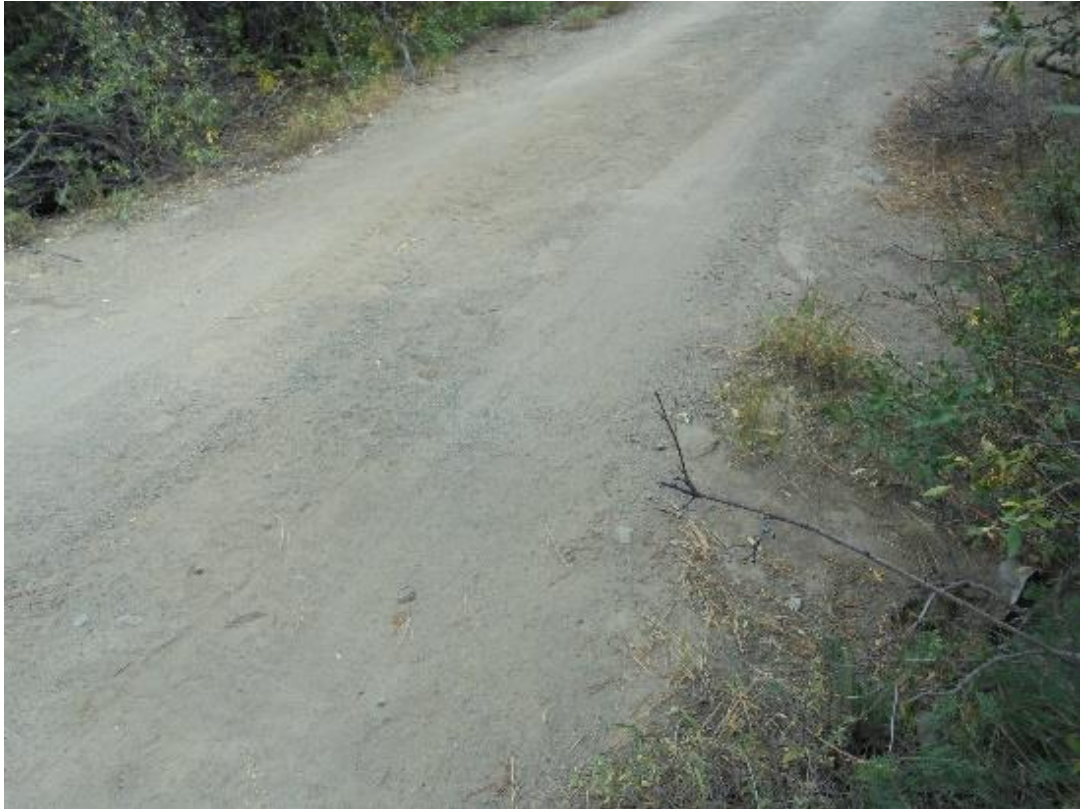
#3	16-20	Quarry	Abandoned quarry, approximately 1.1 acres, 16" culvert at basin outlet.	#34	N/A	Quarry: some signs of sediment leaving area; Regrade and fully restore.	Low	Replace culvert with rock-lined spillway.	\$

Photo 18. #3 – Quarry culvert outlet from basin (looking south).

2. The 2010 assessment recommended that the abandoned Quarry (Site #3) be regraded and fully restored. It is the opinion of the Wildscape team that the regrading and restoring of the quarry site is not necessary, as the quarry is currently functioning as a detention basin and isn't posing a direct threat to water quality. Given its remoteness and minimal impact to water quality, we recommend the site largely be left "as is", with the exception of replacing the clogged culvert with a rocked spillway and possibly enhancing the road/berm feature to protect the road from erosion during large precipitation events and extend the longevity of the "detention feature".

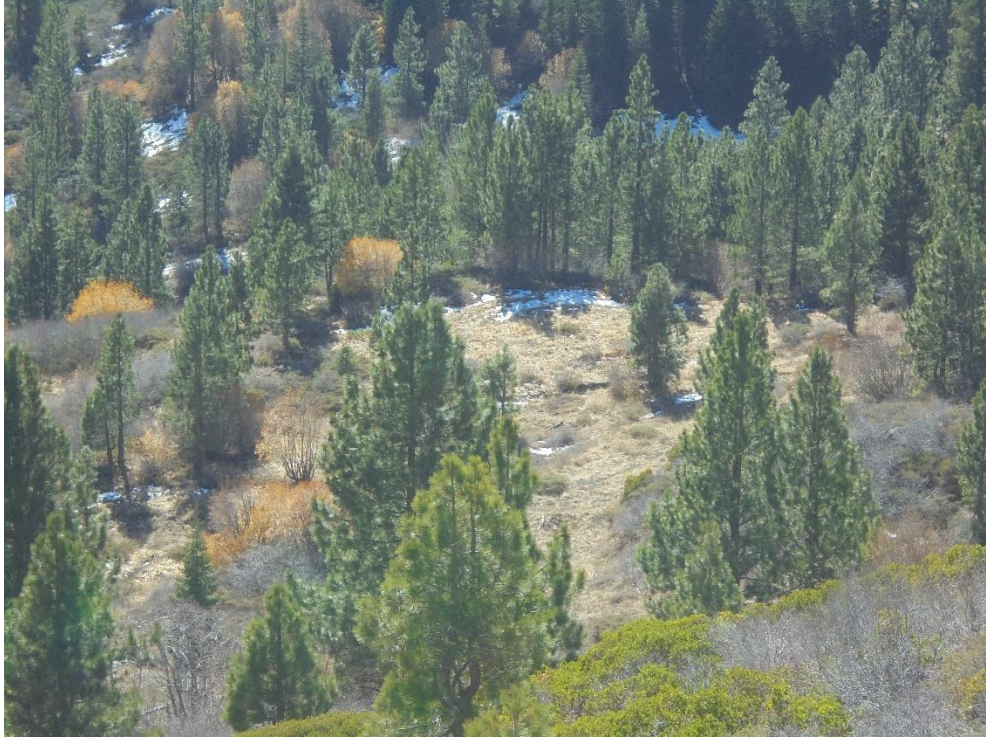
Photo 31. #7 – Project Area C West Logging Landing, alters drainage patterns and has caused significant erosion (looking southwest from above).

3. The 2010 assessment called for water bars or rolling dips along several of the spur roads in Project Area C (Site #7) and only recommended decommissioning one of the steep spur roads. Because the spur roads don't appear to serve any purpose (i.e. fire protection or powerline access) and can only be accessed from a gated road which passes through private property, we recommend that all of the spur roads be decommissioned, regraded as necessary to restore historic drainage patterns, and revegetated as necessary to stabilize bare soils.

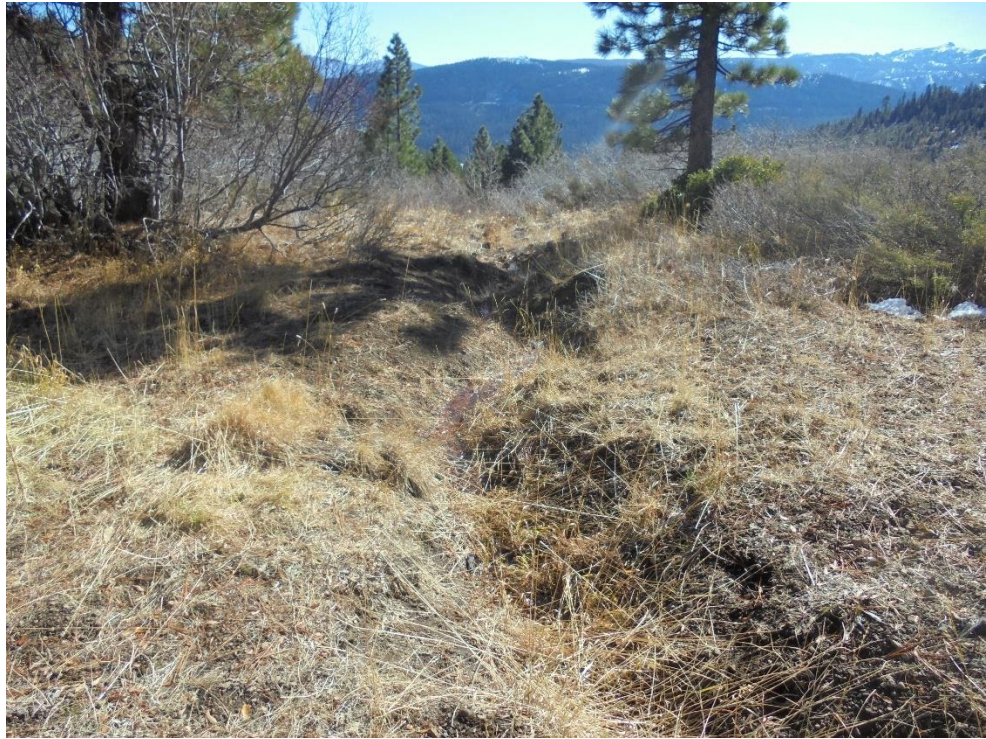
Photo 32. #7 – Project Area C incised drainage channel along east side of West Logging Landing (looking south).

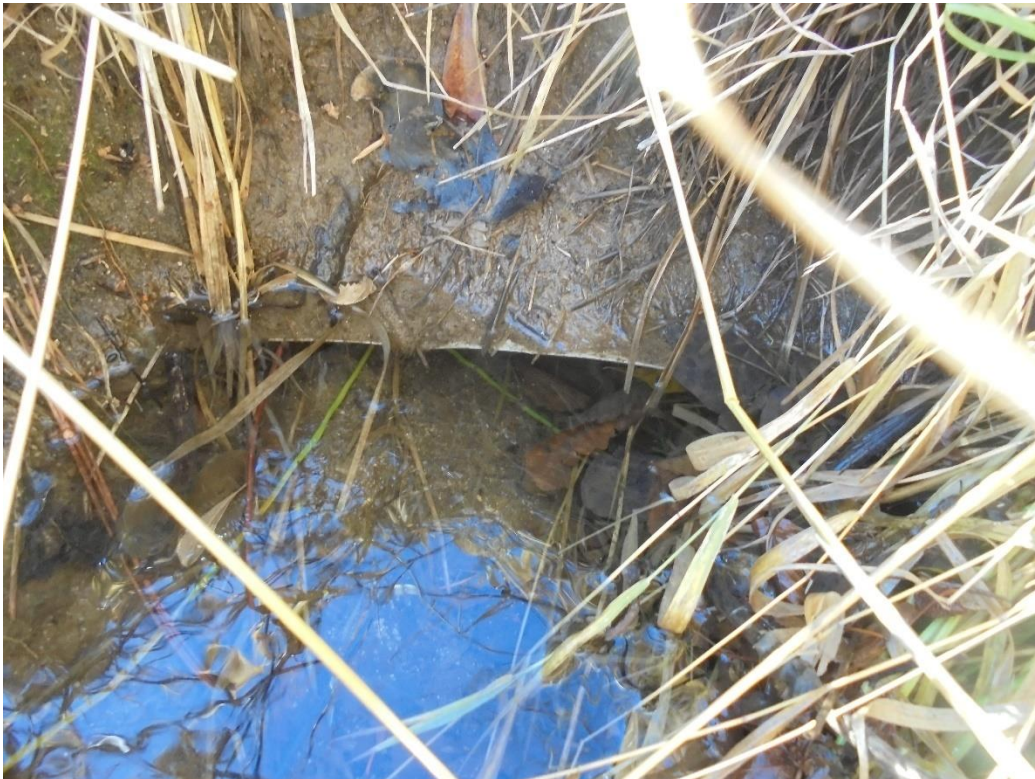
#8	34-36	Crossing #3	Intermittent stream crossing with one culvert, approximately 18" diameter and 80% full of sediment; minimal erosion.	#32	N/A	Culvert mostly blocked; Replace culvert and add rolling dip.	Low	Monitor and consider flushing or replacing culvert if overtopping occurs.	\$

Photo 36. #8 – Crossing #3 culvert outlet approximately 80% full of sediment.

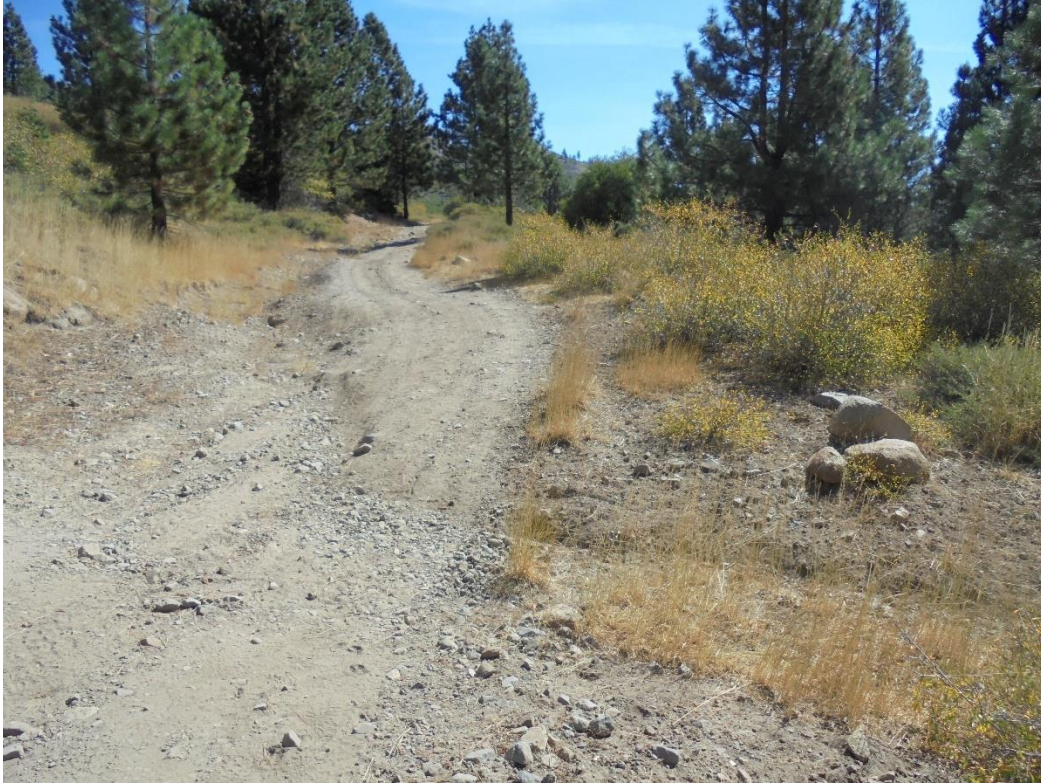
#11a	45	USFS Road East Fork	Approximately 0.15 miles, three failed waterbars, large drainage area.	#21-22	#60-61	Road capturing drainage and actively eroding; install waterbars or rolling dips.	High	Reconstruct existing waterbars, construct new waterbars up-gradient, install rock-lined outlets.	\$

Photo 45. #11a – USFS Rd East Fork (looking east)

The portion of the east fork of the USFS Road that is within the study area is approximately 0.15 miles in length, spanning from the fork to the approximate divide between the Gregory Creek east and west sub-watersheds. This east-west stretch of roadway is moderately sloped at approximately 10% throughout the stretch (drops from elevation 6,835 feet at the east study area boundary to 6,755 feet at the roadway fork over approximately 800 feet) and captures runoff from the hillside to the north. The runoff currently runs the length of the road and discharges to the previously described degraded intermittent stream reach via the diversion channel at the fork.

Three waterbars exist along the stretch (Figure 6 of Appendix A), spaced at approximately 75 feet apart, with the first located approximately 500 feet from the eastern boundary of the Gregory Creek west fork sub-watershed and the last approximately 150 feet from the roadway fork. Minor erosion is evident along the slope south of the road at the outfall of the waterbars, although it is clear that runoff no longer discharges via the waterbar outfalls as intended, due to the failure of the waterbars along the northern edge of the road. The lack of waterbars to divert roadway runoff along the first 500 feet is the likely cause of failure of the existing waterbars (first waterbar overloaded, leading to failure followed by subsequent failure of downstream waterbars). The failed waterbars have resulted in severe gulying along the north edge of the road (Photo 45), substantial sediment transport and added drainage area and runoff entering the degraded reach, which in turn has contributed to the observed downstream erosion.

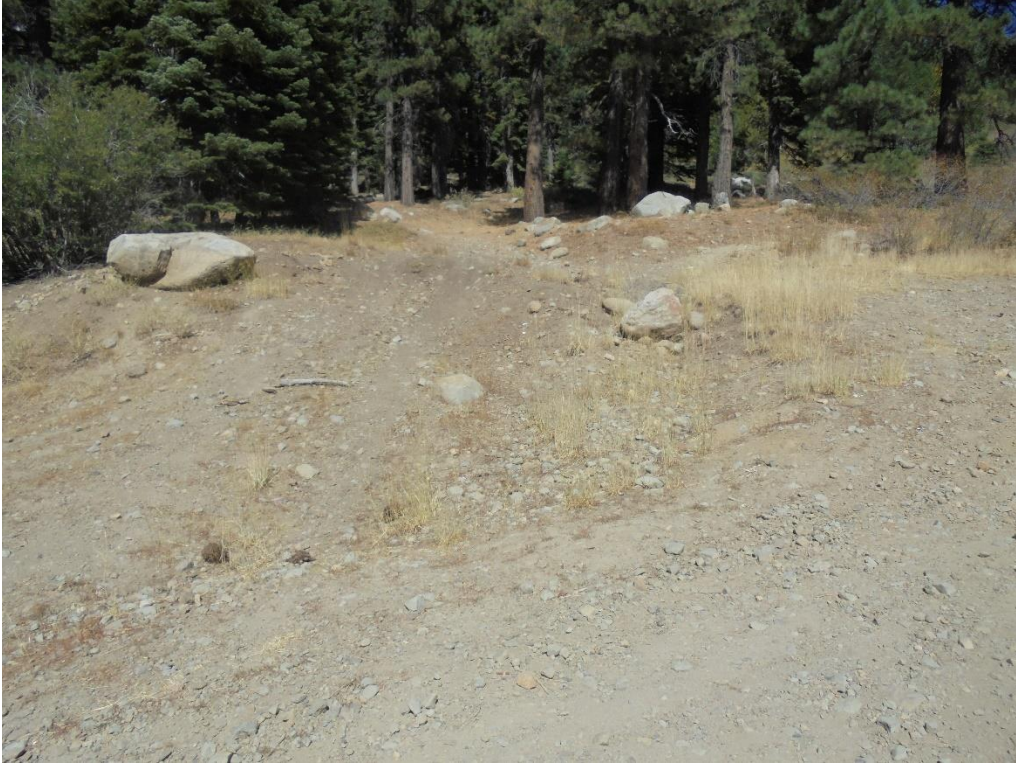
Photo 51. #11c – Logging Landing #2 East Access Road (looking northwest from Billy Mack Road fork).

The east access road to the logging landing appears to be the primary access road. The above described ephemeral drainage runs along the east side of the road and has caused minor gulying. Runoff from the channel joins runoff from the east fork of the road (described above), crosses the road in the west direction, and discharges to the above described degraded intermittent stream reach via the existing diversion channel.

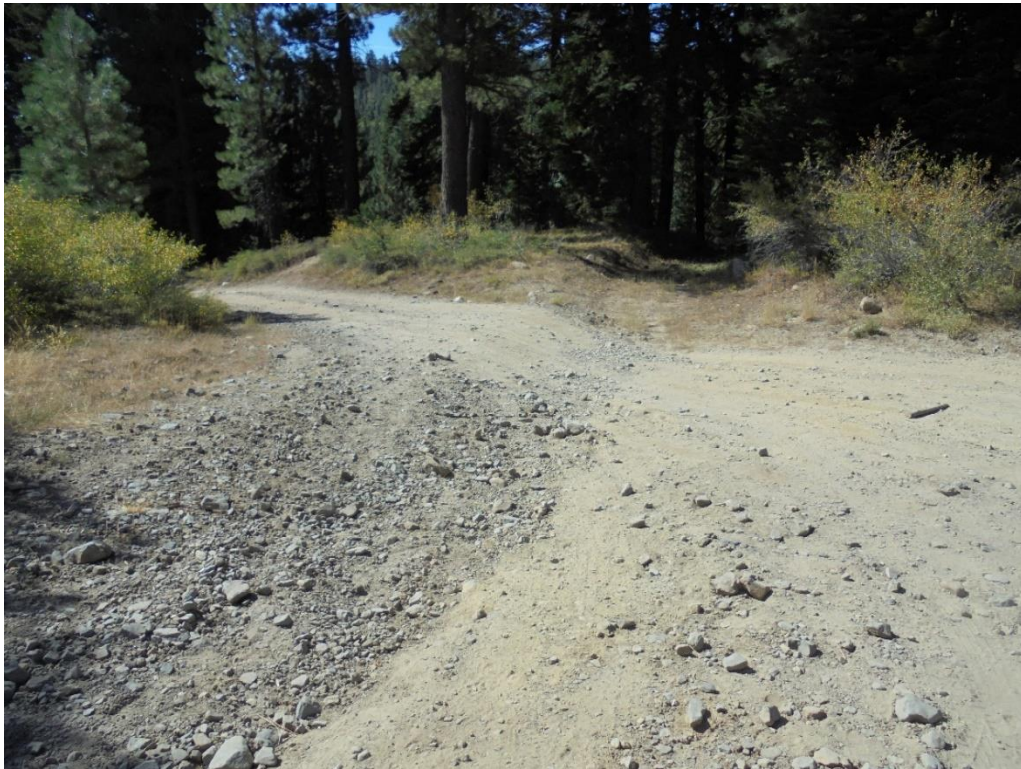
Photo 56. #11f – Billy Mack Road Fork Rolling Dip and Diversion Channel (looking southwest from USFS Road 0676-088 fork).

A rolling dip exists on Billy Mack Road just before the road forks. The rolling dip is in moderate condition (slightly compressed) and appears functional in diverting runoff from the roadway to the adjacent diversion channel, which discharges into the above described degraded intermittent stream reach. The diversion channel is wide and shallow and is unlined with thin vegetation growth. Erosion along the southern bank of the channel is evident, but minimal.

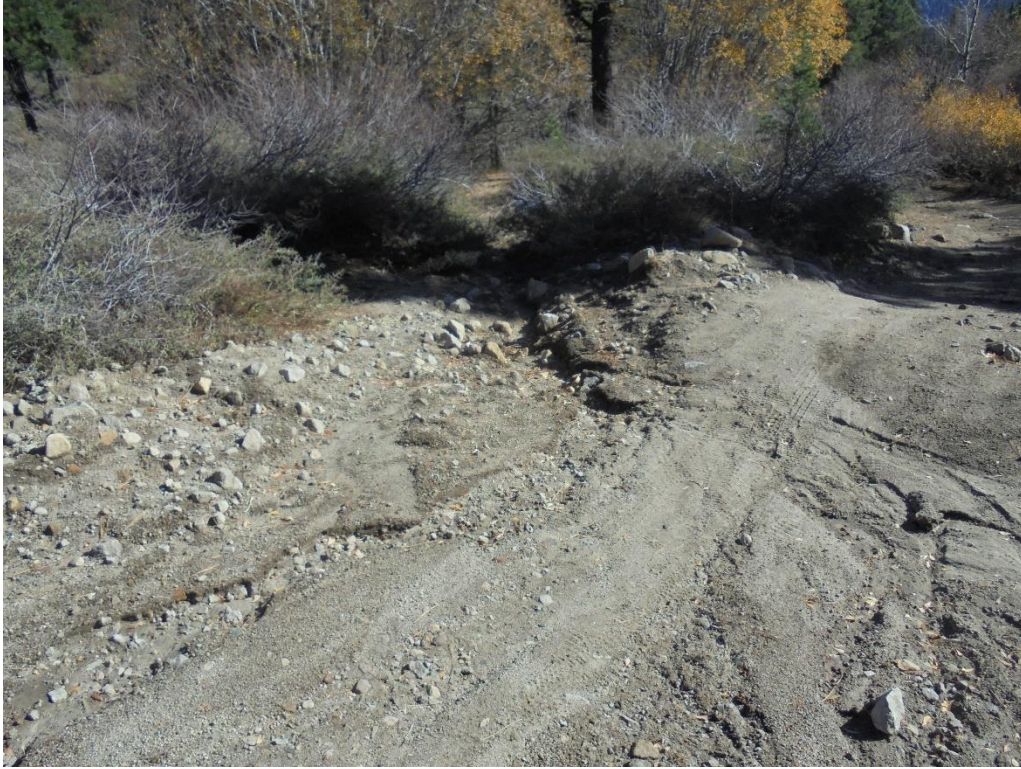
#12	57-69	Billy Mack Road	Approximately 1.5 miles of steep roadways in vicinity of the west for of Gregory Creek, consisting of numerous rolling dips with varying spacing.	#37-38	#75	Roadway capturing water, waterbars not sufficient; Create new waterbars/modify existing.	High	Improve existing rolling dips and install rock outlet protection; construct new rolling dips where spacing is inadequate to prevent roadway erosion.	\$\$

Photo 69. Example of erosive rilling and gullying from inadequate waterbar spacing on Billy Mack Road (taken in November 2016 after large October 2016 storms).

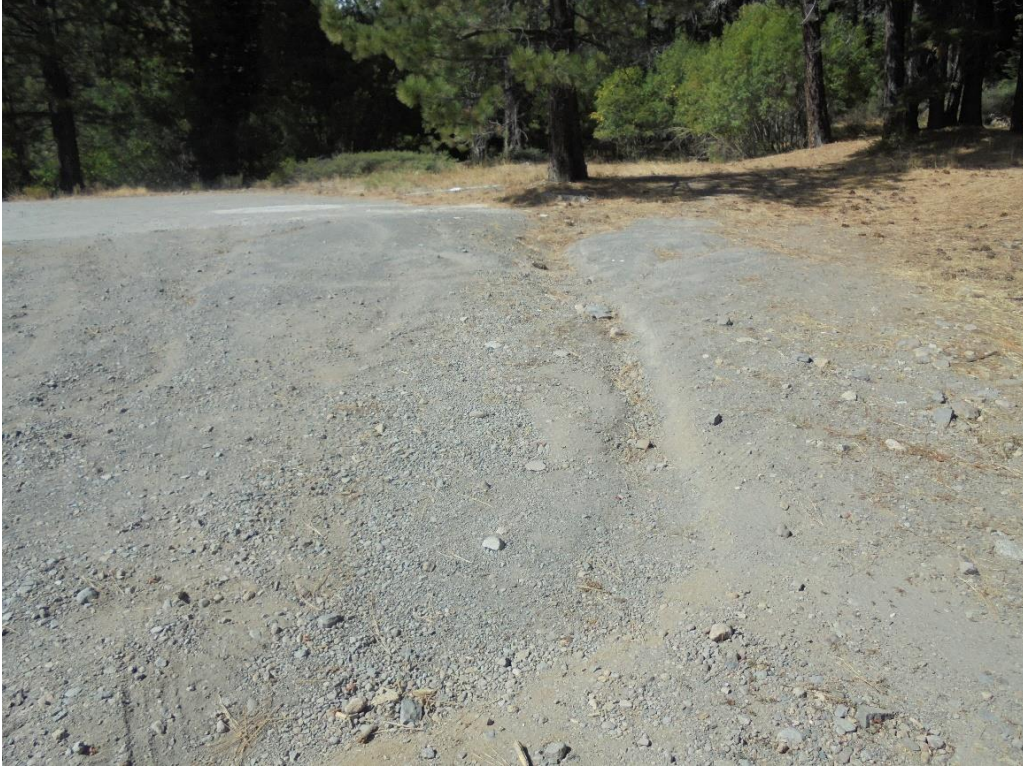
Photo 81. Eroded flowline from northeast corner of #15c – Concrete Pad (looking northwest).
