# Negro Canyon Watershed Assessment

Beth Christman  
*Truckee River Watershed Council*

May 28, 2010

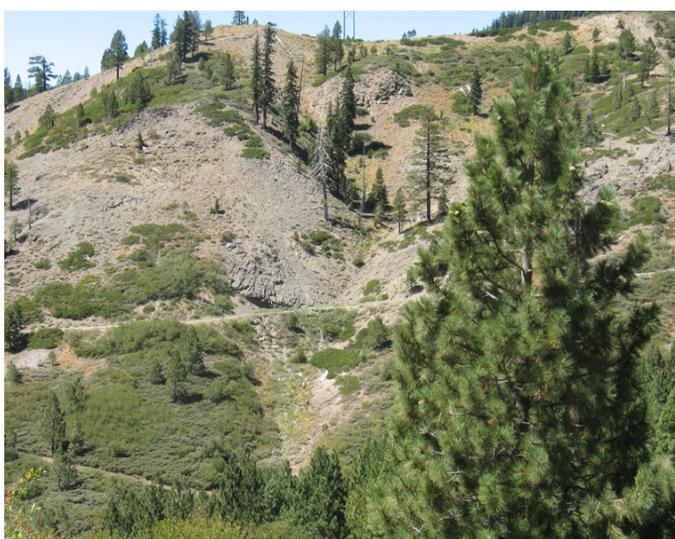
**Figure 3-6. Western Slope of Gregory Creek**

Culverts were often undersized, resulting either in erosion or aggradation and abandonment of the culvert.

Timber harvest road crossings of ephemeral channels were usually constructed of fill and have caused major problems with channels. In most cases, the fill has eroded and the resulting sediment has passed downstream, impacting habitat, causing channel instability, and possibly even causing problems with channel stability on the alluvial fan near the mouth of the creek on Donner Lake. In some areas, particularly in the small, ephemeral channels draining the eastern slope of the watershed, channel fill at road crossings diverted flow down the road. Where flow finally left the road surface, a new channel was created downslope of the road, with resulting erosion and sediment production (Figure 3-6)

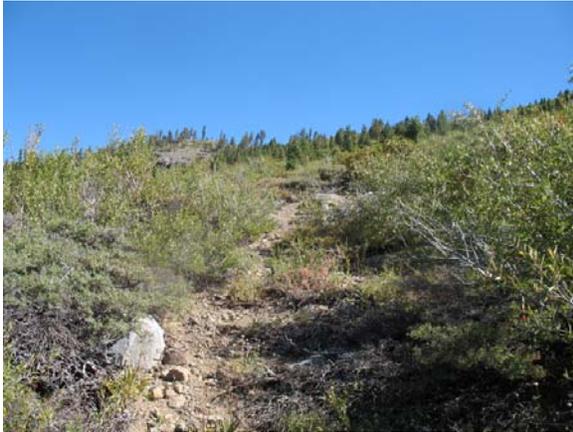
**Figure 3-7. Historic skid trail showing signs of recent erosion.**

On steeper slopes, even relatively lightly disturbed areas such as low-traffic skid trails have continued to concentrate water and erode. This is especially prevalent on the east side of the watershed, where revegetation is less rapid due to somewhat drier conditions and poorer soils, yet some minor skid trails on the west side of the watershed are also actively eroding.

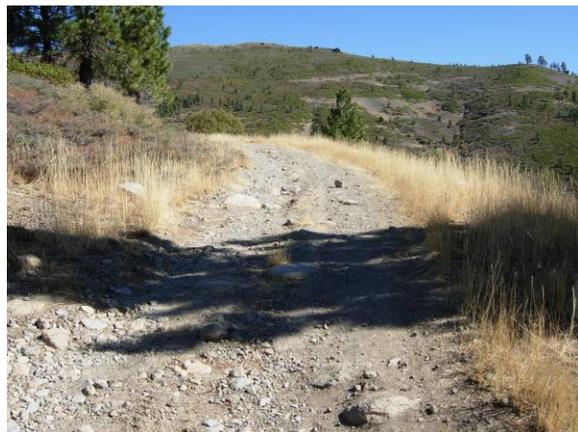
Examples of these hydrologic impacts are abundant throughout the watershed today. Road cuts in the northeastern corner of the watershed were constructed on wetter slopes with spring influence, reintroducing shallow groundwater to road surfaces. Compacted soils on log landings and other heavily used areas have very low infiltration rates and are sources of surface runoff. Skid trails, even those with established shrubs and trees, still concentrate flows due to persistent soil compaction (Figure 3-7). Much of the road network captures and concentrates surface flow (Figure 3-8).

**Figure 3-8. Road capture of surface flow.**

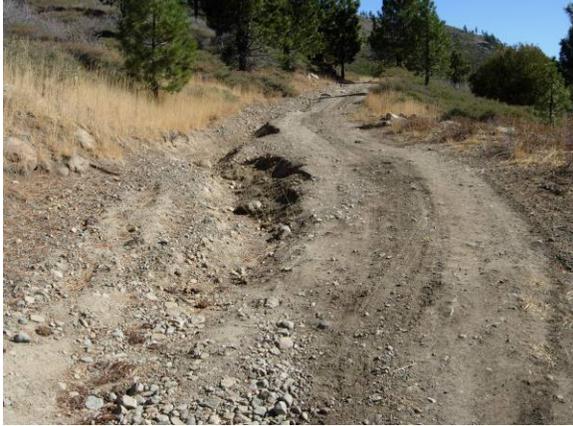
**Photo 60. Looking up north road at gully created by road capture of water.**

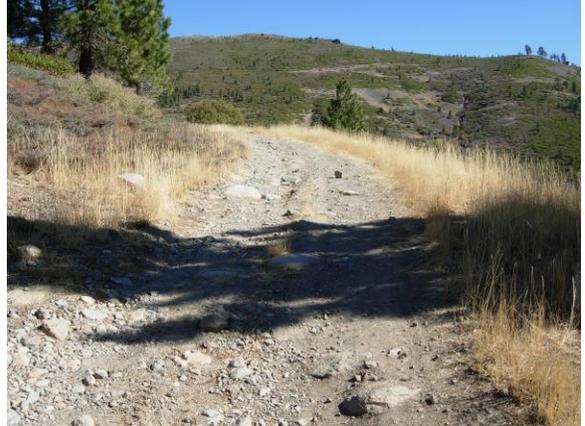
**Photo 61. Looking up north road above photo 60 showing beginning of water capture.**

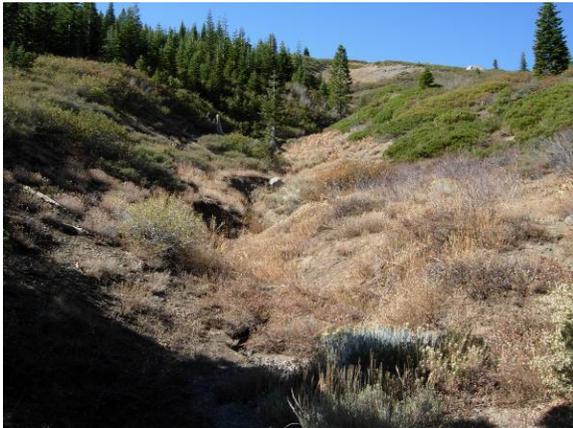
**Photo 65. Looking up slope to photo 67. There is no culvert or stable crossing where this drainage intersects the road.**

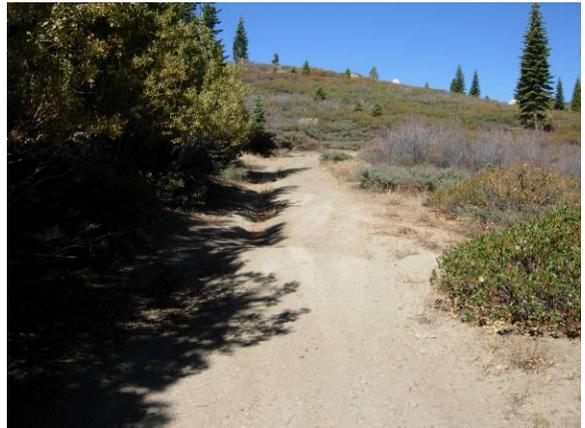
**Photo 66. Roadway capture of drainage. Note that water bar directs water off road into an area that has not historically functioned as a drainage.**

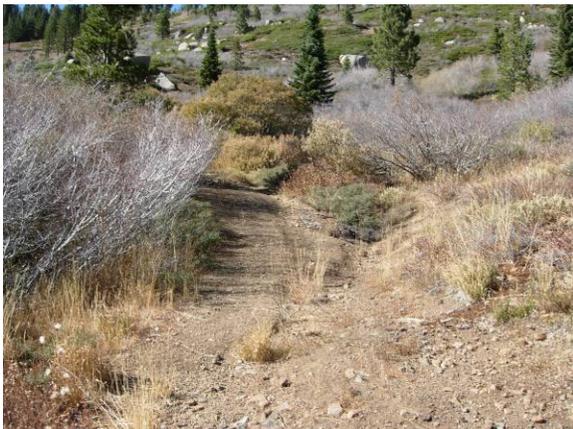
**Photo 72. Gully on road formed by captured drainage.**

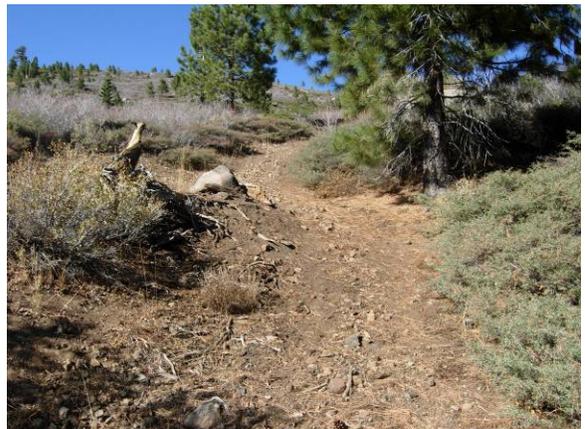
**Photo 73. Old logging road exhibiting signs of erosion.**

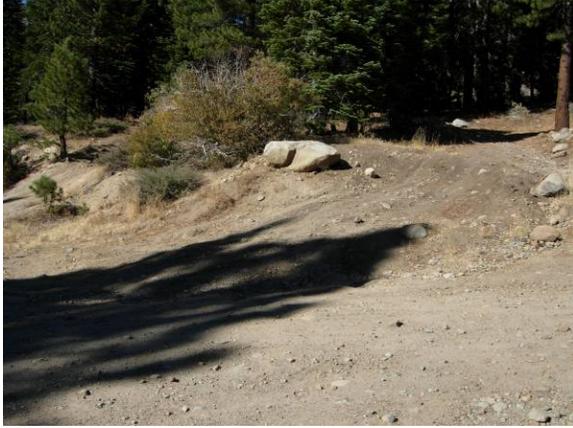
**Photo 74. Short spur trail used by OHV riders with soil berm turned jump. This trail is a large source of erosion.**

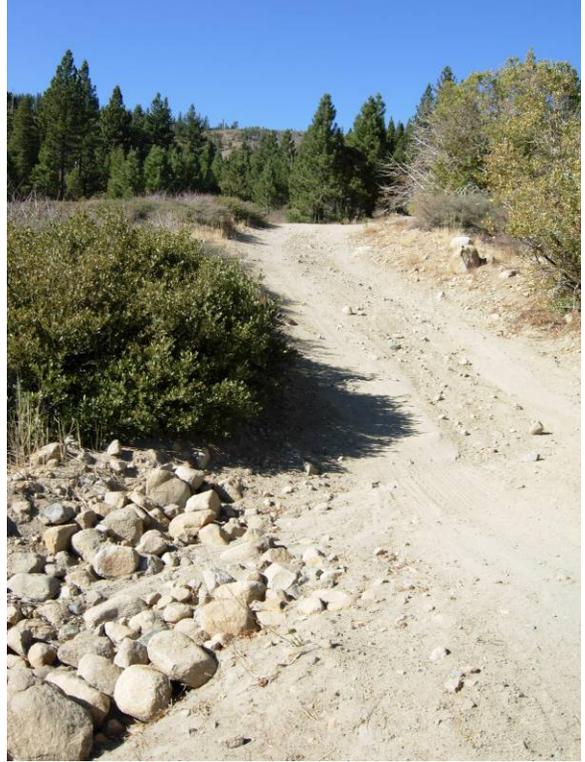
**Photo 75. Main easement road. Note sediment deposited at water bar outlet in foreground.**
