# Boca Watershed Assessment

**USDA Forest Service  
Tahoe National Forest  
Truckee Ranger District  
2020**

**Prepared by**  
Sharon Falvey, Lindsay Ryan, and Rachel Hutchinson

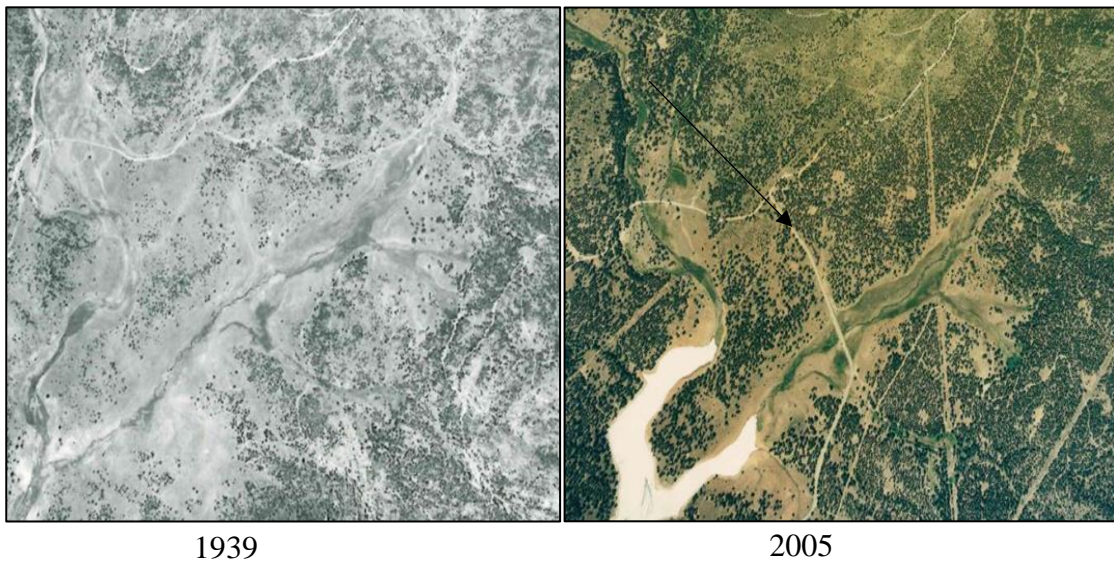
**Figure 4: Hoke Valley. Since 1939, many developments have occurred in Hoke Valley. Notice the addition of County Road 270 (arrow), powerlines, a petroleum pipeline, and a fiber optics cable, all of which cross the meadow.**

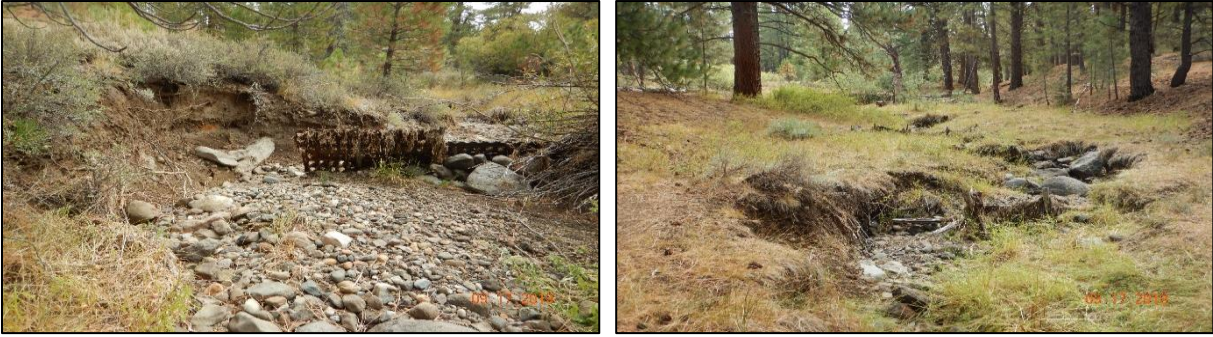
**Figure 6. Failing Marston Mat grade control structures in Canyon 4.**

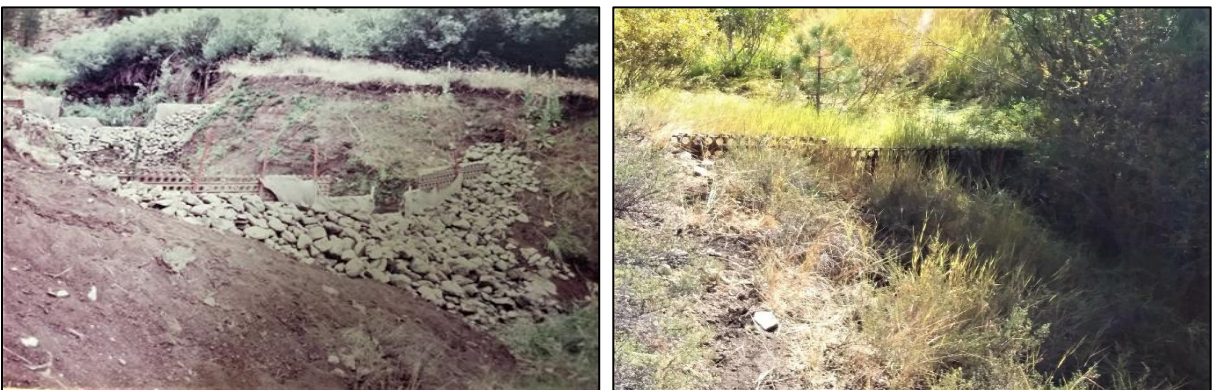
In the modern era, there have been numerous attempts to restore parts of the Boca watershed. In the 1970s and 1980s, Gabion baskets were constructed in several drainages, including Hoke Valley and Canyon 3, in order to stabilize banks and in some cases to induce channel aggradation. During this time, several types of grade control structures were installed in other drainages. These structures were made from metal ‘Marston Mats,’ wooden logs, and stacked rocks (Figures 5 and 6). In some places, these structures performed well and improved stream function for at least 5-10 years after they were installed. However, most structures, especially those outside of wetlands, are now failing. Streams are now cutting around some of the structures and contributing to sediment transport.

**Figure 5. Canyon 4 in 1978 when metal grade control structures were installed (left) and one of those structures in 2019 (right).**

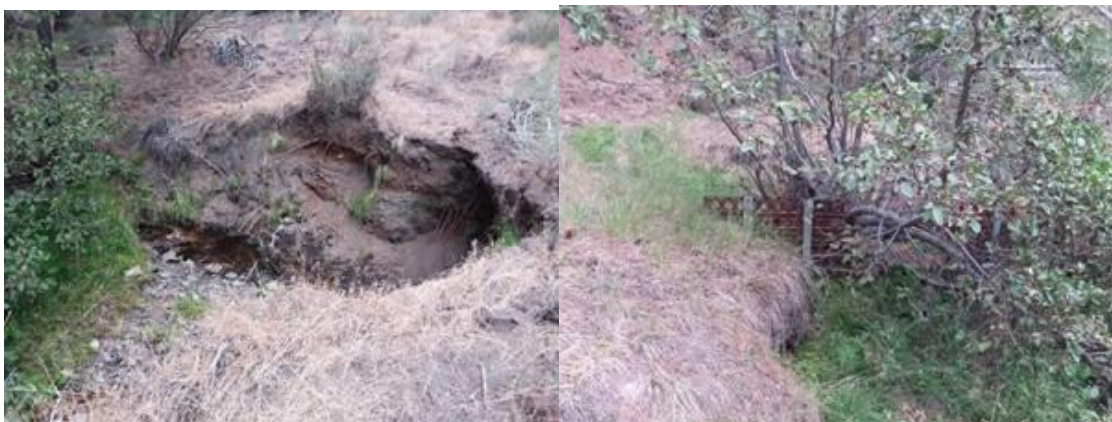
To improve stream conditions, stream stabilizing practices included use of old structures made of repurposed metal ‘Marston Mats’ (Figure 9). The structures were largely successful in aggrading sediments above the structure, but the utility of the design is now outlived and most of these structures have failed (Figure 9). Failure is occurring with the stream cutting around one side of the structure resulting in the stream head cutting up the channel undoing the previous benefit of the structure. The headcuts range from 1 to 3 feet deep and the channel incision varies from 1 to at most about 5 to 6 feet deep. Polygon LTR-A and LTR-B covers restoration considerations for this tributary, the upstream railroad, and the weirs at the bottom end of the drainage (Figure 11).

**Figure 9. Erosion from the stream cutting around the grade control structures shown above.**

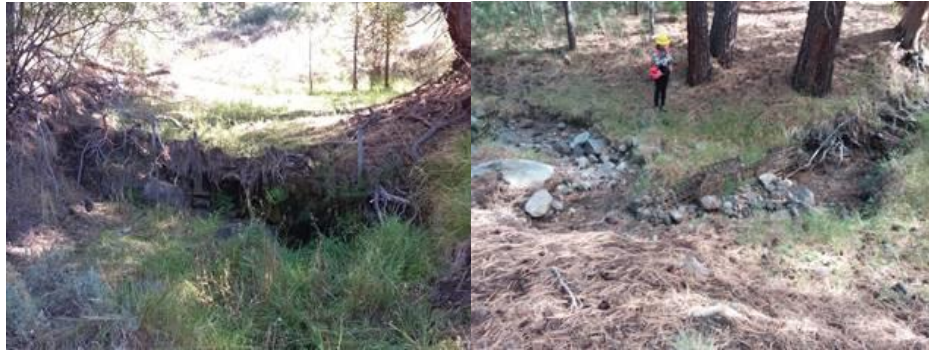
control structures were identified in this drainage, most constructed from Marston Mats but also log and stacked rock structures, many of which are no longer stable or show signs of degradation (Figure 10). The structures extend up the creek about ¾ mile to a sedge willow wetland at the confluence of a tributary. These structures were installed and maintained in the 1970s and 1980s. This area is part of the proposed restoration polygon LTR-B and LTR-A (Figure 11).

Throughout this lower reach, the channel is incised from 2 to about 6 feet. Above the sedge/willow wetland, the stream discharges through a narrow canyon and is incised up to about 9 feet in depth. There are old roads and railroad grades constricting the valley bottom along the stream, leading to the deep incised channel. Due to channel capture on some legacy routes, multiple parallel gullies have developed within a segment of the valley bottom.

**Figure 10. Erosion of grade control structures.**

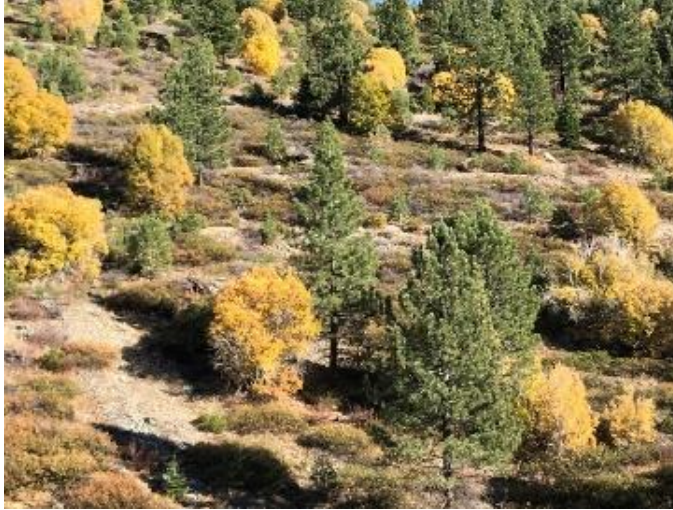
The Merrill Creek and Lower Davies Creek potential restoration areas are shown in Figure 11. The primary characteristics influencing this subwatershed include terracing shown in the upper portion of the assessment area (Figure 14). Some evidence of past terracing failure can be seen on the LiDAR DEM and may have contributed to the braided fan (shown just above the north arm of the stampede reservoir). Restorative actions in HV-J could result in increased fan function (Figure 11). This fan was disrupted in the past from railroad grade and roads developed across the drainage. It is possible the function was further affected from the terrace failure.

**Figure 13. Nonlinear, nonvegetated features and exposed subsoils from terraced area on south facing slope along Merrill Creek.**

This area could benefit from additional planning and more analysis to determine where actions should occur and would be most beneficial. Alluvial fan/road interaction improvements could help to reconnect the hydrology in this area. In addition, terracing restoration may result in some ecosystem services for wildlife and redistribution of the hydrologic system across resources.
