Excerpt from Tributaries Assessment - Pole Creek

Area/Critical Site 1

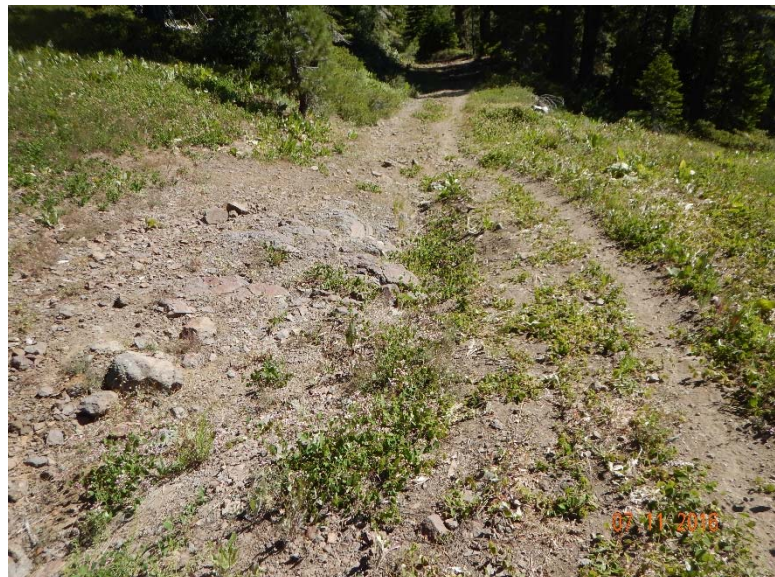
1.2: Leadout for road surface runoff from 1.1. Runoff is high enough that it has incised the outlet and fillslope, forming a flow path (1.3).

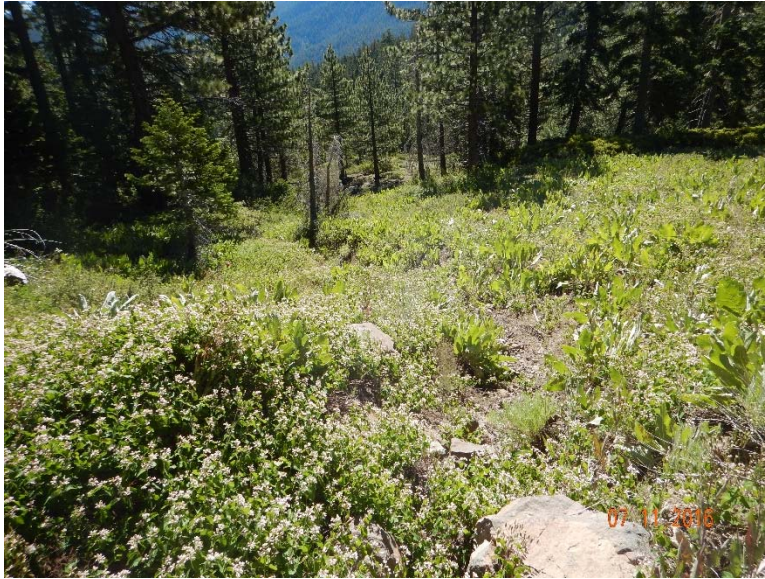
1.3: A flow path in a meadow from accumulated runoff from the Pole Creek East road. This flow path has incised enough to expose bedrock at 1.4. This flow path ultimately feeds the headwaters of the incised channel downstream.

1.4: Bedrock is exposed at this point due to scouring from flow path 1.3.

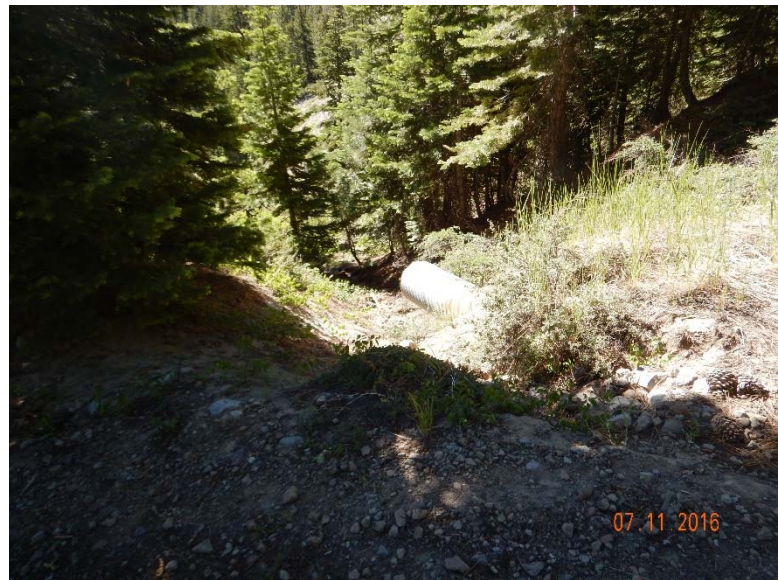
1.7: Flow path of an ephemeral channel with surface runoff from Pole Creek East road. This channel flows into the main incised channel downstream.

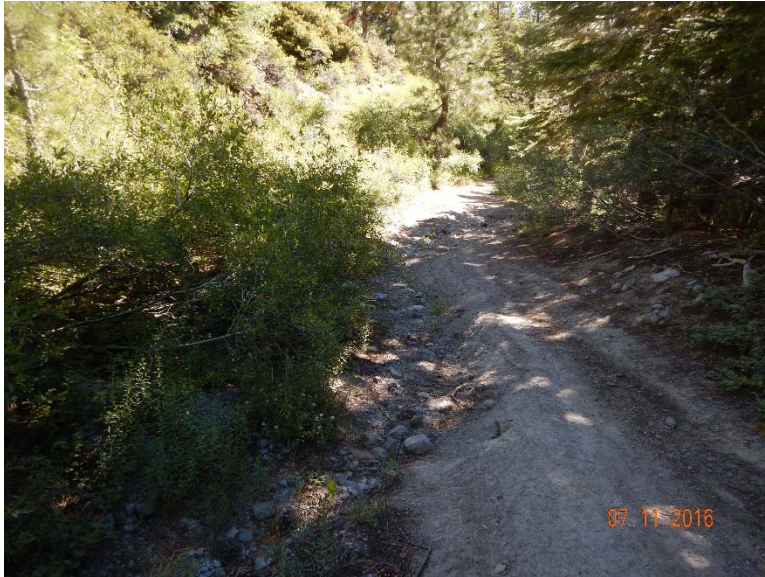
1.10: Segment of Pole Creek East road where an ephemeral channel flows onto. The channel leaves the road at leadout 1.11.

1.11: Leadout where surface runoff from Pole Creek East road and an ephemeral channel leave the road.

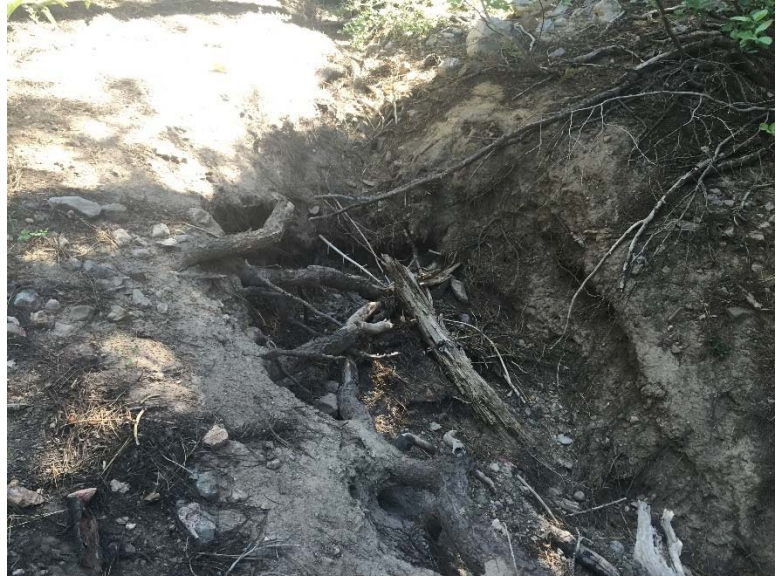
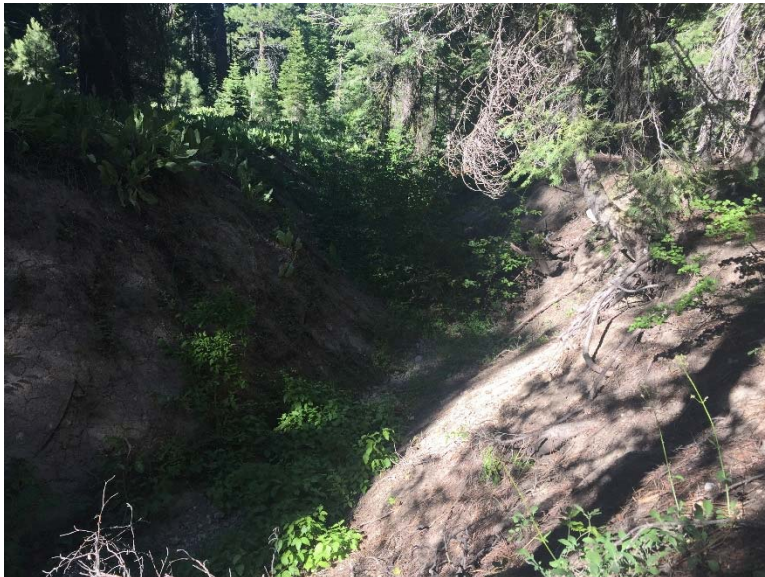
1.21: The current channel downstream of crossing 1.15. This channel is highly incised with average depths of 6 ft. The slope banks are bare and allow for mass movement into the channel. This channel is unnatural and may have formed due to the installation of the Pole Creek East Spur road crossing and the spur roads to the north and south.

Similarly at the downstream end of the site, waterbars/dips should be installed on the road north of the crossing with the main incised channel to mitigate road surface discharge into the channel. This crossing should be reinstalled to allow the flow path to follow its original natural channel, 1.16. Afterwards, the incised channel should be buried. Multiple headcuts were identified on the original channel and an adjacent tributary to the south. They should be repaired to prevent further erosion.

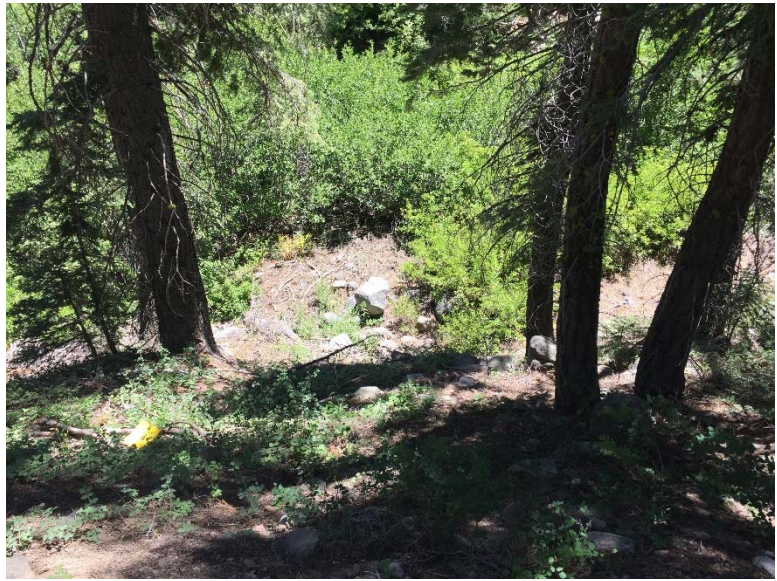
2.7-2.10: Leadout catching excessive amounts of runoff from road. Incision at the outlet and fillslope occurs. Fillslope is failing.

The entire length of road should be obliterated and recontoured to a natural slope gradient. The road is no longer used or maintained. Returning the entire length of road will effectively remove all erosional features from this area and return natural sheet flow over the hillslope.

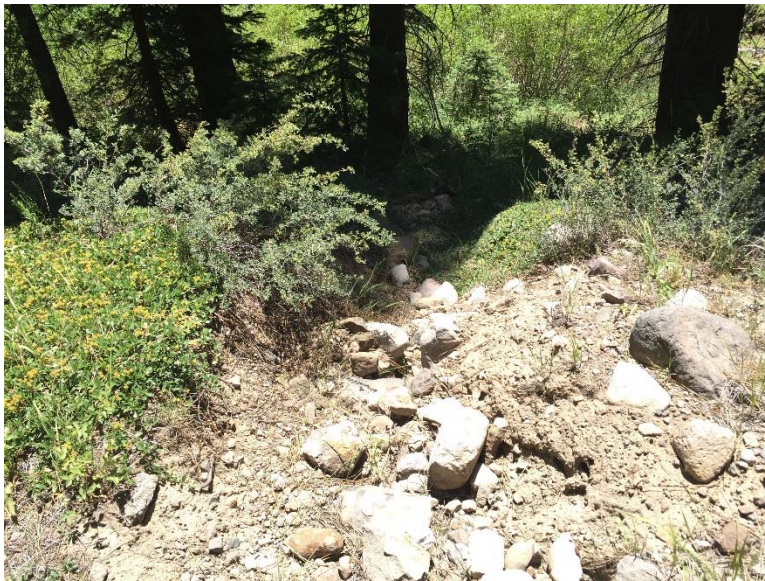
Example of leadout and fillslope incision.

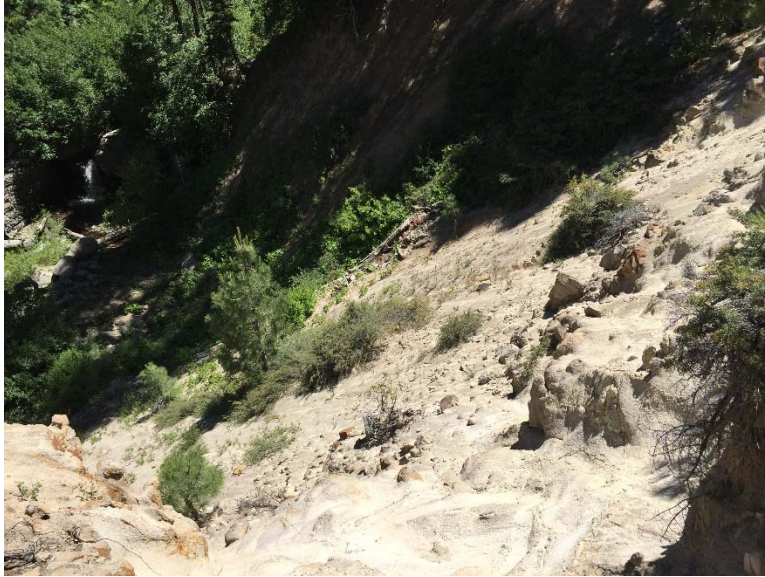
2.11: Segment of road built on toe of a landslide. A washout event may have allowed mass failure of the fillslope. Mass amounts of fillslope is no longer present and has left the remaining fillslope with low vegetation and bare soils.

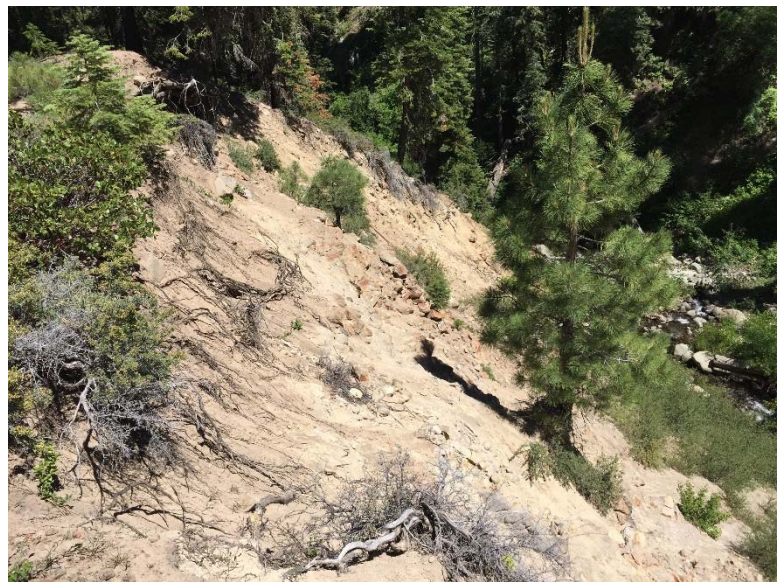
2.12: Exposed cutslope allowing for mass movement of sediment.

2.13: Failing cutslope. Mass movement is collecting on road.

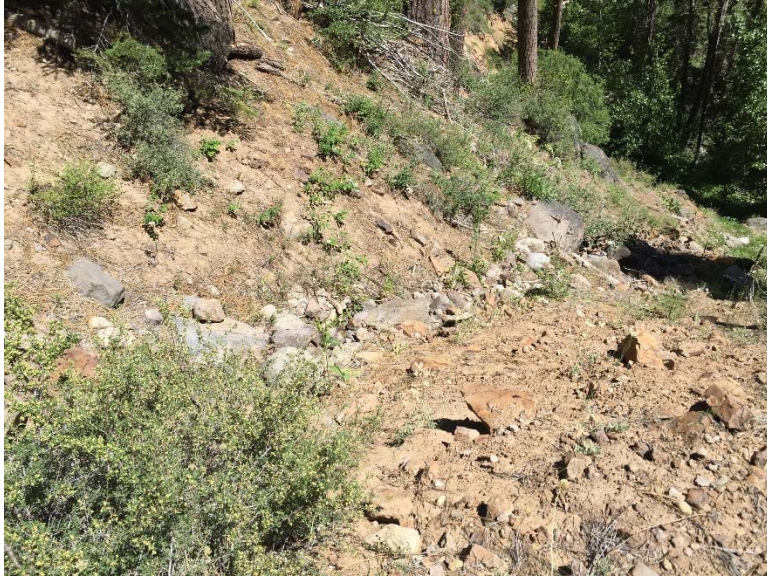
2.14: Stream crossing. Stream is incising fillslope.

2.15: Gully is forming in inside ditch.

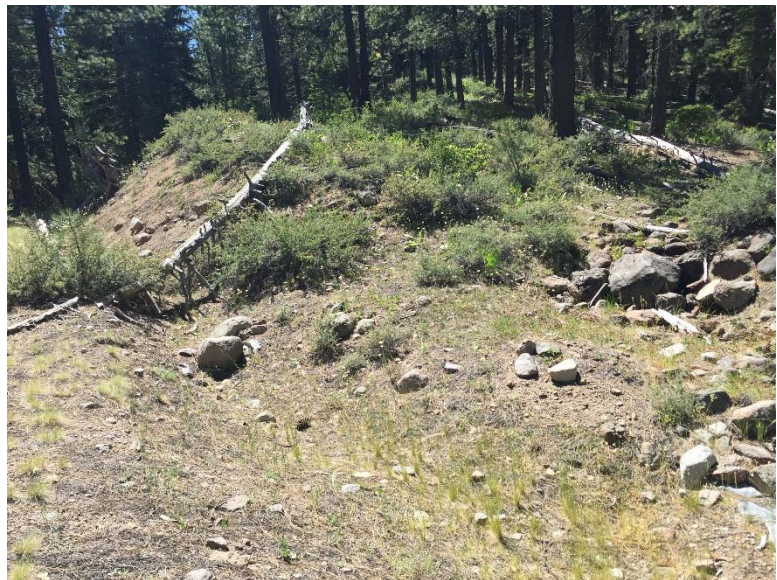
2.18: On private property. Leadout is catching excessive amounts of runoff from the upslope portion of road. Incision at the outlet of the leadout and fillslope occurs.

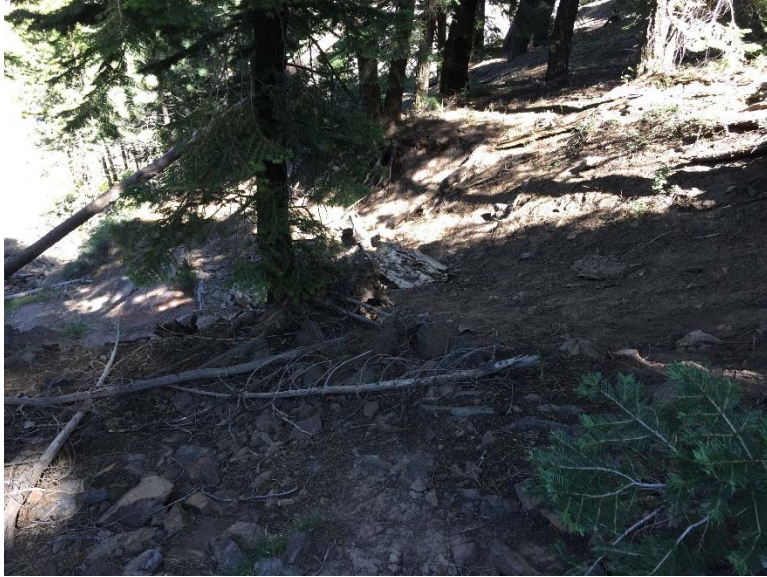
2.19: On private property. Fillslope is failing and exposing bare soils.

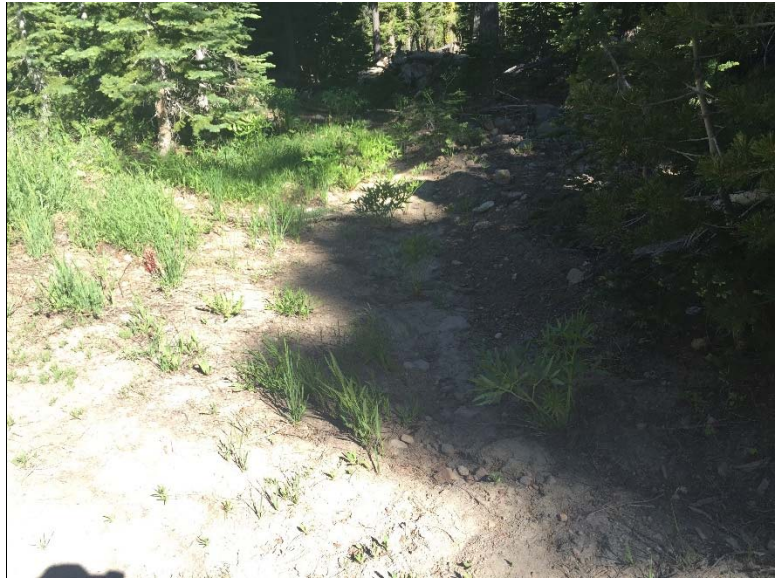
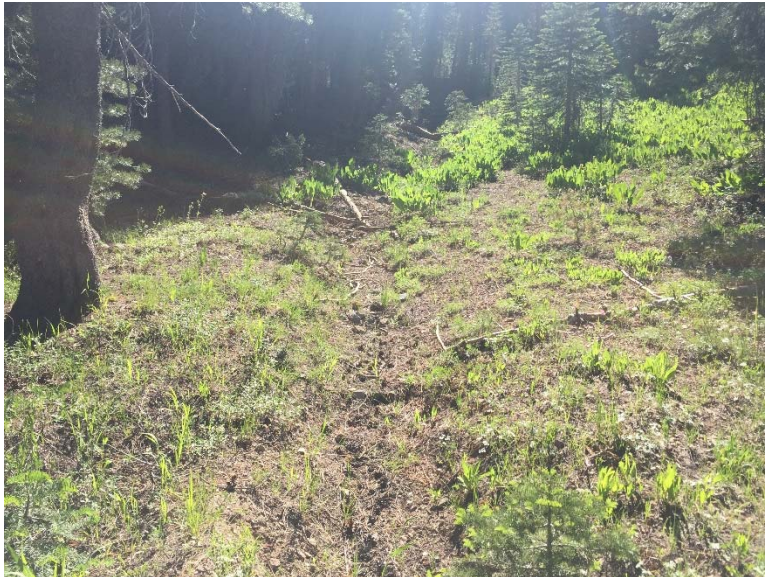
3.4: Unnatural drainage created by the excess runoff from Pole Creek road. This drainage bisects the spur road in the meadow.

Managing surface runoff properly on segments of Pole Creek road upland of the site would help mitigate runoff issues into the meadow. Problematic road segments should have additional waterbars/dips installed and existing ones maintained to prevent the further inset of unnatural flow paths. Any segments directly upland of the meadow should be reshaped to an outsloped design, returning overland sheet flow to the meadow. The skid trail that comes off Pole Creek road to the north should be obliterated to prevent surface runoff to accumulate on the road. The culvert crossing 3.8 will need to be reinstalled and reoriented to direct the channel south instead of southeast from the outlet, following its more natural flow path. The Pole Creek spur road running north and south in the meadow should be obliterated to prevent road surface runoff to accumulate and discharge into unnatural flow paths. The unnatural flow paths in the meadow currently should be recontoured to allow dispersed sheet flow in the meadow. The fill material used for the spur road crossing will need to be removed so the natural V-shape seen upstream can return and prevent further fill material to be eroded into the stream.

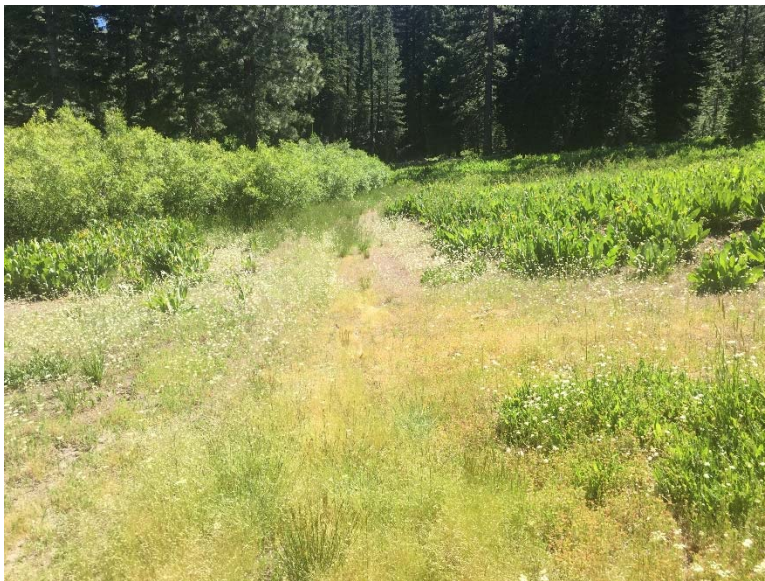
3.14: Segment of spur road in meadow that accumulates some runoff from Pole Creek road.

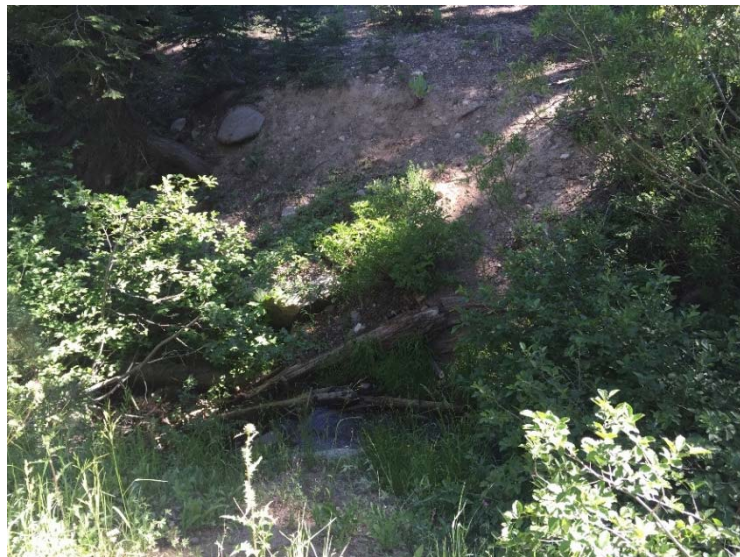
3.18: Fill placed in channel to provide for road crossing at west end of the Pole Creek Spur road. 3.18 is found further west on Pole Creek road from the rest of the features.

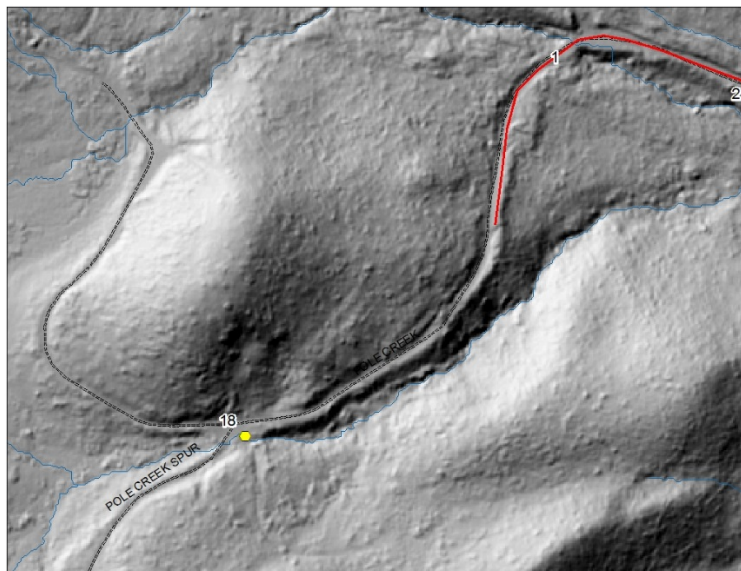
Further west on Pole Creek road, the road again crosses the same channel incising the fill of feature 3.17. A similar problem exists where fill was placed into the channel to allow for a road crossing. Currently, the fill appears to be stable due to the large amount of established vegetation here. There are currently no proposed action for this feature as remediation might be more detrimental than leaving it in its current condition. Further monitoring will continue to ensure its stability and/or determine a proposed action when it is deemed beneficial.
