Euer Valley Meadow

Baseline Stream Condition Inventory Summer 2020

Report prepared by: Sabra Purdy, Trout Unlimited
On Behalf of the Truckee River Watershed Council
May 15, 2021

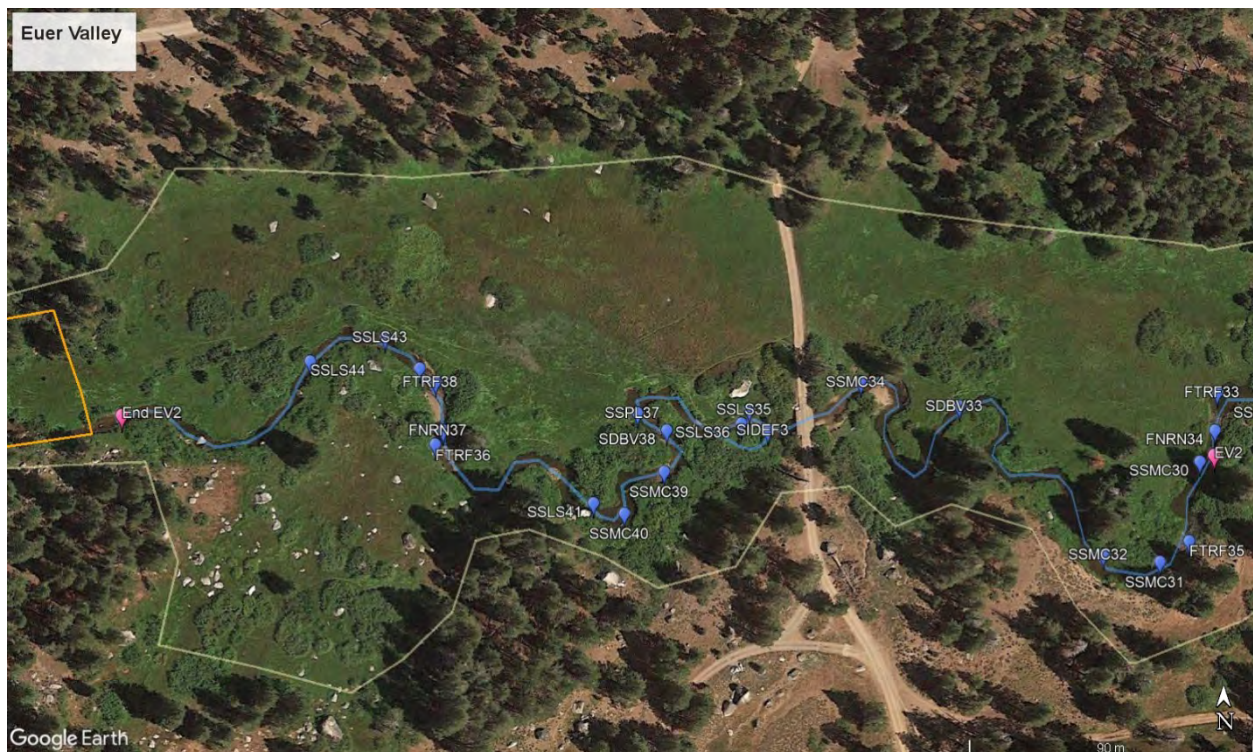
Figure 3. Reach EV2. Note the glacial boulder deposits and remnant channels on the historic floodplain. Current beaver activity was observed in this reach with 2 channel-spanning dams being maintained on the mainstem as well as smaller dams on side channel SIDEF3 just upstream of the bridge crossing. This section of the meadow is constricted by old glacial deposits.

The bridge crossing in EV2 shows some immediate erosion on the downstream side, which commonly indicates an undersized span as well as some channel widening just downstream where horses commonly cross the creek. Heavy recreational use by horses and mountain bikes can impact the stream channel at crossing points creating an unvegetated section of bare soil that may encourage channel widening and erosion.

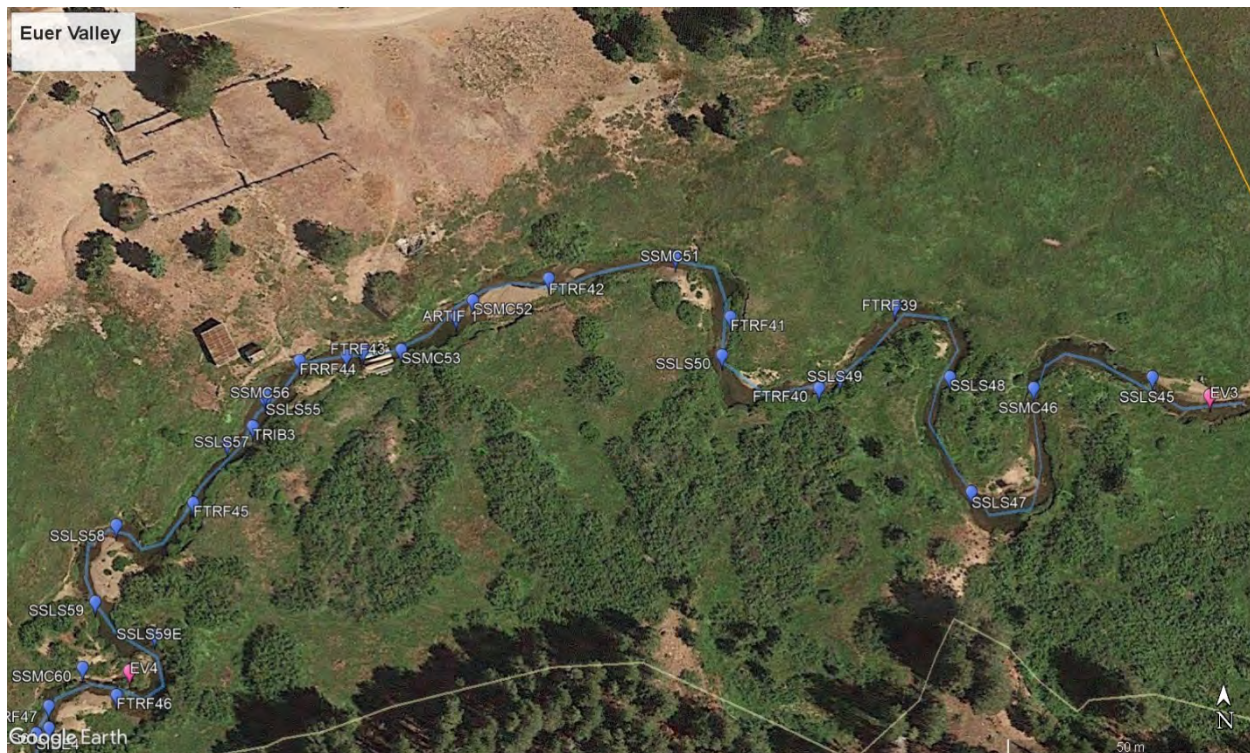
Figure 4. Reach EV3 upstream of the private property with historic outbuildings and corrals leftover from earlier livestock operations. The stream channel is highly altered and incised in this reach.

Near the historic outbuildings, the artificial unit was a series of culverts placed in the stream to enable winter stream crossing by ski trail snow grooming machines. These culverts appear to concentrate flow at the channel margins in higher flow conditions and contribute to stream bank and channel erosion. However, this location has likely had a higher concentration of impacts from livestock and human activities than many other locations on the channel between corrals and outbuilding and snow machine crossing in winter. Though the floodplain is narrow in this reach (Valley width averaged 113 m), there are still a number of remnant channels on the floodplain surface indicating a likely past morphology of more complex, multi-thread channels.

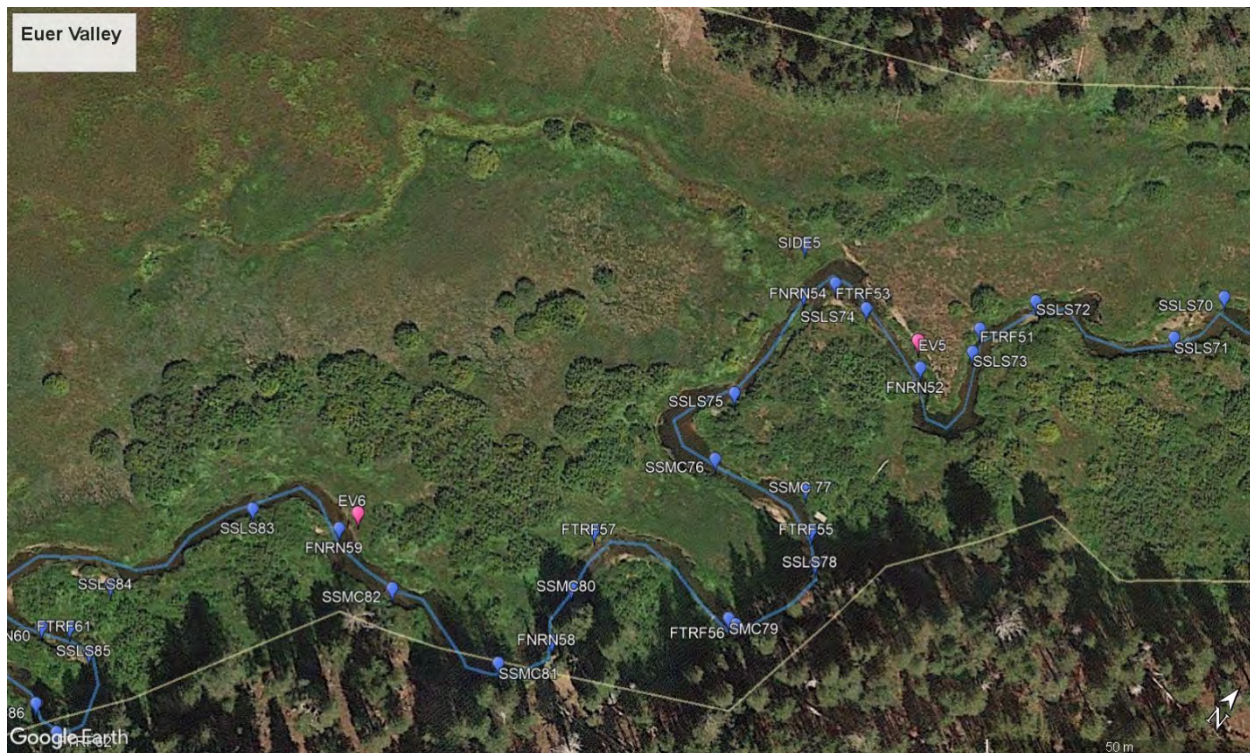
Figure 6. Reach EV5 is characterized by dense willows and a sinuous stream channel.

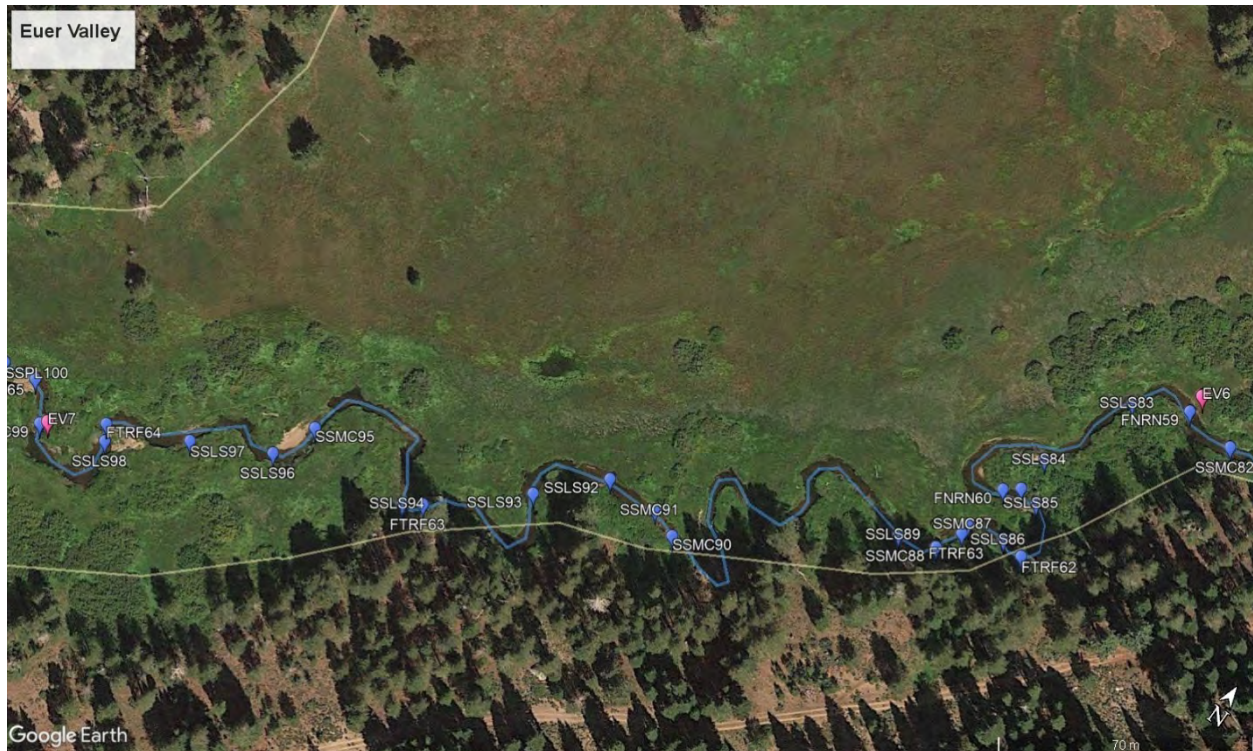
Figure 7. Reach EV6. The valley bottom is wider in this section but the stream channel is pinned tight to the moraine along the right meadow margin. This may have been intentionally diverted or channelized as livestock grazing impacts compounded. Historic channels are still present on the floodplain and likely still convey water in peak flows. Willows sprouted from a historic beaver dam are obvious adjacent to SSMC91.

For much of the reach, the channel is pinned tight to the moraine on the right side of the stream channel. This may be a natural channel migration, but it is also possible (as was common practice by

many livestock ranchers in the Sierran meadows) that the stream was diverted in order to reduce the soil saturation and encourage more mesic grasses to grow (preferred forage for livestock) instead of hydric sedges and rushes that dominate wet meadows and are less nutritious. Another possibility is that the stream captured a livestock trail and diverted itself. The very long side channel that began in EV5 reconnects to the current mainstem near SSL594. This zone is likely where the channel was diverted from the central thread in the meadow.

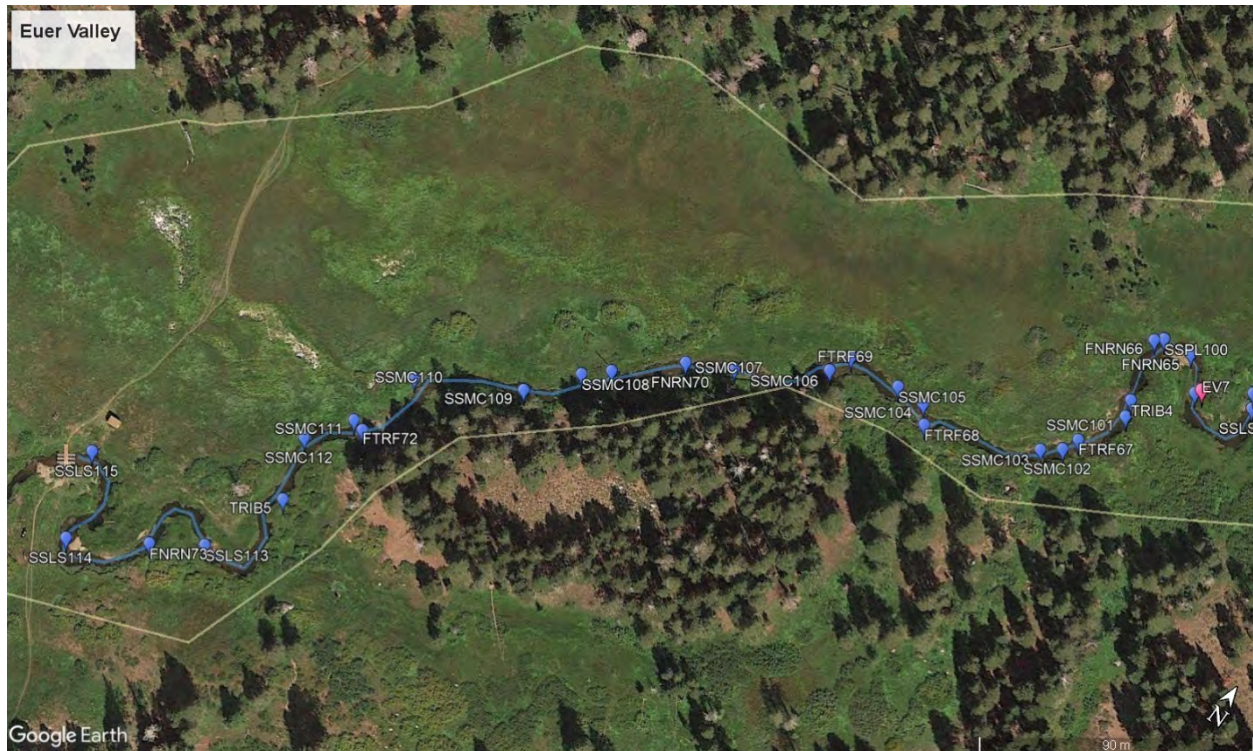
Figure 8. Reach EV7 is the uppermost survey reach. Note the discharge slope peatland/fen habitat on the hillslope at the bottom of the image and areas of shallow groundwater table on the floodplain on the left stream bank.

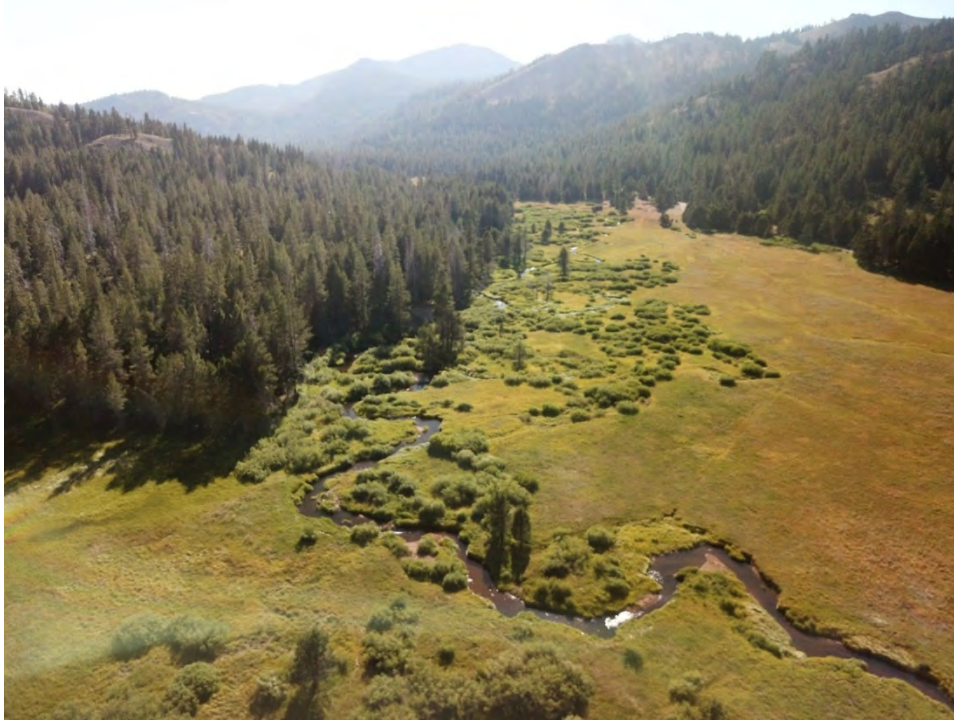
Figure 10. Aerial image of Euer Valley shows a sinuous single thread channel with a developing inset floodplain. It has limited connectivity to the historic floodplain but a relatively high groundwater table mediating soil water content and preserving mesic meadow vegetation structure.

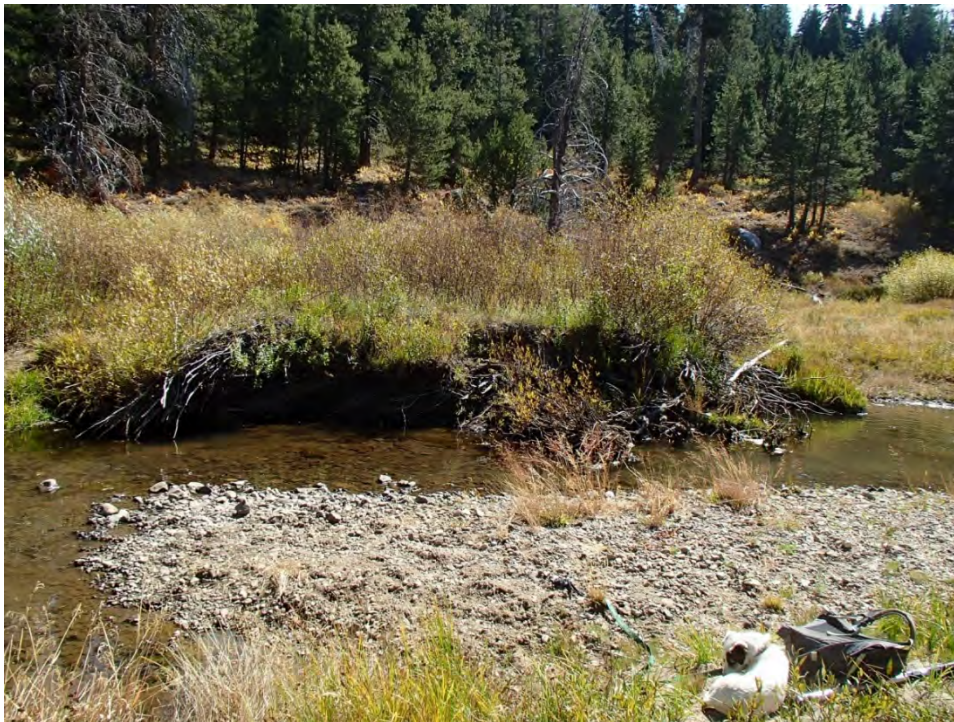
Figure 11. EV1. Beaver Dam Remnants on channel margin where a valley spanning beaver dam once was. The dam is now fully breached across the channel but aggraded sediments remain forming a gravel bar and a row of mature willows has sprouted from the dam remnants on the floodplain.

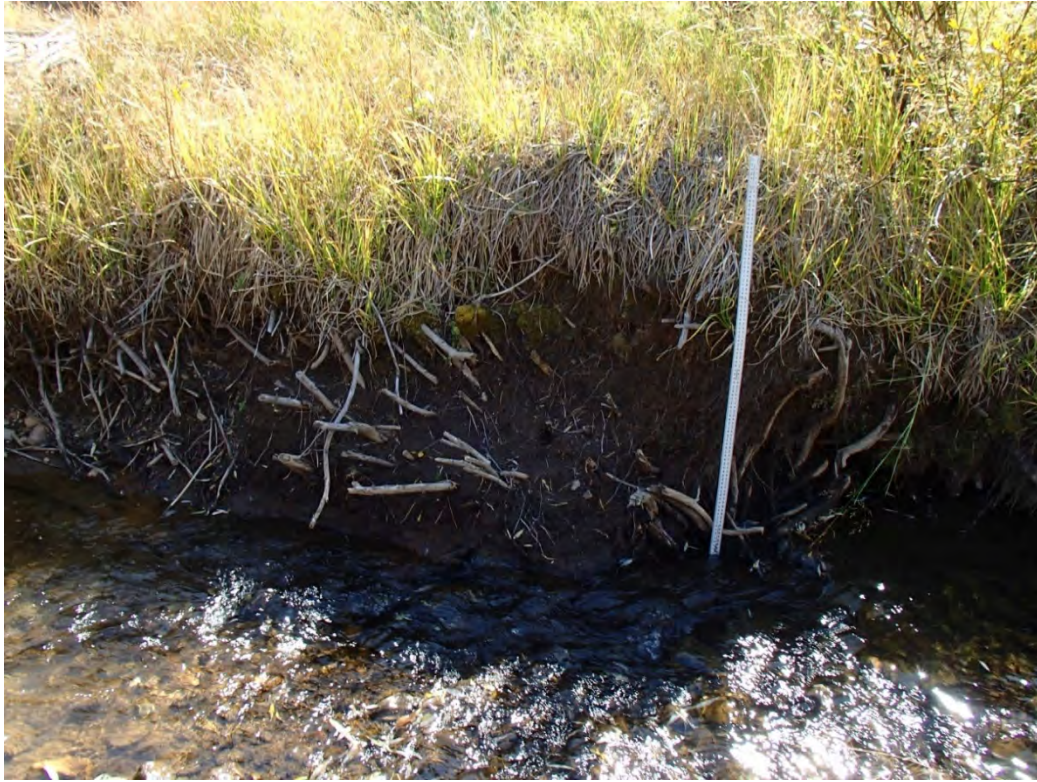
Figure 12. A close up of beaver dam remnants at the channel margin.

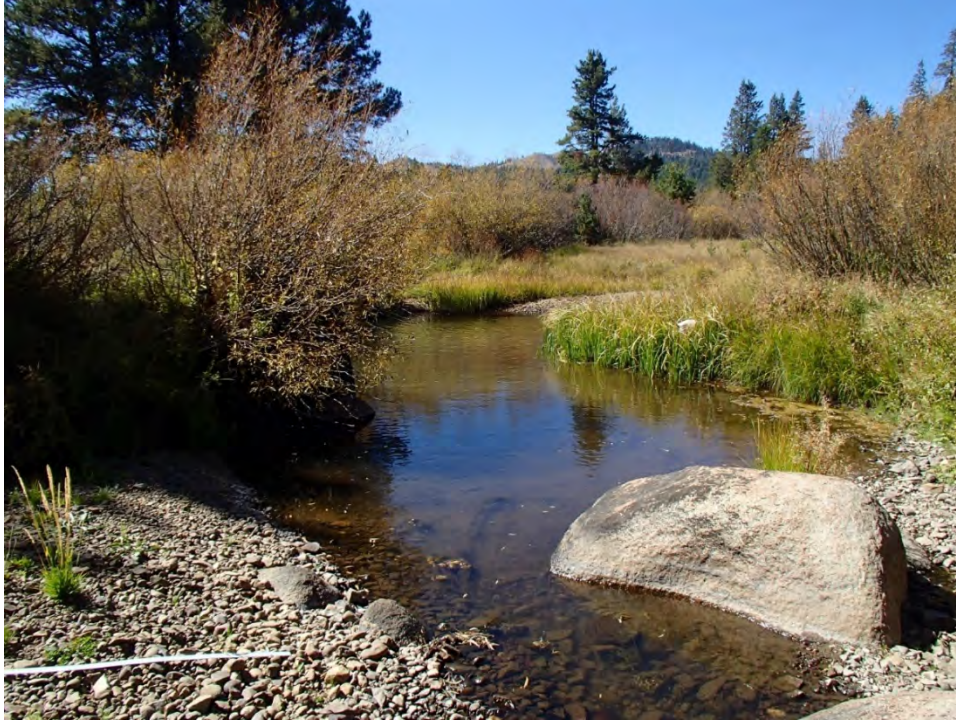
Figure 16. Exposed sediments at the pool crest at the site of a former beaver dam. The effects of the beaver dam remain in the sediment wedge across the channel and the emergent marsh vegetation that formed from the deposition of fine sediments behind the dam. The persistent habitat features created by beaver dams are visible throughout Euer Valley.

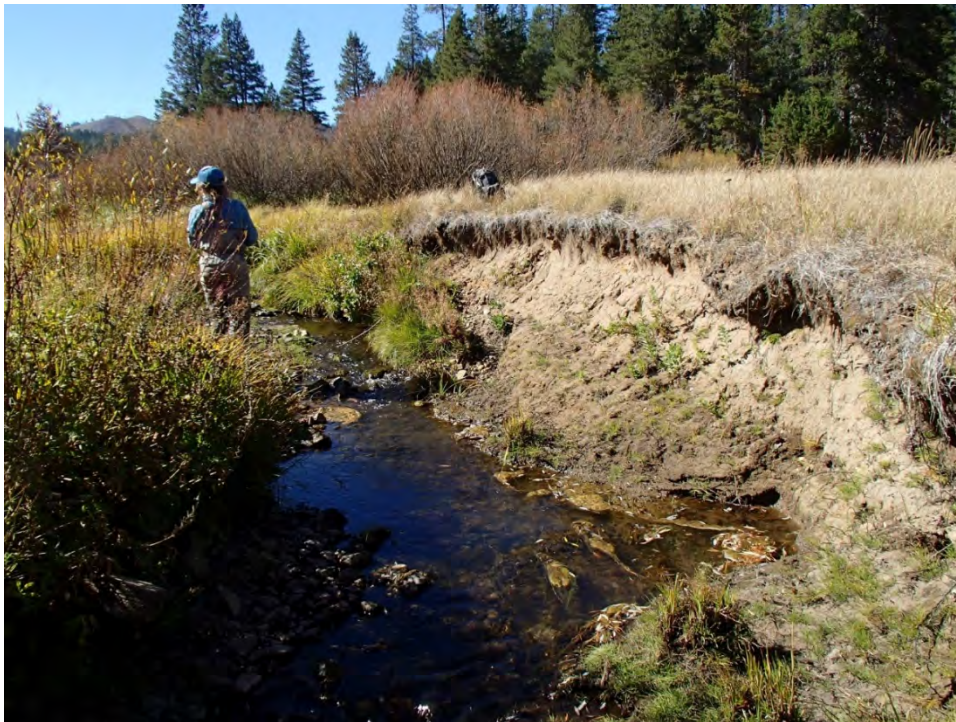
Figure 17. Bank Erosion and incision with the stream disconnected from the historical floodplain.

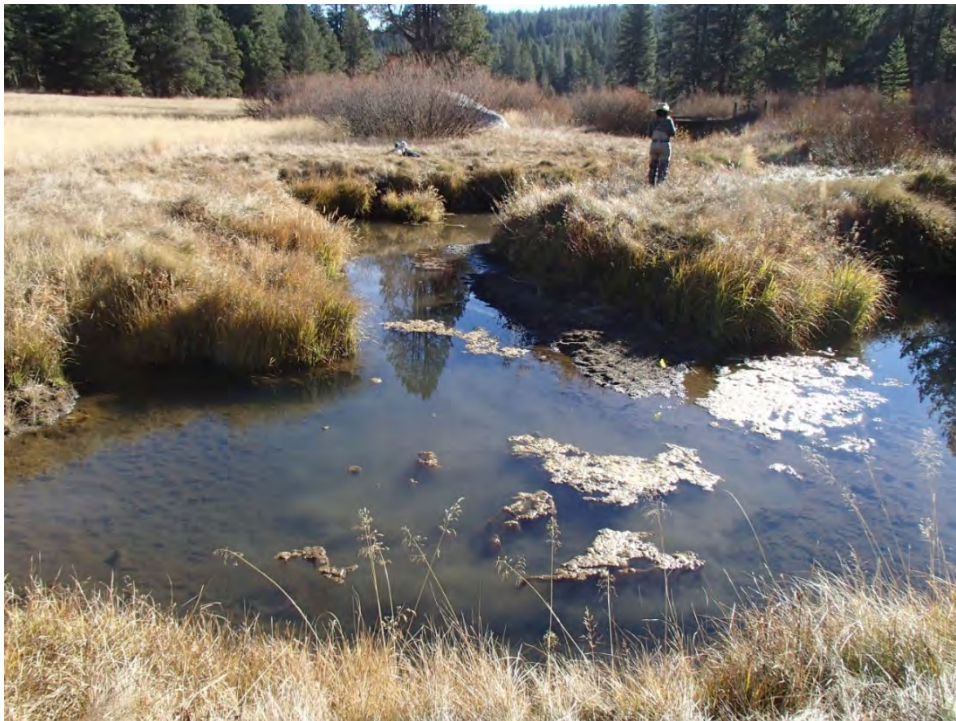
Figure 19. An old, partially breached beaver dam with well-developed meadow vegetation and sod forming on top of it.

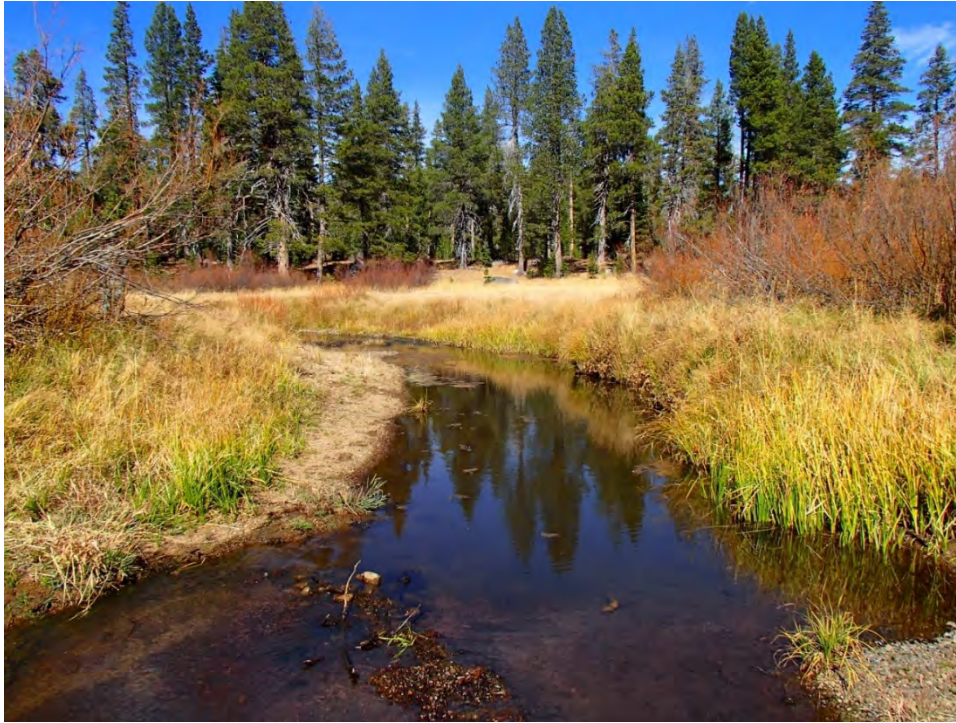
Figure 22. Beaver dam remnants across the channel with major deposition upstream. Emergent marsh habitat develops behind persistent dams and remain after the dam washes out.

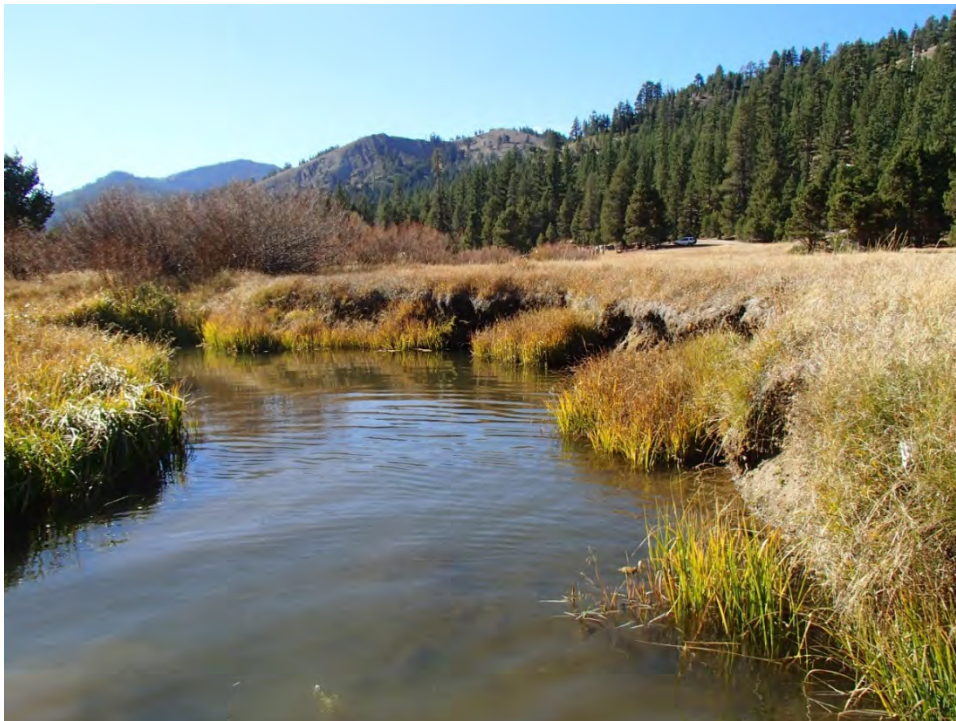
Figure 23. Channel incision disconnects the stream from its floodplain and drives erosion. In this section, multiple beaver dam remnants against the cutbank show the density of beaver activity in Euer Valley.

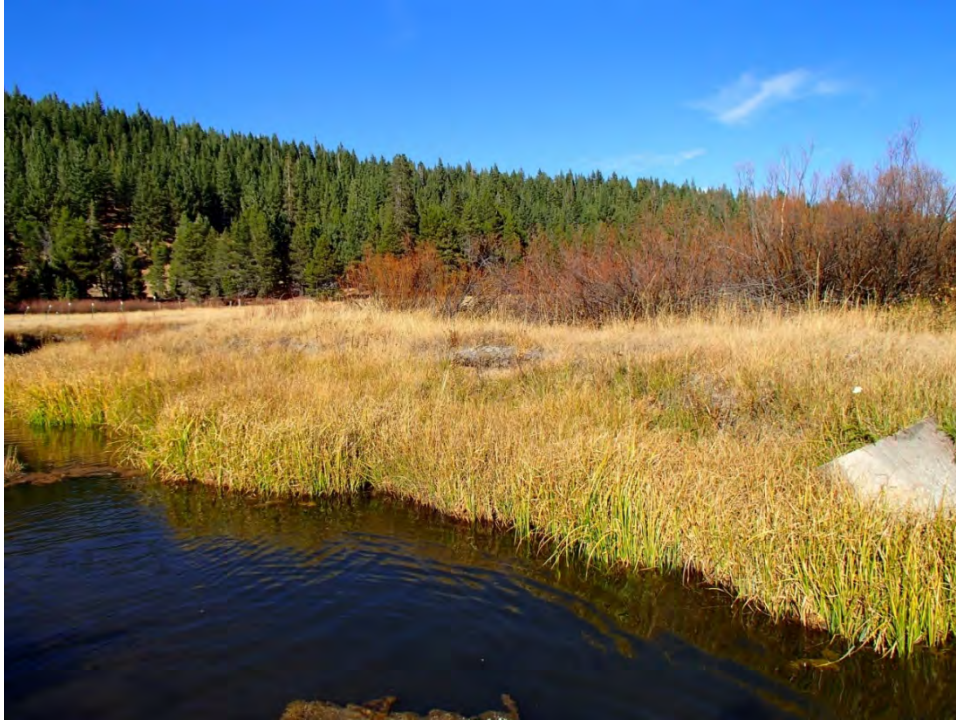
Figure 24. Barely visible old cutbank scars are covered by low angle banks formed by beaver dams.

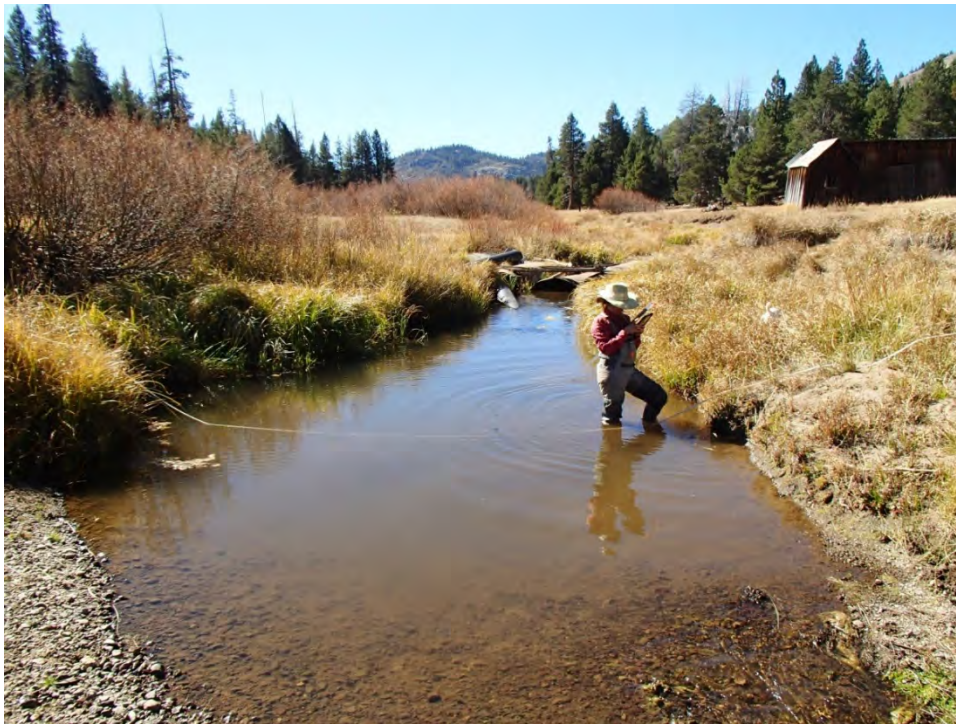
Figure 25. The culvert crossing for snow machines near the old barns in EV3 with multiple beaver dam remnants at the channel margins.

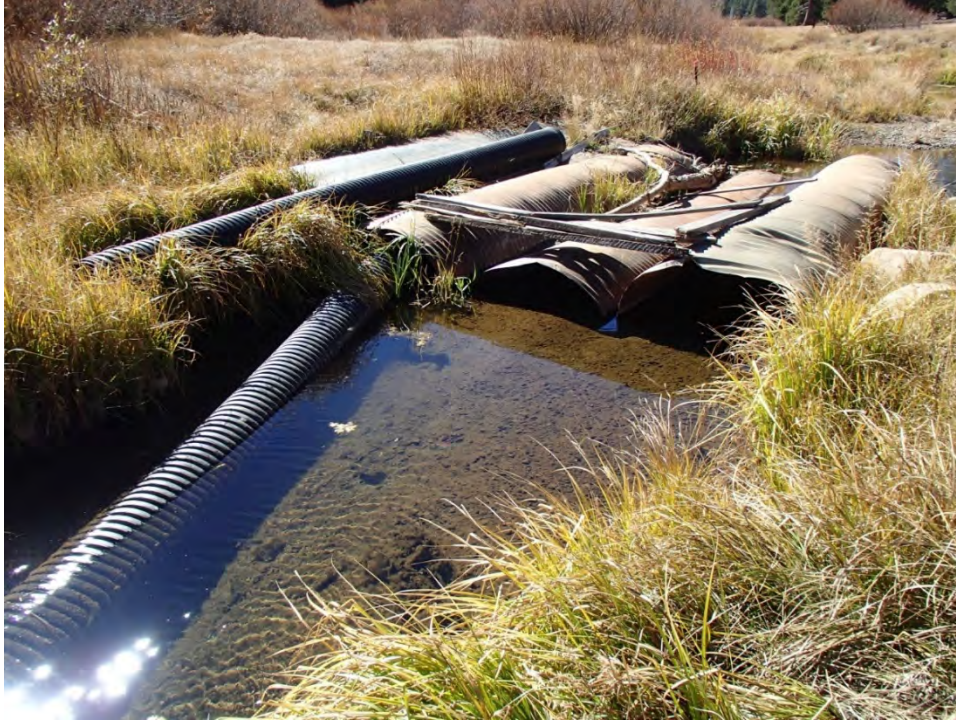
Figure 26. The culverts are filling with sediment and have created some widening at the stream margins

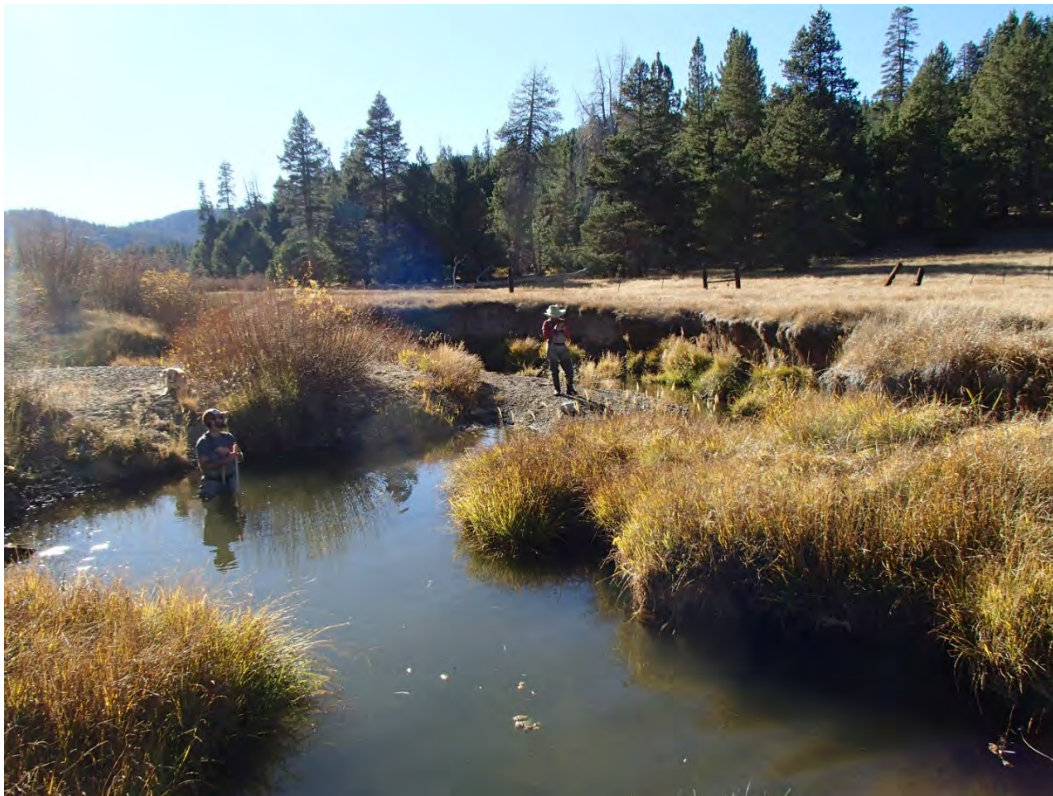
Figure 27. Inset floodplain development within the channel but incision has completely disconnected the stream and its floodplain losing critical floodplain processes. Note multiple beaver dam remnants in the foreground.

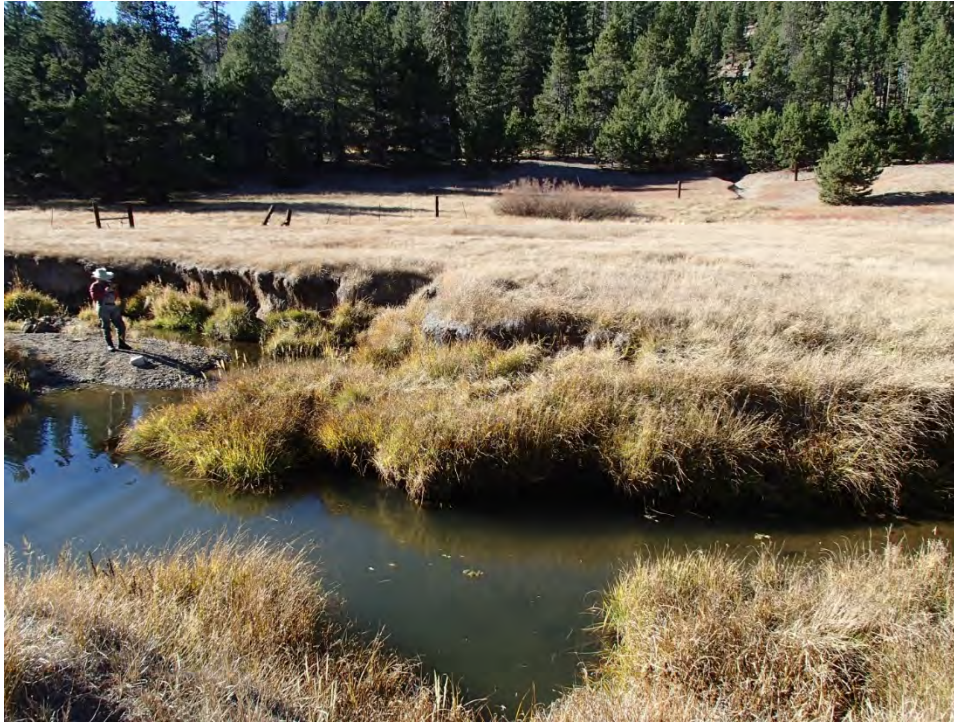
Figure 28. Relic channel visible on the historic floodplain surface with inset floodplain development in the active channel zone with ubiquitous beaver dam remnants front and center.

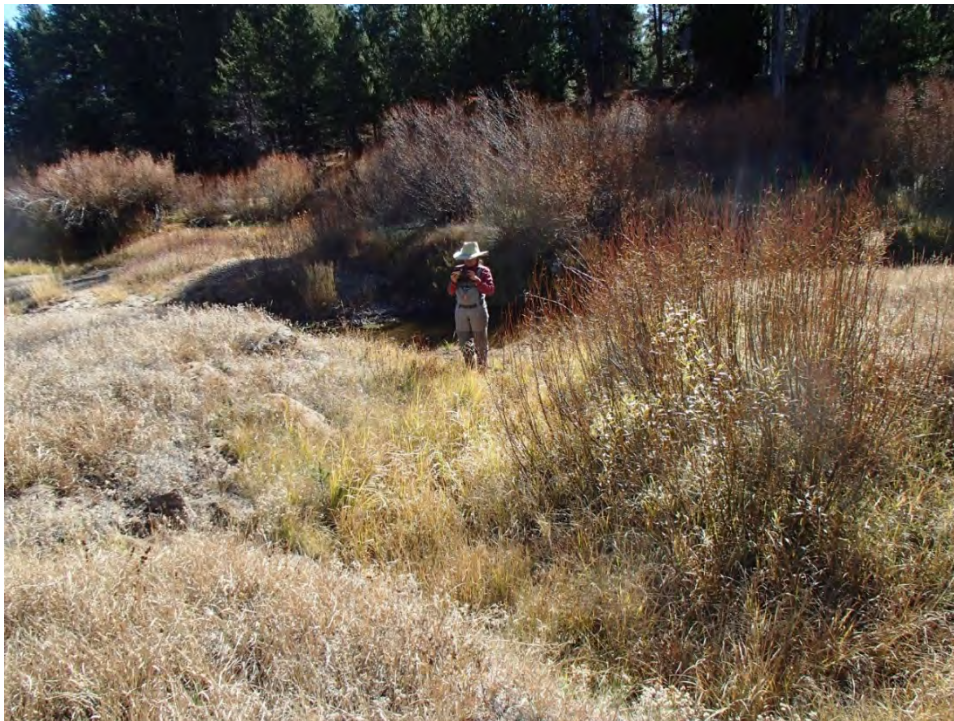
Figure 29. SIDE5 In EV5 may have once been the dominant channel through the meadow but became disconnected due to an avulsion event. This may have been a natural process or it may have been an intentional management decision in order to drain and dry out the wet meadow.

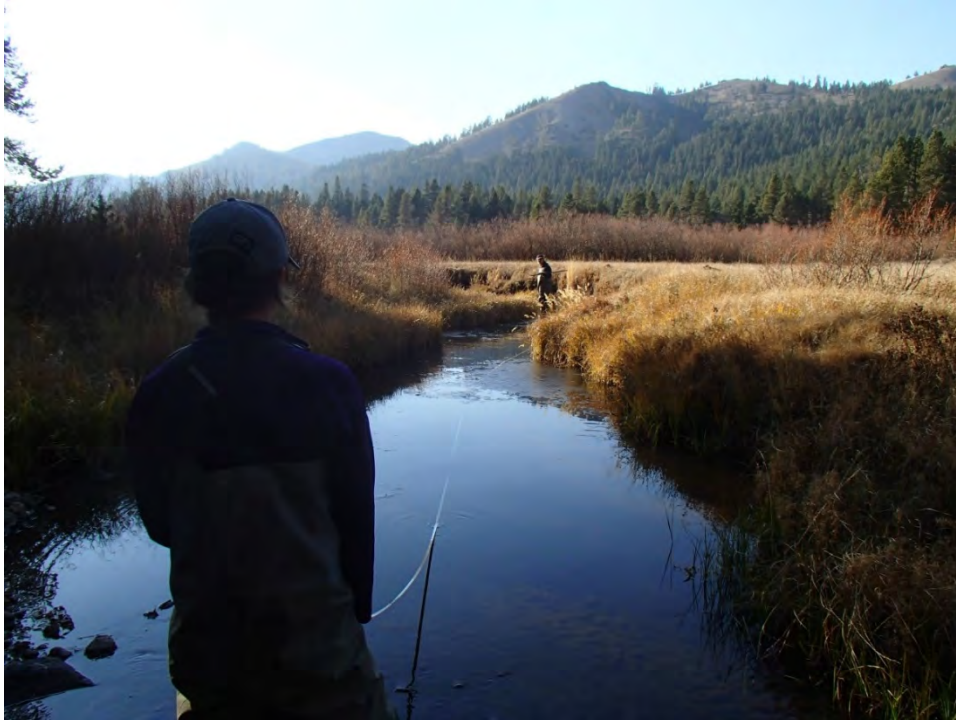
Figure 30. Incised but stable and possibly aggrading channel with bank vegetation developed by former beaver dam located where Helen is standing in the foreground.

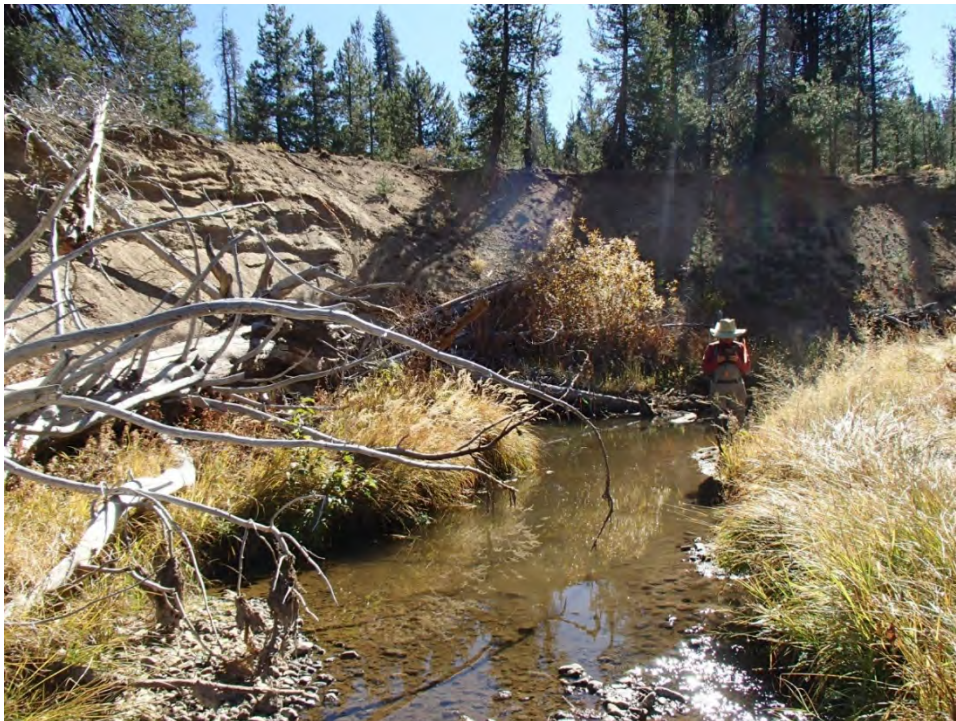
Figure 31. Tall, eroding cutbanks where the stream channel meets the lateral moraine at the margin of the valley provides a recruitment opportunity for large wood and sediment. Note, beaver dam remnant under wood.

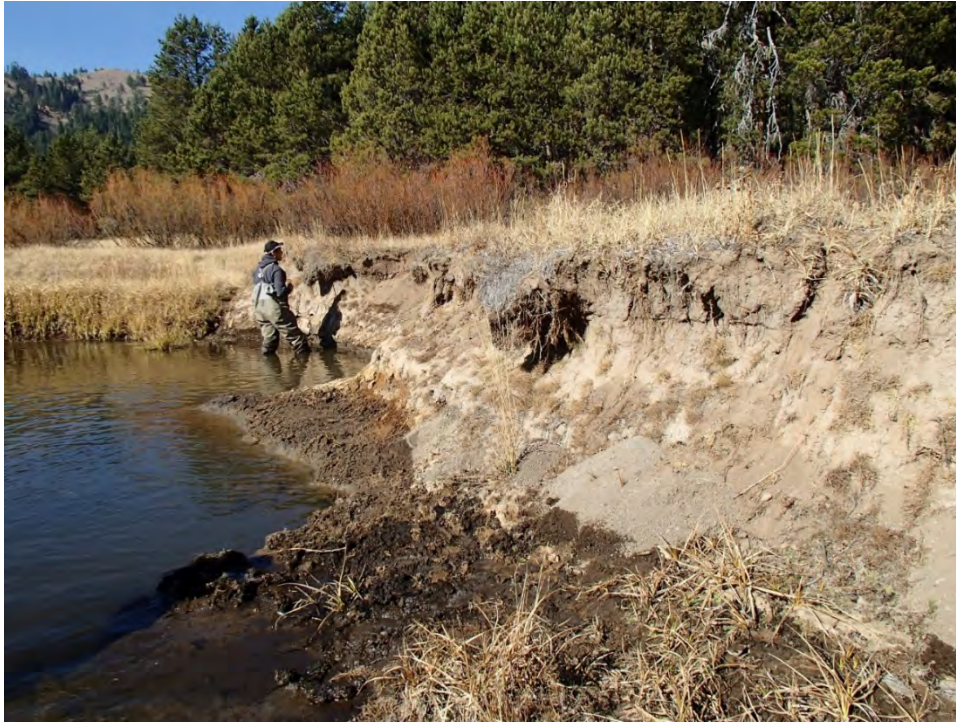
Figure 32. Active erosion and lateral channel migration. Note the depth of channel incision.

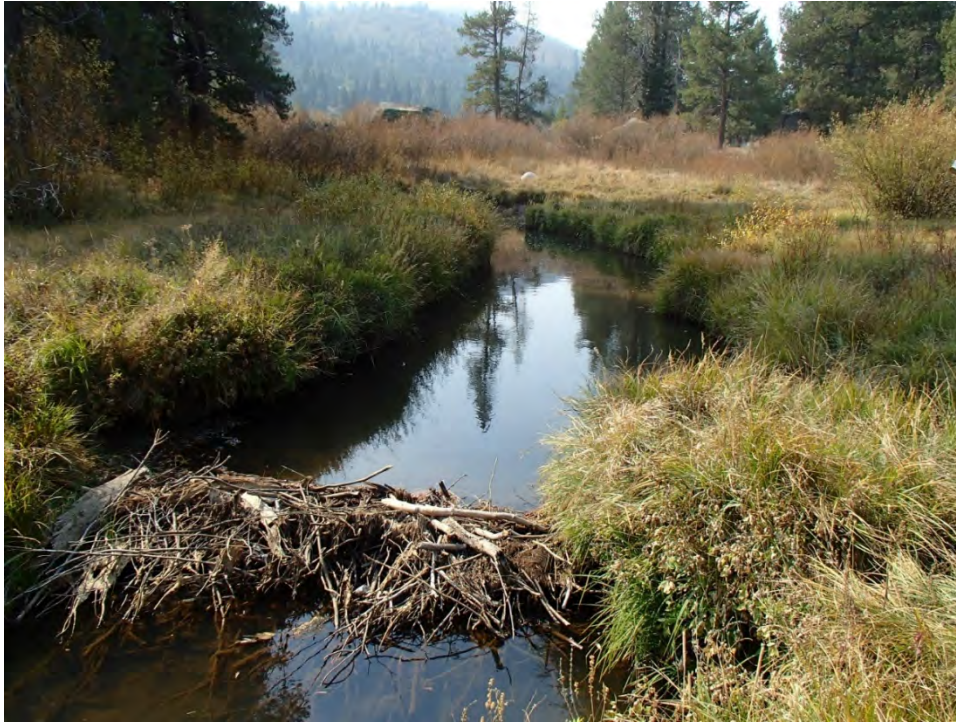
Figure 34. One of few channel-spanning beaver dams currently in the system. Note the pillow-shaped banks developing upstream. These will persist after the beaver dam is breached and provide bank stability and undercut bank habitat.

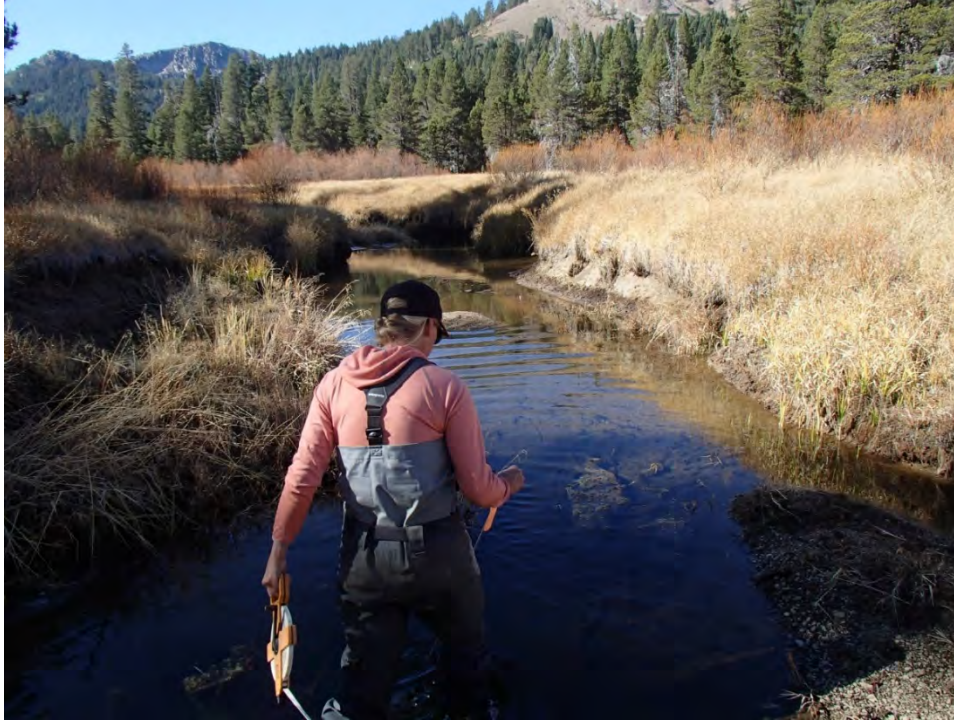
Figure 36. The stream is deeply incised and disconnected from the floodplain but fairly stable. This represents Stream Evolution Model Stage 6 (Quasi-equilibrium) per Cluer and Thorne (2013)
