MEMO

Subject: Prosser Creek Watershed Roads and Trails Assessment

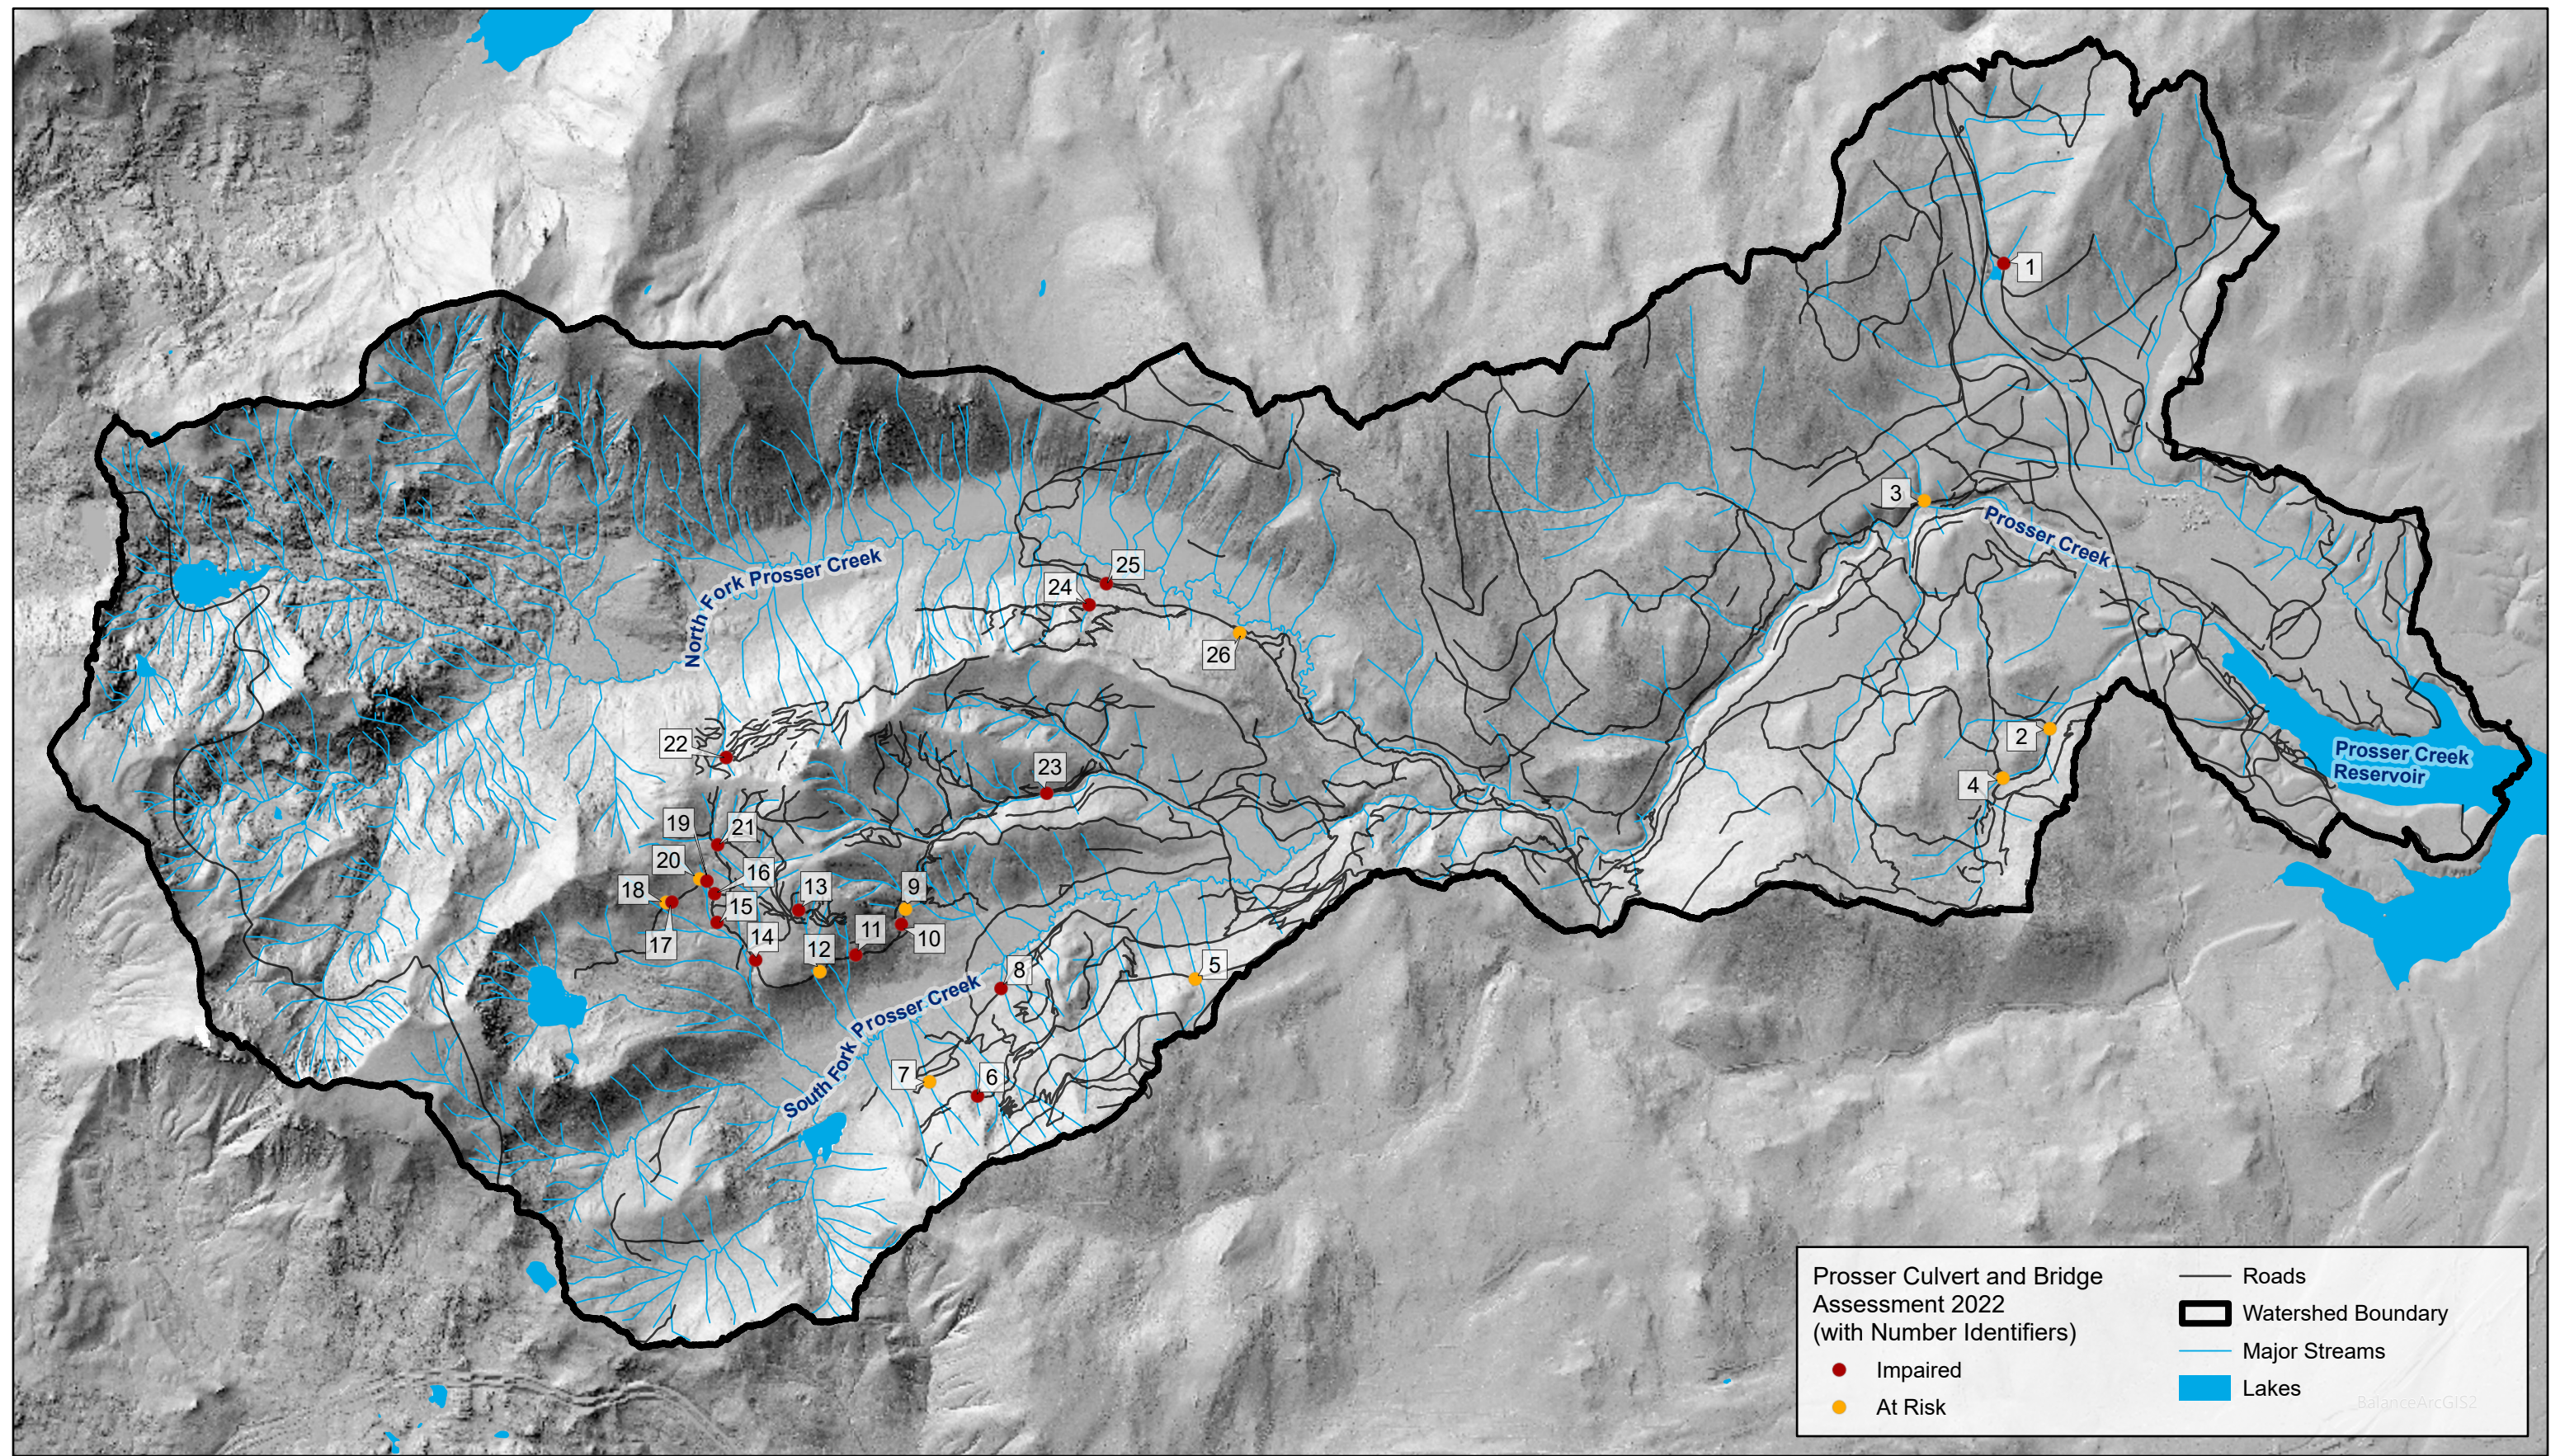
**Figure 3. Culvert and Bridge Conditions
Prosser Creek Watershed, Nevada County, CA**

Table 2. At-risk and impaired culverts Prosser Creek Watershed, Nevada County, CA

ID	Lat	Long	Road Name	Condition	Notes
1	39.416689N	120.196842W	Old Highway 89	Impaired	Filled with sediment
2	39.374751N	120.312389W		At Risk	Unimproved crossing. Stable. At risk of erosion in big event
3	39.374736N	120.312888W	Prosser Creek Trail	At Risk	Small timber bridge. Signs of significant flow and sediment coming down tributary with direct input in creek
4	39.376137N	120.309353W	NFR-89-33-06-05	At Risk	Approx. 18-in CMP. May have overtopped. Channel upstream is in coding and widening. Suggest armor road for high flow spill.
5	39.376281N	120.30997W	Firewalker	At Risk	Erosion upstream of inlet, gully erosion below
6	39.381822N	120.279927W	Firewalker	Impaired	Buried or no culvert, erosion of road prism
7	39.394381N	120.276124W		At Risk	Head cut, erosion,
8	39.395789N	120.274622W	S. Ever Valley Road	Impaired	Partially clogged culvert, road capture
9	39.400886N	120.203878W	Frog Lake Road	At Risk	No culvert, but road crosses active erosional gully

10	39.374141N	120.301443W	Frog Lake Road	Impaired	Buried, partial road capture
11	39.370023N	120.29966W	Frog Lake Road	Impaired	Buried, road capture
12	39.371119N	120.296534W	Frog Lake Road	At Risk	Partially buried
13	39.378555N	120.308394W		Impaired	No culvert, but road could've decommissioned here and topography restored, road capture, channel scour
14	39.373142N	120.292569W	Frog Lake Road	Impaired	Buried
15	39.374158N	120.292209W	Frog Lake Road	Impaired	Buried
16	39.368802N	120.284008W	Frog Lake Road	Impaired	Buried
17	39.369327N	120.267214W	Frog Lake Road	Impaired	Culvert buried in sediment
18	39.382313N	120.197276W	Frog Lake Road	At Risk	Inlet partially sedimented in, inboard ditch and culvert relocate natural drainage into willow forest
19	39.362602N	120.290255W	Frog Lake Road	Impaired	Buried, road now captures stream
20	39.361629N	120.286114W	Frog Lake Road	At Risk	Road runoff entering channel at culvert

21	39.384379N	120.307601W		Impaired	Undersized
22	39.392423N	120.263139W		Impaired	Covered in debris from large colluvial channel
23	39.385587N	120.193185W	Crabtree Canyon	Impaired	No culvert, road dip is also tributary crossing, excess runoff and sediment to creek
24	39.37337N	120.308507W		Impaired	Inlet of culvert covered in sediment
25	39.375287N	120.308693W	Carpenter Valley Road	Impaired	Buried
26	39.370839N	120.305198W	Carpenter Valley Road	At Risk	Filled with sediment and vegetation

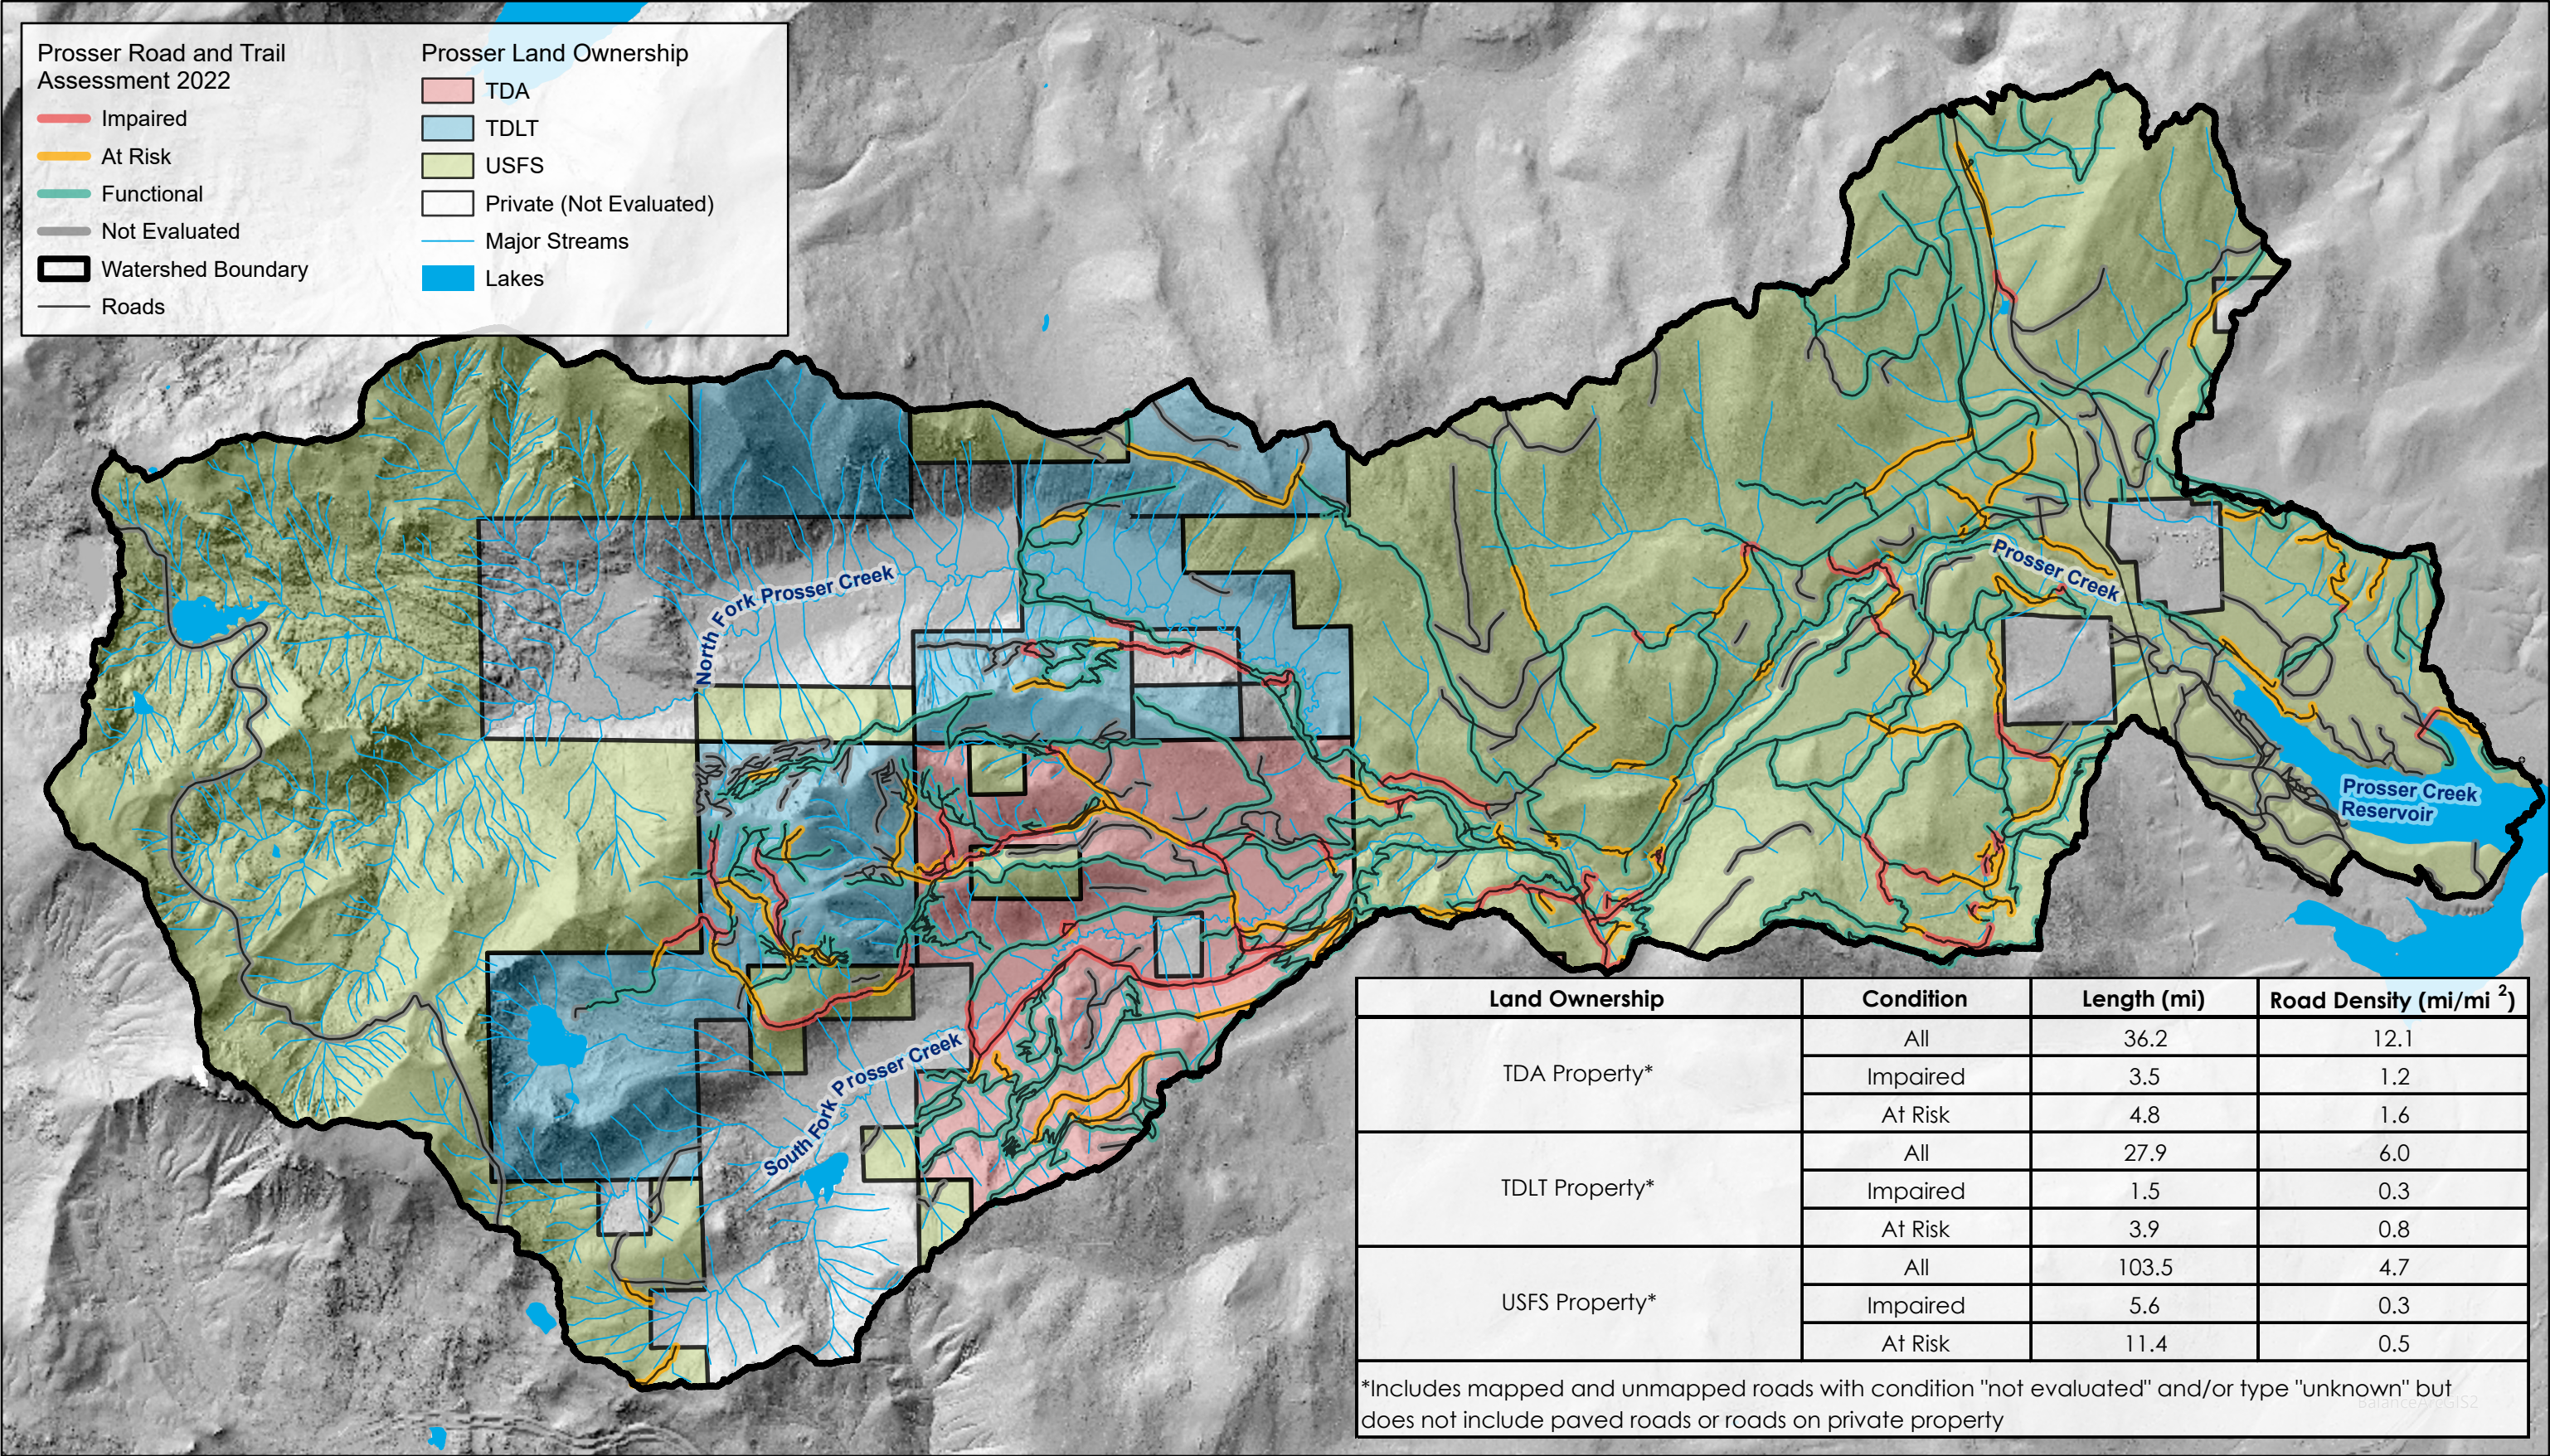
Figure 4. Roads, Trails, and Railroad Grade Conditions and Property Ownership Prosper Creek Watershed, Nevada County, CA

Figure 4 shows road/trail/grade conditions relative to property boundaries and land ownership in the Prosser Creek watershed. **Table 4** provides lengths of 'impaired' and 'at-risk' road/trail/grade conditions and density for each landowner. USFS (Tahoe National Forest) manages the majority of lands in the watershed and includes the bulk of road/trail/grade miles; however, based on feature density, TDA and TDLT manage lands with higher road/trail/grade densities, including those features with 'at-risk' and 'impaired' conditions.

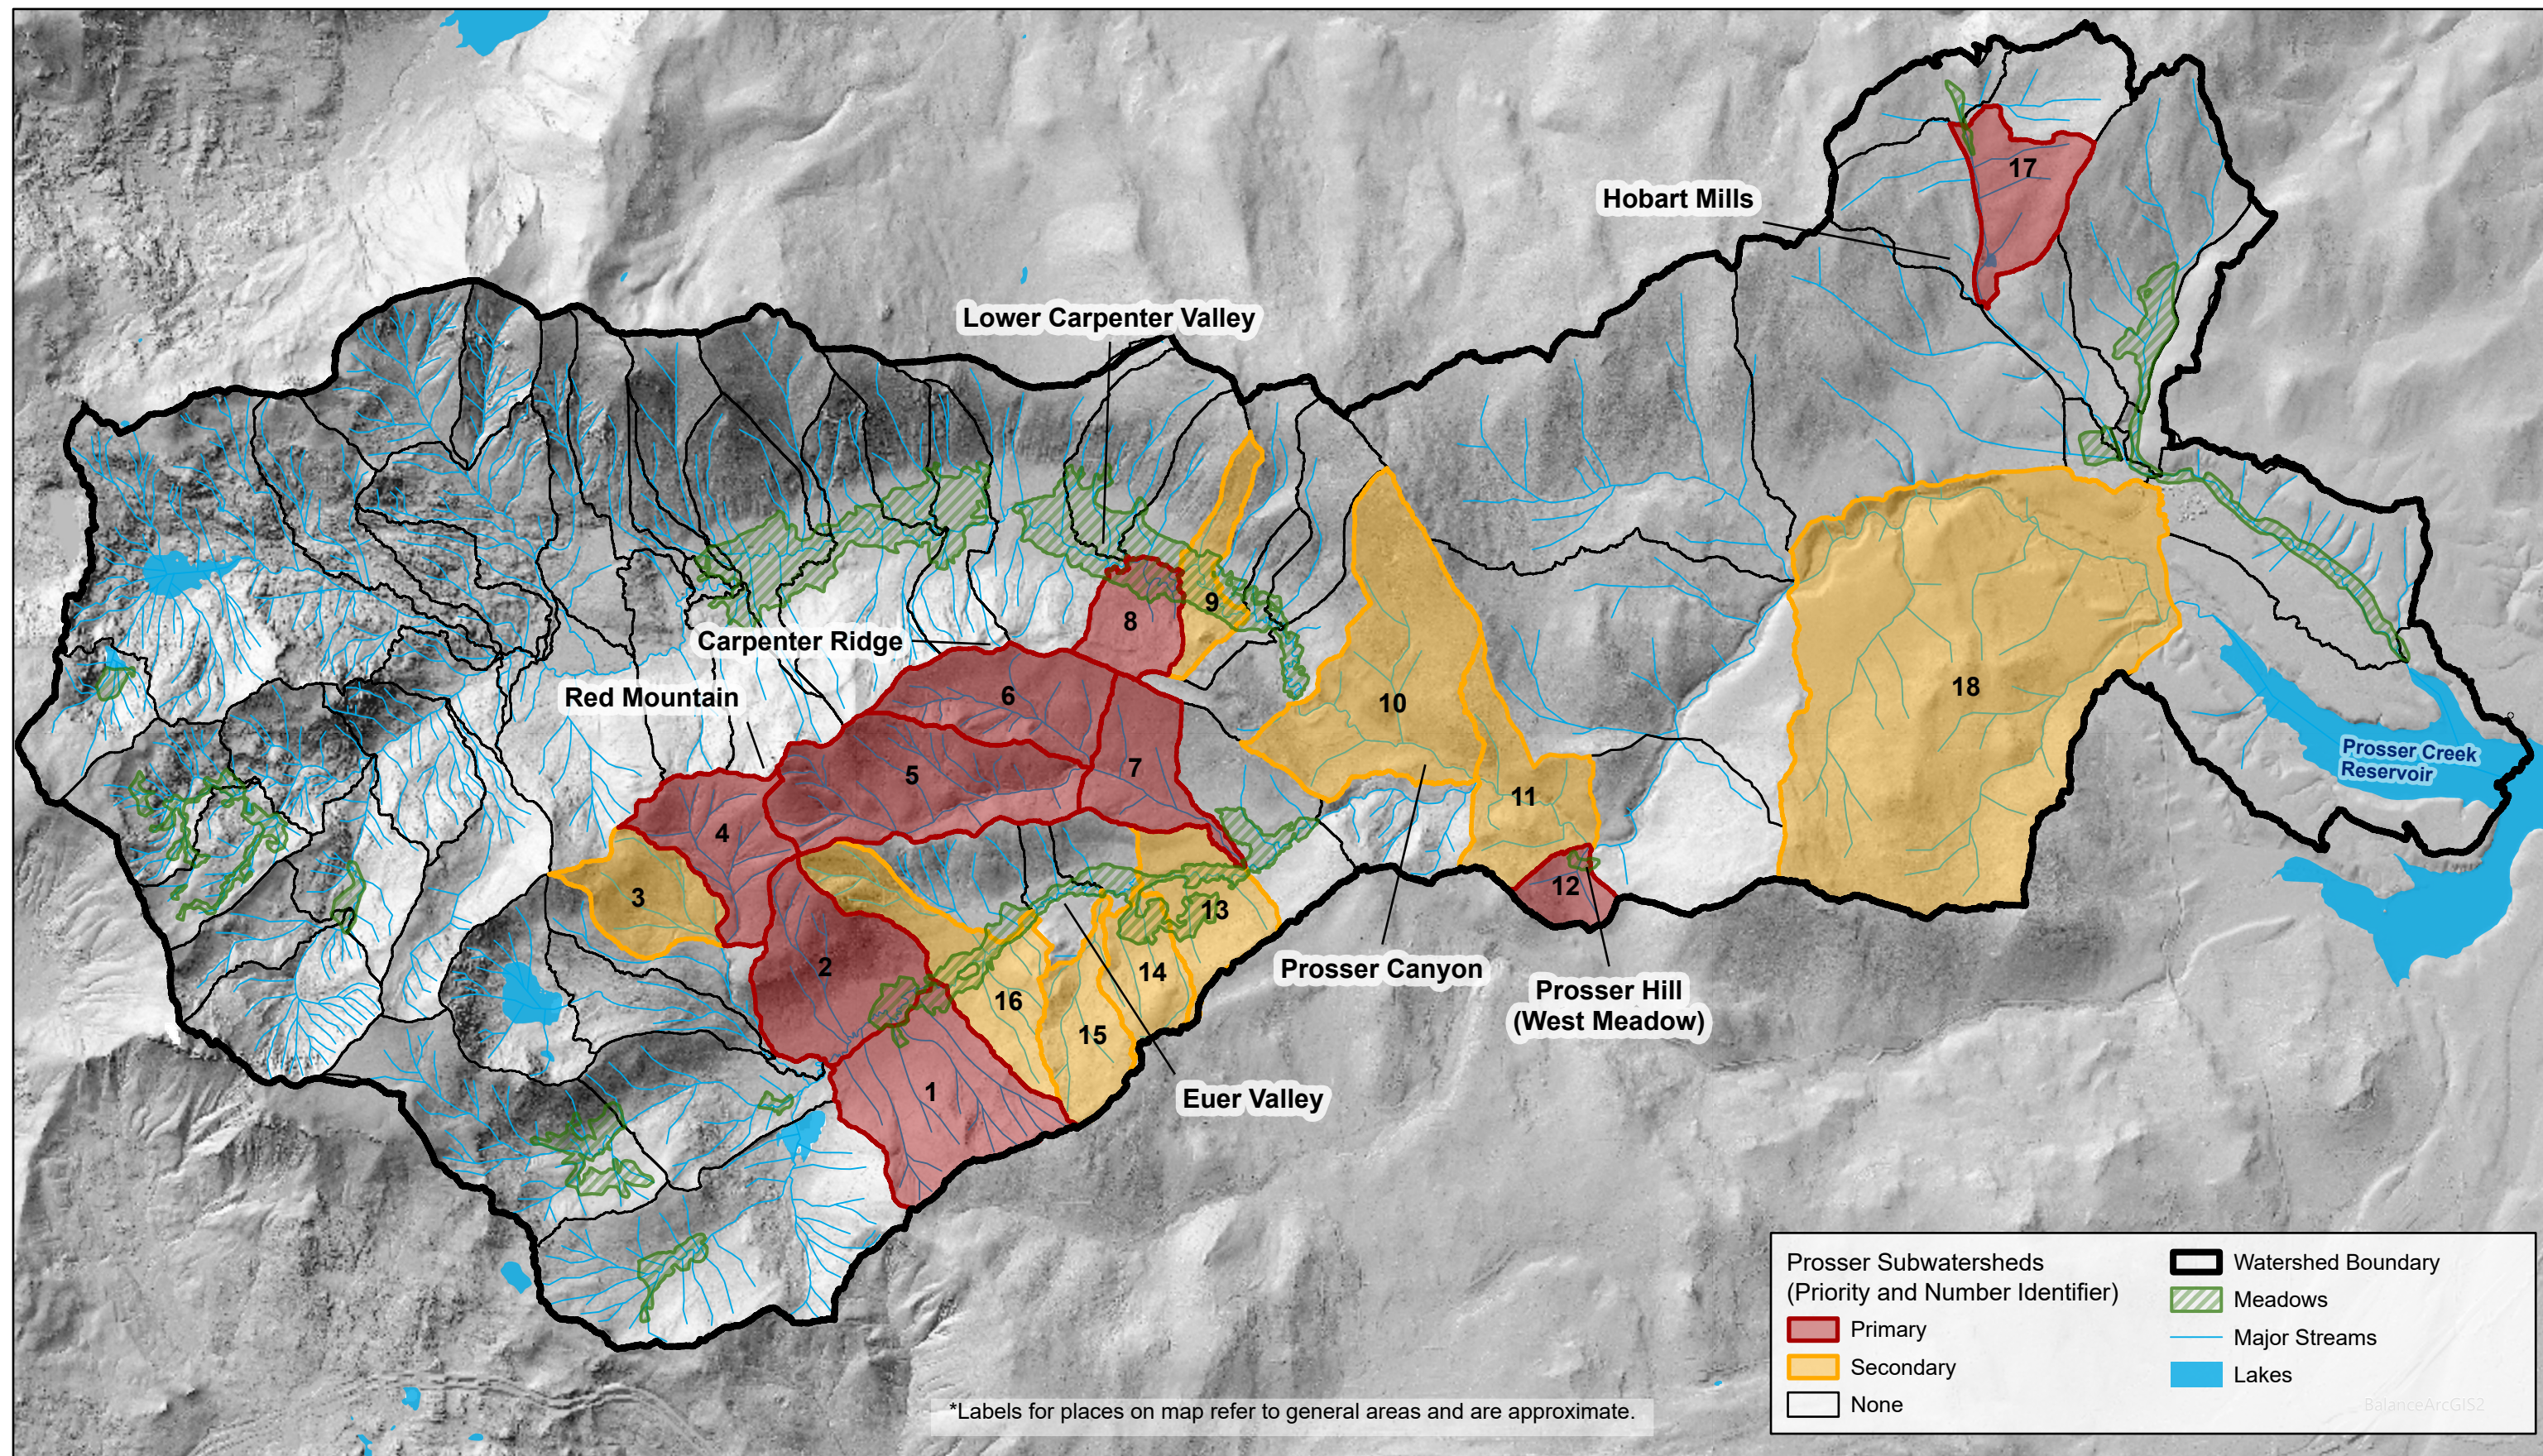
**Figure 6. Priority Subwatersheds Identified in Roads and Trails Assessment
Prosser Creek Watershed, Nevada County, CA**

Figure 6 shows subwatersheds ranked by management priority: (a) primary, (b) secondary, (c) none. **Table 6** lists each subwatershed with a primary or secondary priority, area, and land ownership. In general, areas identified for primary priority management include:

- Ever Valley including Crabtree Canyon
- Red Mountain (south drainage)
- Carpenter Ridge-draining to Lower Carpenter Valley
- Prosser Hill, West Meadow (improvements completed September 2022)
- Hobart Mills Reservoir

- Red Mountain (south drainage)
- Lower Carpenter Valley (minor drainages)
- Prosser Canyon (below confluence of NF and SF)
- Ever Valley (north-facing drainages)
- Prosser Hill and OHV area
