MEMO

To: Beth Christman, Truckee River Watershed Council
From: Brian Hastings, PG, and Erika Groh
Date: October 10, 2022

Subject: Prosser Creek Watershed Roads and Trails Assessment

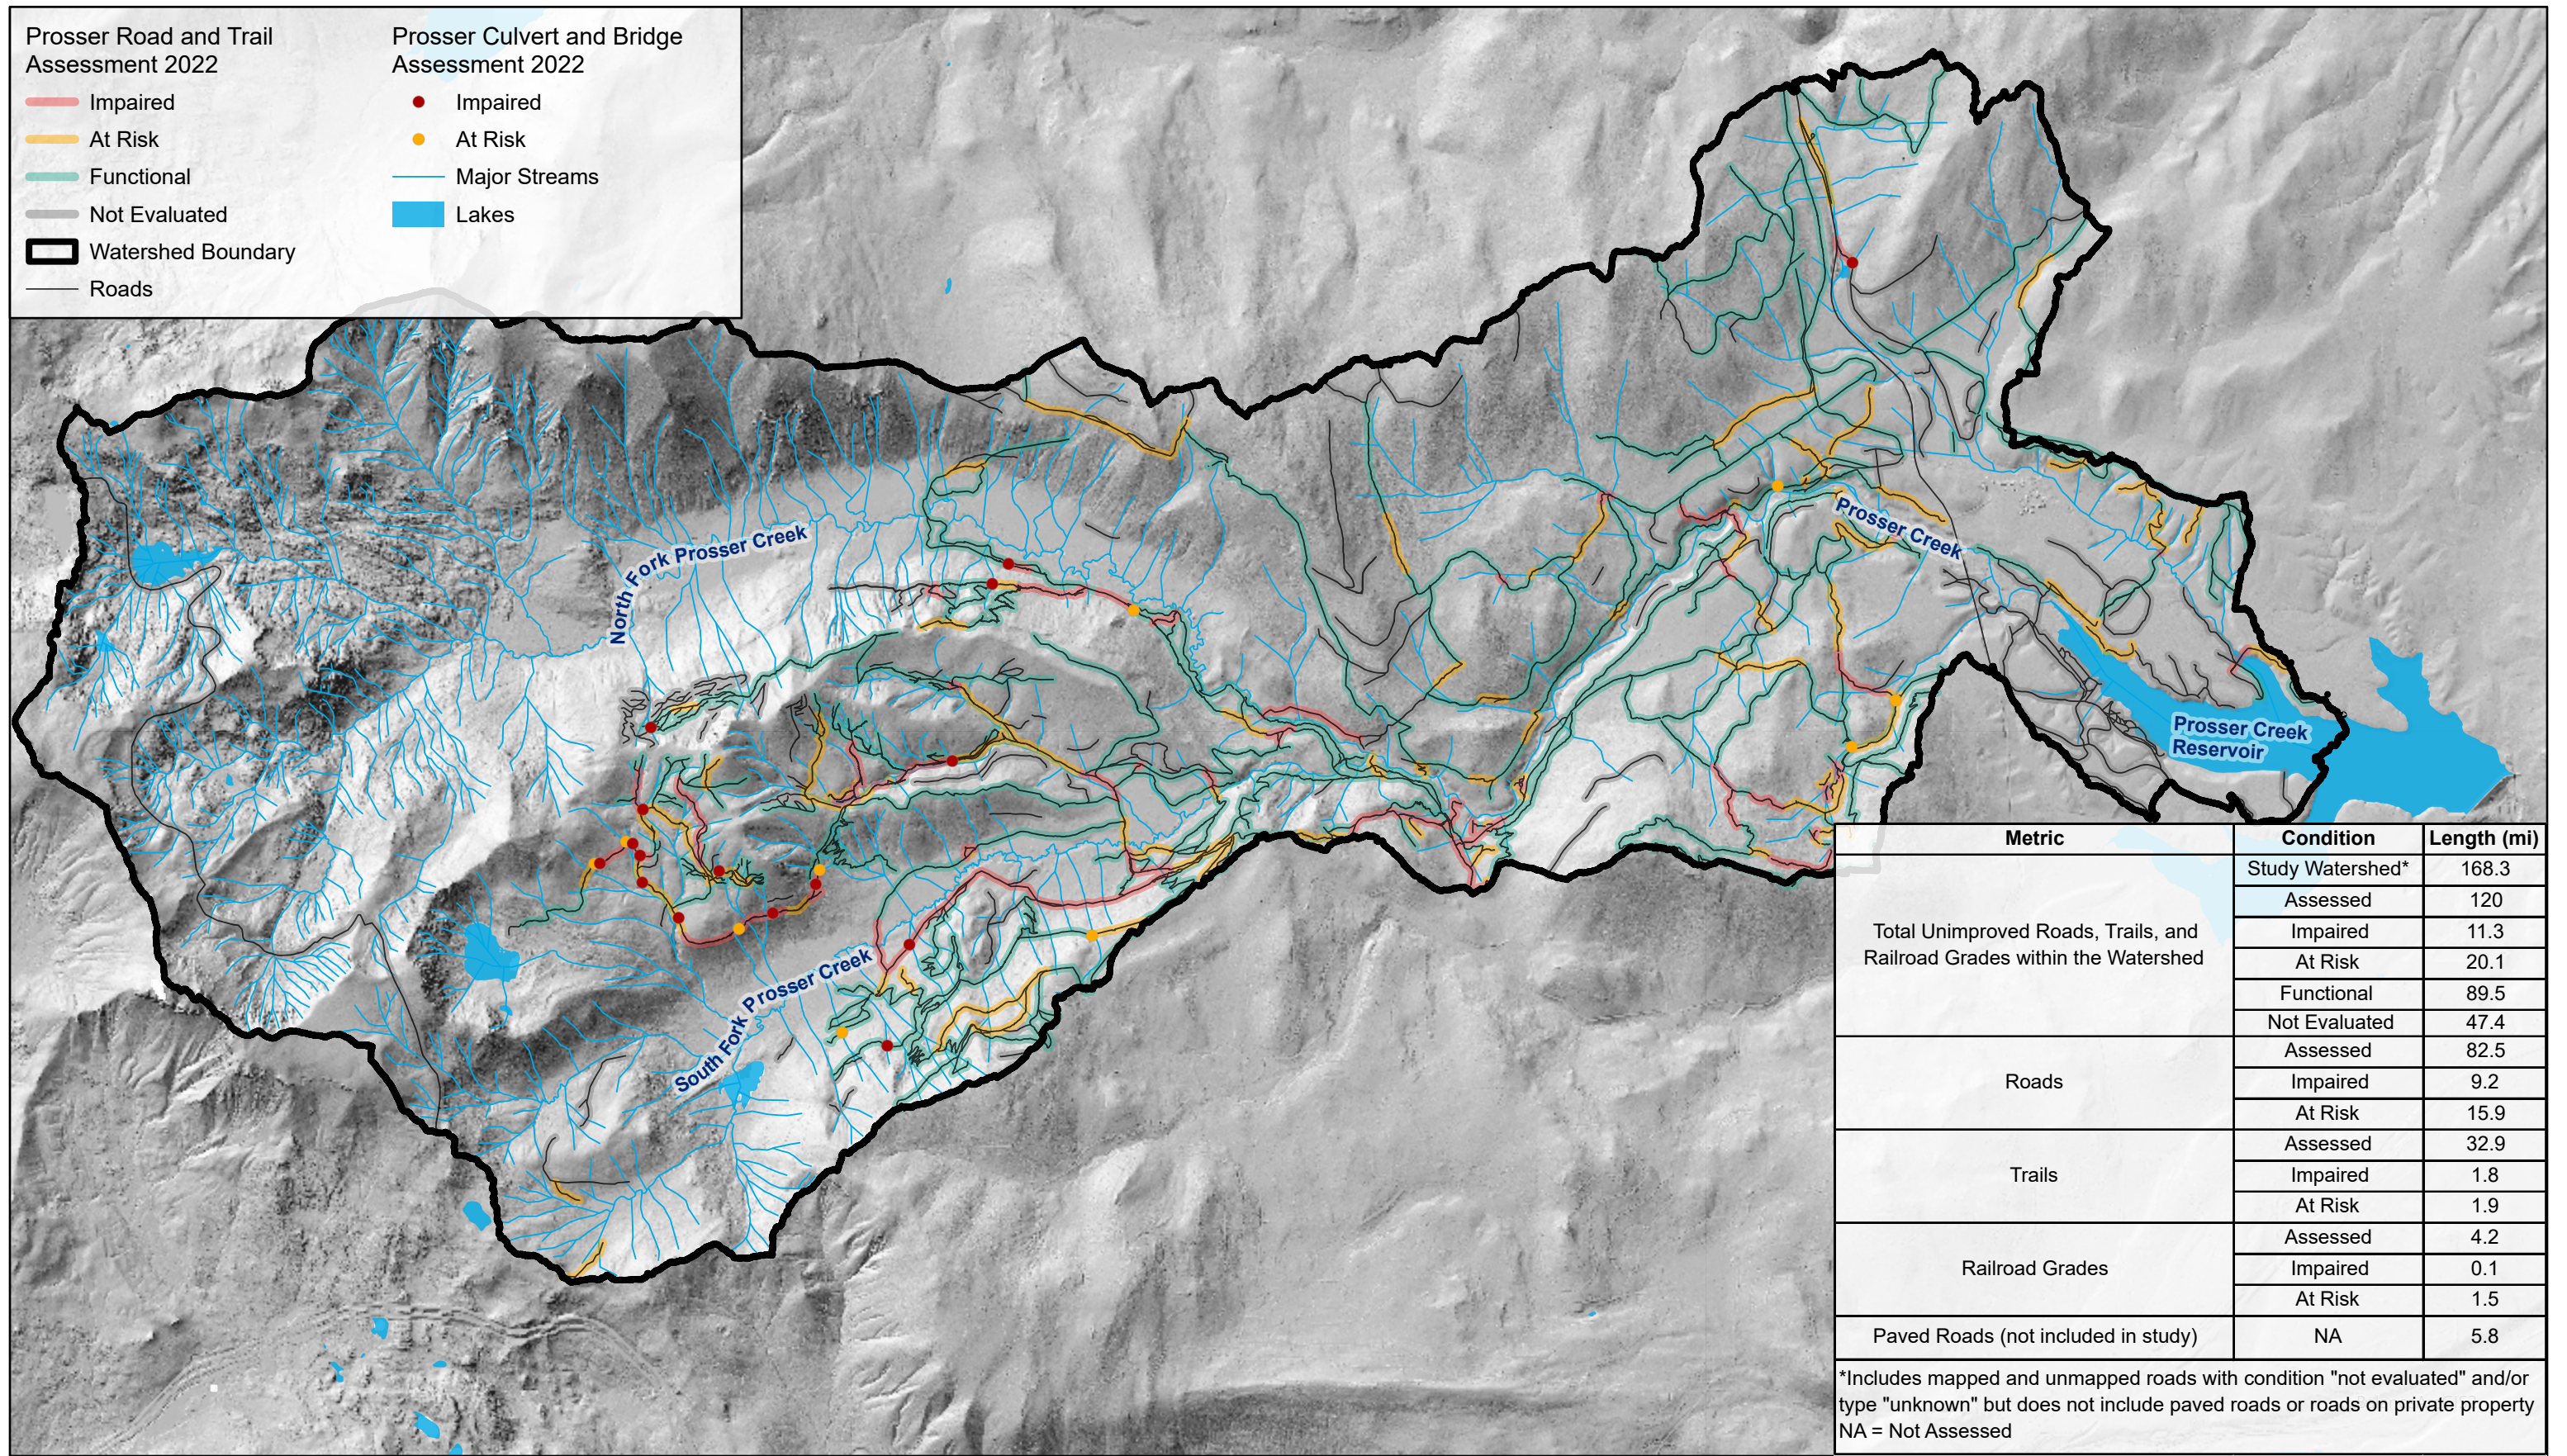
**Figure 2. Roads, Trails, and Railroad Grade Conditions
Prosser Creek Watershed, Above Prosser Creek Reservoir
Nevada County, CA**

Existing roads, trails, railroad grades, and culverts¹ and their current condition are shown in **Figure 2**. Culverts classified as ‘at-risk’ and/or ‘impaired’ are shown in **Figure 3**. Key metrics for roads/trails/grades are provided in **Table 1**, while key metrics for culverts are provided in **Table 2**. Prosser Creek watershed includes 168.3 miles of roads, trails, and railroad grade segments in the watershed or a density of 4.9 miles per square mile. Of these, we assessed 120.9 miles of roads, trails, and railroad grades or 72 percent of all features in the watershed. The remaining 28 percent included paved roads and features that did not meet our criteria for field verification and, therefore, were not evaluated. We identified 26 culverts categorized as ‘at-risk’ and/or ‘impaired’.

Based on our assessment, 75 percent of linear features we assessed were characterized as ‘functional’, while 16 percent were ‘at-risk’, and 9 percent were ‘impaired’. Roads are the dominant linear feature in the watershed accounting for 82.5 miles or 68 percent of the total assessed features; trails totaled 32.9 miles or 27 percent; railroad grades totaled 4.2 miles or 3.5 percent (see Table 1). 16 culverts were identified as ‘impaired’, while 10 were identified as ‘at-risk’ (see Table 2).

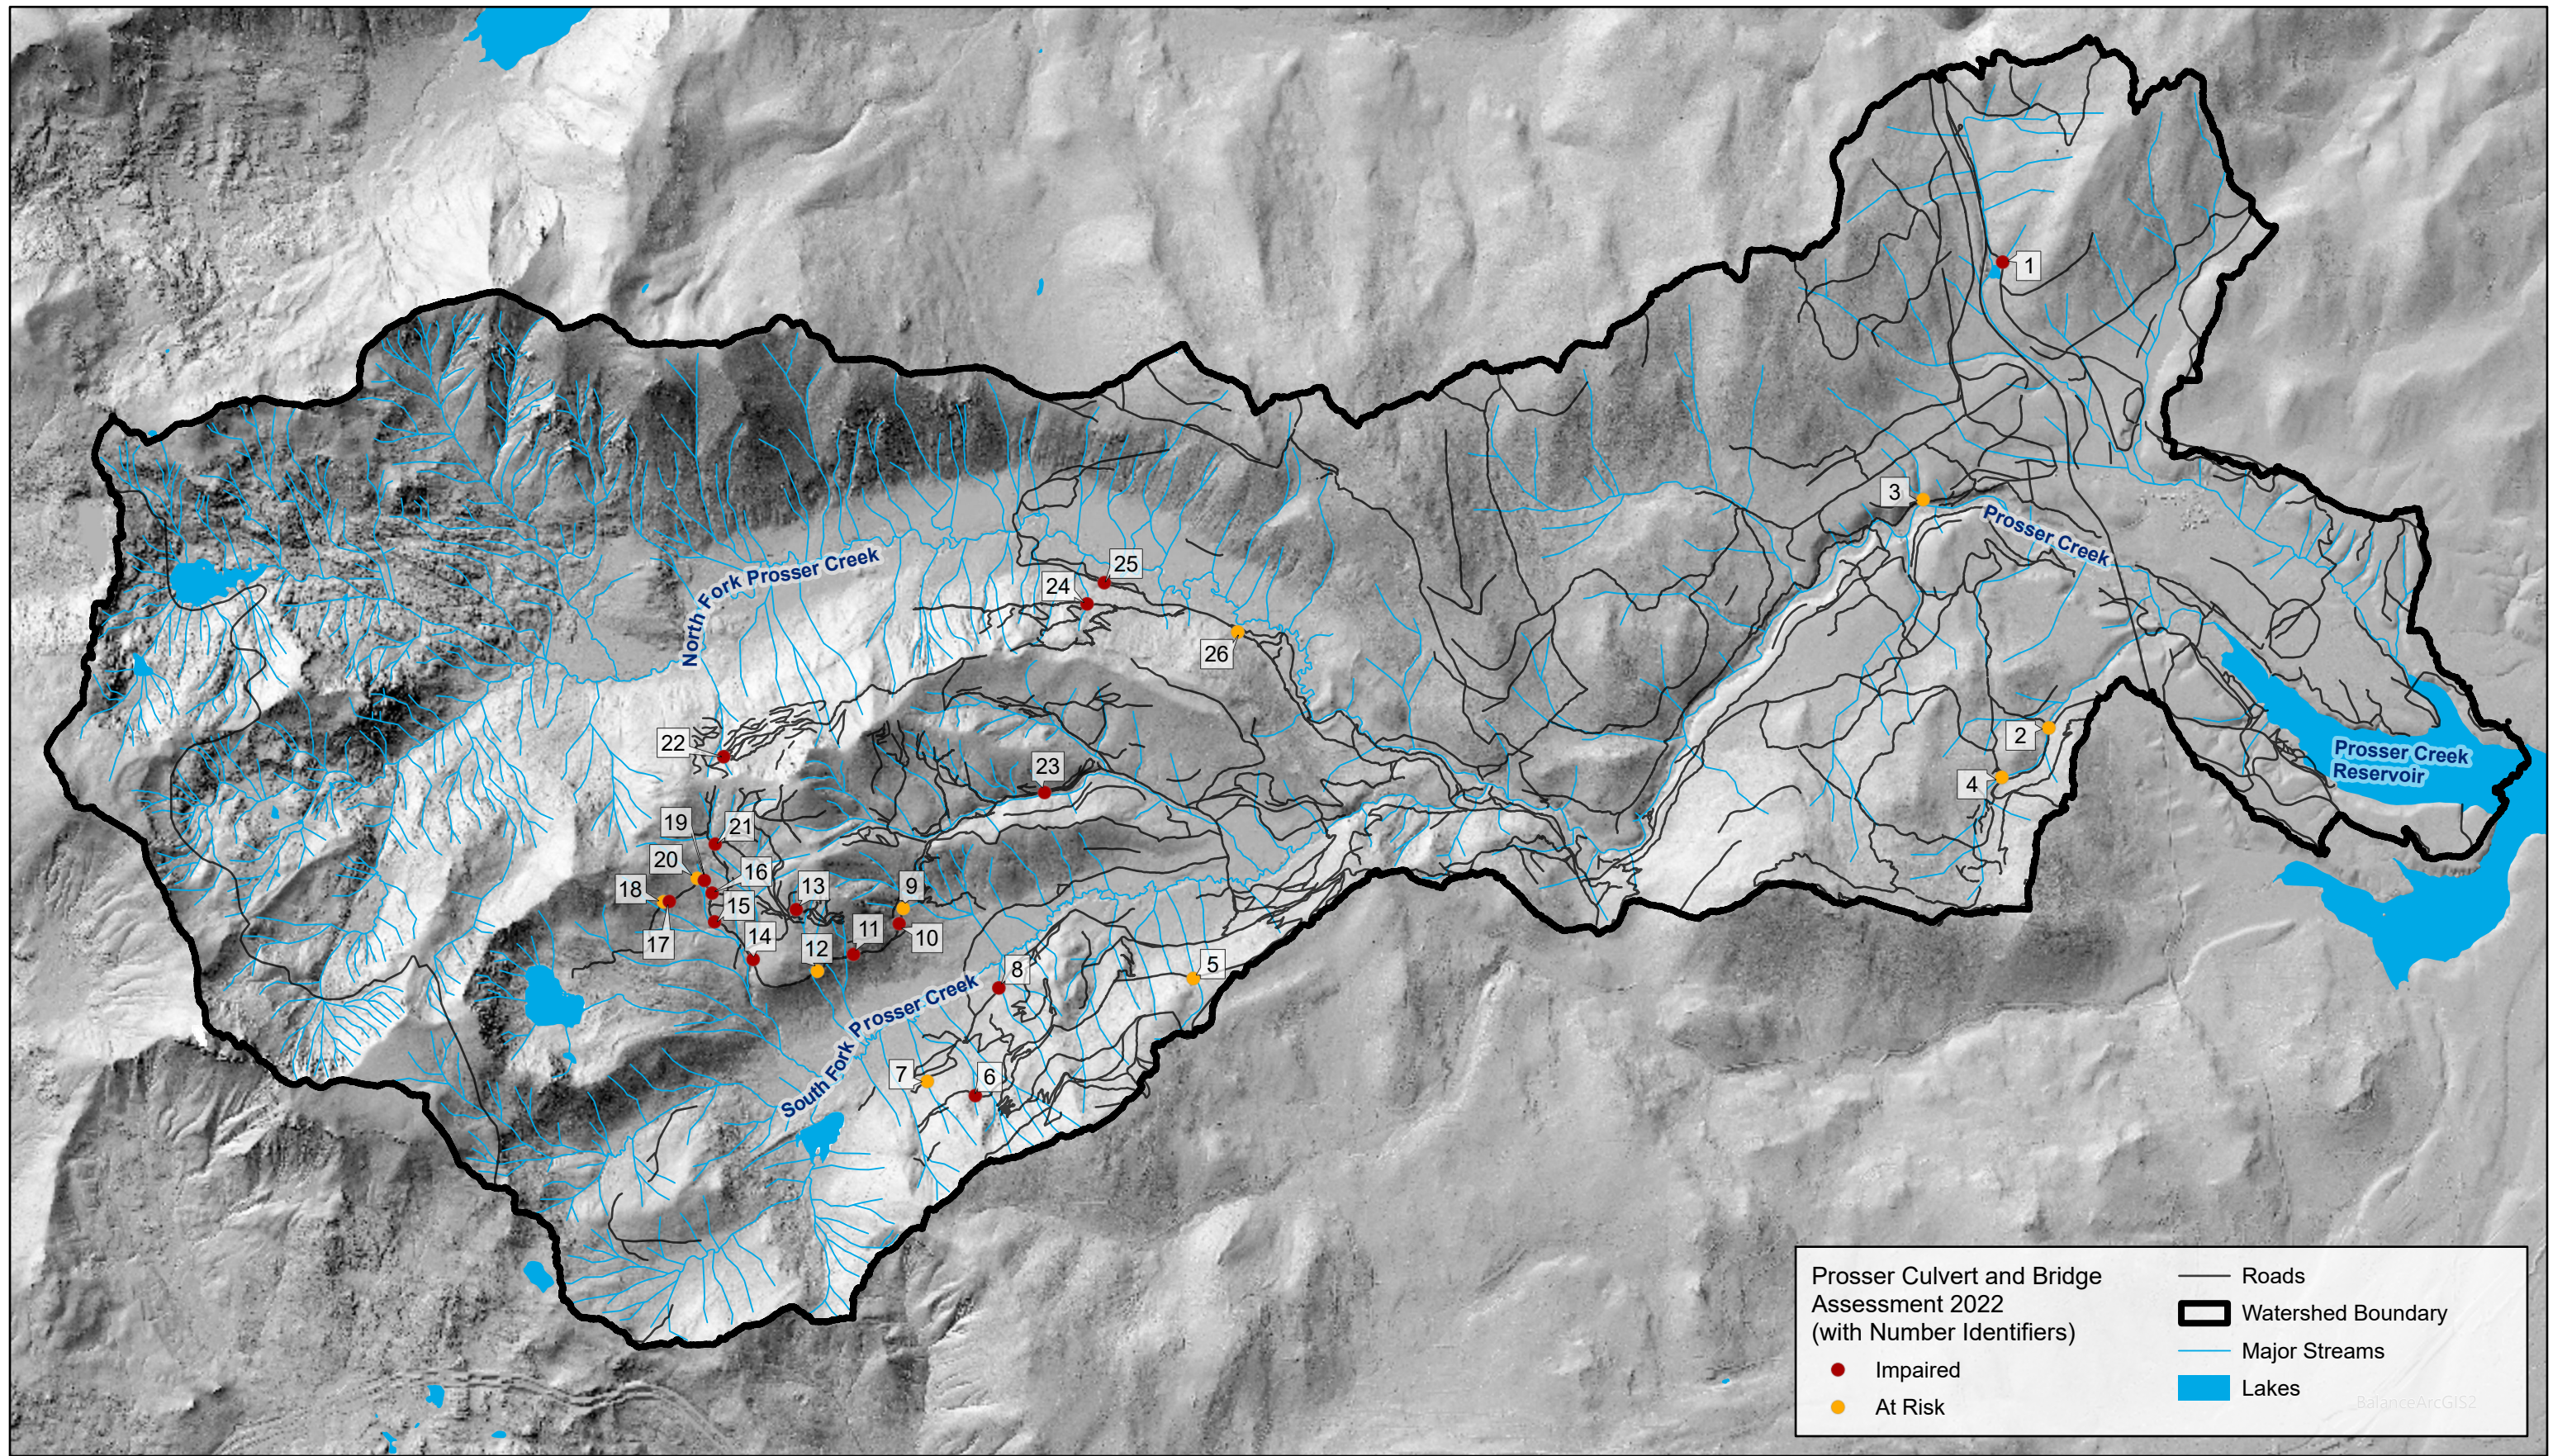
Figure 3. Culvert and Bridge Conditions Prosser Creek Watershed, Nevada County, CA

ID	Lat	Long	Road Name	Condition	Notes
1	39.416689N	120.196842W	Old Highway 89	Impaired	Filled with sediment
2	39.374751N	120.312389W		At Risk	Unimproved crossing. Stable. At risk of erosion in big event
3	39.374736N	120.312888W	Prosser Creek Trail	At Risk	Small timber bridge. Signs of significant flow and sediment coming down tributary with direct input in creek
4	39.376137N	120.309353W	NFR-89-33-06-05	At Risk	Approx. 18-in CMP. May have overtopped. Channel upstream is in coding and widening. Suggest armor road for high flow spill.
5	39.376281N	120.30997W	Firewalker	At Risk	Erosion upstream of inlet, gully erosion below
6	39.381822N	120.279927W	Firewalker	Impaired	Buried or no culvert, erosion of road prism
7	39.394381N	120.276124W		At Risk	Head cut, erosion,
8	39.395789N	120.274622W	S. Euer Valley Road	Impaired	Partially clogged culvert, road capture
9	39.400886N	120.203878W	Frog Lake Road	At Risk	No culvert, but road crosses active erosional gully

10	39.374141N	120.301443W	Frog Lake Road	Impaired	Buried, partial road capture
11	39.370023N	120.29966W	Frog Lake Road	Impaired	Buried, road capture
12	39.371119N	120.296534W	Frog Lake Road	At Risk	Partially buried
13	39.378555N	120.308394W		Impaired	No culvert, but road could've decommissioned here and topography restored, road capture, channel scour
14	39.373142N	120.292569W	Frog Lake Road	Impaired	Buried
15	39.374158N	120.292209W	Frog Lake Road	Impaired	Buried
16	39.368802N	120.284008W	Frog Lake Road	Impaired	Buried
17	39.369327N	120.267214W	Frog Lake Road	Impaired	Culvert buried in sediment
18	39.382313N	120.197276W	Frog Lake Road	At Risk	Inlet partially sedimented in, inboard ditch and culvert relocate natural drainage into willow forest
19	39.362602N	120.290255W	Frog Lake Road	Impaired	Buried, road now captures stream
20	39.361629N	120.286114W	Frog Lake Road	At Risk	Road runoff entering channel at culvert

21	39.384379N	120.307601W		Impaired	Undersized
22	39.392423N	120.263139W		Impaired	Covered in debris from large colluvial channel
23	39.385587N	120.193185W	Crabtree Canyon	Impaired	No culvert, road dip is also tributary crossing, excess runoff and sediment to creek
24	39.37337N	120.308507W		Impaired	Inlet of culvert covered in sediment
25	39.375287N	120.308693W	Carpenter Valley Road	Impaired	Buried
26	39.370839N	120.305198W	Carpenter Valley Road	At Risk	Filled with sediment and vegetation

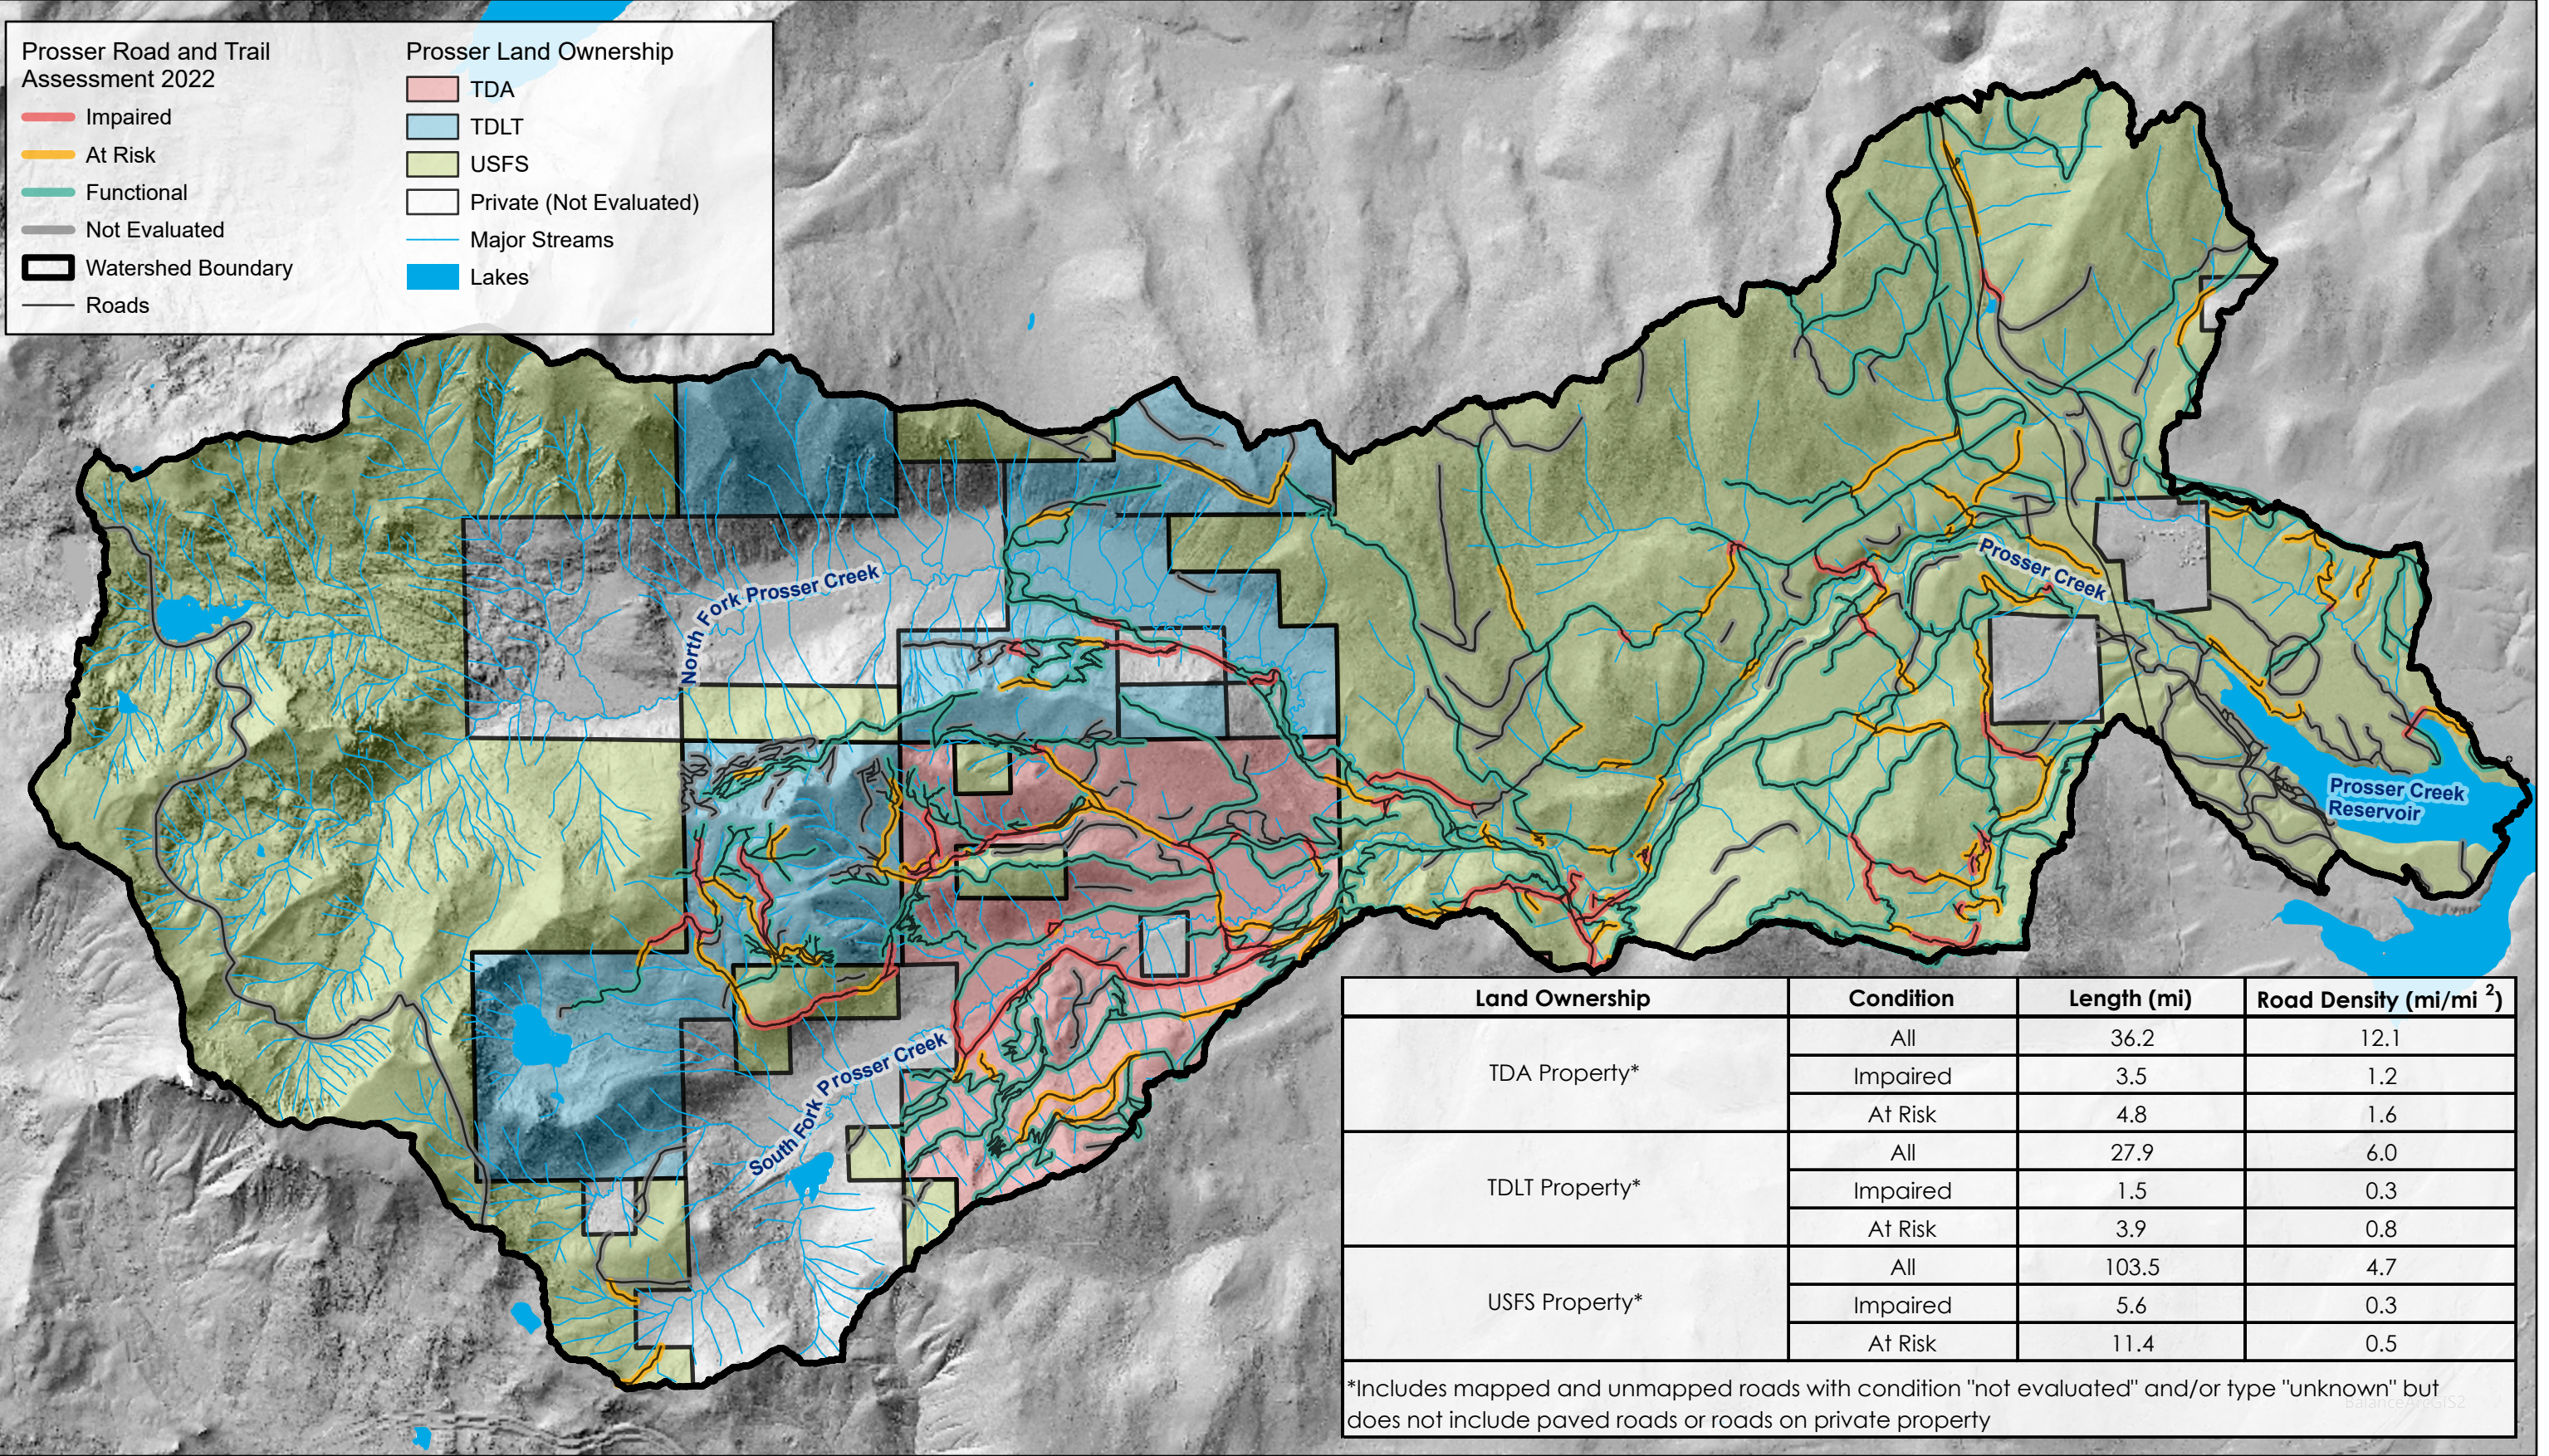
Figure 4. Roads, Trails, and Railroad Grade Conditions and Property Ownership Prosser Creek Watershed, Nevada County, CA

Figure 4 shows road/trail/grade conditions relative to property boundaries and land ownership in the Prosser Creek watershed. **Table 4** provides lengths of 'impaired' and 'at-risk' road/trail/grade conditions and density for each landowner. USFS (Tahoe National Forest) manages the majority of lands in the watershed and includes the bulk of road/trail/grade miles; however, based on feature density, TDA and TDLT manage lands with higher road/trail/grade densities, including those features with 'at-risk' and 'impaired' conditions.

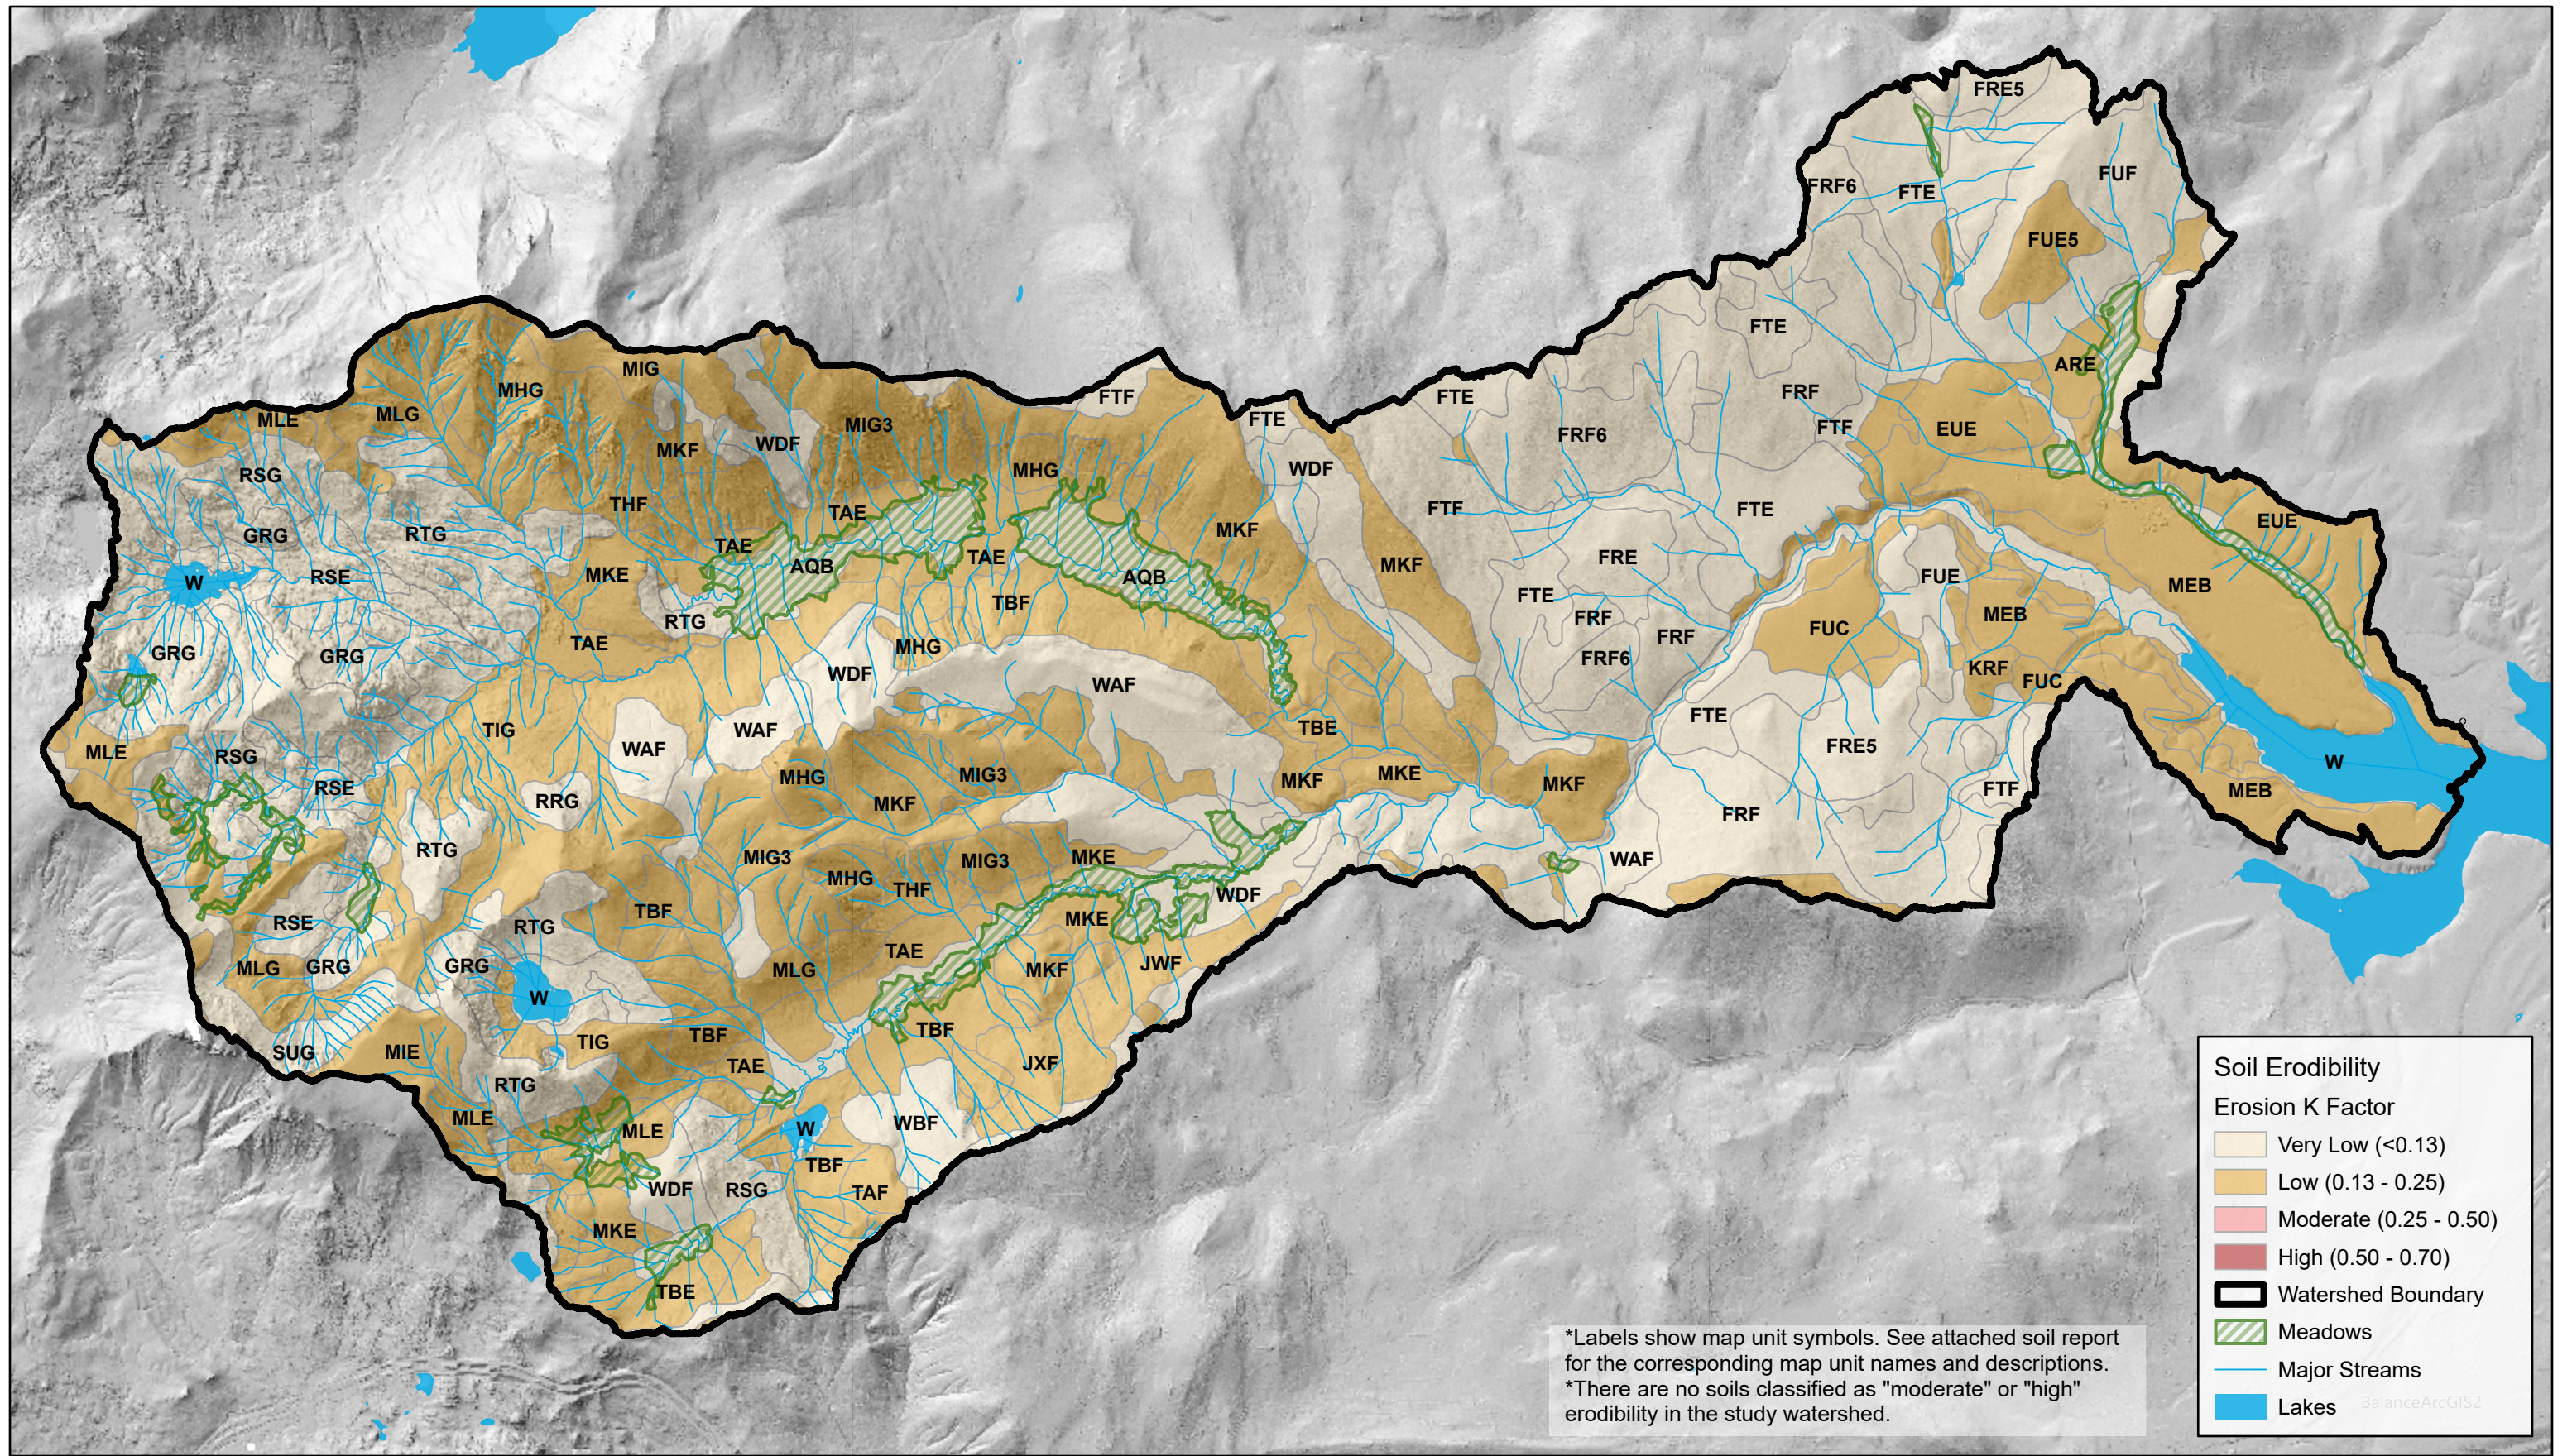
Figure 5. Soil Erodibility
Prosser Creek Watershed, Nevada County, CA

Figure 5 shows road/trail/grade conditions relative to soil erodibility in the Prosser Creek watershed, based on the erosion factor "K" used in the Revised Universal Soil Loss Equation (Renard and others, 1991). The K-factor indicates the susceptibility of a soil to sheet and rill erosion by water. Values of K range from 0.02 to 0.70 with some very rare soils with a value greater than 0.70. The higher the value, the more susceptible the soil is to sheet and rill erosion. It should be noted that these values do not account for the presence of or disturbance from a road, trail or grade. These values also do not capture or identify areas subject to geologic hazards such as landslides and debris flows. Instead, we use these values conservatively to assess potential for erosion if a road, trail or grade discharged runoff to adjacent soils. Soil erodibility classes used in our assessment are provided in **Table 5**. Soils in the watershed are classified as having low to very low erodibility with no soils classified as having moderate, high or very high erodibility.

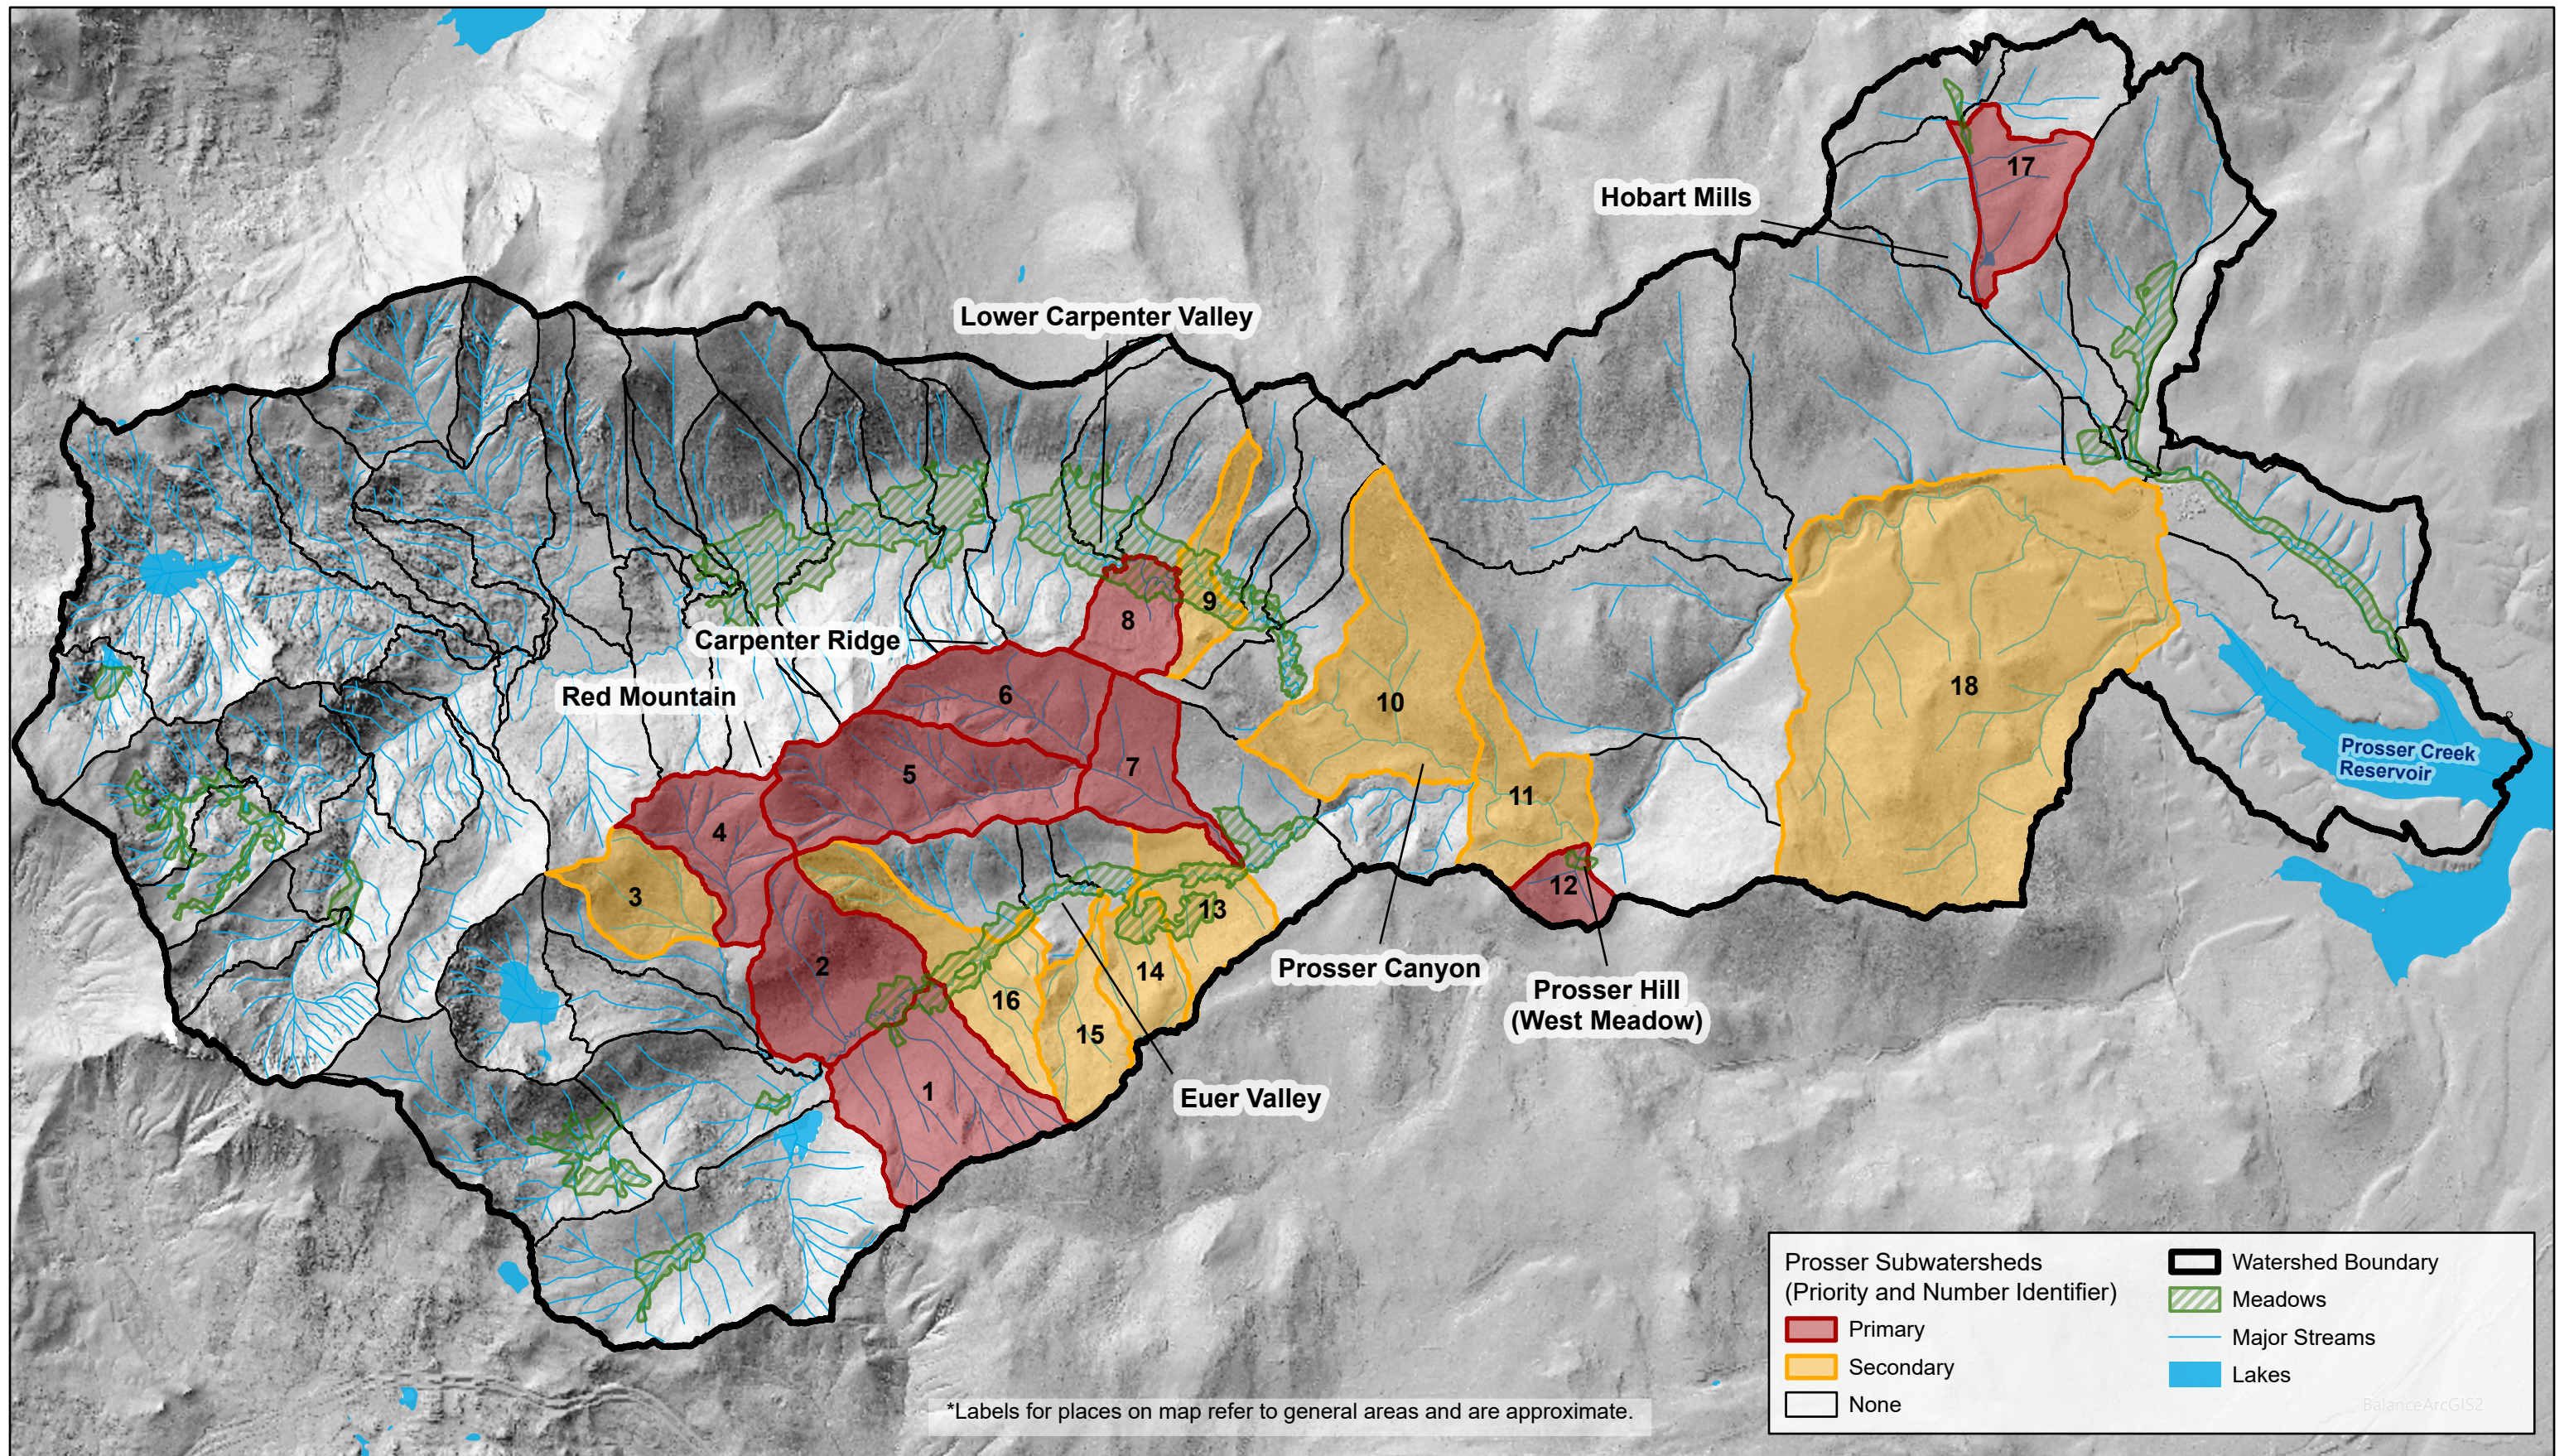
Figure 6. Priority Subwatersheds Identified in Roads and Trails Assessment Prosser Creek Watershed, Nevada County, CA

Figure 6 shows subwatersheds ranked by management priority: (a) primary, (b) secondary, (c) none. **Table 6** lists each subwatershed with a primary or secondary priority, area, and land ownership. In general, areas identified for primary priority management include:

- Euer Valley including Crabtree Canyon
- Red Mountain (south drainage)
- Carpenter Ridge-draining to Lower Carpenter Valley
- Prosser Hill, West Meadow (improvements completed September 2022)
- Hobart Mills Reservoir

- Red Mountain (south drainage)
- Lower Carpenter Valley (minor drainages)
- Prosser Canyon (below confluence of NF and SF)
- Euer Valley (north-facing drainages)
- Prosser Hill and OHV area
