Conceptual Design and Feasibility Study Mainstem Martis Creek Placer County, California

August 2016

**Balance
Hydrologics, Inc.®**

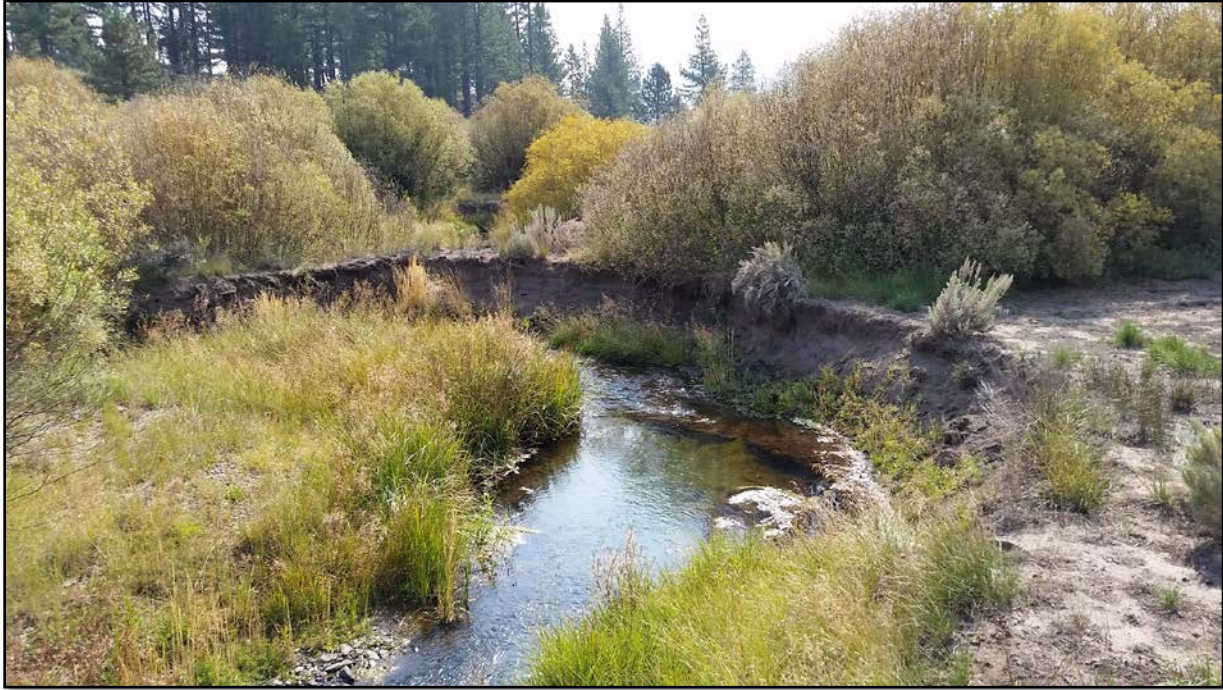
Mainstem Martis Creek exhibits impaired channel functions. In many reaches within the project area we observed recent channel down-cutting or incision of more than 4 to 5 feet below the meadow surface (**Figure 3-1**). As a result, frequent floods are confined within a narrow active channel, disconnected from adjacent floodplains and meadow surfaces. Incised channels also appear to have lowered the adjacent groundwater table and vegetation communities in these areas appear to have converted to more dry upland species, with loss of wetland and meadow habitats. Furthermore, where tributaries and swales enter an incised Martis Creek, large headcuts have formed, threatening additional functioning meadow habitat.

Figure 3-1 Martis Creek. Current conditions in some reaches exhibit an incised channel with disconnected floodplains.

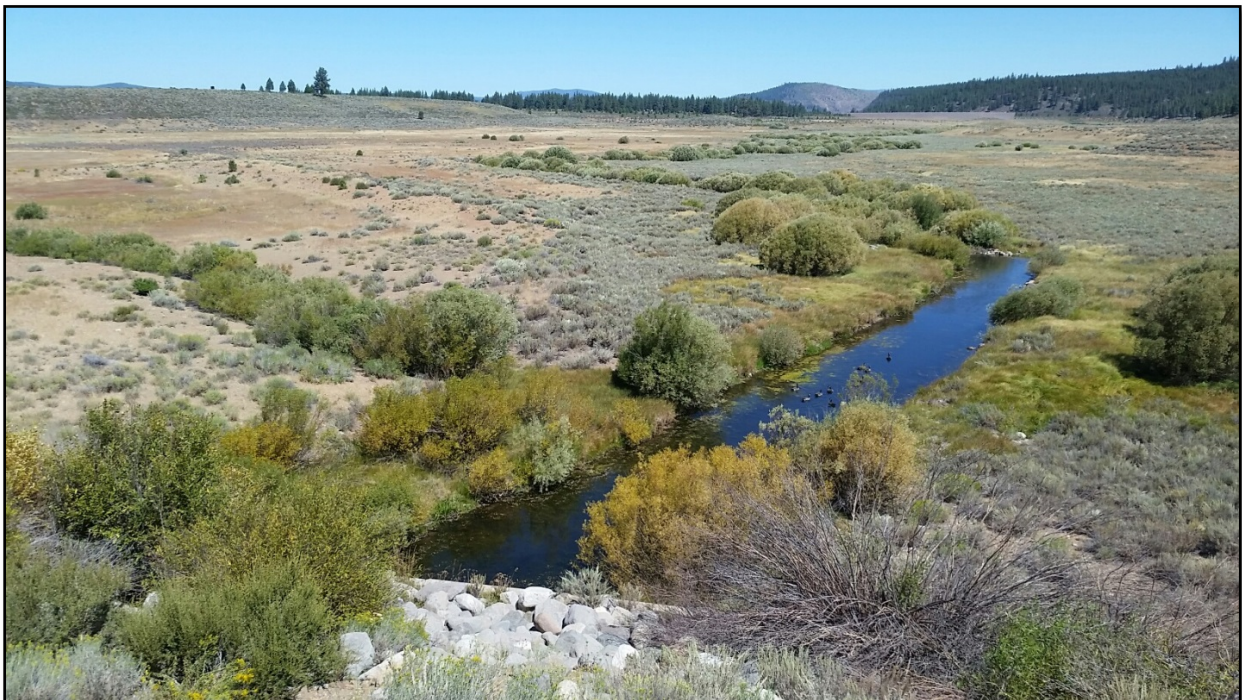
Lower reaches of Martis Creek (reaches 5 and 6, see Plate 1) have undergone straightening, bank hardening, and levee construction (**Figure 3-2**).

Figure 3-2 Martis Creek, Downstream of Highway 267. Channel has been straightened with construction of levees along the left bank.

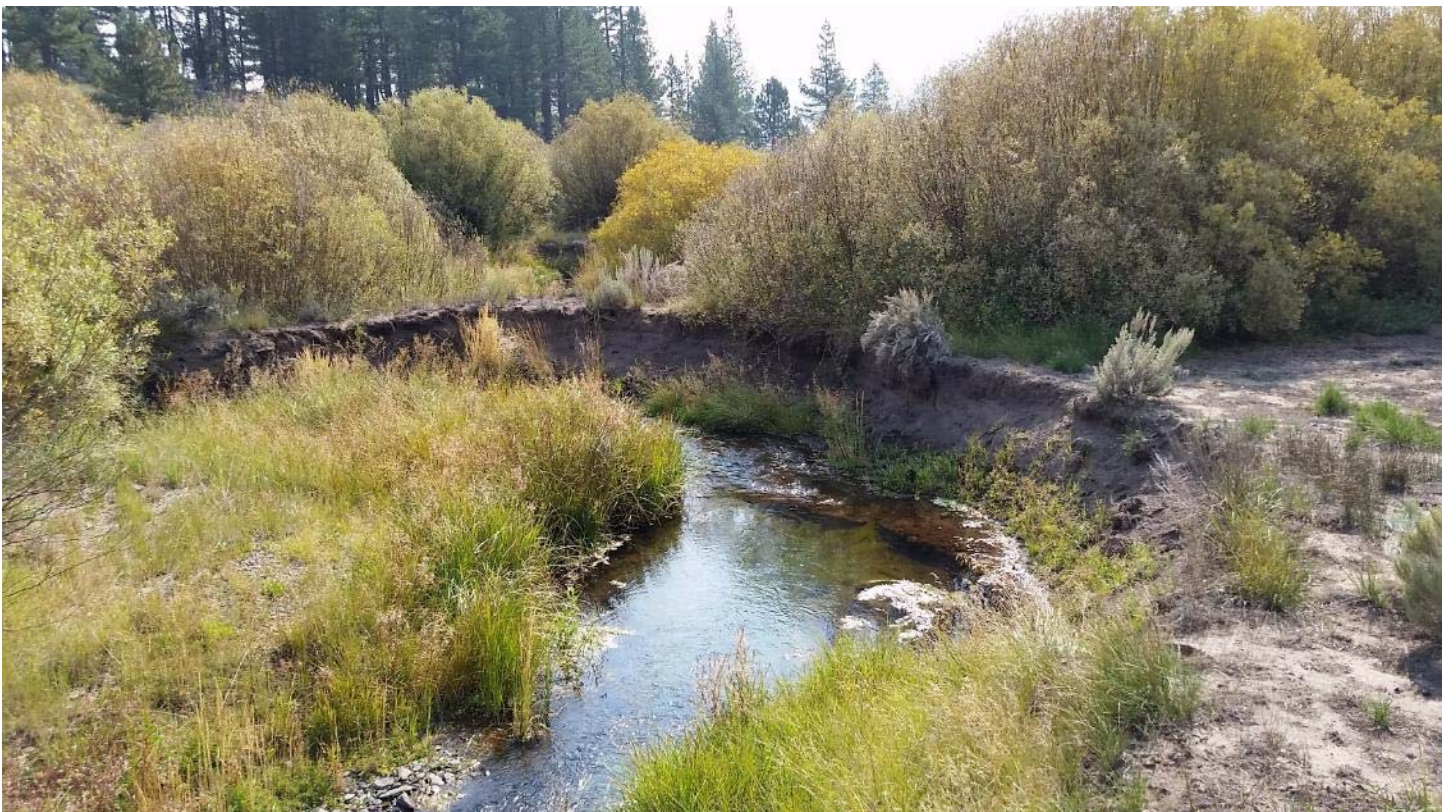
Incised channel and bank erosion, Mainstem Martis Creek, Reach 1

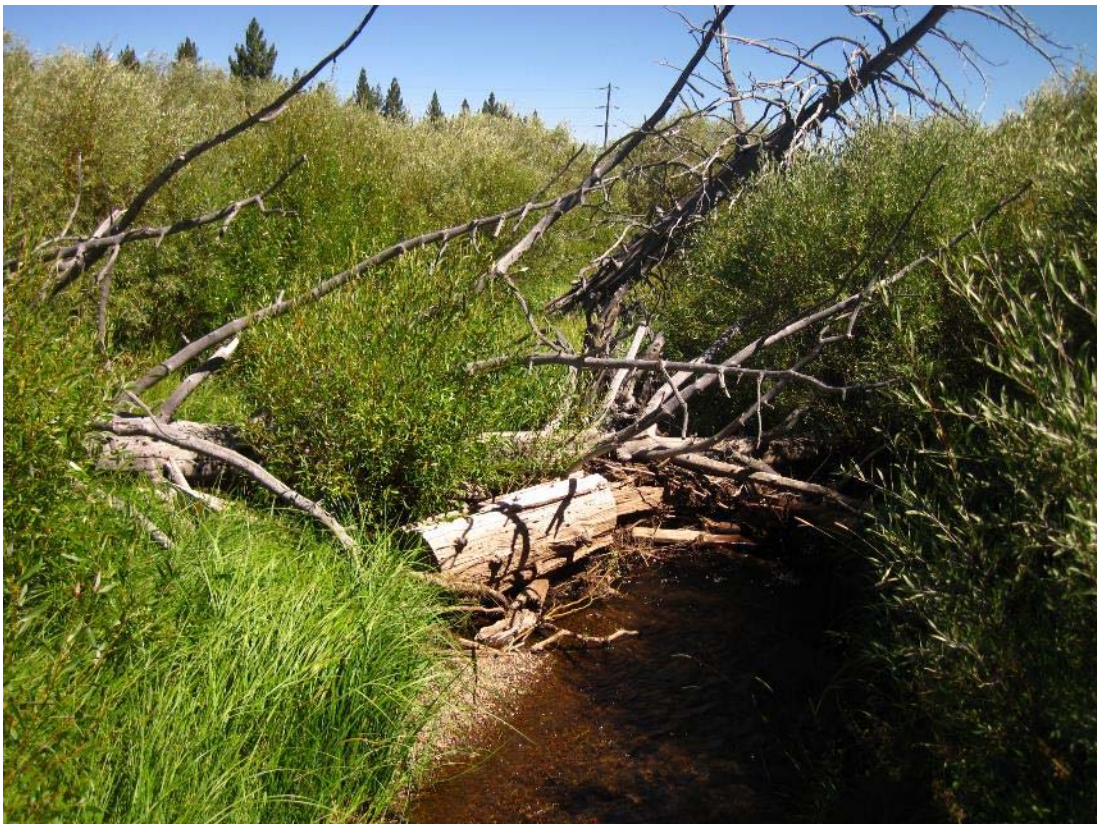
Abandoned point of diversion to irrigation ditch, Mainstem Martis Creek, Reach 1

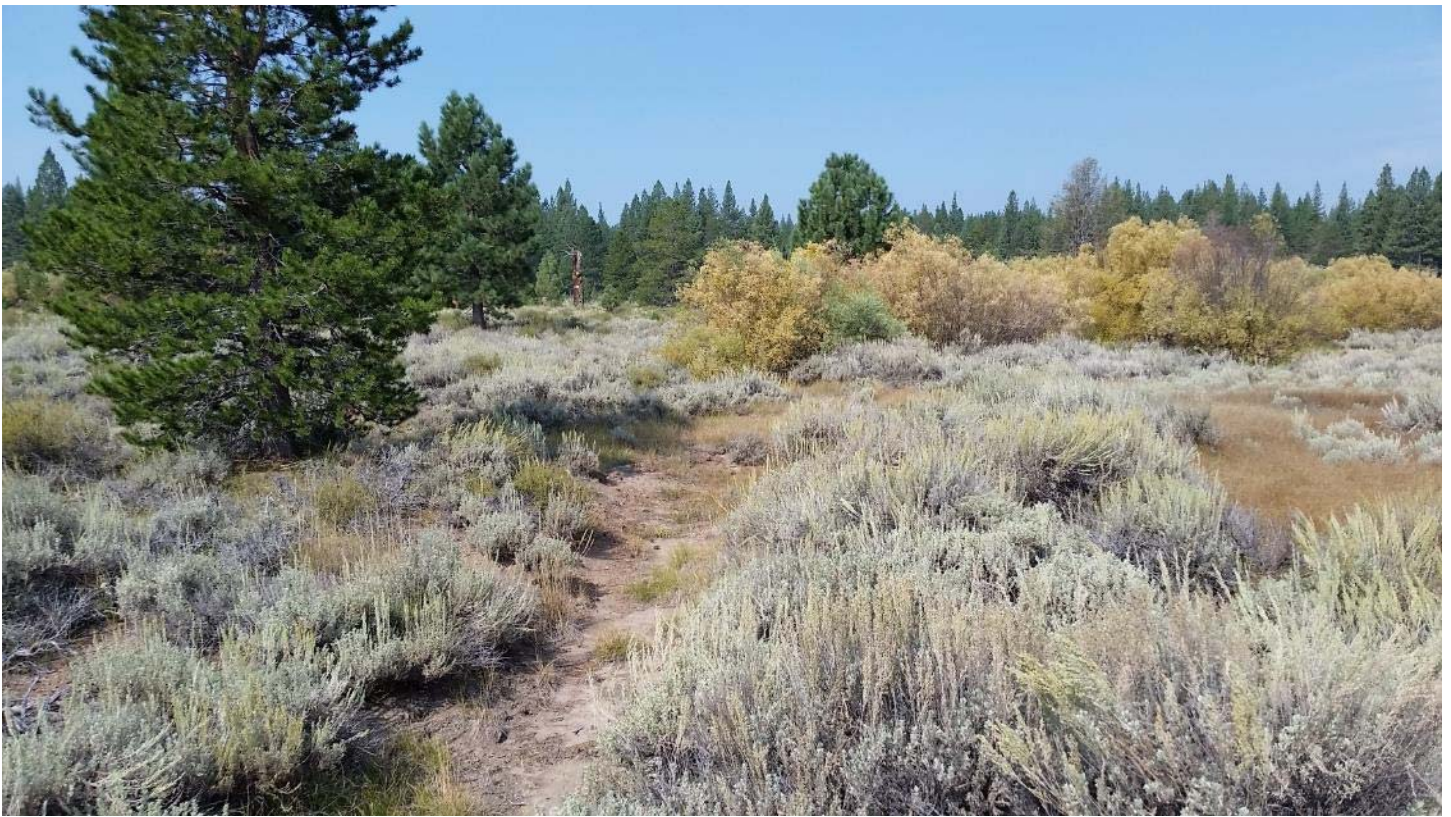
Abandoned irrigation ditch, Mainstem Martis Creek, Reach 1

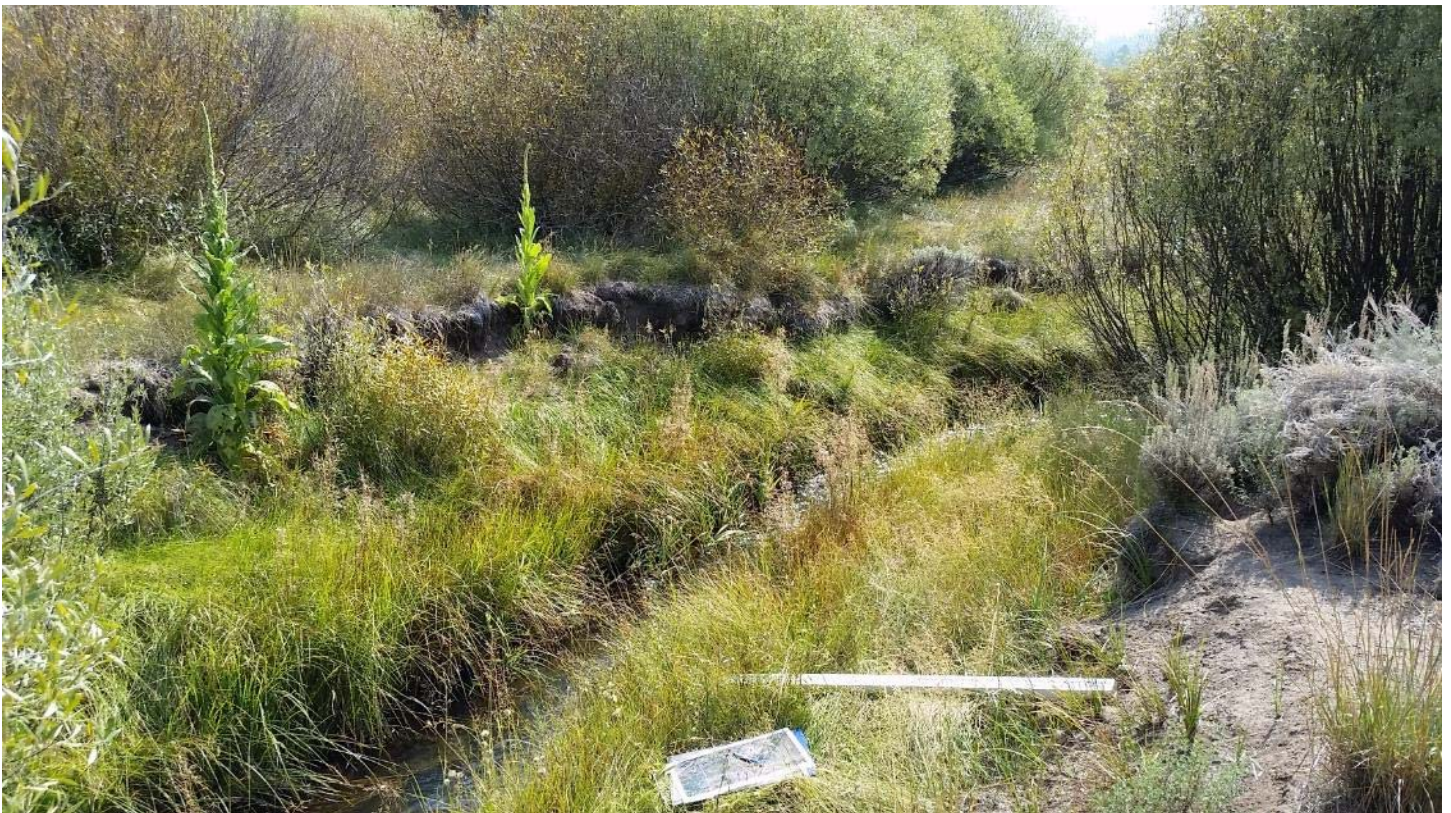
Incised and widening channel, Mainstem Martis Creek, Reach 1

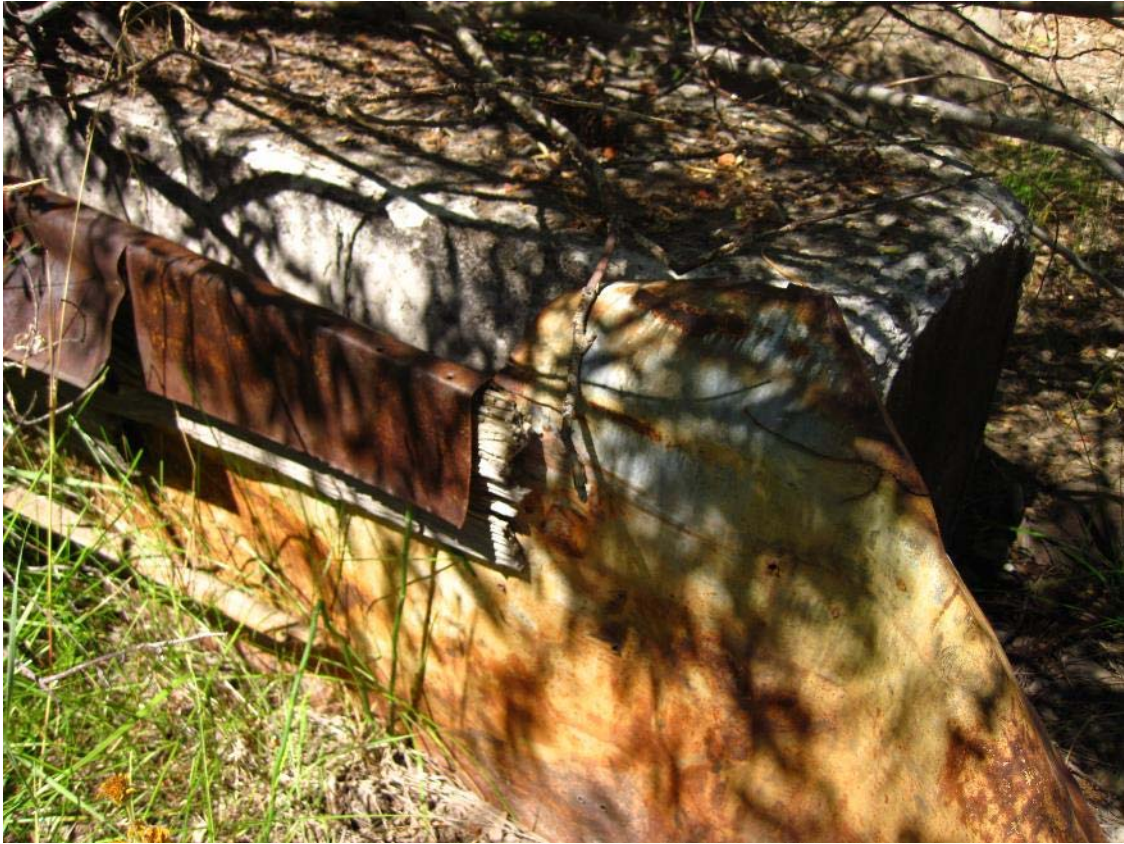
Abandoned diversion structure, Mainstem Martis Creek, Reach 1

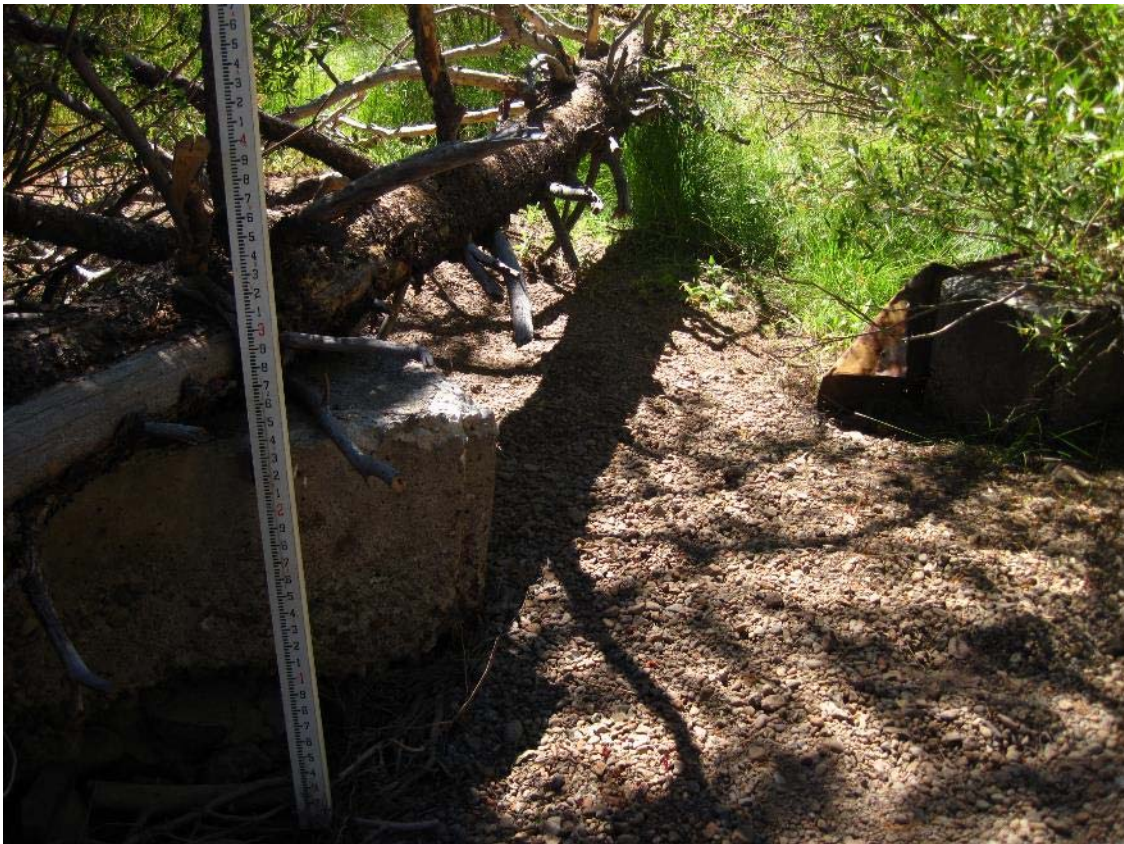
Abandoned diversion structure, Mainstem Martis Creek, Reach 1

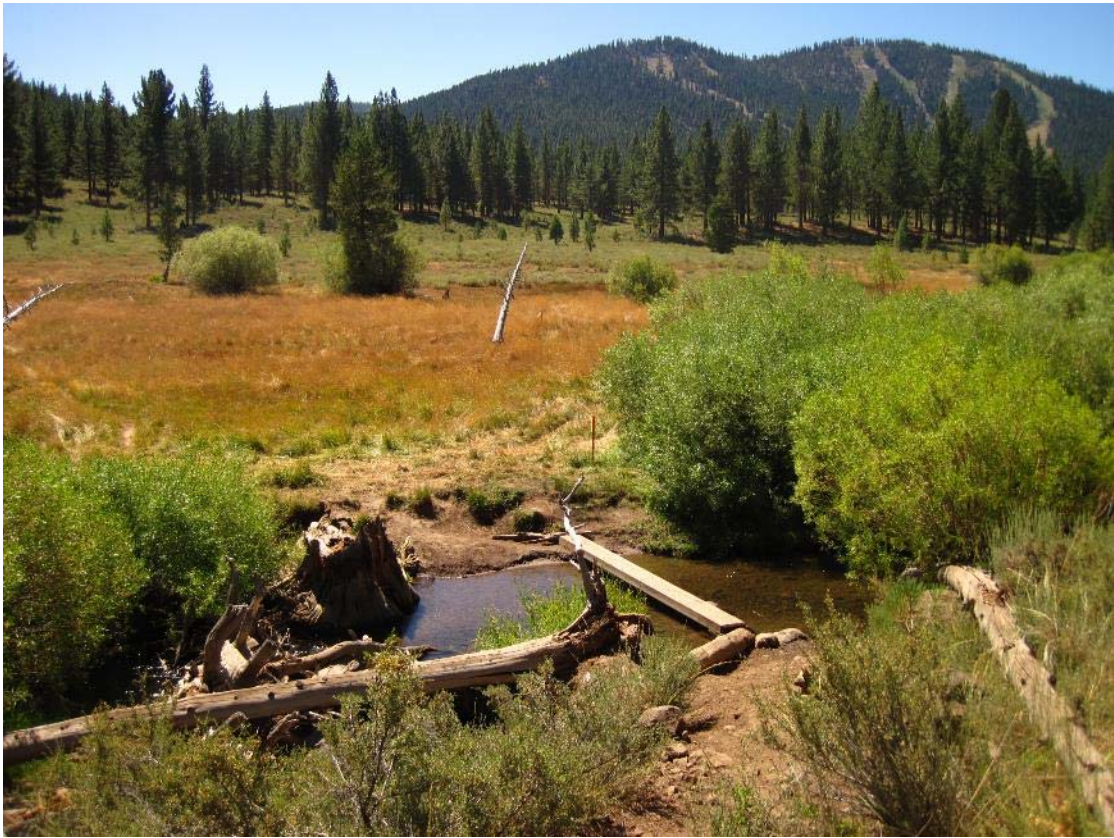
Unofficial footbridge/trail and bank erosion, Mainstem Martis Creek, Reach 1

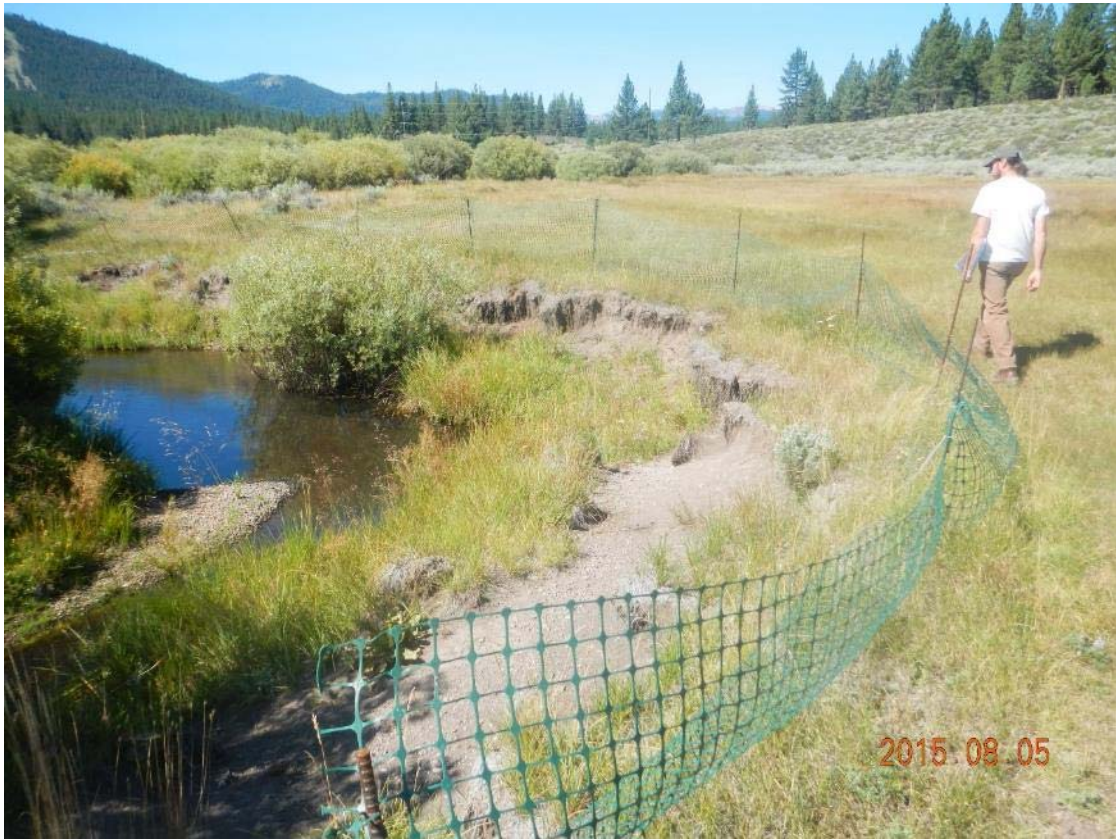
Active bank erosion, Mainstem Martis Creek, Reach 3

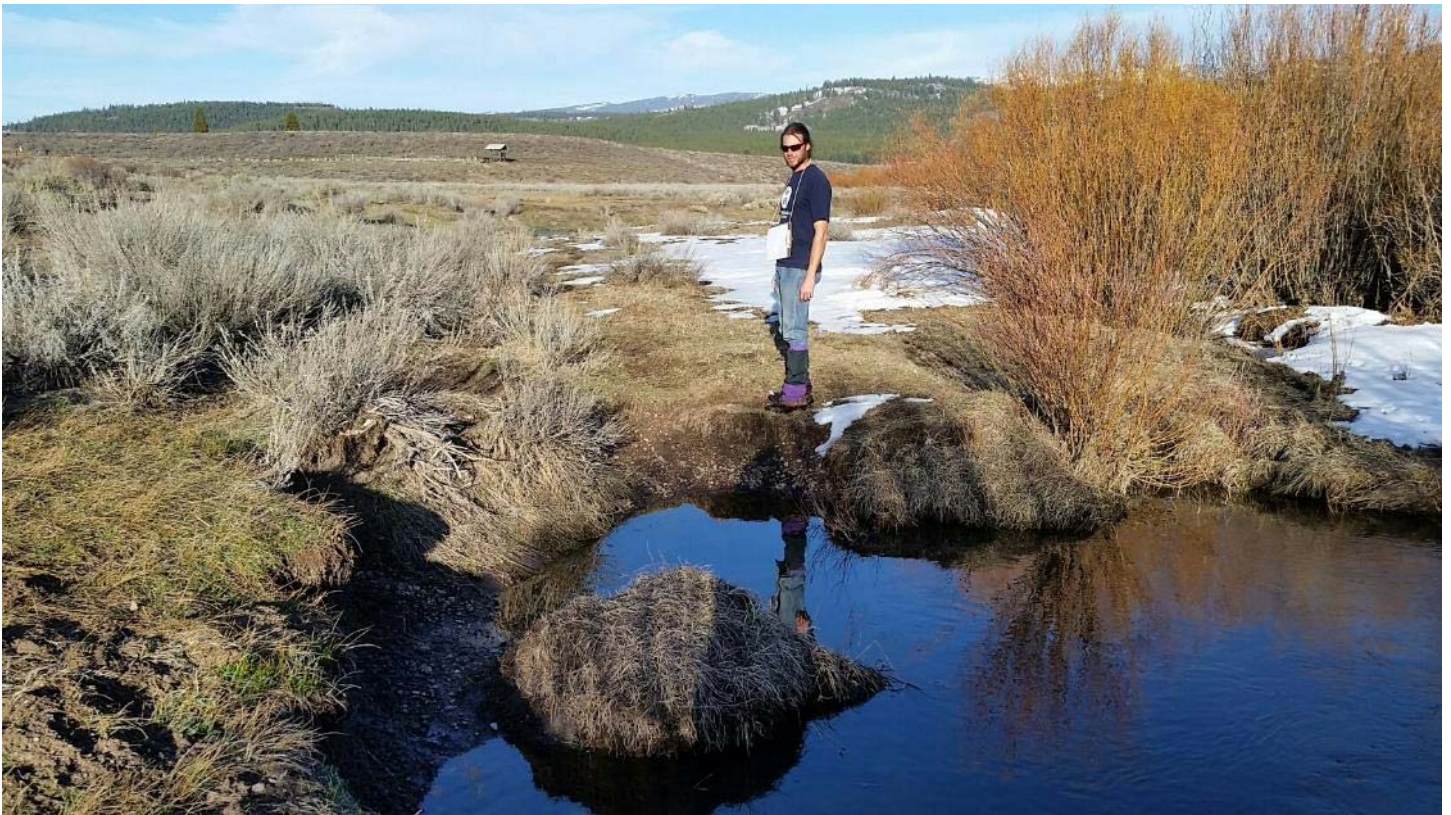
Abandoned floodplain, Mainstem Martis Creek at 50 cfs, Reach 3

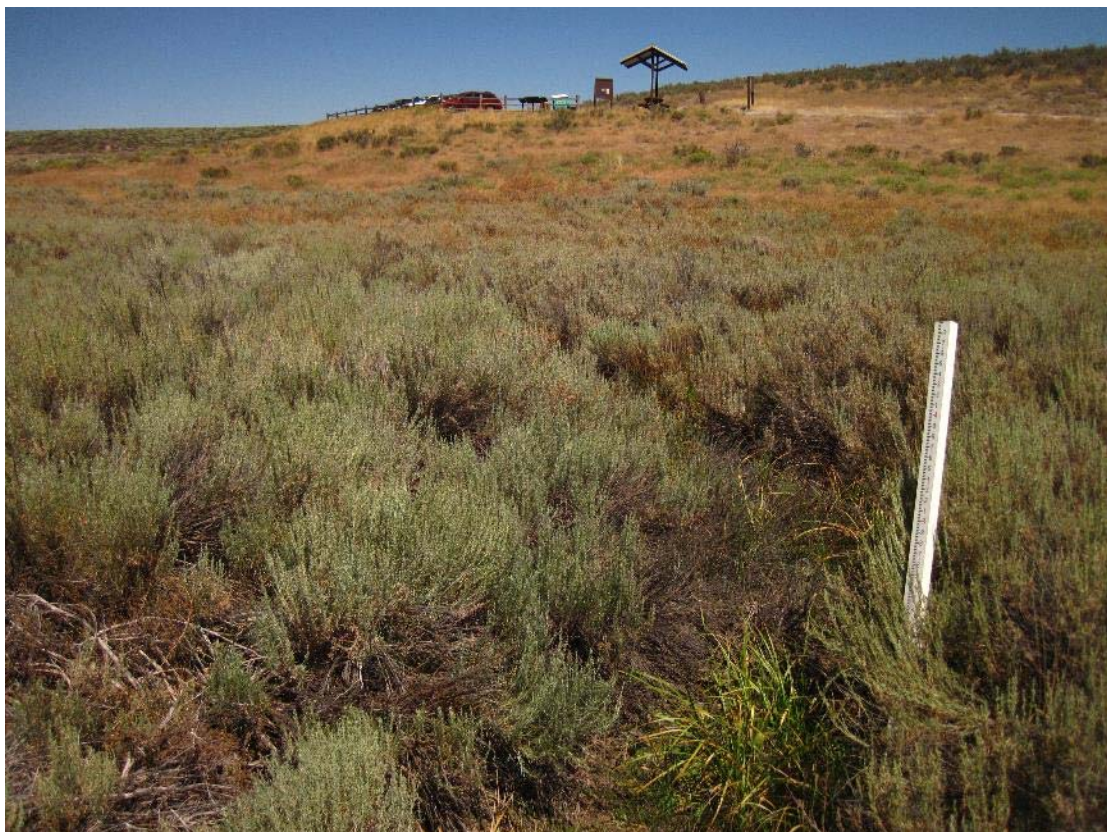
Abandoned floodplain channel, meadow conversion, Mainstem Martis Creek, Reach 3

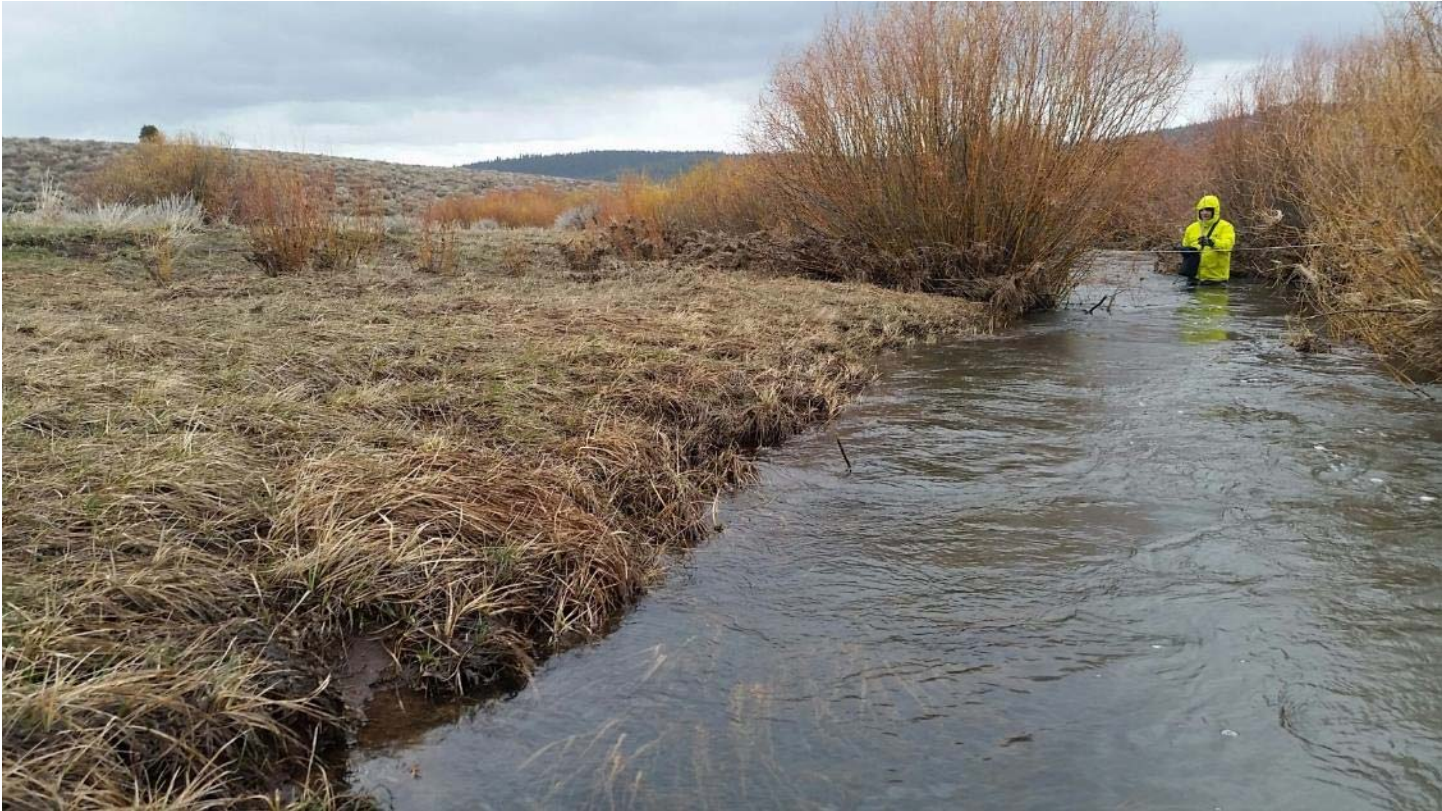
50 cfs, flow confined to a single channel, Mainstem Martis Creek, Reach 3

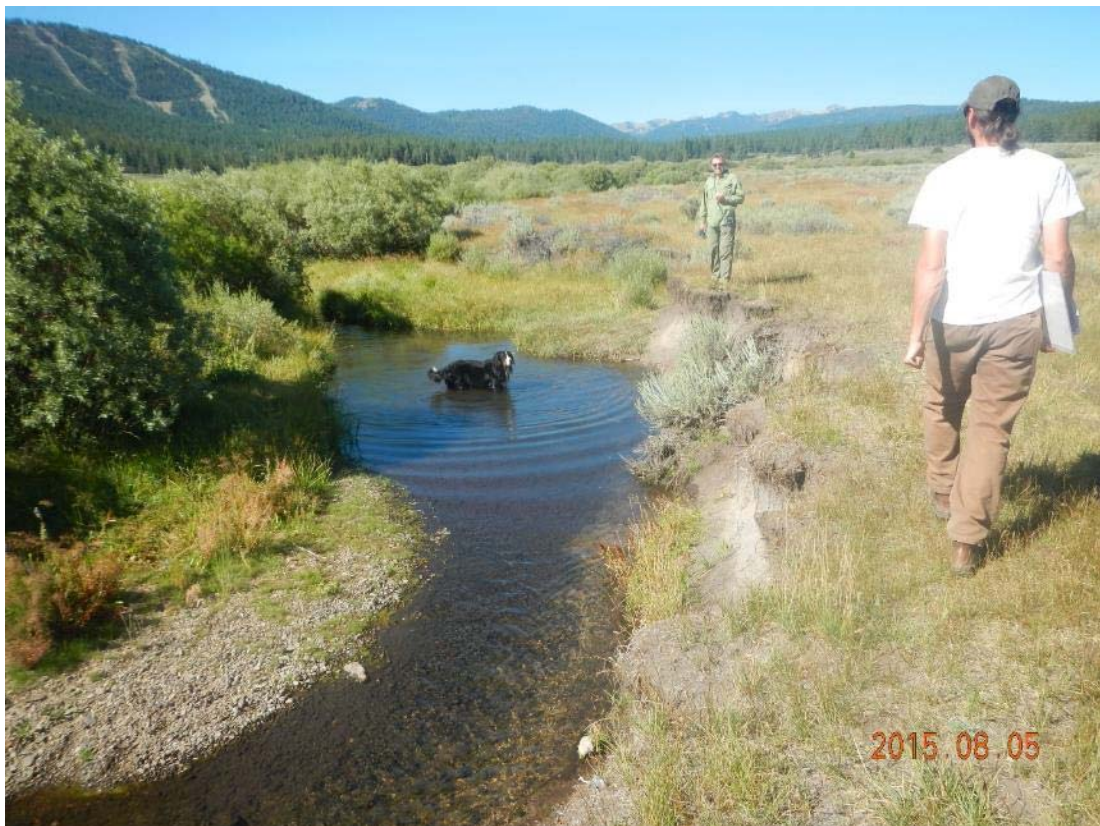
Bank erosion and meadow conversion, Mainstem Martis Creek, Reach 4

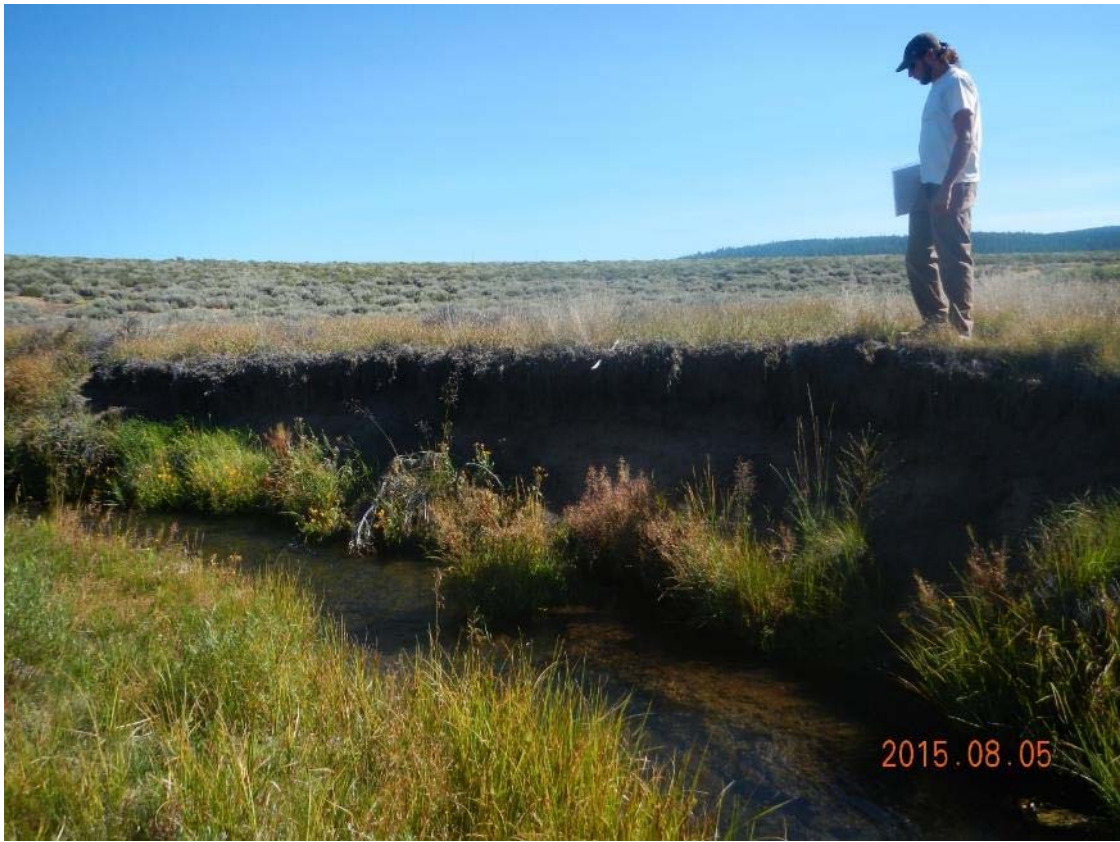
Active bank erosion, widening and meadow conversion, Mainstem Martis Creek, Reach 4

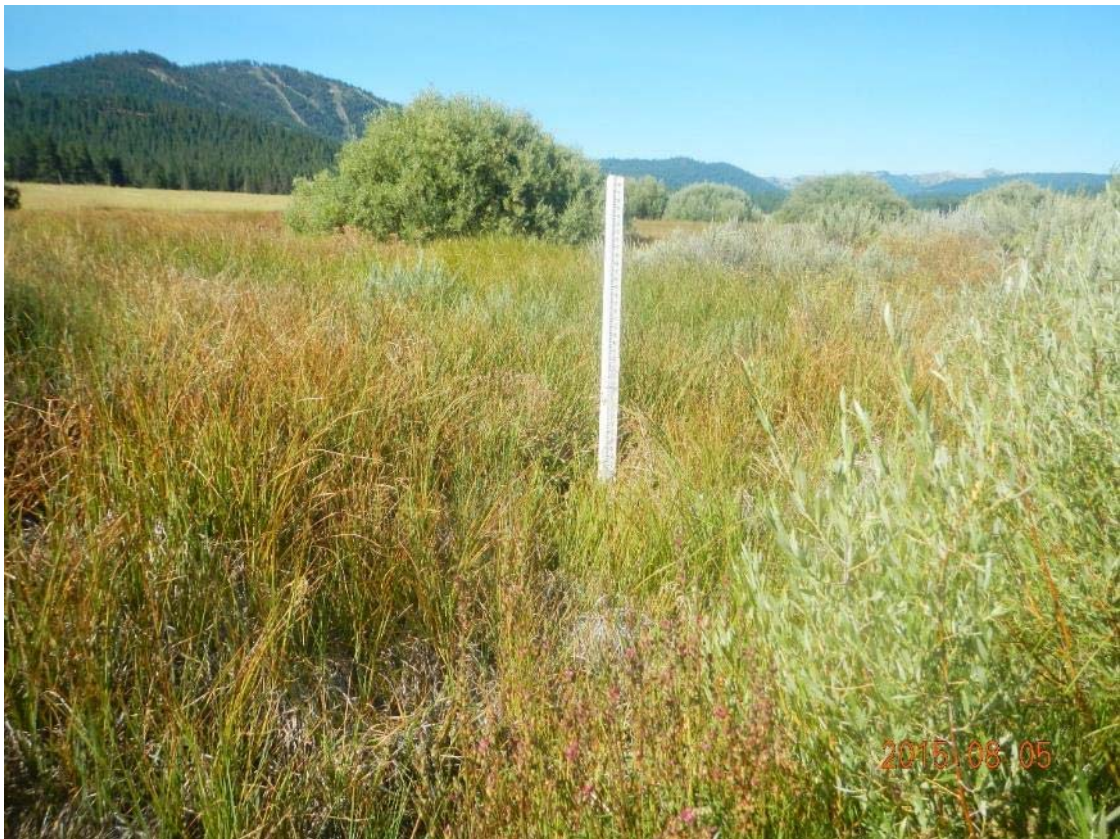
Knickpoint erosion, swale tributary to Mainstem Martis Creek, Reach 4

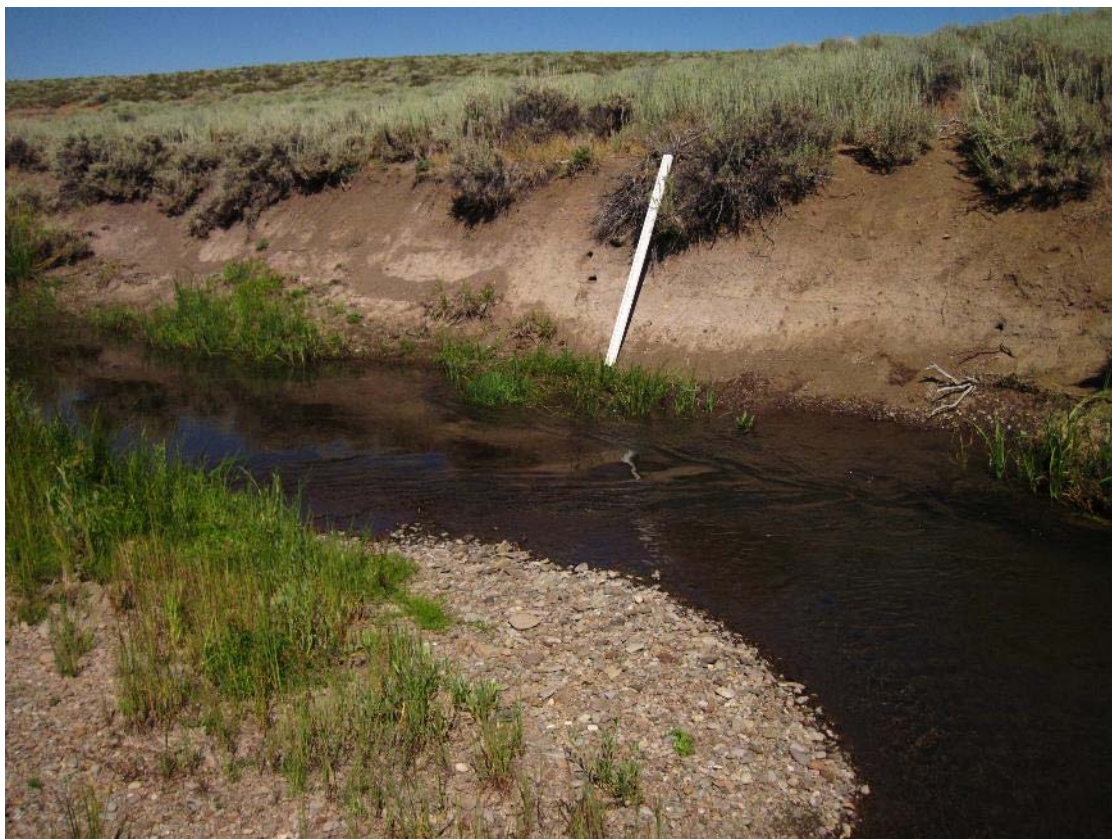
Bank erosion and widening, Mainstem Martis Creek, Reach 4

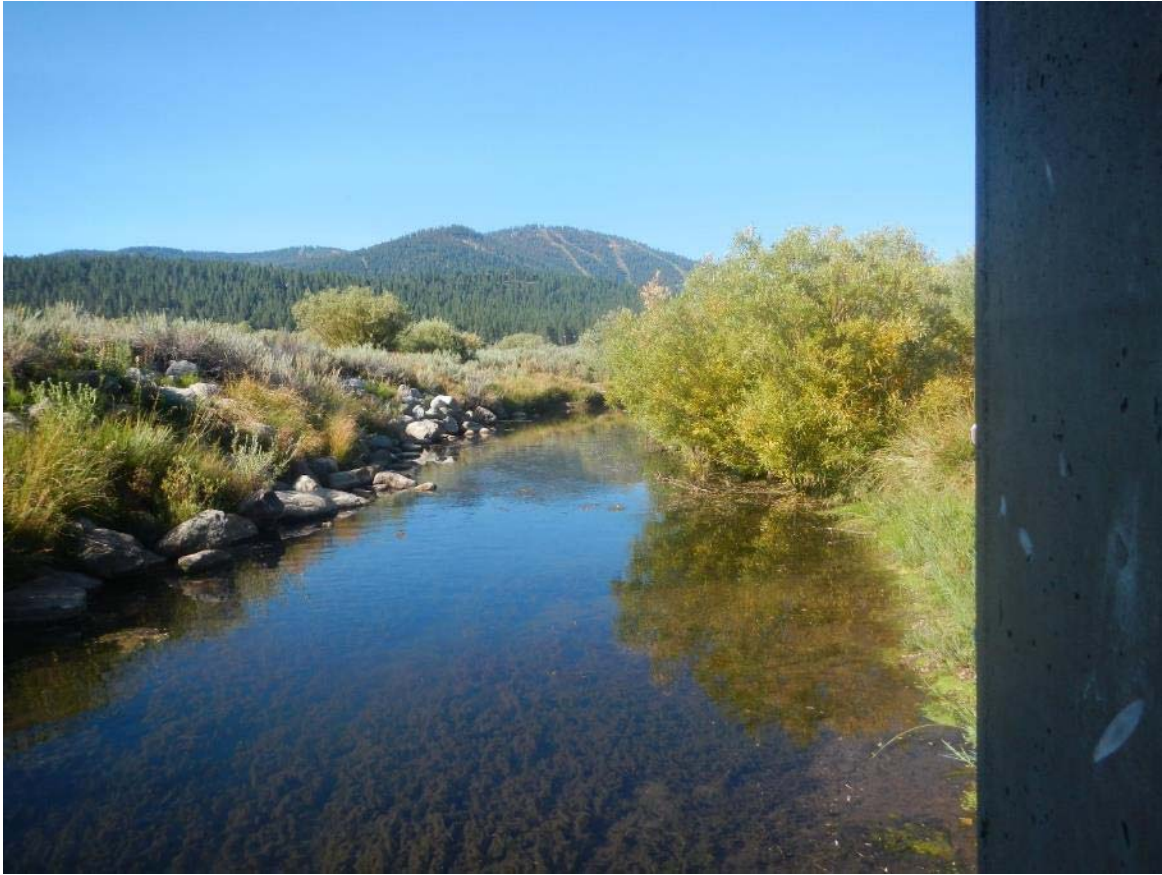
Levee and channel straightening, Mainstem Martis Creek, Reach 5

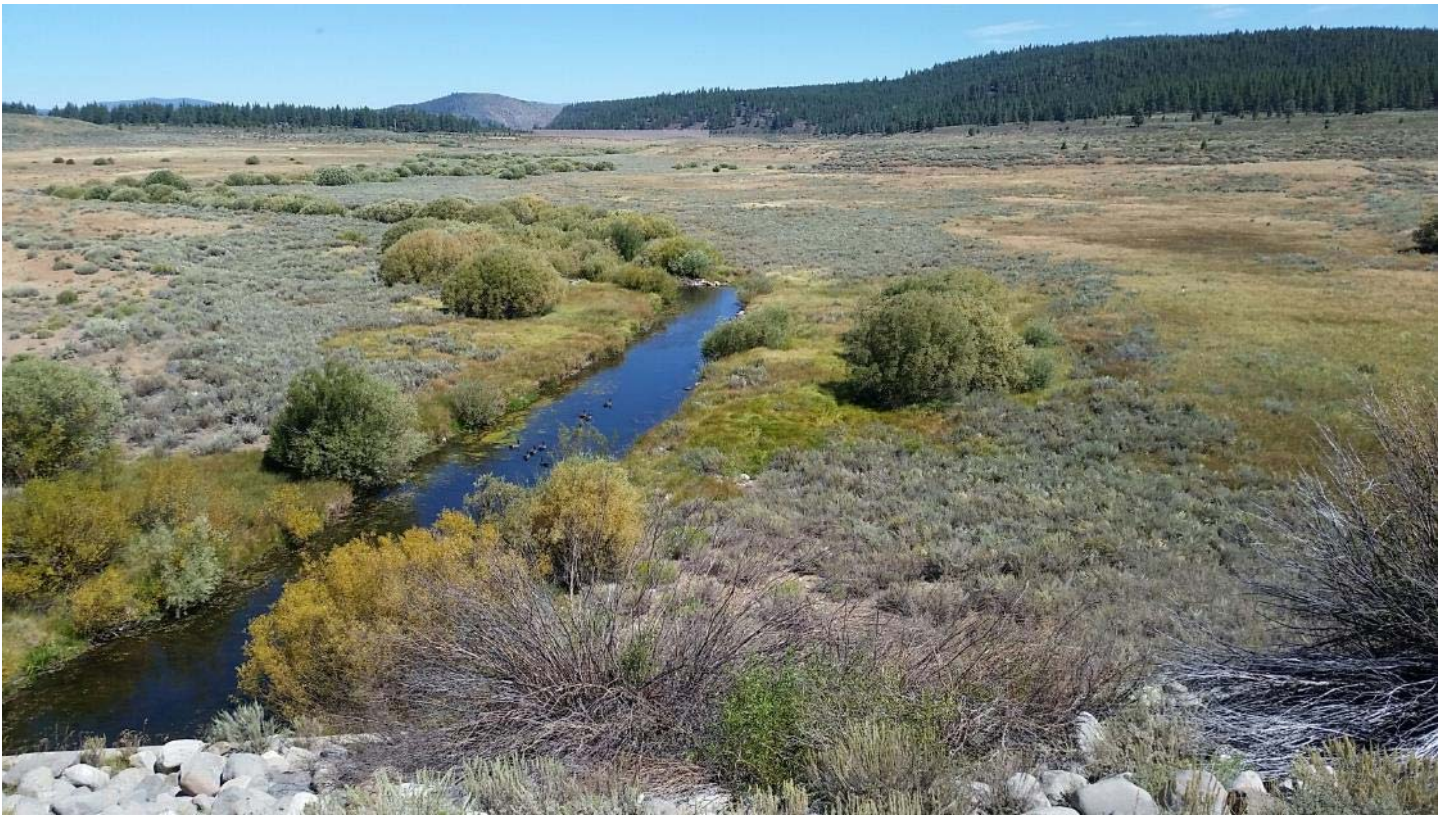
Straightened channel segment, Mainstem Martis Creek, Reach 5

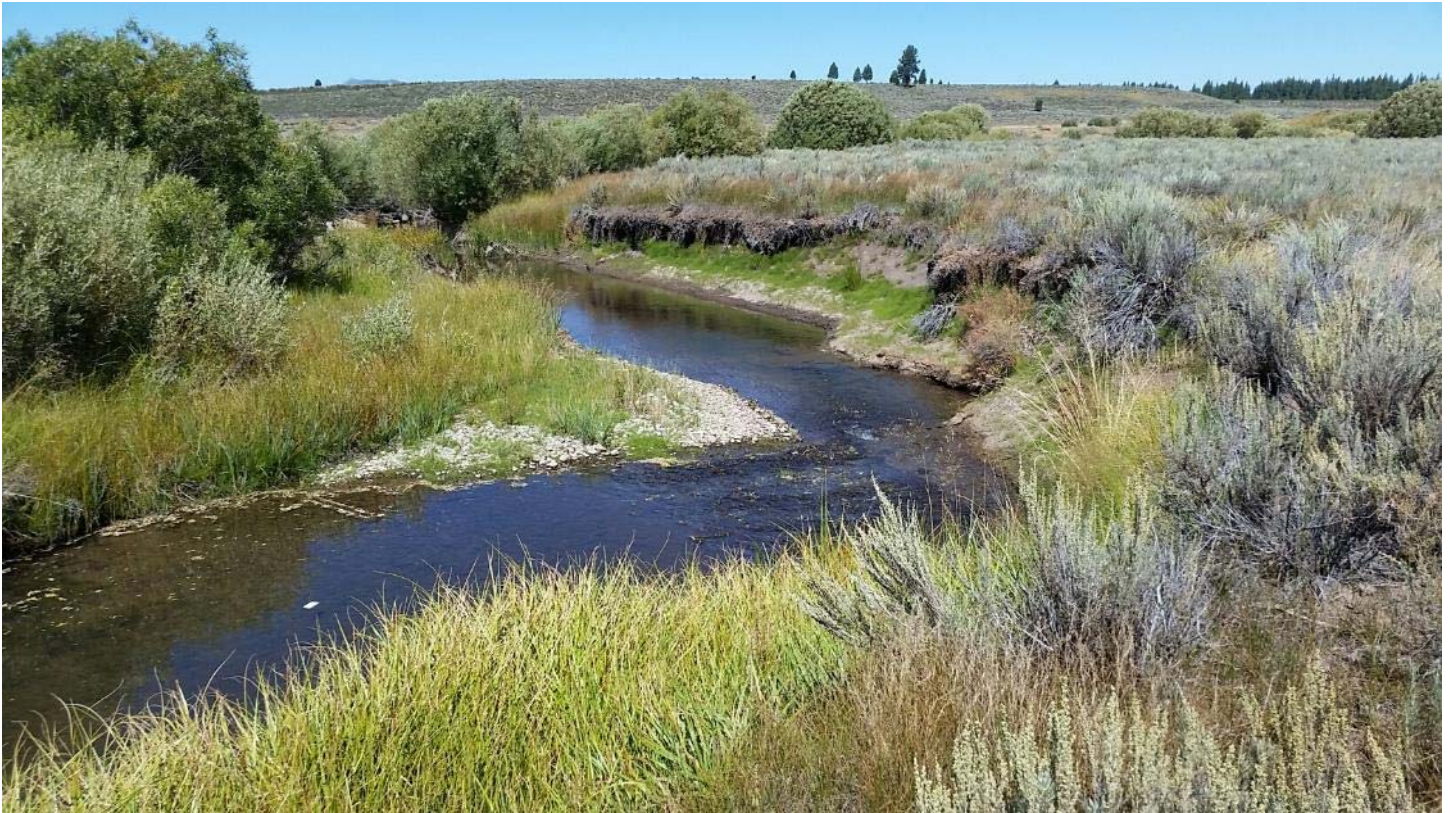
Active bank erosion, channel confined by levee on left bank, Mainstem Martis Creek, Reach 6

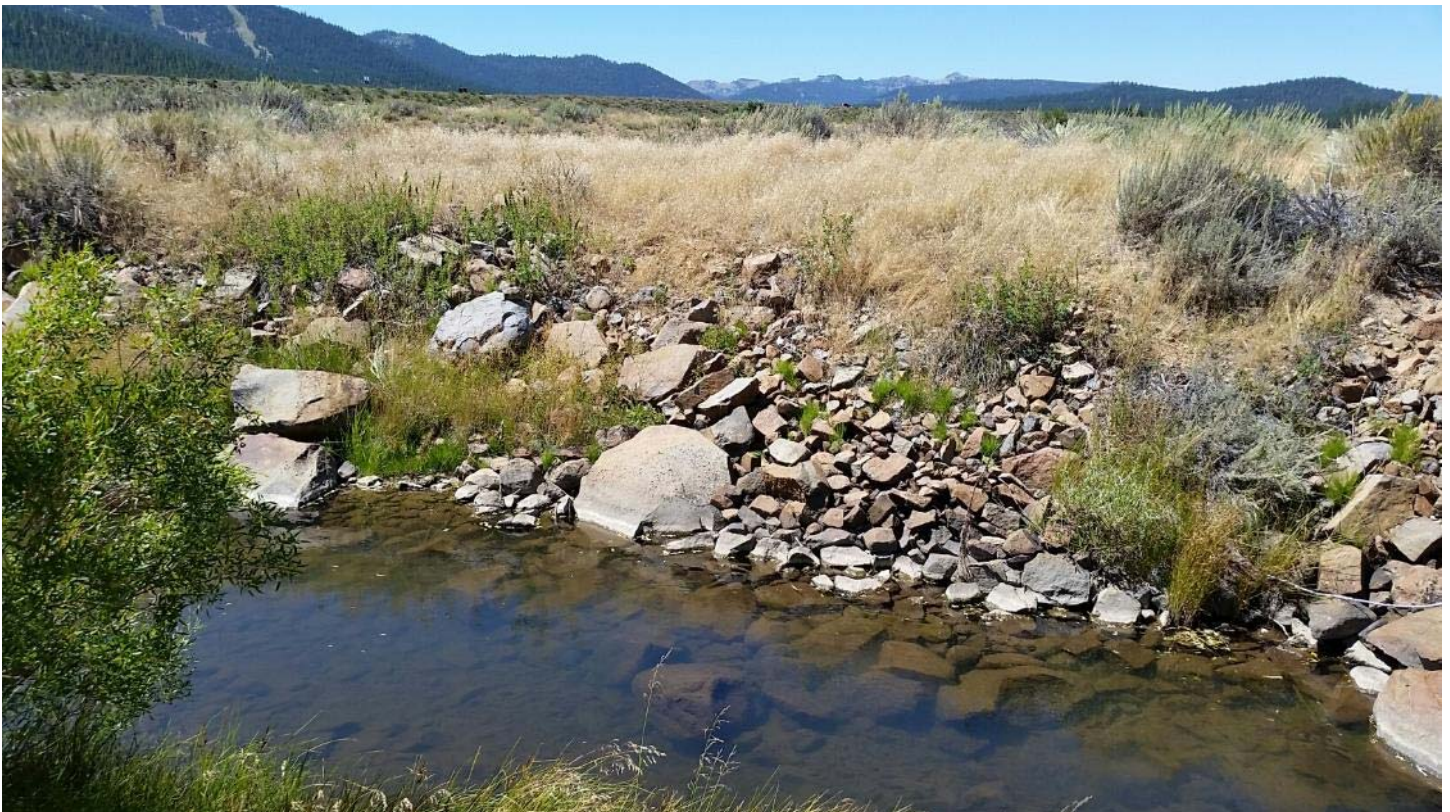
Levee, Mainstem Martis Creek, Reach 6
