Upper Hoke Meadow Restoration Design RFP  
Attachment 2. Photographs of project area

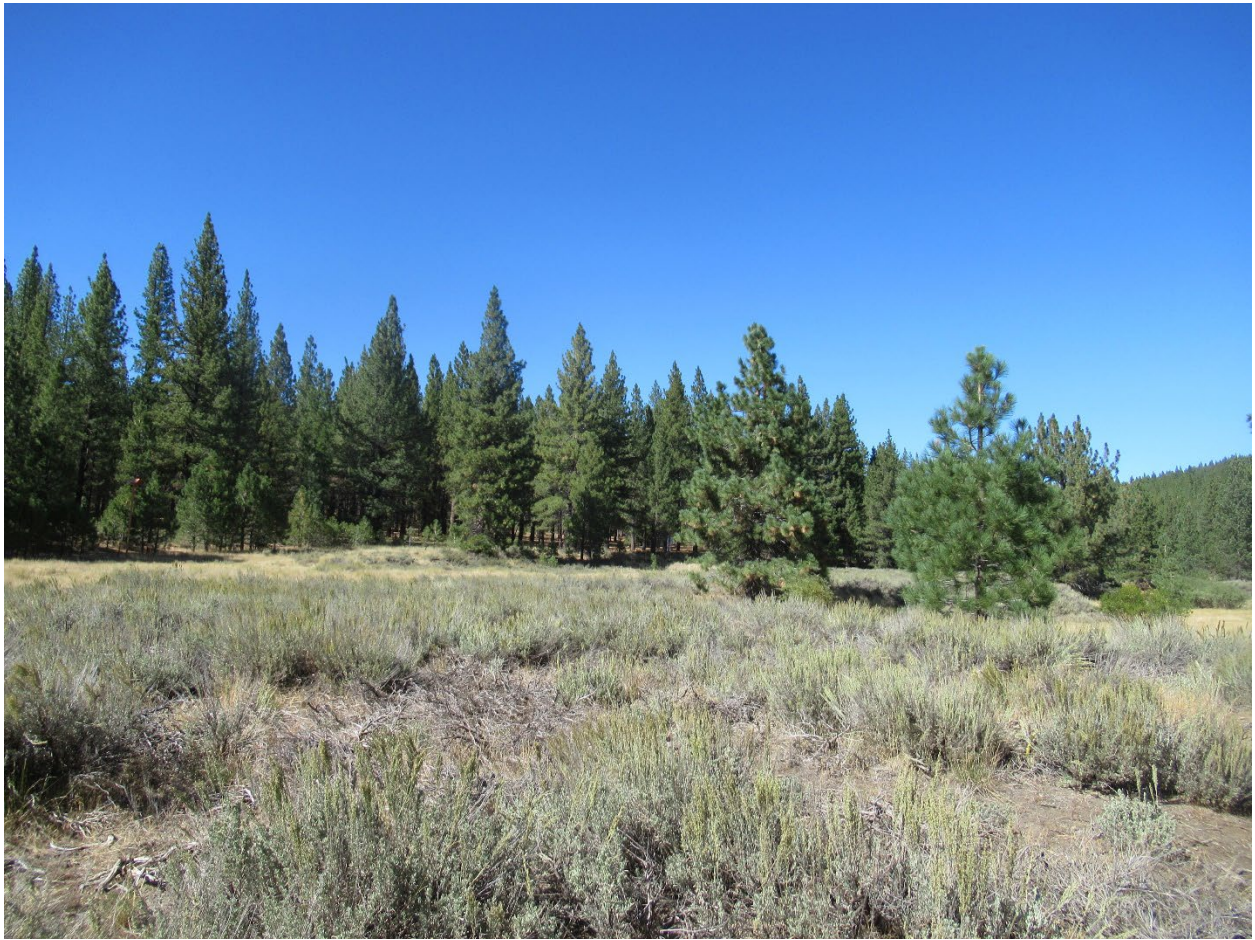
Dried out portion of meadow, disconnected from incised stream channel.

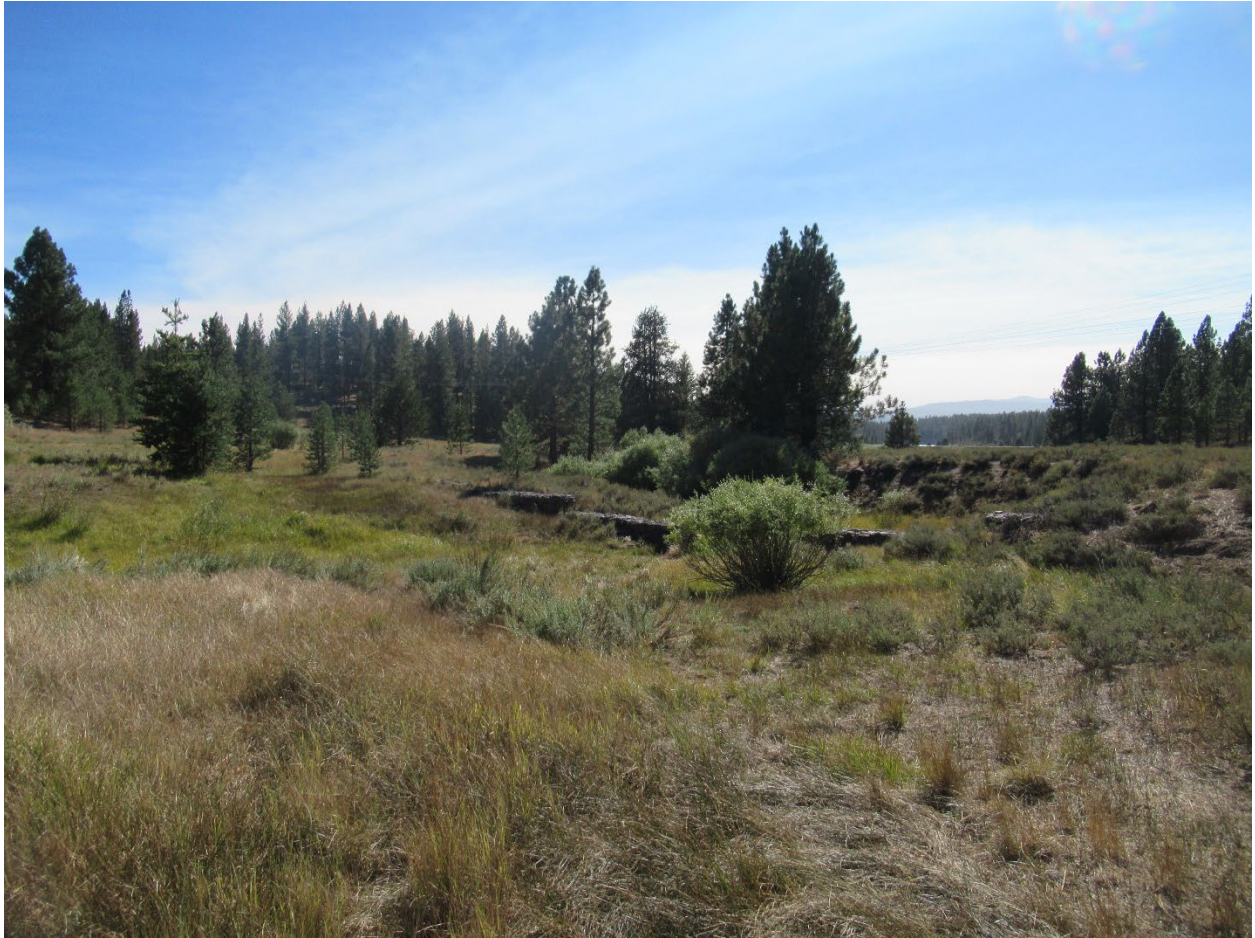
Existing stream channel. A series of rock and cyclone fence gabions were placed in the stream channel at some time in the past, possibly as a strategy to arrest erosion.

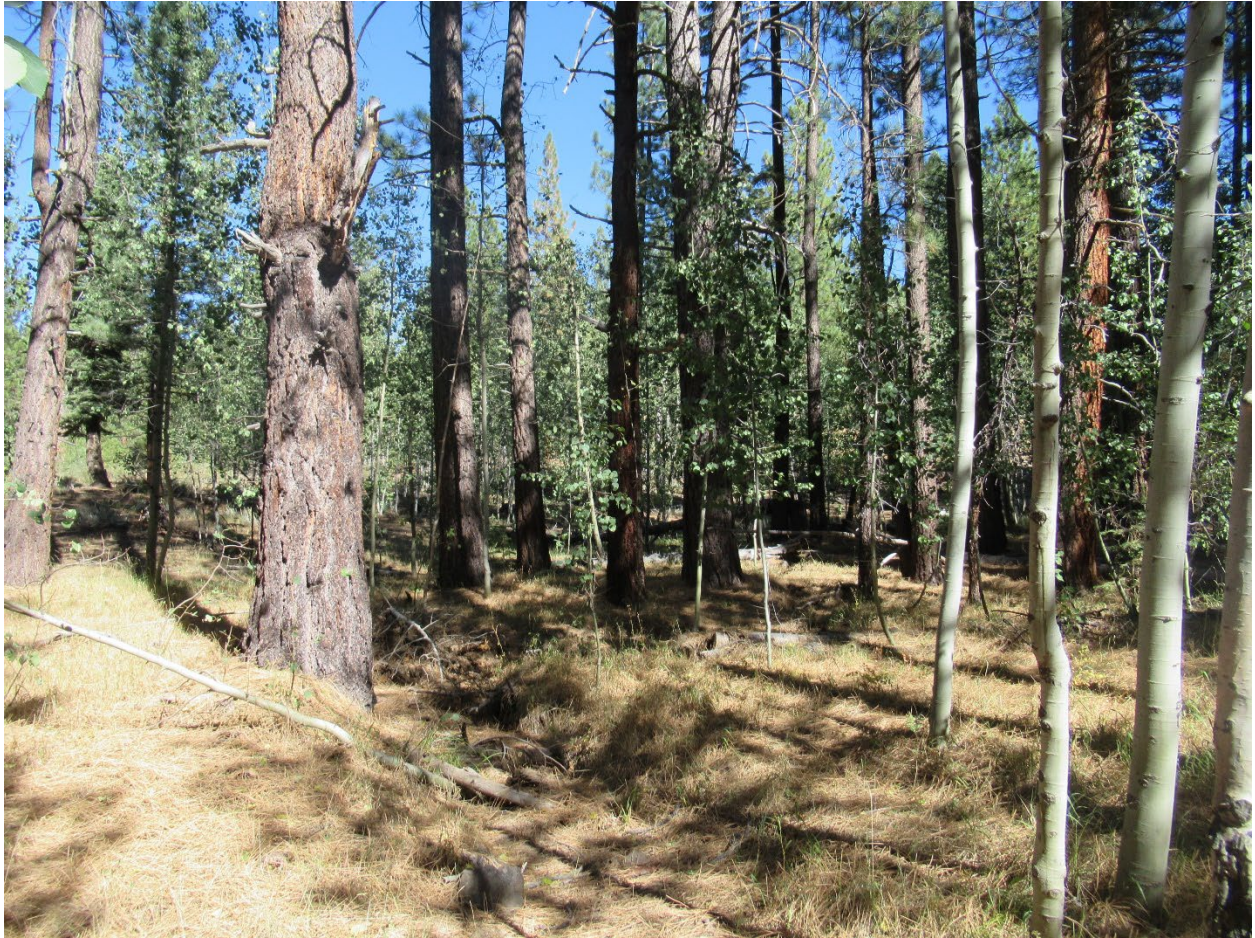
Aspen stand, and some evidence of past ditching. Aspen restoration is one of the objectives of the project.

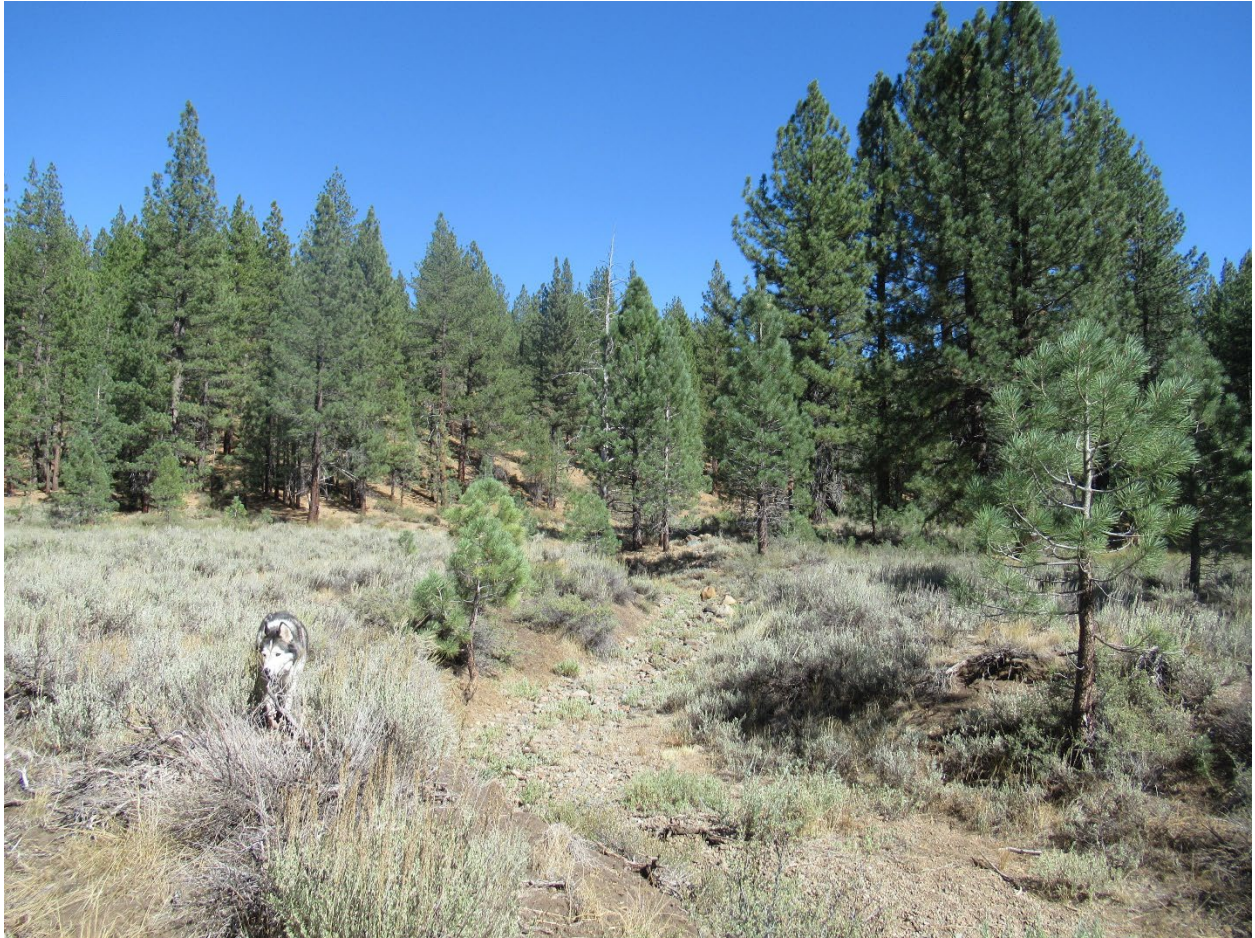
Tributary drainage near upstream end of meadow. Substantial sediment appears to come out of this drainage.

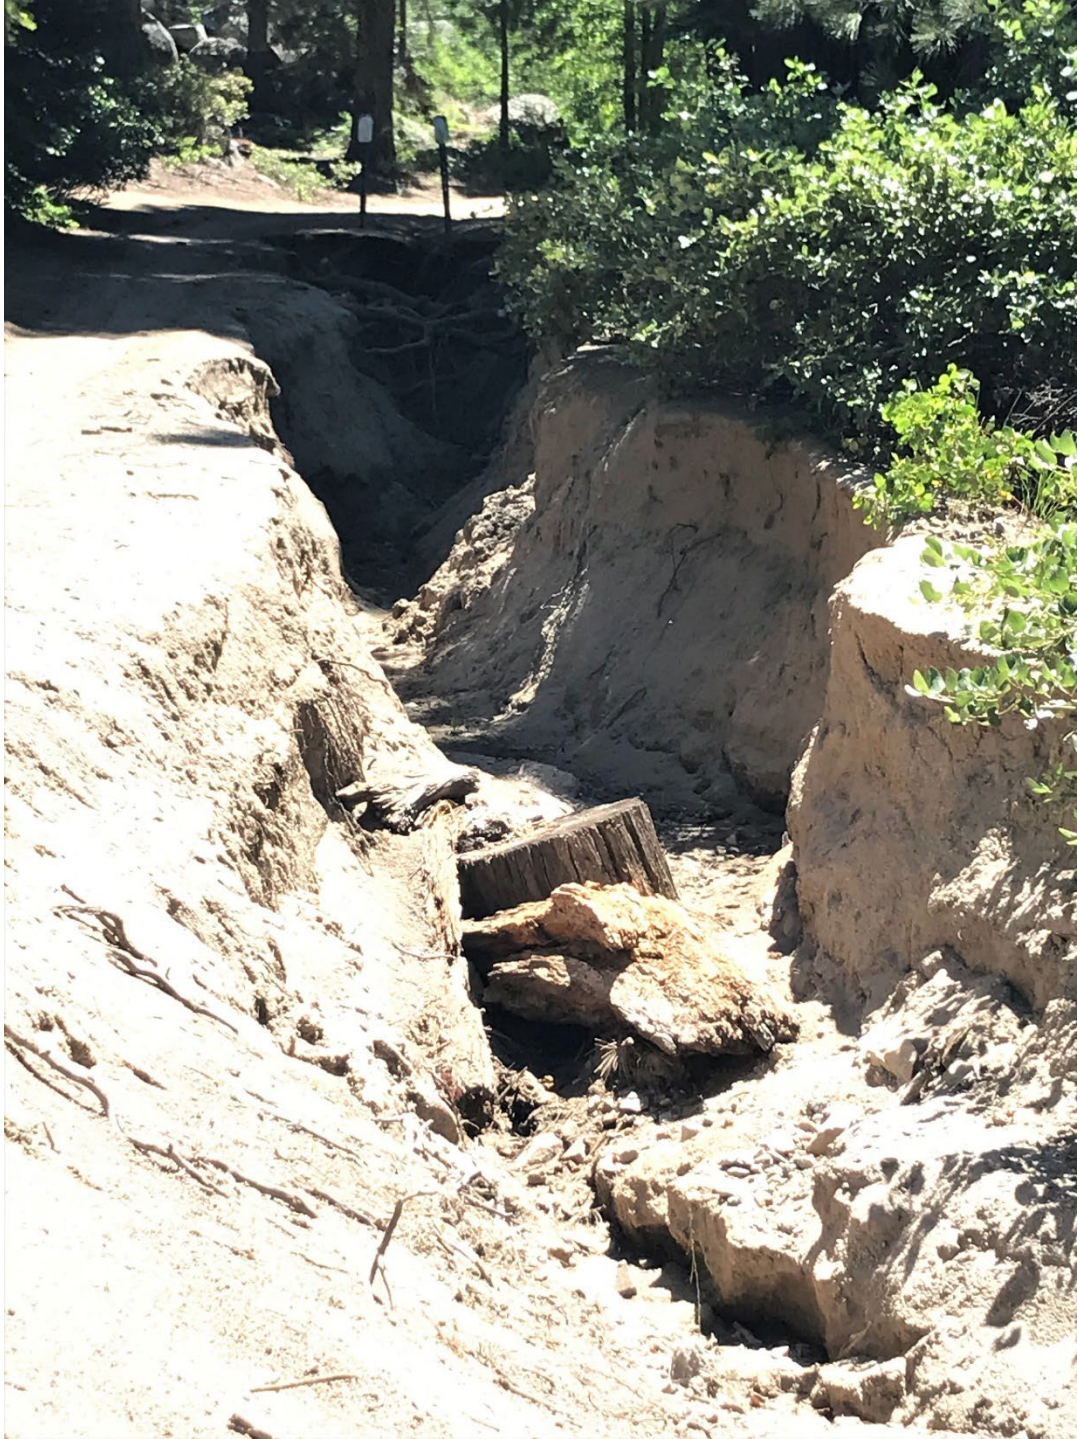
Example of erosion in contributing watershed.

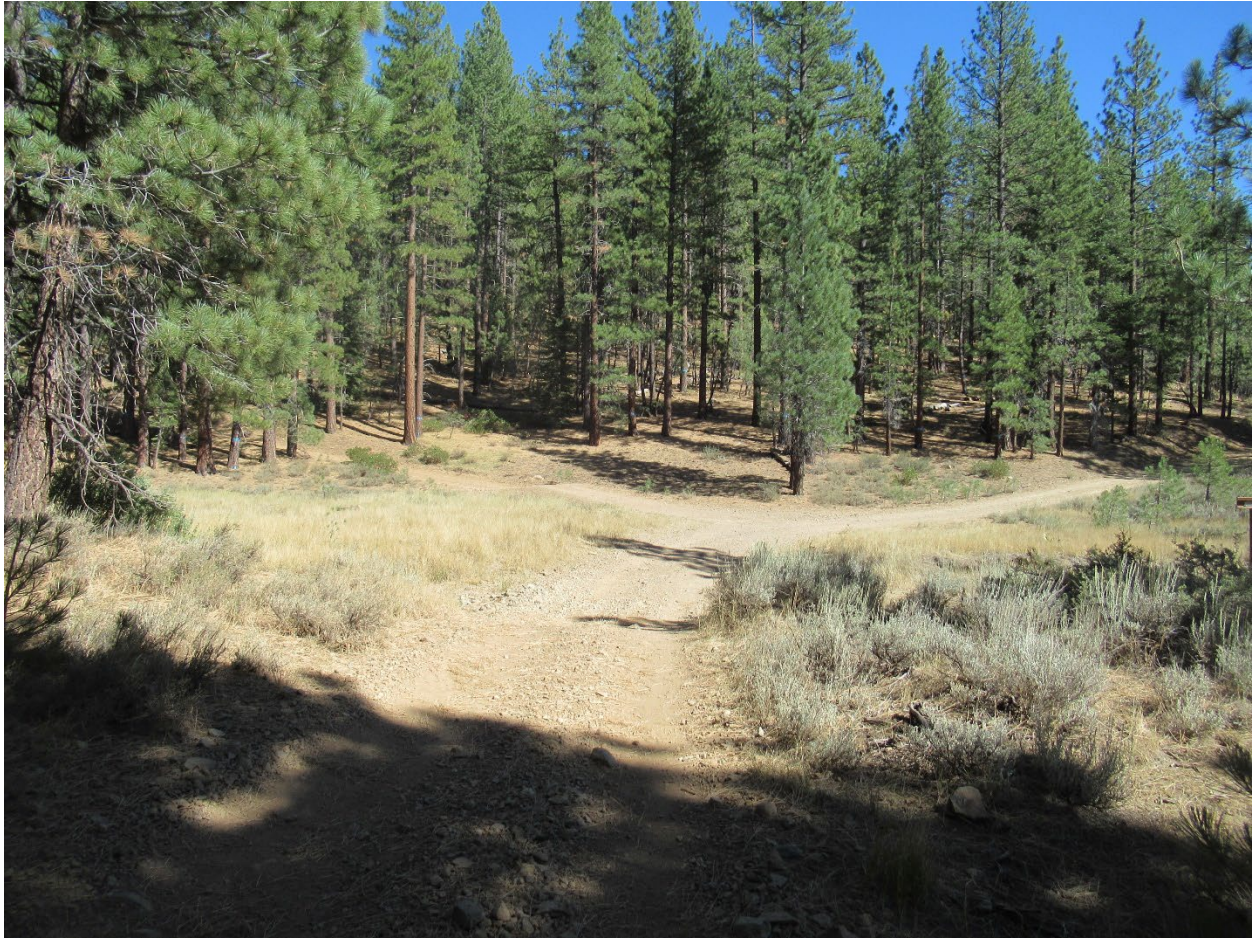
Road crossing near top of meadow on Forest Service Road 72.

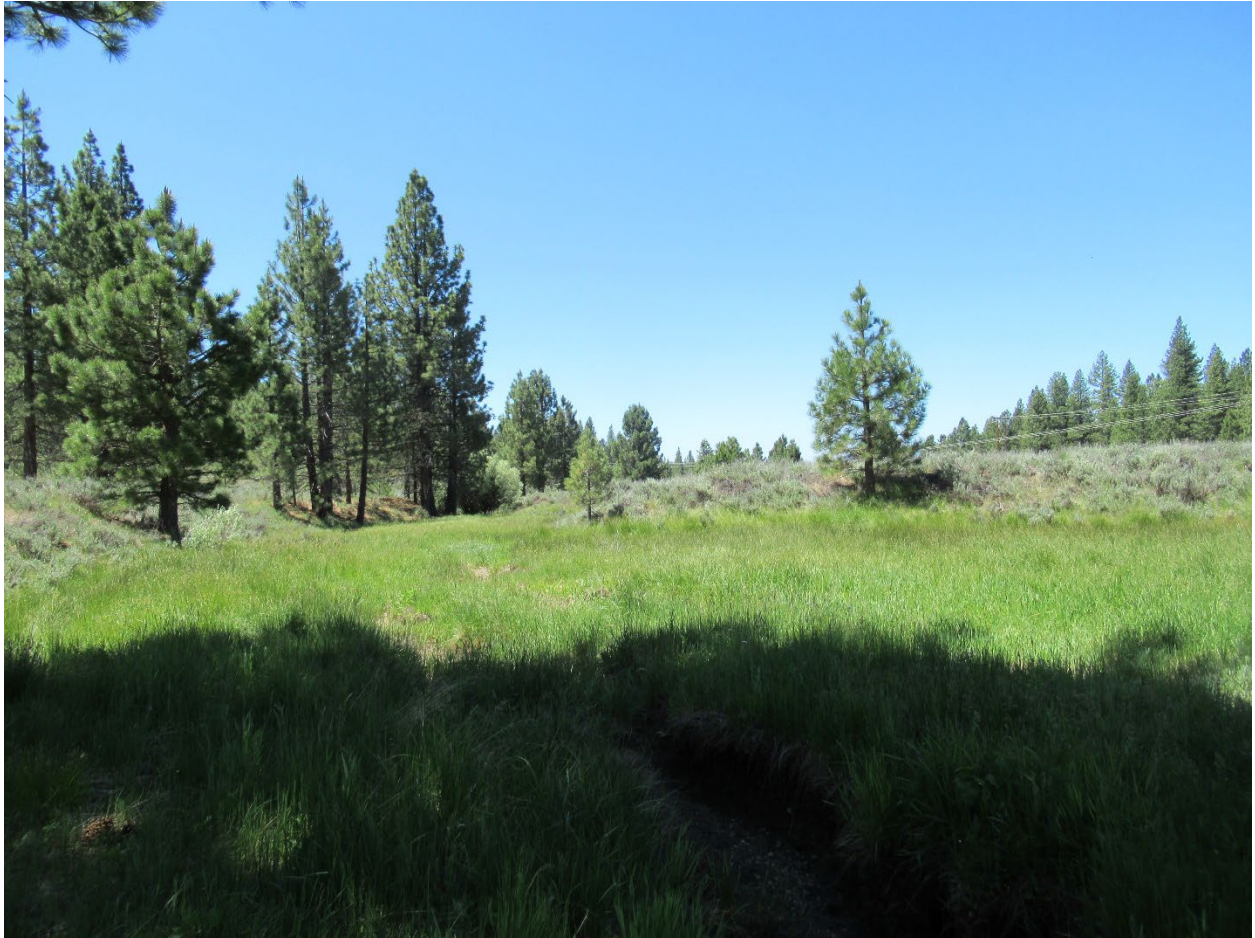
Portions of the existing channel support vigorous wet meadow vegetation.
