Boca Watershed Assessment

**USDA Forest Service
Tahoe National Forest
Truckee Ranger District
2020**

Prepared by
Sharon Falvey, Lindsay Ryan, and Rachel Hutchinson

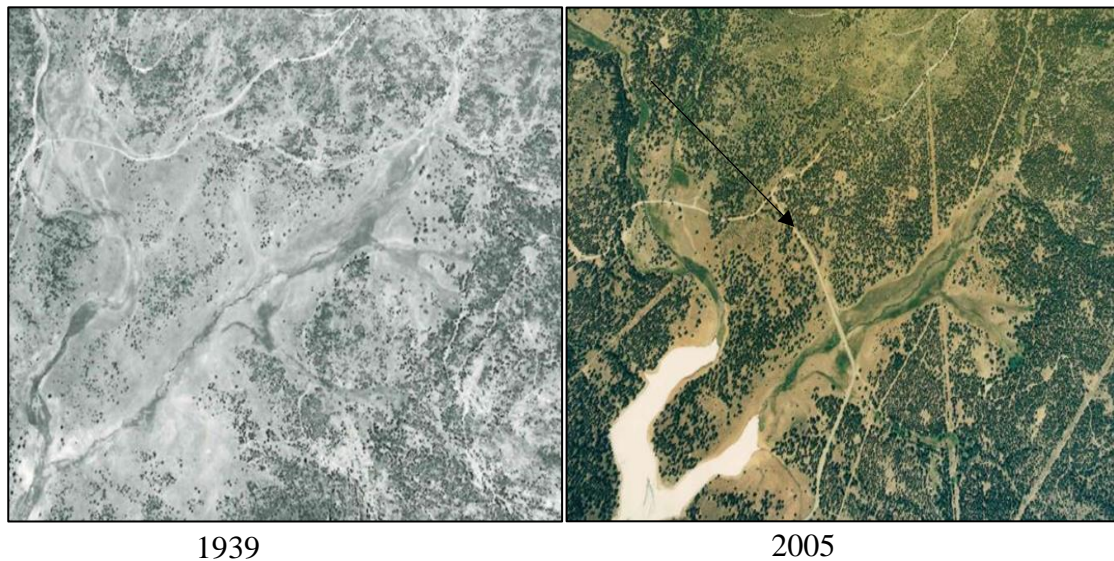
Figure 4: Hoke Valley. Since 1939, many developments have occurred in Hoke Valley. Notice the addition of County Road 270 (arrow), powerlines, a petroleum pipeline, and a fiber optics cable, all of which cross the meadow.

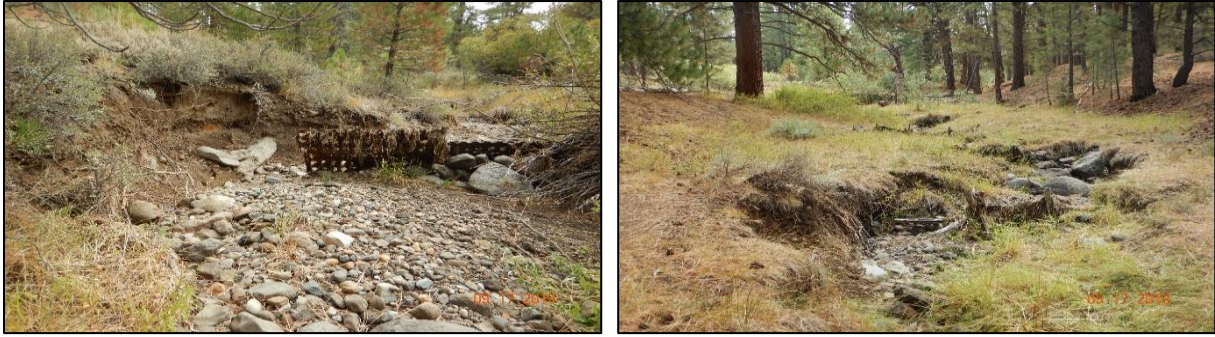
Figure 6. Failing Marston Mat grade control structures in Canyon 4.

In the modern era, there have been numerous attempts to restore parts of the Boca watershed. In the 1970s and 1980s, Gabion baskets were constructed in several drainages, including Hoke Valley and Canyon 3, in order to stabilize banks and in some cases to induce channel aggradation. During this time, several types of grade control structures were installed in other drainages. These structures were made from metal ‘Marston Mats,’ wooden logs, and stacked rocks (Figures 5 and 6). In some places, these structures performed well and improved stream function for at least 5-10 years after they were installed. However, most structures, especially those outside of wetlands, are now failing. Streams are now cutting around some of the structures and contributing to sediment transport.

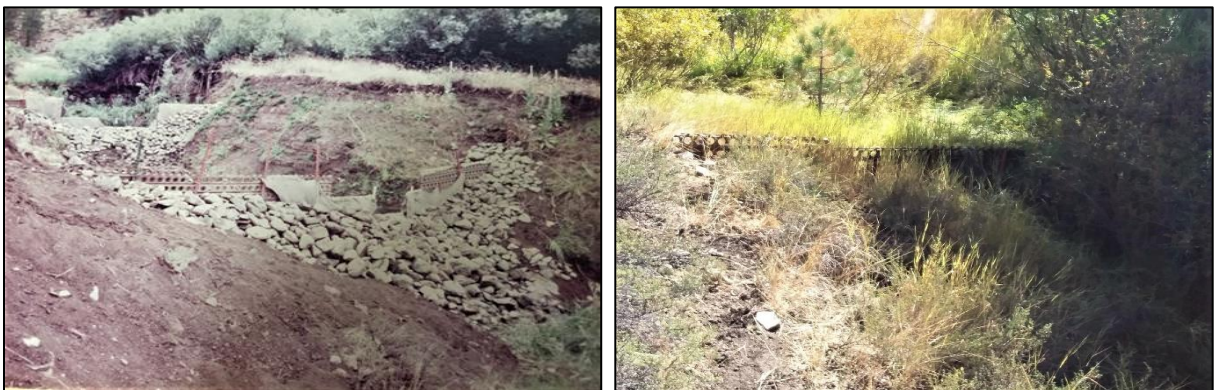
Figure 5. Canyon 4 in 1978 when metal grade control structures were installed (left) and one of those structures in 2019 (right).

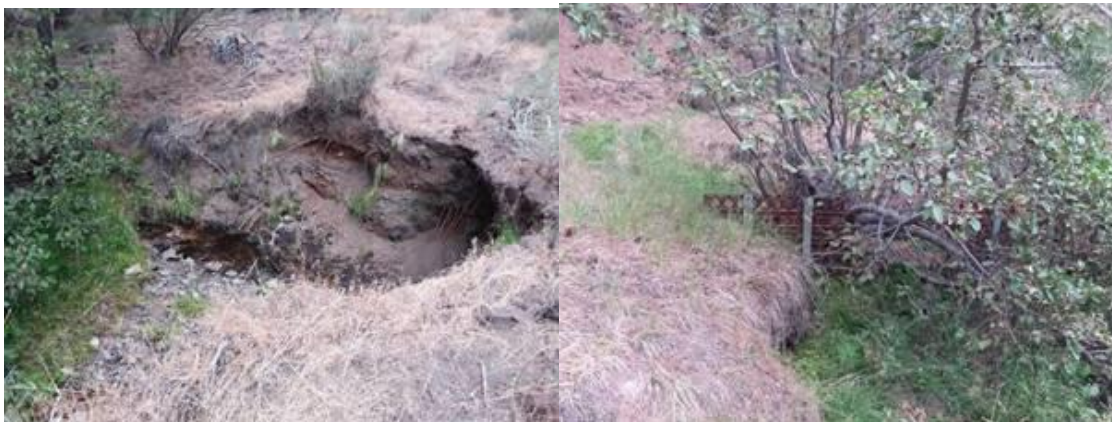
To improve stream conditions, stream stabilizing practices included use of old structures made of repurposed metal ‘Marston Mats’ (Figure 9). The structures were largely successful in aggrading sediments above the structure, but the utility of the design is now outlived and most of these structures have failed (Figure 9). Failure is occurring with the stream cutting around one side of the structure resulting in the stream head cutting up the channel undoing the previous benefit of the structure. The headcuts range from 1 to 3 feet deep and the channel incision varies from 1 to at most about 5 to 6 feet deep. Polygon LTR-A and LTR-B covers restoration considerations for this tributary, the upstream railroad, and the weirs at the bottom end of the drainage (Figure 11).

Figure 9. Erosion from the stream cutting around the grade control structures shown above.

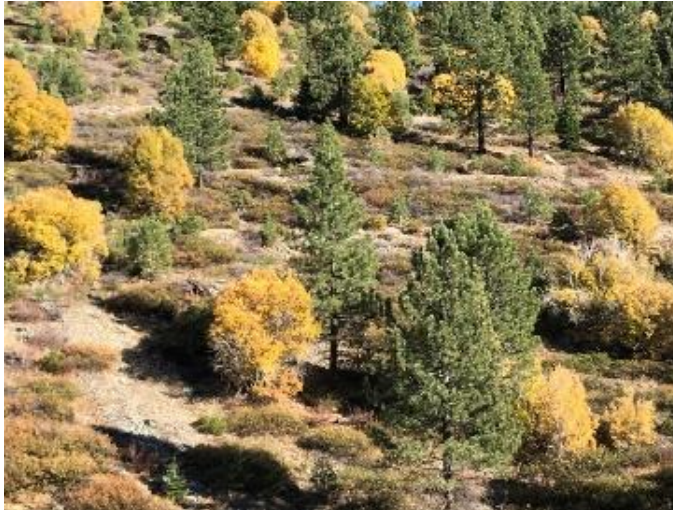
The Merrill Creek and Lower Davies Creek potential restoration areas are shown in Figure 11. The primary characteristics influencing this subwatershed include terracing shown in the upper portion of the assessment area (Figure 14). Some evidence of past terracing failure can be seen on the LiDAR DEM and may have contributed to the braided fan (shown just above the north arm of the stampede reservoir). Restorative actions in HV-J could result in increased fan function (Figure 11). This fan was disrupted in the past from railroad grade and roads developed across the drainage. It is possible the function was further affected from the terrace failure.

Figure 13. Nonlinear, nonvegetated features and exposed subsoils from terraced area on south facing slope along Merrill Creek.

This area could benefit from additional planning and more analysis to determine where actions should occur and would be most beneficial. Alluvial fan/road interaction improvements could help to reconnect the hydrology in this area. In addition, terracing restoration may result in some ecosystem services for wildlife and redistribution of the hydrologic system across resources.

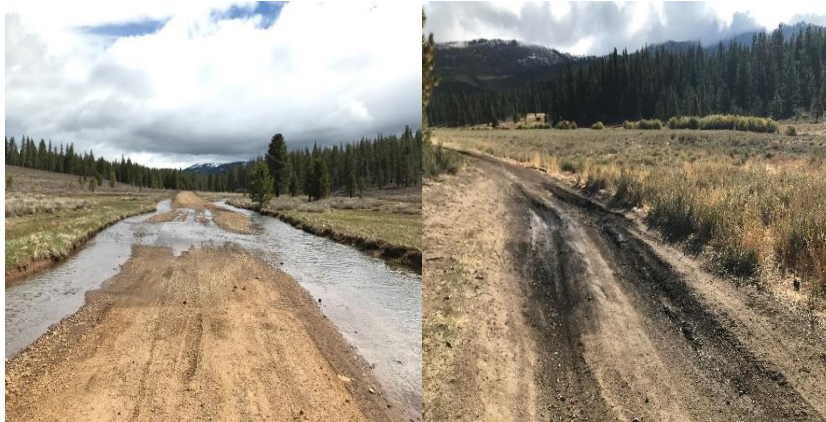
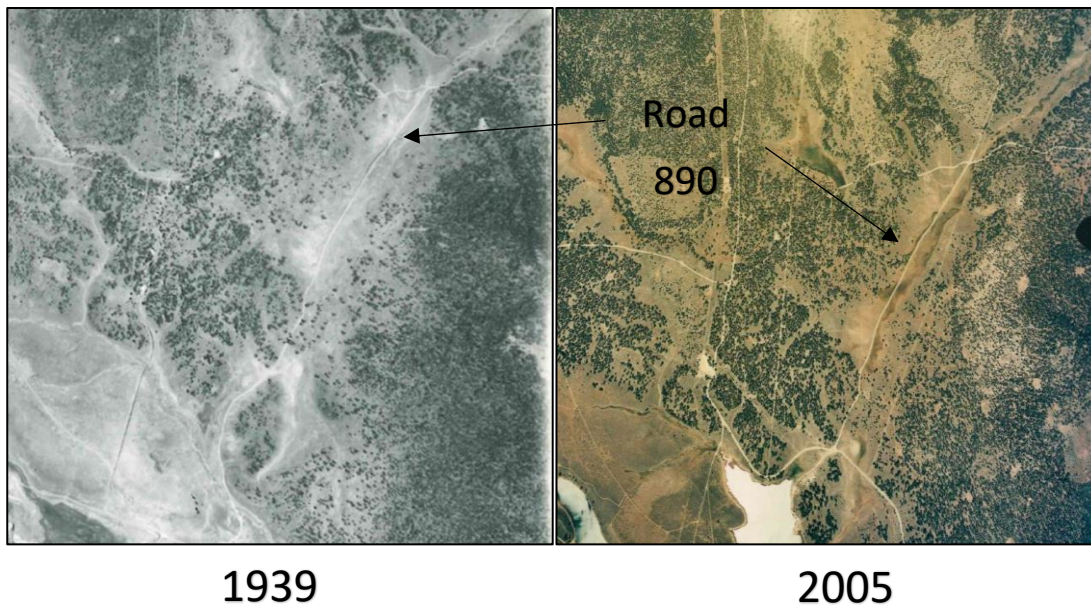
This area is proposed for stream and meadow restoration. The existing county road bisects the meadow and intercepts the west drainage that contributes spring flow down this drainage to the reservoir (Figure 14). It is a seasonal meadow that supports spring blooms of Camas lily, *Camassia quamash*. This meadow is often accessed during the wet season and results in unauthorized OHV trailing the remaining adjacent meadow system.

Figure 14. Since before 1939, County Road 890 has run through this meadow on the west side of Boca Reservoir, just north of Prosser Reservoir. To help restore the meadow, this road could be rerouted.
