**Middle Truckee River  
Total Maximum Daily Load (TMDL)  
Bed Conditions Monitoring Report  
Water Years 2010 and 2011  
Nevada County, California**

Balance Hydrologics, Inc.

December 2012

**Middle Truckee River Total Maximum Daily Load (TMDL)  
Bed Conditions Monitoring Report, Water Years 2010 and 2011  
Nevada County, California**

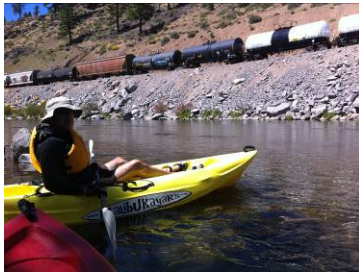
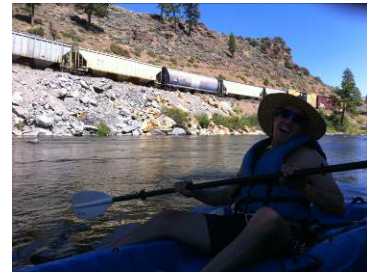
#### WP282

- San Francisco Fly Casting Club (SFFCC)
- RR Track on left bank, dry ravel directly into channel
- Large pool, relatively shallow, fine sediment on bottom seems to increase here compared to upstream locations.

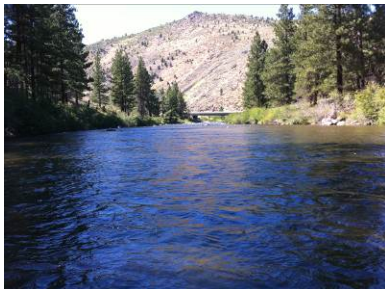
#### WP283

- Long shallow pool downstream of I-80 Bridge, downstream of Prosser Cr. Confluence
- Good access off of I-80, easy to monument
- Pool is shallow and long, straight, with somewhat significant fines accumulation
- Maximum depth in scour holes around boulders in glide

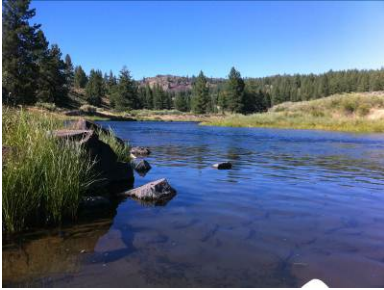
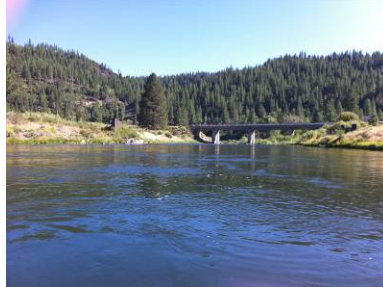
WP284

Pool-Glide-Riffle just upstream of Hirschdale Road Bridge

Quite Deep

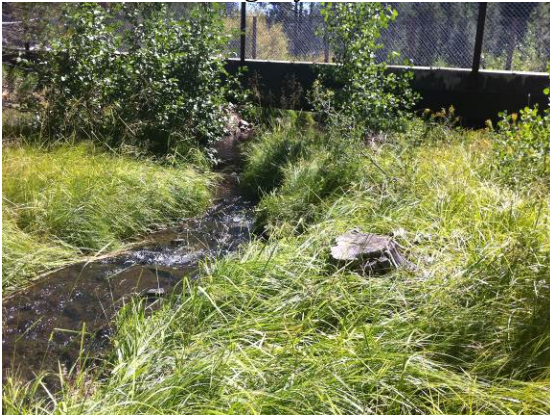
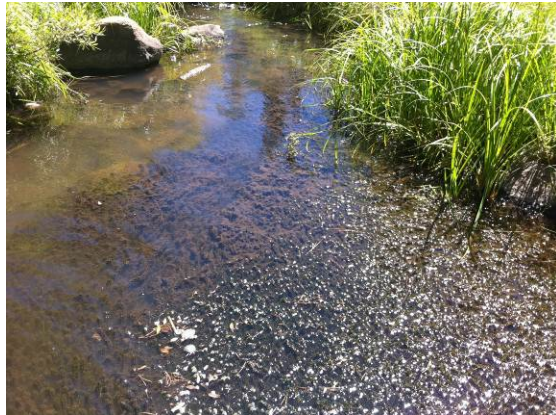
### WP304

- Channel is narrow through a steep meadow with grassy banks and willow/alder riparian cover
- Step pool morphology with channel width of ~4 to 5 feet
- Cobble-boulder substrate with abundant algae, some fines in pools, mostly gravels
- Water is slightly turbid

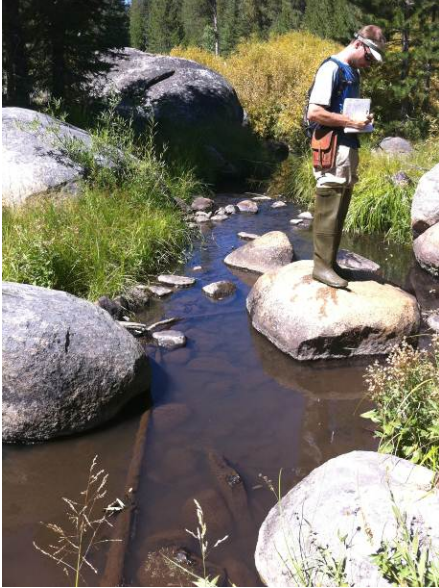
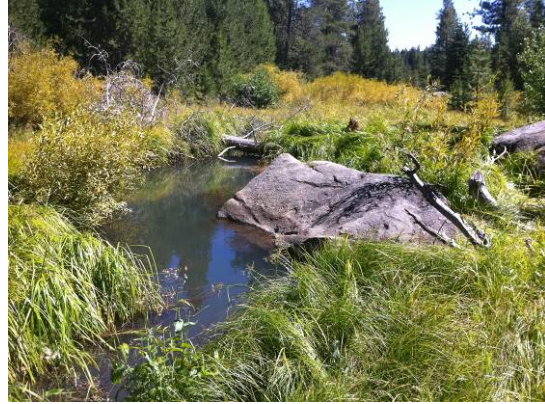
#### WP305

- Riparian corridor opens up to meadow, with deep pools (~3-ft deep)
- Beaver are present and active, with multiple well-developed side channels
- Glacial erratics present throughout meadow

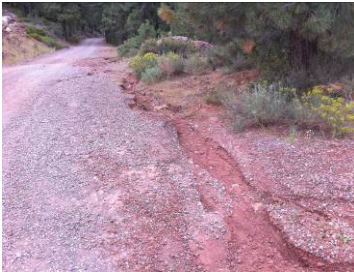
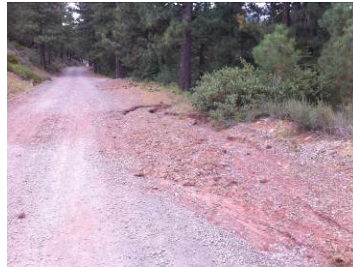
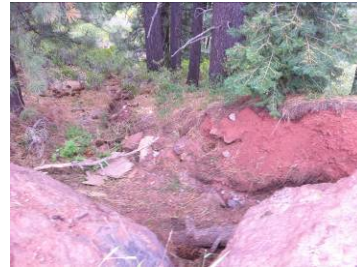
#### WP293

- Gravel pit and runoff spills to channel, offering continuous hydrologic connection between quarry and stream channel

Our reconnaissance of Trout Creek indicates that the channel is largely stable through the study reach (See Appendix A); however, drainage from Euer Valley Road and the aggregate quarry just upstream of Highway I-80 is likely a significant source of erosion. These sediment sources should be evaluated in more detail in order to consider potential mitigation options. Bed sedimentation indicators such as V-star and pebble counts are anticipated to reflect localized conditions, rather than effects of watershed management activities in upstream areas. If these are to be used to monitor long-term and watershed-wide changes, a large number of representative reaches should be used.

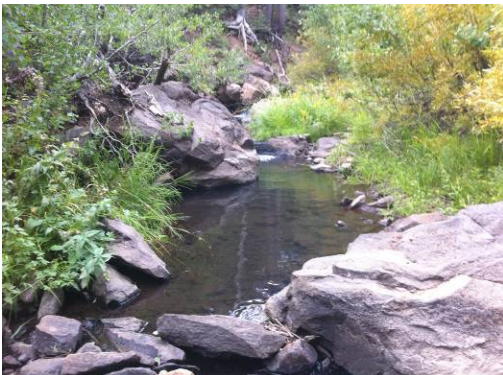
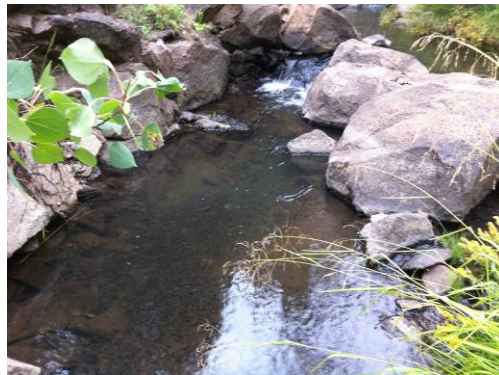
#### WP291

- Boulder-lined step pools with steep right bank and dry ravel above andesitic bedrock
- Occupied van encampment on left bank above channel
- Estimated  $V^* = 10$  percent of pool is filled with fine sediment

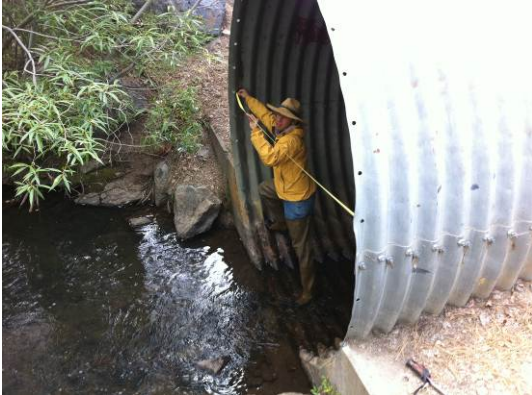
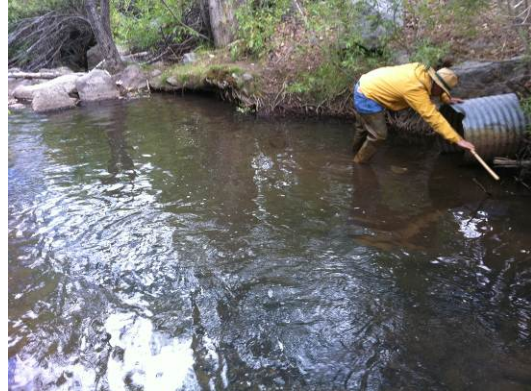
WP287

- Mouth of I-80 culvert (8.5-ft CMP)
- 24-inch CMP discharging from right bank, immediately downstream of I-80 culvert outfall.

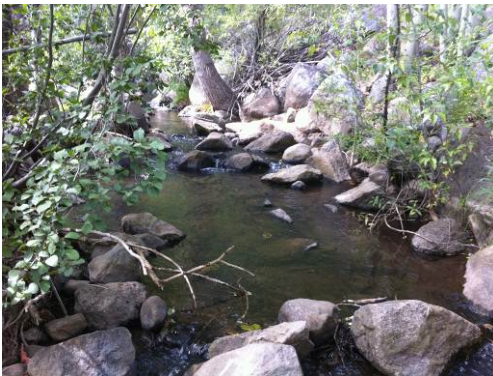
WP285

- Between I-80 and Jibboom St
- Small path from right bank to channel
- Channel consists of boulder-cobble step pools with significant fines accumulated on bed
- Evidence of runoff from road and road sand entering channel

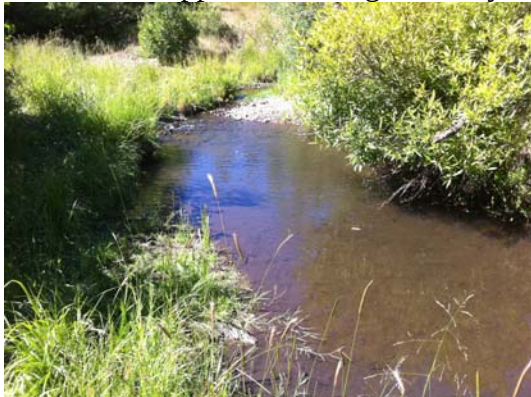
### **WP272**

- Pool appears to be significantly filled with fines

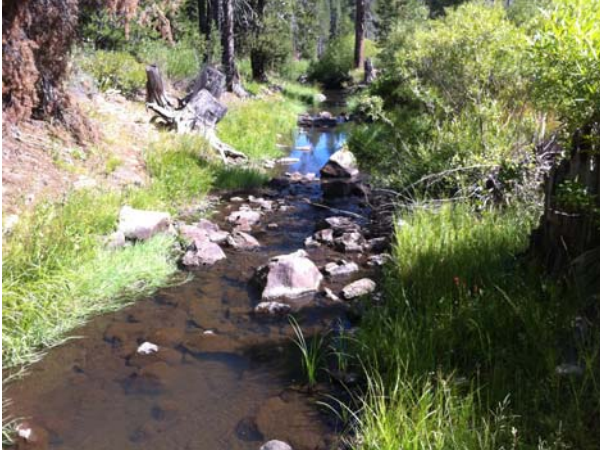
### **WP276**

- Boulder-cobble reach, narrow riparian corridor

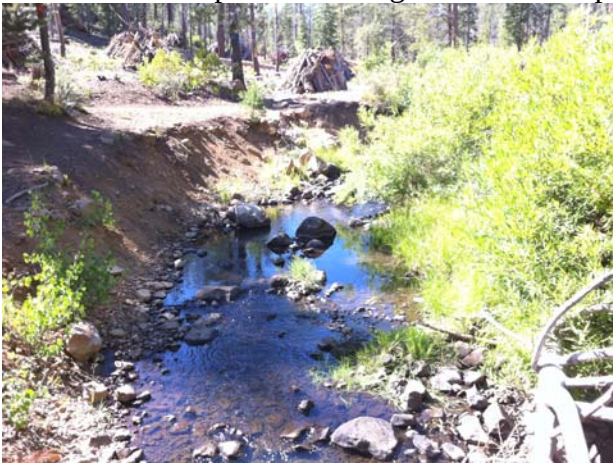
#### WP277

- Single-thread channel, limited beaver activity
- Right bank failure with trail at top of bank
  - o Height = 8 ft
  - o Length = 60 ft
  - o Boulder-cobble in silt matrix
- Forest management (thinning) to within ~20 ft of channel)
- This is a potential reveg / stabilization project

Alder Creek is largely controlled by streamwood and beaver-controlled step pools in the upper portions of the watershed. Downstream and immediately upstream of Schussing Way, we observed a number of bank failures. As on Trout Creek, these sediment sources should be evaluated in more detail in order to consider potential mitigation options. The relatively dynamic and unstable nature of this reach also precludes the application of V-star and pebble-counts as long term monitoring methods.

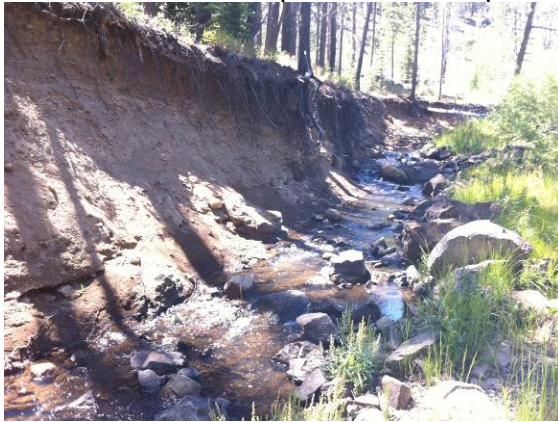
#### WP257

- Downstream end of right bank failure
- Estimated bank failure length: 80 ft.
- Bank failure height: 10 ft.
- Failure is in sub-rounded cobble in gravel and sand matrix, fining upward to silty matrix near top of bank. Interpreted to be glacial outwash.

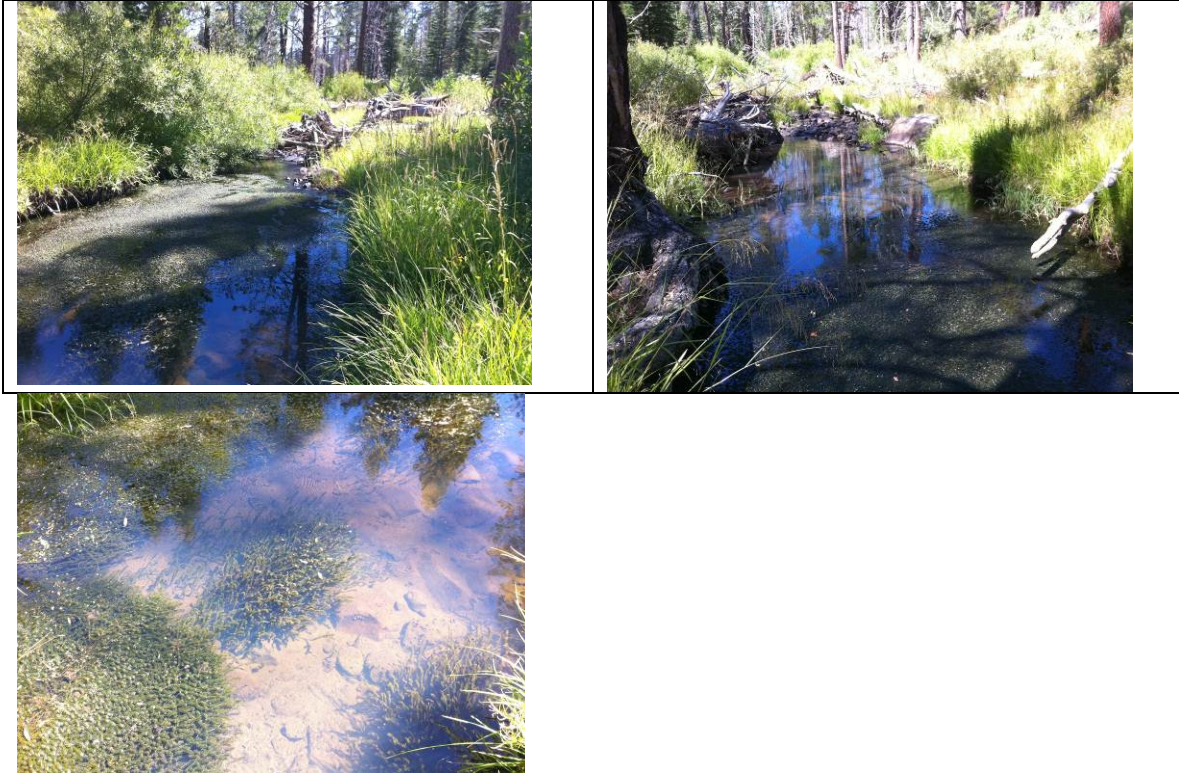
#### WP252

- Step pool morphology, with riffles
- Plunge pool is ~10' long x 8' wide, with cobble riffle downstream
- Abundant wood, some log jams appear to have been cleared (attempted to be cleared) as evidenced by fresh saw cuts

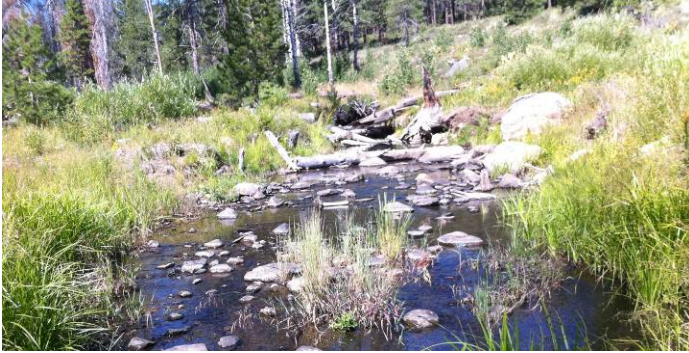
WP251

- Right bank slope failure at soil/bedrock interface
- Boulder cobble bed downstream of slope failure, with 75-ft wide boulder and cobble floodplain
- Discontinuous bedrock outcrop\
- Extensive beaver activity

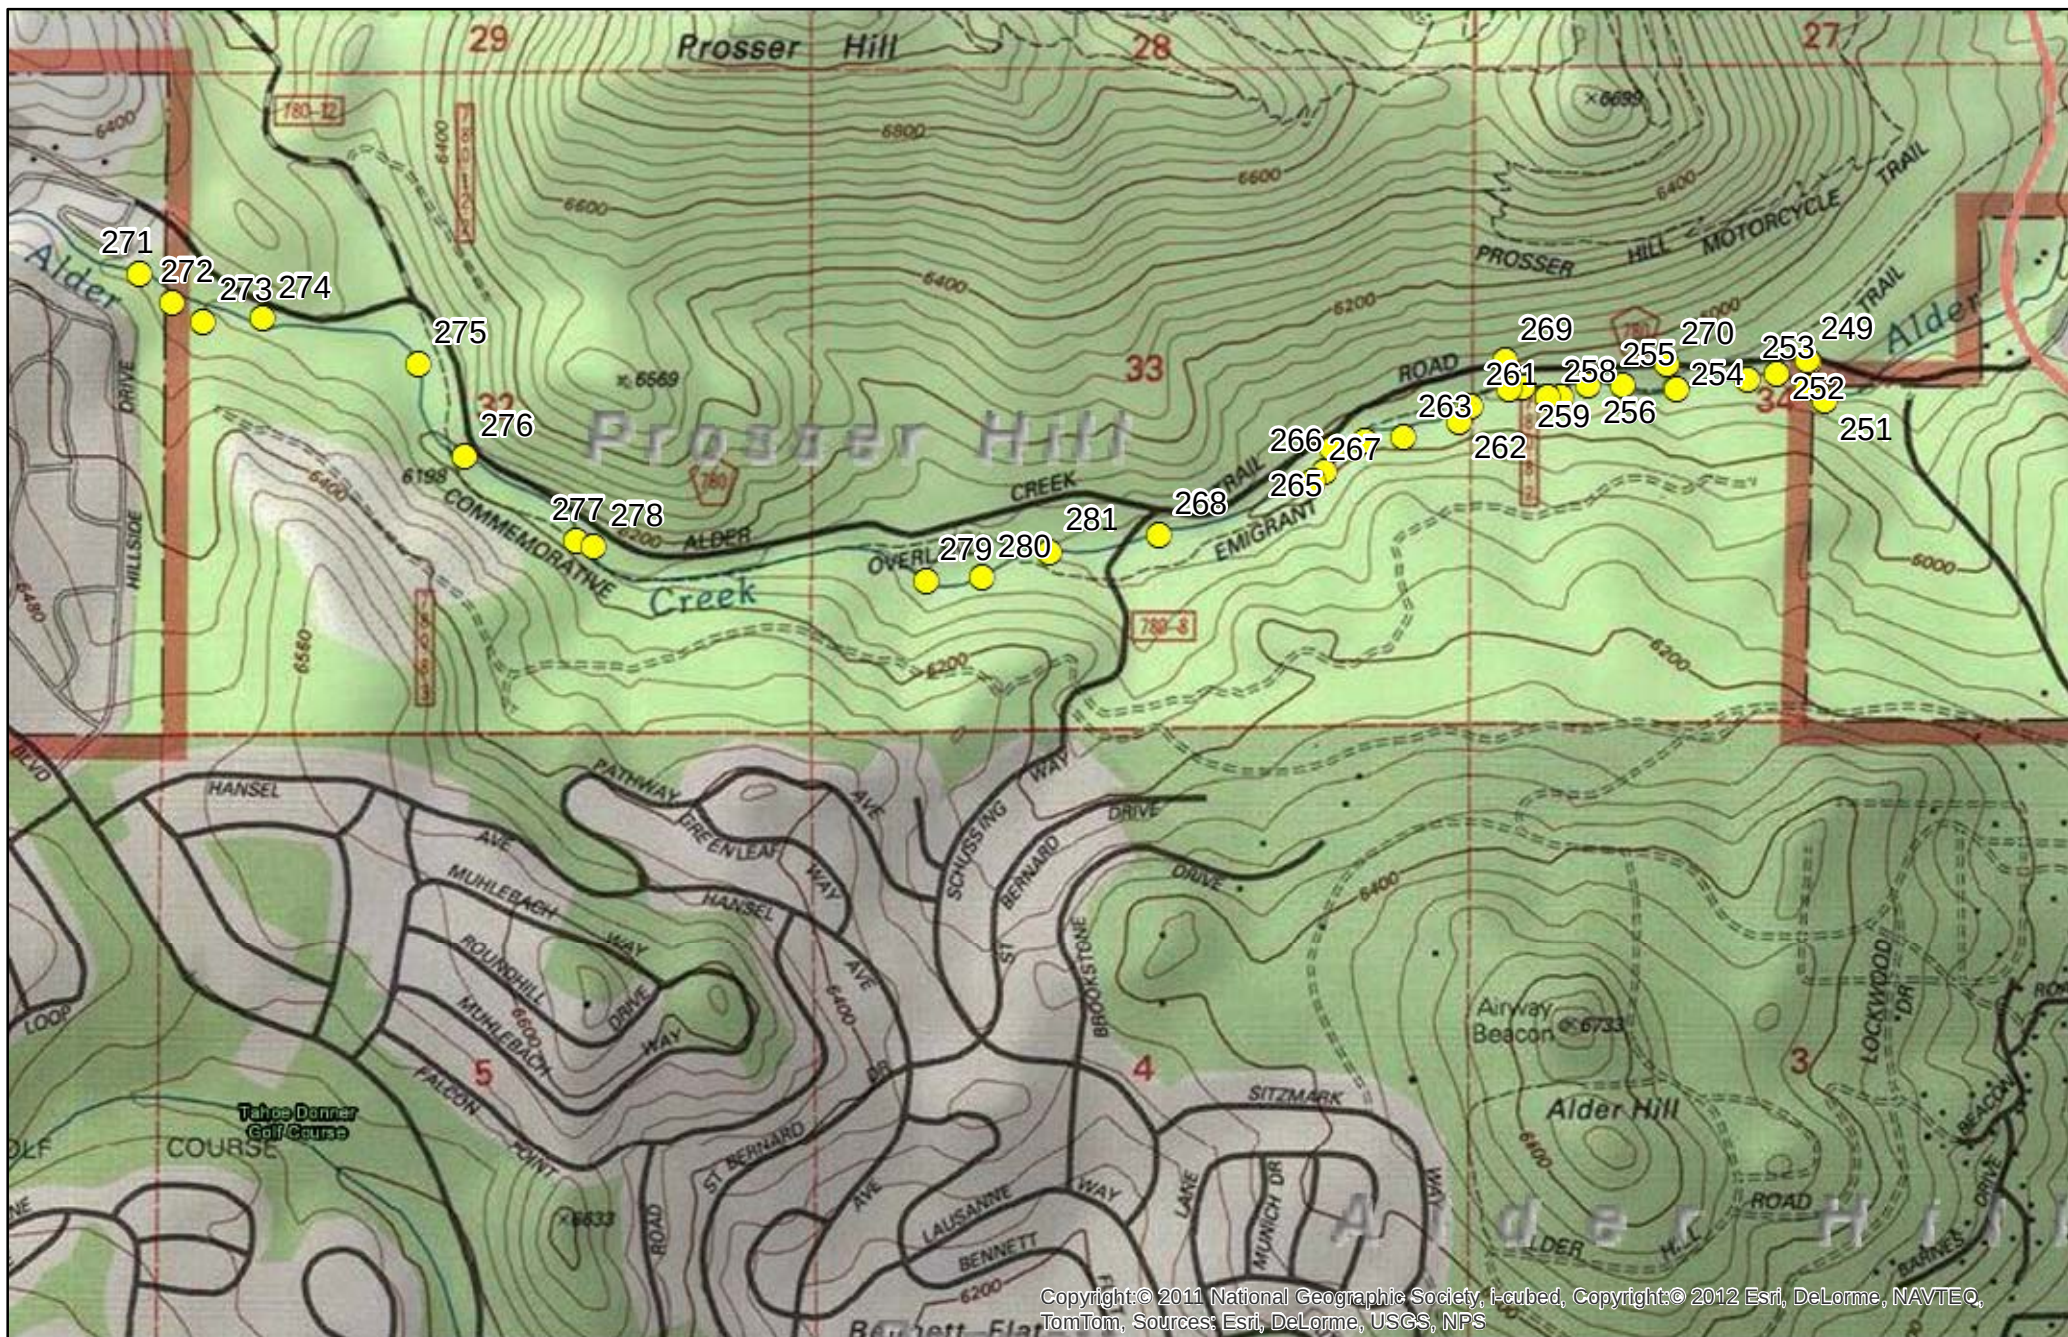
**Figure A3. Alder Creek reconnaissance observation locations  
Middle Truckee River TMDL Assessment and Monitoring  
Nevada County, California**
