**Middle Truckee River
Total Maximum Daily Load (TMDL)
Bed Conditions Monitoring Report
Water Years 2014
Nevada County, California**

Balance Hydrologics, Inc.

December 2014

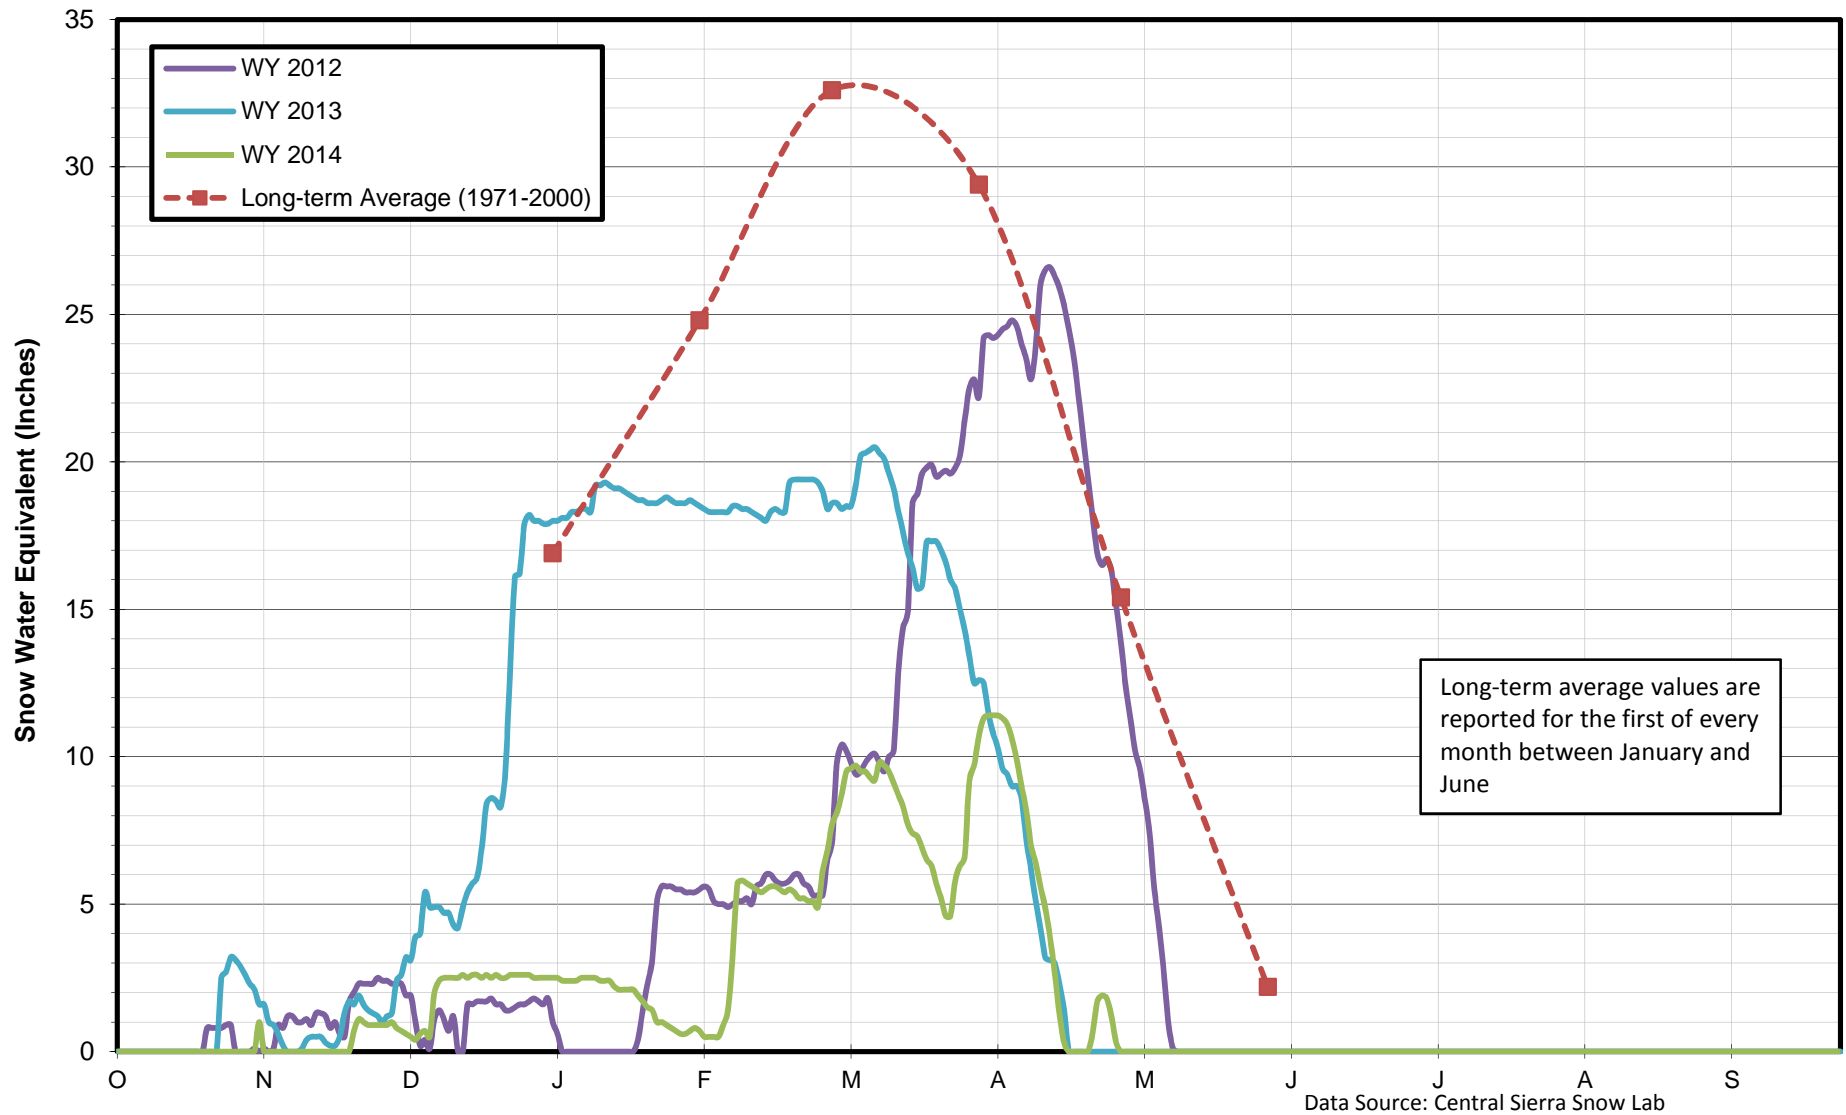
Figure 2. Snow-water equivalent snowpack, Central Sierra Snow Lab, Soda Springs, California, water years 2012, 2013, and 2014 as compared to long-term average. The Snow Lab is located approximately 11 miles west of Truckee, California at 6,950 feet elevation.

Water year 2012 was characterized by below-average snowpack and streamflow conditions. The snowpack at the Central Sierra Snow Laboratory (CSSL) held well below-average water content into the late winter (Figure 2), until a series of early spring storms delivered more than half of the year's snowpack. Warm spring temperatures melted the snow quickly; the maximum daily mean flow of 819 cubic feet per second (cfs) in the Truckee River occurred on April 27, 2012, and by early May the snowpack at CSSL was zero. The peak instantaneous stream flow was 1,140 cfs on January 21, 2012.

Water year 2014 was characterized by record low snowpack and streamflow conditions, and marked the third consecutive below-average precipitation year. Consistently warm temperatures and low precipitation amounts resulted in the snow water equivalent being less than one third of the long-term average for the entire water year. The snowpack at CSSP was zero by May 1, 2014. Both the maximum daily mean and maximum instantaneous streamflow in the Middle Truckee River occurred on February 9, 2014, and were 613 and 724 cfs, respectively.

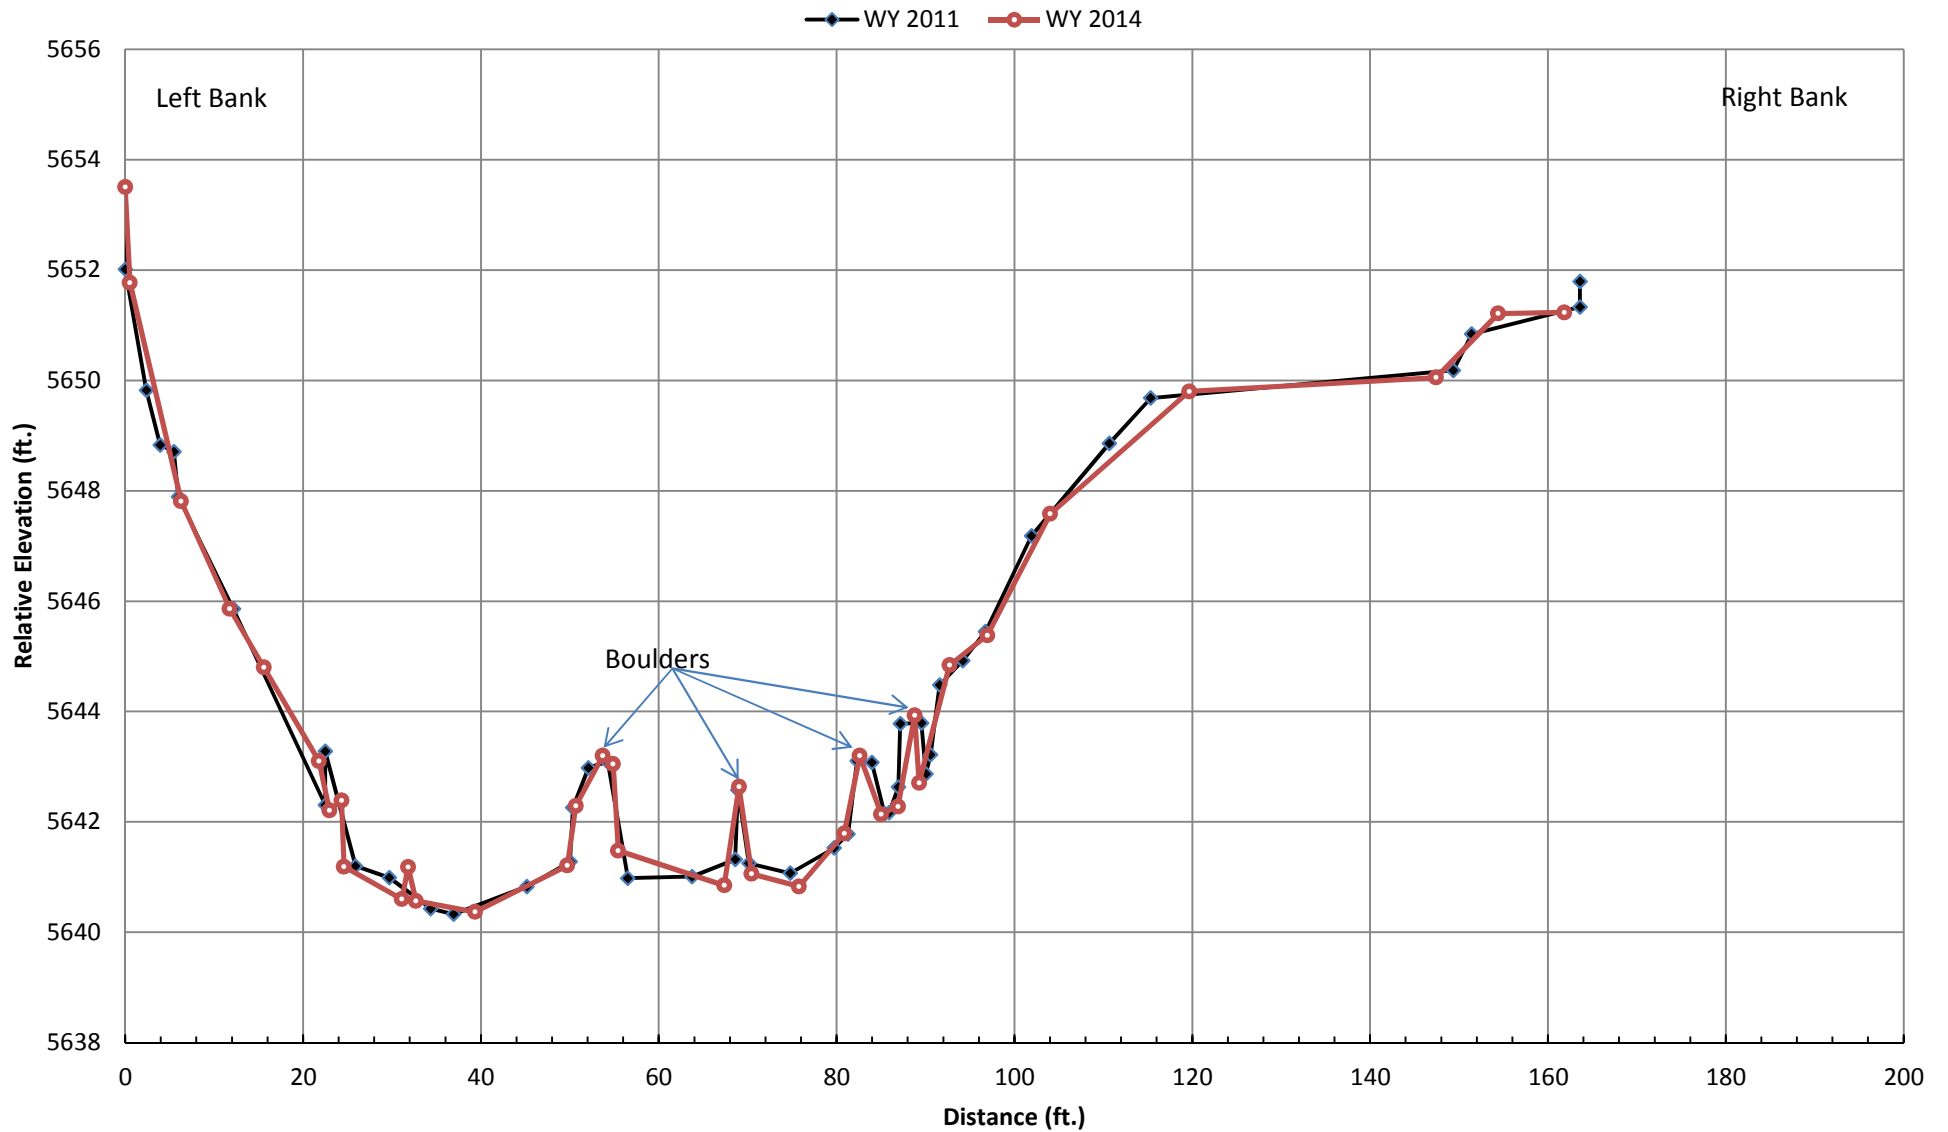
Figure 5. Cross-section 1 (Station 162) at the San Francisco Fly Casting Club (MTFC), Middle Truckee River, Nevada County, California.

Most differences between WY 2011 and WY 2014 cross sections can be attributed to differences in point locations and interpolation between points. A small amount of aggradation (roughly 0.25 ft) was detected in Cross section 2, the pool at the bottom of the boulder riffle. Small shifts in the channel bed can be discerned in Cross section 3 (glide) and Cross section 4 (riffle) in areas corresponding to those where geomorphic mapping indicated change. The bed material in these sections is dominated by loose, coarse gravel, and it is plausible—even in below-average hydrologic years—that the bed shifted slightly.

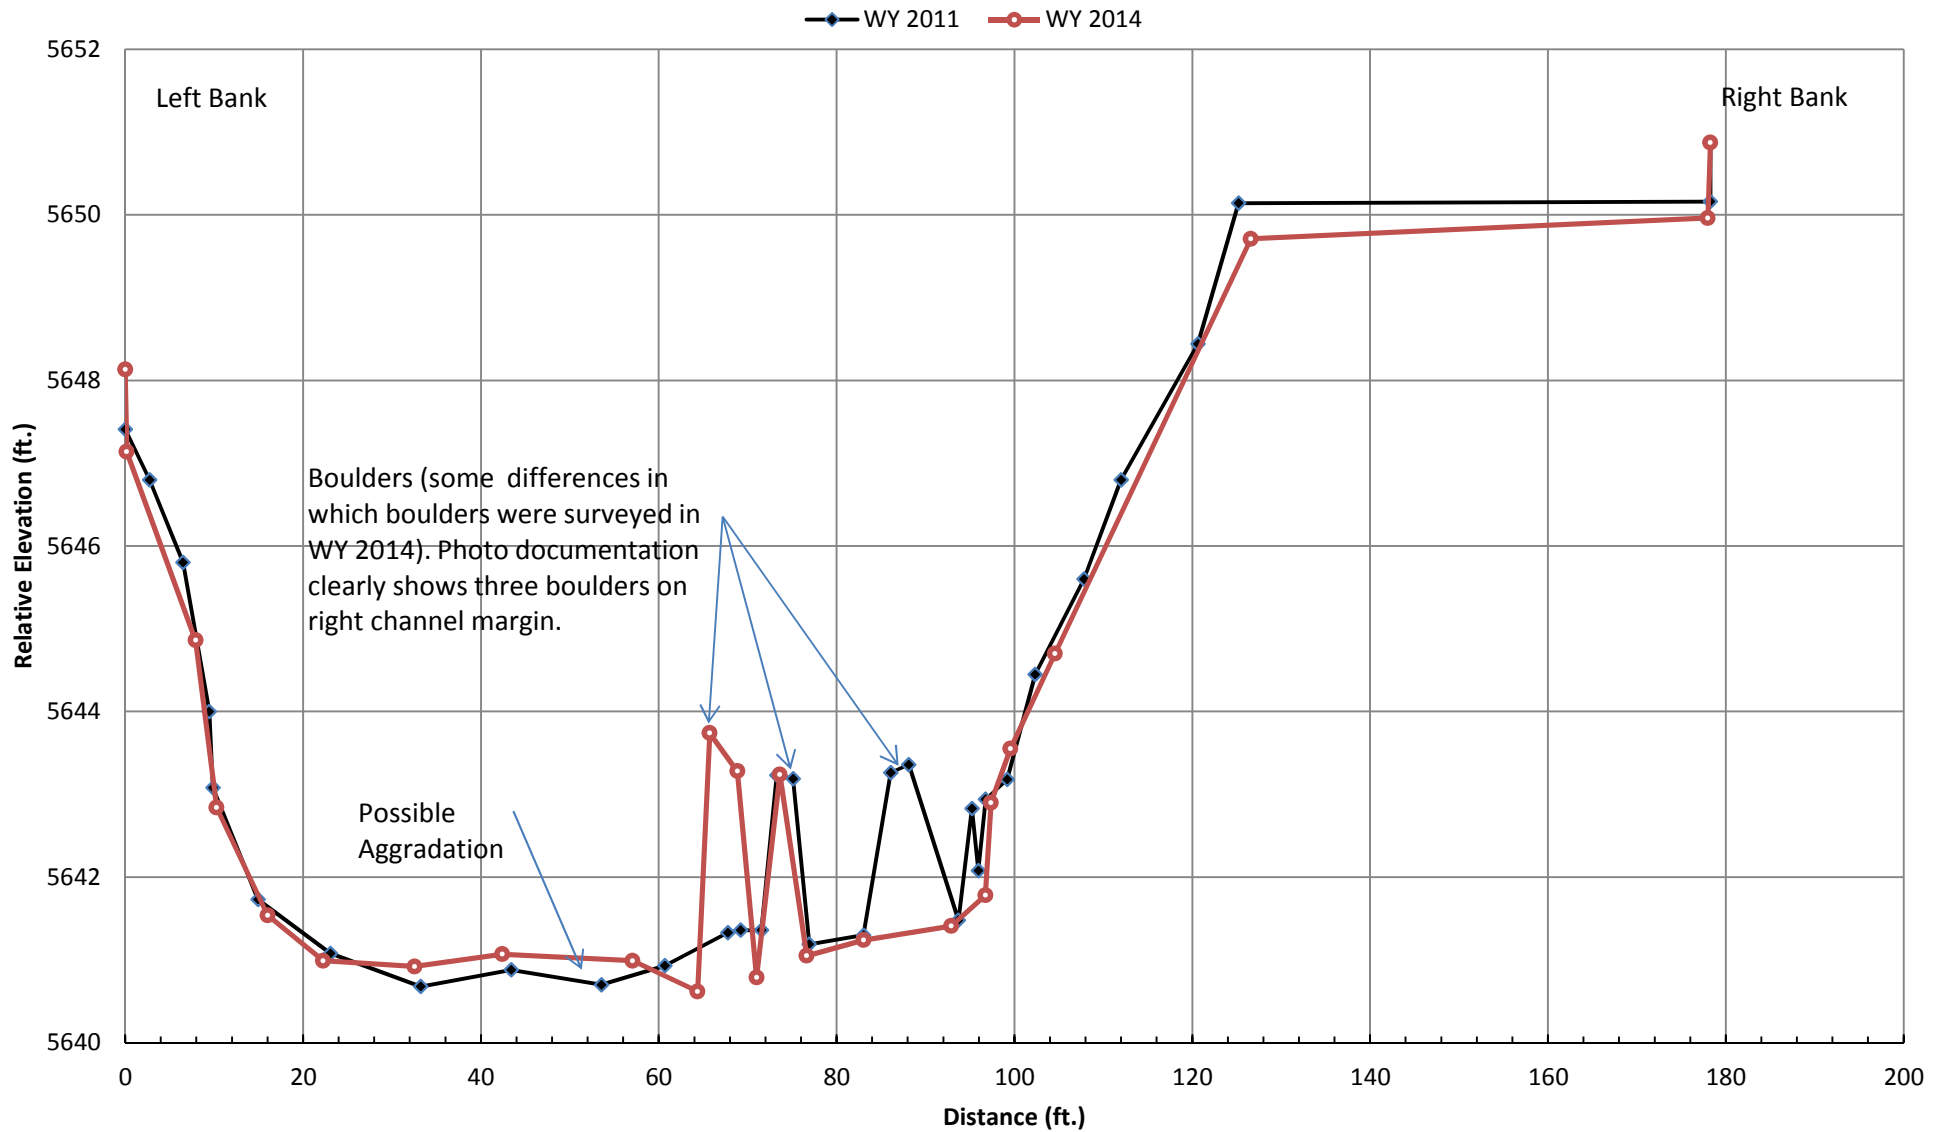
Figure 6. Cross-section 2 (Station 234) at the San Francisco Fly Casting Club (MTFC), Middle Truckee River, Nevada County, California.

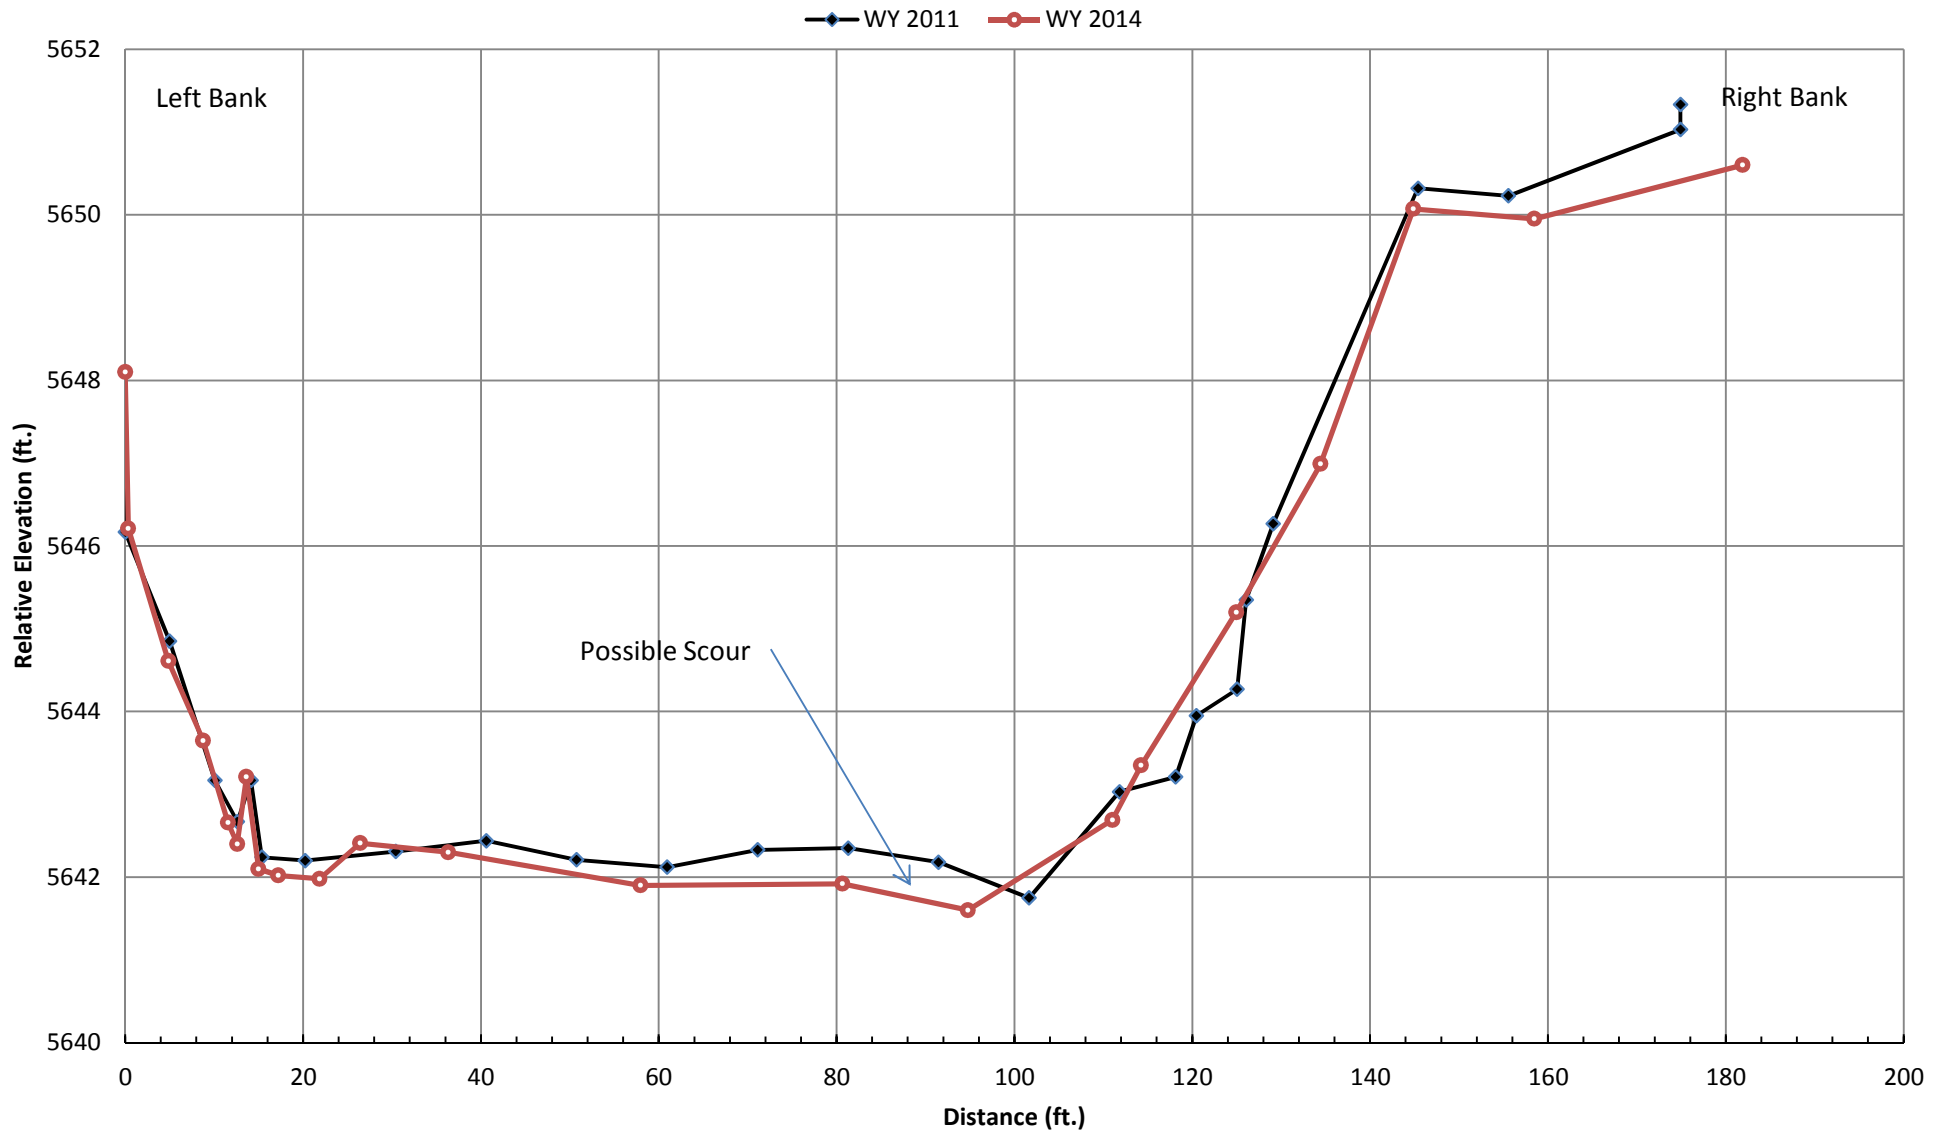
Figure 7. Cross-section 3 (Station 324) at the San Francisco Fly Casting Club (MTFC), Middle Truckee River, Nevada County, California.

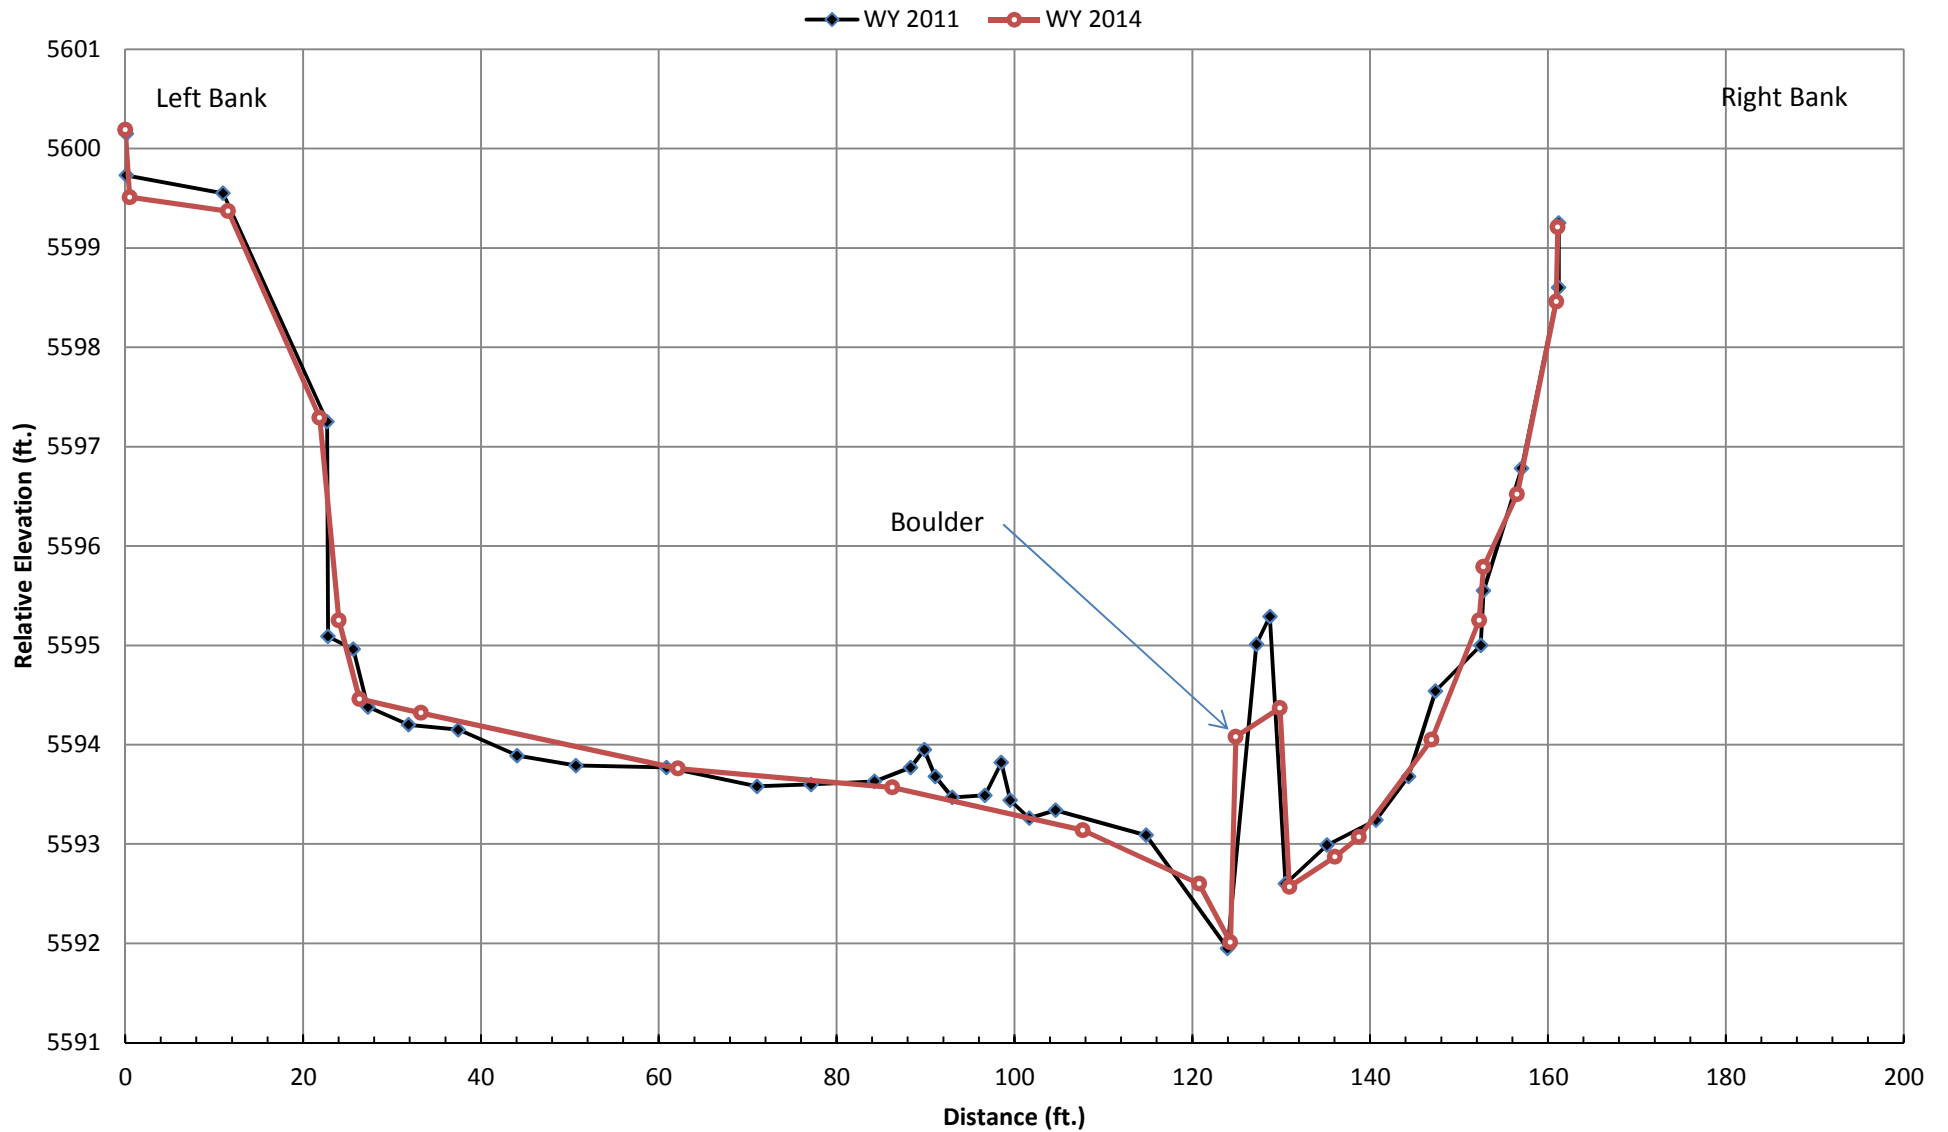
Figure 12. Cross-section 2 (Station 402) at Horseshoe Bend (MTHB), Middle Truckee River, Nevada County, California.

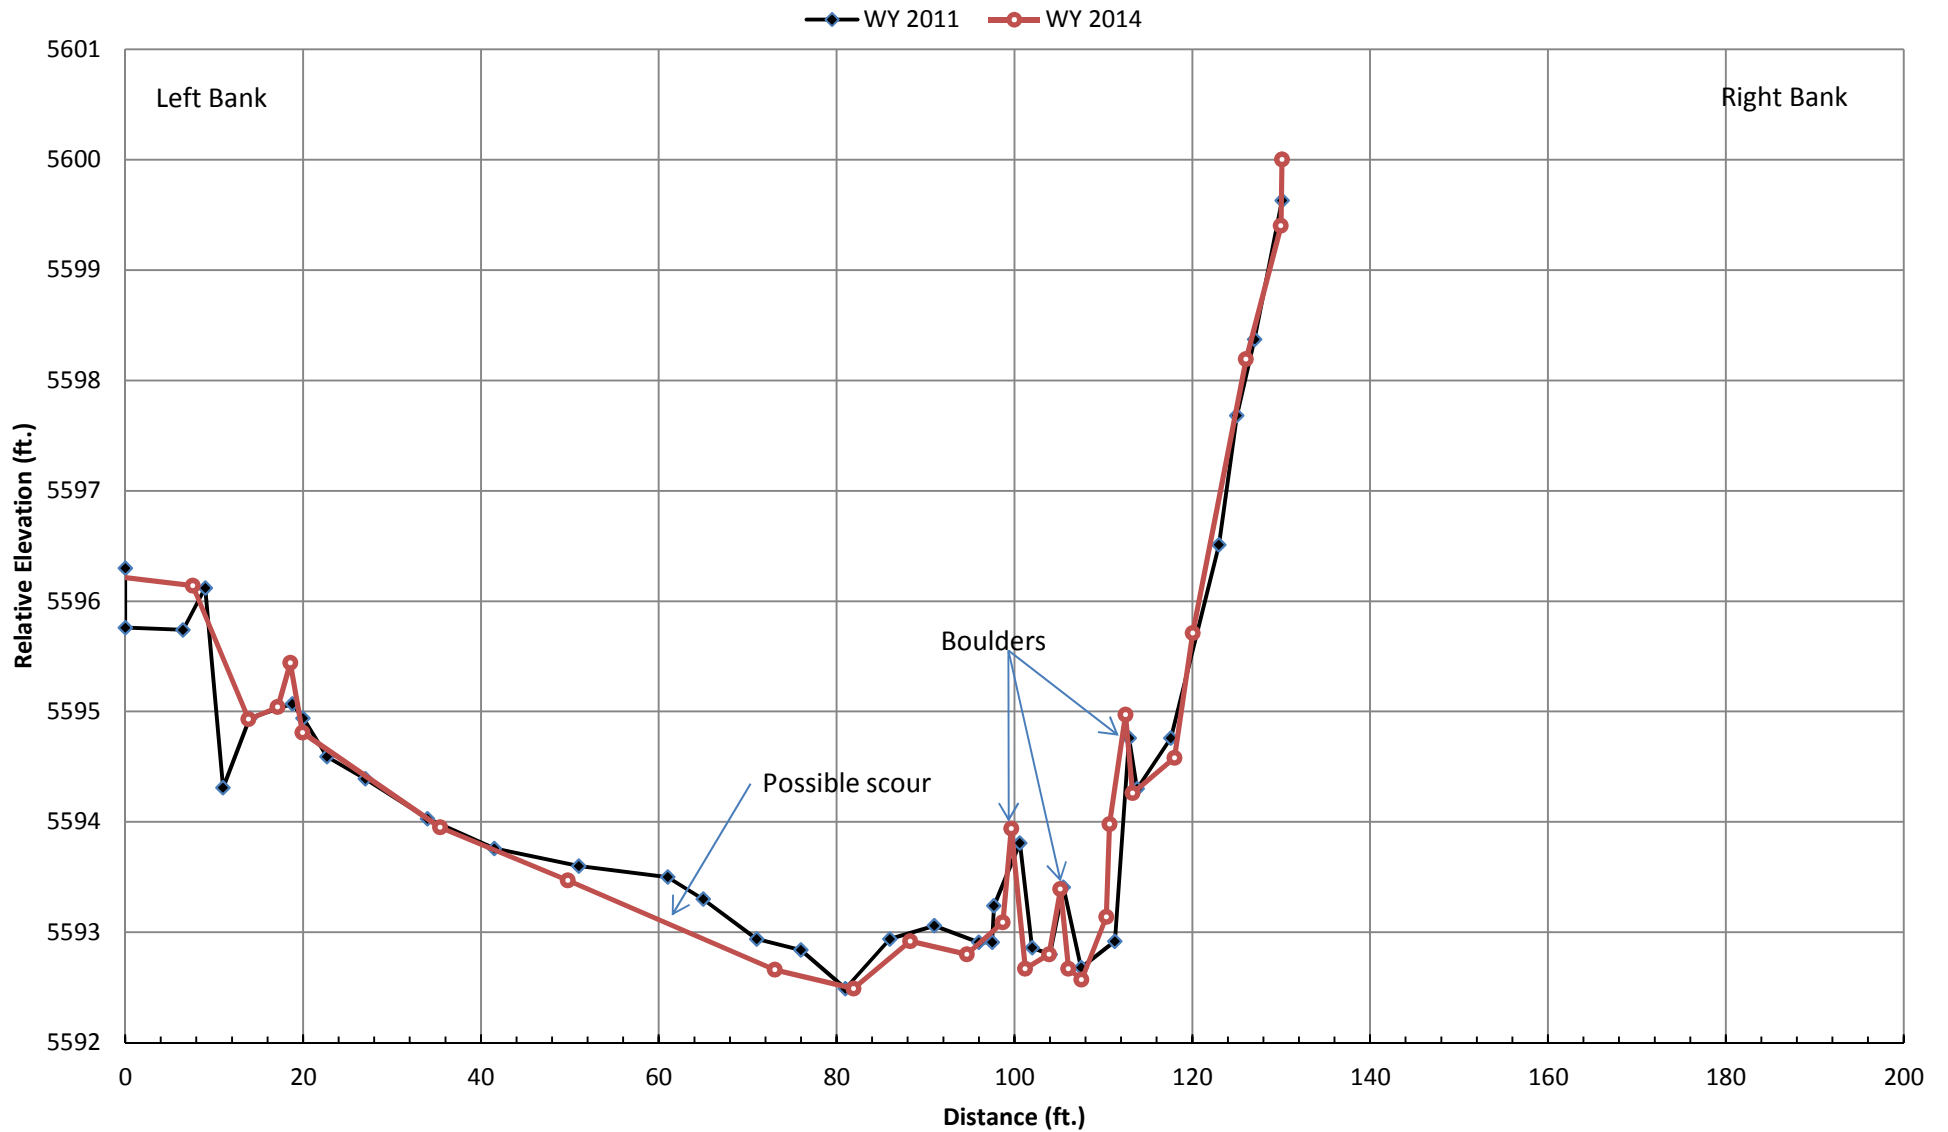
Figure 13. Cross-section 3 (Station 667) at Horseshoe Bend (MTHB), Middle Truckee River, Nevada County, California.
