# Coldstream Canyon Watershed Assessment

## Final Report

Prepared for: The Truckee River Watershed Council  
Prepared by: River Run Consulting and Hydro Science

**March 2007**

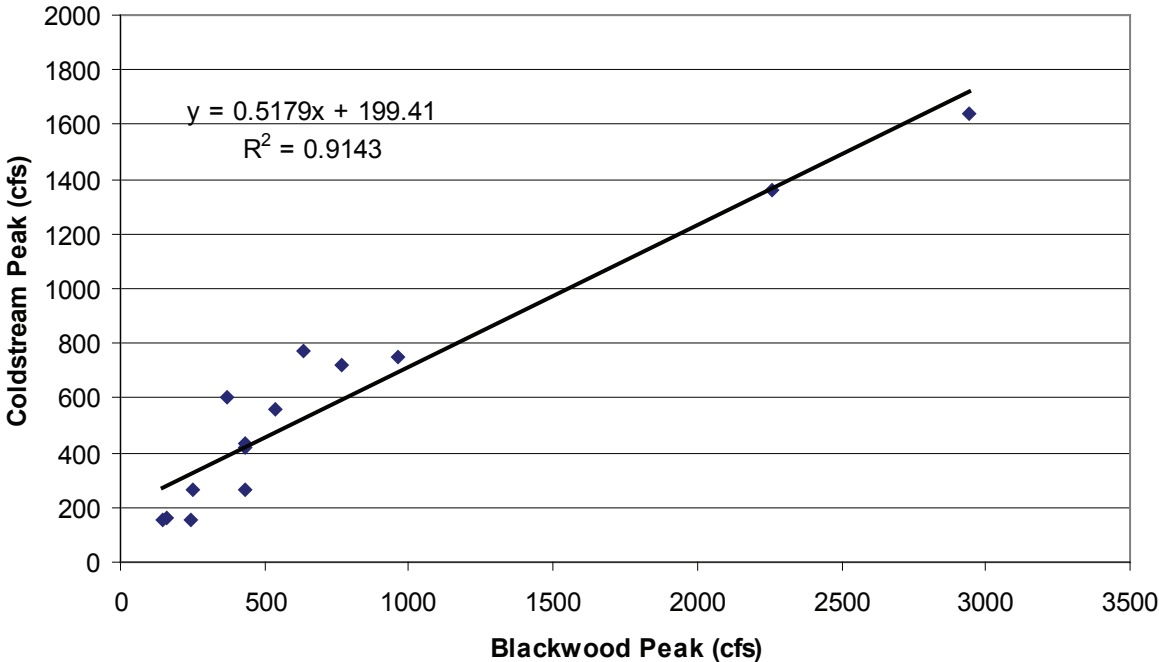
**Figure  
2-6**

**Peak flow regression analysis, Cold Creek and Blackwood  
Creek.**  
Regression analysis used to derive peak flood estimates for Cold Creek.

A flood flow frequency analysis was performed using two different methods. The first fitted the 14 years of annual peak flow estimates derived from the Donner Creek data as described above to a log-Pearson Type III probability distribution (U.S. Geological Survey 1982). The log-Pearson distribution is a three parameter distribution and the results are highly sensitive to the skew. In cases when there is less than 25 years of data, it is recommended that a regionalized

Despite the similar size and geology, Cold Creek produces much lower peaks than does Blackwood Creek for flows in excess of 1,000 cfs. It is not known if this is an artifact of differences in the storms for the two highest observed flows, or if Blackwood indeed consistently produces higher peaks during rare flood events. The higher flood flow estimates produced using just the 14 peak flow observations from Cold Creek produces higher flow estimates because the small data set, by coincidence, includes the 1997 event, which is the flood of record for many of the streams in the area. The inclusion of that outlier in a small data set results in a larger skew coefficient. It is reasonable to conclude that the true recurrence interval estimates lie somewhere between the estimates derived by the two different analyses.

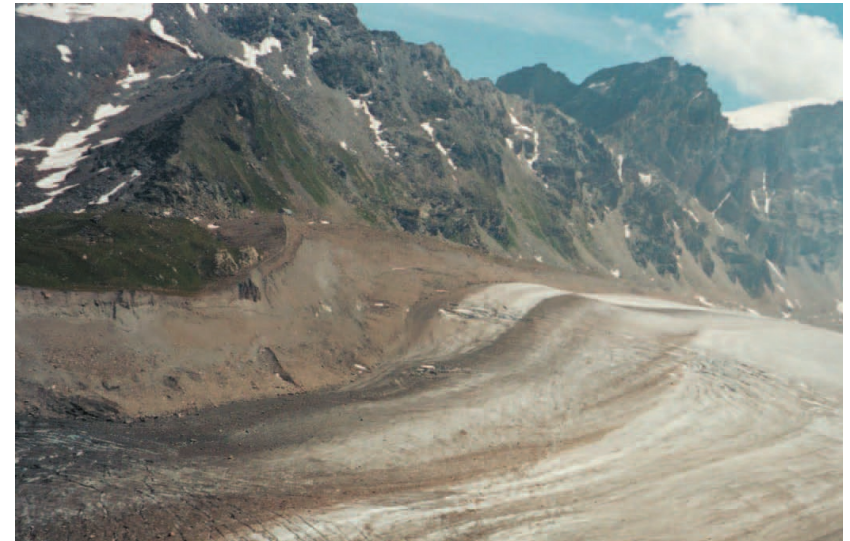
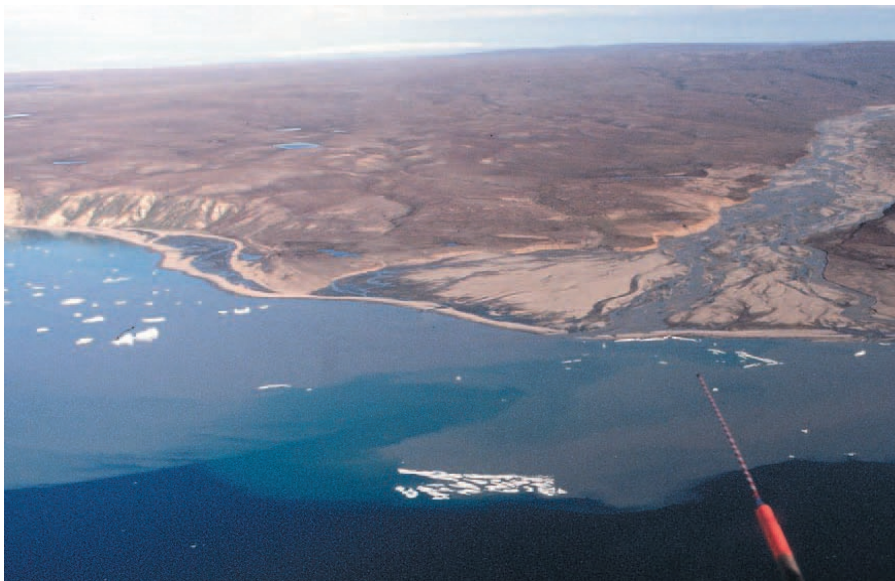
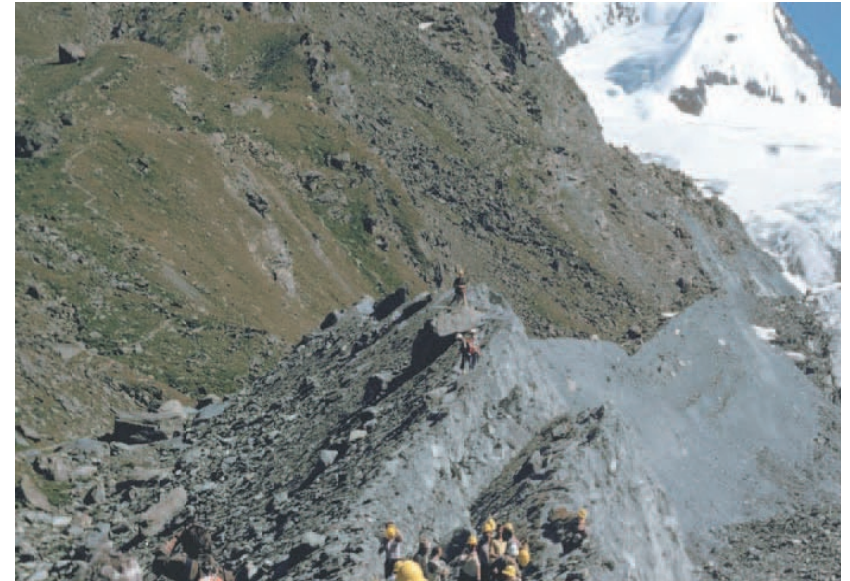
**Figure  
2-12**

**Glacial depositional landforms.** Top Left: Lateral moraines confining braided outwash plain. Note drainage development on and through moraines, and outwash plains developing between the ice and adjacent moraines (kame terraces). Bottom Left: Delta in active construction at mouth of braided outwash plain. Top Right: Retreating glacier, hillslopes and moraines recently deglaciated. Bottom Right: Recently deglaciated moraine. Note instability and deposits from hillslope erosion developing between ice and toe of slope.

An extensive array of depositional features is created by glaciation, either directly by glaciers or by running water cause by glacial melting. Figure 2-12 shows several of these landforms in modern glaciated environments. Moraines are berm-like mounds deposited on the lateral and terminal margins of the glacier, and can be quite large; the east end of Donner Lake is a moraine, and smaller terminal moraines formed as the Donner glacier receded are clearly visible on perspective topographic views as small spurs along the south valley wall just west of the Cold Creek canyon (Figure 2-9). Ground till is deposited directly by glaciers in various patterns on valley floors. Fluvial deposits laid down in glacial environments, during periods of high supply of both sediment and water, include braided outwash plains, kame terraces along glacier margins, and alluvial fan and deltaic deposits. Ponding behind moraines, till, or in braided outwash plains results in lacustrine (lake) deposits.

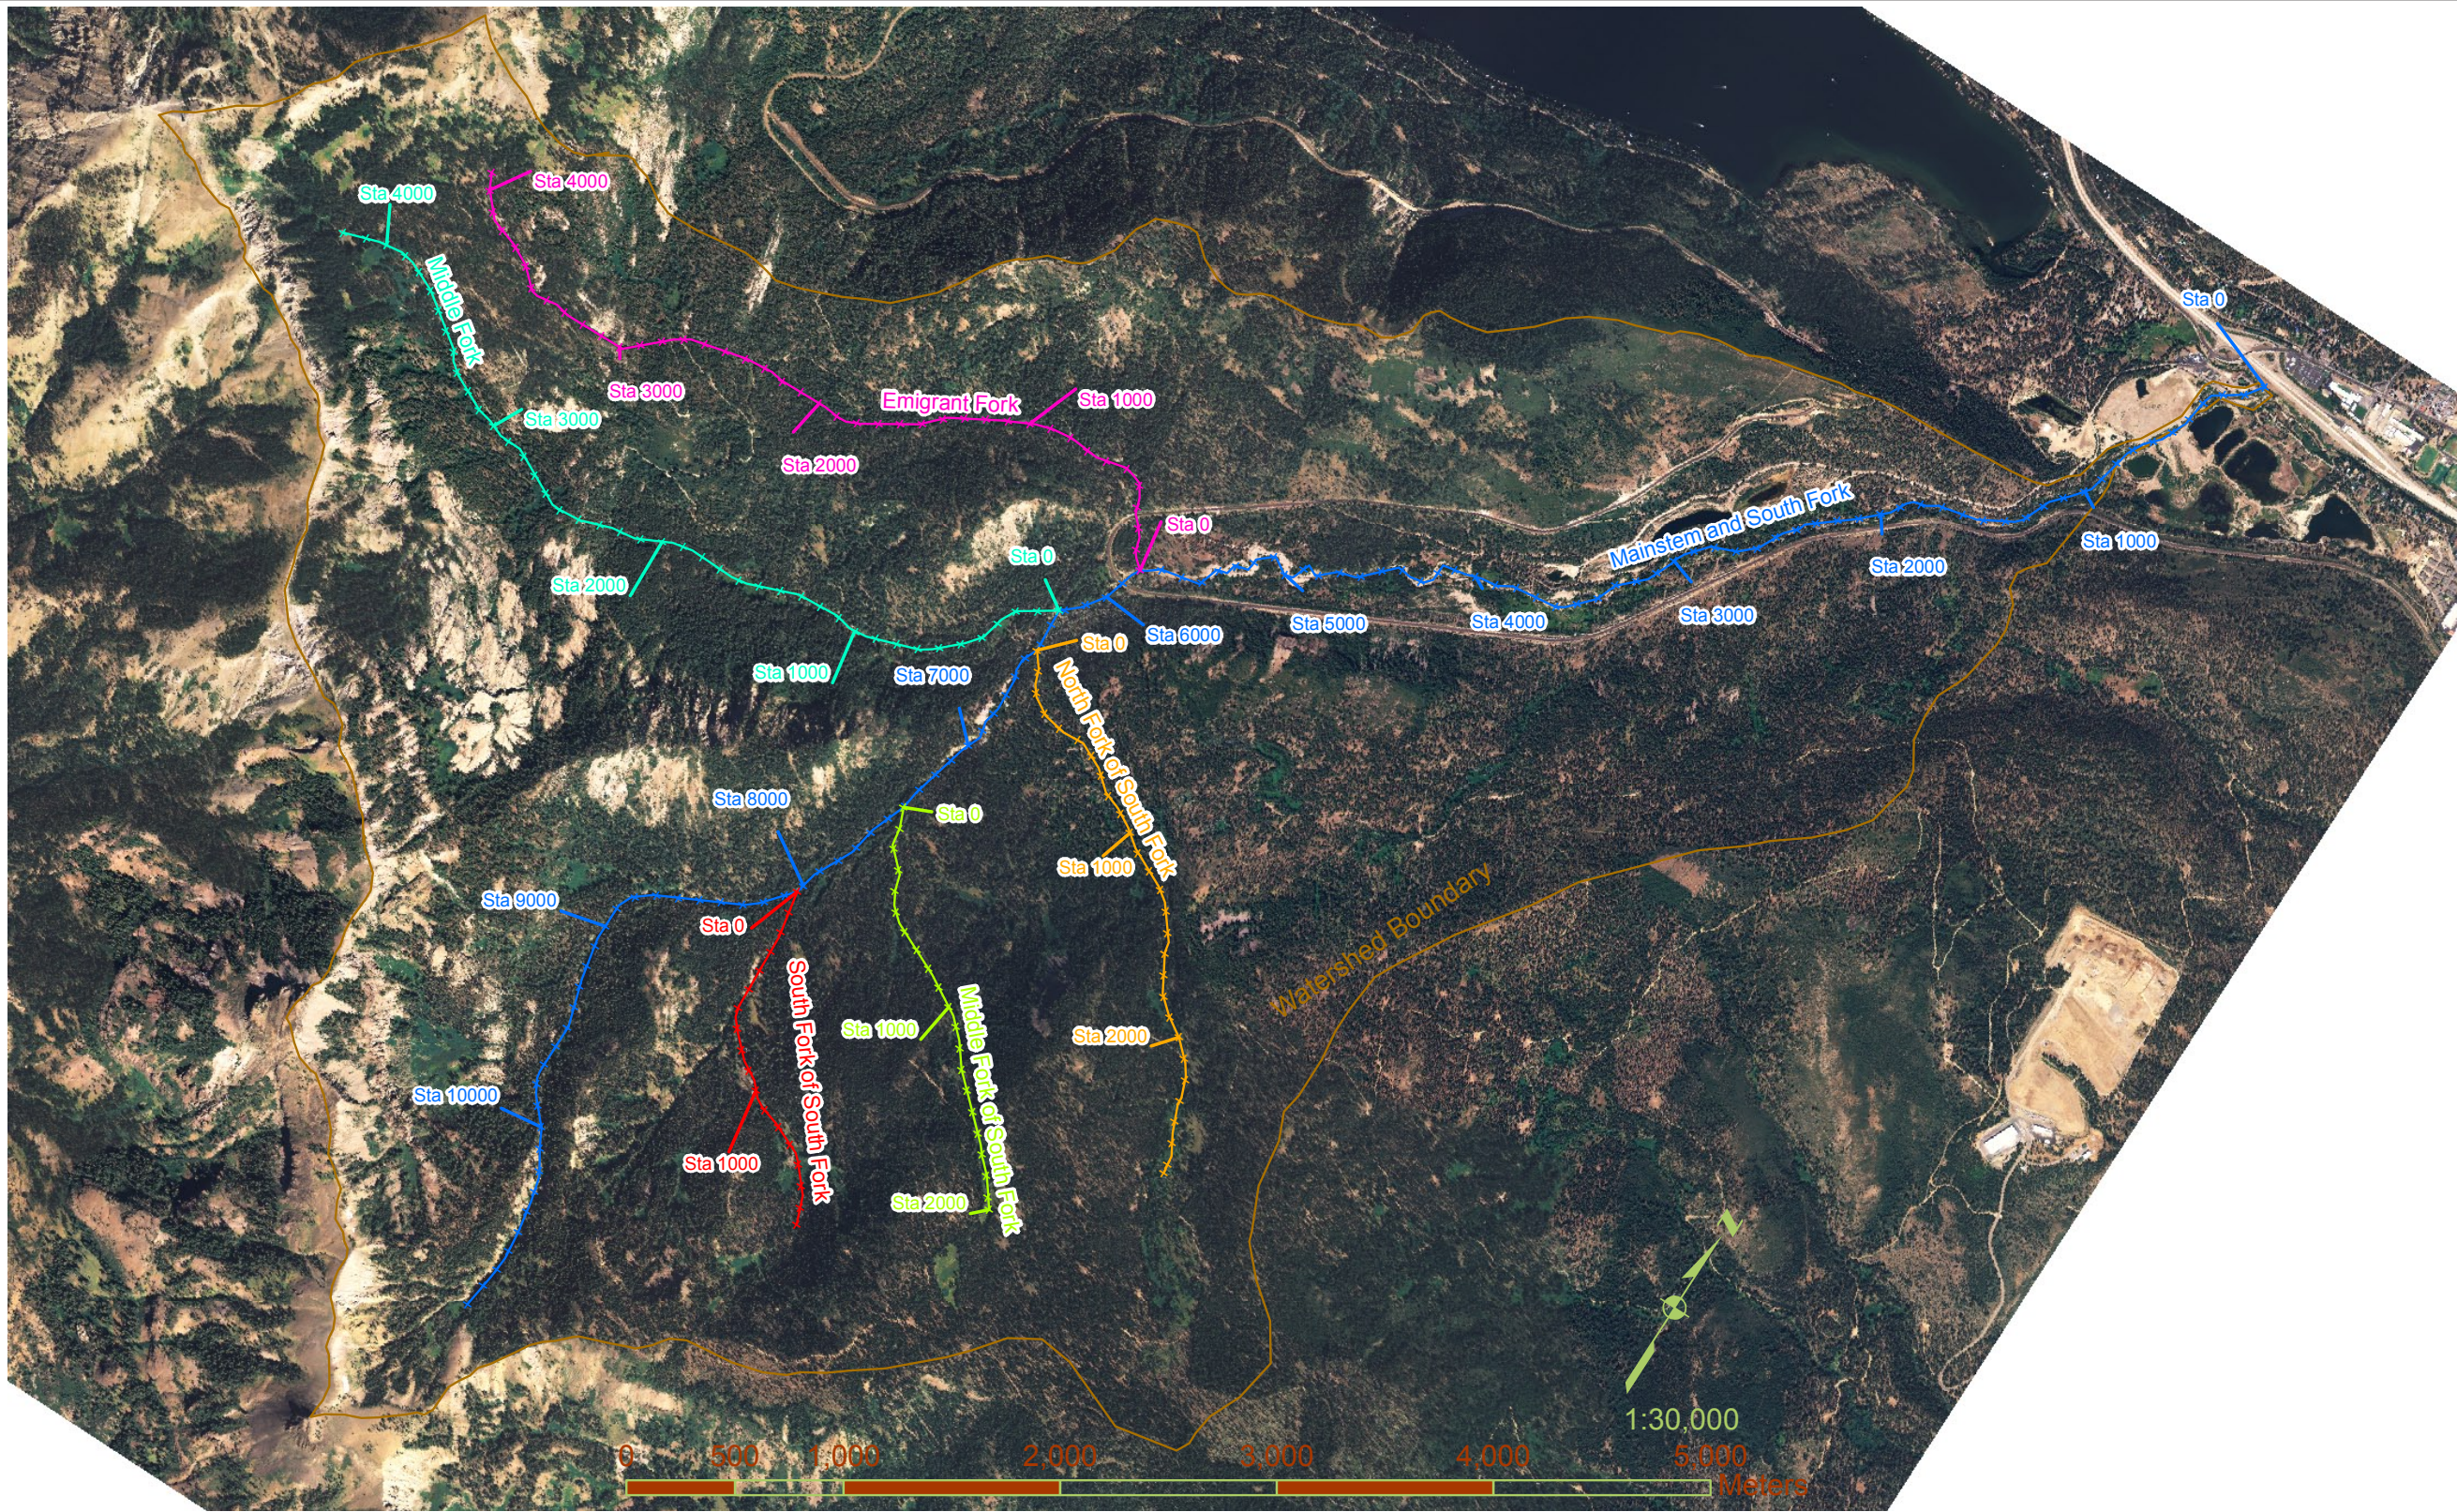
**Figure 2-17**

**Stationing for valley bottom profiles.**

Tics on channel centerlines represent 100m stations. Stationing for the mainstem is distance upstream from the confluence with Donner Creek. Stationing for tributaries is distance upstream from the confluence with the Mainstem-South Fork.

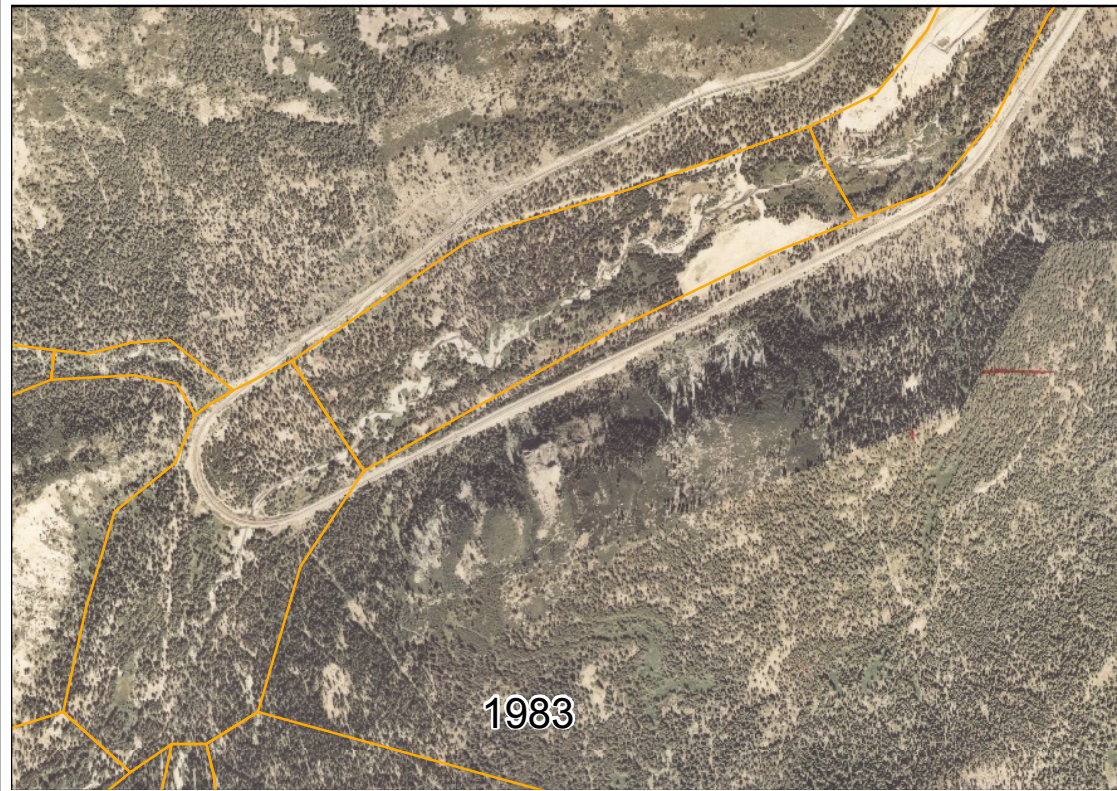
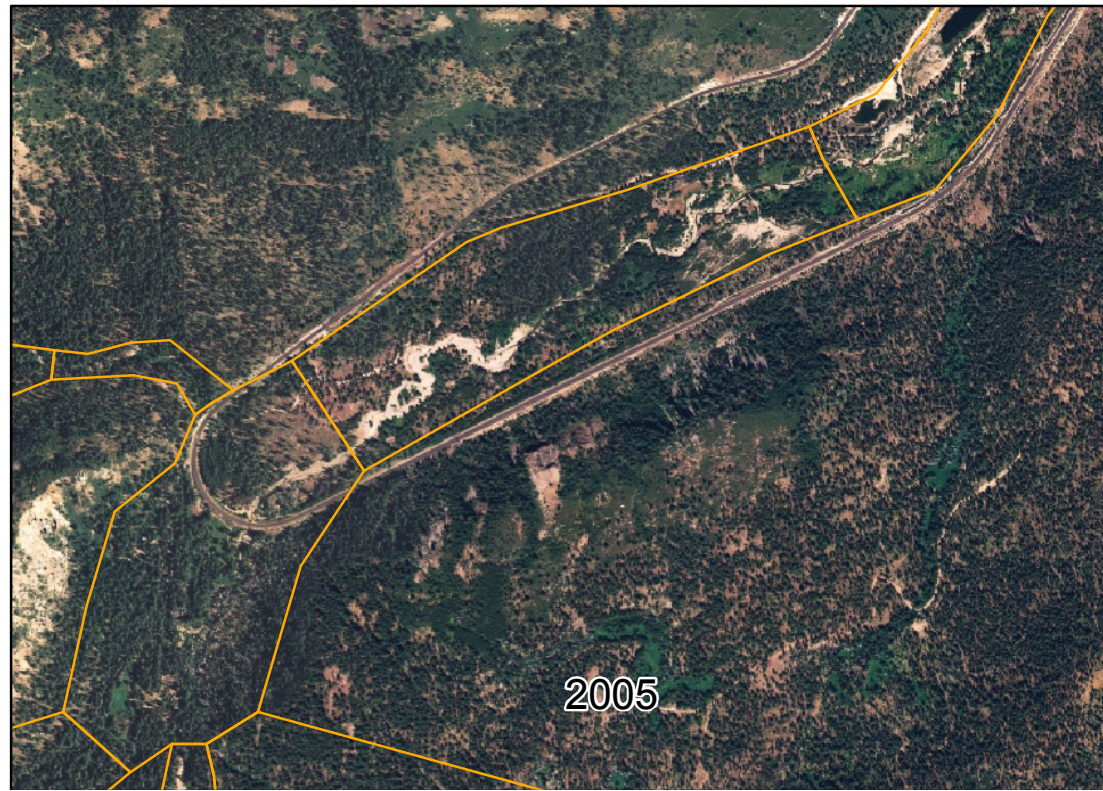
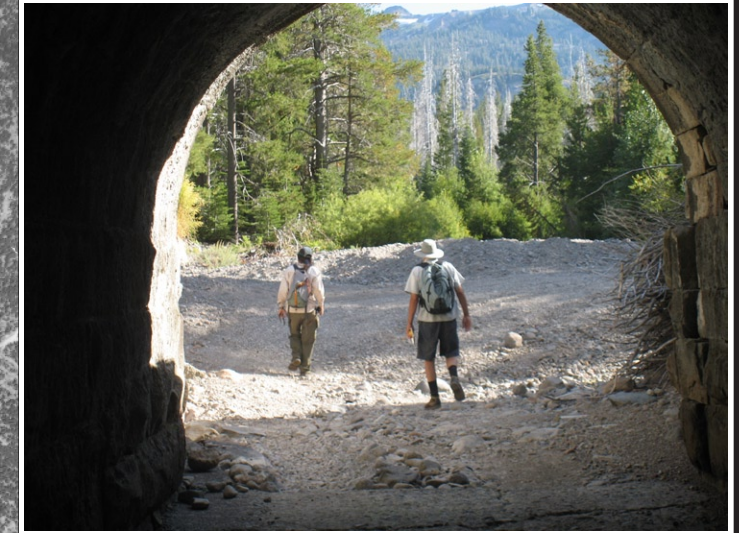
**Figure 3-11**

Note progressively increasing erosion over time in reach downstream of railroad culvert. Top right photo shows the narrow railroad culvert, with large bar upstream. Lower right photo is an example of the destabilized channel near the downstream end of the landform.

Note that between 1983 and 2005, the destabilized reach in the Upper Valley eroded dramatically (Figure 3-11); most of this erosion occurred during the 1997 flood, when the channel moved by nearly 100 ft. in some locations, threatening a historic portion of the Emigrant Trail on State Parks land (Cynthia Walck, California State Parks, personal communication). Our cumulative watershed analysis showed that watershed condition had improved considerably by 1997, yet massive channel erosion still occurred.

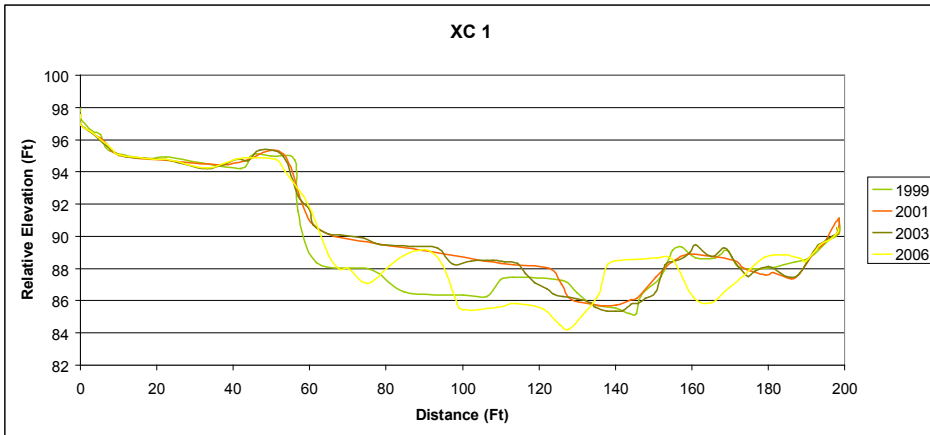
**Figure  
3-12**

**State Park cross sections in the unstable portion of the  
Upper Valley landform.**

Channel instability in this area is extremely high, with large-scale changes in cross section and planform during larger rain-on-snow storms. Cross sections repeated over time by California State Parks near the upstream end of the landform show that individual locations are both laterally and vertically unstable, aggrading in some events and degrading in others (Figure 3-12). High rates of erosion produce large quantities of sediment from within the reach, much of it coarse, which contributes to instability. Instability will continue in the reach for the foreseeable future as the channel adjusts to the sediment supply available from both the upper watershed and sediment produced by channel adjustment within the reach. The net effect has been to convert a landform which was likely neutral in terms of sediment deposition and erosion prior to human disturbance into a landform which primarily exports sediment.
