Coldstream Canyon Floodplain Restoration

February 12, 2013

California Department of Parks & Recreation

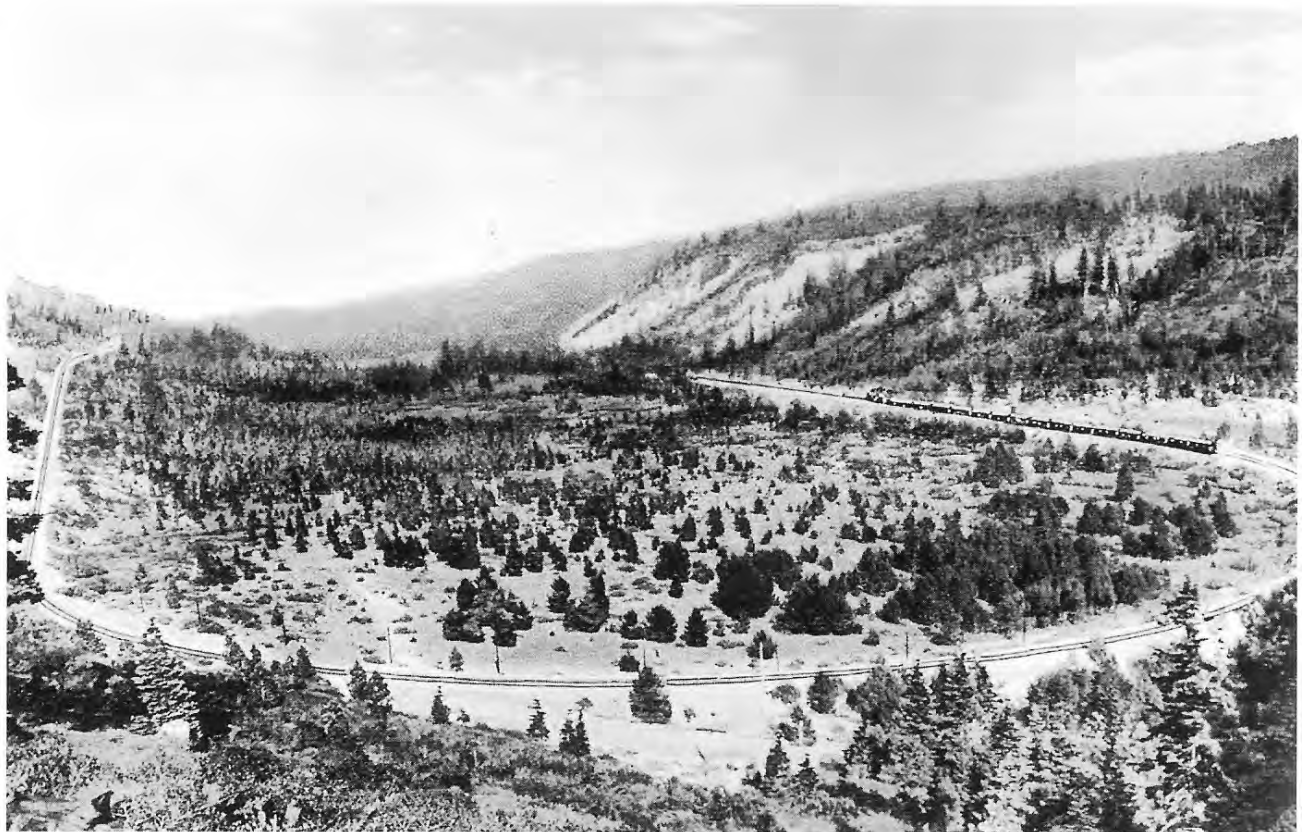
Plate 65a

Taken about 2.5 miles southwest of the previous photo pair, this view looks down Coldstream Valley from Horseshoe Bend. The camera point for plate 64a is at the upper left in the distance. The horseshoe was a unique feat of engineering that allowed the tracks to maintain the specified grade up the mountain. The view shows trees in early stages of regeneration after loggers removed the original stands. The riparian zone to the left of center supports many willows, while shrubs and herbs grow in the openings between trees. —Courtesy Special Collections Department, University of Nevada, Reno

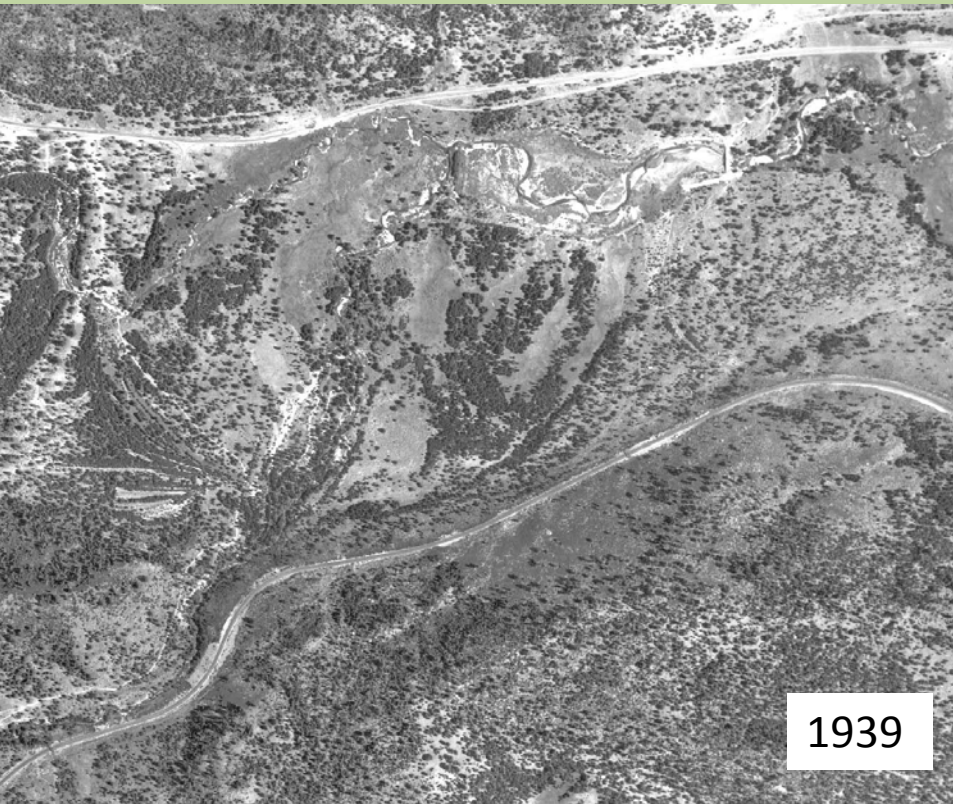
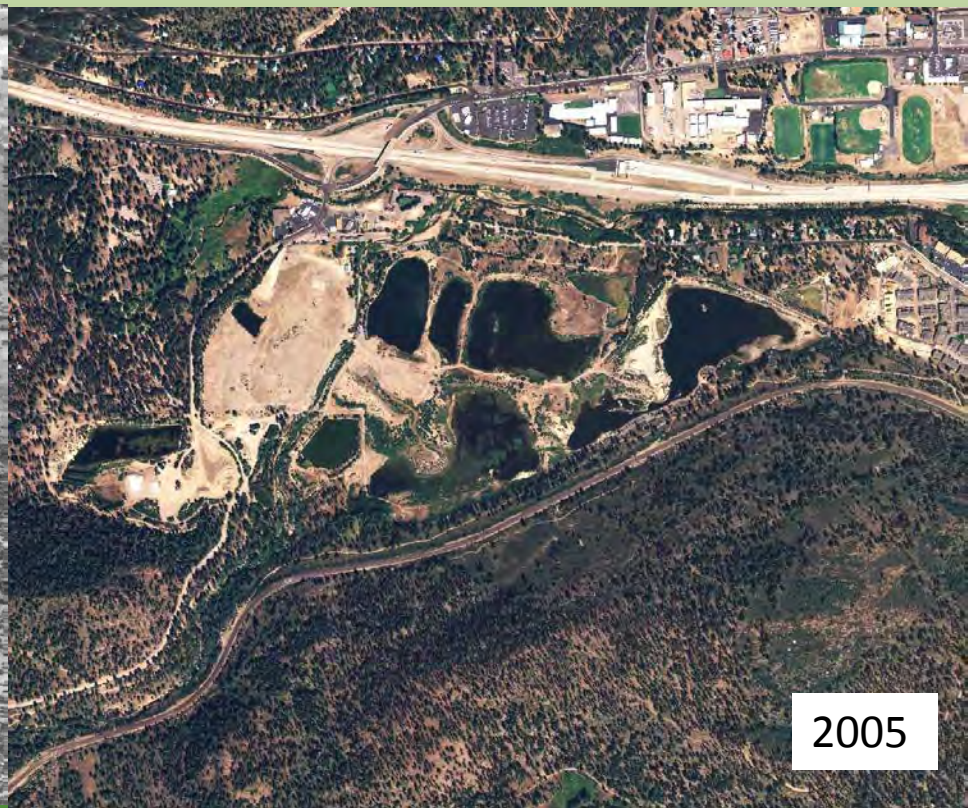
Channelization for gravel mining caused incision and erosion

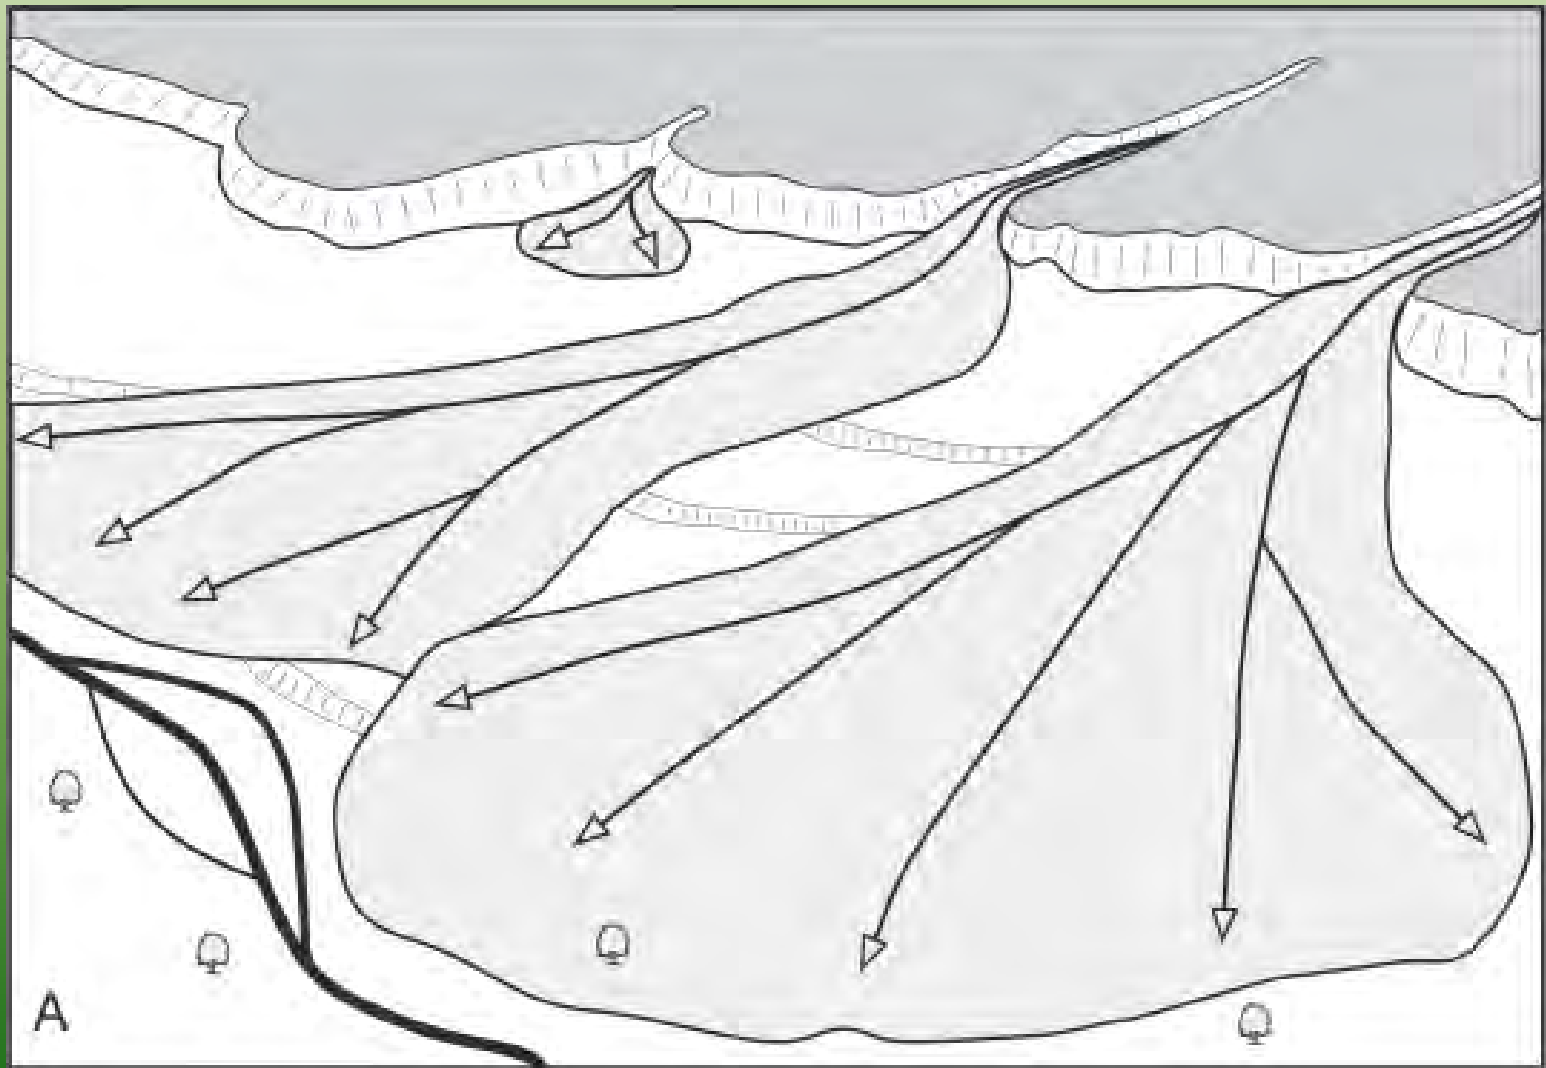
Fan at confluence

Increased slope leads to incision

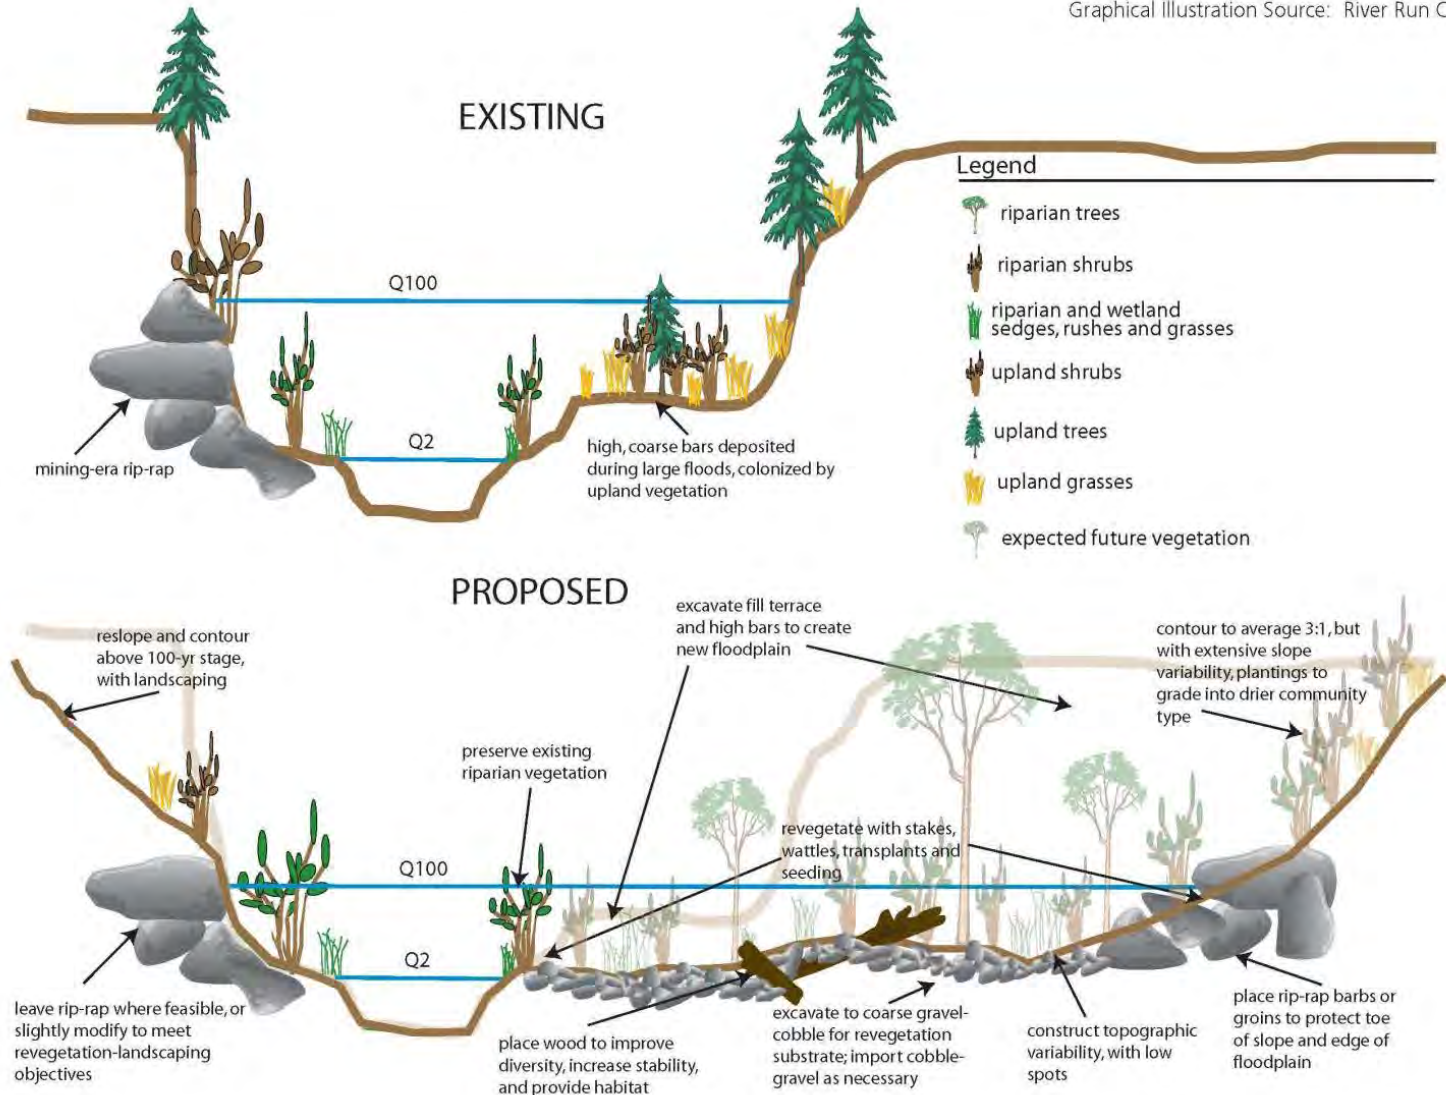
Floodplain creation

Graphical Illustration Source: River Run Consulting

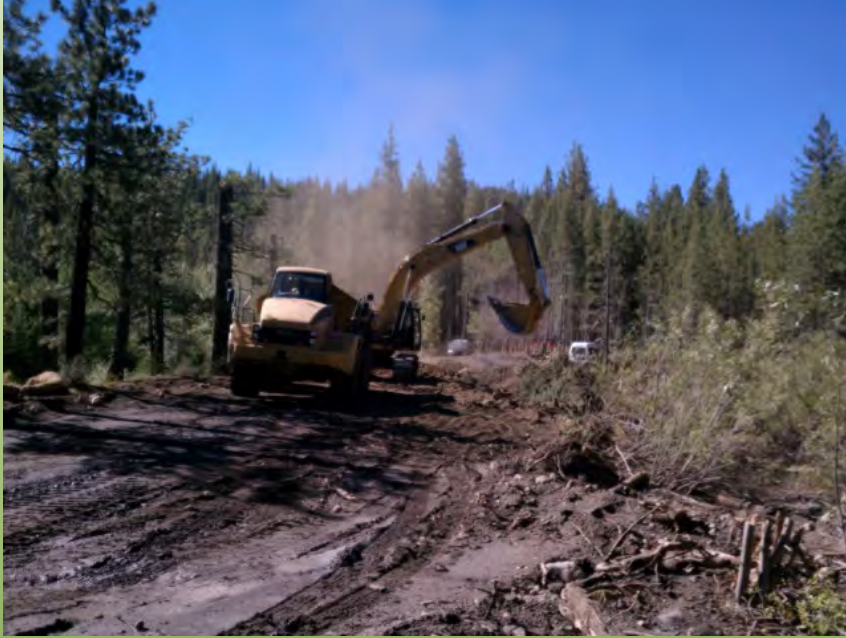
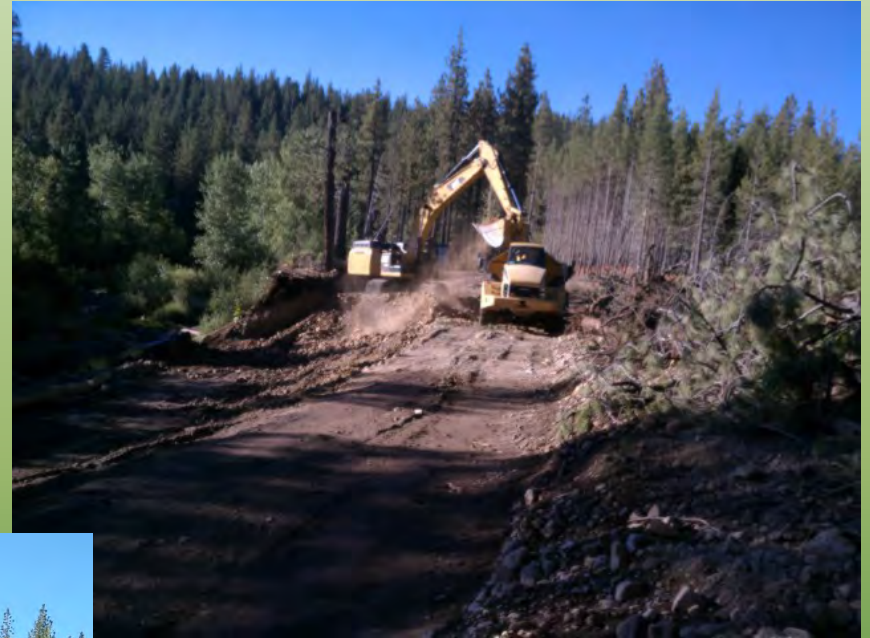
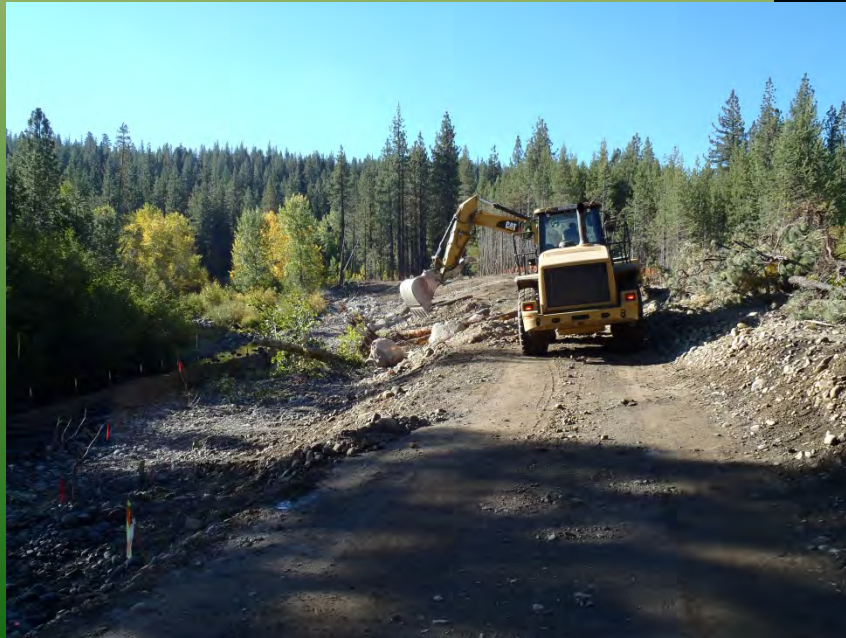
Excavation sequence

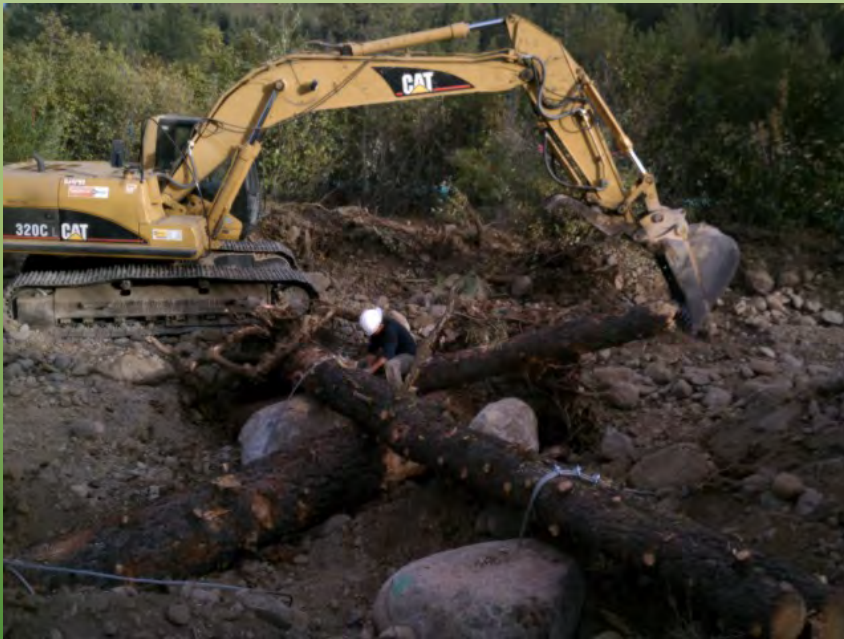
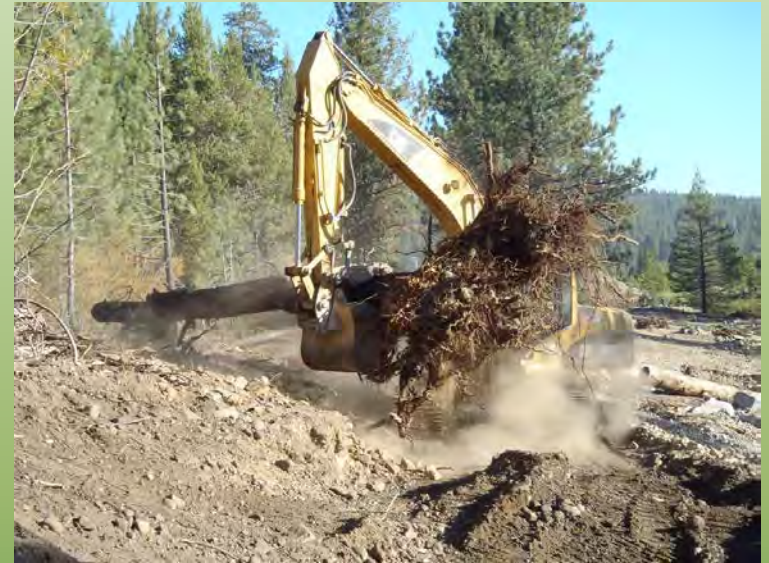
Barb construction

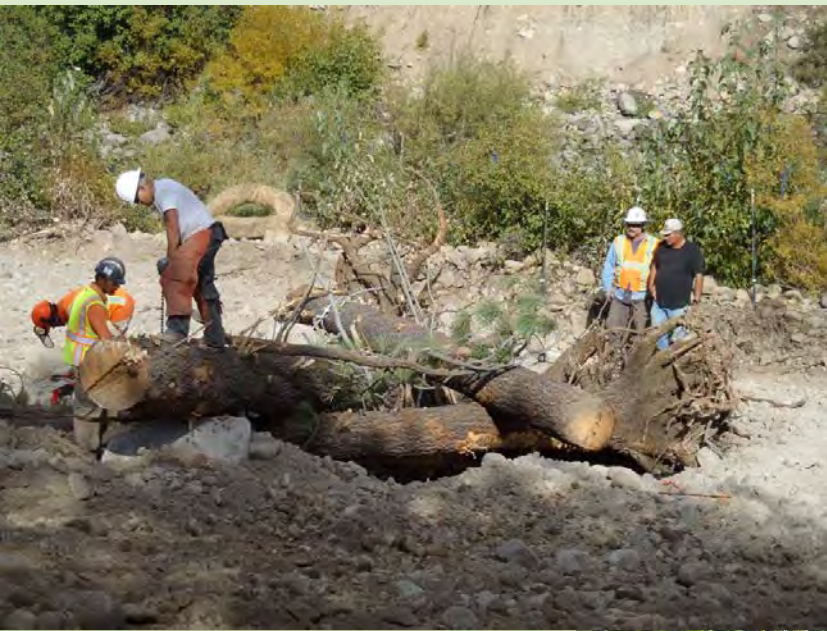
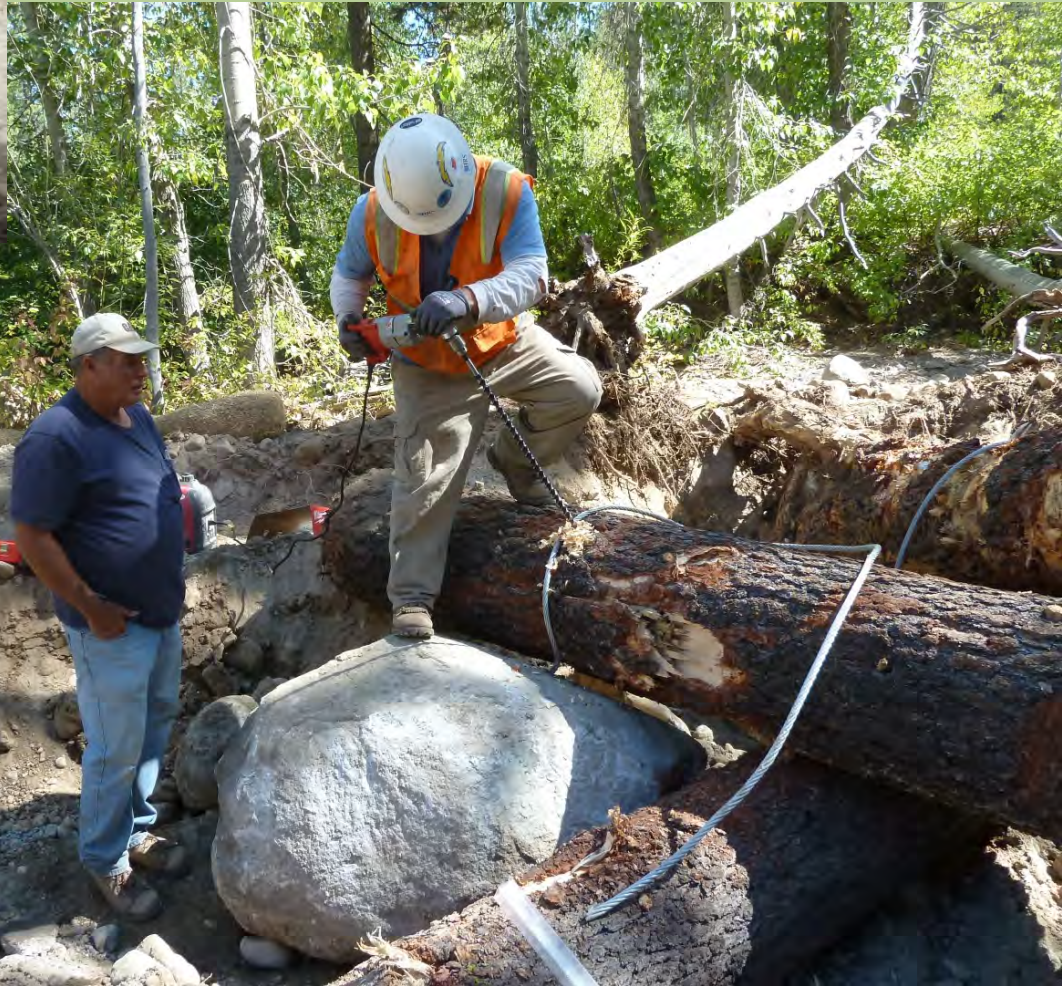
Barb anchoring

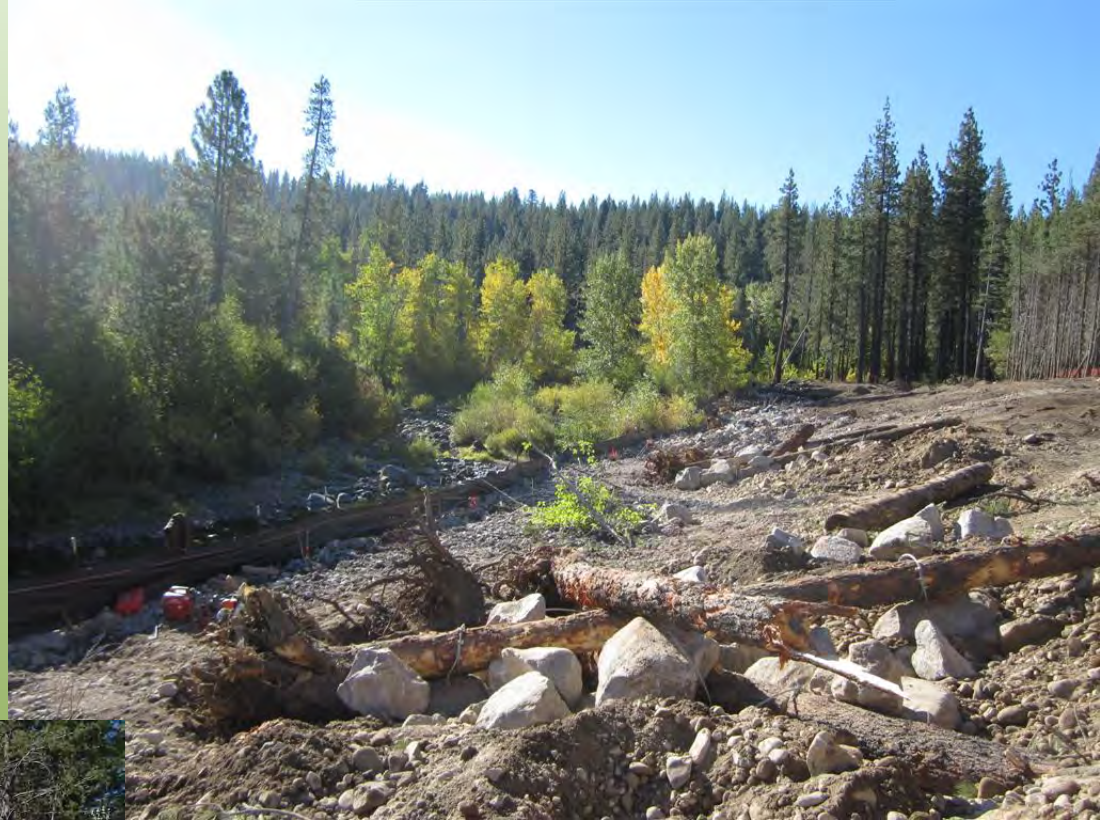
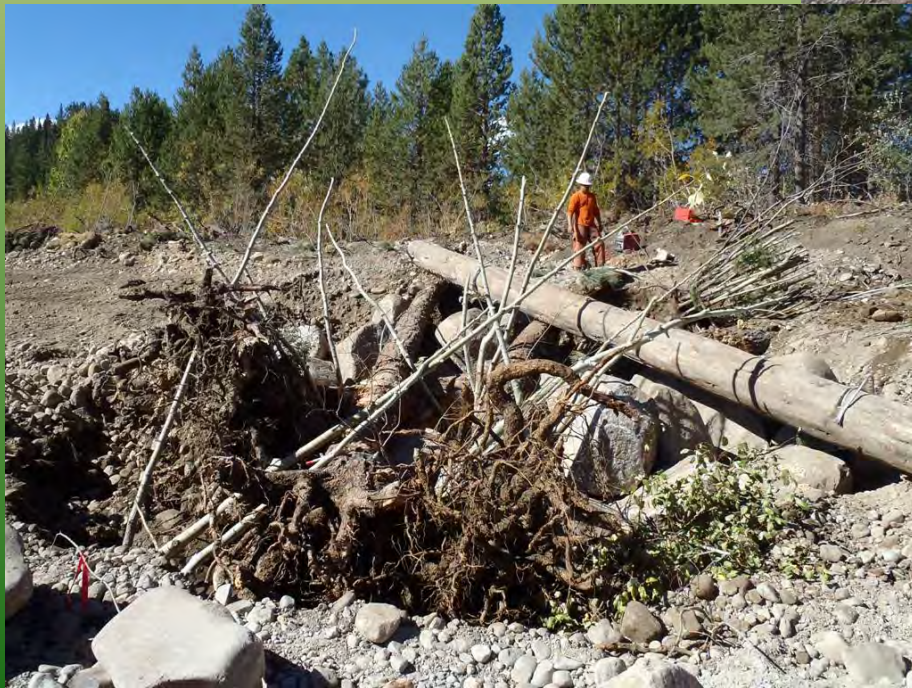
Barbs = Woody debris
structures

deflect flow &
provide habitat

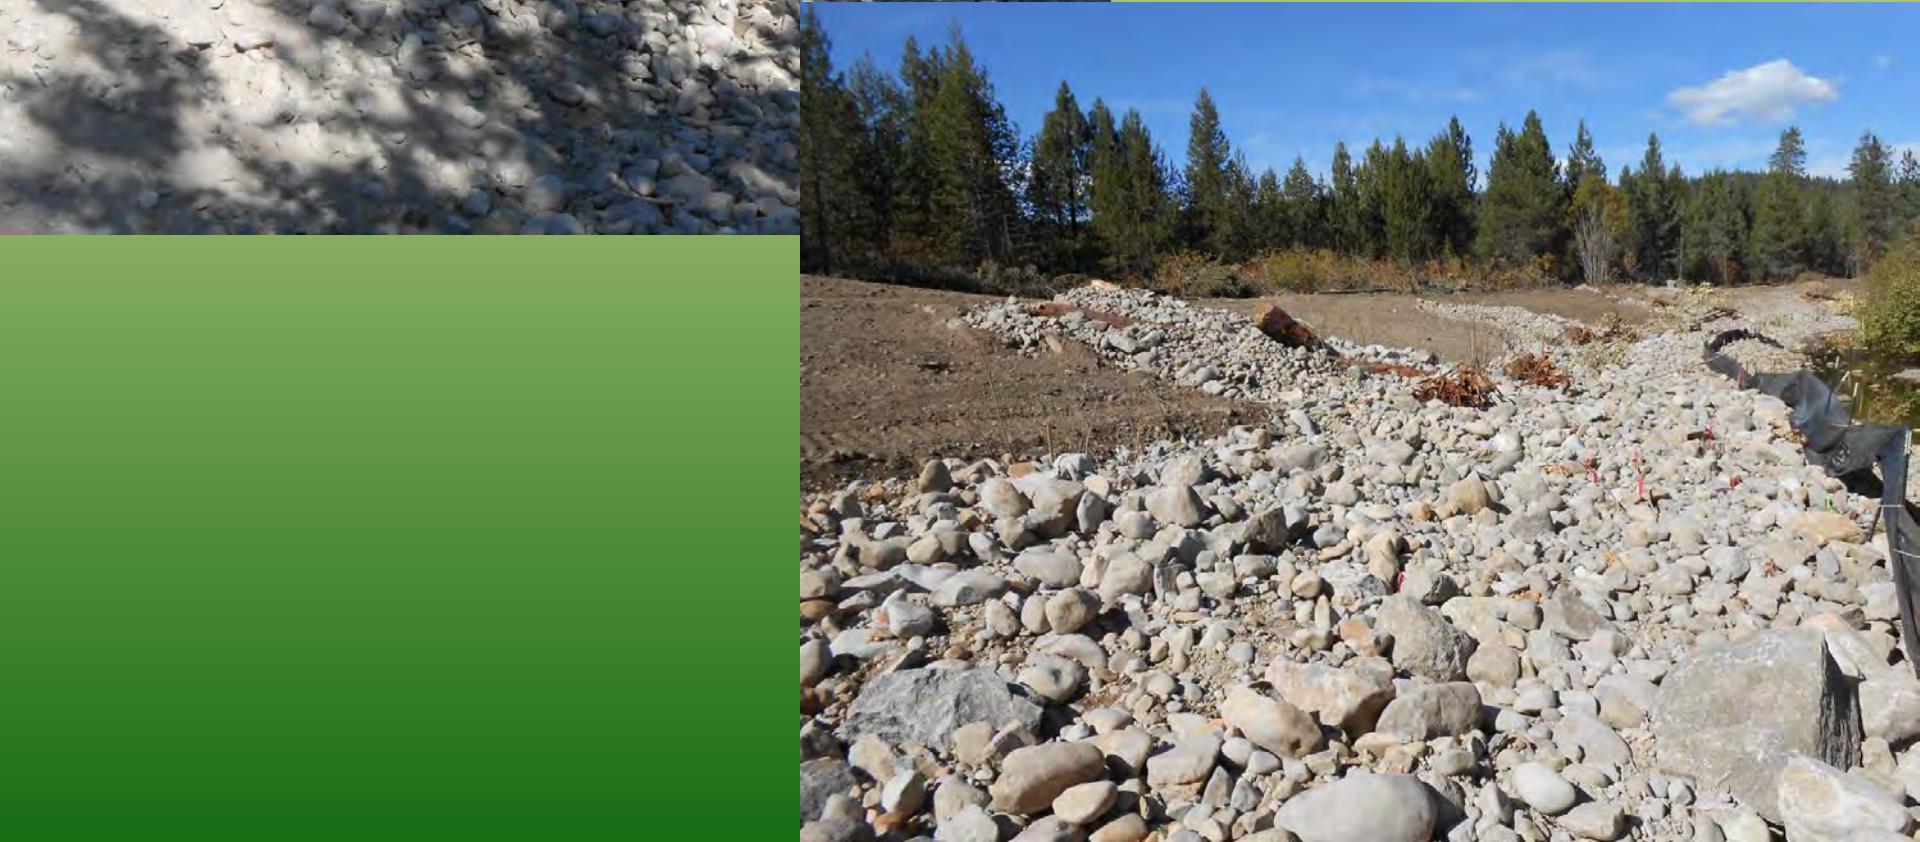
Completed barb and
floodplain armor

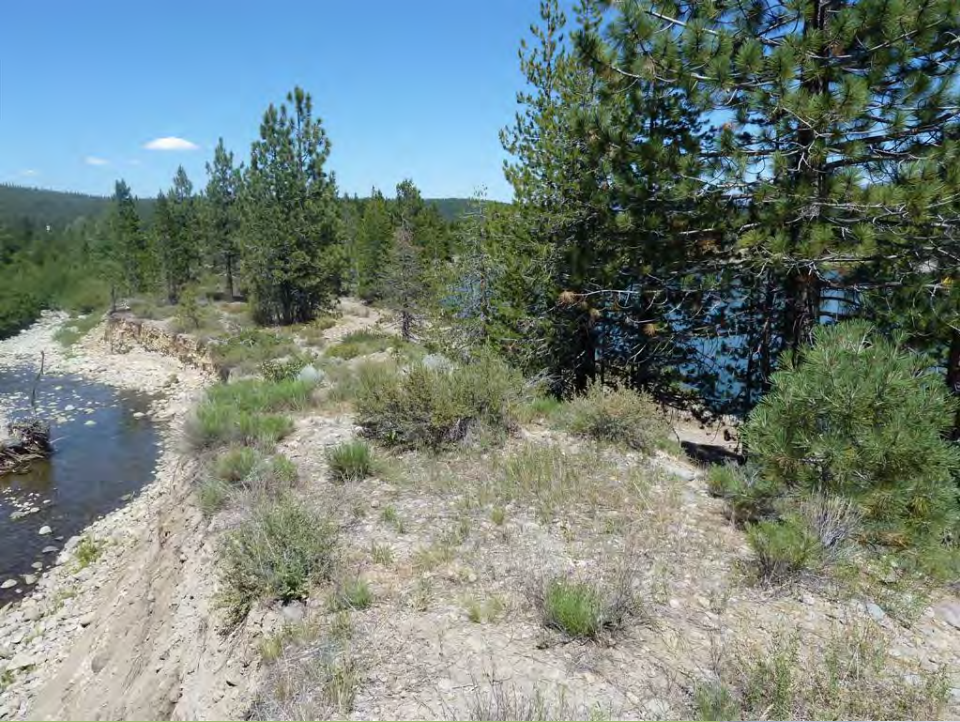
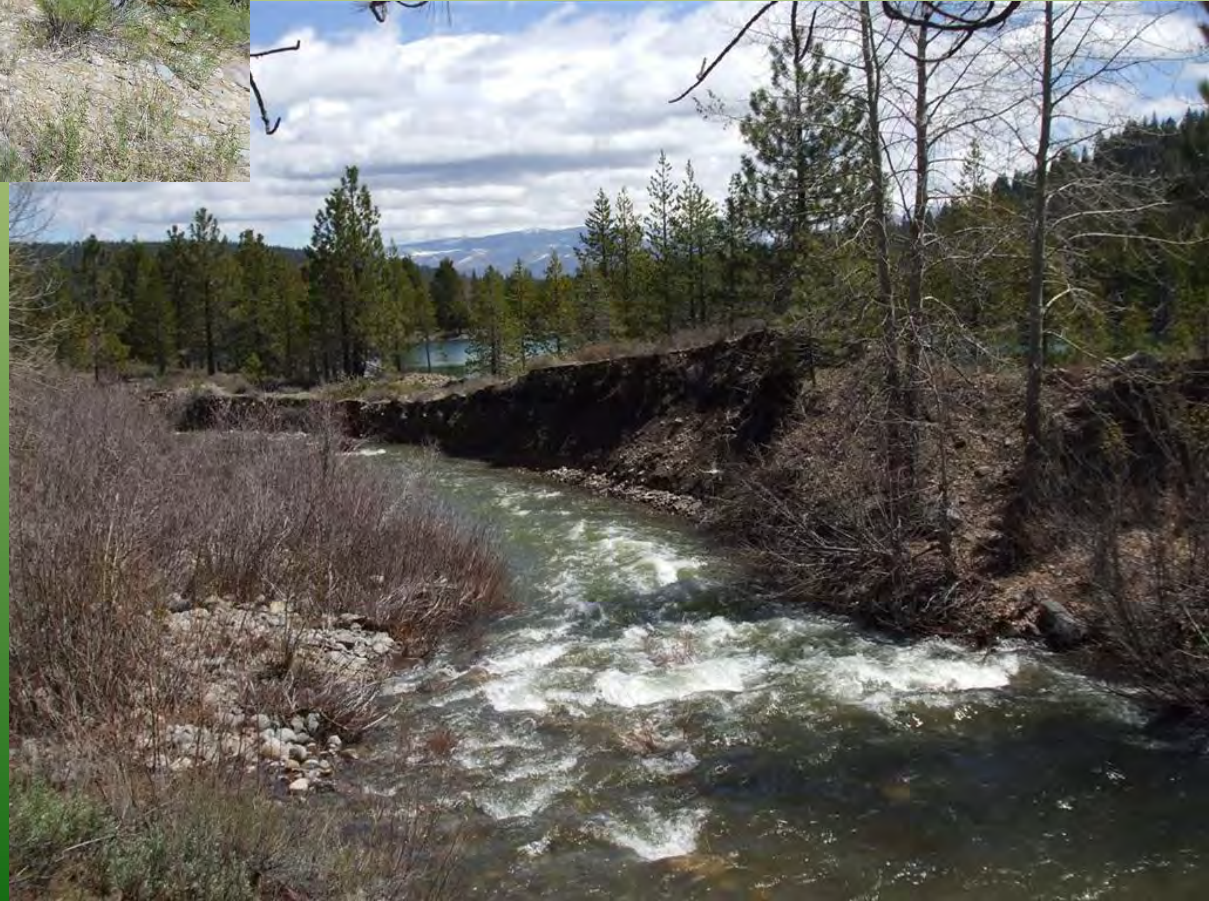
Eroding right bank risks
pond capture

Right bank
structure

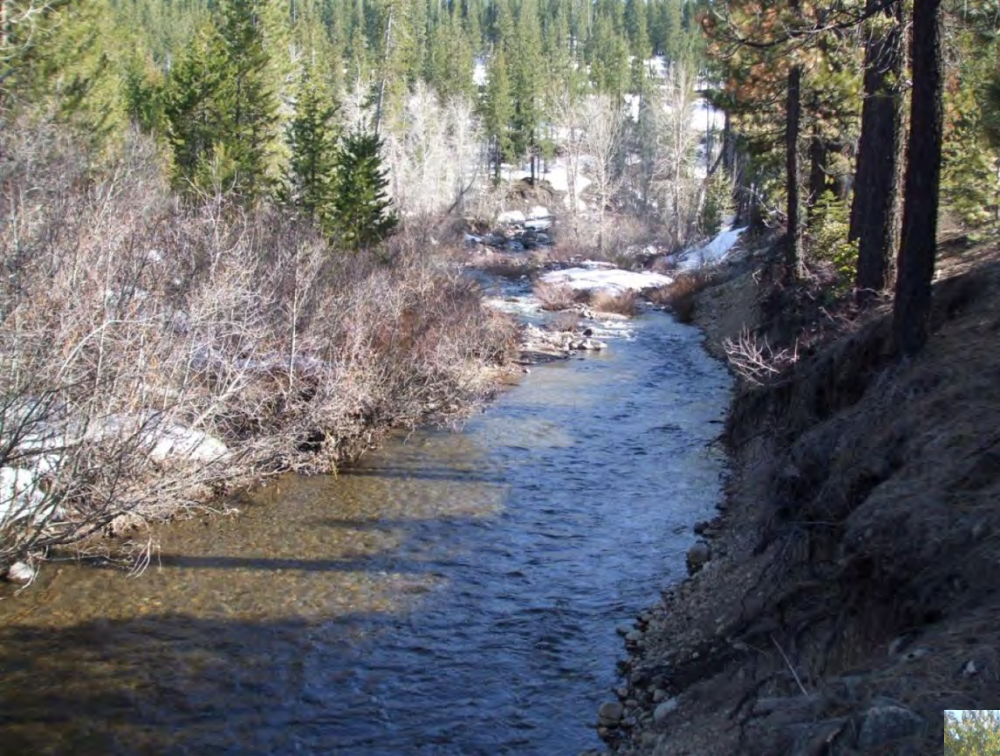
Pre
Tall eroding bank

Post
Bank laid back with
inset floodplain

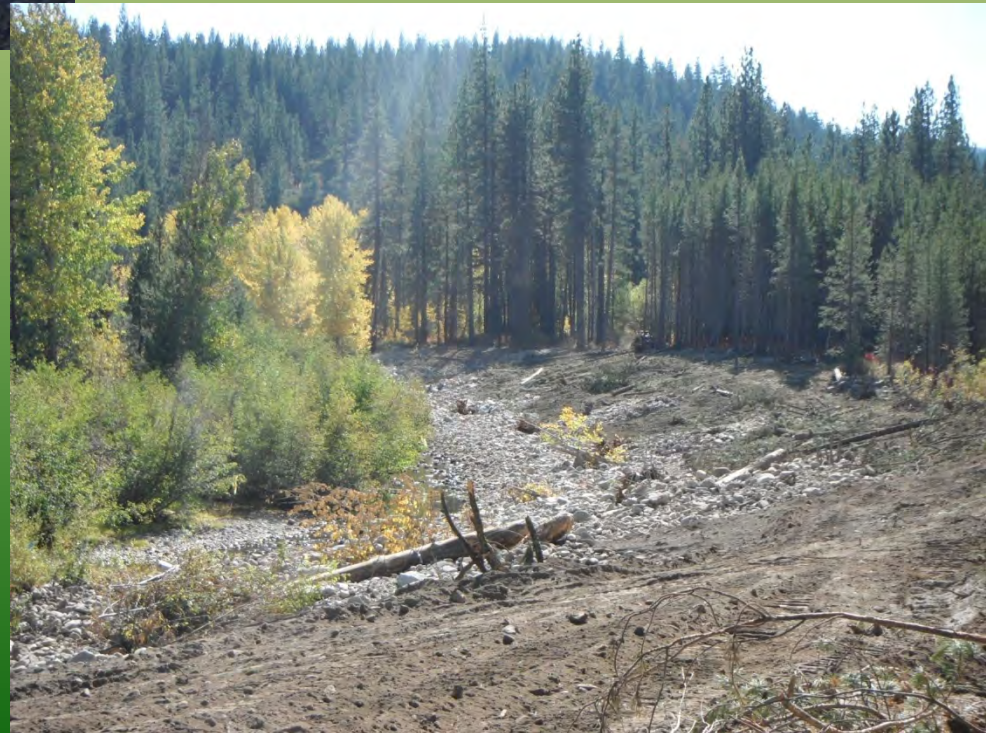
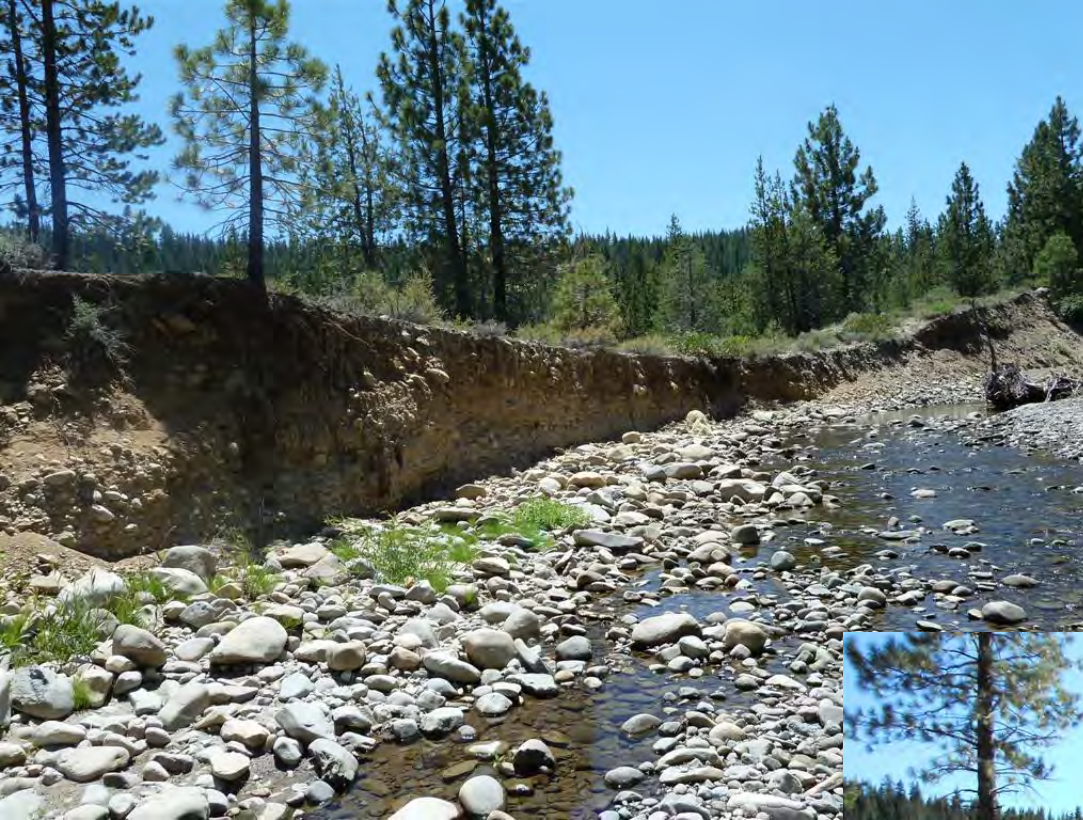
Pre
Tall eroding
bank by pond

Post
Bank laid back,
armored and planted

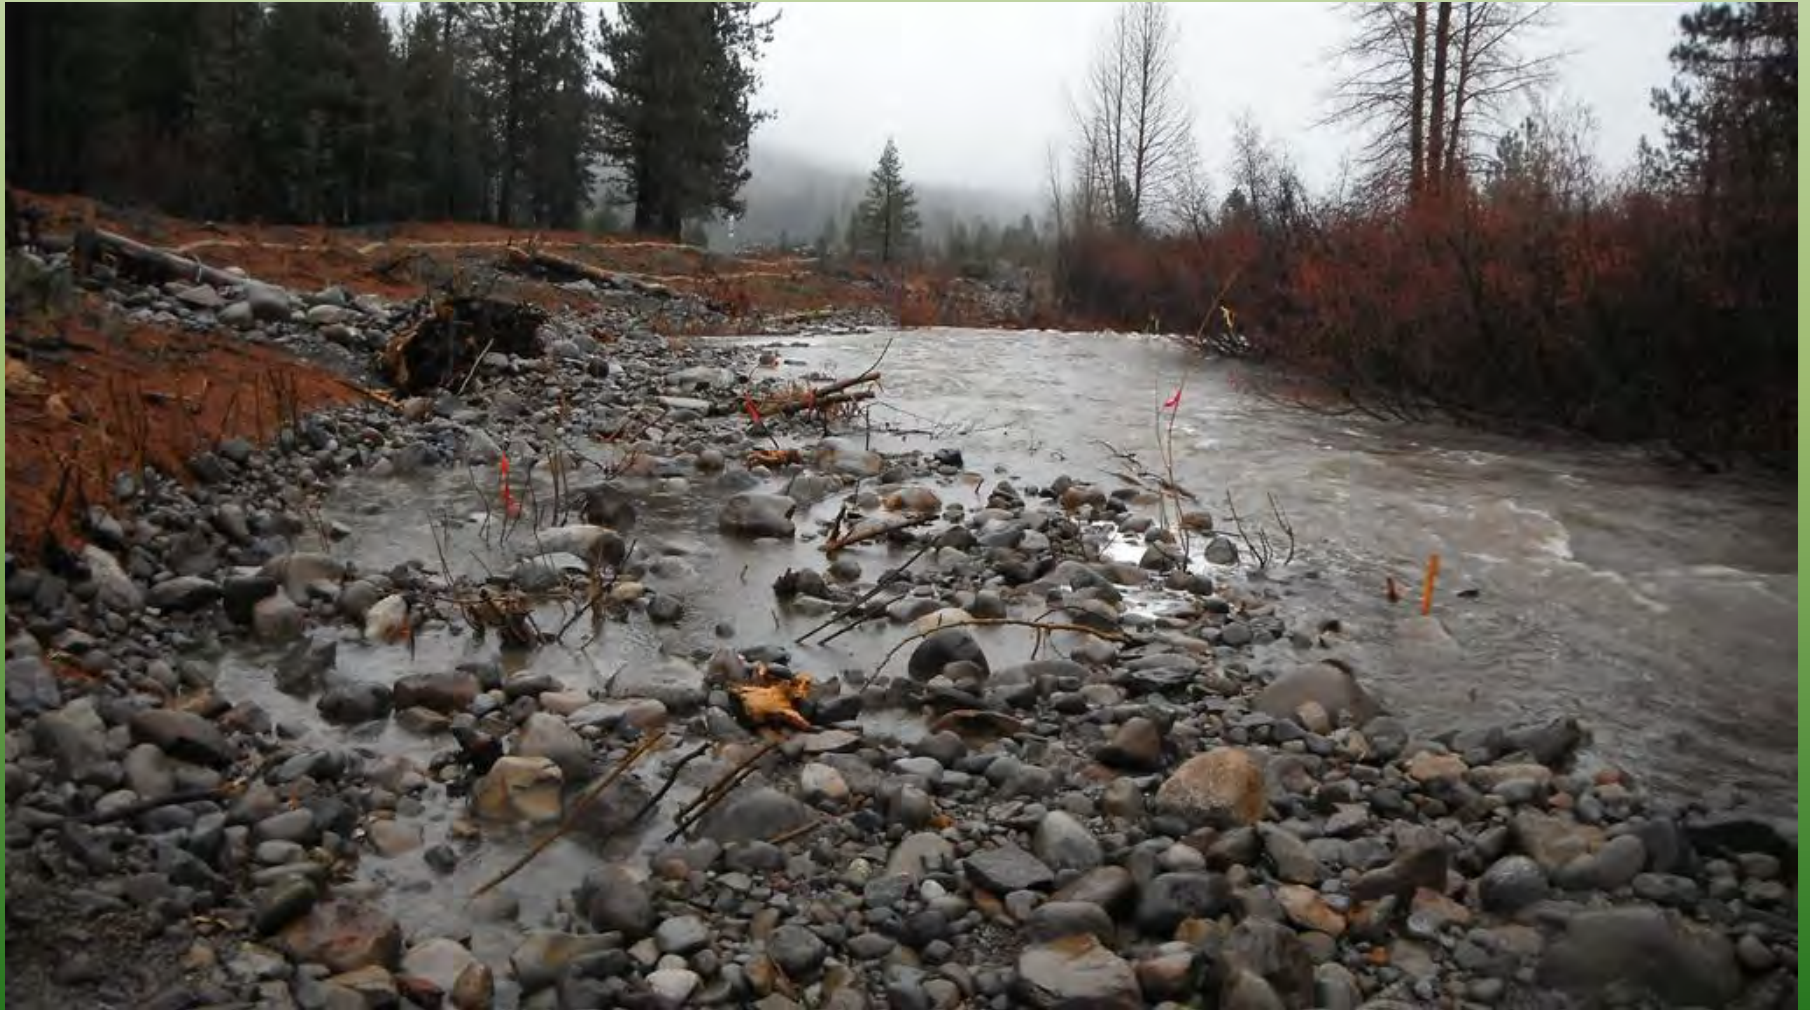
December flood
