Donner Basin Watershed Assessment

Final Report

Project Number: 15-1011

**Prepared for
Truckee River Watershed Council**

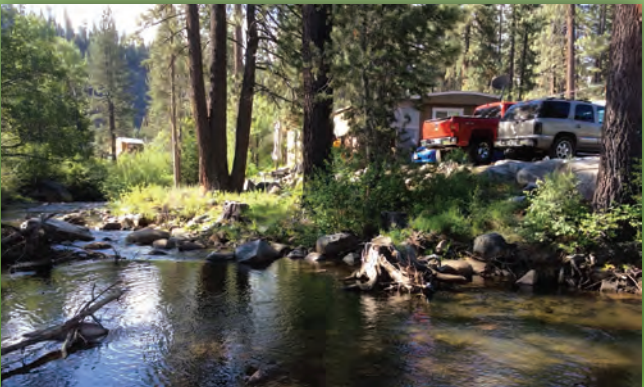
Proximity of mobile homes to Donner Creek. Photo by Jai Singh, cbec (2015).

Photo by Jai Singh, cbec (2015).

Project Benefits	
Benefit	Comments
Geomorphic / Physical Processes	The project will restore a historic floodplain of Donner Creek, greatly enhancing physical processes and broadening the stream corridor's functional width. The removal of bank armoring on the right bank will also enhance the geomorphic condition of the stream.
Hydrology	The broadened stream corridor and more active floodplain will enhance infiltration of flood flows into the shallow groundwater table. Pocket depressions in floodplain areas may also provide temporary storage of flood waters.
Water Quality	The larger and more frequently inundated floodplain areas will provide opportunities for sediment deposition and the capture of pollutants.
Fine Sediment Reduction	Greater levels of fine sediment deposition will likely occur with the broader stream corridor and more active floodplain. The project may also reduce future fine sediment loading from stream bank erosion along the project reach.

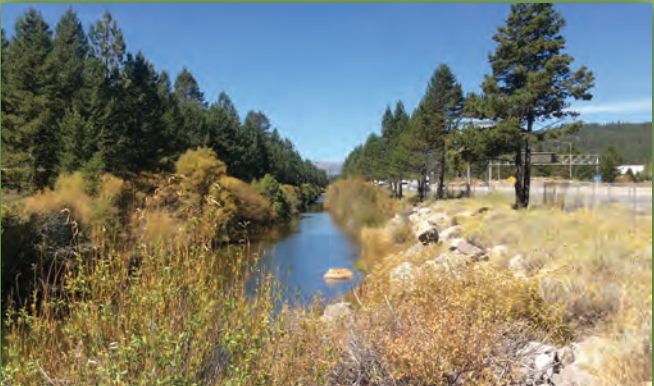
Looking upstream straightened reach of Donner Creek, with I-80 to right. Photo by Jai Singh, cbec (2015).

Looking upstream straightened reach of Donner Creek, with I-80 to the right. Photo by Jai Singh, cbec (2015).

Project Benefits	
Benefit	Comments
Geomorphic / Physical Processes	The installation of large wood structures within the channelized section of Donner Creek will enhance physical processes in a highly simplified and degraded reach. The large wood will promote localized deposition of sediment in some areas while increased scour in others.
Hydrology	Depending on the design, the large wood structures may enhance the interaction of surface flows with the shallow groundwater table.
Water Quality	The increase complexity of the channel and the creation of deposition areas may improve water quality and enhance sediment deposition.
Fine Sediment Reduction	Deposition areas created by the large wood structures may capture fine sediment both in the channel and along the narrow inset floodplain present in some sections of the channelized stream corridor.
Habitat	By enhancing physical processes, the large wood will increase the diversity and quality of habitat present within the channelized reach. The large wood will also provide cover for aquatic species, and may enhance riparian vegetation communities.

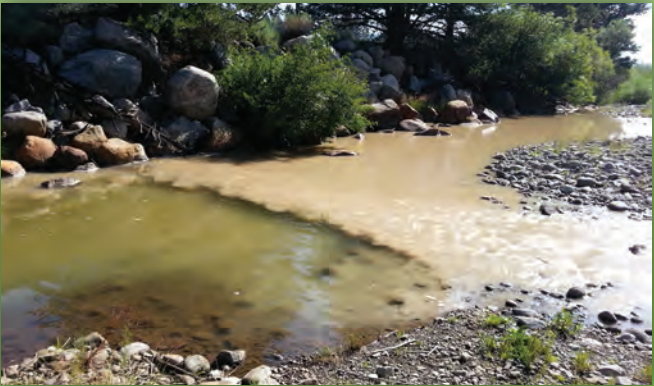
Heavily armored banks at confluence. Photo by Jai Singh, cbec (2015).

Fine sediment delivery from Cold Creek from summer thunderstorm. Photo by Jai Singh, cbec (2015).

Project Benefits	
Benefit	Comments
Geomorphic / Physical Processes	The project would create a much wider active stream corridor and enable more frequent floodplain inundation. The design will also rehabilitate the streams' natural physical processes and their capacity to create and maintain aquatic and riparian habitat.
Hydrology	The broadened stream corridor and more active floodplain would enhance infiltration of flood flows into the shallow groundwater table. Pocket depressions in floodplain areas may also provide temporary storage of flood waters.
Water Quality	The larger and more frequently inundated floodplain areas would provide opportunities for sediment deposition and the capture of pollutants.
Fine Sediment Reduction	Greater levels of fine sediment deposition will likely occur with the broader stream corridor and more active floodplain. The project will also reduce the entrenchment of the stream channels and may reduce future fine sediment loading from stream bank erosion.

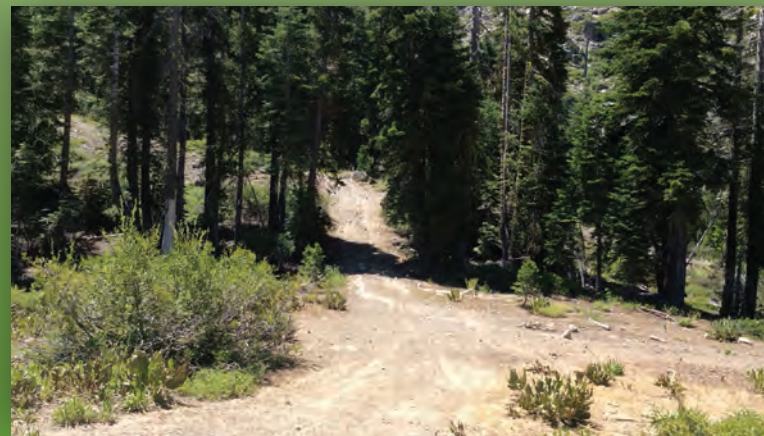
Gully erosion on backcountry road. Photo by Jai Singh, cbec (2015).

Backcountry road showing signs of sheet erosion. Photo by Jai Singh, cbec (2015).

Project Benefits	
Benefit	Comments
Geomorphic / Physical Processes	These projects will reduce hillslope erosion from rilling and gullying, thus lessening excessive fine sediment loading and associated impacts to sediment dynamics in receiving streams.
Hydrology	Decommissioning and improving roads will lessen historic impacts to the basin's hydrology by lessening the concentration of runoff along artificial flow paths. This in turn will promote infiltration and reduce peak flows in receiving streams.
Water Quality	These projects will improve water quality by reducing fine sediment loading to receiving streams and Donner Lake.
Fine Sediment Reduction	These projects will stabilize eroding roads and hillslopes, thus addressing one of the largest human-induced sources of fine sediment to the basin.
Habitat	Decommissioning roads will provide local improvements to forest and meadow habitat. It may also provide indirect benefits by reducing off-road vehicle traffic and creating more contiguous habitat areas. The stabilization of unpaved roads will alleviate active erosion and likely reduce fine sediment loads to Donner Lake tributaries, thereby improving aquatic habitat quality.

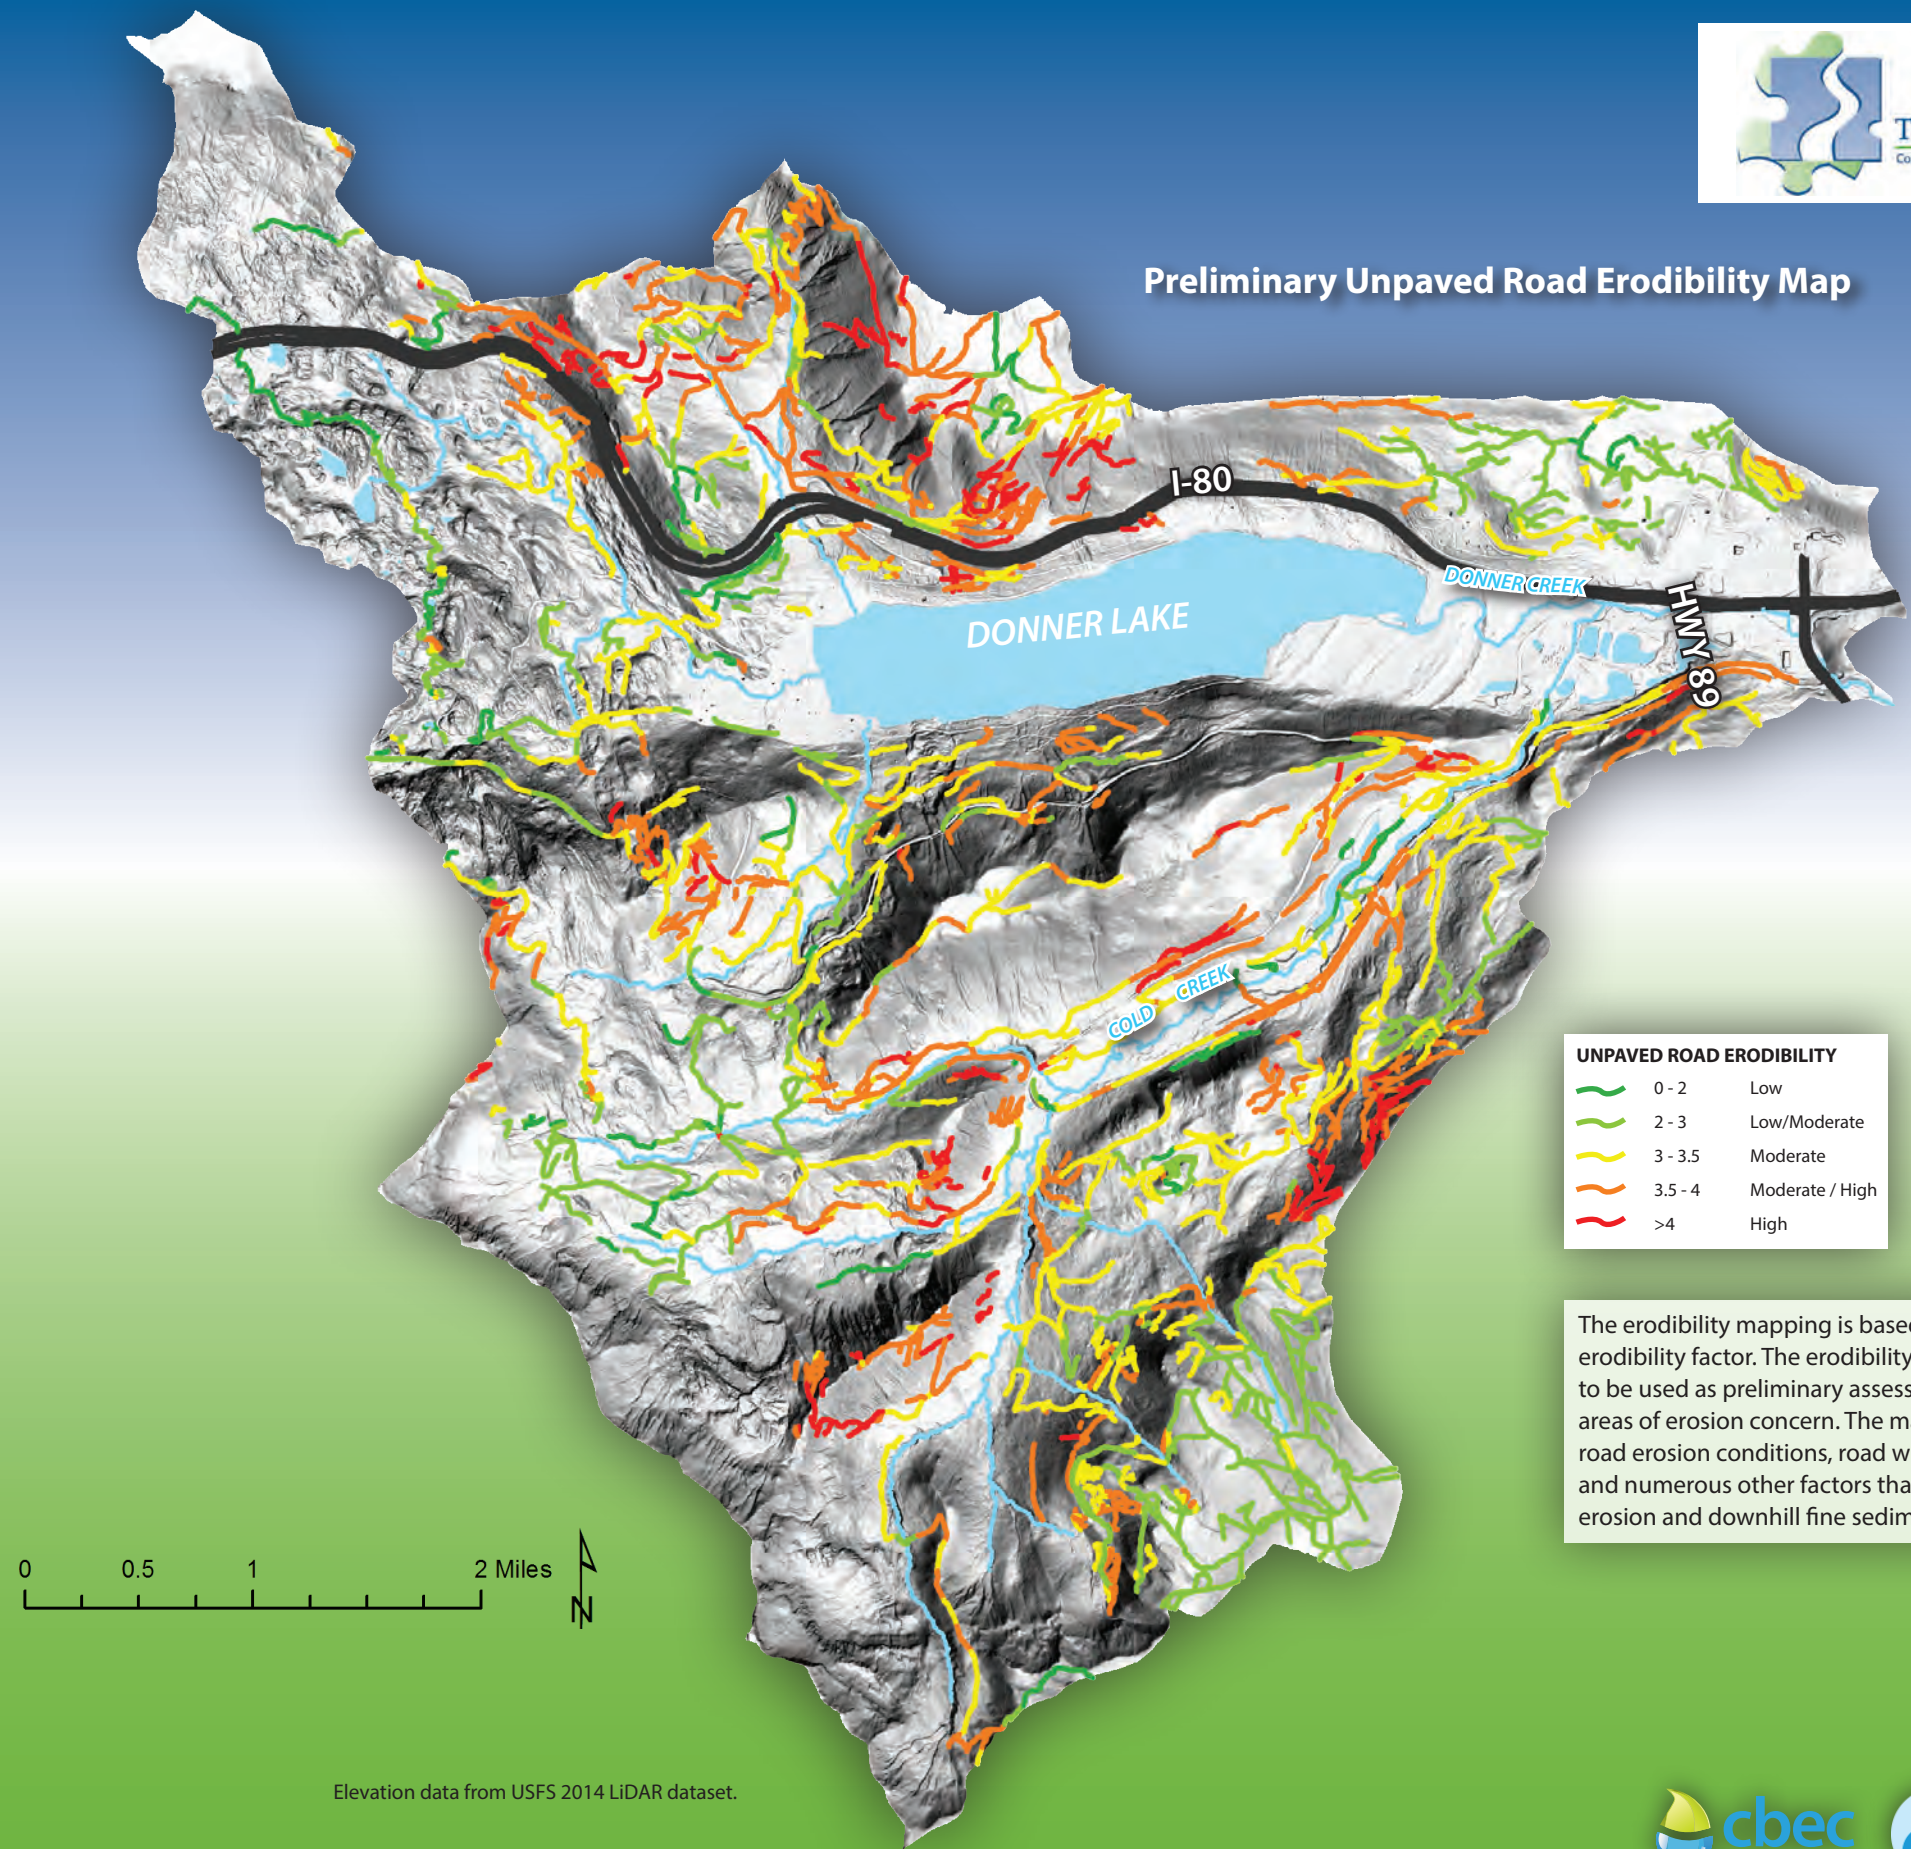
Preliminary Unpaved Road Erodibility Map

UNPAVED ROAD ERODIBILITY

0 - 2	Low
2 - 3	Low/Moderate
3 - 3.5	Moderate
3.5 - 4	Moderate / High
>4	High

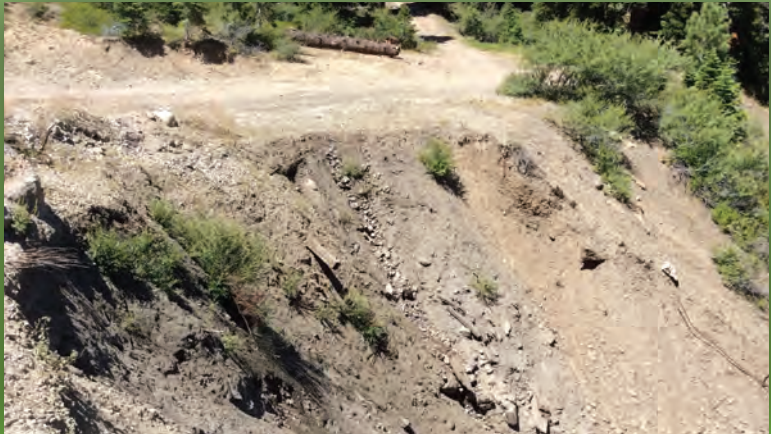
Severely eroding gully along railroad grade. Photo by Jai Singh, cbec (2015).

Hillslope erosion along retired railroad grade. Photo by Jai Singh, cbec (2015).

Project Benefits	
Benefit	Comments
Geomorphic / Physical Processes	These projects will reduce hillslope erosion, thus lessening excessive fine sediment loading and associated impacts to sediment dynamics in receiving streams.
Hydrology	Stabilizing hillslopes along the railroad grade will lessen historic impacts to the basin’s hydrology by reducing the concentration of runoff along artificial flow paths. This in turn will promote infiltration and reduce peak flows in receiving streams.
Water Quality	These projects will improve water quality by reducing fine sediment loading to receiving streams and Donner Lake.
Fine Sediment Reduction	These projects will stabilize eroding hillslopes, thus addressing a very significant human-induced source of fine sediment to the to Donner Lake and the basin’s stream network
Habitat	Hillslope stabilization will alleviate active erosion and likely reduce sediment loads into Lakeview Canyon, Summit Creek, and Donner Lake, thereby improving aquatic habitat quality in these systems. It will also provide local improvements to forest and meadow habitat.

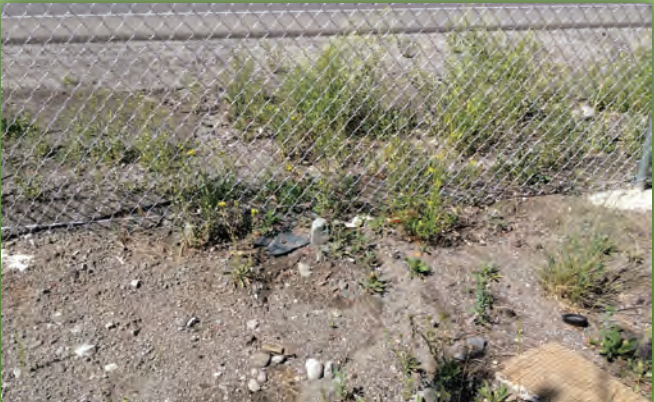
Existing buffer between I-80 (right) and Donner Creek (left). Photo by Jai Singh, cbec (2015).

Localized erosion and debris from I-80 runoff. Photo by Jai Singh, cbec (2015).

Project Benefits	
Benefit	Comments
Geomorphic / Physical Processes	The capture of stormwater and fine sediment by the vegetated buffer strip and infiltration trench will help reduce impacts to physical processes within Donner Creek.
Hydrology	The infiltration trench will store stormwater and promote infiltration, thereby reducing the impacts of urbanization on the basin's hydrology and lessening the peak stormwater flows entering Donner Creek.
Water Quality	The project will capture a portion of the stormwater pollutants from the interstate, reducing the loading of hydrocarbons, metals, trash and other contaminants from the road surface before they enter Donner Creek.
Fine Sediment Reduction	The vegetated buffer and infiltration trench will help capture fine sediment derived from traction sand applied to the interstate during the winter season that is subsequently pulverized by vehicle traffic.
