#### Truckee River Watershed Council

# Piecing Together the Restoration Puzzle

Cedar House, Feb. 9th, 2016

Beth Christman, Director of Restoration Programs

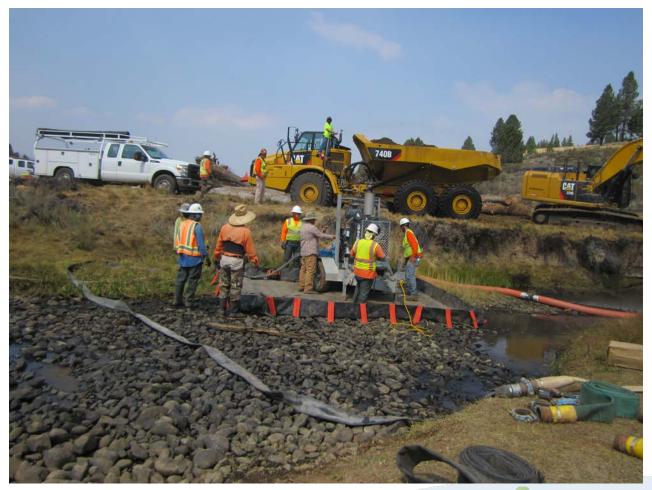
#### Isolate Work Area

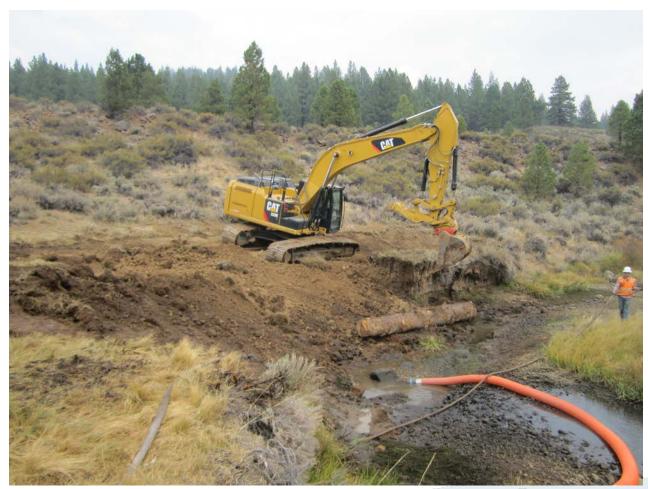
# **Coarse Grading**

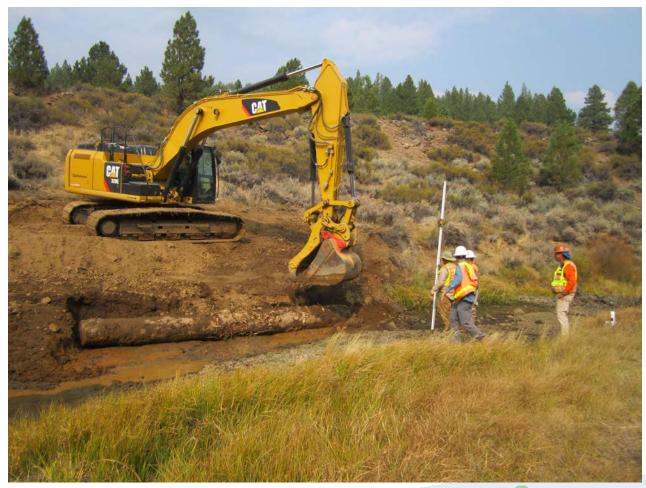
# Setting Footer Log

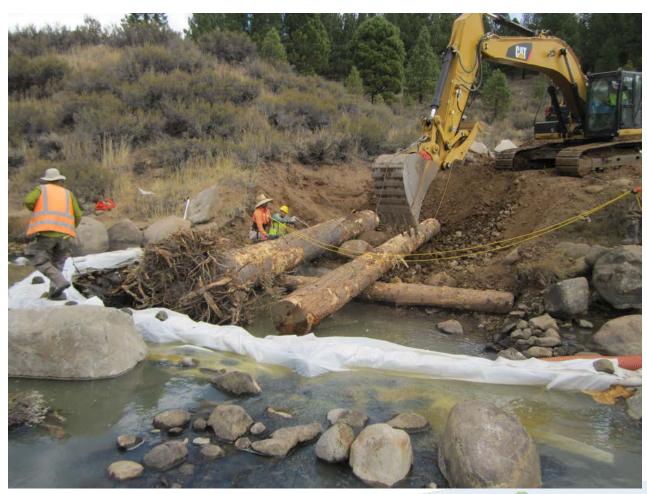
# **Building Log Structures**

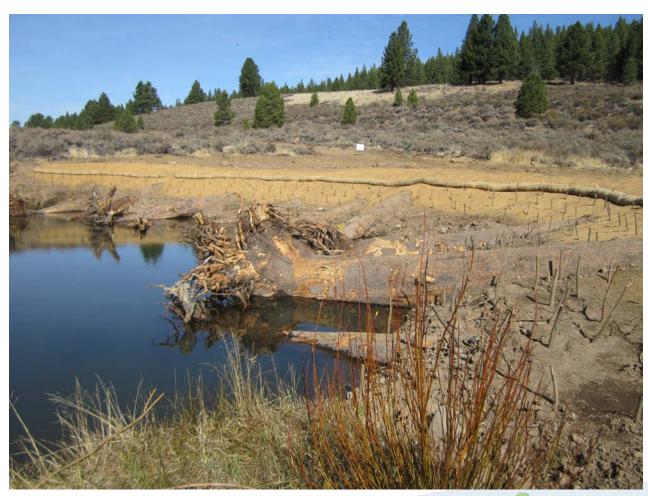
## Plant Willows, Stabilize Area

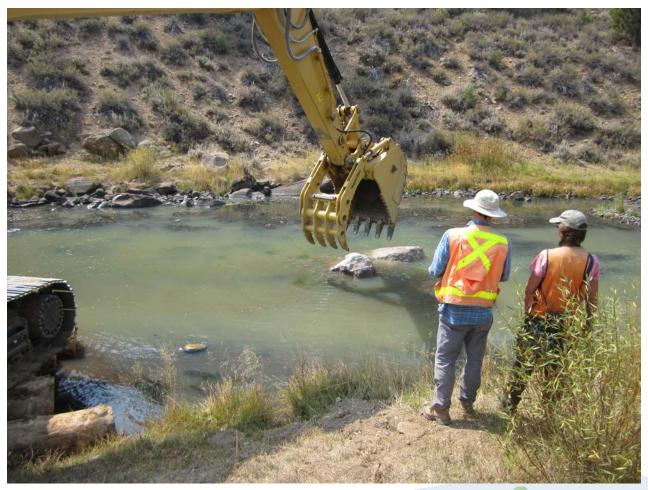
# Place Boulders

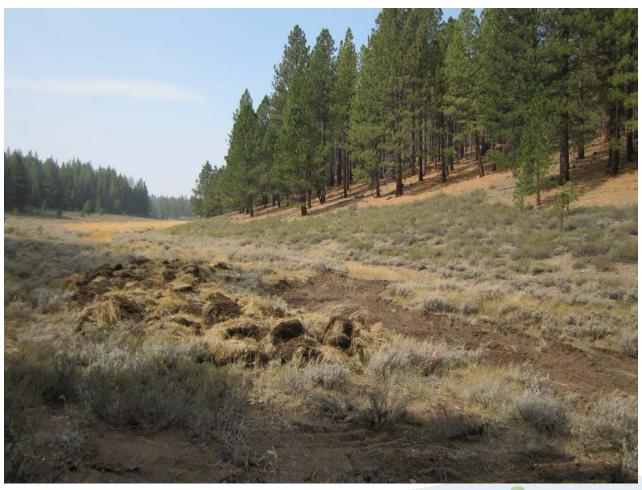
# Salvage Sod and Topsoil

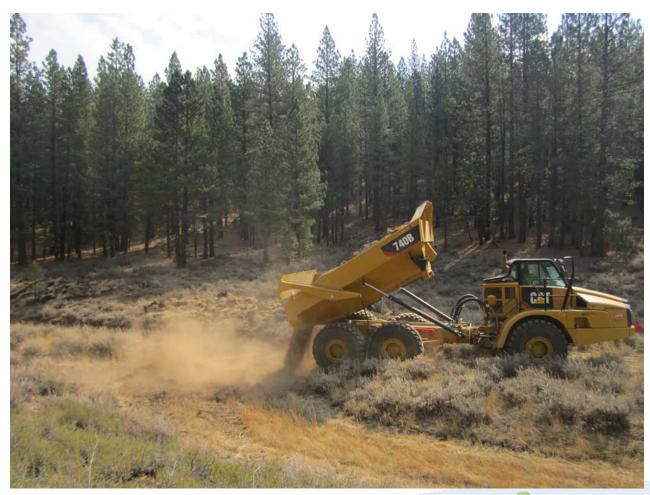
## Generate Fill

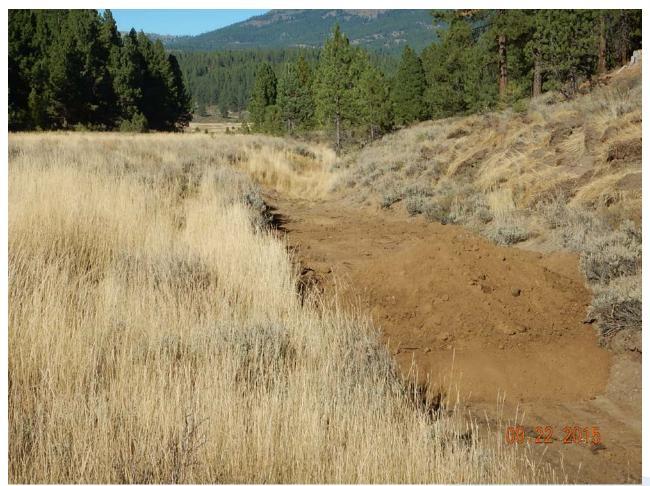
# Shape Fill

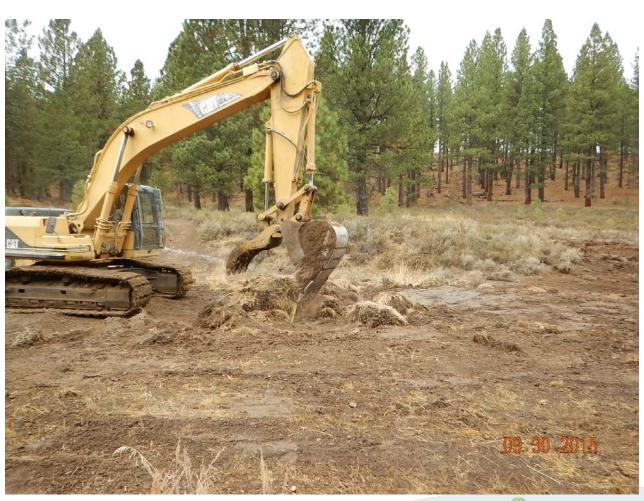
## Replace Topsoil and Sod

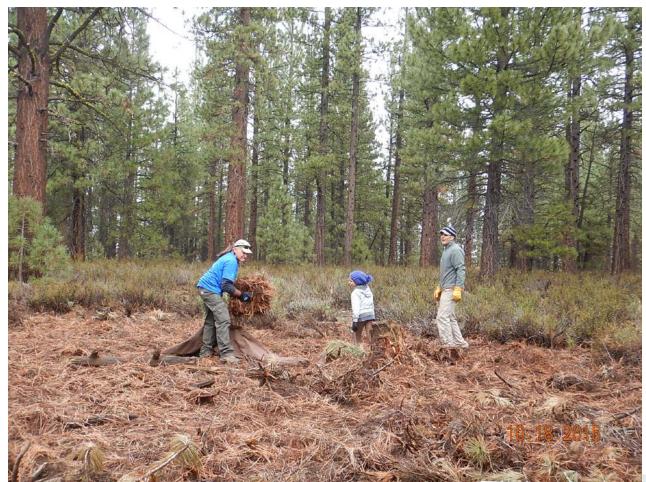
## Seed and Mulch Site

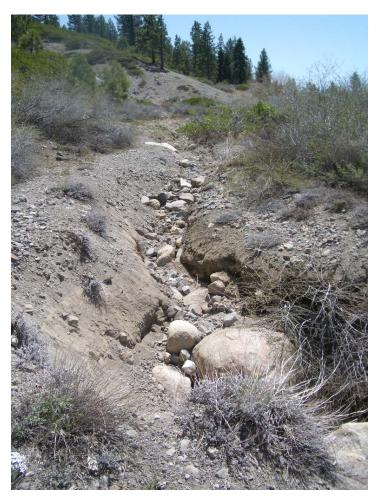
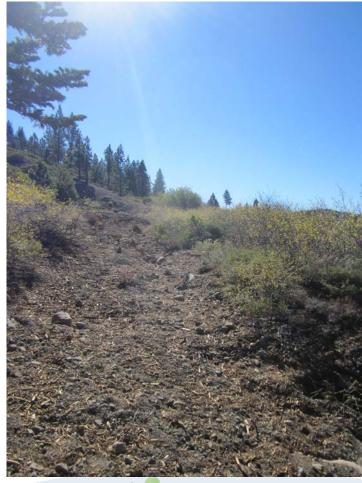
## **Restored Drainages**

Pre-project

Post-project

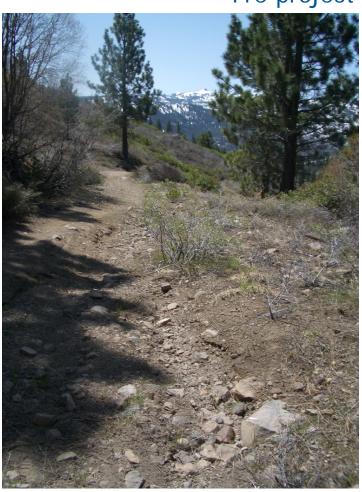
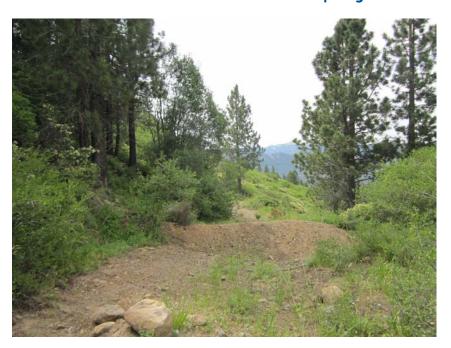
## Removed Road Beds

Pre-project

#### Post-project

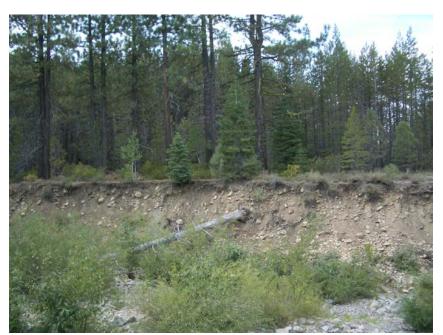
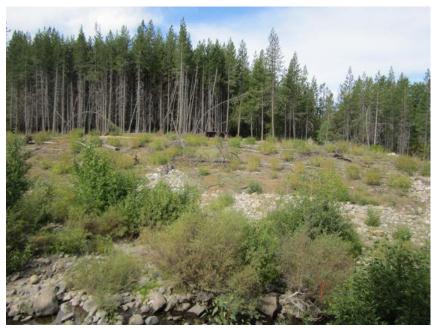
# Create Floodplain

Pre-project

2015 Post-project

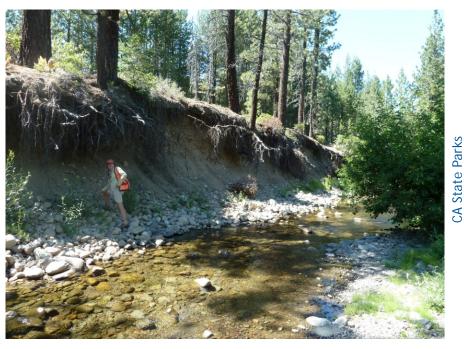
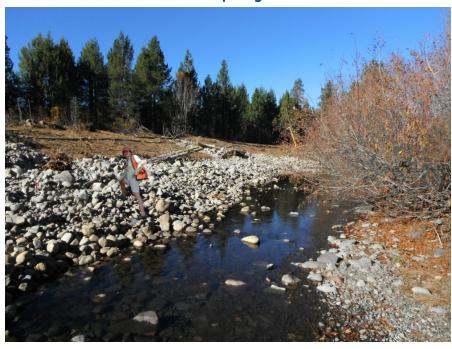
## **Grade Eroding Banks**

#### Pre-project

#### 2012 Post-project

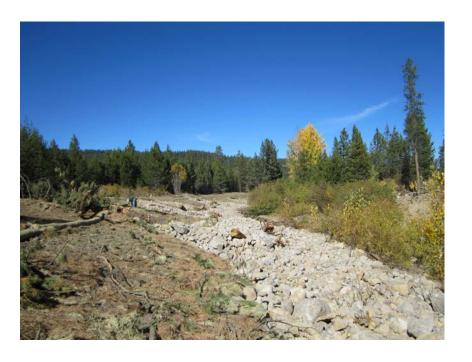
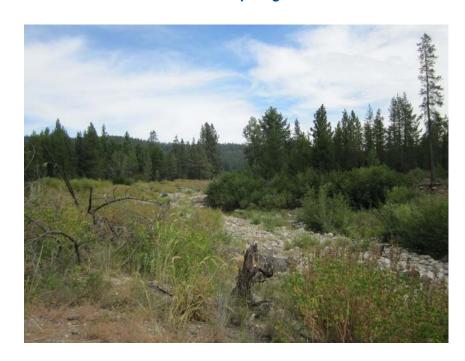
## **Vegetation Matures**

2012 Immediately post-project

2015 Post-project

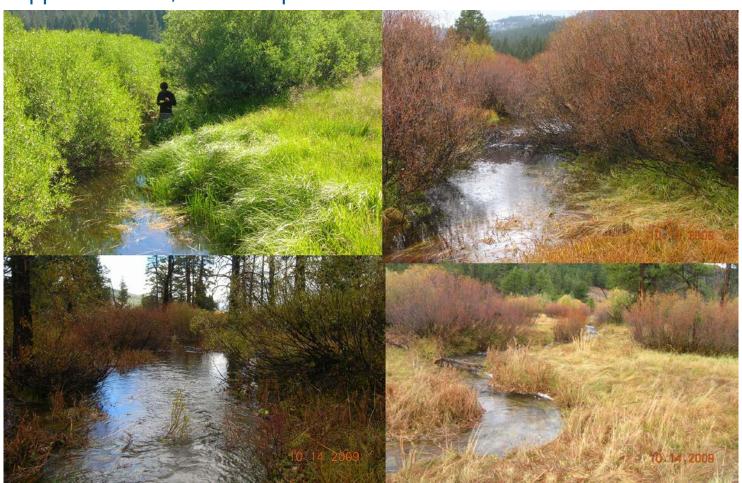
#### **Restored Channels**

Upper Meadow, 1 month post-restoration

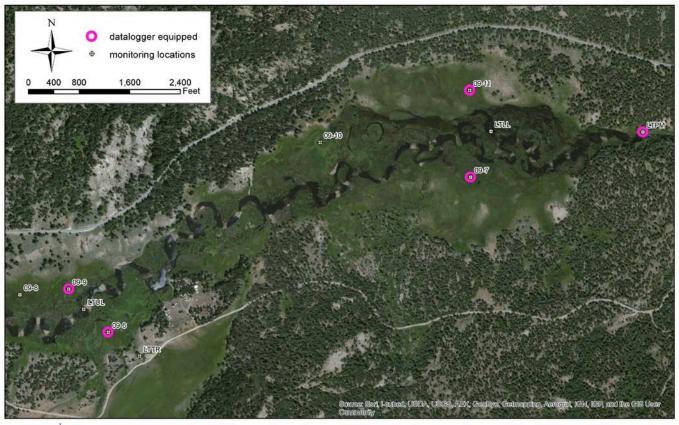
## Middle Meadow Monitoring Wells

Figure 3. Location of groundwater and surface water monitoring stations Middle Perazzo Meadow, Sierra County, California

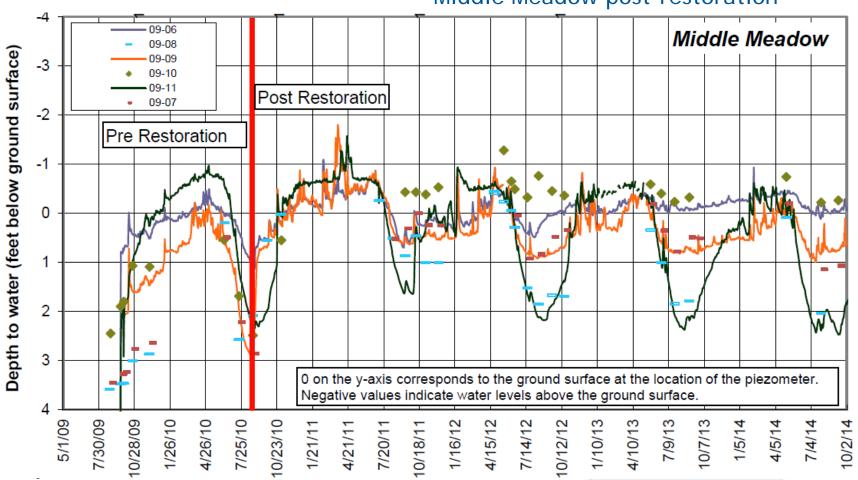
### Groundwater Monitoring Results

1 - 6 foot increase in Upper and Middle Meadow post-restoration

- Groundwater
- Surface Flow
- Results:
  - Improved Hydrologic function
  - Increased floodplain connectivity
  - Increased groundwater table

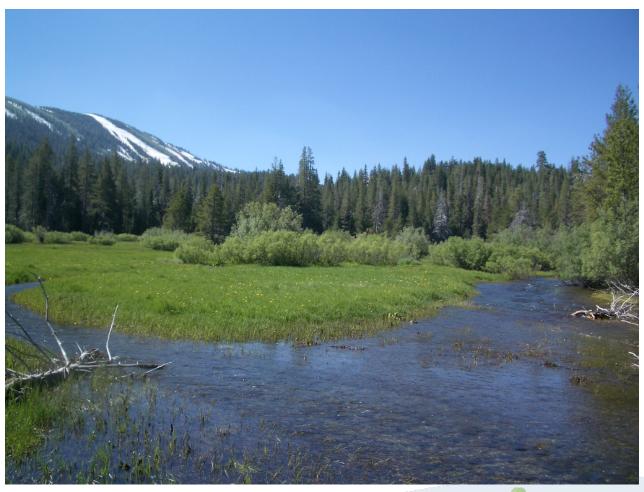
### Annual Overbank Flow

#### Restored Upper Meadow July 2011
