Martis Watershed Assessment

Placer and Nevada Counties, California

April 2012

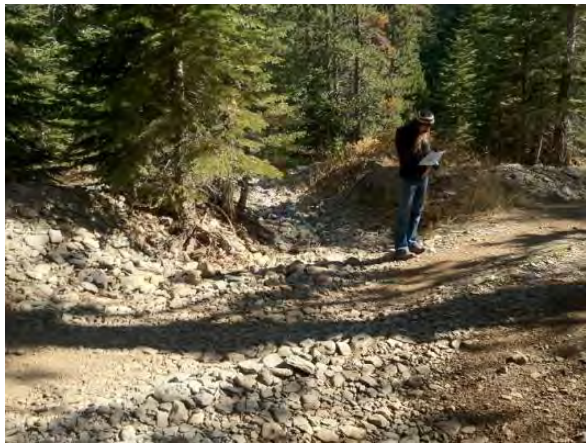
Reach 14 – Artificial confinement of channel at 700 road crossing. (photo credit: Kevin Drake, IERS)

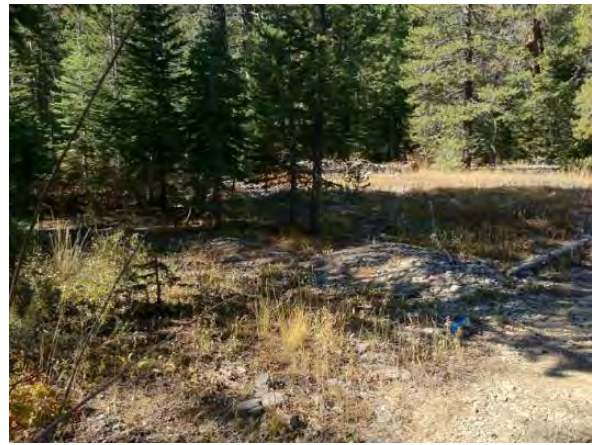
Reach 14 – Depositional material at south end of Sawtooth Meadow. (photo credit: Kevin Drake, IERS)

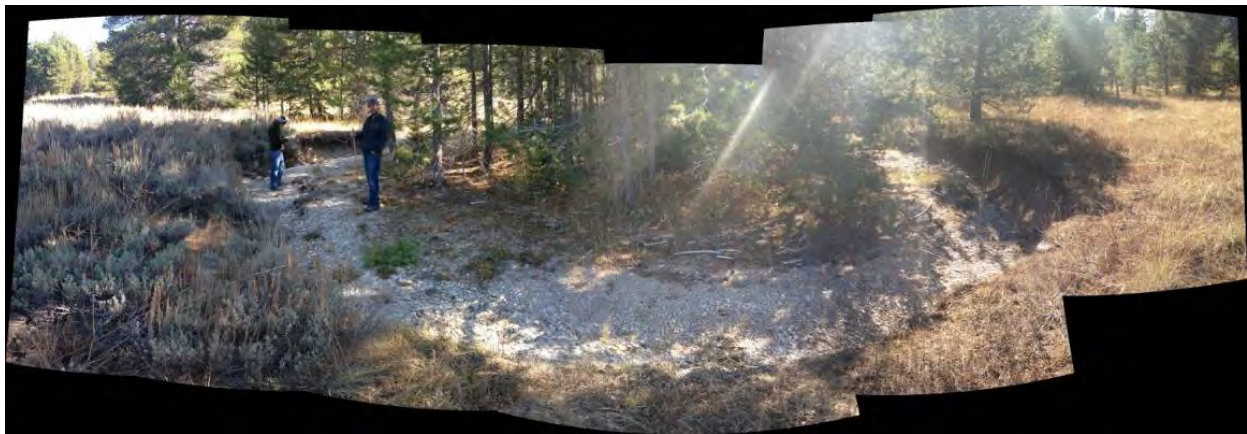
Roughly 550 feet downstream of the 700 Road crossing, Martis Creek crosses a meadow we have termed "Sawtooth Meadow." At this meadow, the braided channel system returns to a single, actively incising channel. Channel downcutting is apparently resulting in upland vegetation encroachment into the meadow (shrub-scrub and pines). The impacted portion of the channel (Reach 14) could be addressed through a range of low-tech solutions, such as debris jam construction to promote sedimentation, multiple channels, and/or active channel migration. Similar actions taken at the upstream road crossing to distribute streamflow across the meadow, rather than concentrating it into one channel, are also likely to aid in the natural recovery of the system.

Reach 14 – Incised channel through Sawtooth Meadow. (photo credit: Kevin Drake, IERS)

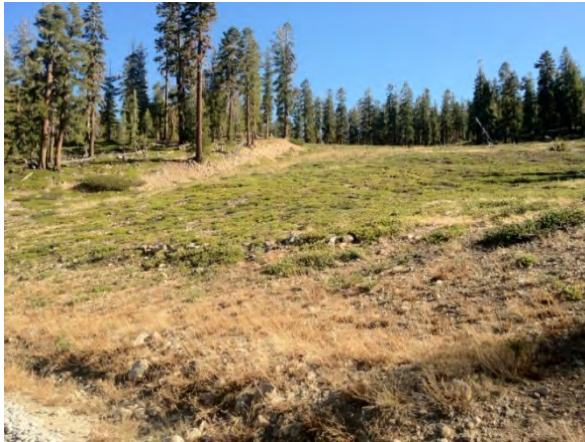
Older, smooth-graded ski run with well-established vegetation and no significant erosion issues. (photo credit: Kevin Drake, IERS)

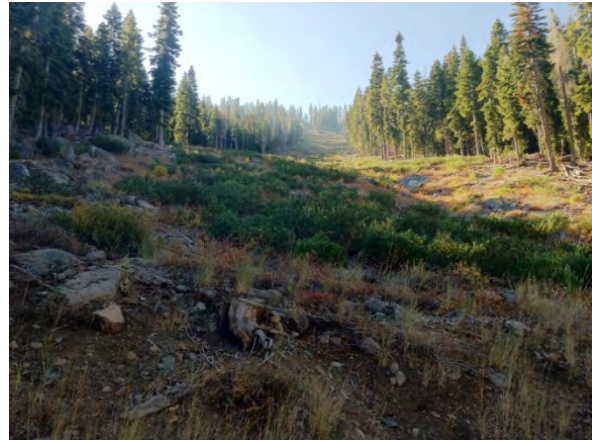
Ecological techniques: cleared, not graded, and leaving topsoil in place. Shrubs are mowed regularly to maintain skiable surface condition. (photo credit: Kevin)

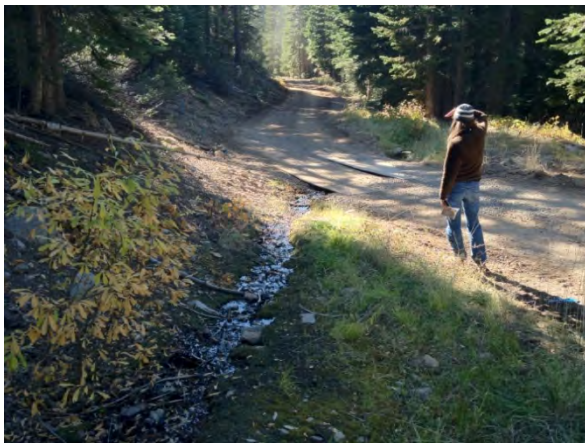
Spring feeding Kiwi Creek. Note use of trench plates to minimize road impacts. (photo credit: Kevin Drake, IERS)

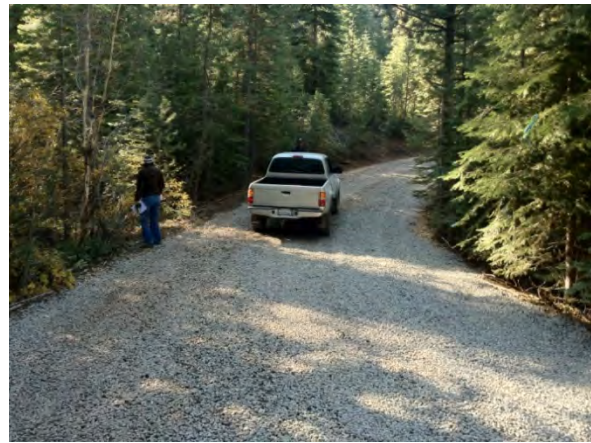
Road armored with rock at small tributary crossing. (photo credit: Kevin Drake, IERS)

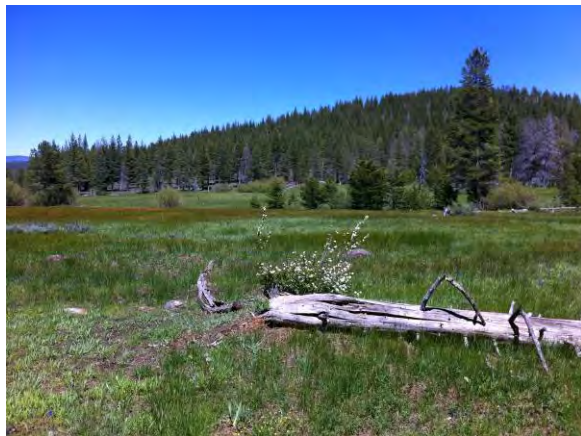
Reach 4 – Upland vegetation encroachment, evidenced by pines growing along channel, increasing in age from downstream to upstream (left to right). (photo credit: David Shaw, Balance Hydrologics)

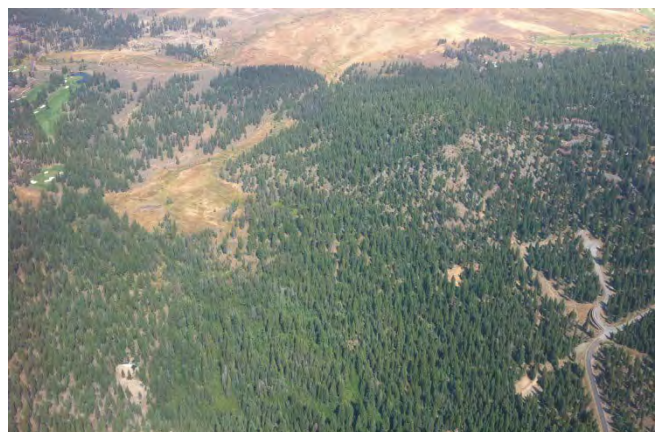
Reach 4 – Lookout Mountain Meadow is spring-fed and is downstream of recent or ongoing subdivision for residential and recreational use. (photo credit: David Shaw, Balance Hydrologics)

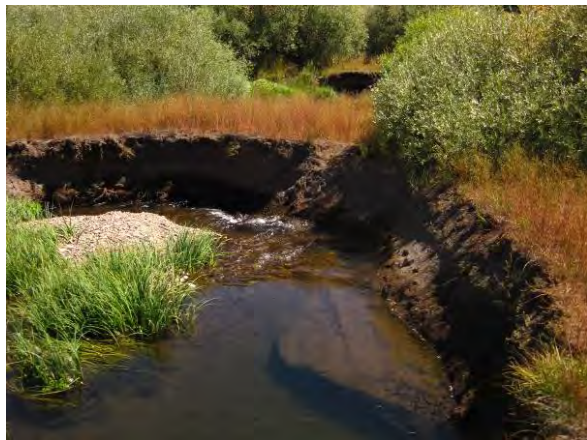
Reach 1 – Channel incision and bank erosion associated with nearby abandoned diversion structure. (photo credit: Brian Hastings, Balance Hydrologics)

Incision in this area may be attributed to increased runoff, primarily following the development of roads—first for logging and then for residential development. Installation and operation of the old diversions may have also modified the natural channel system and morphology, disrupting streamflow and hydraulics in some areas, and also distributing water across the meadow surface for grazing purposes in others. As these structures fail or are removed, the channel responds, often unpredictably.

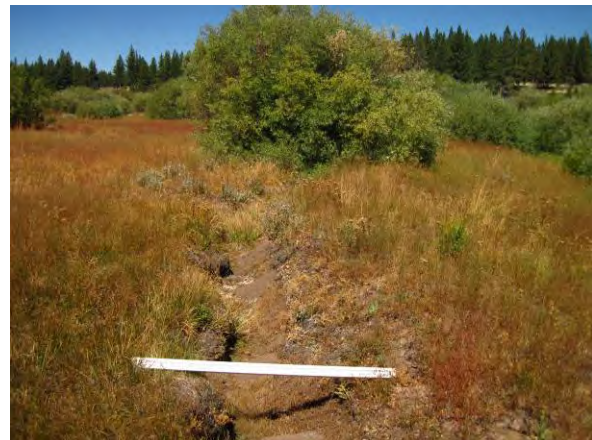
Reach 1 – Abandoned irrigation ditch in meadow. (photo credit: Brian Hastings, Balance Hydrologics)

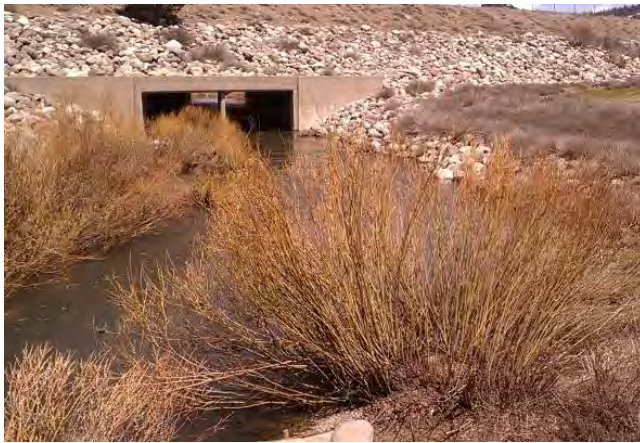
Martis Creek flows through a long straight pool, approximately 300 feet in length, immediately downstream of a double box culvert under Highway 267. Historical aerial photograph investigations indicate that the timing of incision both upstream and downstream of the highway is coincident with several iterations of road and culvert construction. Downstream of the crossing, the channel appears to

Reach 6 – Martis Creek modified channel at Highway 267. Historical aerial photography indicates that incision episodes correspond with various iterations of highway and channel modification in this location. (photo credit: David Shaw, Balance Hydrologics)

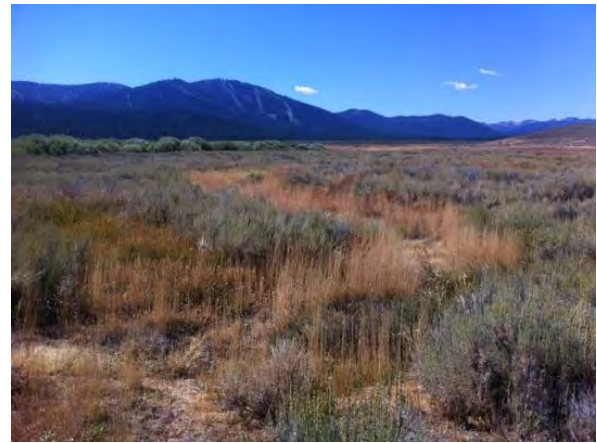
be incised and actively widening, with a quasi-equilibrated channel bed approximately 4- to 5-feet below an apparently abandoned floodplain surface.

Reach 6 – Relict channel and upland vegetation along Martis Creek Floodplain downstream of Highway 267, a result of channel incision and floodplain abandonment. (photo credit: David Shaw, Balance Hydrologics)

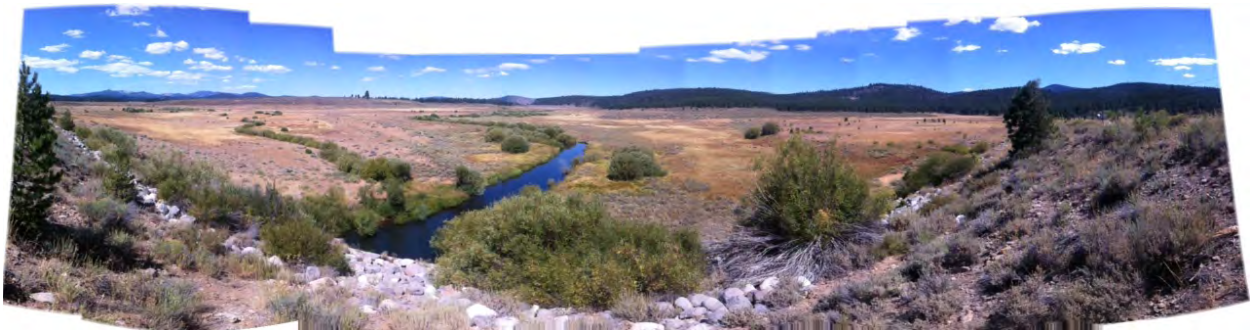
Reach 14 – Borrow pits, modified channels, levees, and floodplain desiccation along Martis Creek downstream of Highway 267. (photo credit: David Shaw, Balance Hydrologics)

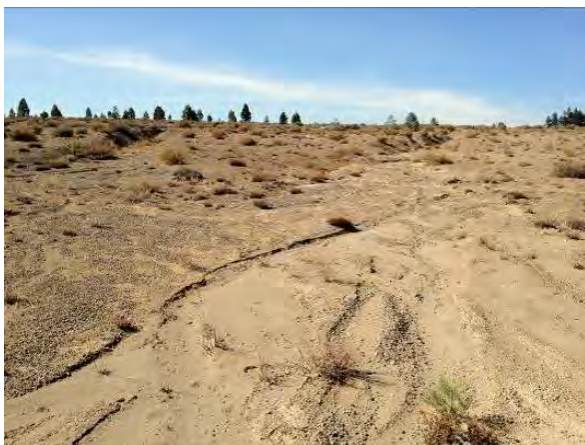
The area between Highway 267 and Martis Dam is within the Martis Dam maximum pool, and has been heavily disturbed. Legacy impacts in this area may be somewhat associated with land use (grazing and logging) in the upper watershed, but the most extensive and extreme disturbance is associated with quarrying and borrow pit excavation during construction of Martis Dam and Highway 267. A number of small channels have been re-routed or destroyed, while other small channels have formed as rills and gullies on artificially steepened slopes with insufficient soils to support vegetation. A small tributary flows into Martis Creek downstream of the Highway 267 crossing. This stream appears to be perennial (flowing in early September 2011), and currently flows in a straightened ditch through a number of borrow pits.

Site W – Depositional “fan” from erosion in former borrow areas. (photo credit: Kevin Drake, IERS)

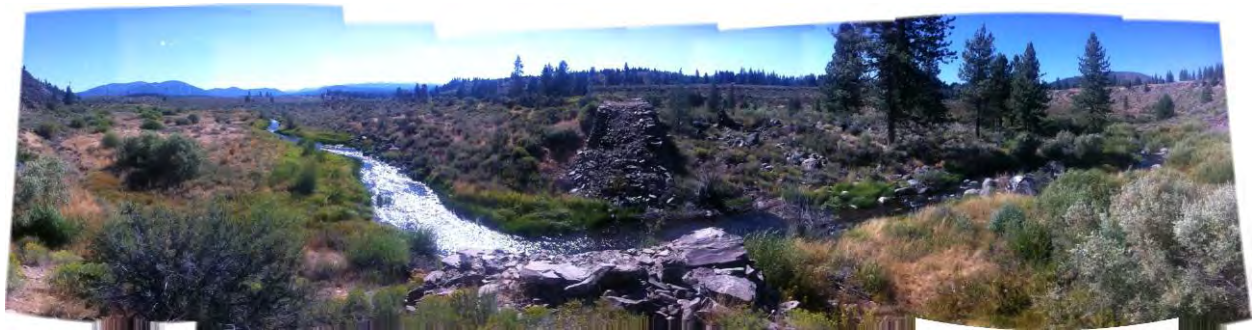
Immediately upstream of the confluence with the Truckee River, Martis Creek flows into a meadow which appears to have been established in part due to sediment deposition behind an historical dam. The channel has since incised into this meadow, as evidenced by numerous abandoned, or perched secondary channels. Based on aerial photograph interpretation, meadow incision appears to have occurred before 1952. As a result, the meadow vegetation largely consists of upland shrubs.

Reach 10 – Abandoned dam, incised channel, and desiccated meadow near mouth of Martis Creek (photo credit: David Shaw, Balance Hydrologics)

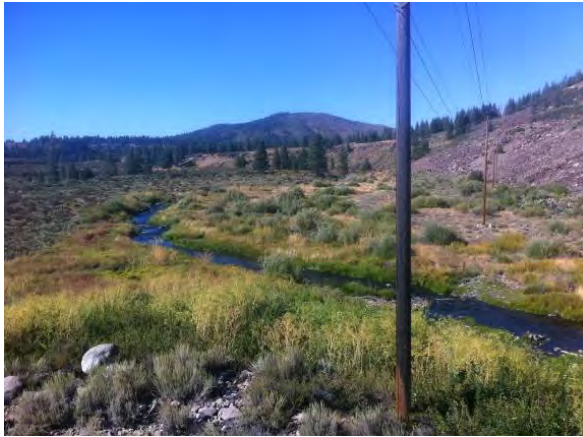
Reach 10 – Entrenched channel in meadow upstream of abandoned dam. (photo credit: David Shaw, Balance Hydrologics)

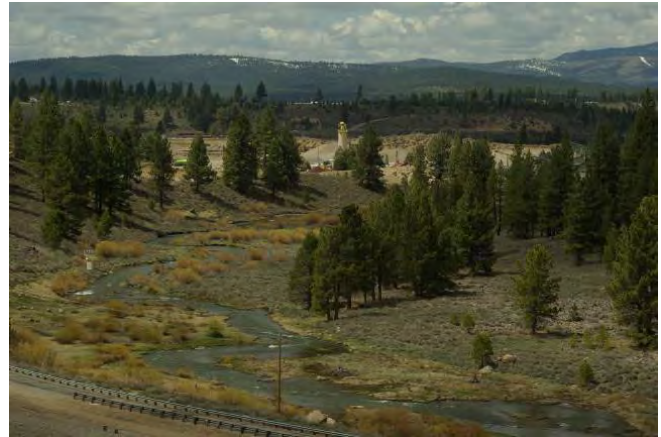
Martis Creek is heavily modified immediately downstream of Martis Dam, and flows across a meadow, but appears to be minimally incised. Downstream of the meadow, the creek follows the trace of a major regional fault, at the base of a talus slope, which may be serving to control the channel and meadow elevation. The rather straight and steep nature of the channel in this location, along with an abundant supply of large boulders, has given rise to a step-pool channel form through much of the straight reach. While historical ground sluicing or placer mining activities may have taken place in along this reach, the active gravel mining operation on the left (west) bank of the stream does not appear to have significantly altered the stream course in this area.

Reach 11 – Grade-controlled channel and meadow downstream of Martis Dam. Streamflow in this photograph is approximately 180 cfs, slightly lower than the estimated 2-yr flow. (photo credit: Brian Hastings, Balance Hydrologics)

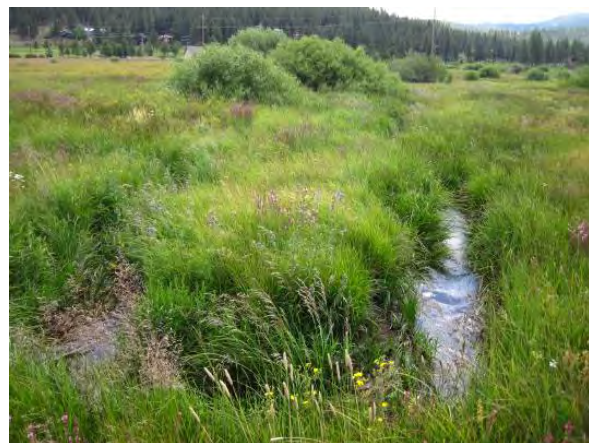
West Martis Creek in Martis Valley, downstream of Northstar Golf Course (photo credit: Brian Hastings, Balance Hydrologics)

Although this area has undoubtedly been disturbed, the current channel exhibits effective channel-floodplain connectivity with well-vegetated banks dominated by wetland vegetation. As such the channels have relatively low width to depth ratios with little channel incision and/or headcut formation,

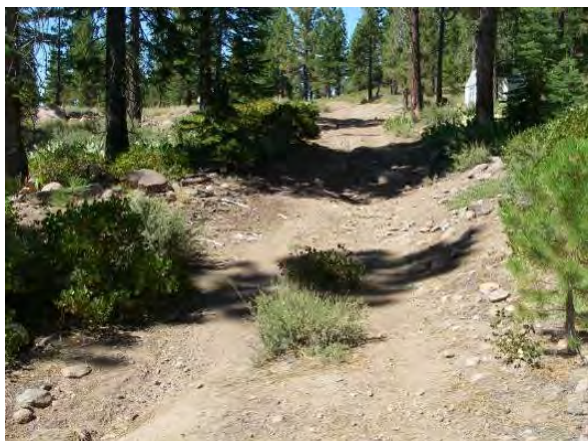
Site P – evidence of erosion and water capture on the main road. (photo credit: Kevin Drake, IERS)

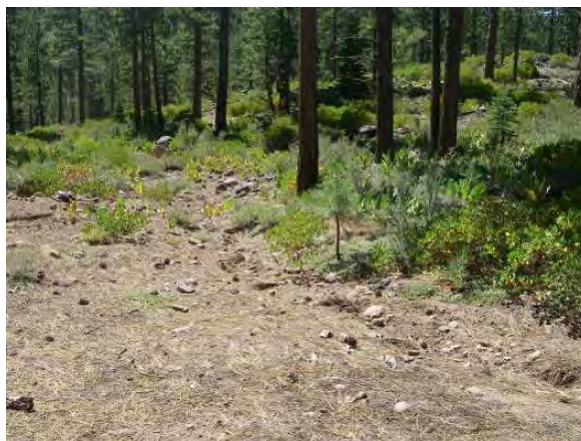
Site P – concentrated flow leaving road, flowing downslope. (photo credit: Kevin Drake, IERS)

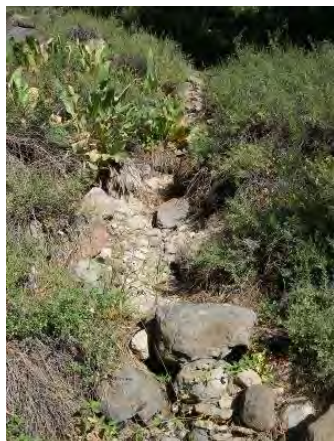
Site P – incised channel connecting sediment and concentrated road runoff directly to Middle Martis Creek. (photo credit: Kevin Drake, IERS)

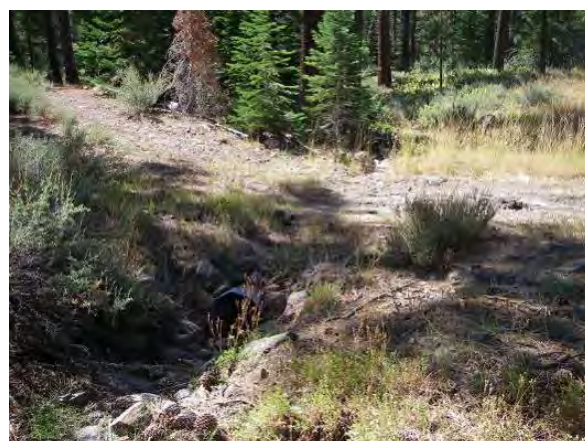
Site Q – spring-fed drainage culverted under road.

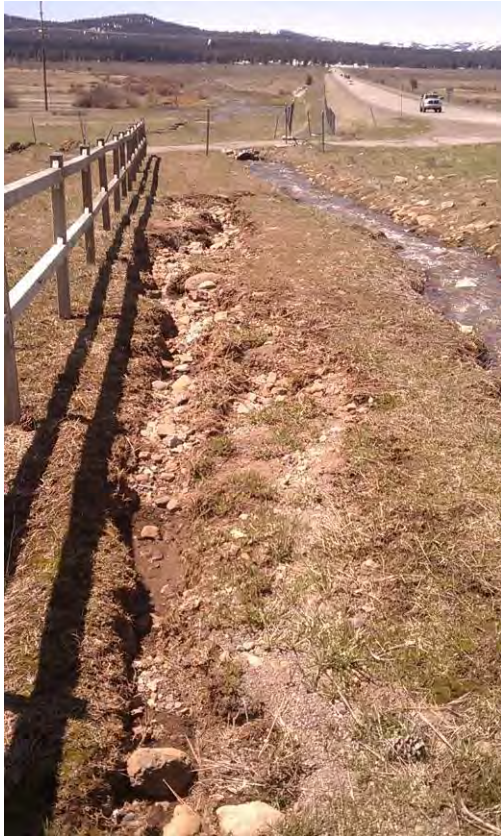
- Moderate flows (seasonal peaks) overflow the channel immediately downstream of the Highway 267 crossing, and flow onto the highway.
- High flows overtop and erode the Golf Course maintenance road when culvert capacity is exceeded.
- Flows overtop channel banks and are directed toward the highway, where a large berm has been constructed to keep water off the road. This drainage configuration focuses some portion of the streamflow into a roadside ditch which conveys flow directly to Martis Creek.
- Flow concentration and confinement in a single channel has led to channel instability, erosion, and headcut development in a number of locations, most notably near Frank's Fish Bridge and the Martis Wildlife Viewing Area Trail.

Reach 2 – Overflow from Middle Martis Creek is confined to the south side of Highway 267, rather than following the topography and flowing through the meadow on the north side of the highway. (photo credit: Brian Hastings, Balance Hydrologics)

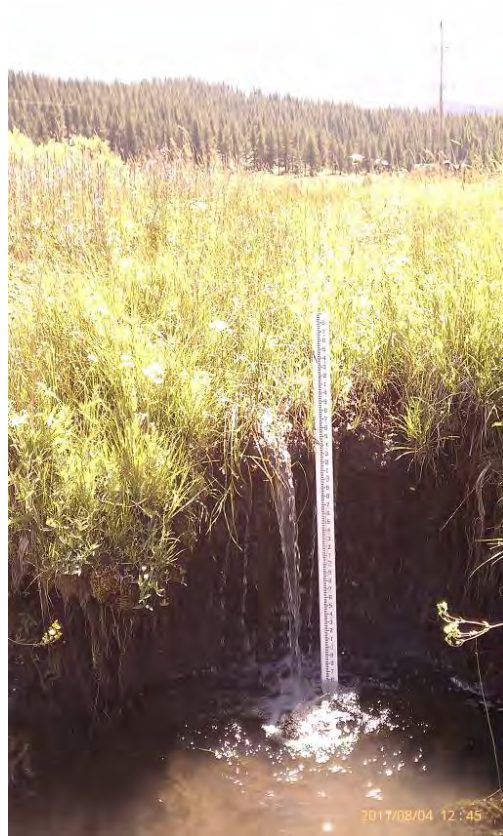
Reach 2 – Near confluence of Middle Martis Creek and Martis Creek. Lowered base level on Martis Creek, increased runoff, and focusing of drainage have led to headcut development and propagation. (photo credit: Brian Hastings, Balance Hydrologics)

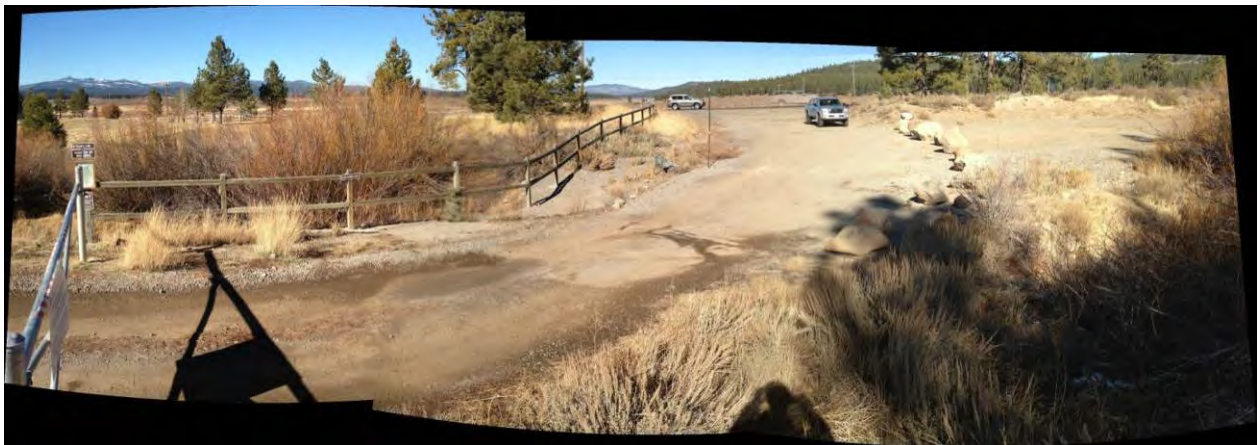
Overflow from Middle Martis Creek floods over golf course access road during large runoff events. (Photo credit: Kevin Drake, IERS)

While it may be possible to address each of these issues independently (i.e. replacing culverts and maintaining drainage ditches), we recommend that the causes of the problem be addressed, so that some portion of the total flow be maintained on the north side of the highway, where remnant channels remain.

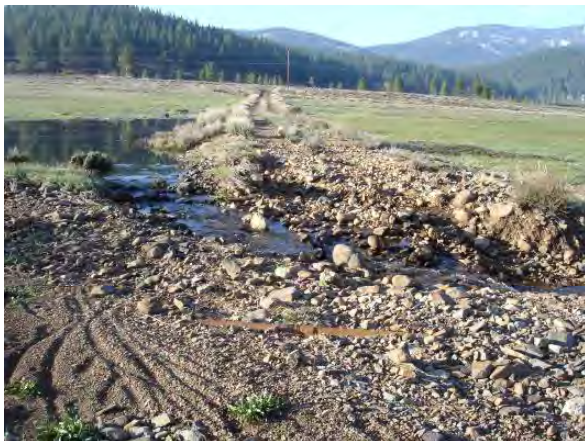
Site I – road impoundment interrupts meadow flooding patterns, causing intermittent road damage and vehicle access issues. (photo credit: Kevin Drake, IERS)

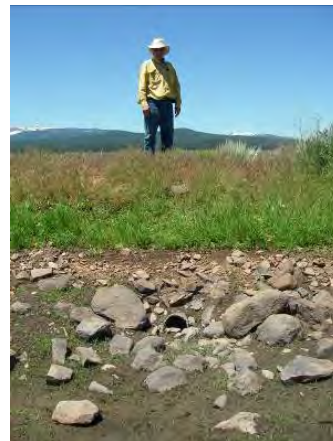
Site I – undersized culverts under road are clogged and insufficient to convey surface water to west side of road impoundment.(photo credit: Kevin Drake, IERS)

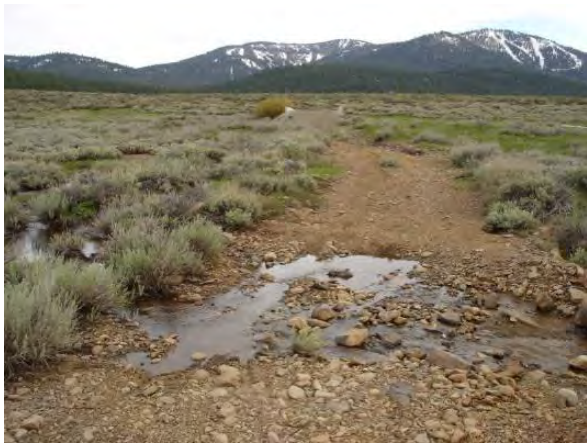
Site H – ephemeral branch of creek crossing road in unplanned/unstable location. (photo credit: Kevin Drake, IERS)

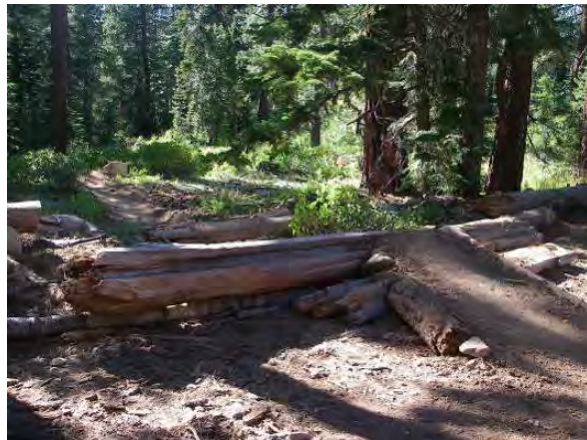
One of many downhill mountain biking trails and jump features in the East Martis subwatershed. (photo credit: Kevin Drake)

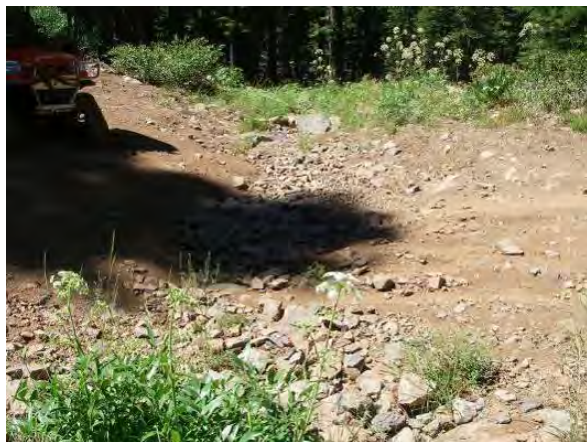
Site S – crossing is fairly stable but could benefit from broadening and armoring sideslopes. (photo credit: Kevin Drake, IERS)

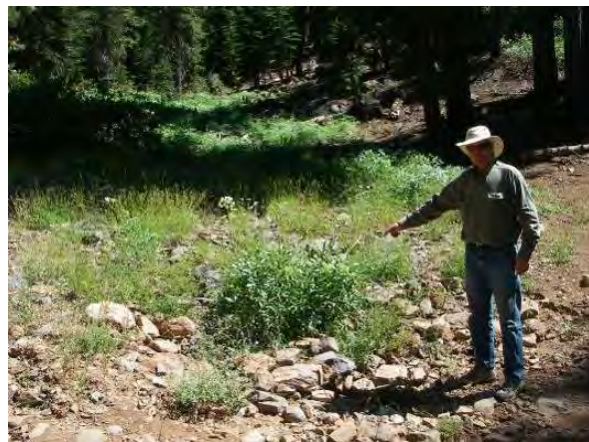
Site S – hand-placed rock above road for energy dissipation and sediment capture in ephemeral drainage. (photo credit: Kevin Drake, IERS)

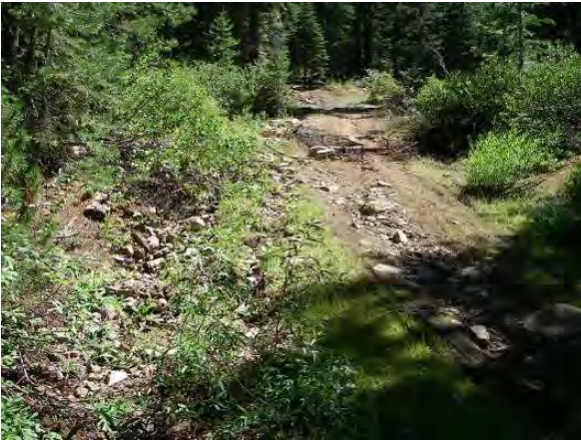
Older secondary logging roads run downslope parallel to several tributaries to East Martis Creek, contributing surface runoff and sediment from the road surface directly to the channels (Reaches 5 and 15). Streams connected to these road segments exhibit varying levels of incision with head cuts and large depositional areas, which is likely a result of flashy peak flows due to road runoff. Large, compacted landings are also present at or near some of these segments, which contribute additional surface runoff and sediment to stream channels. Water bars are installed at landing 36 near Site N that route runoff directly to the stream channel. These areas of high connectivity between roads, landings and stream channels are a key restoration opportunity in the East Martis subwatershed.

Landing 36 – runoff from this heavily compacted landing drains directly to stream channel (Reach 15). (photo credit: Kevin Drake, IERS)

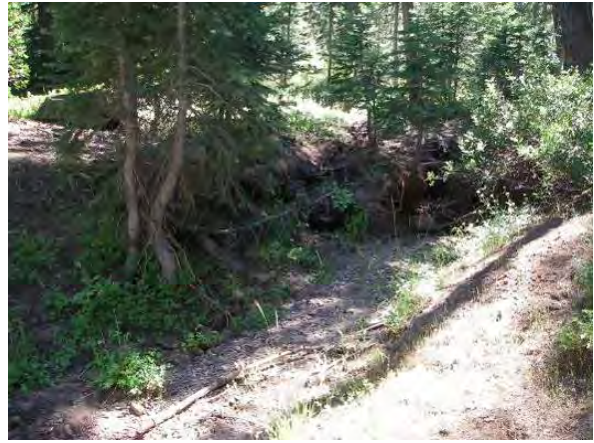
Reach 15 – substantial headcut roughly 50 feet downstream of road crossing. (photo credit: Kevin Drake, IERS)

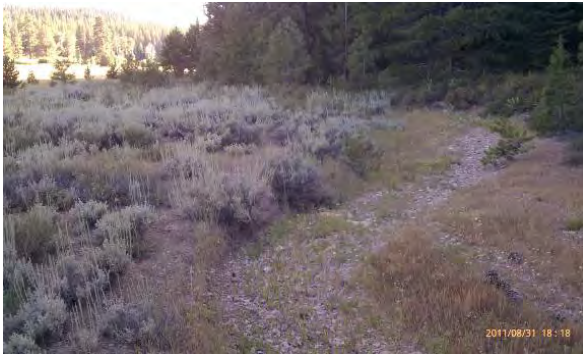
Klondike Meadow drains a 1.1 square mile area with a high density of roads, historical logging infrastructure, and historical grazing operations. The primary drainage is a branch of upper East Martis Creek, and appears to have been re-routed or captured by a railroad grade such that it now flows down the margin of the valley, rather down the topographic low along the axis of the valley. The re-located channel is heavily disturbed, and is serving as a sediment source to downstream areas. Disturbance is likely due to a combination of factors; including increased runoff and sediment delivery from upstream road surfaces, flow concentration along historical railroad or logging road grades, and flow concentration associated with user-created mountain bike and OHV trails. Minor headcuts have developed at meadow outlet, but appear to be stable and largely controlled by bedrock.

Site O, Reach 5 – Drainage capture along historical grades near the head of Klondike Meadow has eroded marginal areas at the edge of the valley. Stream capture also keeps excess runoff from the meadow surface, and has likely helped limit the extent of channel erosion in the meadow. (photo credit: Brian Hastings, Balance Hydrologics)

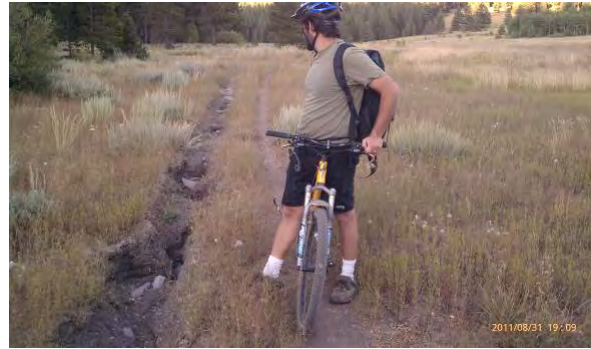
Reach 5 – Stream capture continues due to OHV and mountain bike use under current conditions. (photo credit: Brian Hastings, Balance Hydrologics)

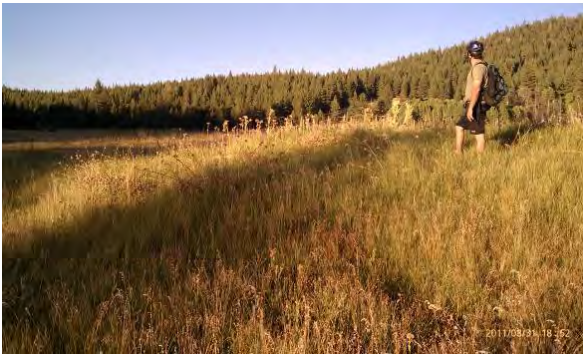
Numerous spring-fed perennial tributaries and groundwater mounds, or fens are present at and near Klondike Meadow. (photo credit: Brian Hastings, Balance Hydrologics)

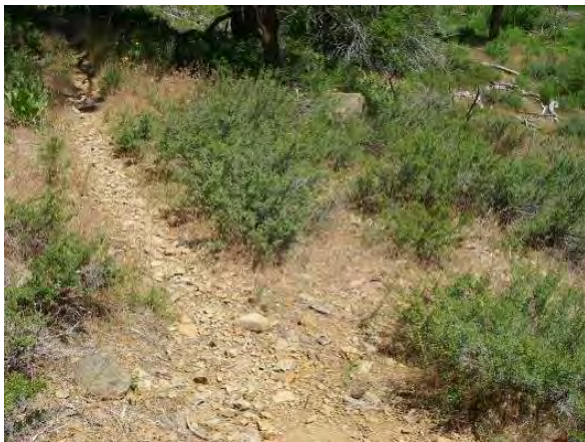
Site M – evidence of water capture on hiking trail near creek. (photo credit: Kevin Drake, IERS)

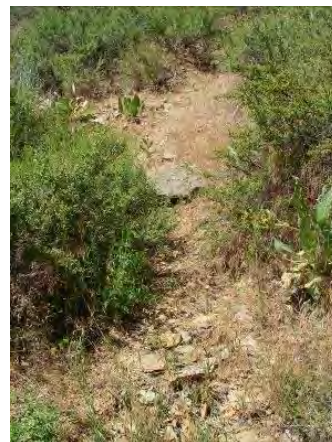
Site M – flow path through well-vegetated area connects trail runoff to creek.(photo credit: Kevin Drake, IERS)

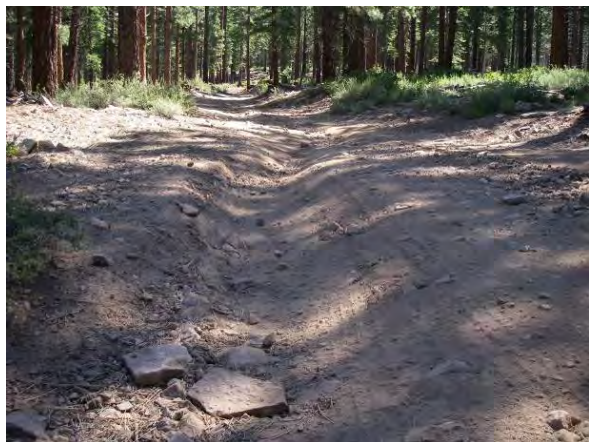
Site E – large gully present before smooth grading.(photo credit: Kevin Drake, IERS)

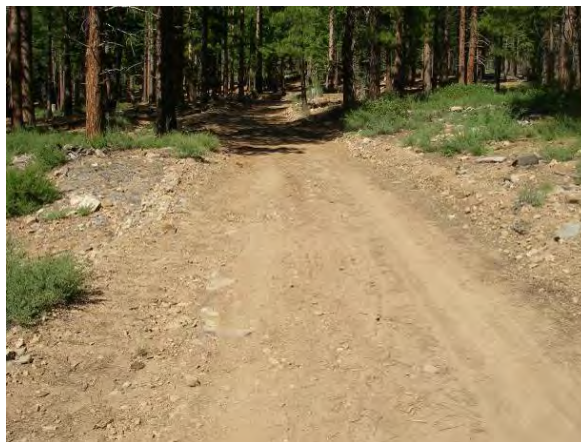
Site E – one season after smooth grading, rilling was observed in the exact same location as the gully. (photo credit: Kevin Drake, IERS)

Rainfall simulation monitoring conducted at Waddle Ranch by IERS indicates that the common practice of grading forest roads increased sediment yield by nearly an order of magnitude (9 times) compared to actively used road conditions immediately before grading and more than 200 times compared to reference conditions (intact forest with minimal disturbance)⁶. This monitoring confirms that roads are

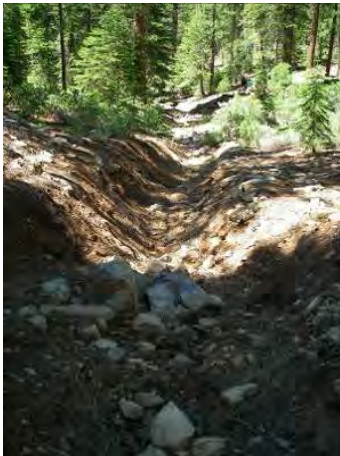
Reach 16 – deeply incised ephemeral drainage, likely used as a skid trail for logging. (photo credit: Kevin Drake, IERS)

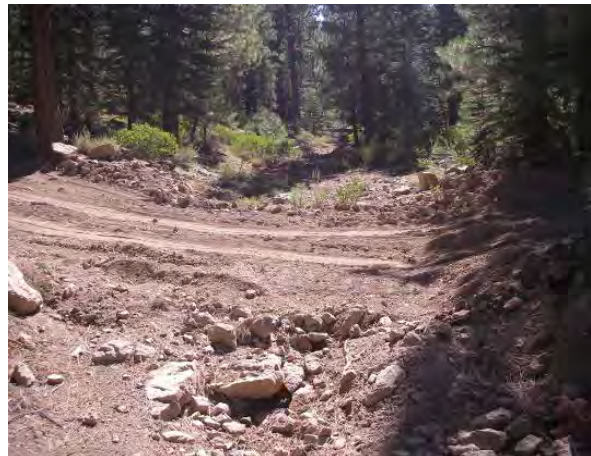
Reach 16 at haul road crossing shortly following road grading. (photo credit: Kevin Drake, IERS)

Of particular concern is an area of high road-drainage connectivity on the main haul road from Waddle Ranch onto SPI land above Dry Lake. An ephemeral drainage (Reach 16) runs parallel to the main road in a narrow, deeply incised channel (most of which is on SPI-owned land). This drainage appears to have been used as a skid trail during past logging, resulting in a straightened, incised channel. This drainage has been realigned in an effort to avoid washing out the haul road. However, the haul road intercepts this drainage in several locations, which has caused accelerated erosion (gullying) on the road surface and sediment transport directly to Dry Lake (Site B). Just downslope from Site B, runoff is diverted from the road via a water bar into a braided network of channels/gullies, which cross a rarely used road enroute to its terminus at Dry Lake. A small headcut has formed just downstream of where the channel crosses the old haul road due to the change in gradient (Site A).

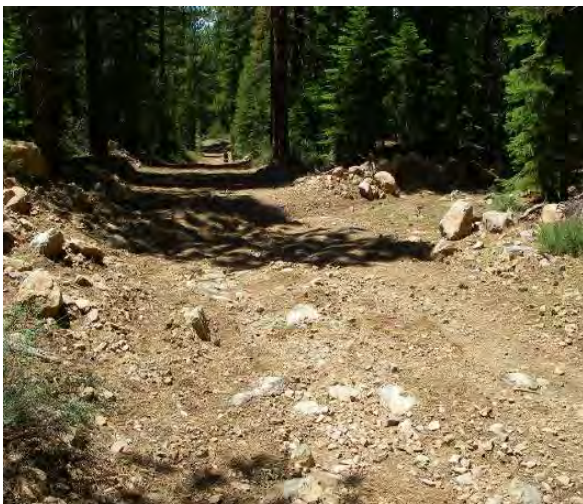
Site B – accelerated erosion on haul road above Dry Lake. (photo credit: Kevin Drake, IERS)

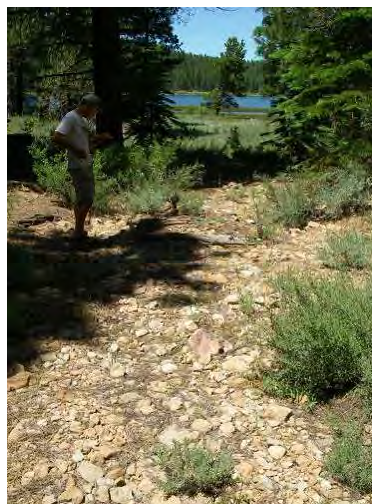
Site A - ephemeral drainage crossing old road above Dry Lake. Headcut has developed just downslope of road. (photo credit: Kevin Drake, IERS)

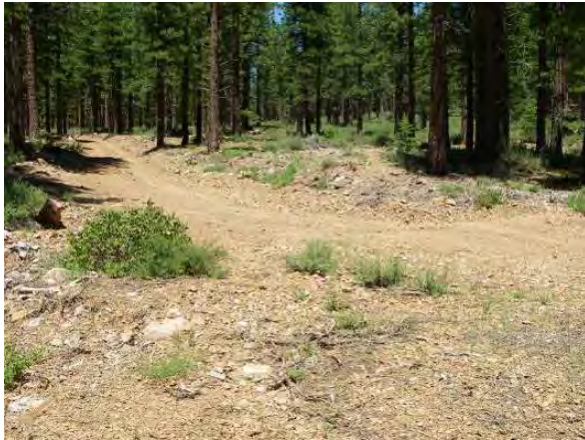
Site C – road runoff connects directly to ephemeral drainage. (photo credit: Kevin Drake, IERS)

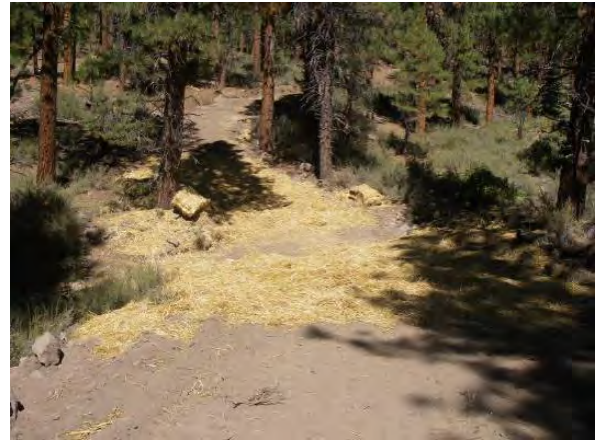
Site F – haul road with unimproved crossing at ephemeral drainage to Martis Creek Lake. Straw was spread after logging in 2009 as a best management practice. (photo credit: Kevin Drake, IERS)

Haul roads cross directly through and/or contribute significant runoff to ephemeral drainages in several locations at Waddle Ranch. At Site C, a rolling dip shunts road runoff directly to an ephemeral drainage. Minor scouring and sediment deposition was observed. This road segment is effectively the “headwaters” for this drainage. At Site F, a haul road crosses a large ephemeral drainage from the road surface directly into the At all of these locations, the road surfaces create grade breaks that would likely result in head-cutting and large amounts of sediment being mobilized in large runoff events.

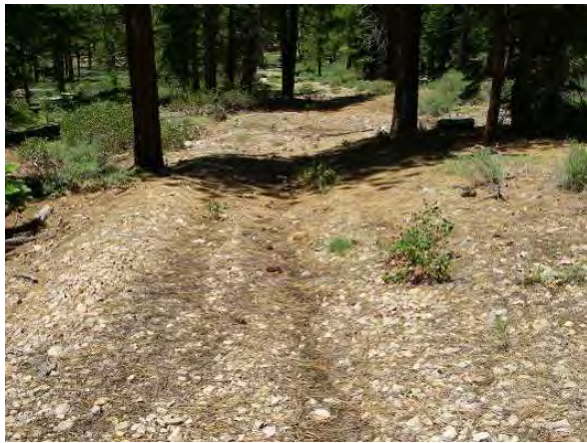
Site D – skid trail likely created during 90's-era logging. (photo credit: Kevin Drake, IERS)

Historic skid trails are widespread at Waddle Ranch, continuing to alter drainage patterns by concentrating runoff into a semi-hidden network of erosion-prone gullies. Skid trails are created by dragging felled trees over the ground to a central point. The primary land disturbances associated with skidding are displacement of duff and topsoil, soil compaction, and reshaping of the forest floor into linear swale-like features. Most skid trails run to historic landing areas, which are typically located along historic or active roads, increasing the hydrologic connection between these legacy areas and their potential impacts on water courses during episodic runoff events. Even after decades of no human use, many of these historic skid trails still have heavily compacted soils and exhibit evidence of long-term water capture.

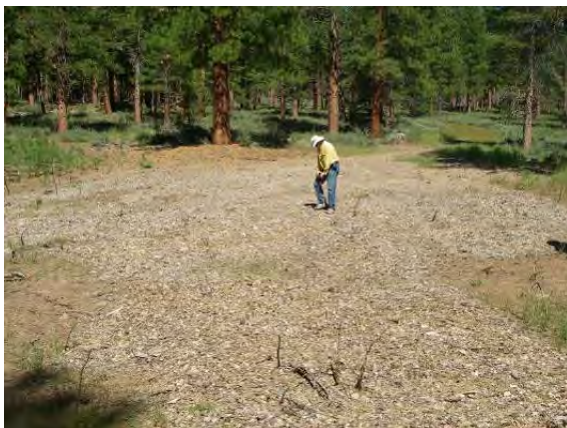
Landing 11 (L11) – compacted landing covered in 1-2 inches of wood chips. (photo credit: Kevin Drake, IERS)

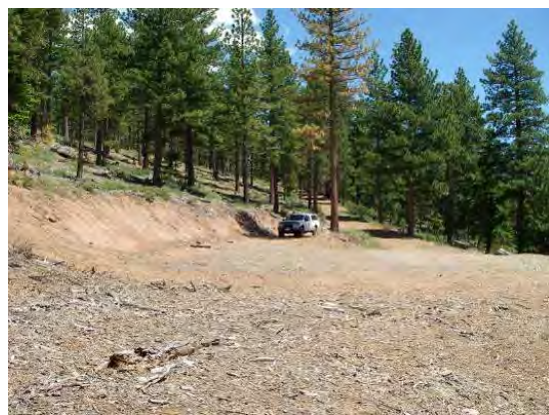
Landing 1 (L1) – large landing with eroding cut and fill slopes. (photo credit: Kevin Drake, IERS)

18 landings have been visually identified and inventoried along 6.3 miles of road at Waddle Ranch to date, and there are believed to be many more. This equates to 2.8 landings per road mile assessed, which is comparable to the actively managed SPI-owned land in the East Martis Creek watershed, where landing density was 3.1 landings per road mile assessed. Most landings identified to date are historic landings and some were re-used and further impacted during 2009 logging operations. The size and physical condition of landings varies widely. For instance, landing 11 was covered in wood chips following use in 2009. However, soils are still quite compacted and no vegetation has re-established. Landing 1, in contrast, has large, eroding cut and fill slopes and more than 10,000 square feet of nearly bare, heavily compacted soil. Many of the other historic landings at Waddle Ranch have been colonized by vegetation (primarily trees and shrubs) but are still very compacted.

Results of monitoring by IERS in 2009 indicate that historic landings and other legacy impacts (e.g. old logging roads and skid trails) continue to remain relatively compacted despite the increasing vegetation

on those sites⁷. Soils that are compacted tend to remain in that state for a long period of time with some reduction in soil density occurring but not enough in most cases to return the site to original levels of infiltration or productivity. Most landings at Waddle Ranch are low in slope angle and therefore, may not be perceived as a high erosion risk. However, the cumulative impacts of these large compacted areas on watershed hydrology and sediment transport should not be underestimated, especially since landings are typically connected to roads and skid trails, which are very efficient at conveying the increased runoff from these areas and exacerbating erosion and drainage issues downslope.

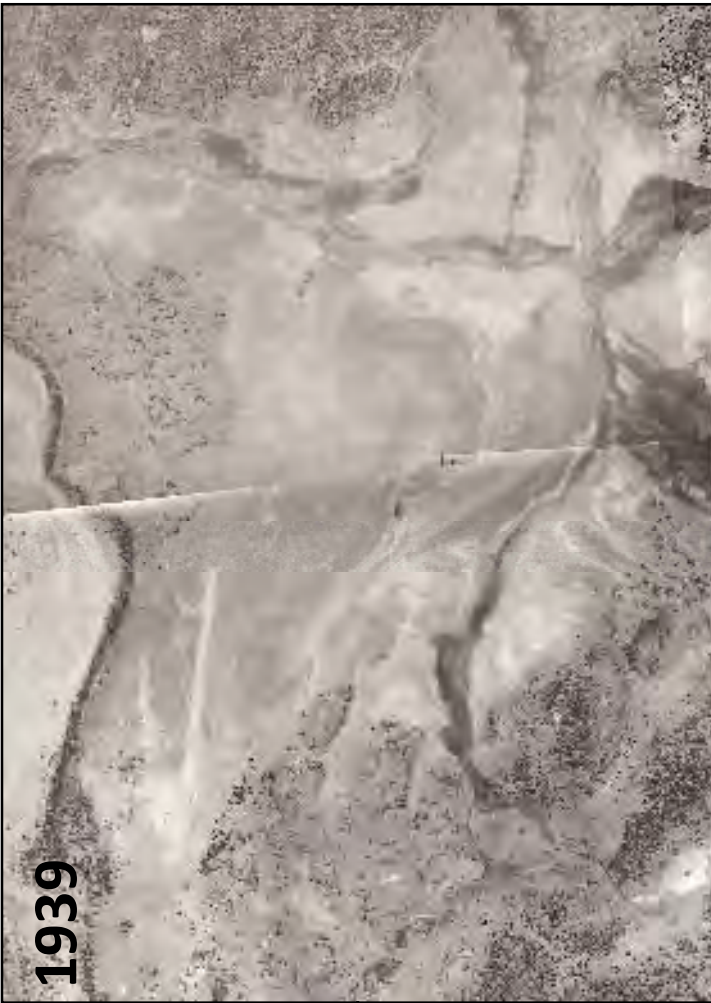
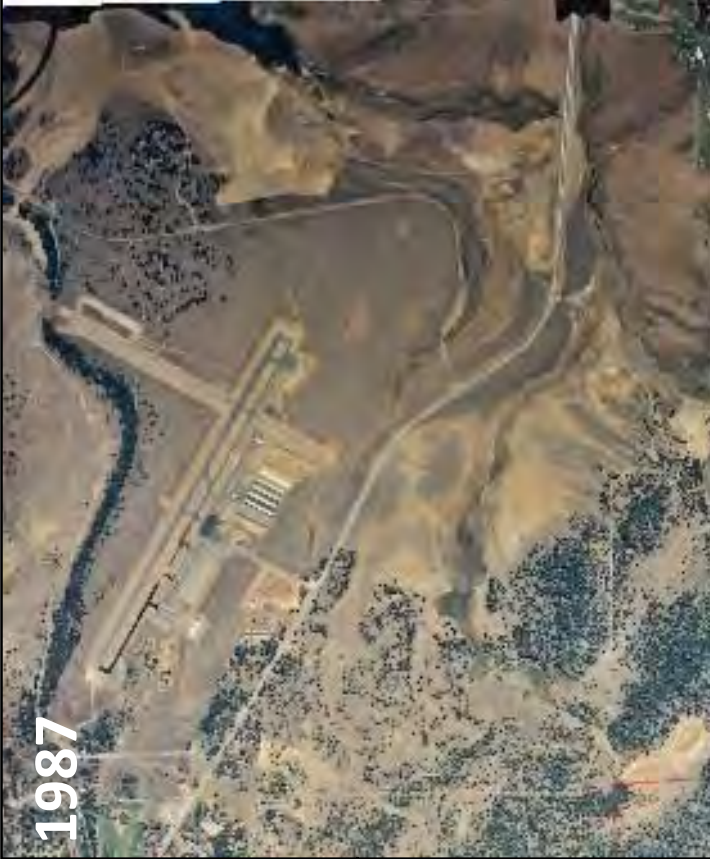
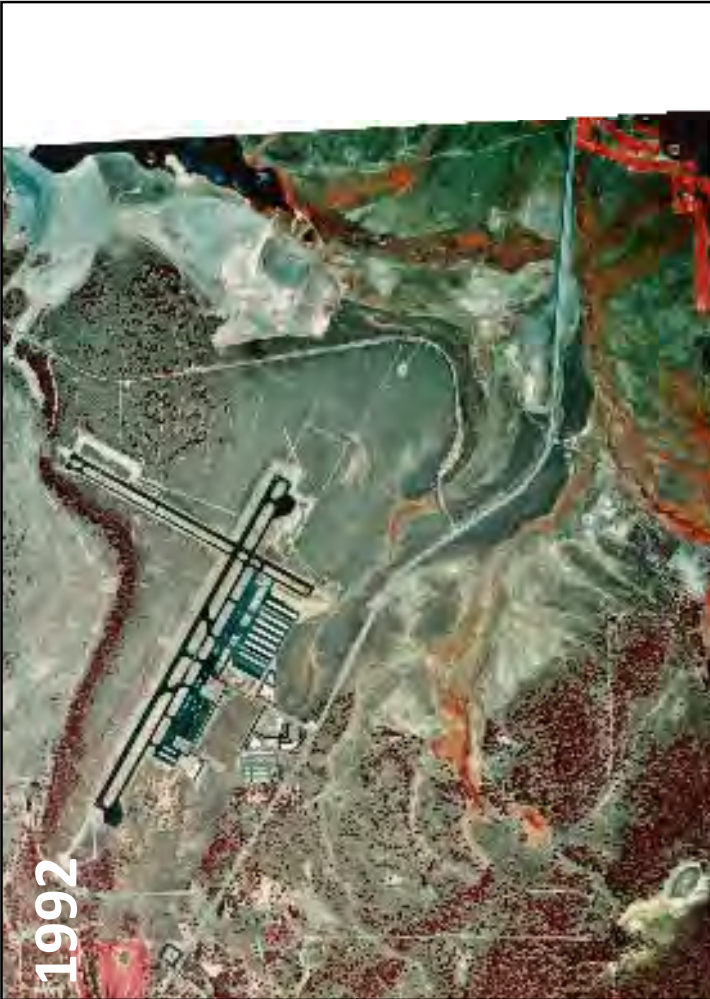
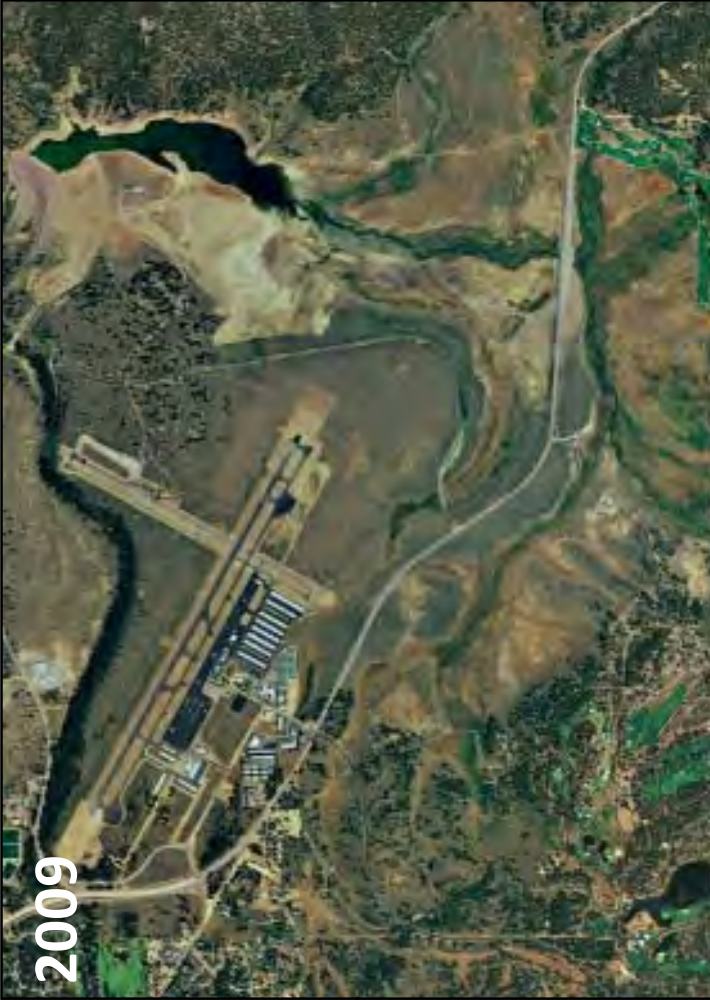
Early 1900s intensive logging, 1930s increased road traffic, 1941 Joeger Ranch 1940s-1970s stand re-entry/modern-era logging, 1960s sheep herding, quarrying 1950s airfield enlargement, 1960 Olympics, Highway 267 improvements, 1964 airport improvements 1970 Martis Dam, 1972 Northstar

1980s modern logging continued 1993 Town of Truckee incorporated 1990s Martis Camp, Lahontan and Big Springs Estates 2000s Northstar expansion 2005 Martis Valley Agreement 2007 Waddle Ranch protected open space

Figure 17. Visual timeline 1939 to 2011, Martis Valley, Martis Watershed, Placer and Nevada Counties, California

Figure 17 illustrates visible changes in the Martis Valley using a sequence of historical aerial photographs between 1939 and 2009. The figure is supplemented with a summary of significant land uses and historical events, or major floods that occurred in the watershed. The suite of historical aerial photographs shown were examined to establish locations where channel conditions may have changed, with specific attention paid to: a) channel planform changes such as meander cut-offs, transition from braided channel to single channel, and human modifications (diversions, straightening, etc.); b) presence, absence or change of riparian or point bar vegetation; c) increased channel widths, and; d) absence or presence of new channels.⁴ Examples of typical watershed changes are included in Figures 18, 19, 20, and 21.
