Martis Watershed Assessment

Placer and Nevada Counties, California

April 2012

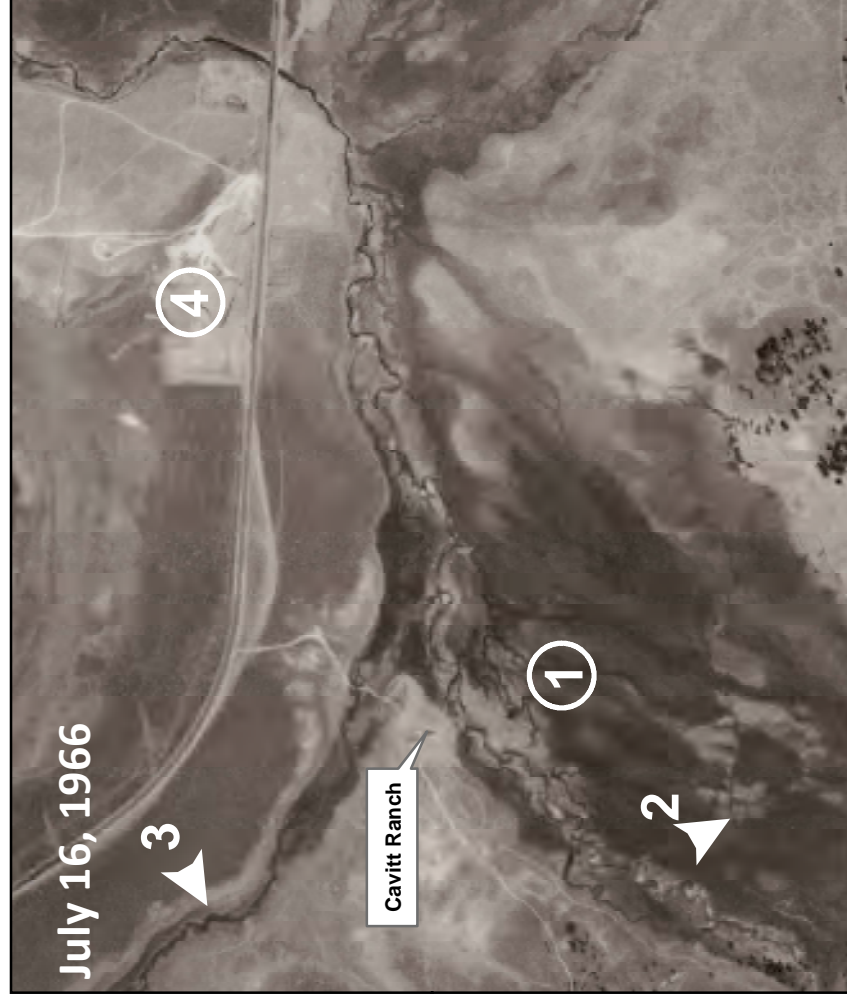
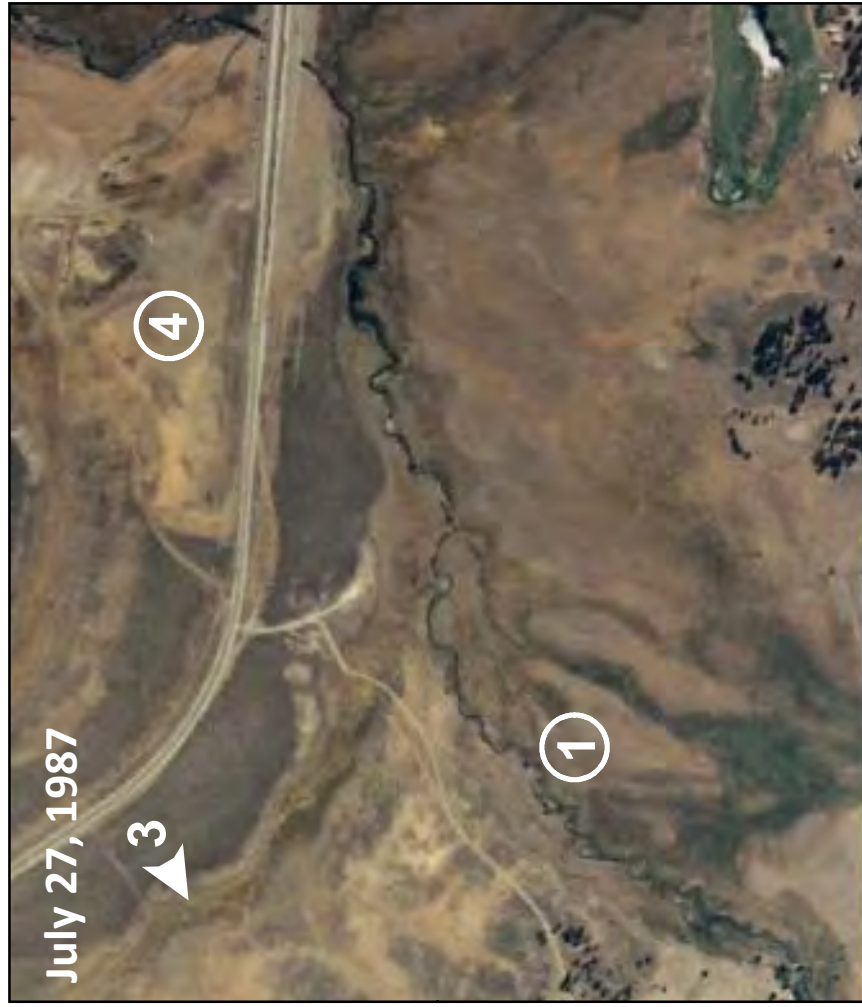
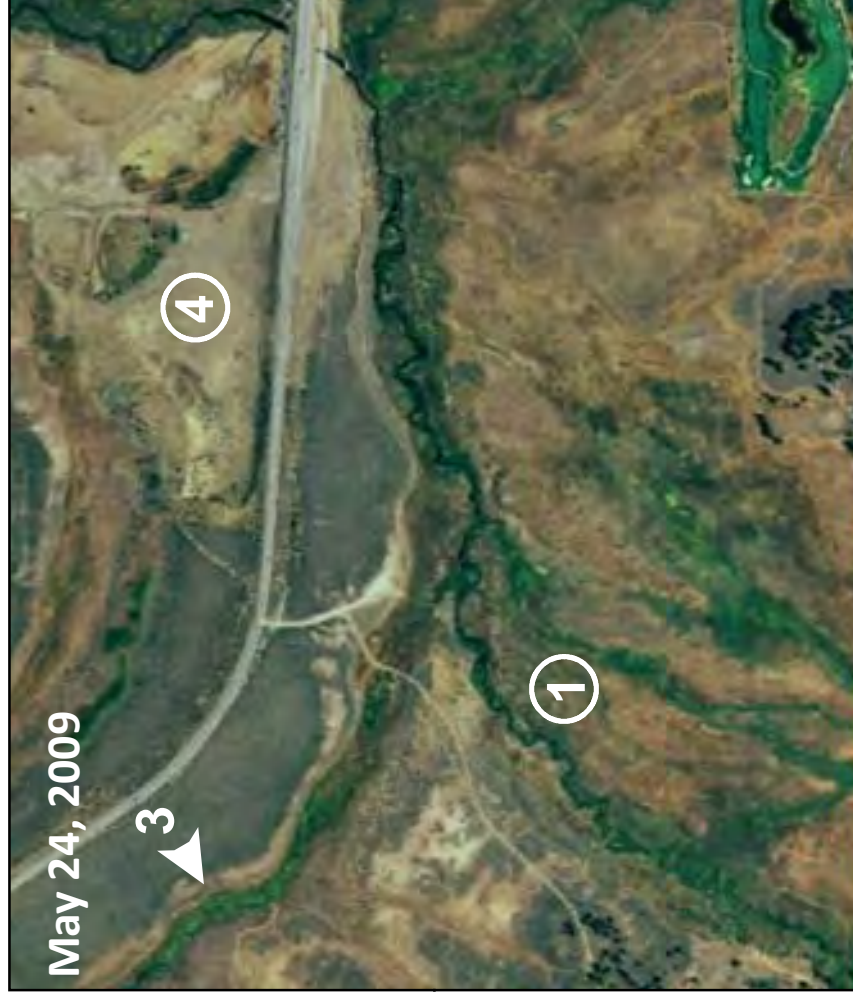
Figure 18. Selected channel changes, 1939 to 2009, Martis Valley, Placer and Nevada Counties, California
1) Martis Creek exhibited multiple channels historically, whereas today, only a single channel exists; 2) Irrigation ditches watered the meadow; 3) tributaries incised and widened; 4) quarry expansion supported airport, road improvements (1963) and Martis Dam construction (1970).

Figure 17 illustrates visible changes in the Martis Valley using a sequence of historical aerial photographs between 1939 and 2009. The figure is supplemented with a summary of significant land uses and historical events, or major floods that occurred in the watershed. The suite of historical aerial photographs shown were examined to establish locations where channel conditions may have changed, with specific attention paid to: a) channel planform changes such as meander cut-offs, transition from braided channel to single channel, and human modifications (diversions, straightening, etc.); b) presence, absence or change of riparian or point bar vegetation; c) increased channel widths, and; d) absence or presence of new channels.⁴ Examples of typical watershed changes are included in Figures 18, 19, 20, and 21.

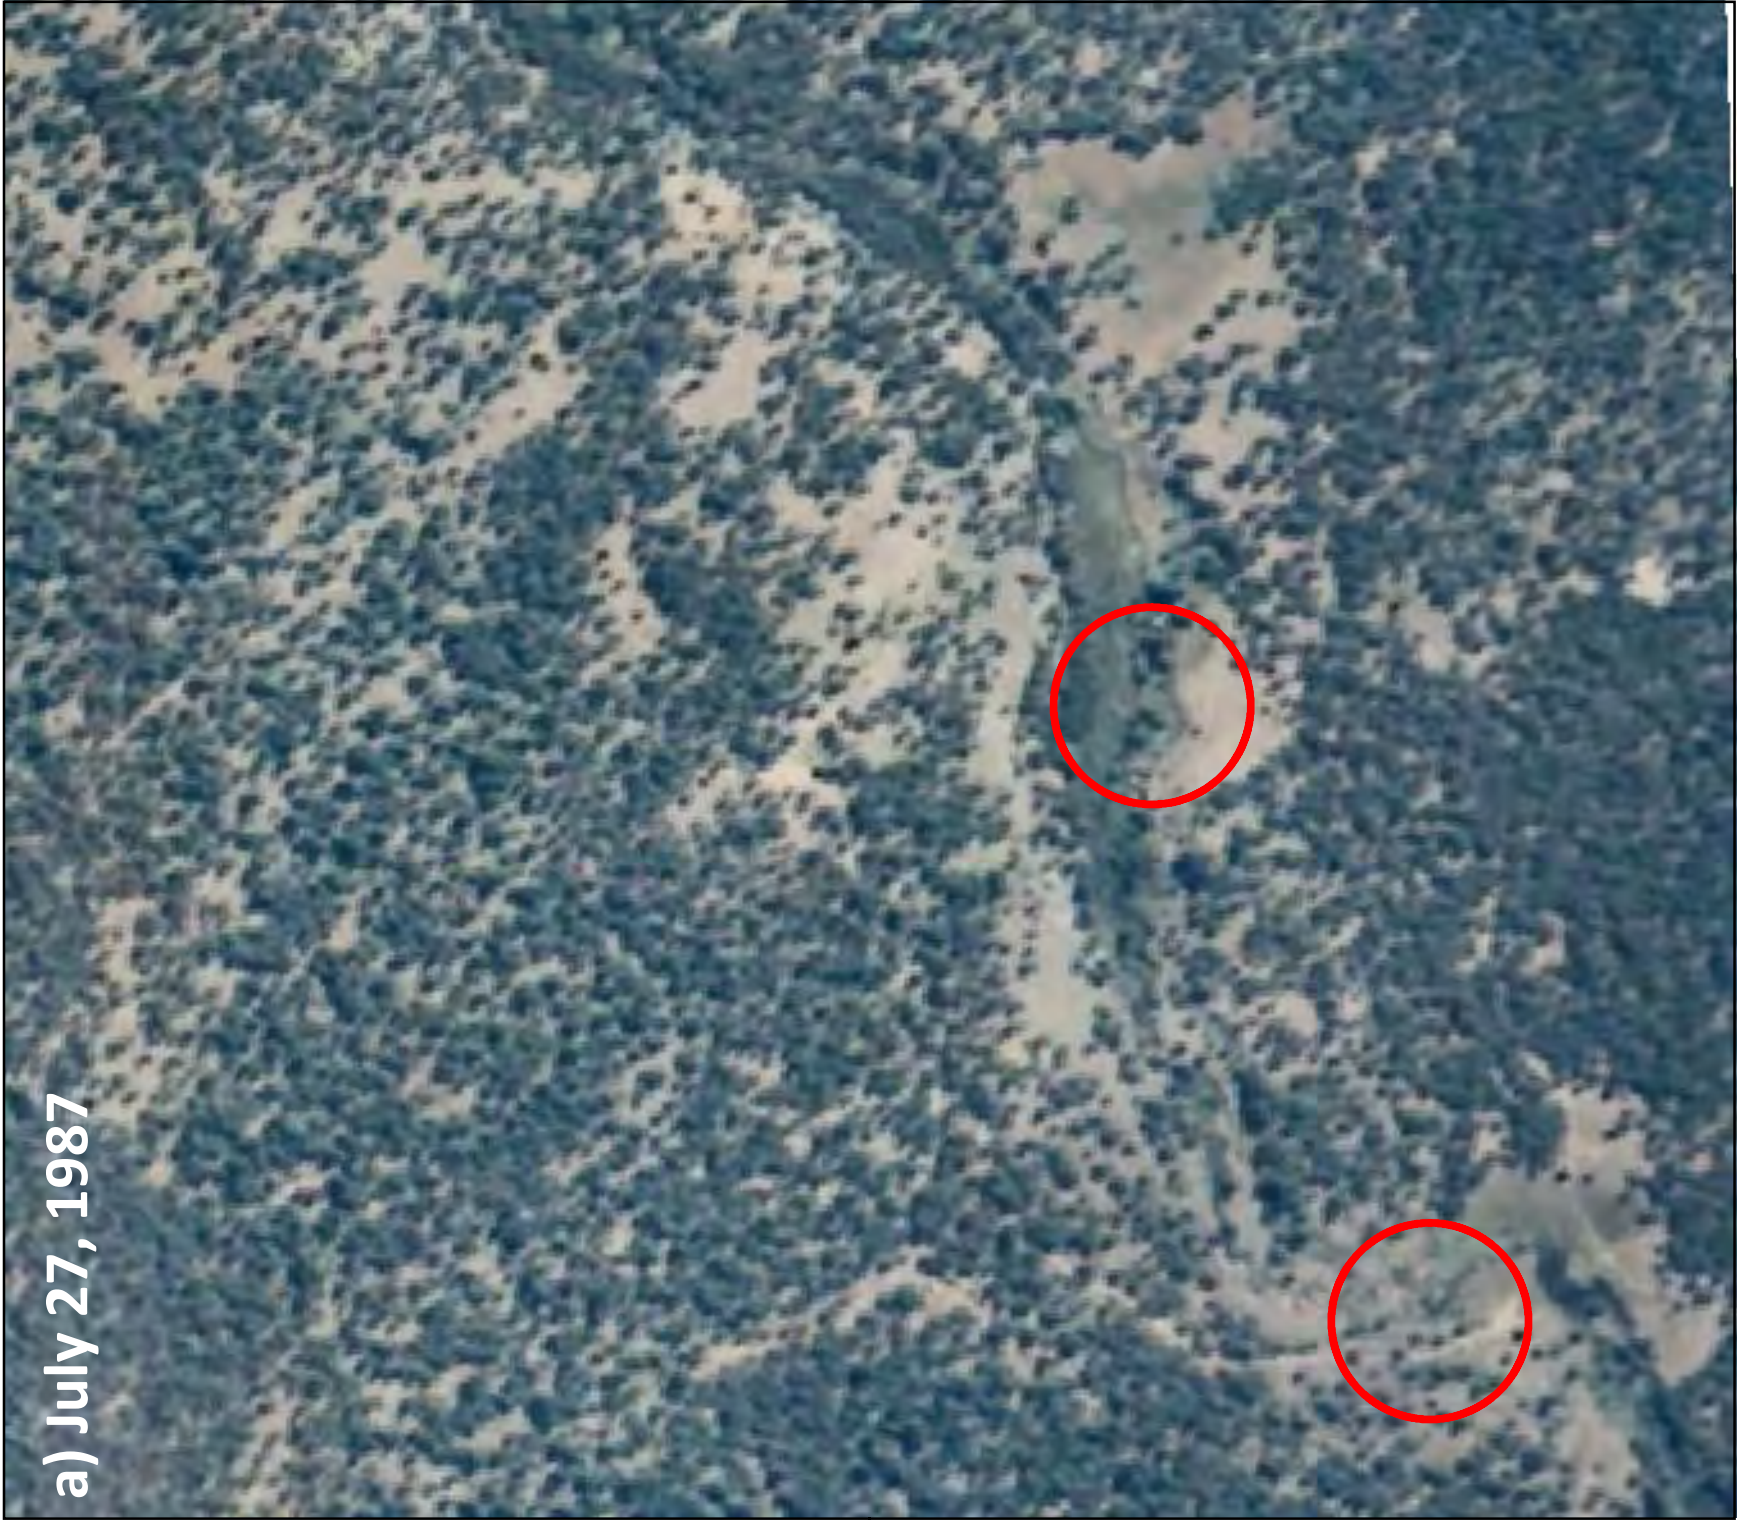
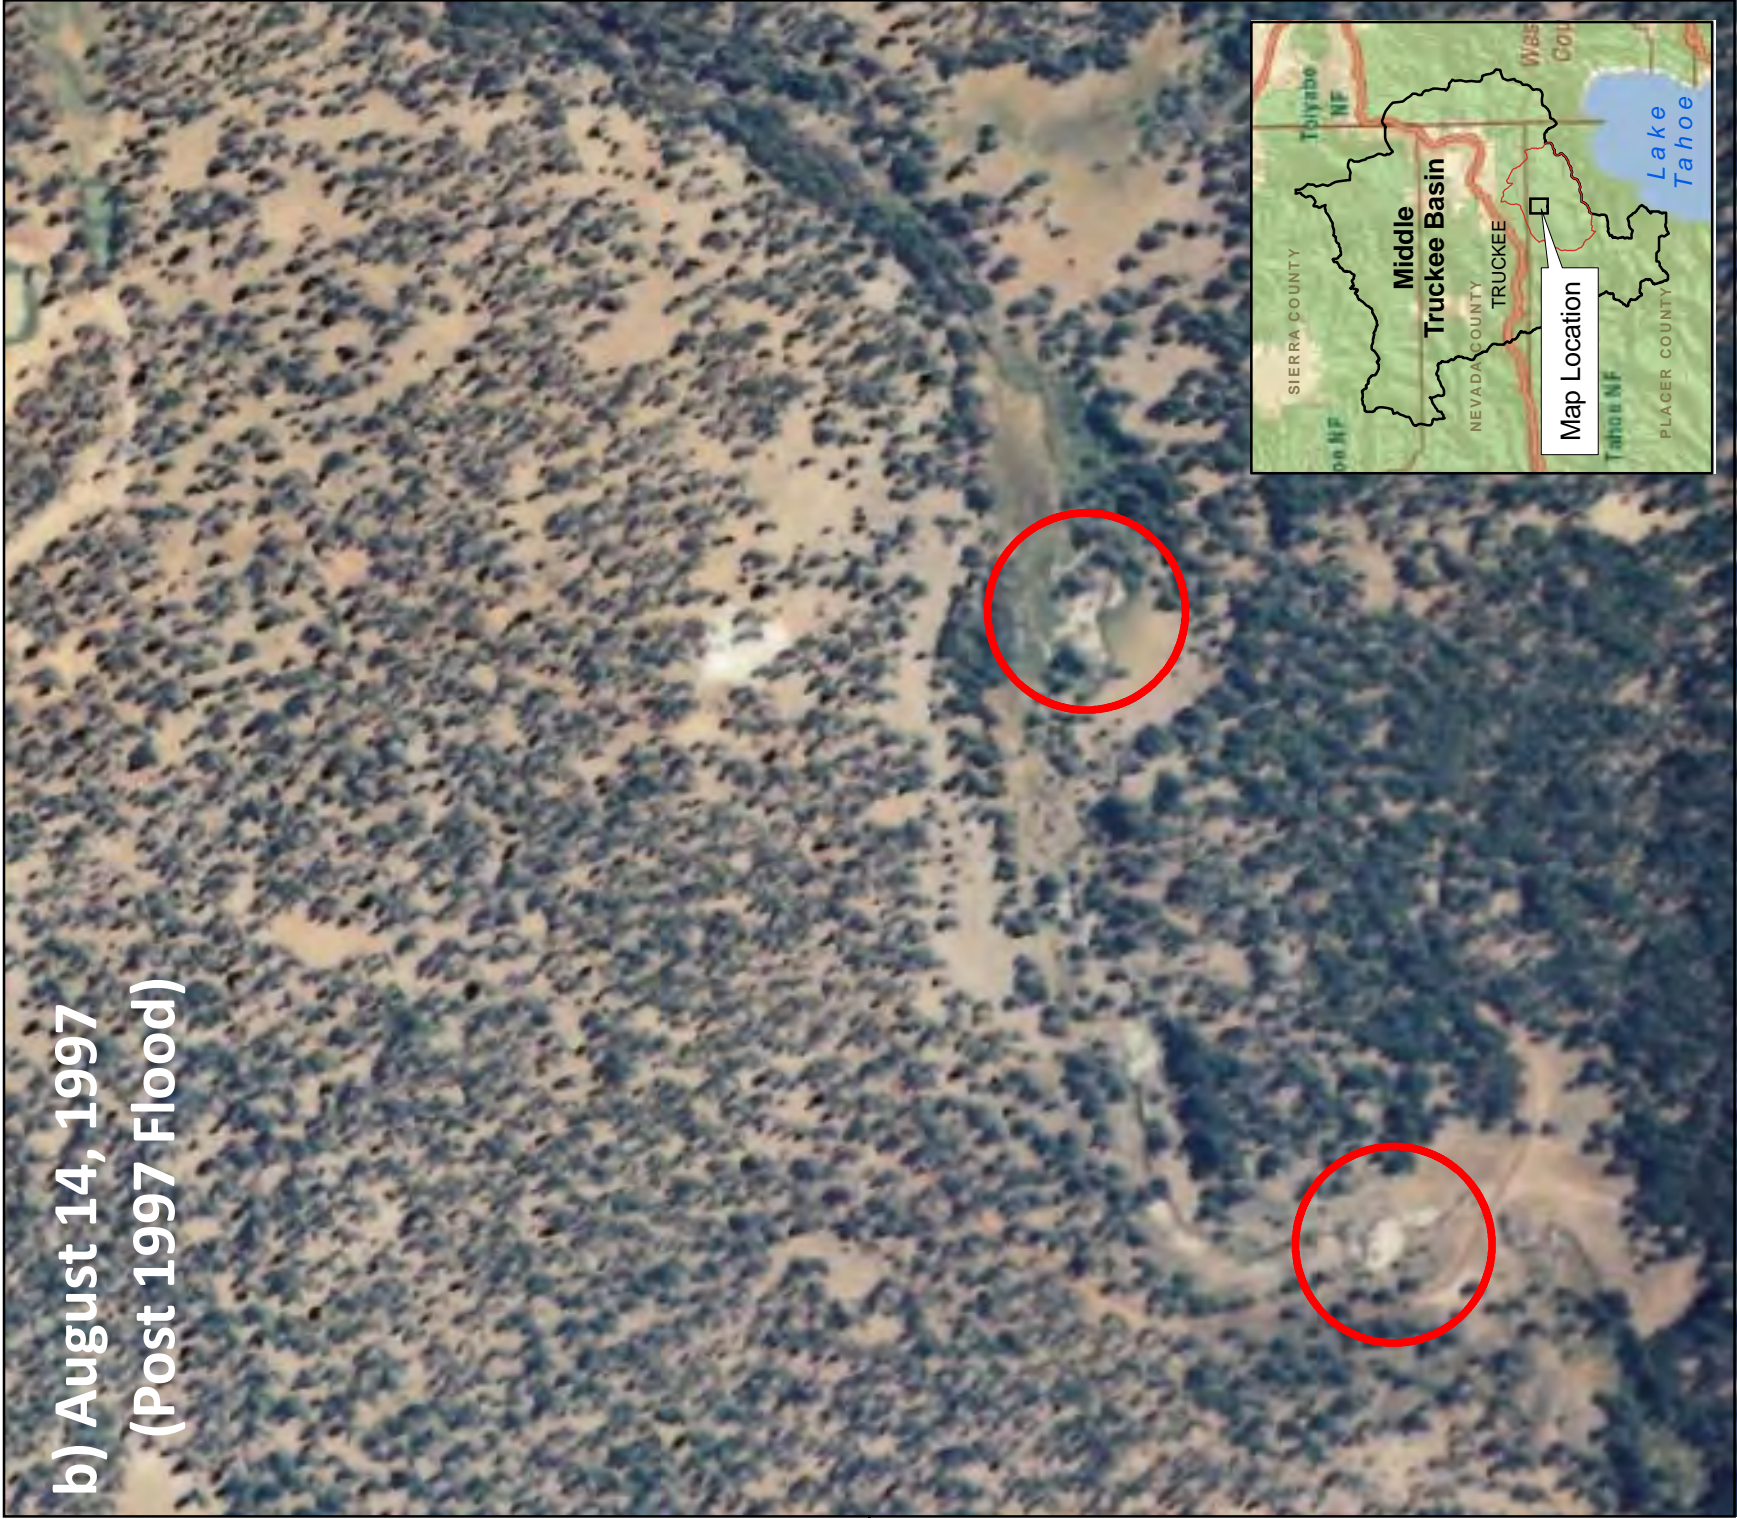
Figure 20. Selected changes in channel morphology: Martis Creek at Old Schaeffer Mill, Martis Valley; a) 1987; b) 1997. Red circles indicate visible erosion and deposition of sediment which may be the result of the January 1, 1997 flood. Historical disturbances (mill) may exacerbate the effects of floods.
