final technical report

Perazzo Meadows Geomorphic Assessment

for Truckee River Watershed Council

May 2008

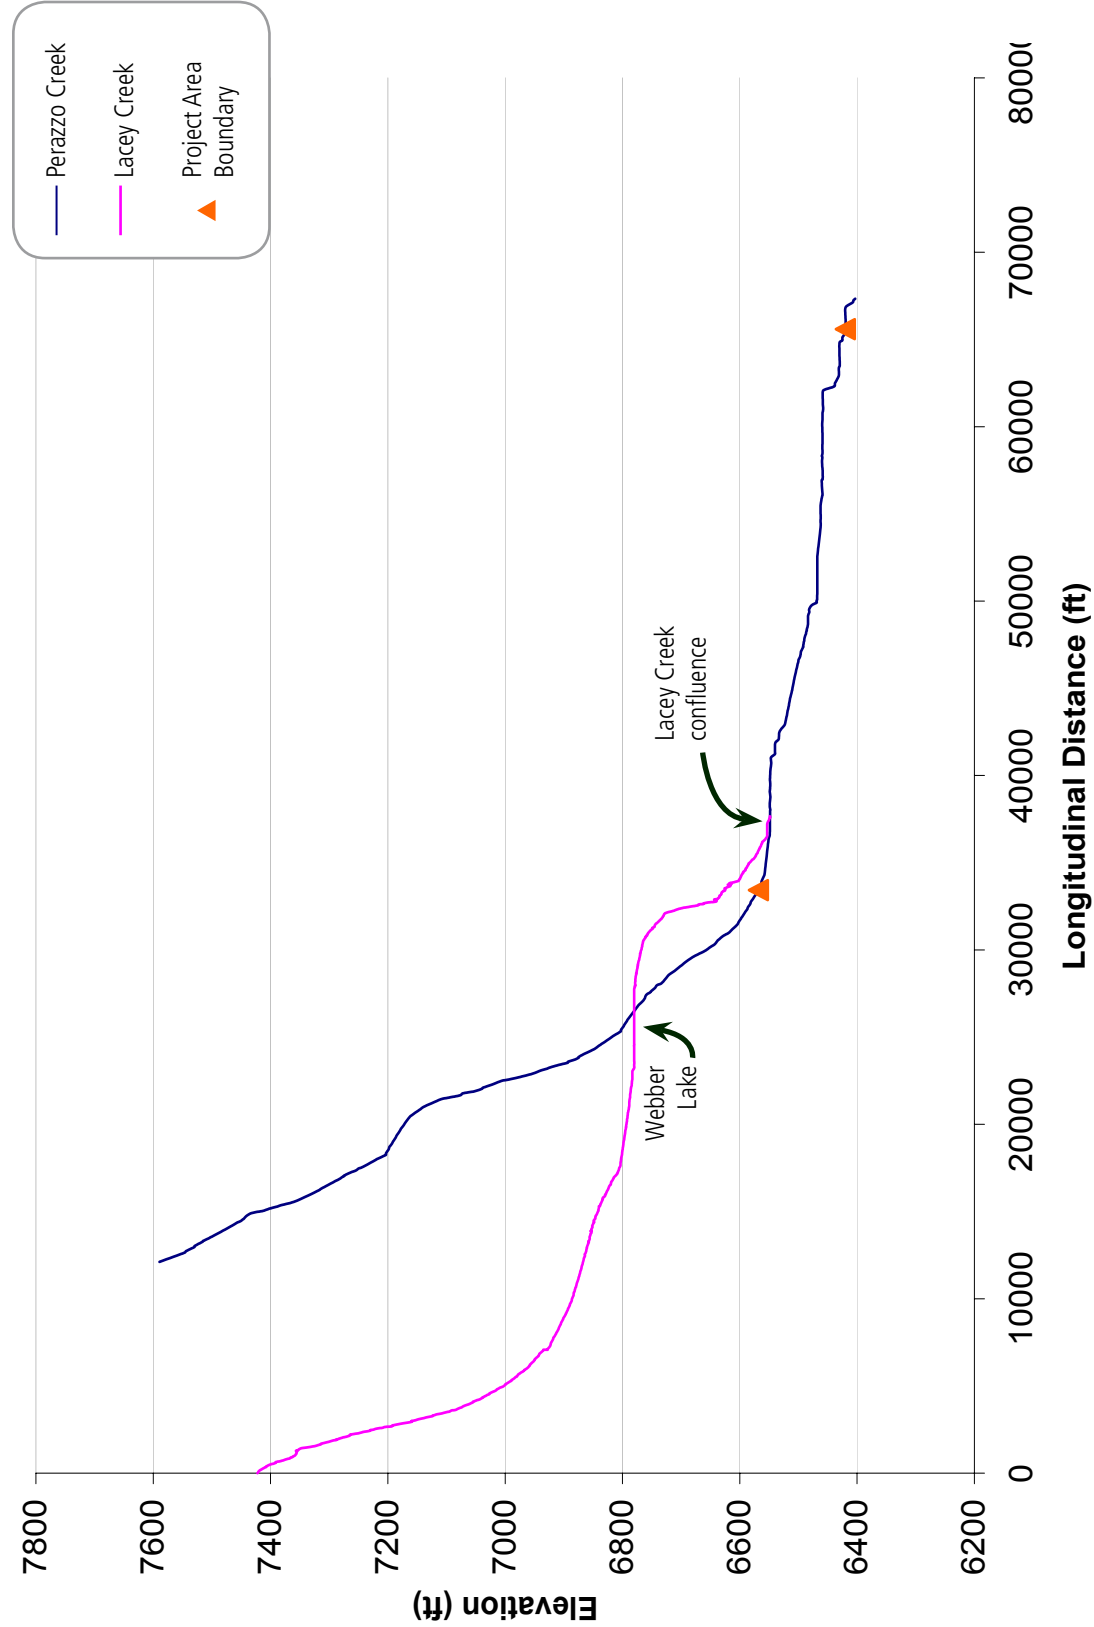
Project Watershed Thalweg Longitudinal Profile

FIGURE 4a: Longitudinal profile of Perazzo and Lacey Creeks. Profiles were developed from 10-meter digital elevation models provided by U.S. Geologic Survey. The project reach is located where the profile flattens out from the higher gradient, narrow valley sections upstream.

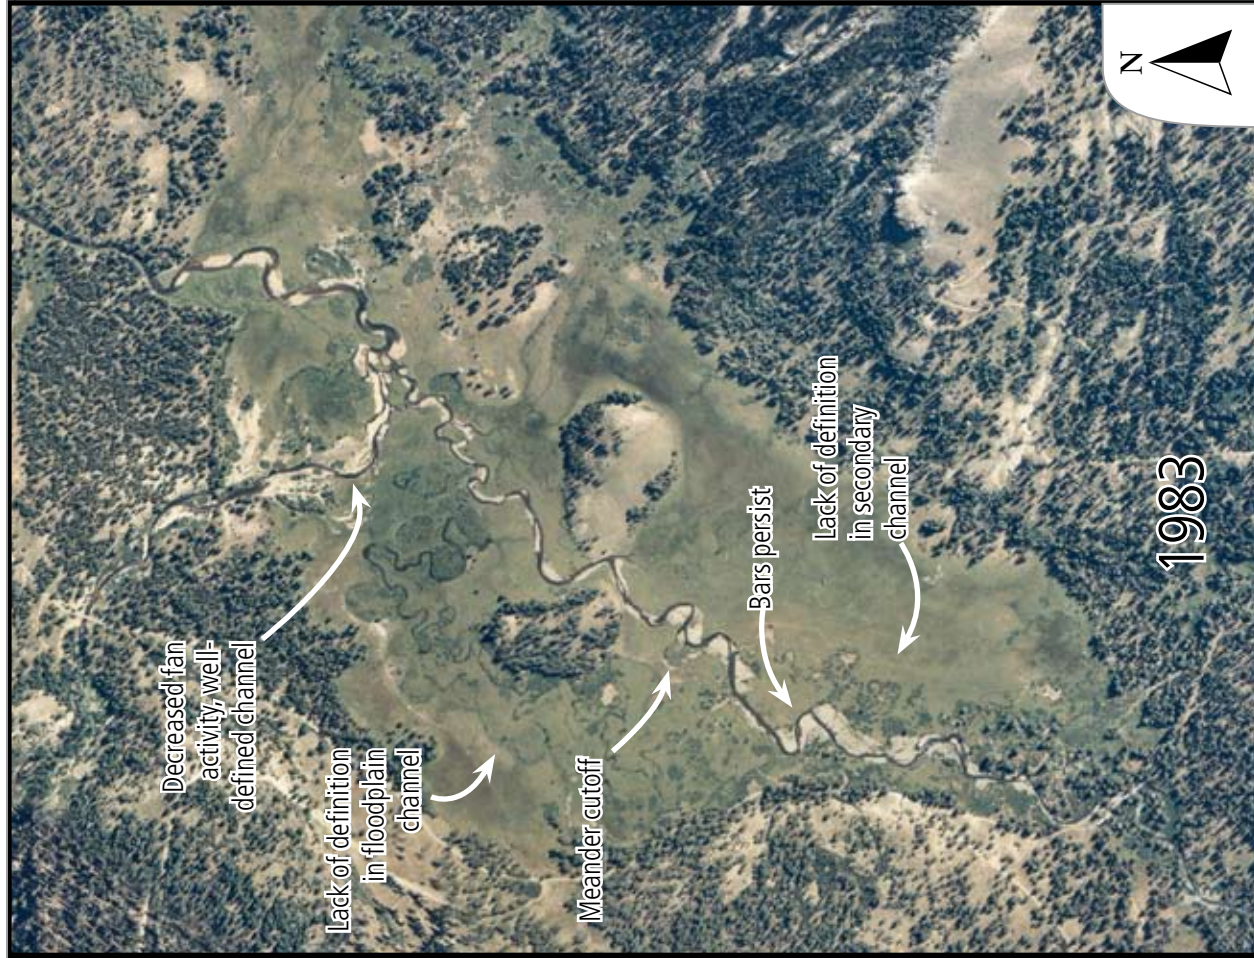
FIGURE 6: 1966 and 1983 historic aerial photos of upper Perazzo Meadows and the Lacey Creek confluence. Significant bar formation occurred throughout the meadow between 1952 and 1966 and persists through 1983. Part of this could be attributed to active fans on Perazzo and Lacey Creek, but is also a result of poor access to floodplain channels, most likely due to channel incision. (Source: Tahoe National Forest)

Between 1952 and 1966 significant changes occur in the upper portion of Perazzo Meadows with a rapid progression through Stages 3, 4, and 5 (Figure 6). The fan emanating from Perazzo Canyon is well defined in the 1966 photo as compared to previous photos, large bars have formed in the main channel downstream of the fan, and access to historic floodplain channels appear less distinct. The Lacey Canyon alluvial fan also has enlarged with bars persisting downstream on the mainstem of the channel. Two large rain on snow events occurred in February, 1963 and December, 1964 with estimate return periods of 35 years and 15 years, respectively. Two large events occurring back to back most likely pushed the system past a breaking point. By 1983, access to the historic floodplain channels appears limited and the large, unvegetated bars that appear in the 1966 photos persist, even to this day.

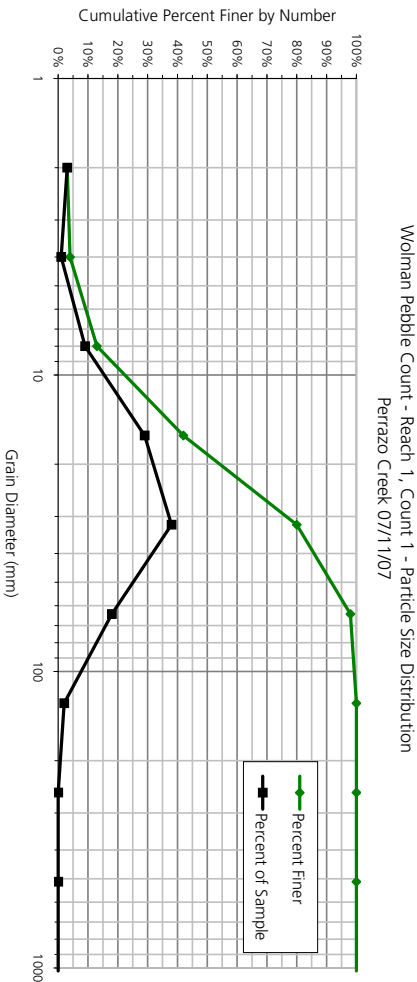
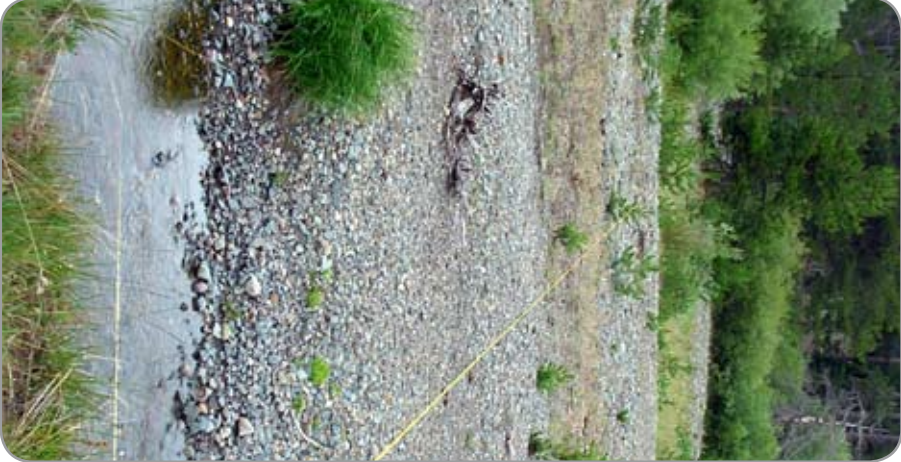
Reach 1 - Count 2 - Riffle Sample		
Sample taken from riffle near upstream end of the reach.

FIGURE 9a: Bed material sampling for Site 1, Reach 1 within the Perazzo Meadows project area. Samples were taken on active bars and at riffles within the low flow channel.

Shear values from the hydraulic model were used in conjunction with grain size (Figures 9a, b, c, d, e, f) information to assess bed mobility at each cross-section. The analysis was not conducted at Site 2 since the current bed material is a result of overbank deposition. Cross section specific bed mobility estimates were calculated using the Shields equation of particle motion (Shields, 1936; Simons and Senturk, 1992) to produce an estimate of the percentage of the bed that would be expected to move under a range of flow conditions. The discharges analyzed included the 1.5-year, 2-year, 5-year, and 10-year events. Results of this analysis are presented in Figure 12 and Table 4.

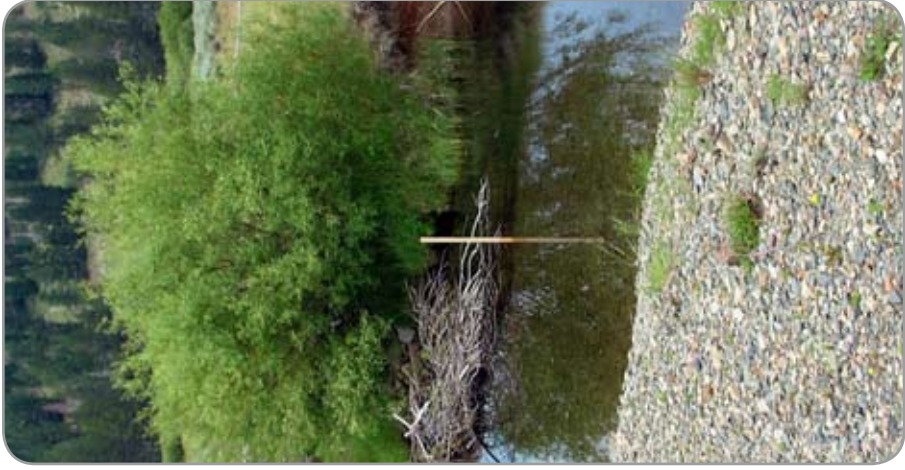
Reach 2 - Count 1 - Bar Sample			
Sample taken from bar crest above bankfull channel.			
D ₁₆	D ₅₀	D ₈₄	
19	42	85

FIGURE 9b: Bed material sampling for Site 3, Reach 2 within the Perrazo Meadows project area. Samples were taken on active bars and at riffles within the low flow channel. (NOTE: Pebble count data was not collected for Reach 2, Site 2 since the site is located in an historic channel that has been filled with fine sediment over time via overbank deposition from the primary channel)

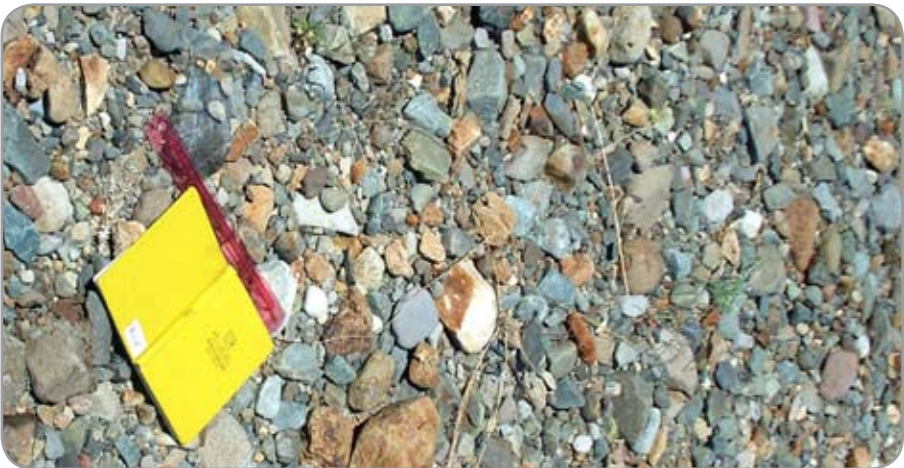
Reach 4 - Count 1 - Bar Sample		
Sample taken from upstream bar above the bankfull channel.		
D ₁₆	D ₅₀	D ₈₄
7	12	17

FIGURE 9c: Bed material sampling for Site 4, Reach 4 within the Perrazo Meadows project area. Samples were taken on active bars and at riffles within the low flow channel..

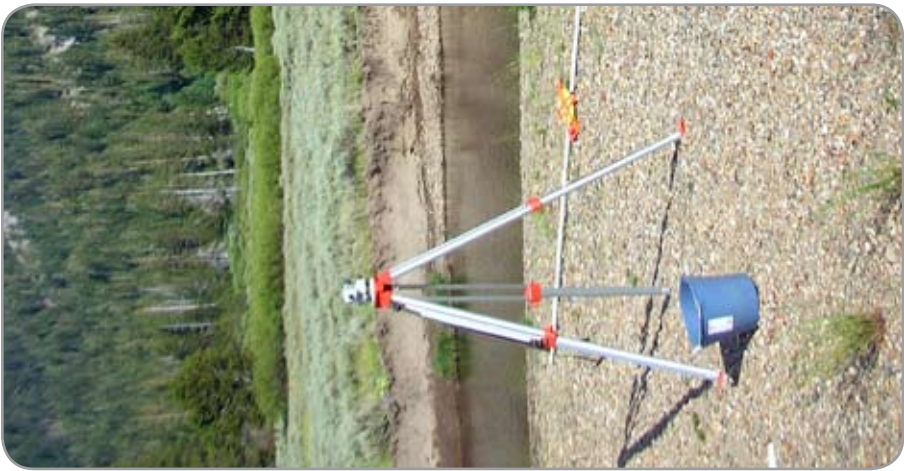
Reach 8 - Count 1 - Bar Sample
Sample taken from high bar above the bankfull channel at the upstream end of the reach.

Reach 8 - Count 2 - Riffle Sample
Sample taken from riffle within the bankfull channel at the upstream end of the reach.

FIGURE 9d: Bed material sampling for Site 5, Reach 8 within the Perazzo Meadows project area. Samples were taken on active bars and at riffles within the low flow channel.

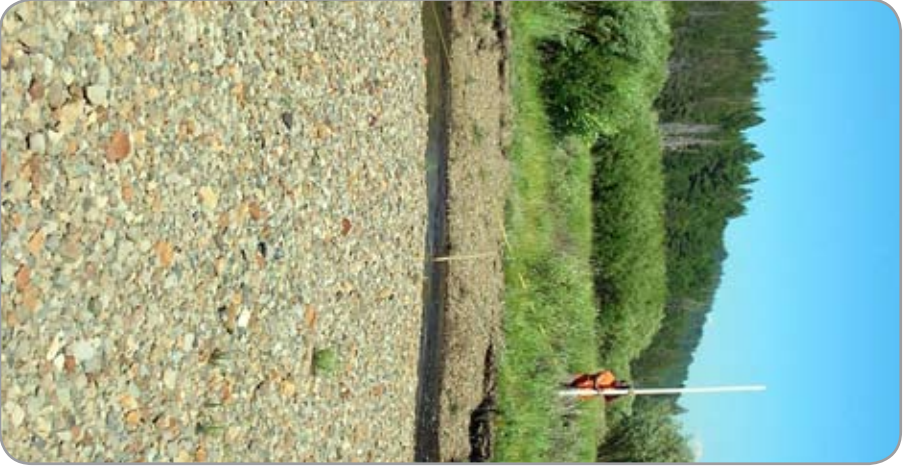
Reach 11 - Count 1 - Bar Sample		
Sample taken from bar above bankfull at upstream end of reach.

Reach 11 - Count 2 - Riffle Sample		
Sample taken from adjacent riffle within bankfull channel.

FIGURE 9e: Bed material sampling for Site 6, Reach 11 within the Perazzo Meadows project area. Samples were taken on active bars and at riffles within the low flow channel.

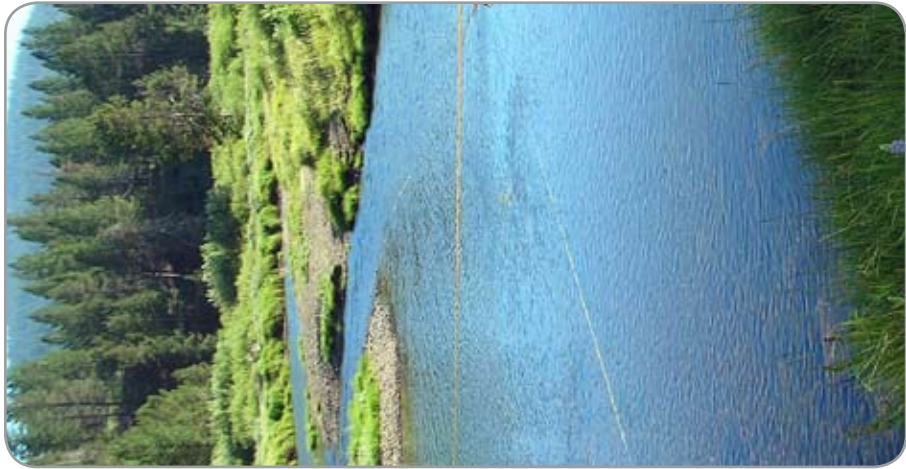
Reach 13 - Count 1 - Bar Sample
Sample taken from bar surface above the bankfull channel at the upper end of the reach.

FIGURE 9f: Bed material sampling for Site 7, Reach 13 within the Perazzo Meadows project area. Samples were taken on active bars and at riffles within the low flow channel.

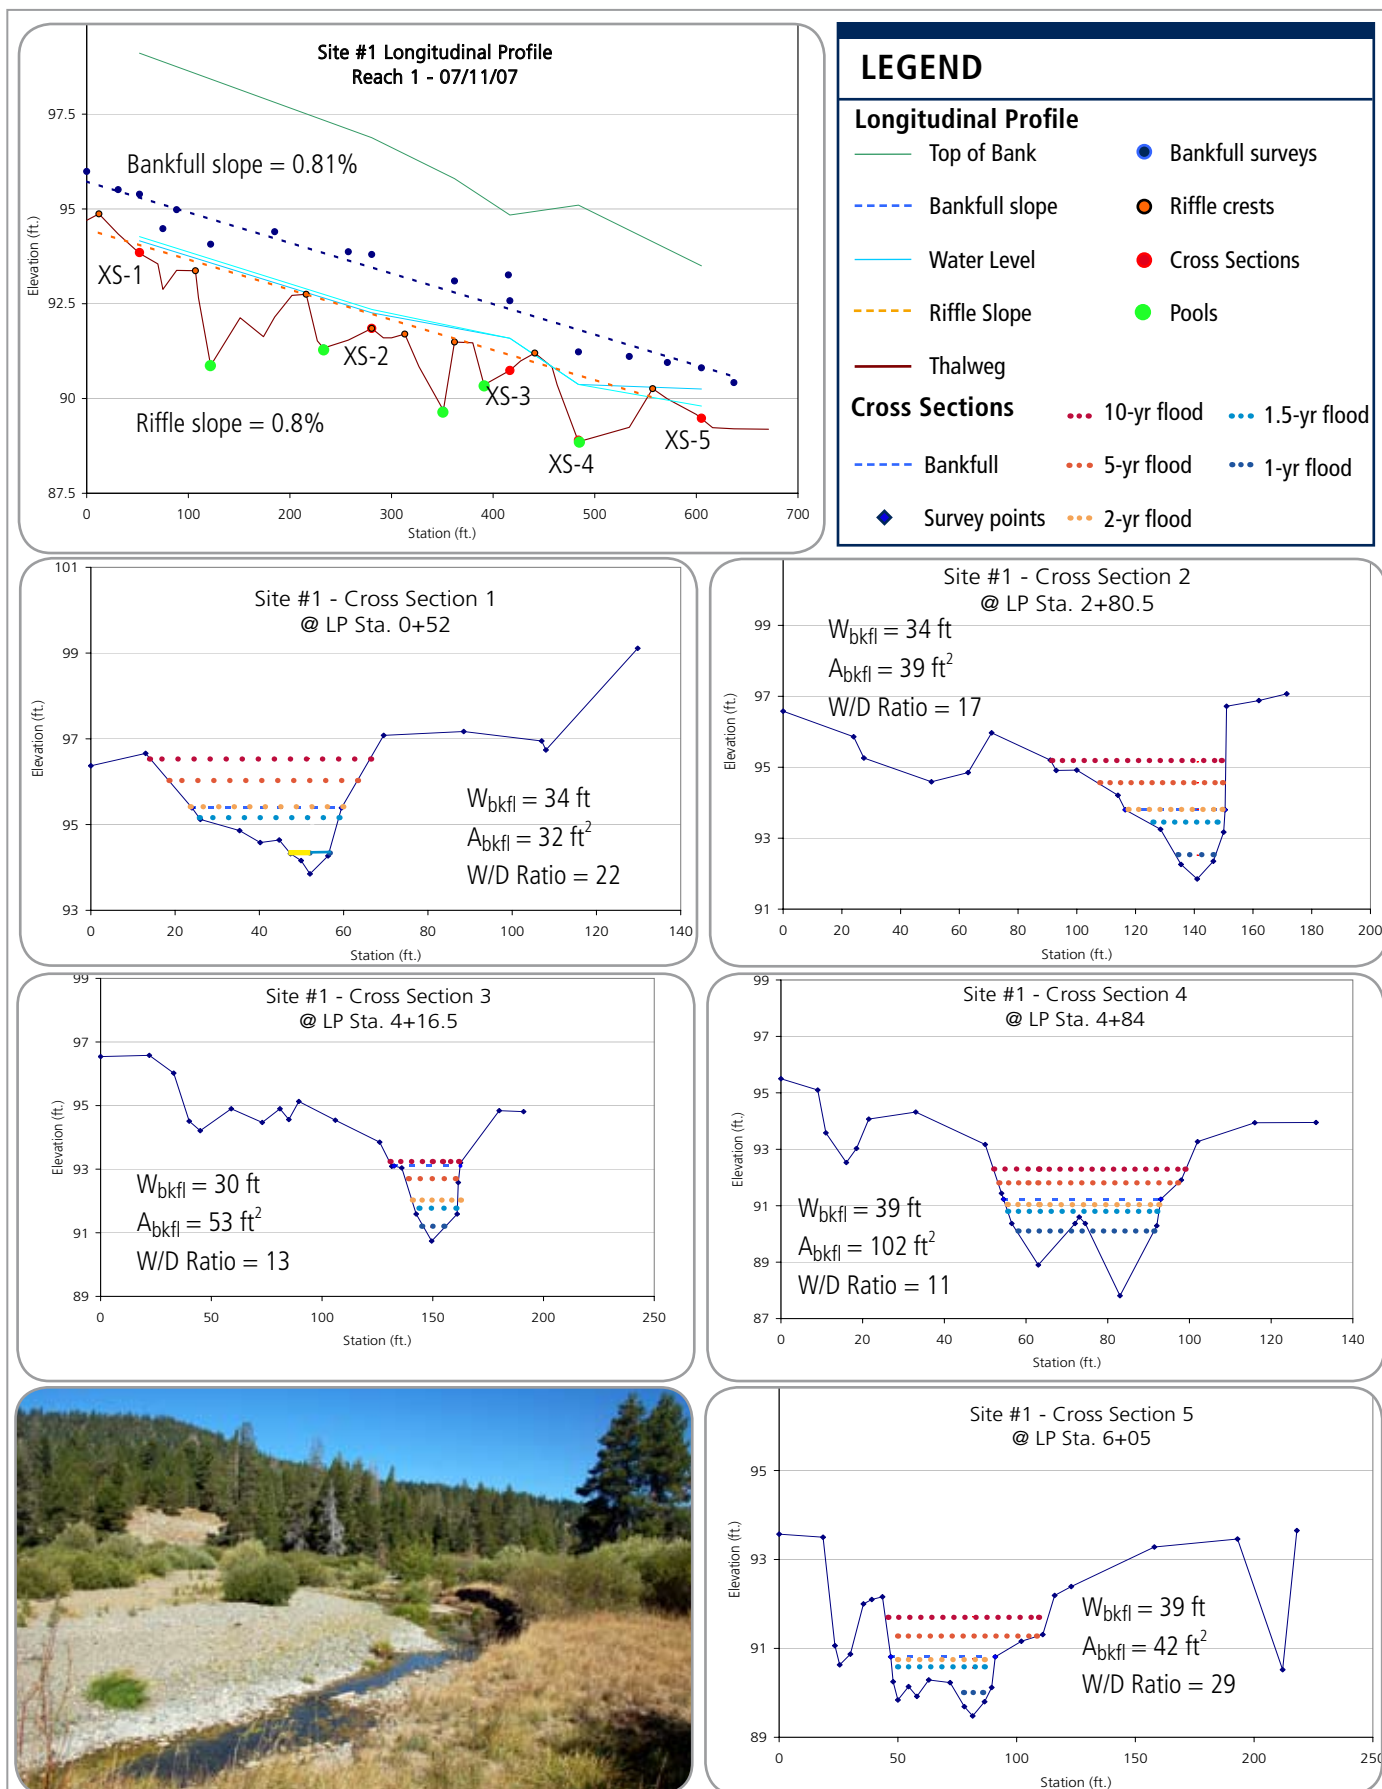
FIGURE 11a: Survey data results for Site 1, Reach 1. All survey data was collected in the field using an auto-level, tape, and rod. Peak water surface elevations were developed using a 1-dimensional hydraulic model (HEC-RAS). Wbkfl = Bankfull width; Abkfl = Channel cross-sectional area at bankfull; W/D = Width to Depth; LP = Long profile.

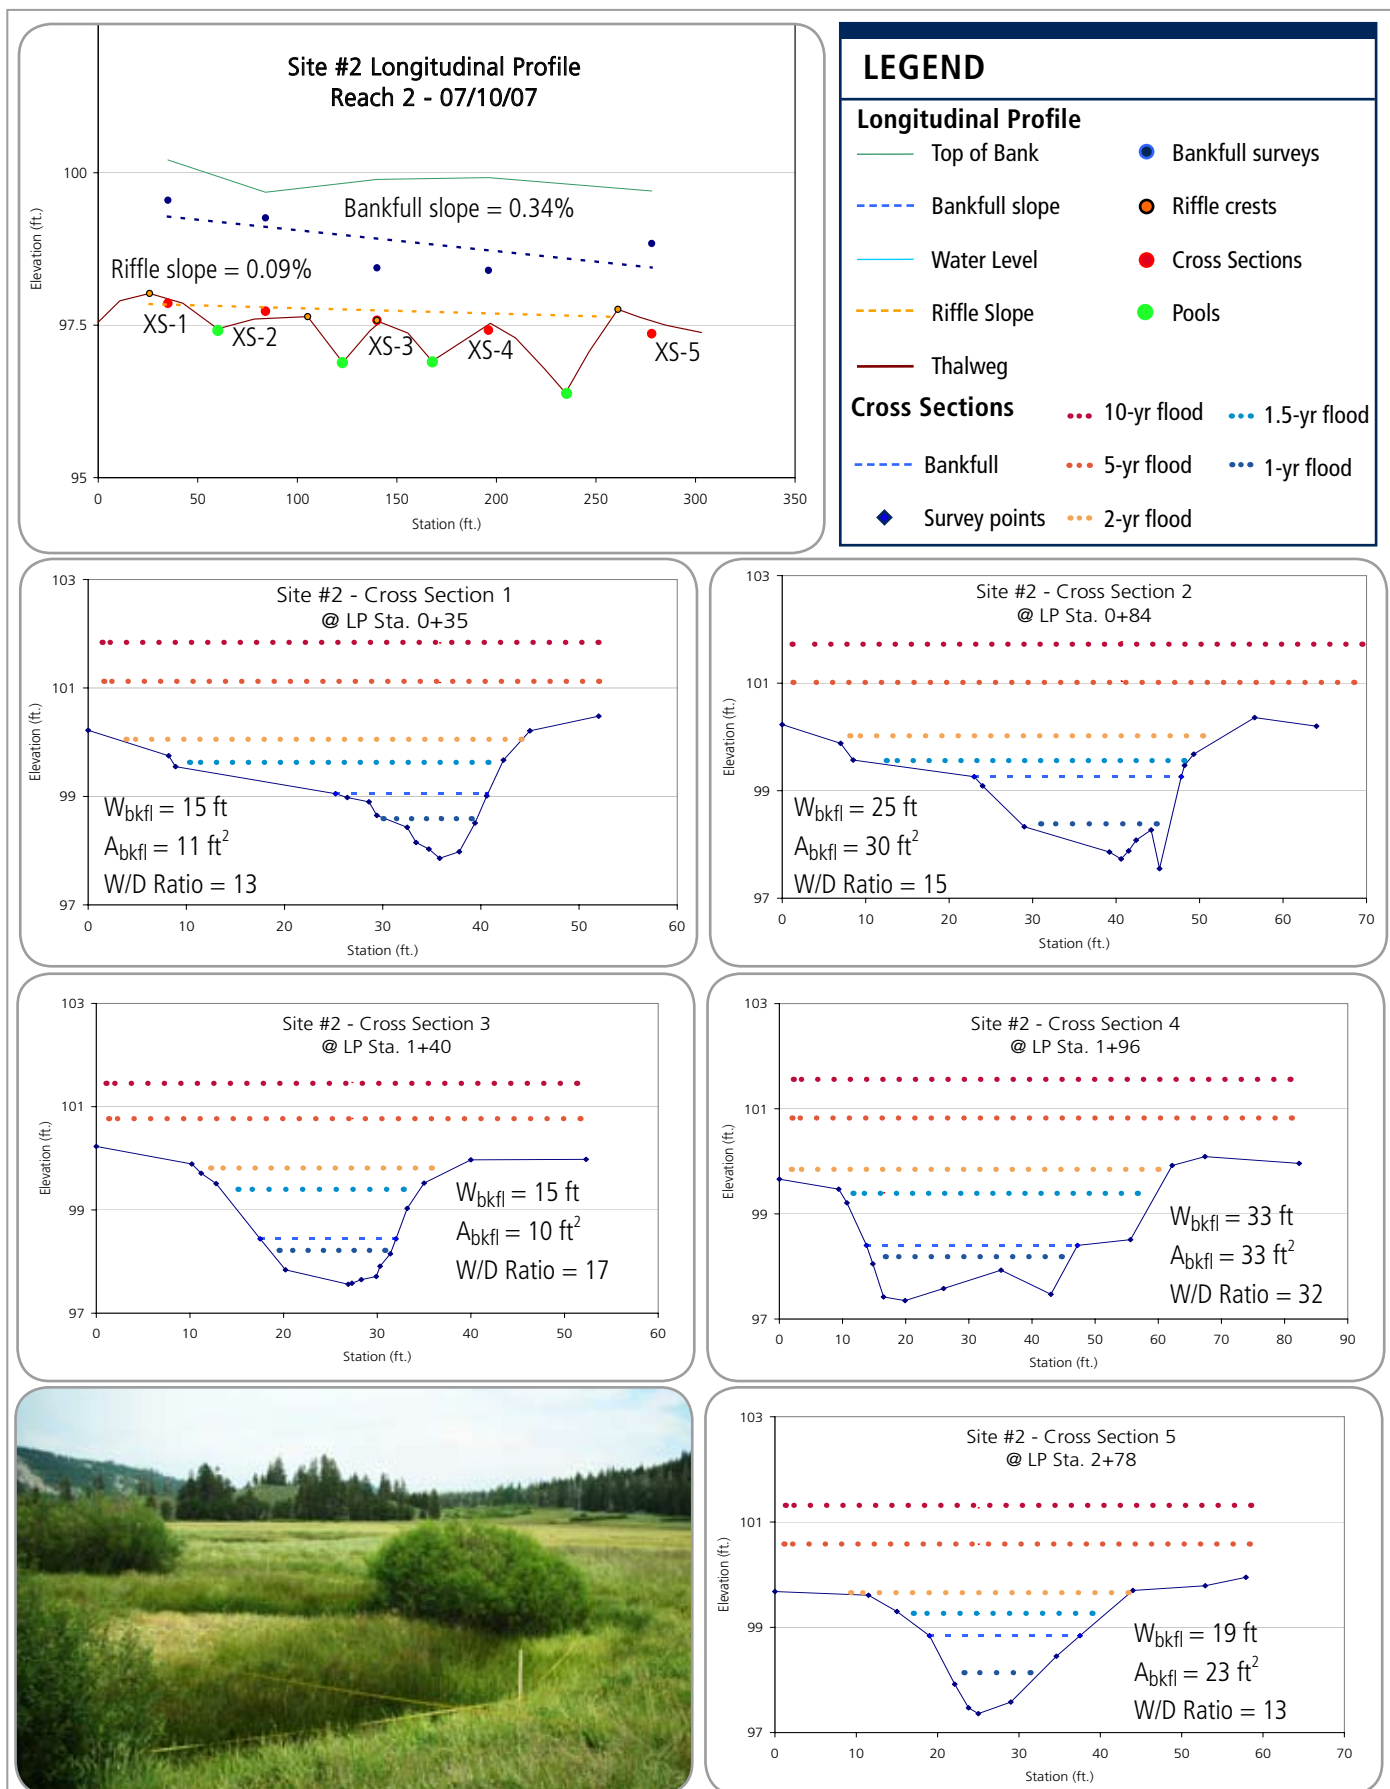
FIGURE 11b: Survey data results for Site 2, Reach 2. All survey data was collected in the field using an auto-level, tape, and rod. Peak water surface elevations were developed using a 1-dimensional hydraulic model (HEC-RAS). W_{bkfl} = Bankfull width; A_{bkfl} = Channel cross-sectional area at bankfull; W/D = Width to Depth; LP = Long profile.

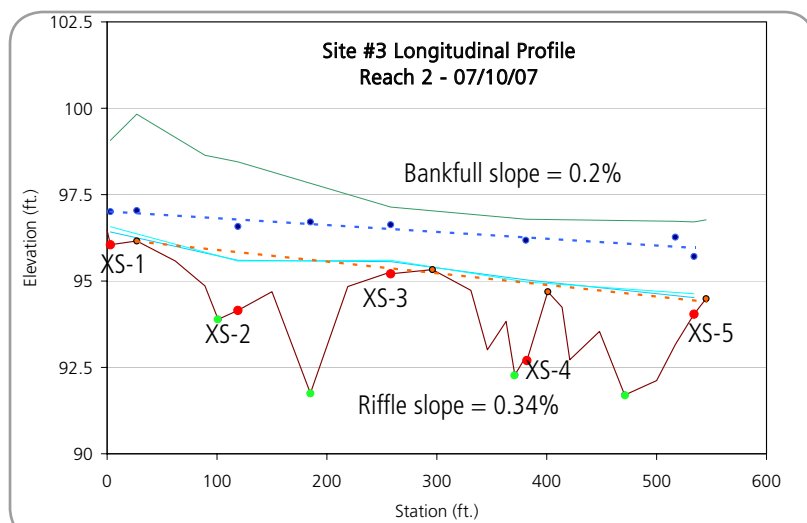
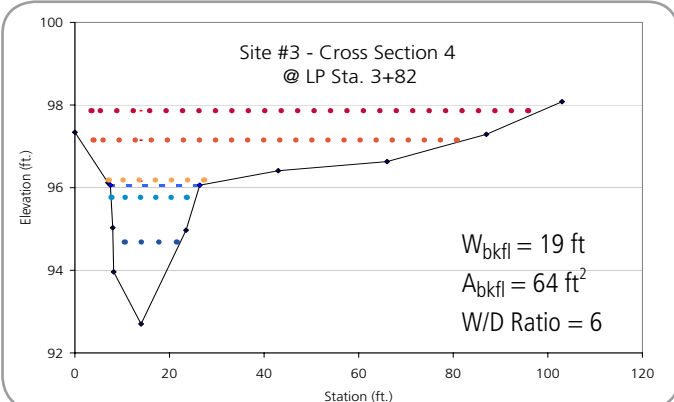
FIGURE 11c: Survey data results for Site 3, Reach 2. All survey data was collected in the field using an auto-level, tape, and rod. Peak water surface elevations were developed using a 1-dimensional hydraulic model (HEC-RAS). W_{bkfl} = Bankfull width; A_{bkfl} = Channel cross-sectional area at bankfull; W/D = Width to Depth; LP = Long profile.

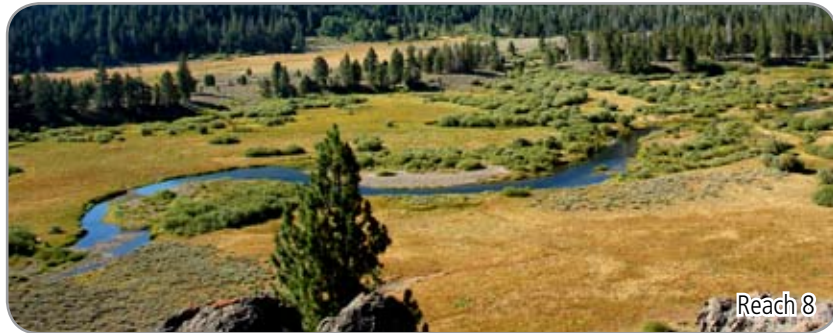
Average Radius of Curvature by Reach

Reach		2	3	4	8	9	10	11	13
Current Channel	Average Radius (ft.)	69	81	86	115	118	105	131	131
	Standard Deviation	22	30	18	48	24	7	48	13
	N	3	4	4	7	7	2	3	4
Historic Channel	Average Radius (ft.)	61	64	-	132	81	94	102	83
	Standard Deviation	28	23	-	28	35	20	28	46
	N	12	11	-	7	6	5	4	2
Current vs. Historic % Difference		12%	23%	-	13%	37%	11%	24%	45%

The results of the radius of curvature analysis show a moderate increase in radius of curvature between existing and historic channels within each reach, except in Reach 8 where radius of curvature decreases. It is not clear why this is the case. The most likely cause for the increase in the radius of curvature through most of the reaches is due to the presence of increased bed load and bar formation, and the likelihood that a significant component of channel change was associated with meander cut-offs that straightened the channel. In the 1983 photo (Figure 6) a meander cut-off is shown that clearly increases the radius of curvature of that portion of the channel. A larger radius of curvature is then enforced by the presence of coarse material on the bar that is immobile during most flow conditions.
