# TRUCKEE RIVER WATERSHED COUNCIL

## Martis Wildlife Area Restoration Intermediate Design Plans (65%)

### 1. Site Plans

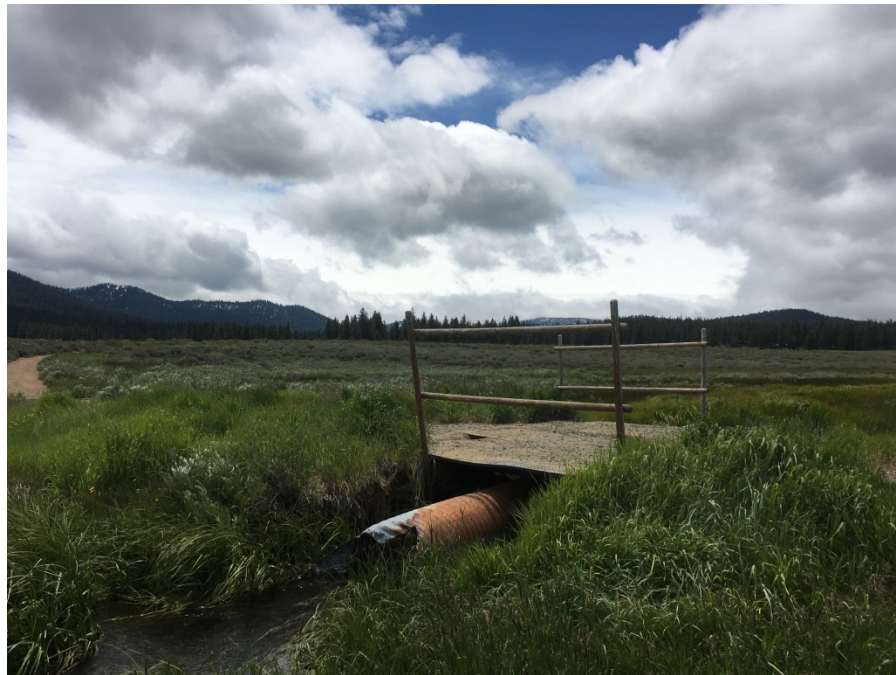
Figure 1- Eastern culvert along unnamed tributary to Martis Creek. Culvert has failed and has eroded under the current recreational trail bridge.

- Culvert Replacement and Stream Restoration  
Current conditions include two failed 24 inch culverts that have caused streambank and recreational trail damage (see photos below). Site plan includes:
  - o Major project activities
  - o Limit of project area

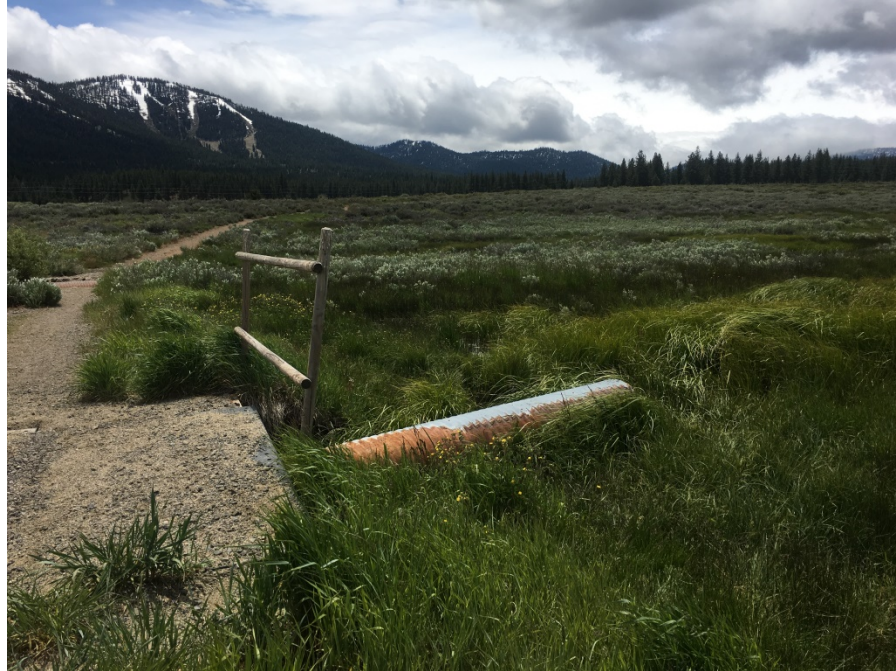
Figure 2- Eastern culvert along unnamed tributary to Martis Creek. Culvert has failed and is breached on north side of recreational trail.

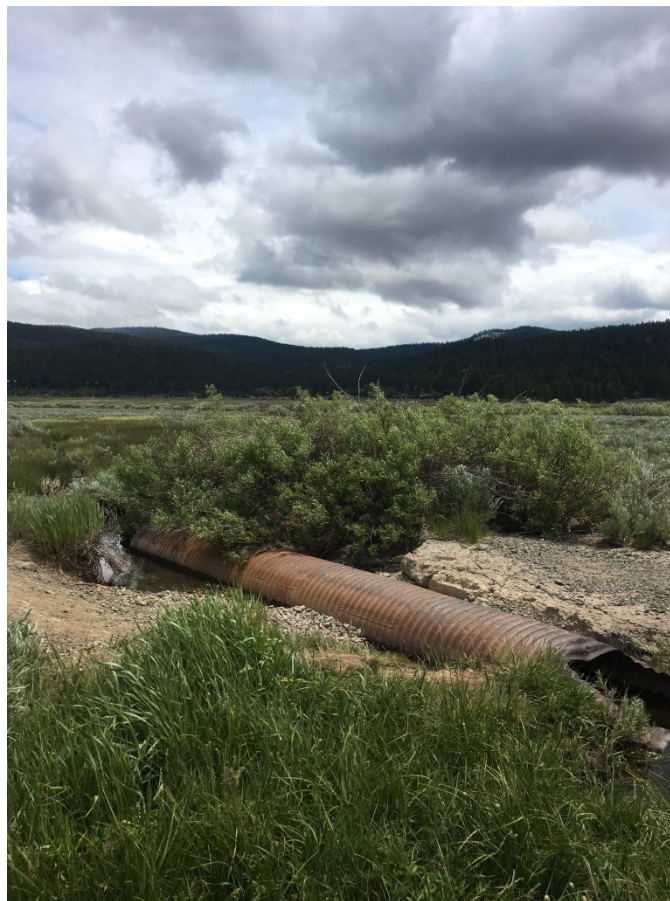
Figure 3- Western culvert on unnamed tributary to Martis Creek. Culvert has been eroded and exposed. High flow events exceed current culvert capacity.

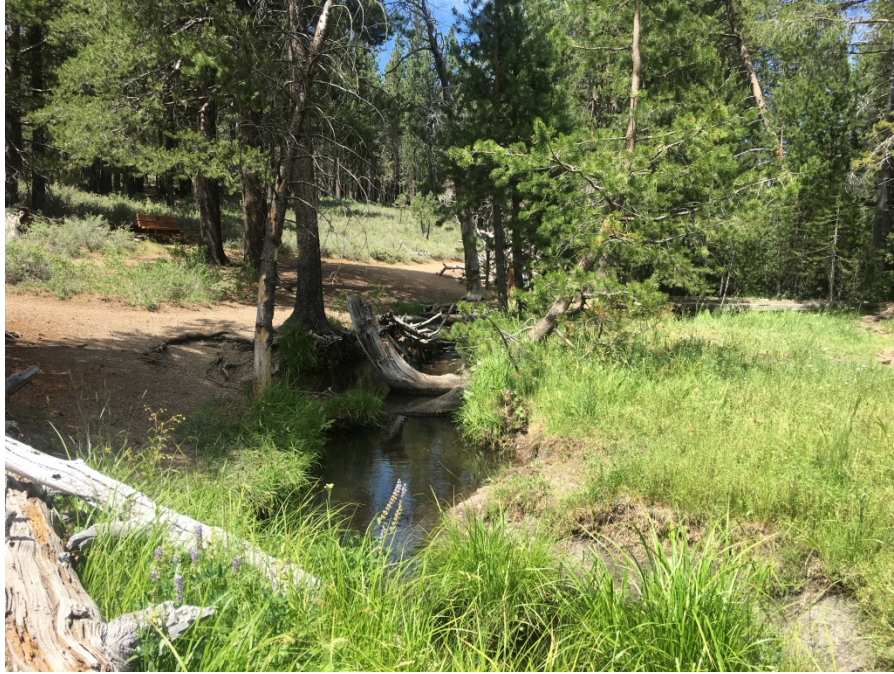
Figure 4- Lookout Mountain Tributary facing east/downstream. Stream incision and bank erosion evident.

Current conditions include an approximately 200 foot section of Lookout Mountain Tributary that has incised 2 to 3 feet. Site plans include:

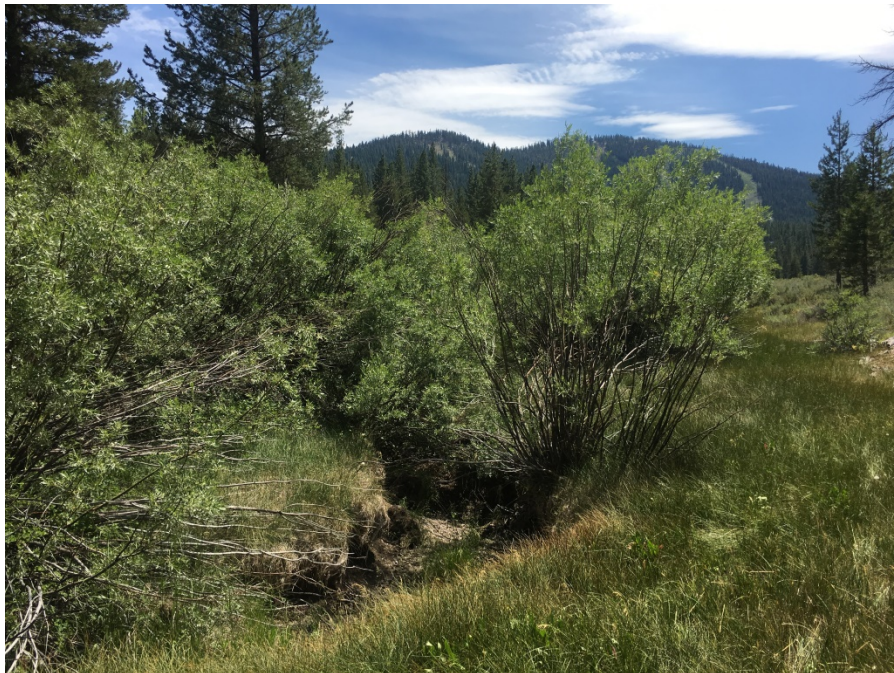
Figure 5-Lookout Mountain Tributary facing southwest/upstream. Stream incision evident.

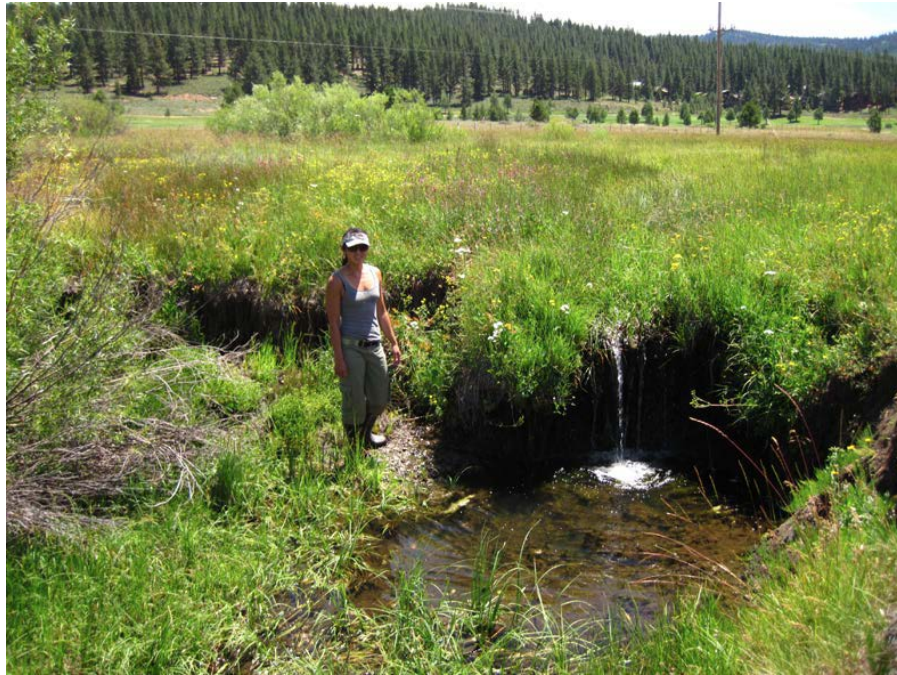
Figure 6-Middle Martis Creek headcut.

Current conditions include an approximately 3-4 foot headcut. Site plans include:

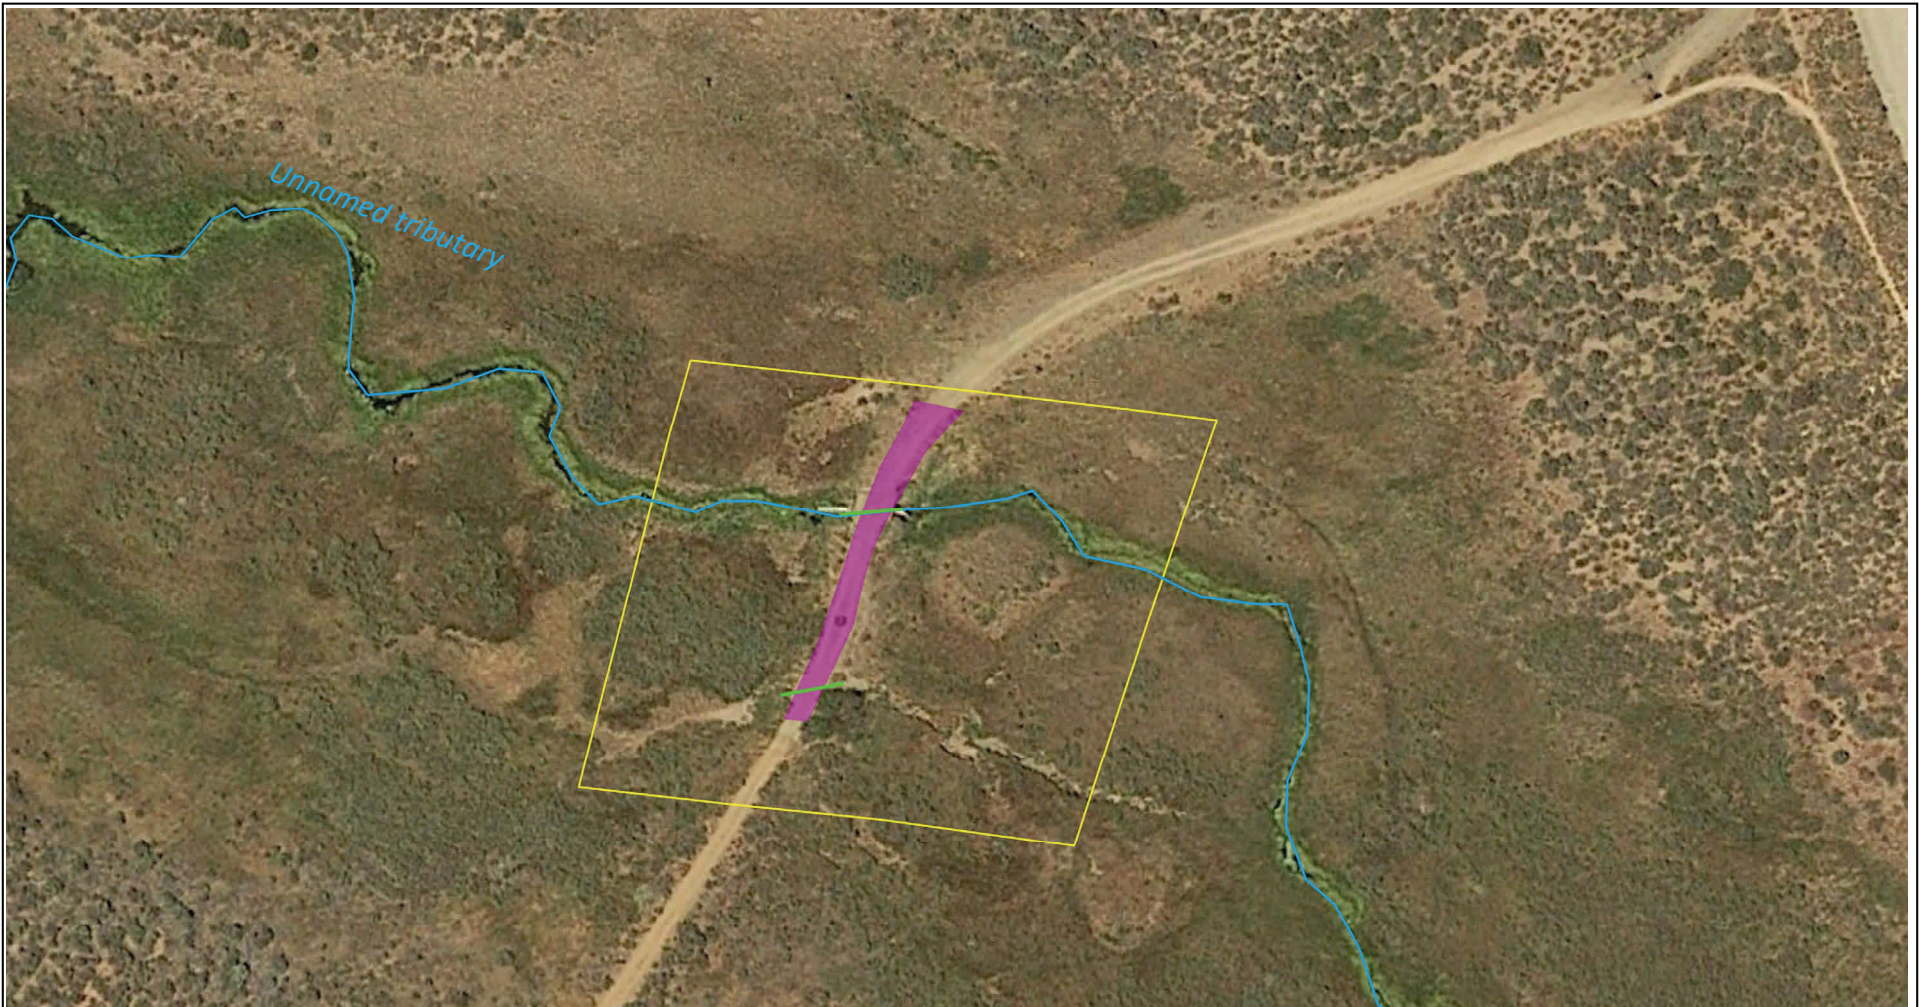
Truckee River Watershed Council  
Implementation of Martis Mainstem and  
Wildlife Area Wetland Restoration  
Culvert Replacement and Stream  
Restoration

Culvert replacement

Trail tread repair

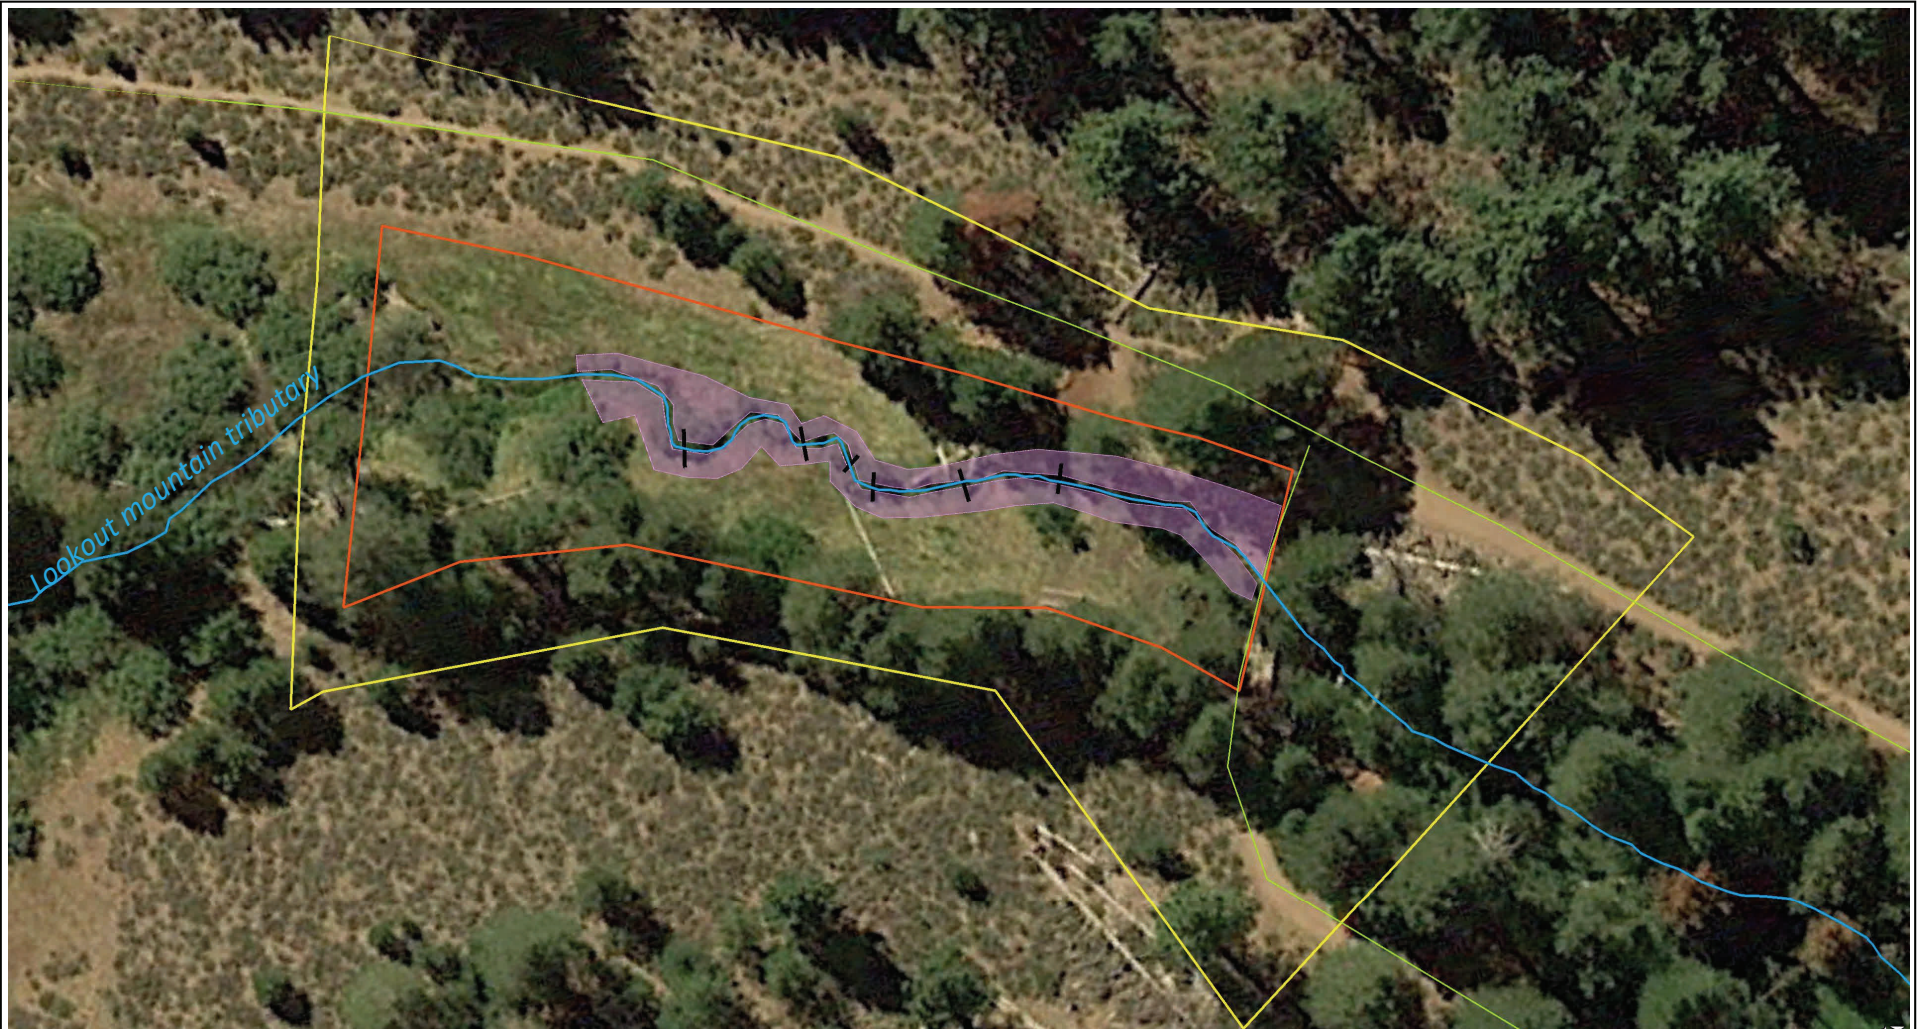
Truckee River Watershed Council  
 Implementation of Martis Mainstem and  
 Wildlife Area Wetland Restoration  
 Lookout Mountain Tributary

- Project area
- Temporary exclusion fencing
- Bio engineered check dam
- Recreational trail
- Riparian meadow infill planting

- o Major project activities
- o Limits of project area
- o Bio-engineered check dam detail
