To: Beth Christman, Truckee River Watershed Council
From: David Shaw and Peter Kulchawik
Date: August 21, 2018

RE: Design Basis Memorandum: Lower Perazzo Meadow Restoration, Sierra County, California

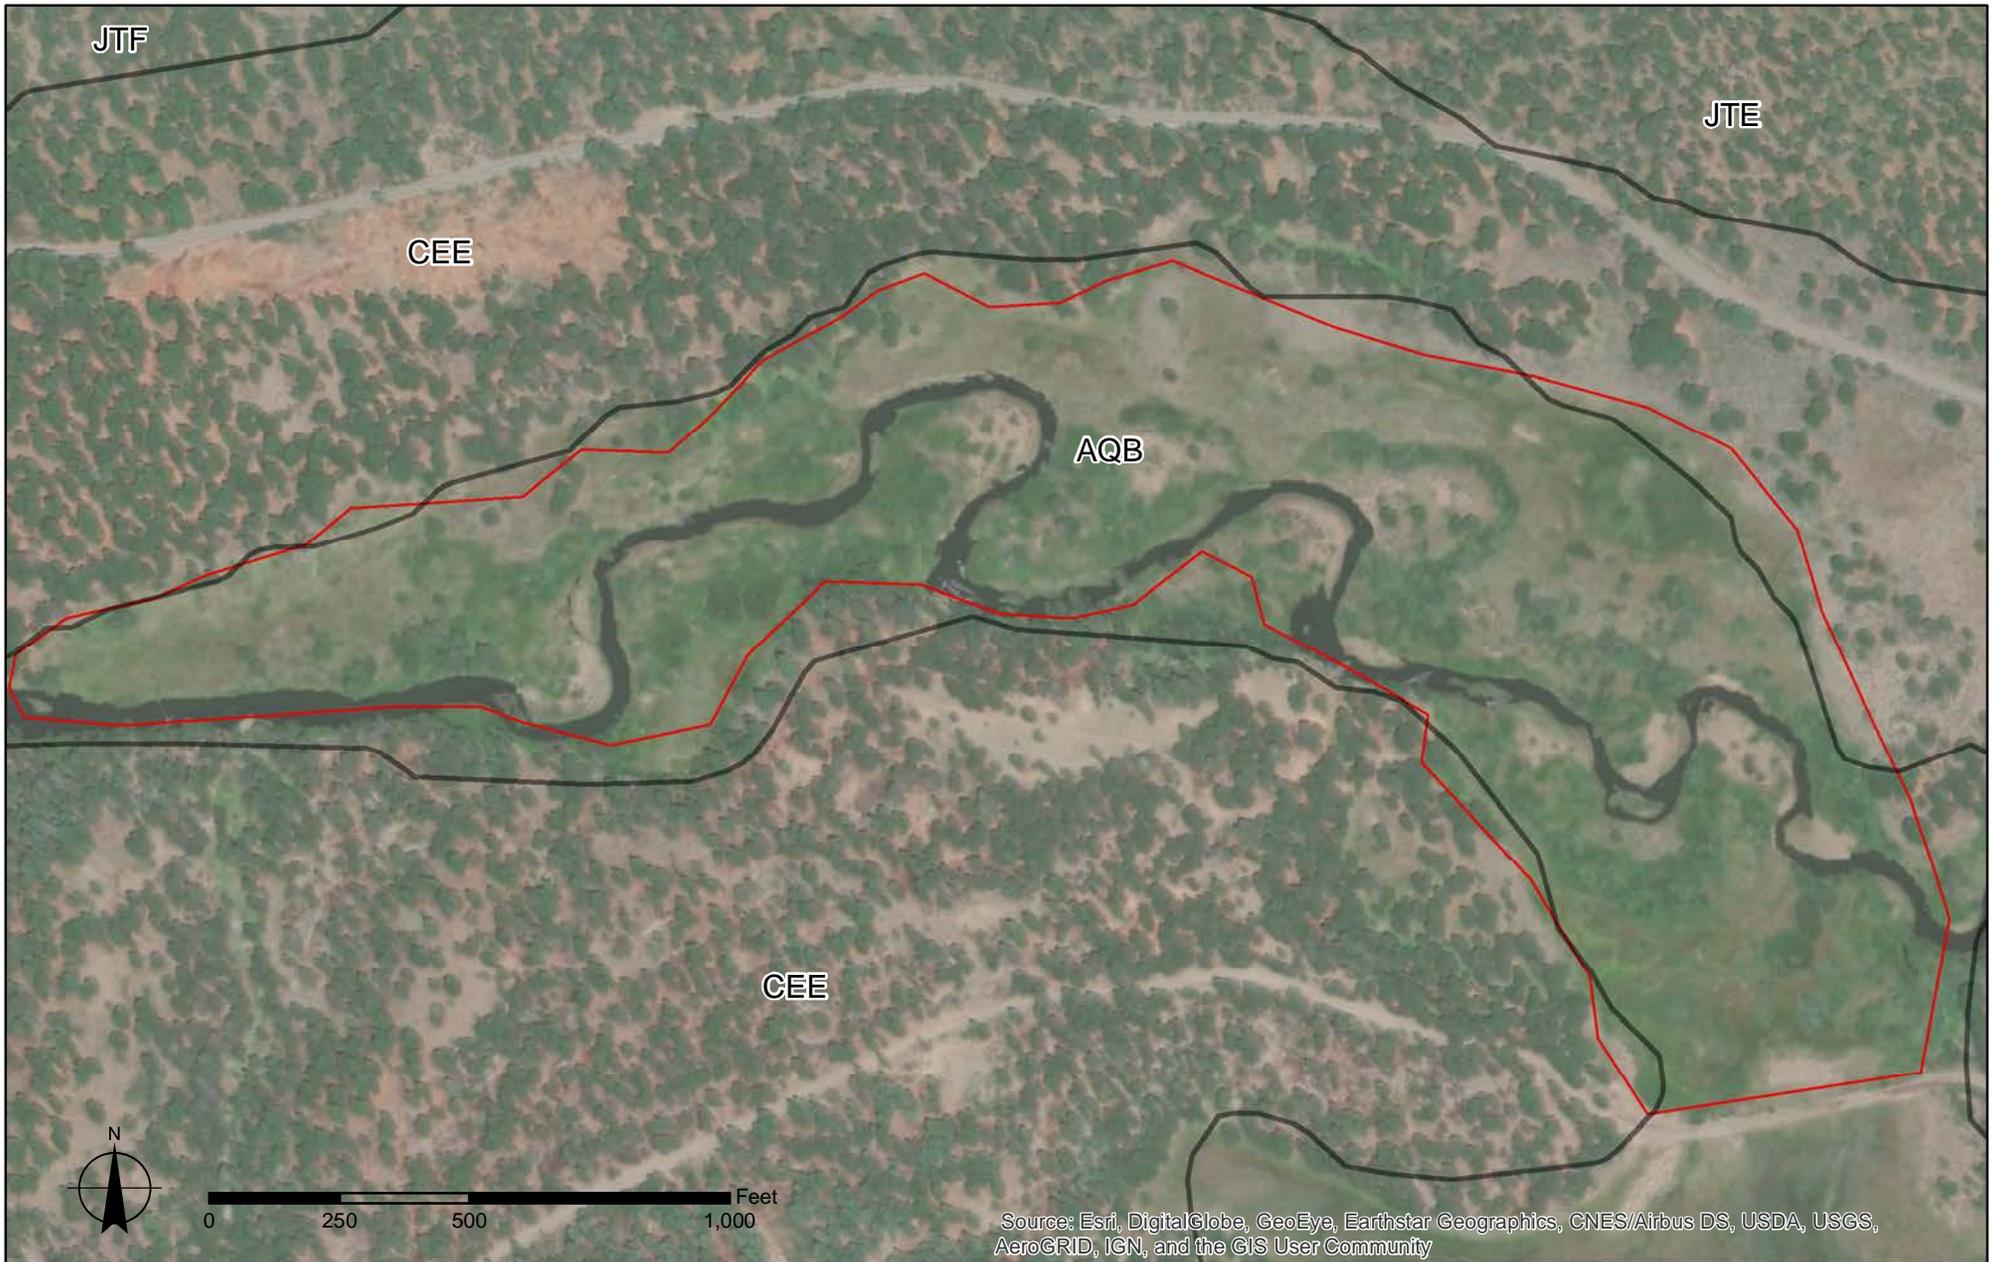
**Figure 4. Lower Perazzo Meadow General Soil Types
Sierra County, California**

- Soil Series**
- ABQ** Aquolls and Borolls
 - CEE** Celio-Gefo-Aquolls
 - JTE** Jorge-Tahoma
 - JTF** Jorge very stony sandy loam

Source: NRCS Web Soil Survey www.nrcs.usda.gov

Lower Perazzo Meadow soils are mapped as Aquolls and Borolls, 0 to 5 percent slopes, and adjacent hillsides are mapped as the Celio-Gefo-Aquolls complex, 2 to 30 percent slopes. Aquolls and Borolls are wetland soils found along the stream corridor and at distal toes of alluvial fans. They are poorly drained (Hydrologic Soil Group D) soils and are noted as having a high-water table during much of the year. These soils also support wetland vegetation such as alder, willow, rush, and sedge.

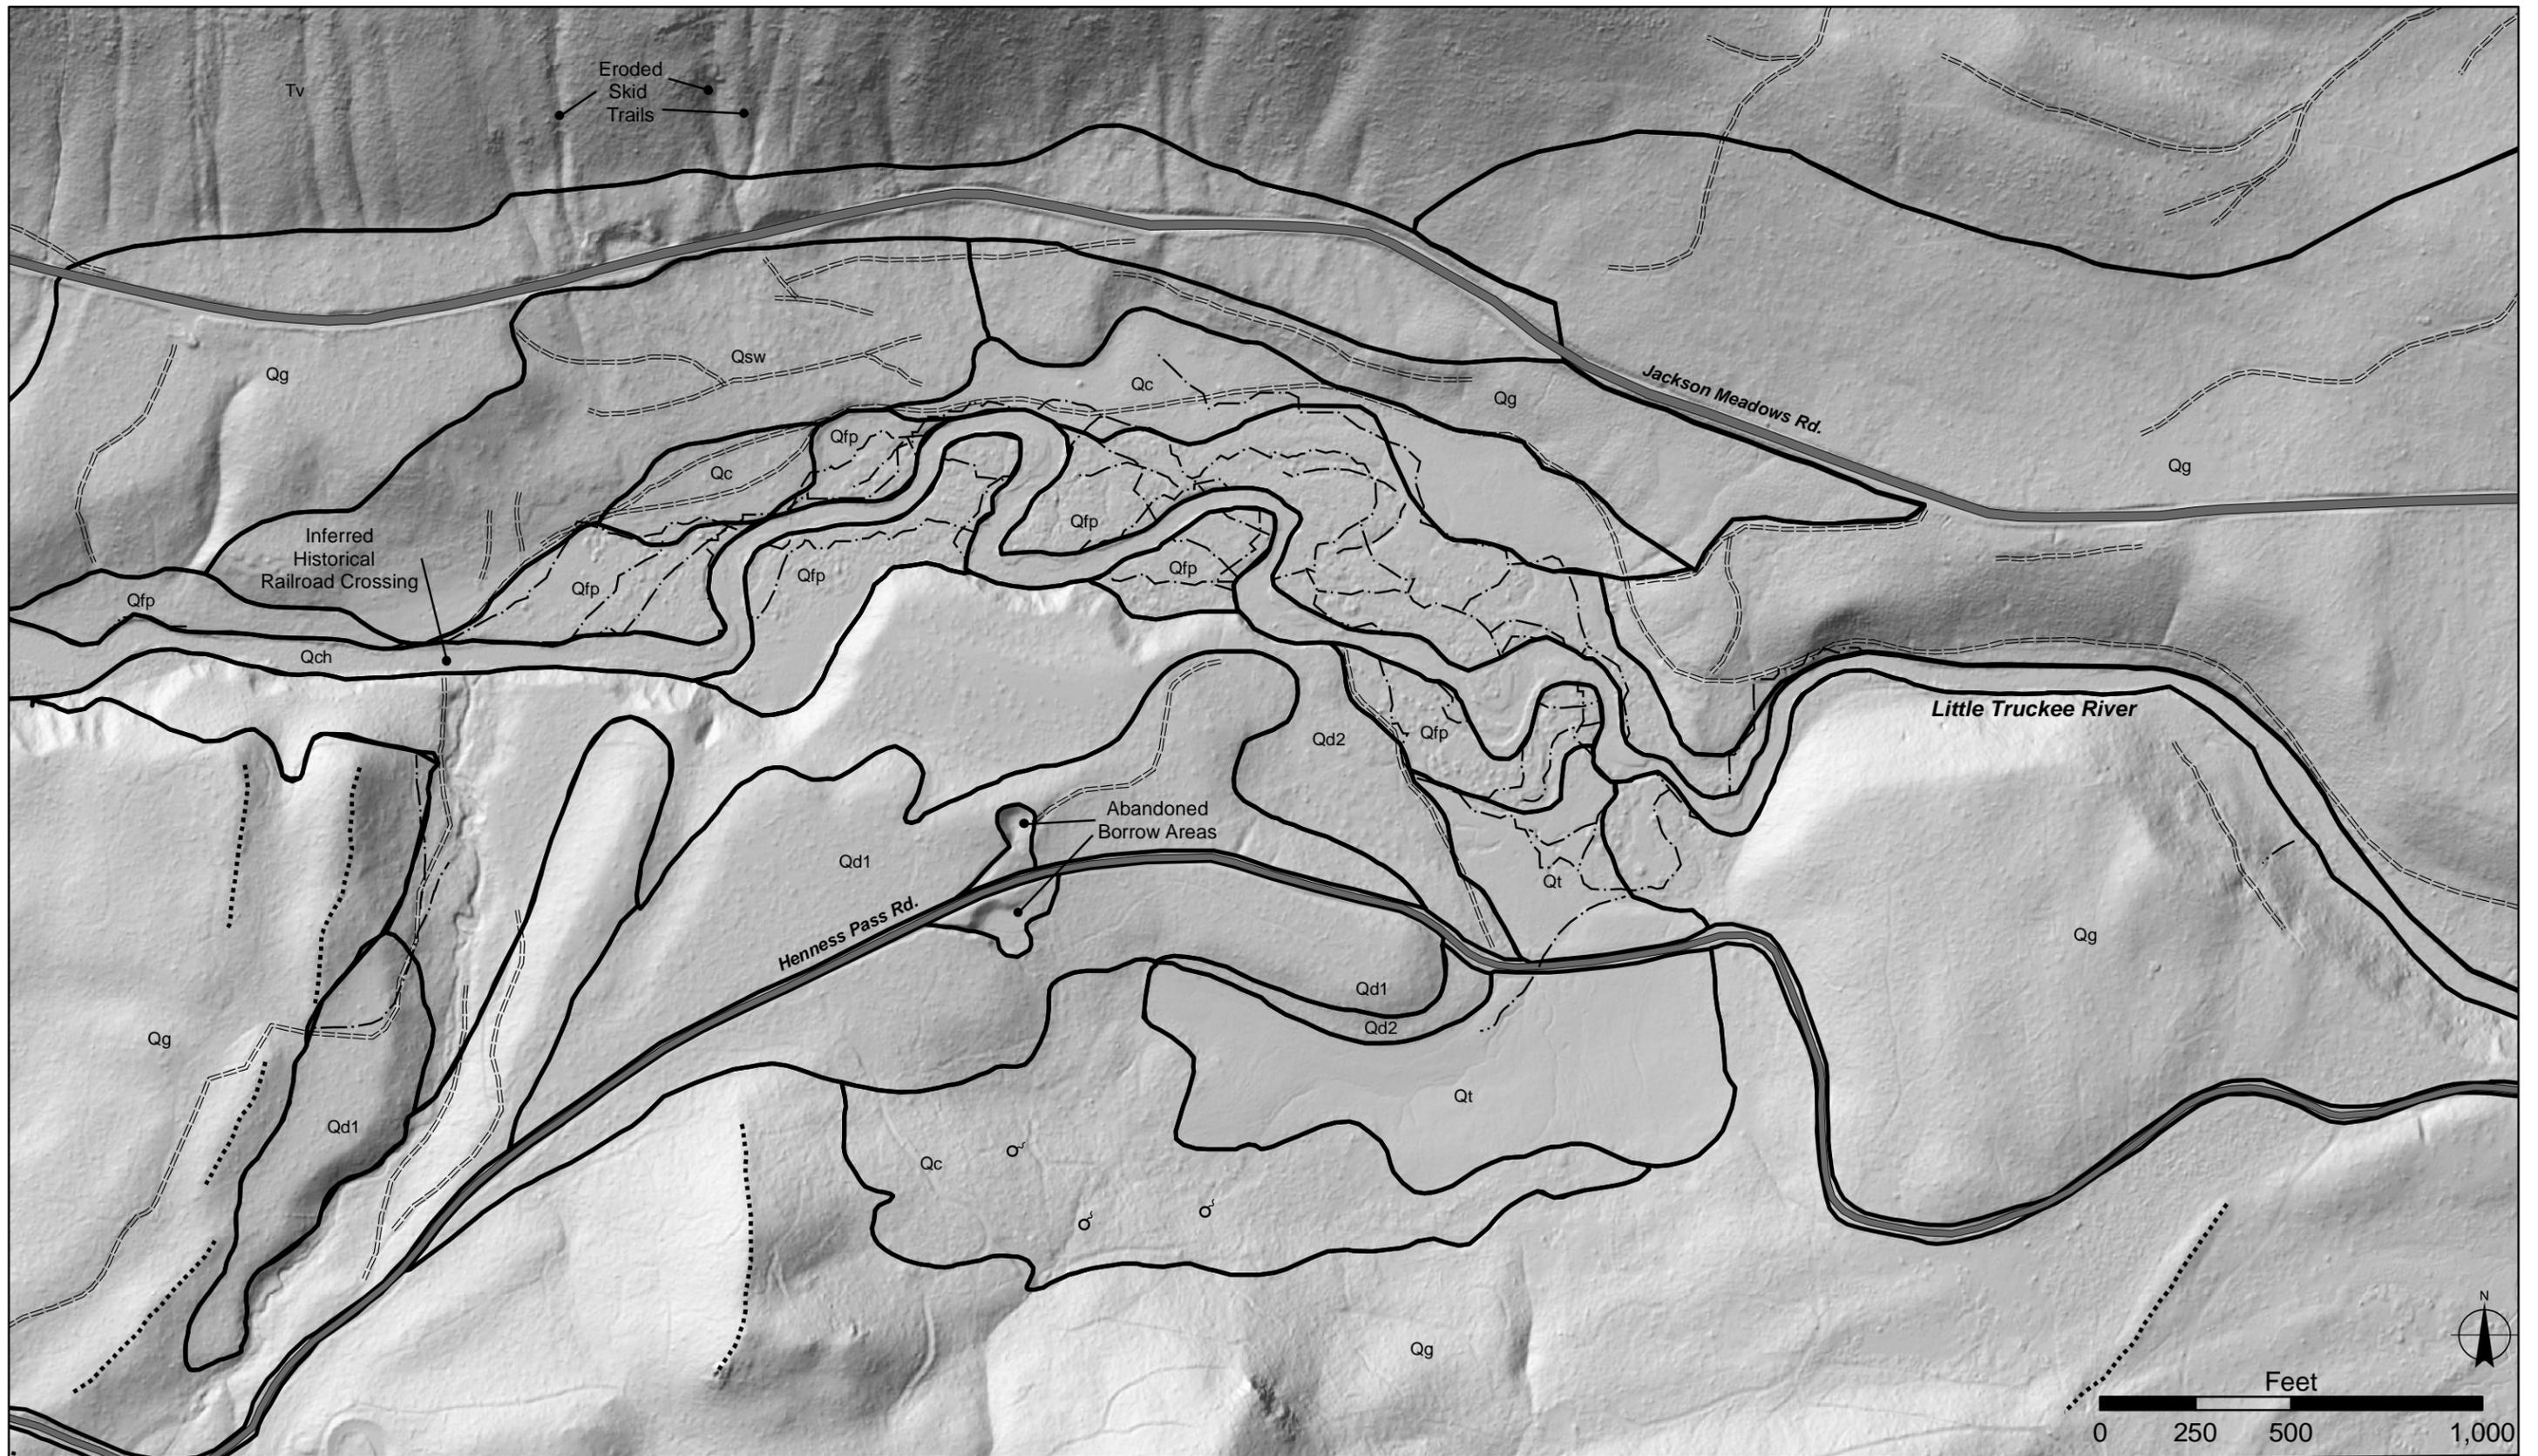
Figure 5 . Geomorphic Features and Historical Disturbance, Lower Perazzo Meadows, Sierra County, California
 Source: Hillshade Source USFS 2013

- Qch Active channel
- Qc Colluvium
- Qfp Floodplain deposits
- Qsw Slope wash
- Qd2 Younger delta deposits (sand and gravel)
- Qd1 Older delta deposits (sand and gravel)
- Qg Glacial drift (poorly sorted sand, silt, gravel and boulders)
- Tv Volcanic bedrock

To develop a contextual understanding of dominant processes on-site, Balance developed a Geomorphic Features and Disturbance Map (Figure 5). Field-mapping indicates that the site is underlain by colluvium, floodplain deposits, slope wash, younger and older delta deposits, glacial drift, and volcanic bedrock. The prominent terraces located south of the Little Truckee River appear to be deltaic deposits that settled in standing water. Field reconnaissance observations, desktop topographic analysis, and subsurface investigations by NV5 (2018; Appendix A) suggest that colluvial deposits on the north side of

the meadow are historical material that was deposited during or after logging activity in the area and on the order of 2 to 4 feet thick. Excavation of these deposits for use as channel fill is anticipated to re-expose meadow soils and the meadow surface, which was buried due to human disturbance.
