Memo

Subject: Design Basis Memorandum: Sardine Meadow Restoration Project, Sierra County, California

The Truckee River Watershed Council (TRWC) has contracted with Balance Hydrologics (Balance) to conduct field investigations, analysis, and provide design services for restoration of Sardine Valley Meadow in Sierra County, California. The purpose of this memo is to describe findings of our site investigation and background research, present Intermediate (65%) Design Drawings, and document the basis for the design.

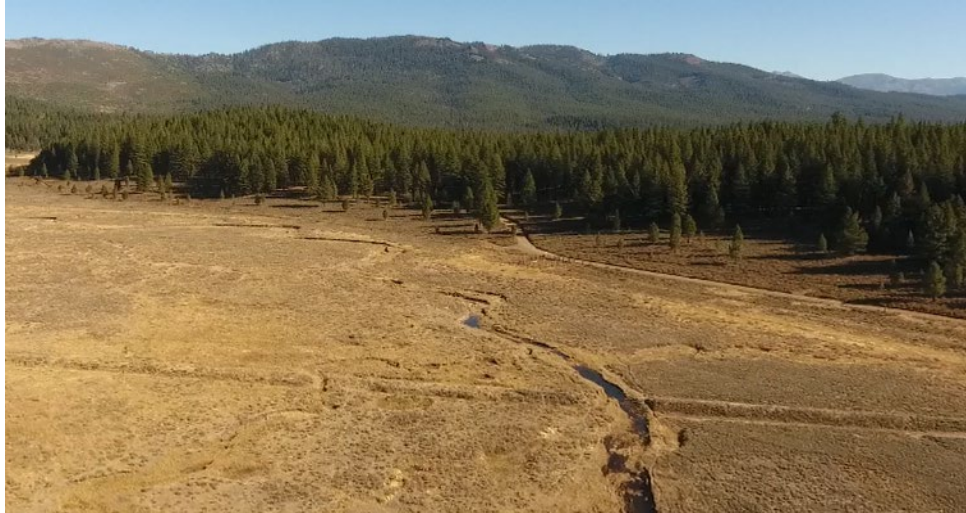
Figure 6. Railroad crossings have forced flows into a single location, causing erosion and incision, Davies Creek, looking southeast.

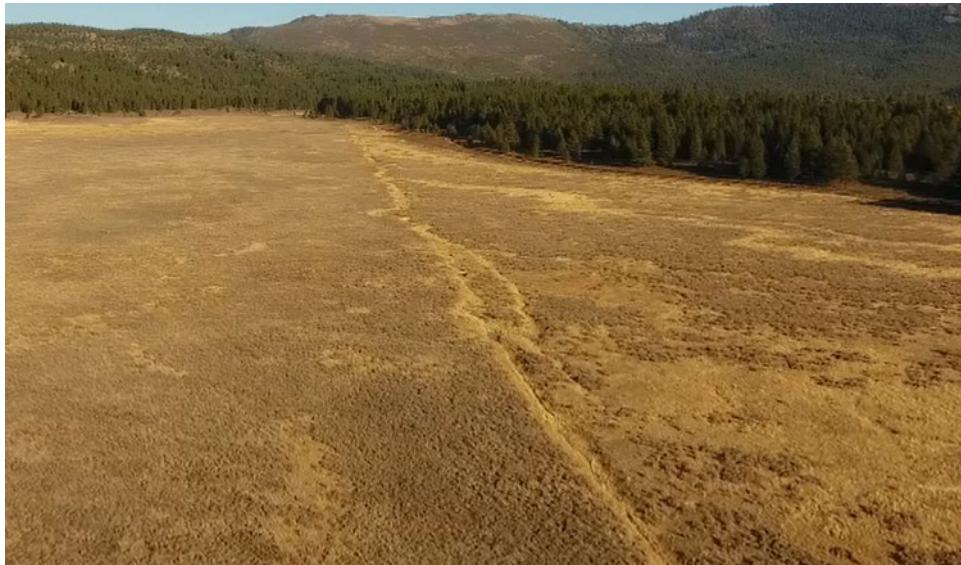
converted to upland (Figure 7). At the north end of the project site, a series of springs is present, at least two of which appear to have been excavated into ponds with constructed outflow channels (Figure 8).

Figure 7. Road construction has captured flow and limited transmission of sheet flow across the meadow, Sardine Meadow, looking east.

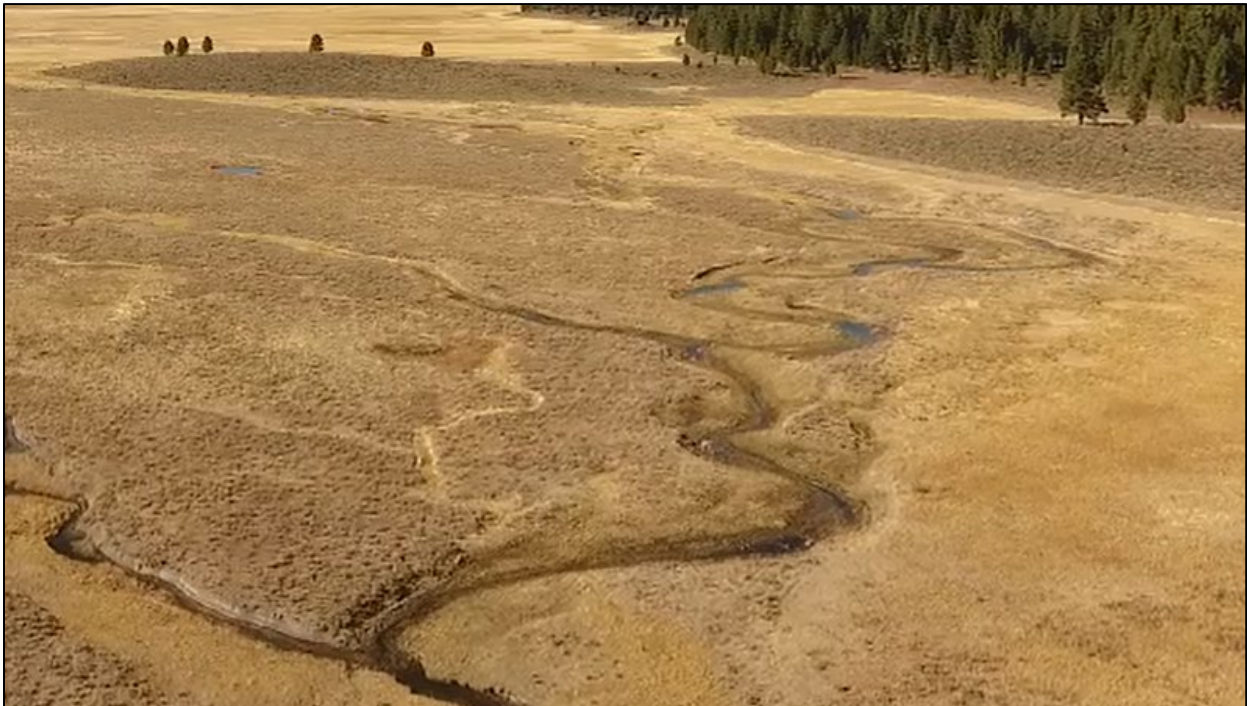
Figure 8. Upper Meadow at the northern end of project, looking upstream (west) at a spring-supported perennial swale system. Alternative A includes several earthen plugs to increase the depth, extent, and duration of ponded water in the channel and inset floodplain. Alternative B includes excavation of inset floodplains from adjacent upland areas to expand the extent of spring-fed perennial wet meadow across a greater area.

- **Upper Meadow Alternatives A and B: Channel plugs and Inset Floodplain Excavation.**
 - A. Alternative A is mostly consistent with the design initially put forth by the TNF but limits the originally envisioned extent of channel fill to only include strategically placed earthen plugs. The plugs would backwater upstream areas to increase the extent and depth of ponded water. The total area of disturbance and required fill volume would be less than originally anticipated with this approach but would still force more frequent inundation of secondary channels. This would likely cause a conversion of existing functional wetland floodplain habitat from perennial wet meadow to shallow ponded areas.

- B.** Alternative B, on the other hand, would consist of excavating converted upland areas to bring the grade down, closer to the current water surface, in order to expand the perennial floodplain and wetland habitat that is present. This work would also generate fill for use in other areas of the project and would be advantageous in that the generated fill material would be fine-grained and consistent with existing soils at the site. Both alternatives address modifications to spring-fed ponds and ditches that have been constructed for cattle-grazing operations. Additional subsurface investigations in this area are warranted to better understand the degree to which excavated sub soils can be successfully planted with wetland vegetation.
