**Perazzo Meadows Restoration  
Hydrologic Monitoring Data Report  
Upper and Middle Perazzo Meadows  
Water Year 2010**

**Sierra County, California**

Balance Hydrologics, Inc.

December 2010

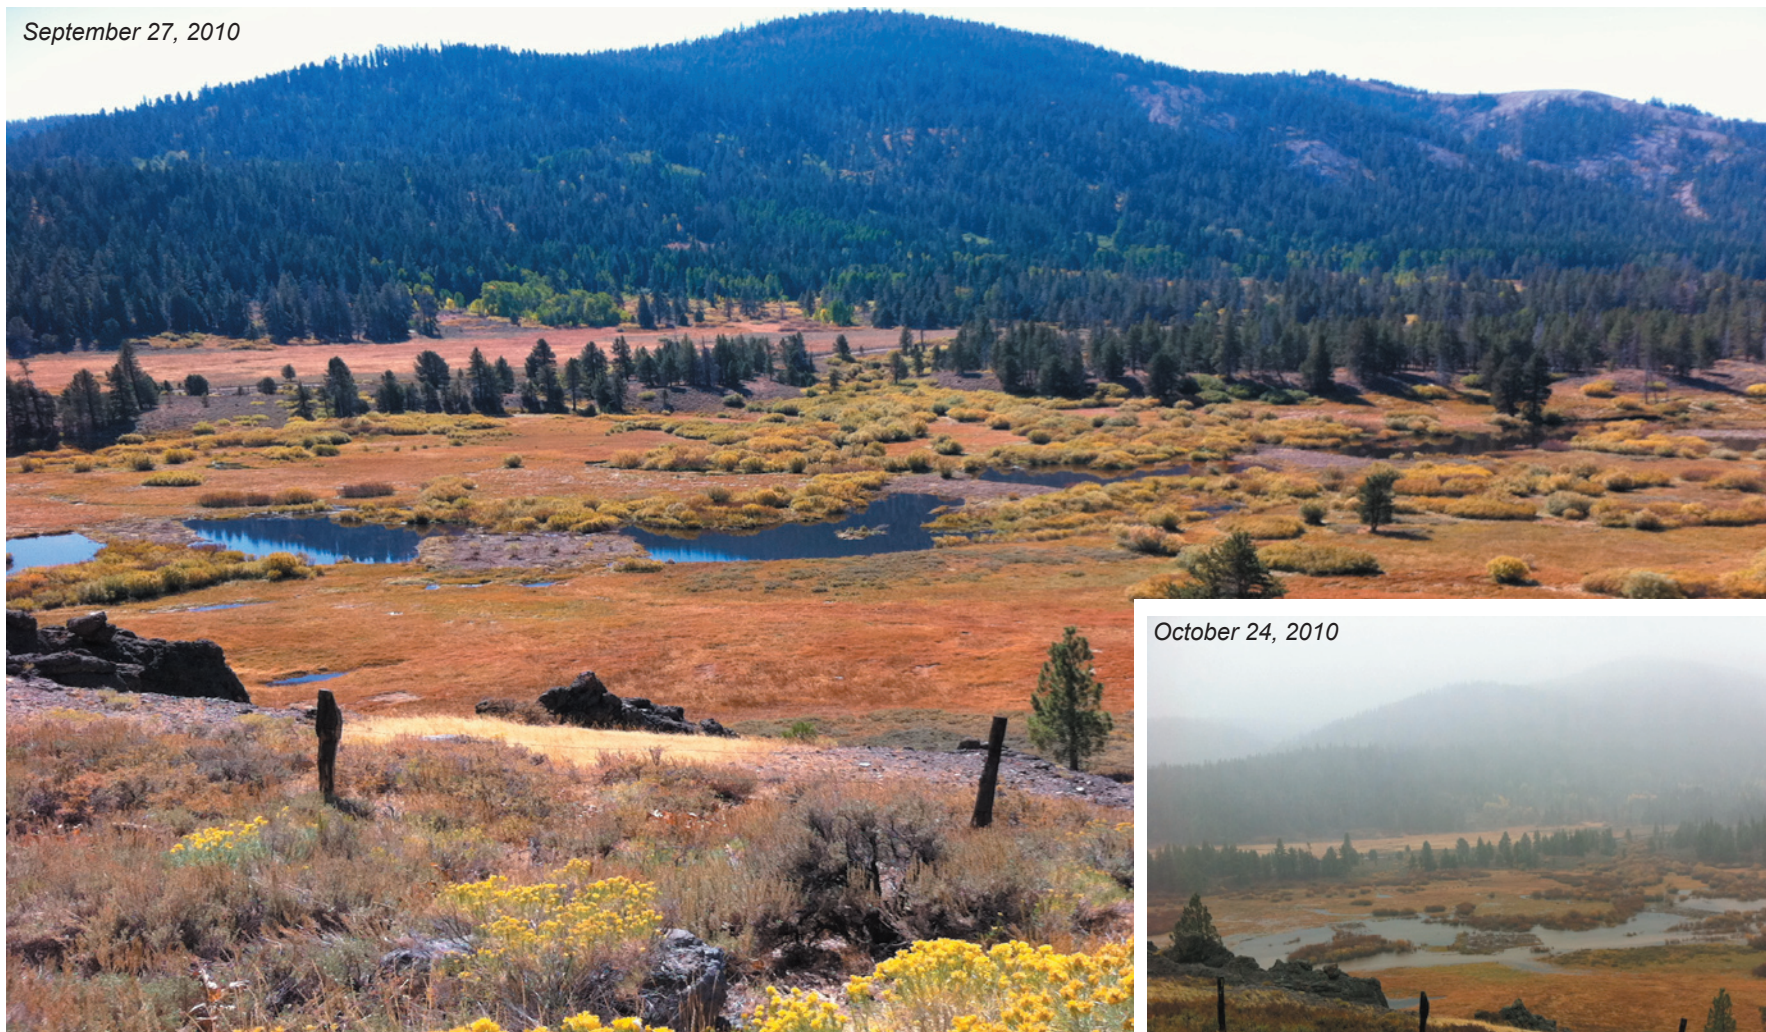
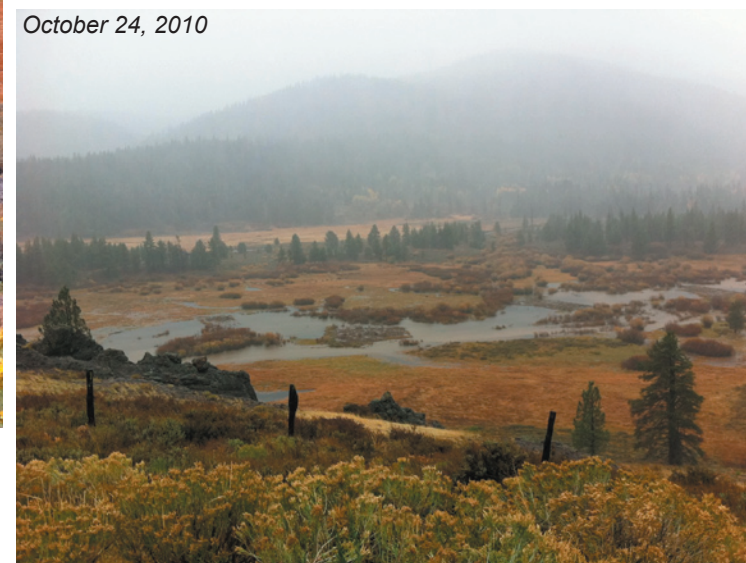
209116 Figure 2 Middle Meadow

Figure 2. Middle Perazzo Meadow, post-restoration  
Sierra County, California

approach to block the channel with the aim of spreading water across the valley floor to reoccupy multiple relic channels that have been abandoned. Figure 2 shows post-project conditions in the Middle Meadow and Figure 3 is an oblique aerial photo showing post-project conditions in the Upper Meadow.

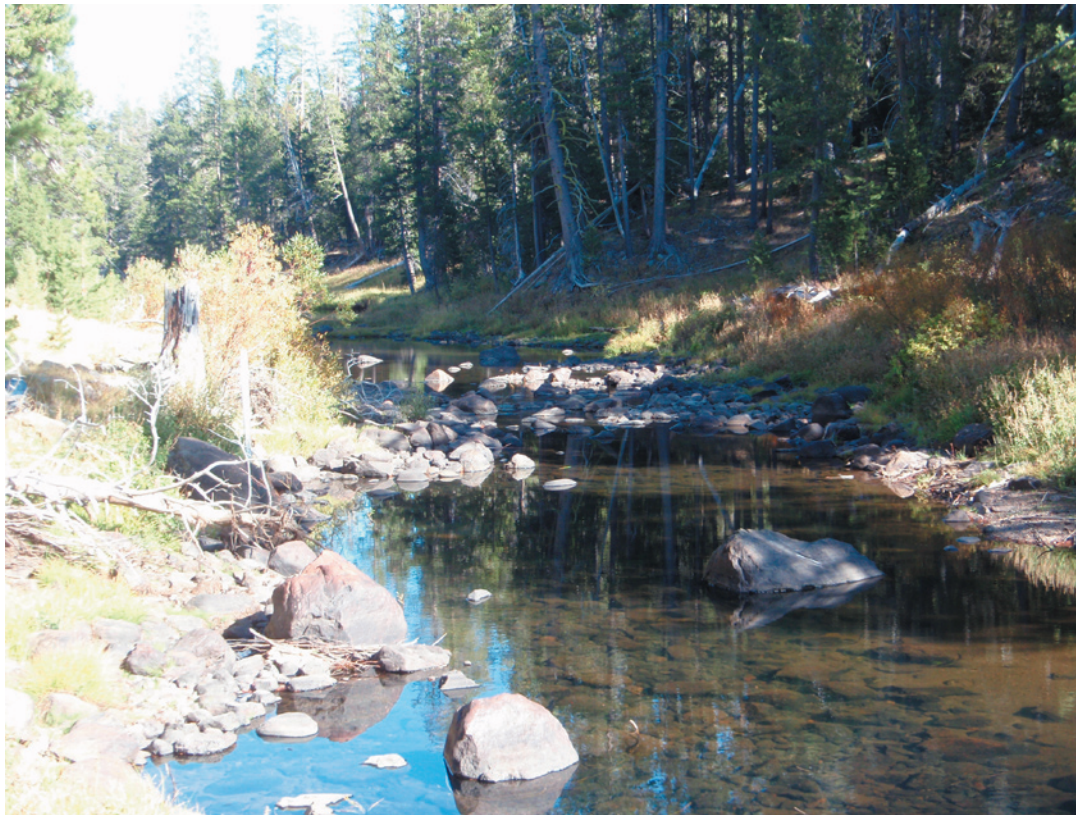
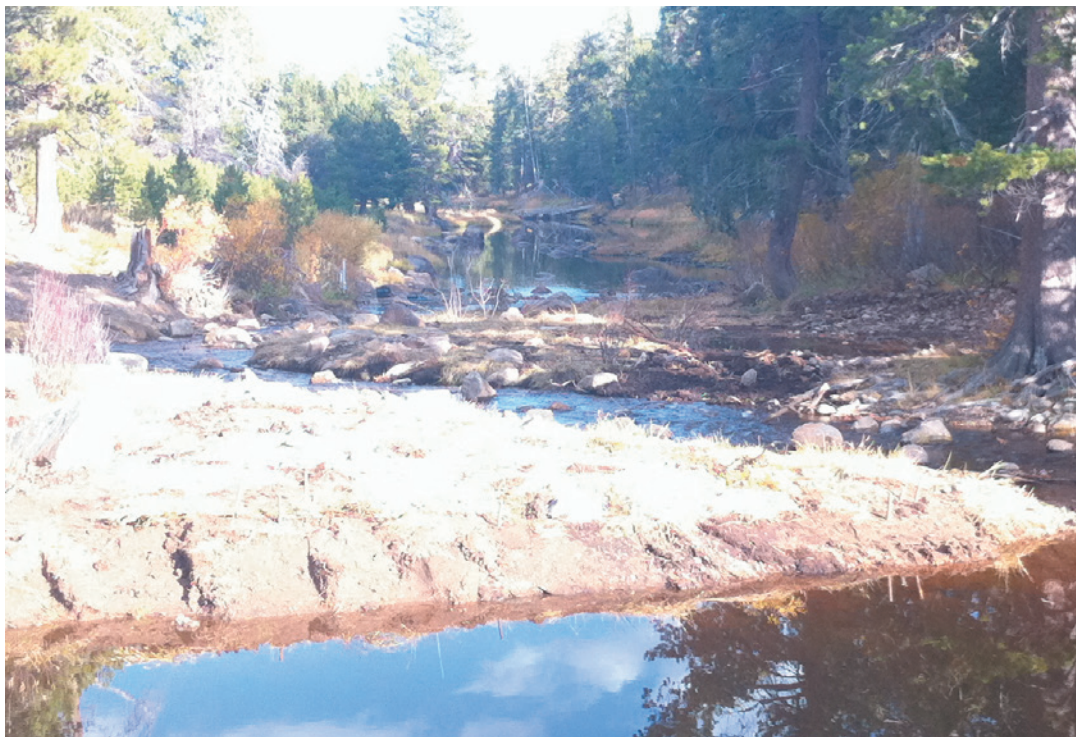
*Prior to restoration  
and relocation*

*After restoration and  
gage relocation*

Figure 6. Little Truckee River at the Middle Perazzo Meadow outflow (Balance stream gaging station LTPM) Sierra County, California

The streamgage is located on the right bank of the Little Truckee River where the channel exits the Middle Meadow and enters a straight narrow reach. The gaging site was chosen due to relatively shallow depths to bedrock, as indicated by the high concentration of large angular boulders with uniform lithology. The gaging site has been designated as 'LTPM' (Little Truckee at Perazzo Meadows) according to Balance gaging station naming conventions. The watershed of 32.7 square miles receives an average of 47.4 inches of precipitation, as estimated from precipitation data recorded from 1979 to the present at Independence Lake (SNOTEL site 541).

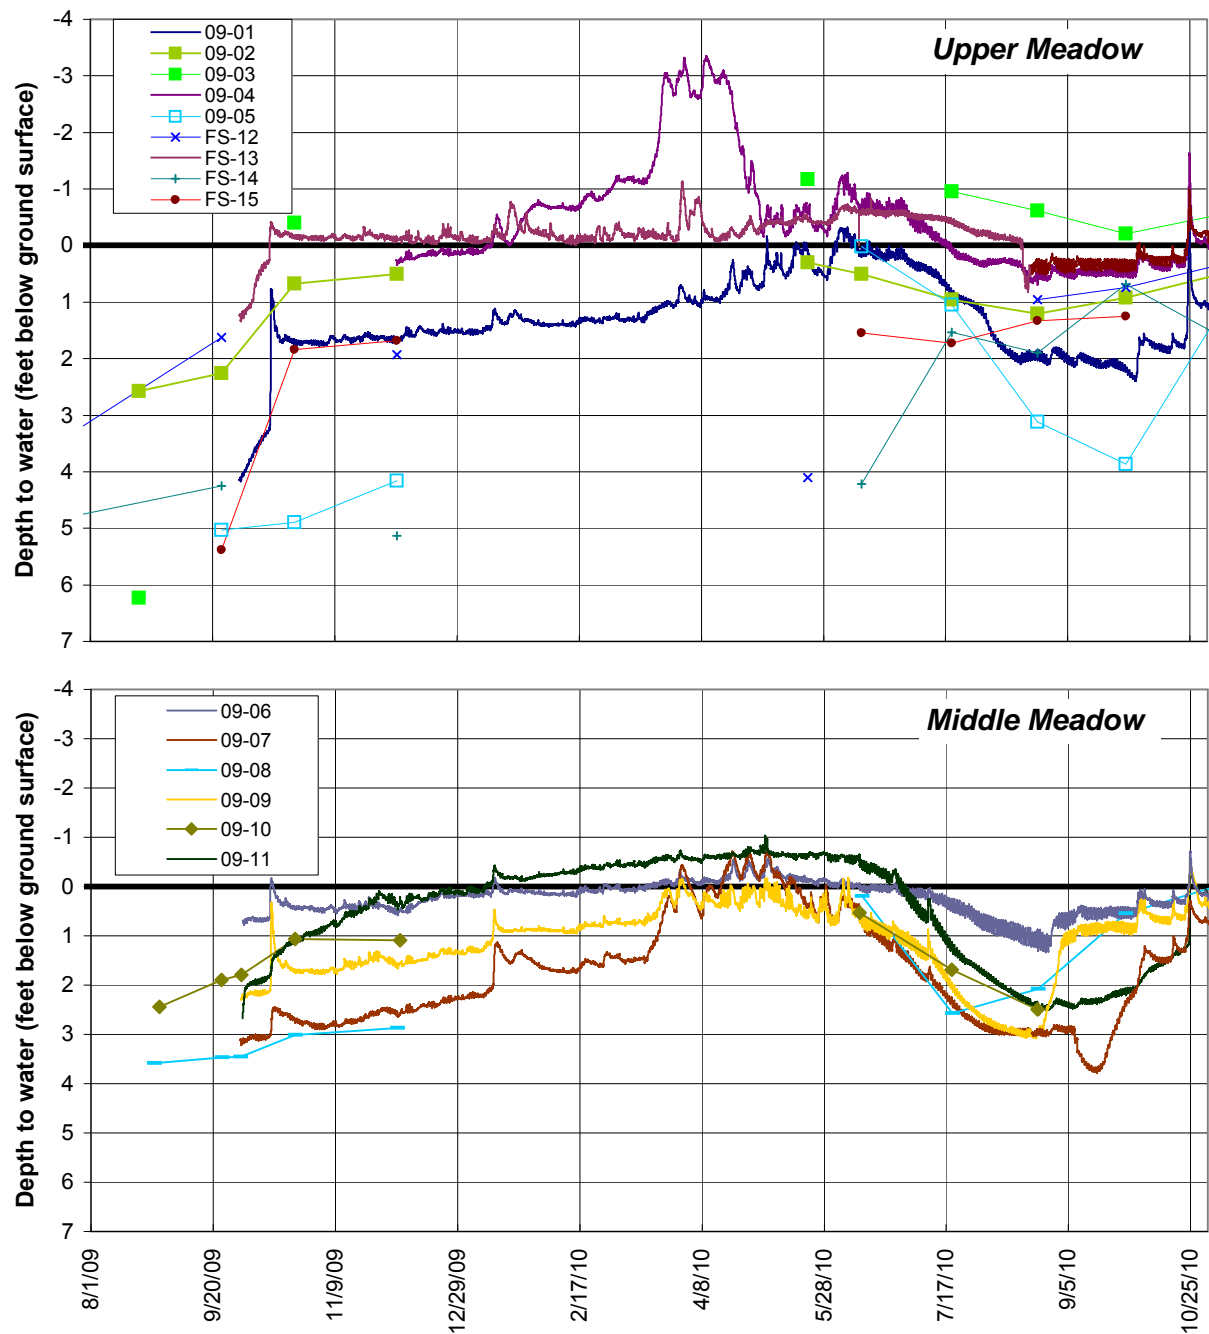
**Figure 7. Depth to groundwater over the monitoring period, Upper and Middle Perazzo Meadows, Sierra County, California**  
See Figures 4 and 5 for piezometer locations.

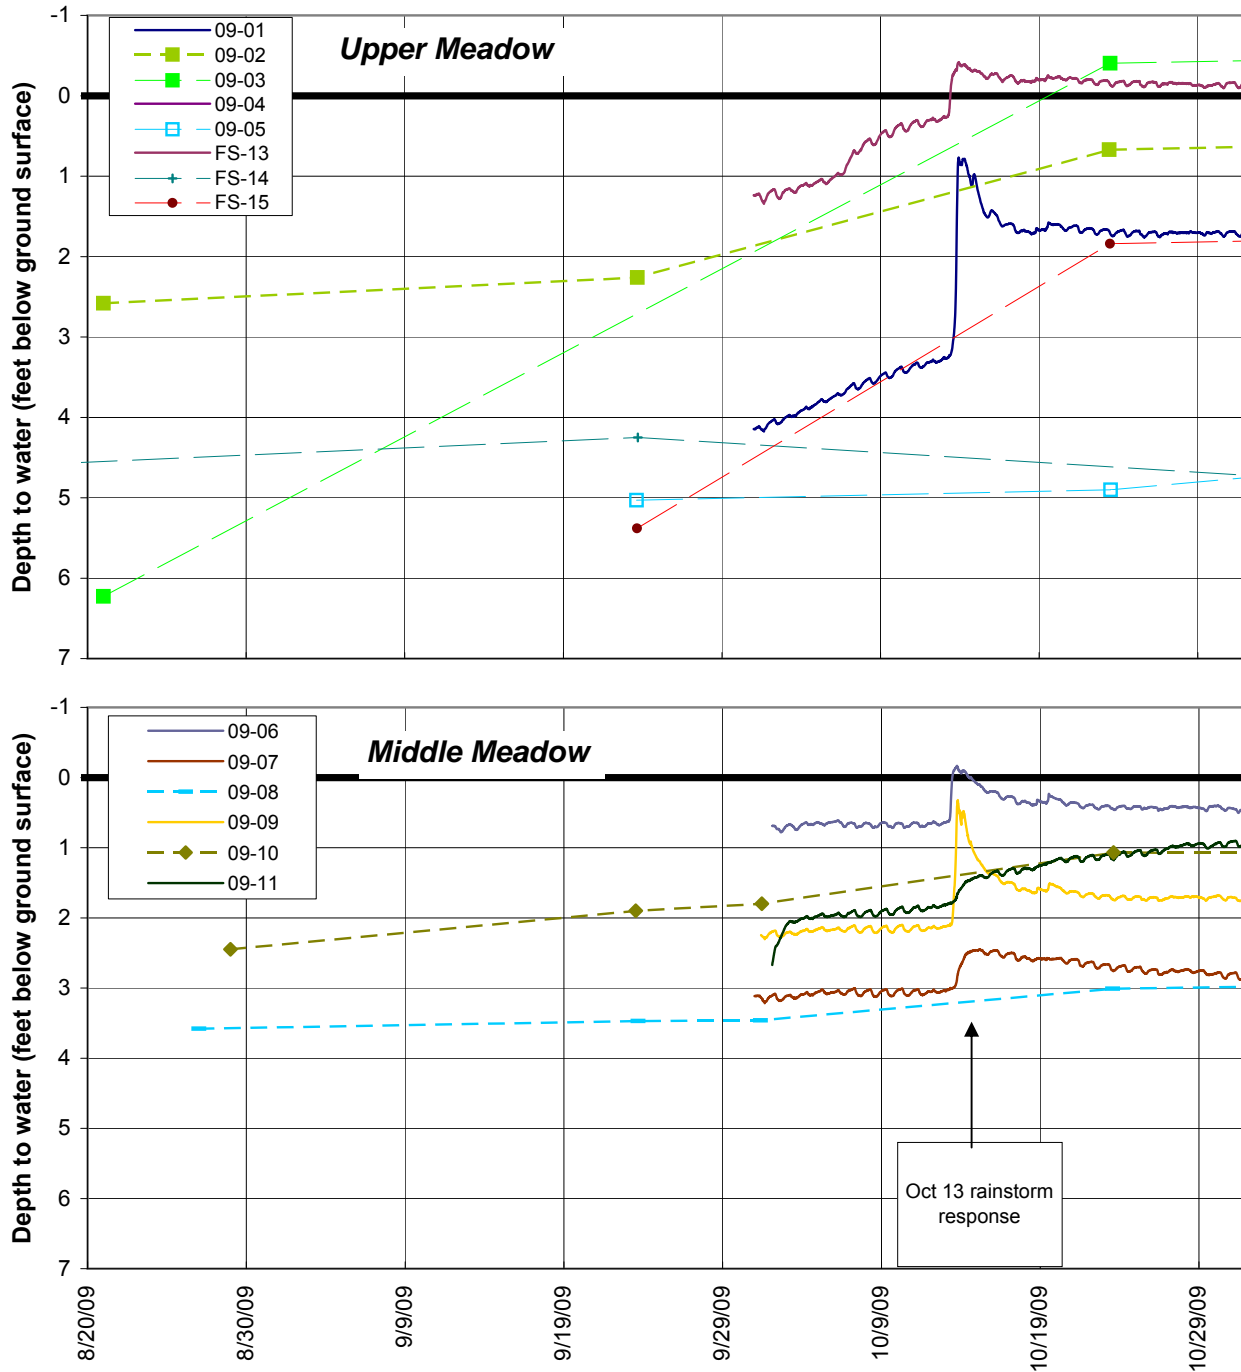
**Figure 12. Depth to groundwater before and after restoration in Upper Perazzo Meadow, Sierra County, California**

Conditions in the Middle Meadow are representative of un-restored meadow functioning under the same hydrologic conditions. Prior to the October 13 storm, groundwater levels ranged from 2.4 to 3.6 feet bgs. Groundwater response to the rainstorm was variable across the Middle Meadow. In the upper portion of the meadow, groundwater levels rose and fell rather abruptly, returning to levels slightly (0.03 to 0.04 feet) higher than pre-storm levels. In the southeast portion of the Middle Meadow, below the confluence with Cold Stream, the response was similar; the net increase in water table conditions about the same, but the recession after the storm was more extended, presumably due to contributions from Cold Stream and springs associated with the Cold Stream alluvial fan (Figures 5 and 12).

Figure 12 shows the observed groundwater conditions in both meadows during Upper Meadow restoration in Fall 2009. Datalogger-equipped piezometers in the Upper Meadow show an initial response to restoration activities, with groundwater levels slowly increasing by approximately 1 foot until the significant rainstorm of October 13, 2009. Shortly after restoration of the Upper Meadow, groundwater in areas near the existing channel or new channels rose anywhere from 1.5 feet (in Piezometers 09-01 and 09-02) to 6.5 higher (09-03) from pre-construction and pre-storm levels, and remained fairly high (Table 2, Figure 12).

In upland areas, as represented by Piezometers 09-05 and 09-14, we observed virtually no long-term increase in shallow groundwater levels until the snowmelt period, when soil saturation

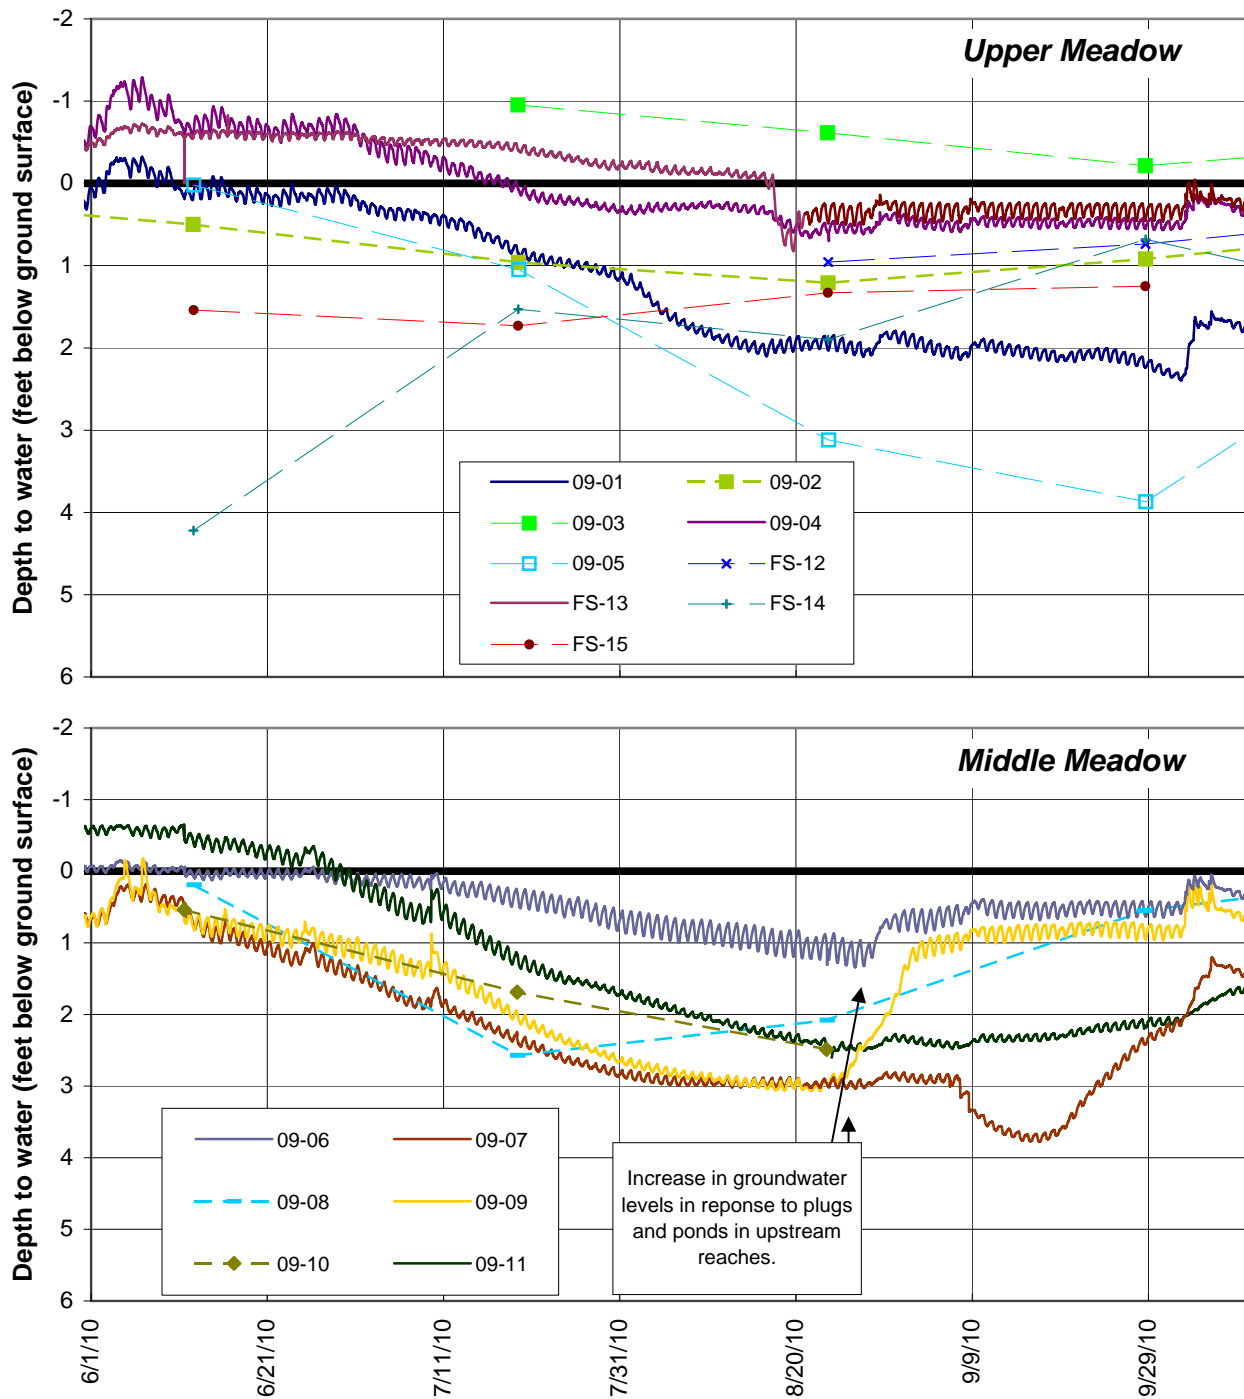
**Figure 13. Depth to groundwater before and after restoration of Middle Perazzo Meadow, Sierra County, California**  
See Figures 4 and 5 for piezometer locations.

Figure 13 shows observed groundwater conditions in both meadows during late Summer 2010, when plugs were being repaired in the Upper Meadow and plug and pond construction was taking place in the Middle Meadow. Groundwater levels increased throughout the meadow, with limited responses in areas already supported by elevated groundwater conditions. In these spring-supported areas, groundwater conditions increased by 0.1 to 0.25 feet. In other areas, such as the northwestern and north-central portion of the Middle Meadow, more substantial increases were observed, ranging from 1 to 3 feet.

It is interesting to note that in some cases, groundwater conditions fell by 0.5 to 0.75 feet and recovered over the course of 10 to 20 days during restoration, as the river was temporarily dewatered when water was being dammed upstream.
