DESIGN BASIS REPORT

LACEY MEADOWS RESTORATION DESIGN

SIERRA AND NEVADA COUNTIES, CALIFORNIA

Balance
Hydrologics

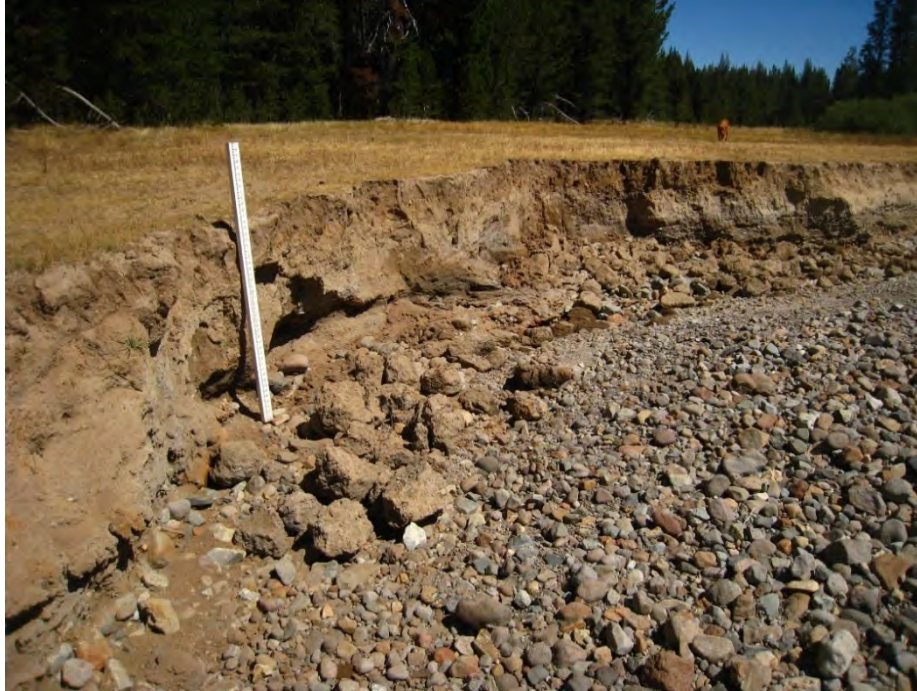
Figure 2-4 Example of Channel Incision and Meadow Desiccation in Upper Lacey Meadow, Reach G (b).

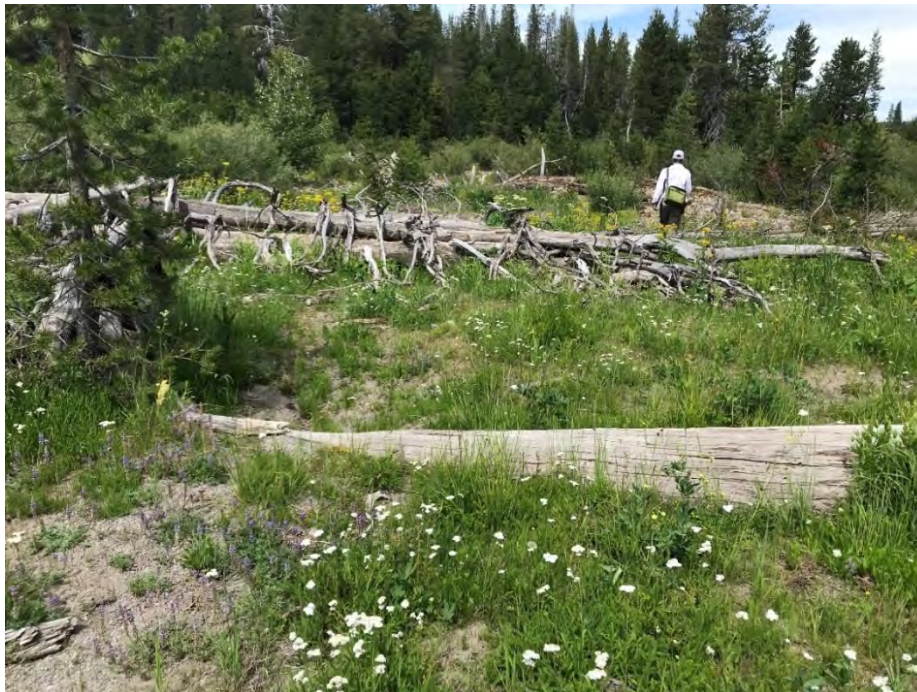
Figure 2-5 Example of Wood Recruitment and Sediment Deposition or Channel Aggradation in Lacey Creek, Upper Lacey Meadow, Reach H.

Sediment and wood transport are key physical functions provided by Lacey Creek in Upper Lacey Meadow, and induce channel migration and aggradation, especially across the alluvial fans at the Upper end of the Meadow. In lower-gradient reaches, Lacey Creek exhibits active bank erosion and dynamic bar movement, further promoting wood recruitment by undermining and felling trees in areas adjacent to the upland forest. Instream wood provides roughness that encourages local and reach-wide deposition (**Figure 2-5**). These processes are common in at the heads of each meadow and are analogs for restoration elements that can be used to reverse channel incision.

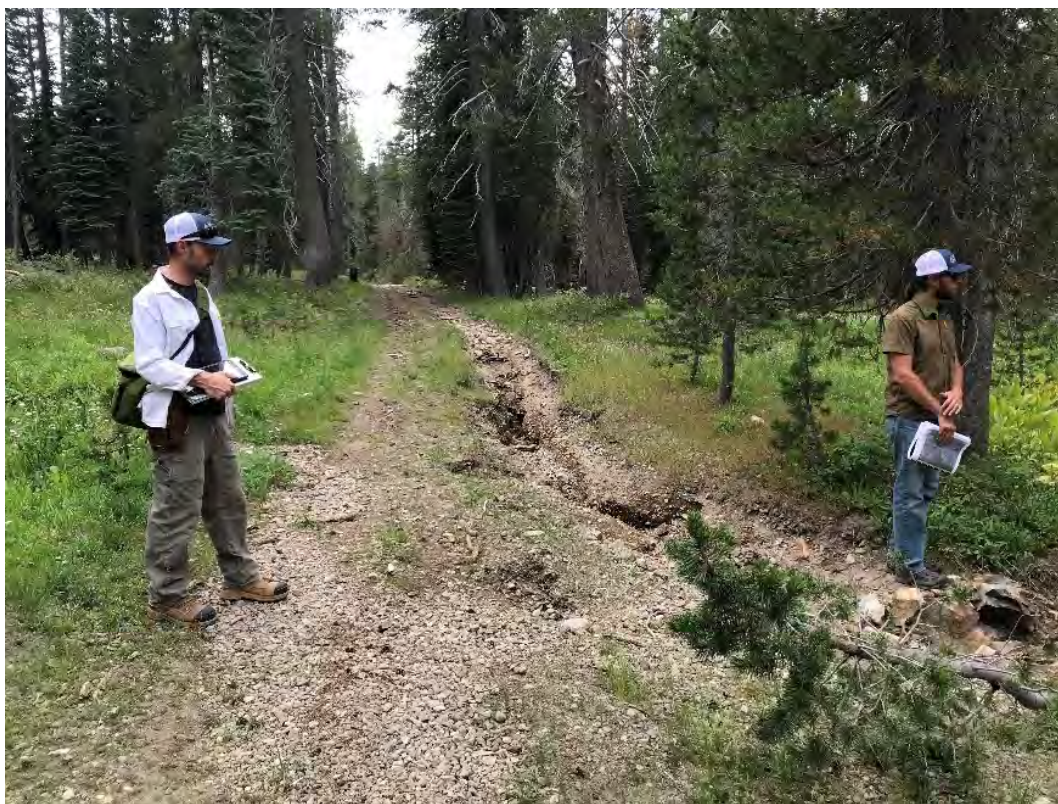
Figure 3-2 Example of Road Capture from Webber Lake Road.

In Lacey Creek watershed, roads are primarily responsible for road capture, excess runoff, meadow dissection and degradation, and hillslope and in-channel erosion. We illustrate examples of these impacts in **Figure 3-1**, **Figure 3-2**, **Figure 3-3** and **Figure 3-4**.

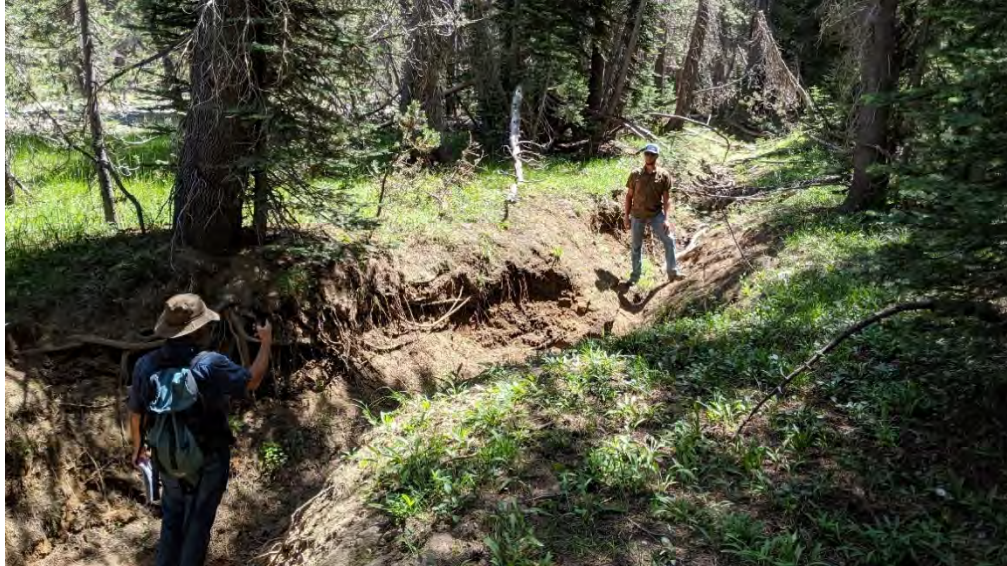
Figure 3-3 Example of Road Runoff Concentrated in a Natural Channel, Upper Lacey Meadow, Reach I (a).

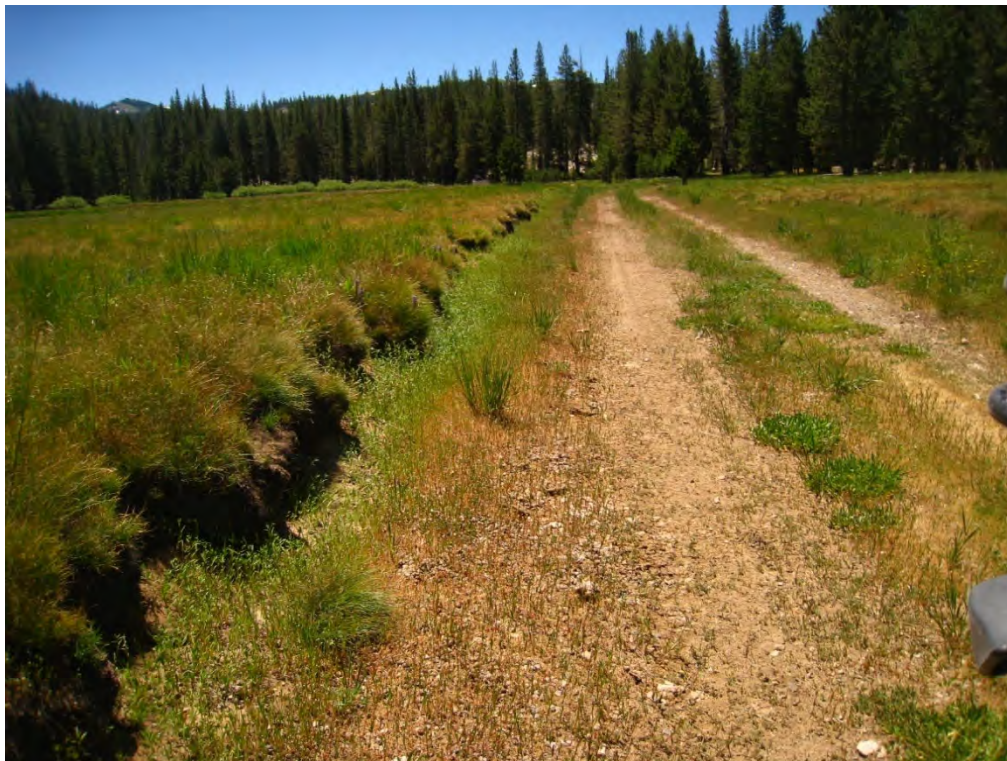
Figure 3-4 Evidence of Meadow Dissection and Degradation, Lower Lacey Meadow along Webber Lake Road.

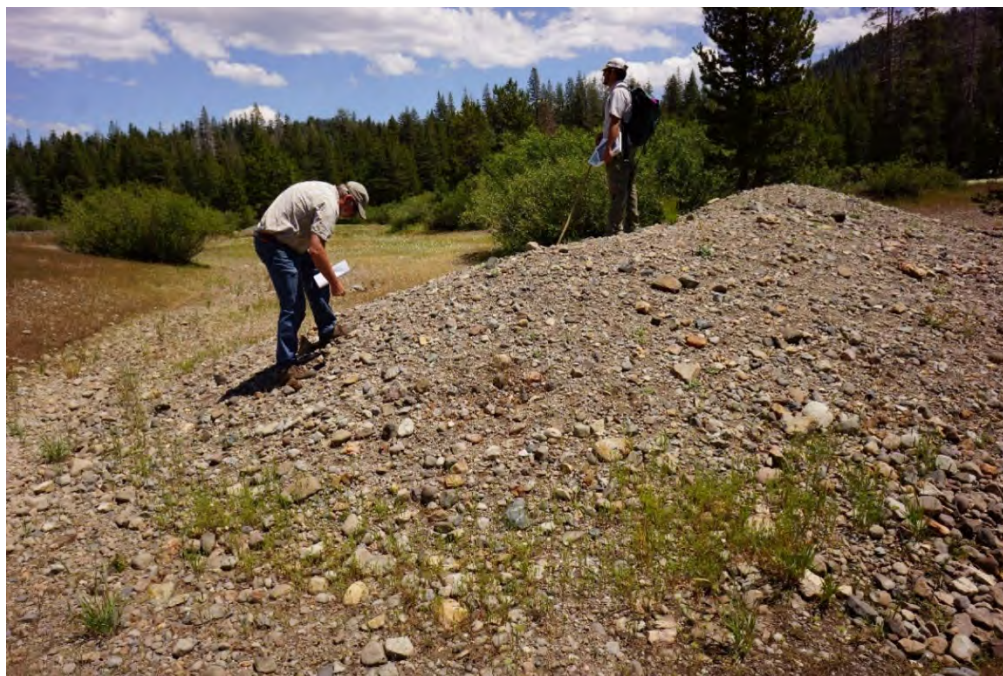
Figure 3-5 Example of a Gravel Push-up Dam Located in a Historical Channel of Lacey Creek, Upper Lacey Meadow, Reach G (b).

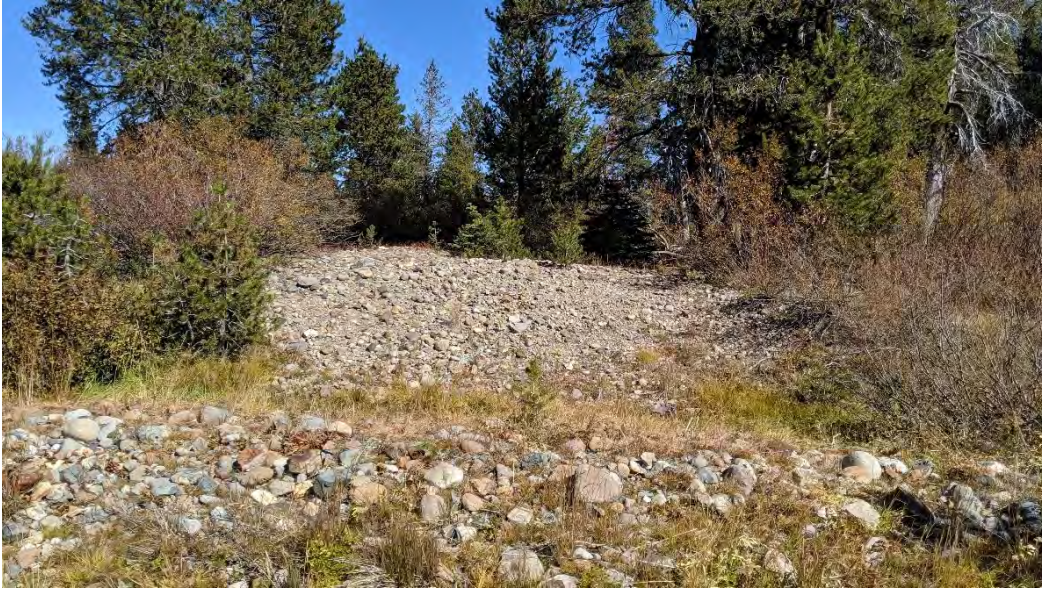
Figure 3-7 Former Main-Channel Blocked by a Push-up Dam, Lacey Creek, Upper Lacey Meadow. This dam encouraged channel avulsion to the northern side of the meadow and through the forest [Reach G(a)], depriving meadow of hydrologic support.

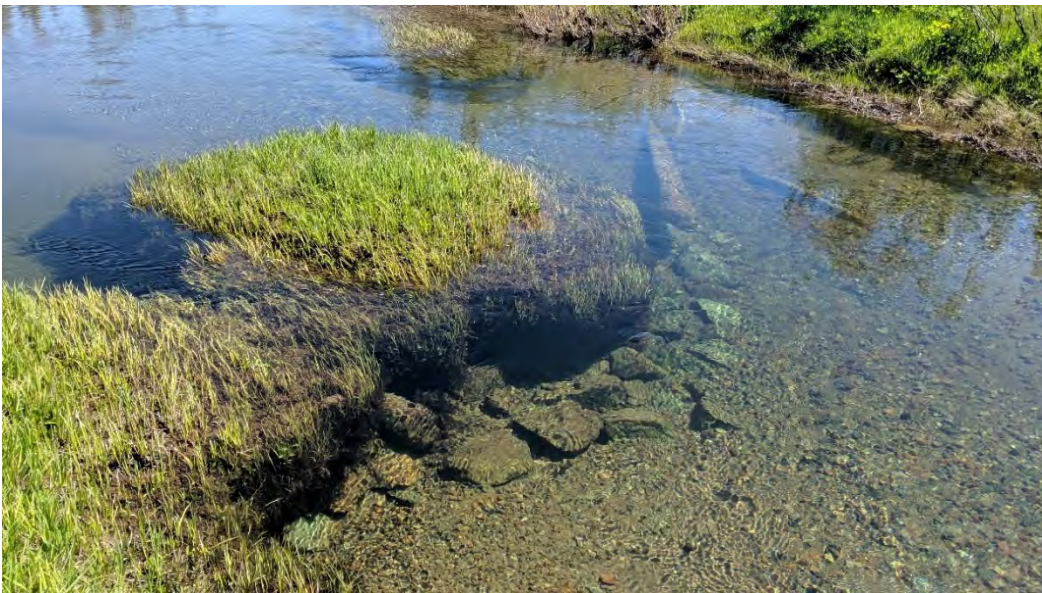
Figure 3-8 Example of an Old Rock and Log Dam or Diversion Structure, Lacey Creek, Lower Lacey Meadow, Reach B.

Channel modifications and manipulations of natural stream patterns in montane meadows were common practices over the last century or more. In Upper Lacey meadow, there is both field and photographic evidence that these channel modifications occurred. Gravel piles or push-up dams observed in remnant channels suggest they were placed to dam channels and divert flow (**Figure 3-5**). Similarly, a review of historical aerial imagery between 1952 and 1966 suggests that channel avulsion was encouraged to divert the channel from the upper meadow (**Figure 3-6**). The location of the channel avulsion in the imagery corresponds to the presence of an old gravel push-up dam immediately upstream used to block flows to the meadow, probably to support drier conditions in the meadow for grazing (**Figure 3-7**). Lacey Creek was also modified in other ways using large rock and logs for flow deflection or diversion (**Figure 3-8**).

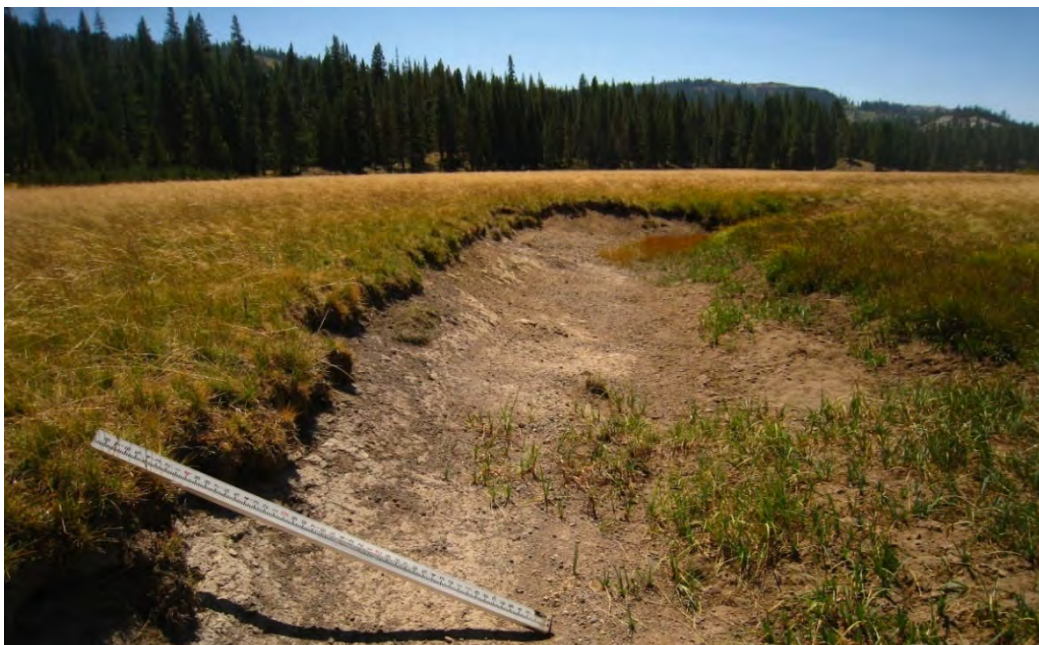
Figure 3-9 Example of Bank Erosion from Sheep, Lower Lacey Meadow, Southeast Tributary.

Sheep grazing is a part of the historical and on-going land use of both the upper and lower meadow. Sheep tend to congregate near the creek for a source of drinking water. In the process, bank trampling is often a consequence (**Figure 3-9**) and accelerates bank erosion and channel migration.

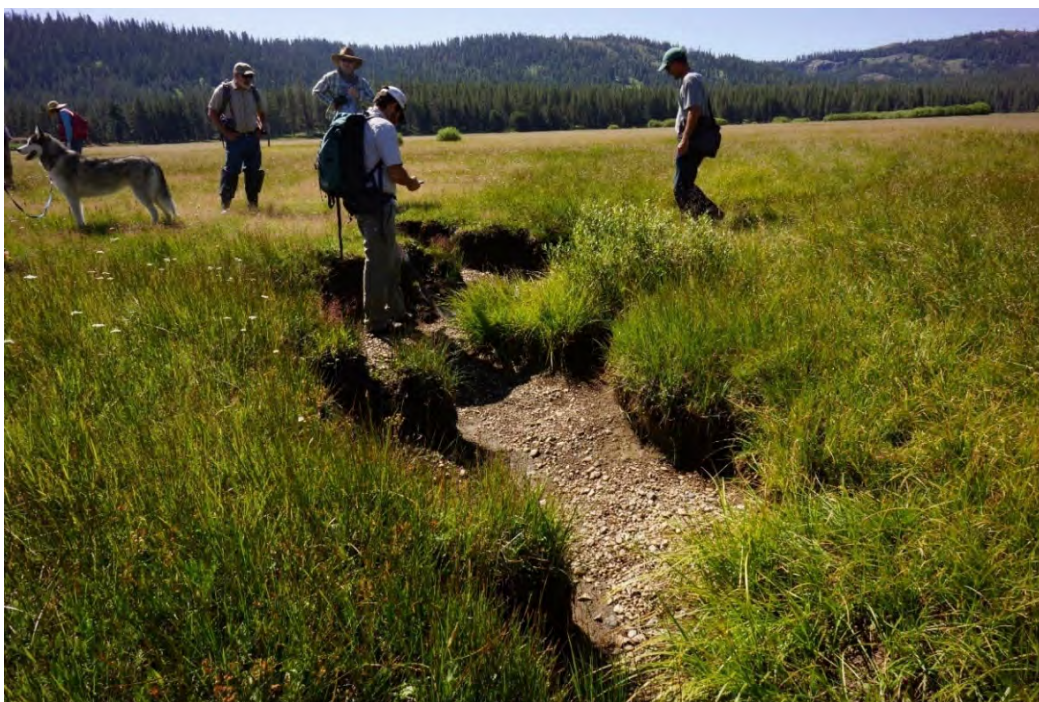
Figure 3-10 Example of Headcut Erosion from Fluctuating Webber Lake Water Levels, Lower Lacey Meadow, West Tributary.

changes in an alluvial system such as Lacey Creek has resulted in knickpoint erosion and headcut migration (**Figure 3-10**). Under current management, the fish screens are no longer used (Svahn, J., pers. comm, 2019), but observed leakage under the dam continues to influence lake level fluctuations to a larger degree than under natural conditions.

Webber Lake is a natural water body; however, its outlet is modified by a low-head dam constructed in 1915. From 1985 through 2017 seasonal installation and operation of fish screens on the dam have at times inadvertently augmented lake water levels by an additional 1.0 to 2.0 feet. The screens were frequently blocked by in-lake vegetation that drifted to the outlet, effectively increasing water levels in the lake. Together, the dam and fish screens have augmented the natural range of water levels in Webber Lake by over 3.0 feet. The result is a seasonally fluctuating base level for Lacey Creek and tributaries to the lake. A migrating base level changes processes such as soil wetting, drainage, and groundwater levels in Lower Lacey Meadow, and alters the location of sediment deposition and delta formation in Lacey Creek. A peak flow event occurring during rapid changes in base level, such as from a high lake stage to a lower lake stage, could result in bank failures, knickpoint creation and headcutting—features that are observed today in secondary channels in Lower Lacey Meadow near Webber Lake (see Figure 3-10).

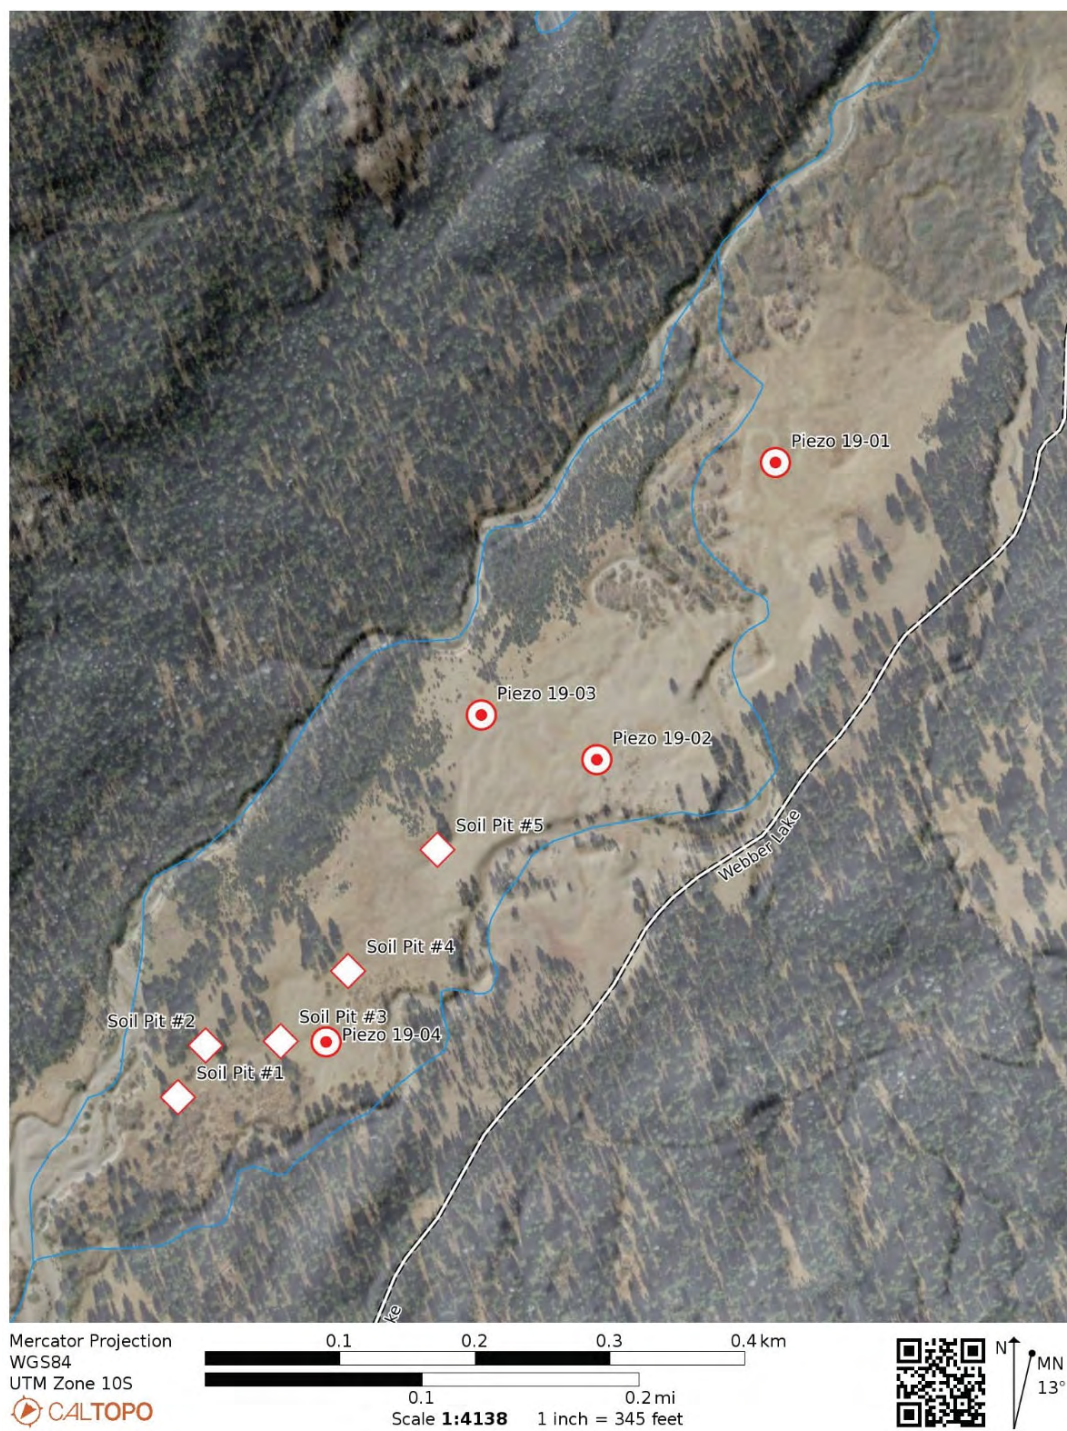
Figure 4-1 Locations of Soil Trenches and Groundwater Piezometers, Upper Lacey Meadow

In October 2019 and again in September 2020, Balance geomorphologists worked with a local contractor to excavate trenches between 4 and 9 feet deep in both the Upper and Lower Meadows to characterize subsurface soils at locations where grading of pilot channels is proposed and observe groundwater conditions. Many of the trenches were used to install piezometers for monitoring groundwater conditions over time (**Figure 4-1** and **Figure 4-2**). In this section, we describe subsurface conditions and preliminary recorded groundwater levels for the periods of record (Upper Meadow: fall 2019 through fall 2021; Lower Meadow: fall 2020 through fall 2021).

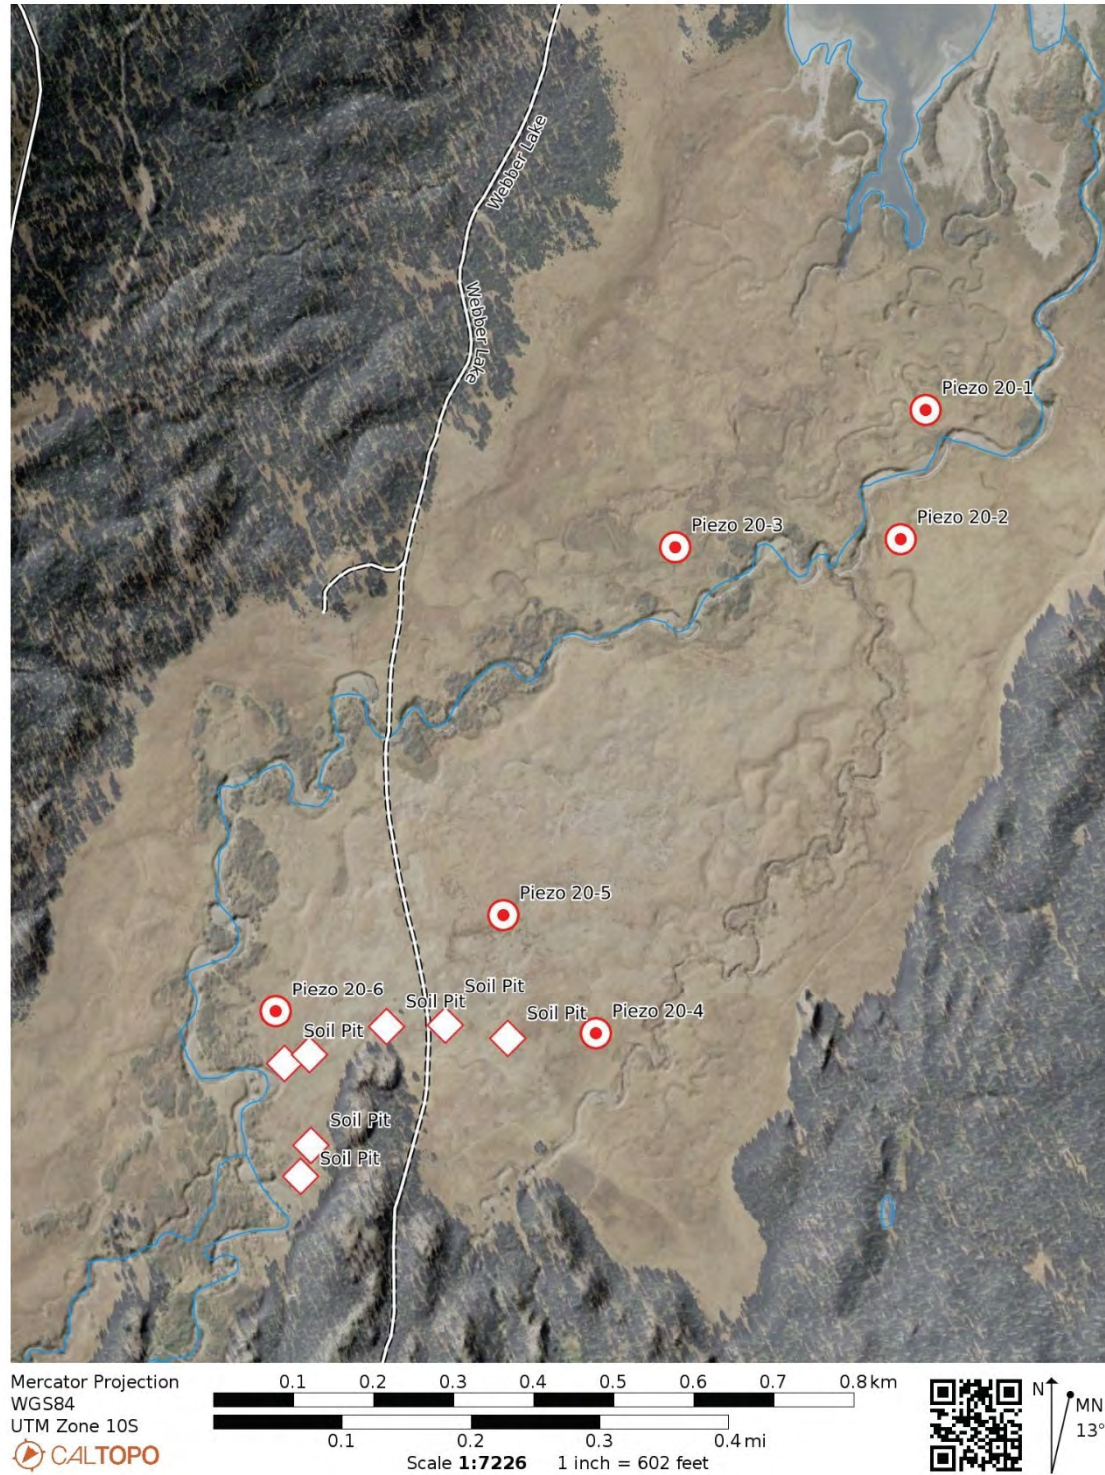
Figure 4-2 Locations of Soil Trenches and Groundwater Piezometers, Lower Lacey Meadow

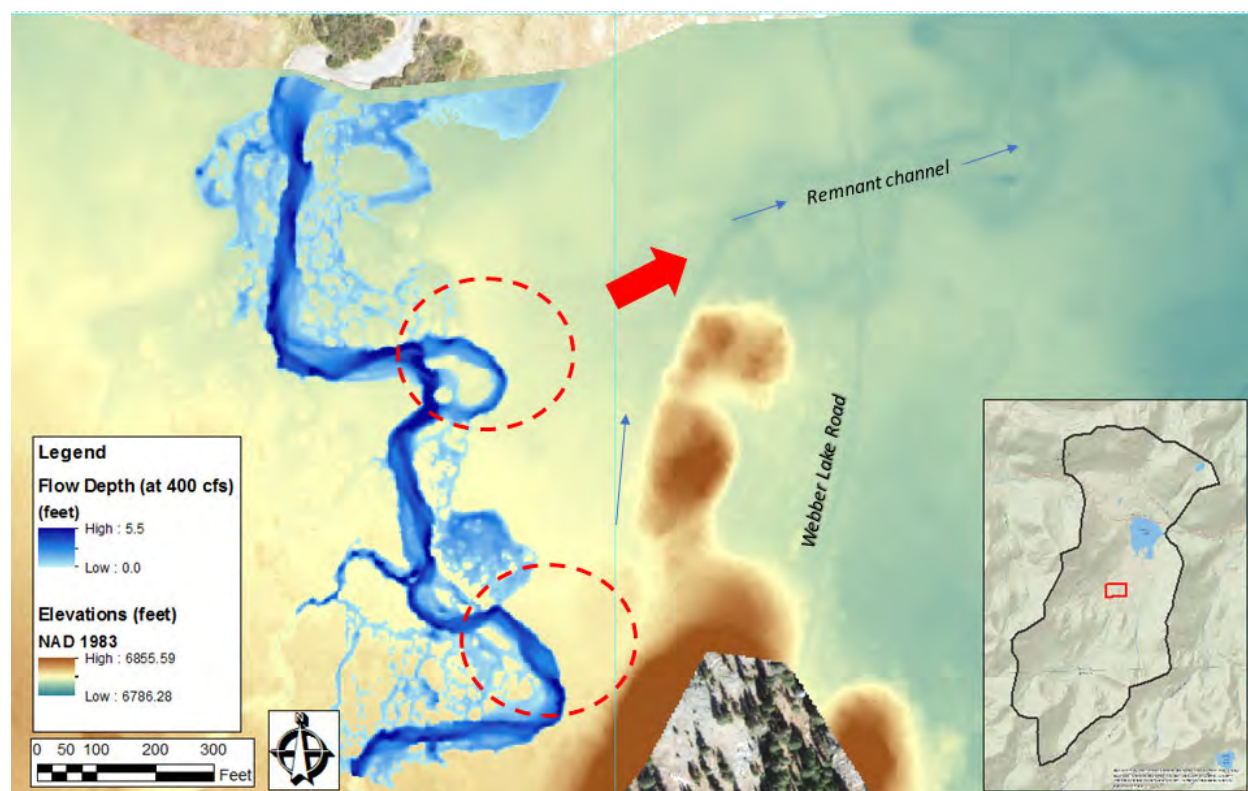
Figure 4-6 Hydraulic Model Results for WY2017 Peak Flow (estimated 400 cfs) in Existing Channel, Lower Lacey Meadow. Red arrow indicates remnant channel, while dashed circle identifies area proposed for splitting channel flow; flow direction is from bottom to top of page.

In **Figure 4-6**, we illustrate estimated peak flow for WY2017 (~400 cfs) for Lacey Creek at the entrance to the Lower Meadow using a digital elevation surface developed from LiDAR-based topography (USFS, 2013). Similar to the Upper Meadow, a peak flow with an estimated 5- to 10-year recurrence is mostly contained within the existing channel and illustrates the incised condition of Lacey Creek in the Lower Meadow.

In **Figure 4-6**, we also identify a former remnant channel that may have supported more dispersed flow across the Lower Meadow. Under peak flow shown in **Figure 4-6**, the remnant channel is disconnected from the water surface by less than 1 foot. This area could be restored to promote flow into the existing remnant channel.

Multiple active channels once characterized both Upper and Lower Lacey Meadows as evidenced by remnant channels in the meadows observed in the field, historical imagery, and on LiDAR-based imagery (see **Figure 4-5** and **Figure 4-6**). Grading of pilot channels is proposed where there is opportunity to direct a portion of the total streamflow toward remnant channels with relatively little disturbance. Pilot channels are paired with either an instream wood structure or a debris riffle to minimize disturbance. In general, an in-channel structure is proposed within Lacey Creek to increase flow depths which in turn decreases the required pilot channel excavation depth to redirect streamflow toward remnant channels. The threshold for pilot channels becoming active varies; in some locations the pilot channel is intended to be the low flow channel and in other locations the pilot channel is perched above Lacey Creek such that it is active during periods of elevated flow.
