Donner Creek Restoration
Figure 1. Regional Location Map
Truckee, CA

Donner Creek Restoration Project Request for Bid Attachment 2 – Project Photos

Photos include access and staging areas, followed by restoration areas from upstream to downstream.

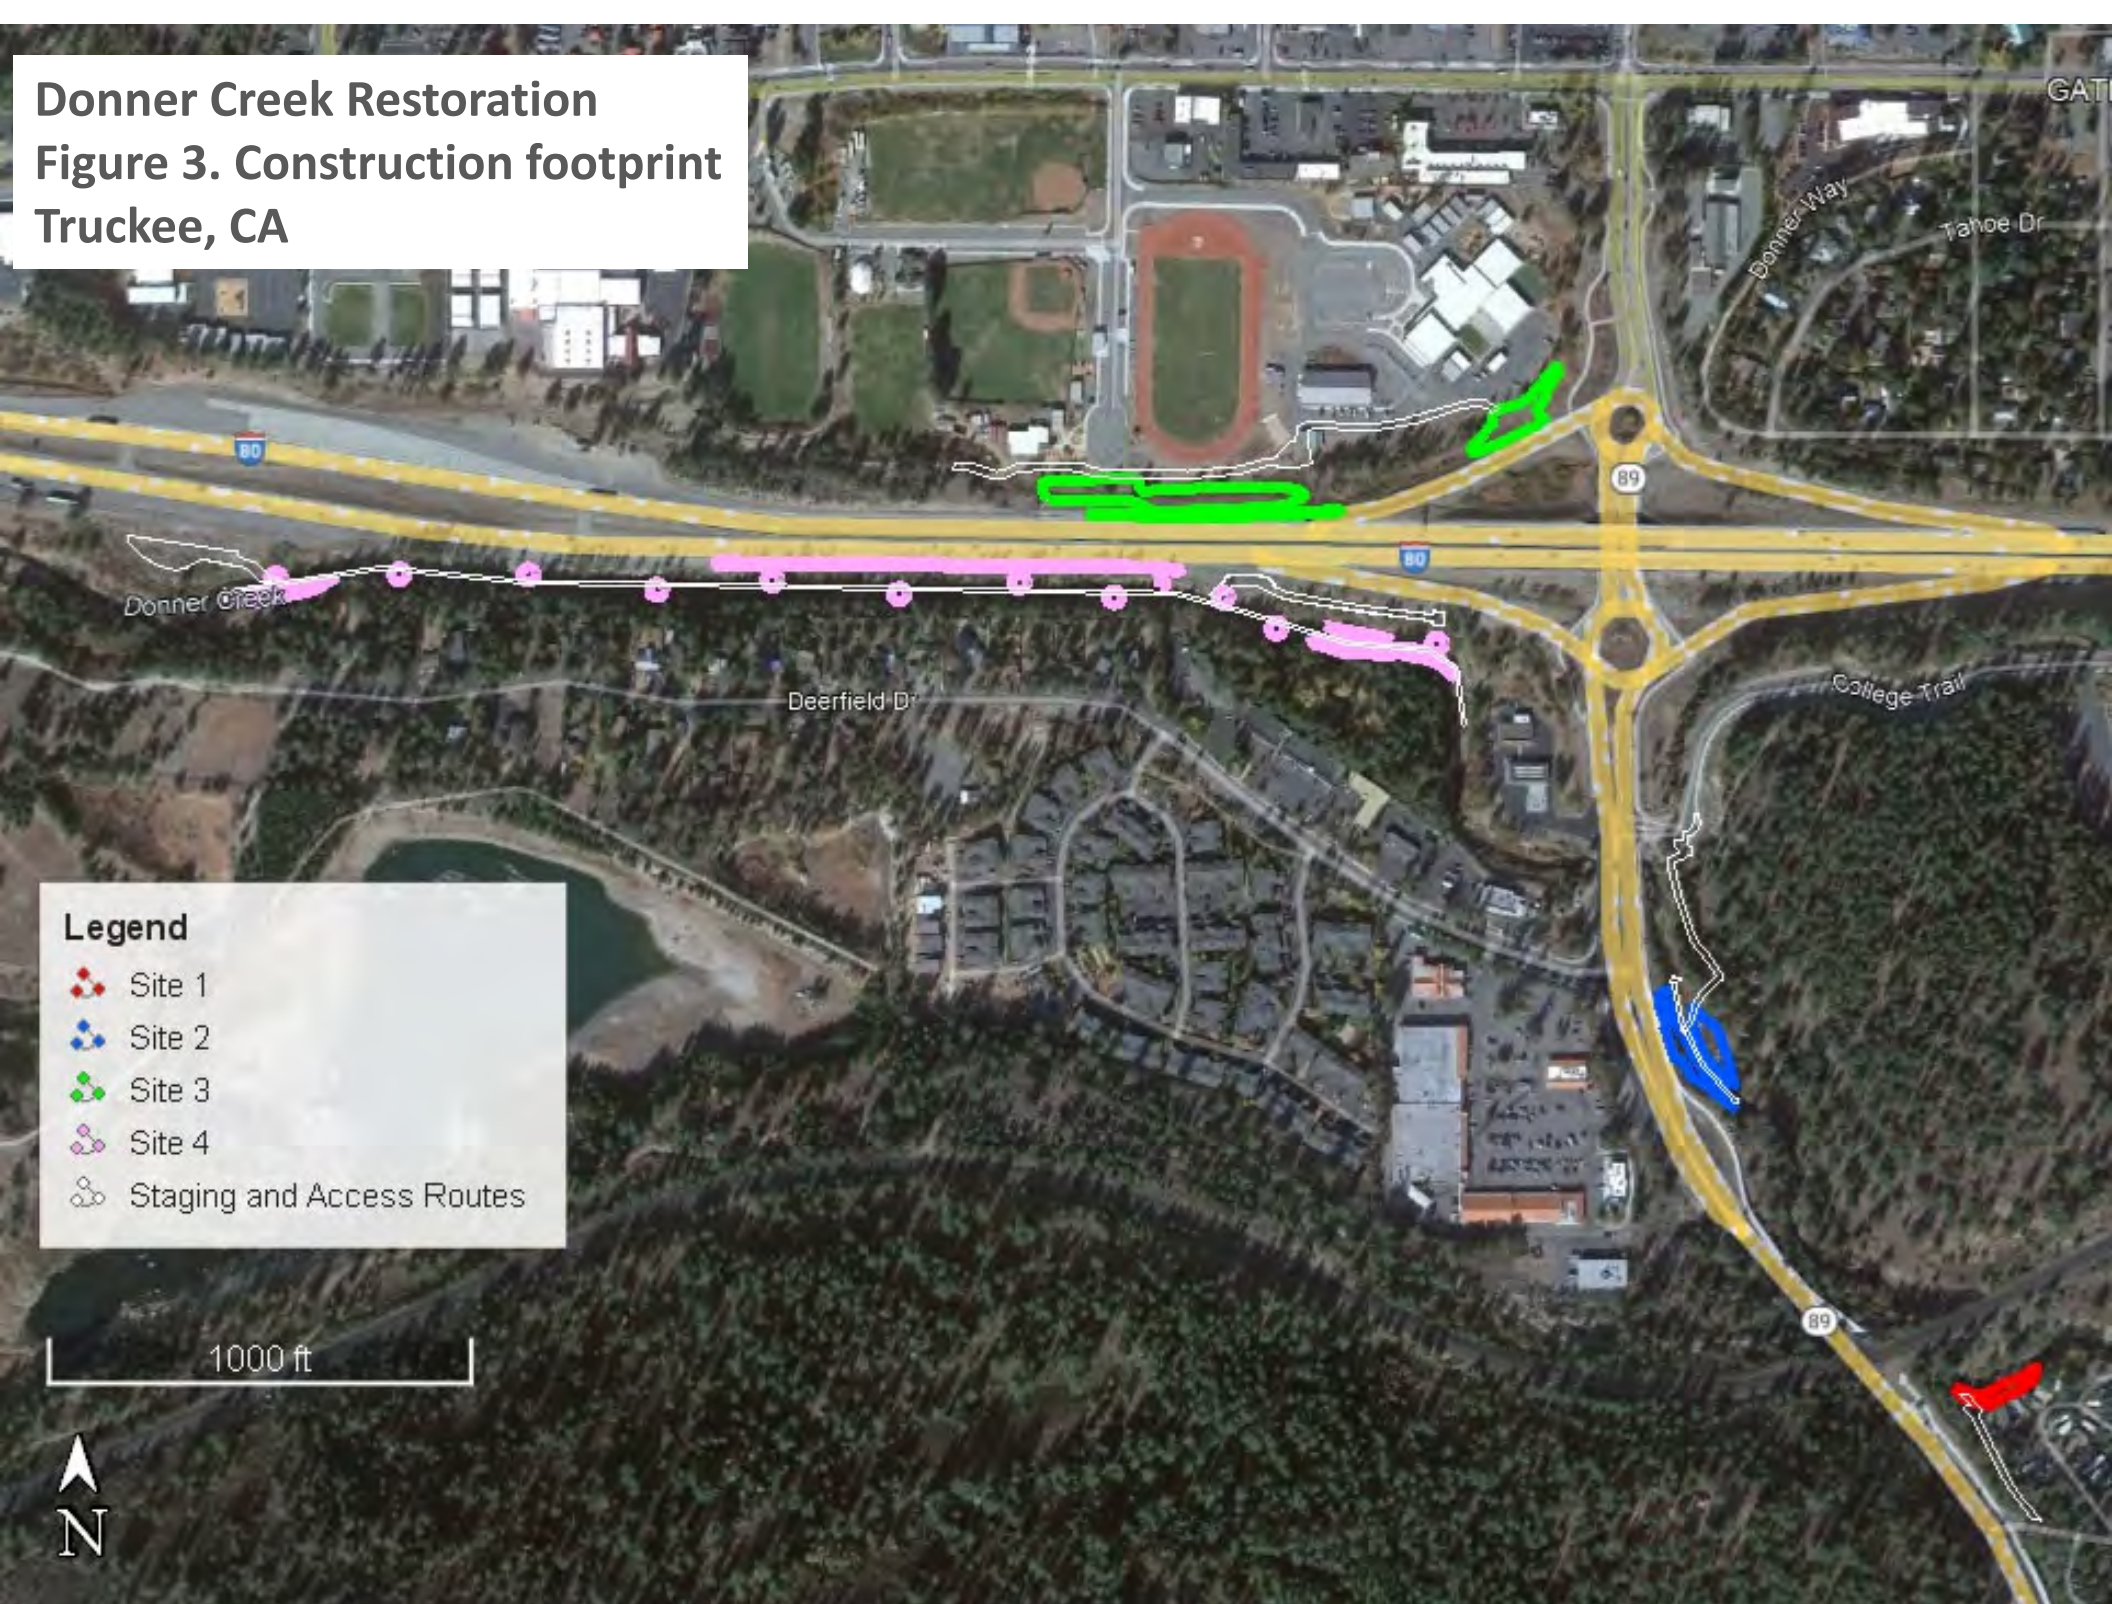
Donner Creek Restoration
Figure 3. Construction footprint
Truckee, CA

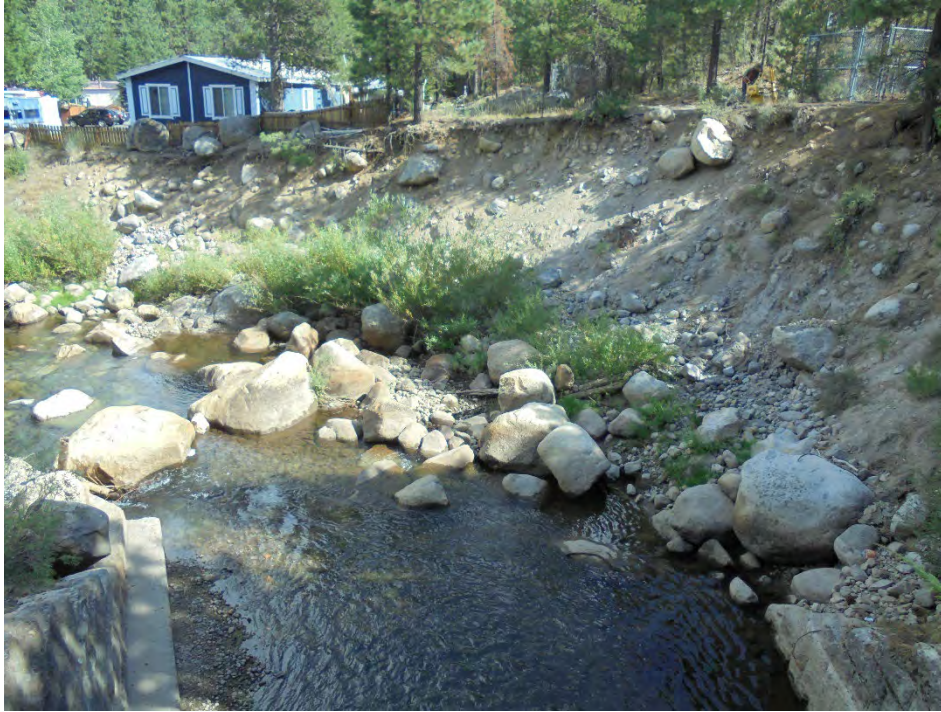
Access ramp. Construct temporary access ramp to enable equipment access to floodplain bench work area. Work from upstream and downstream extents of work area back toward access ramp. Pull out access ramp when working up bank and use material to backfill RSP. Photo taken facing East (8/7/2017)

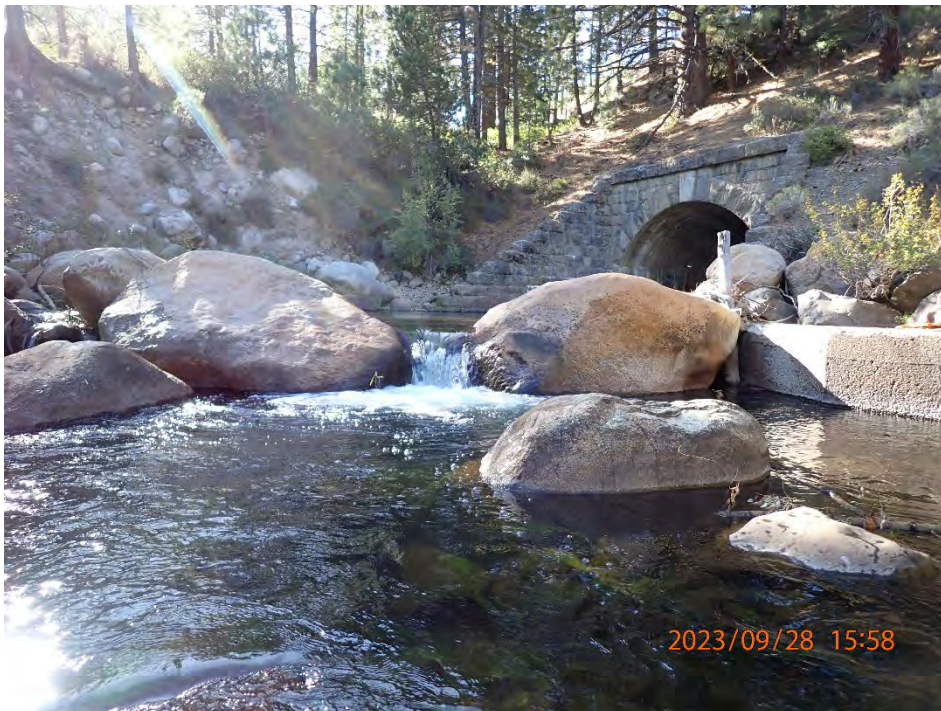
Outflow of railroad culvert. Taper RSP and tie into (E) large boulder at (E) wingwall. Photo taken looking West (9/28/2023)

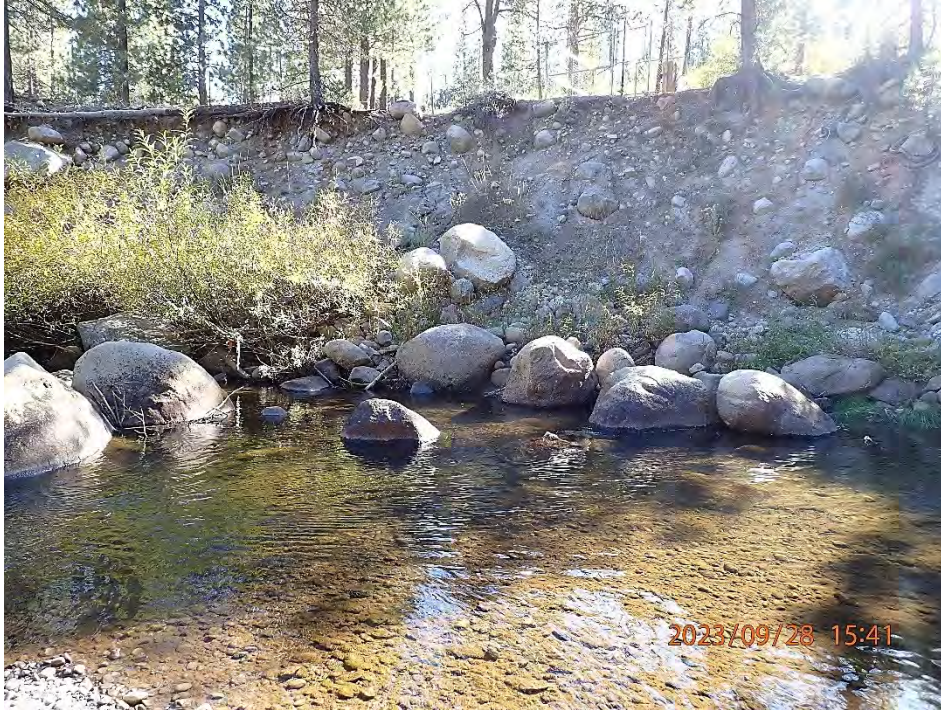
Cutbank below railroad culvert, approximately Section A-A. Install rootwad revetments as directed by the engineer. Restore to 1.5:1 slope. Install boulder, willow, seed/blanket treatments. See section details. Photo taken looking West (9/28/2023)

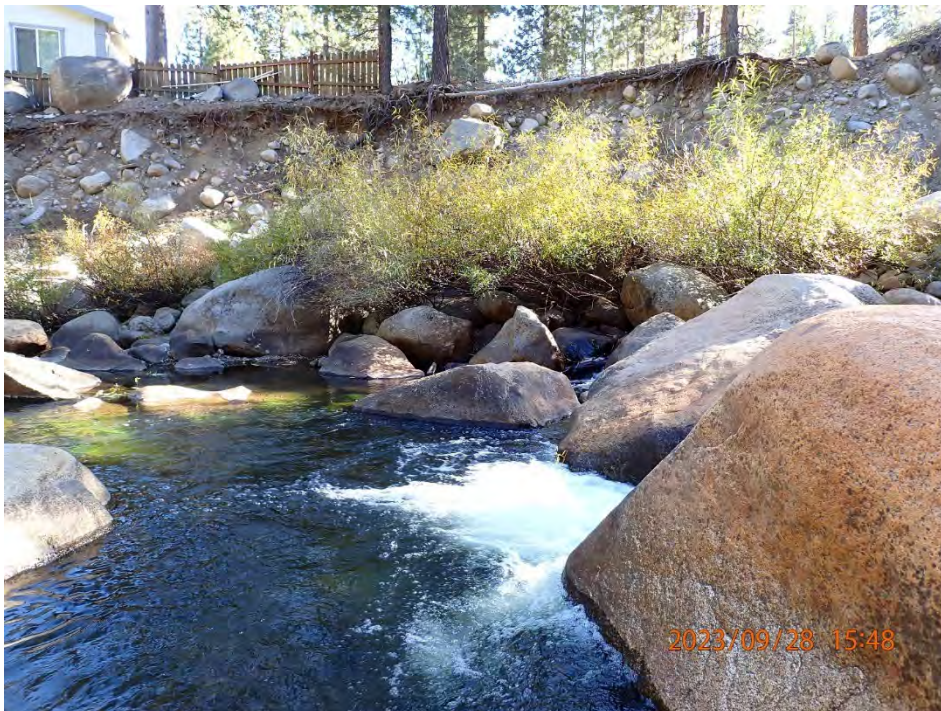
Cutbank below mobile homes, approximately Section B-B. Regrade and incorporate spoils into boulders as backfill (top center of photo). Install Caltrans 1-ton RSP at toe transition to Caltrans 1/2-ton and 1/4-ton RSP moving upslope. See section details (left of photo). Photo taken looking South (9/28/2023)

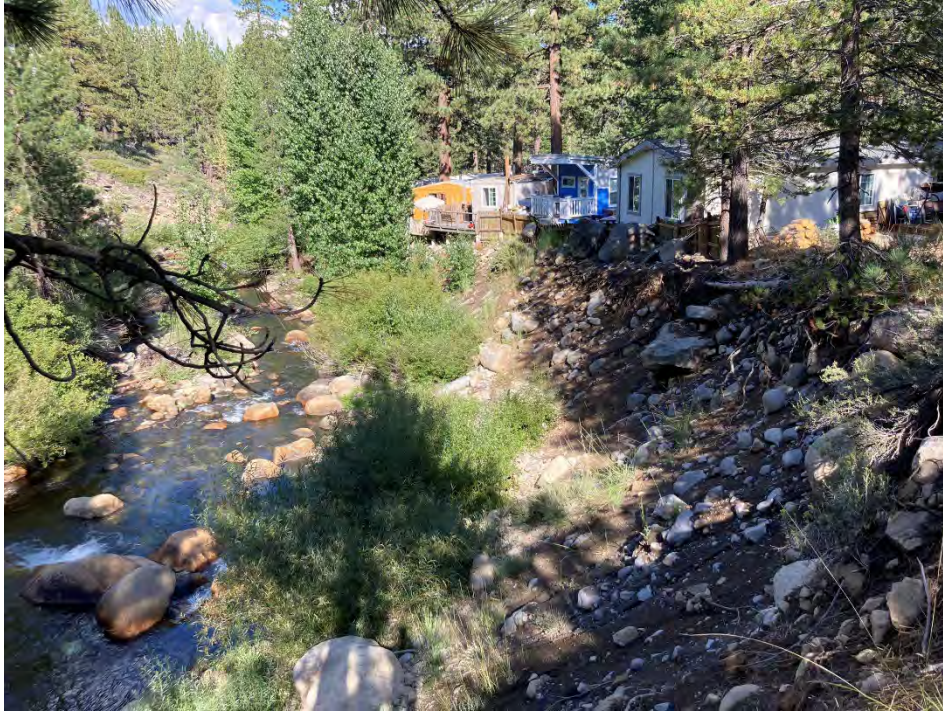
Cutbank below mobile homes. Install Caltrans 1-ton RSP at toe transition to Caltrans 1/2-ton and 1/4-ton RSP moving upslope see section details. Taper RSP and tie in behind (E) aspens. Photo taken looking South (8/23/2023)

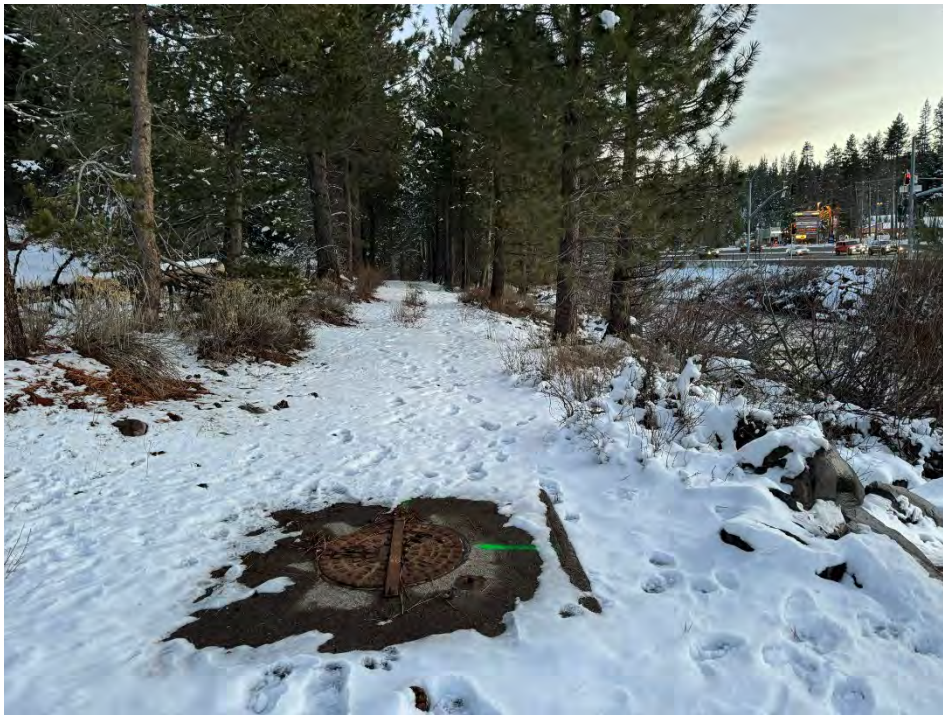
Access route via (E) utility access road. Depending upon equipment size/loading, steel plates May be required where access intersects with (E) sewer. Photo taken looking South (1/5/2024)

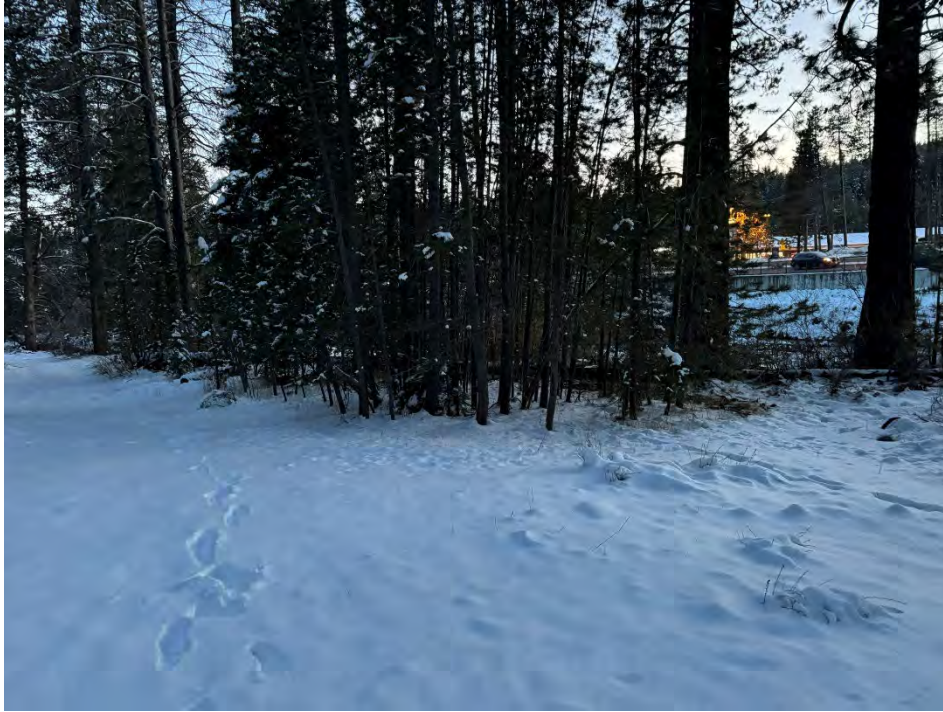
Access route. Small trees and brush to be removed. Photo taken looking West (1/5/2024)

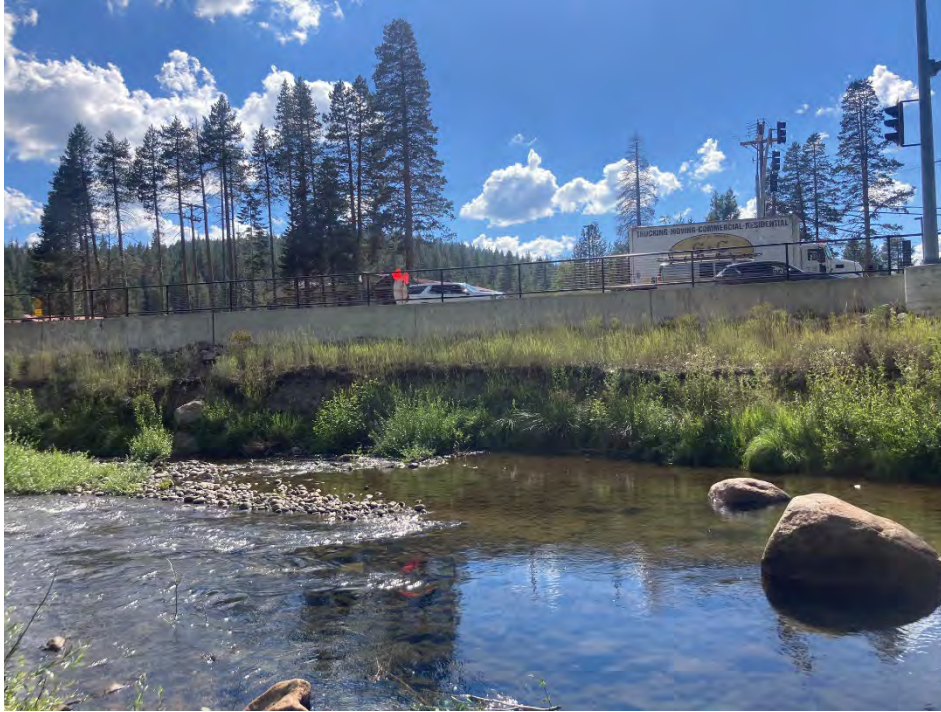
Approximately Section A-A. Install boulder bendway weirs to redirect flows to channel center and east floodplain and secondary flow channels. Rebuild west bank to 1.5:1 max slope. Key in boulders and install plantings and willow poles to stabilize bank. Photo taken looking West (8/23/2023)

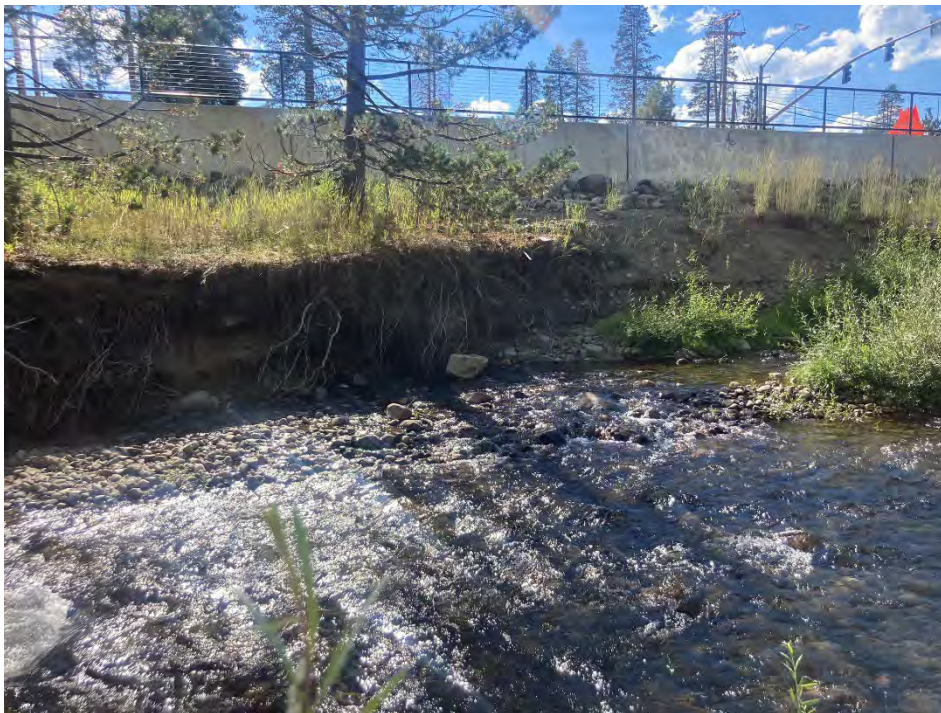
Rebuild west bank to 1.5:1 max slope. Key in boulders and install plantings and willow poles to stabilize bank. Install 10' wide rocked sections to maintain creek views. Preserve (E) vegetation to the extent practicable. Photo taken looking West (8/23/2023)

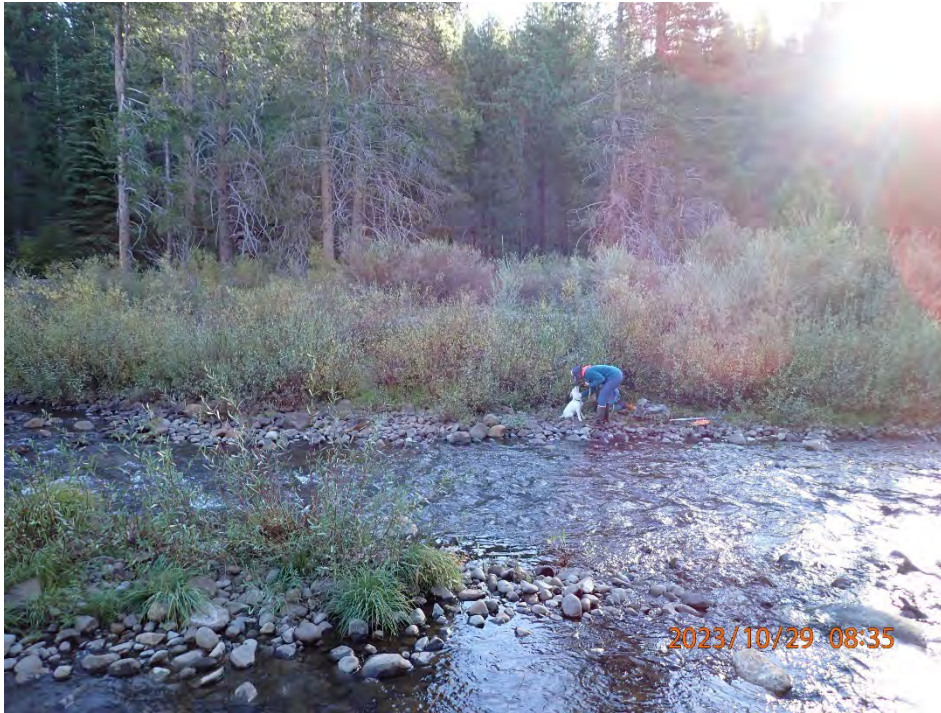
Lower the channel bar 1' to 2' and spot grade as directed by the engineer. Photo taken looking East (10/29/2023)

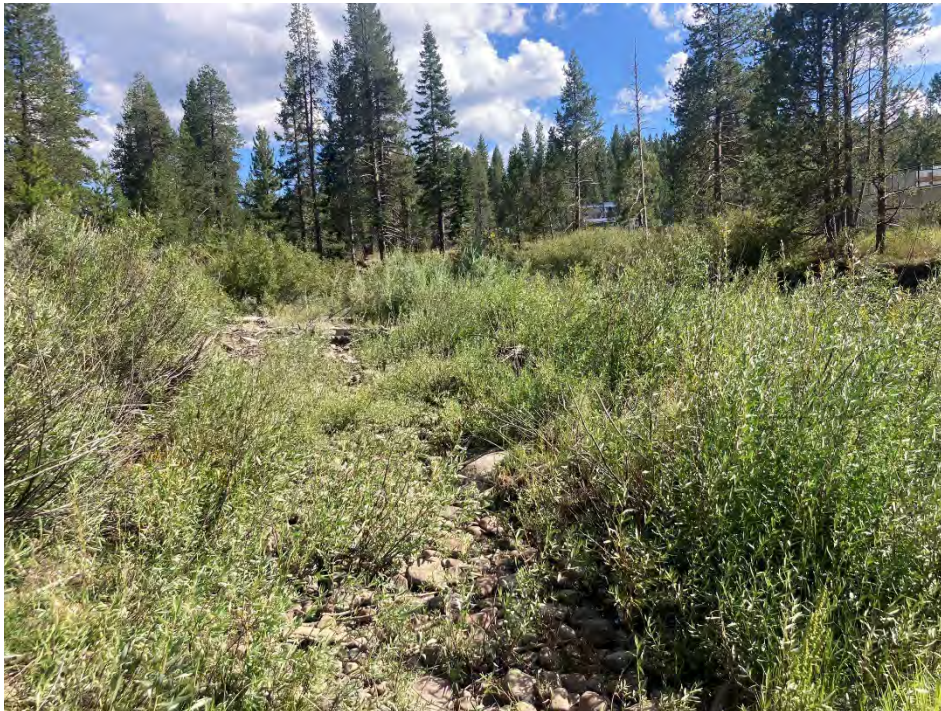
Rework east gravel bar to restore floodplain and activate secondary flow channels. Photo taken looking South (8/23/2023)

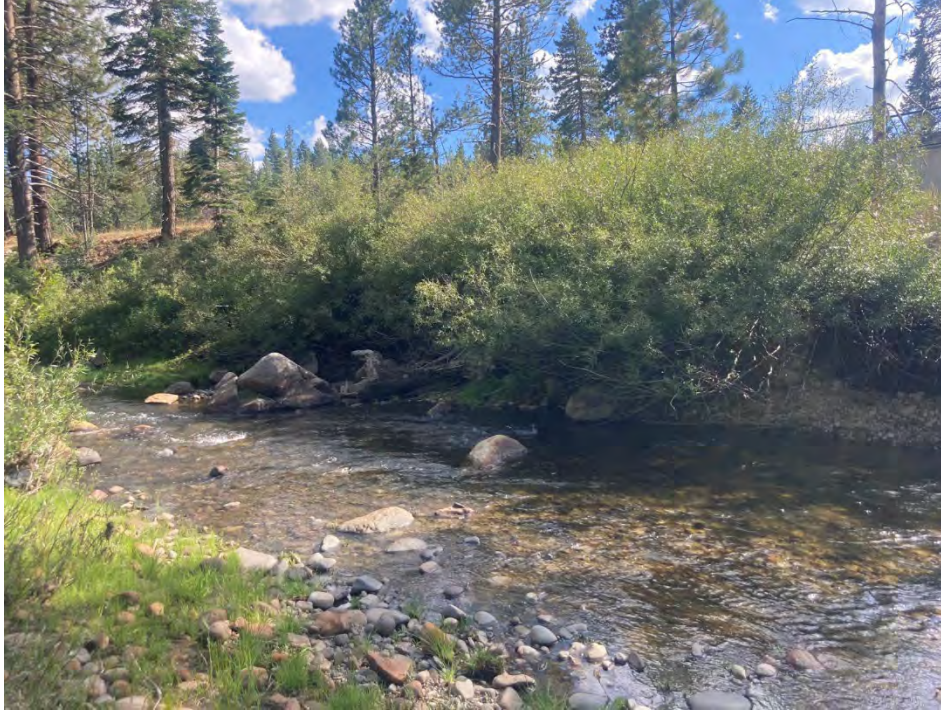
Southern end of Site 2. Extend boulder toe protection to end of bank opposite secondary channels.
Photo taken looking West (8/23/2023)

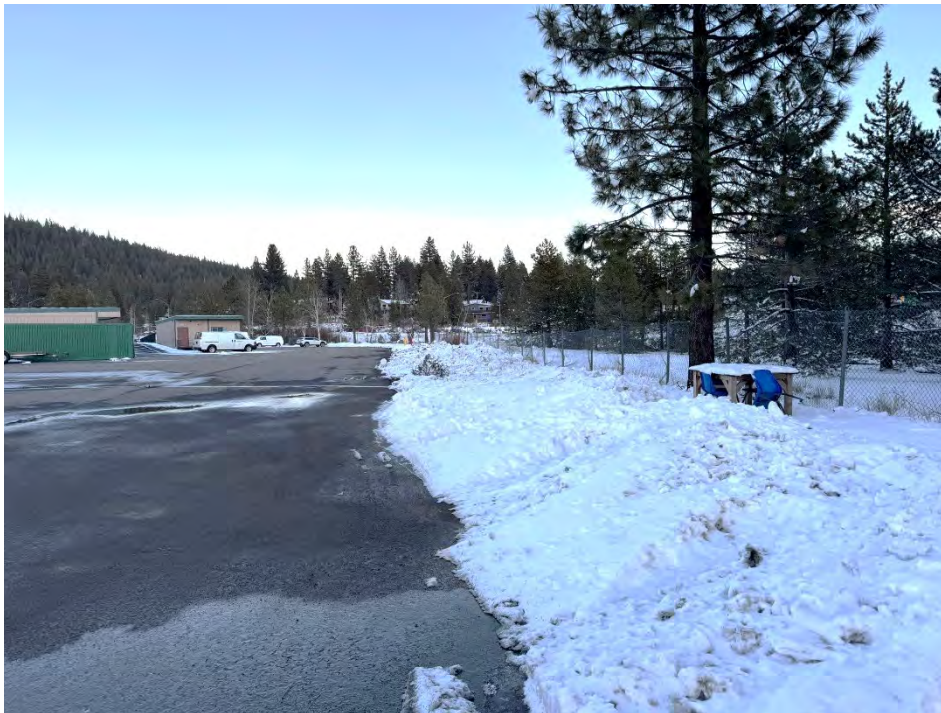
Access road from staging area to eastern grading area. Contractor shall photograph/video pre- and post-construction condition of school access roads and restore any damages to original condition. Photo taken looking East (1/5/2024)

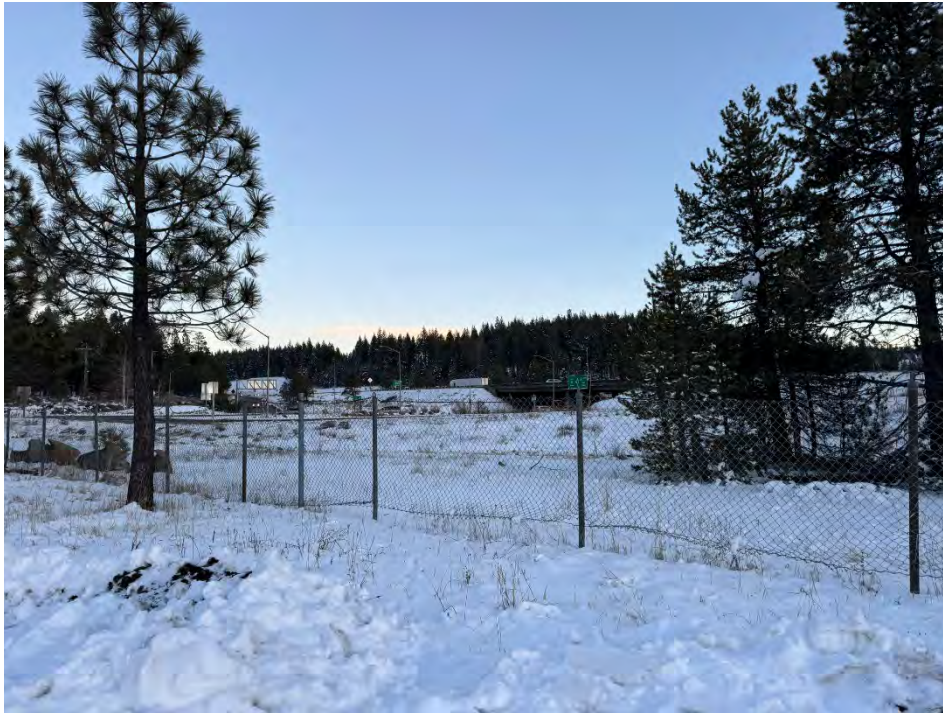
East access entry. Remove section of (E) chain link fence see Note 1. Photo taken facing Southeast (1/5/2024)

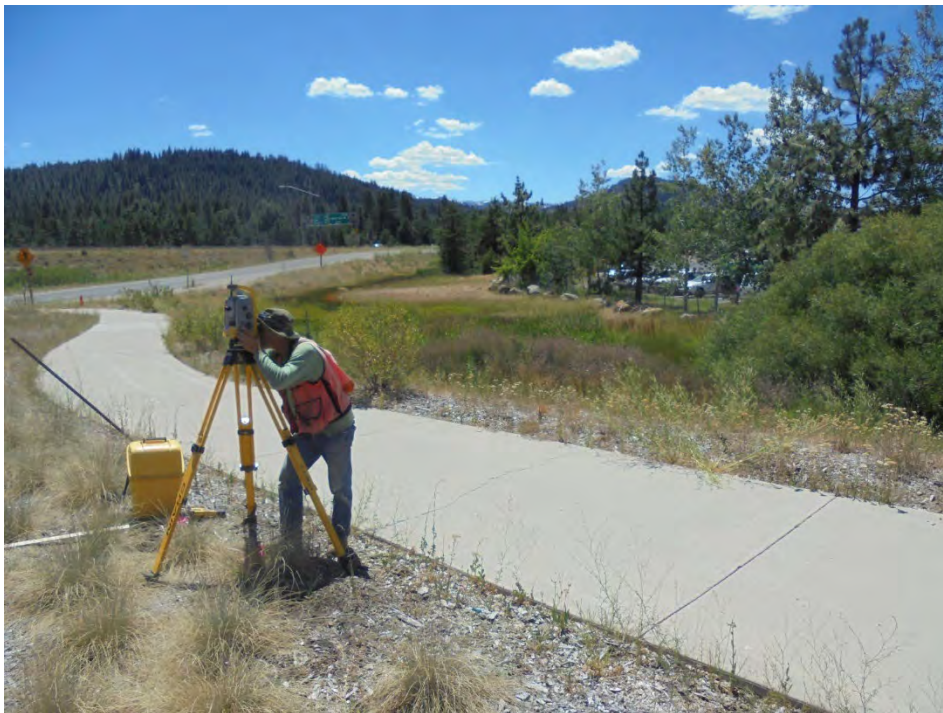
Eastern grading area. Excavate as shown per field direct to expand floodplain area. Check location clay layer prior to excavating to 5886' depth. Photo taken looking West (7/27/2017)

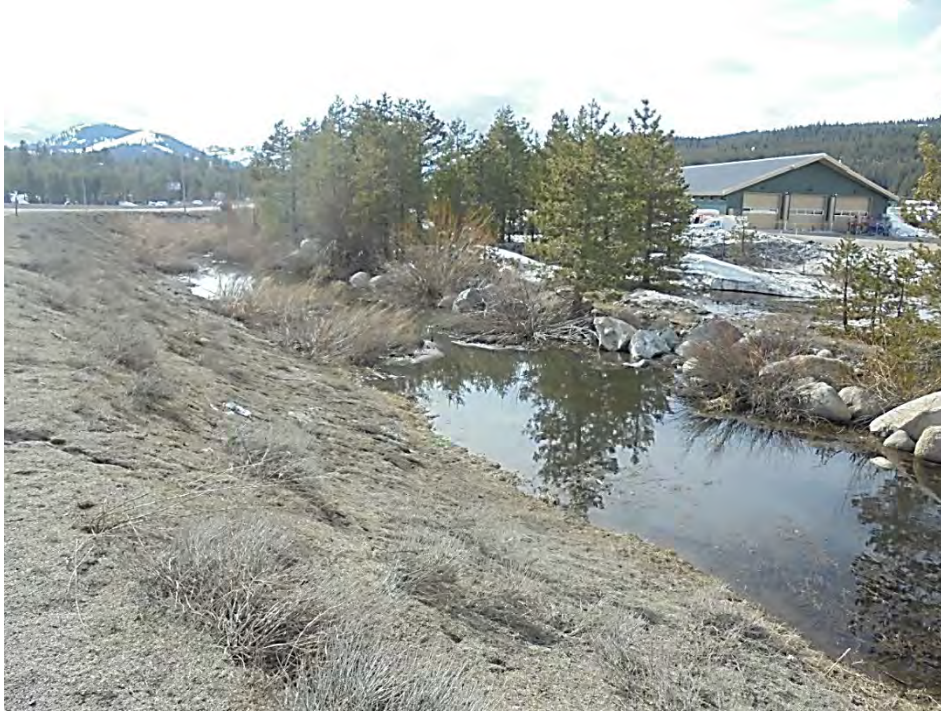
Eastern grading area, approximately Section A-A. Excavate as shown per field direct to expand floodplain area. Check location clay layer prior to excavating to 5886' depth. Photo taken looking West (3/29/2017)

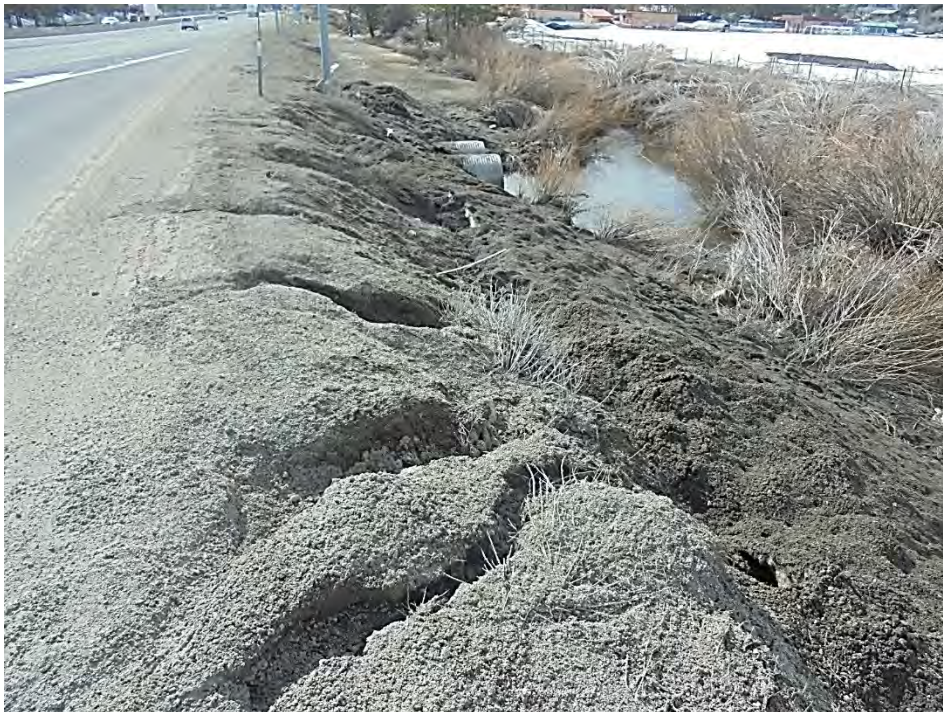
Eastern end of western grading area. Erosion from I-80 Westbound and culverts to Donner Creek. Install (n) grass-lined swale/infiltration trench w/check dams at 100' O.C. Photo taken looking West. (3/29/2017)

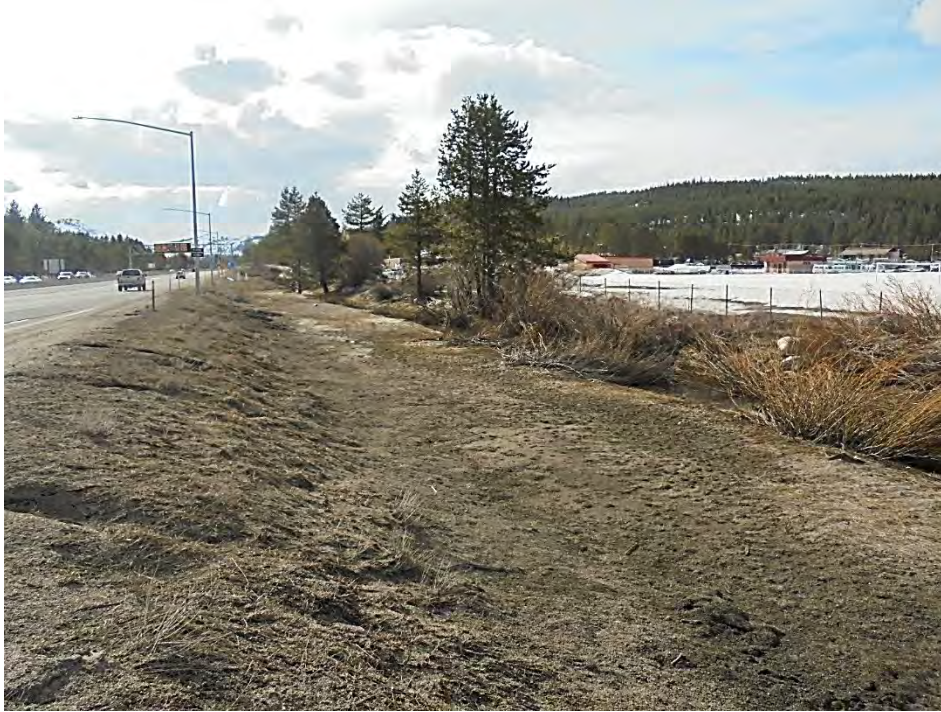
Western grading area taken from culverts to Donner Creek. Excavate as shown per field direct to expand floodplain area (right of photo). Check location clay layer prior to excavating to 5887' depth. Install (n) grass-lined swale/infiltration trench w/check dams at 100' O.C. (left of photo). Photo taken looking West. (3/29/2017)

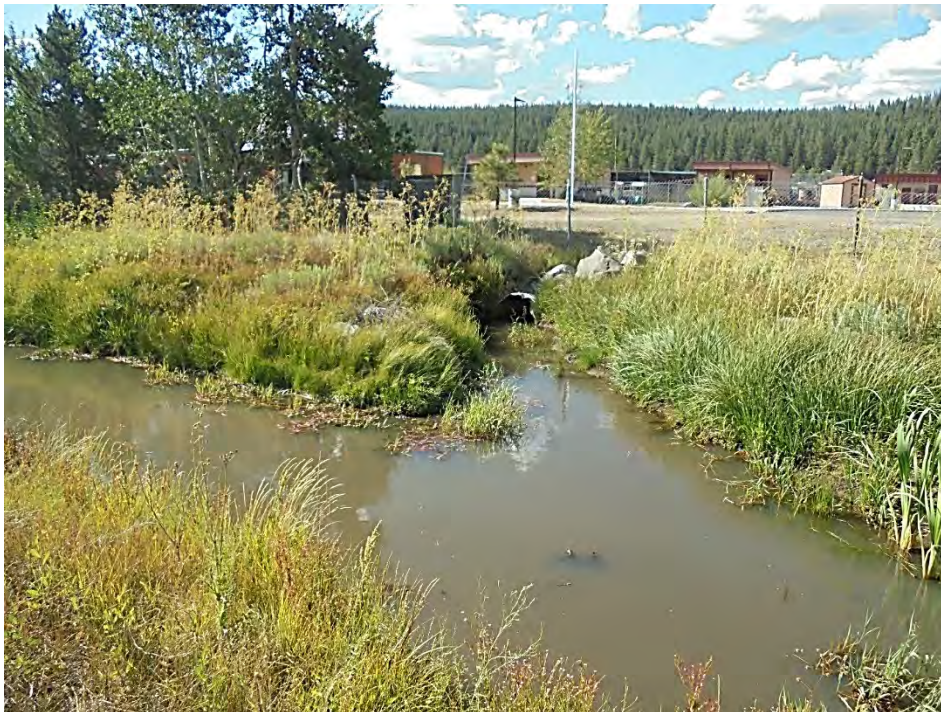
Western grading area. Tie into ex 5888' contour at culvert outlet (center of photo). Excavate as shown per field direct to expand floodplain area (right of photo). Check location clay layer prior to excavating to 5887' depth. Photo taken looking West (7/27/2017)

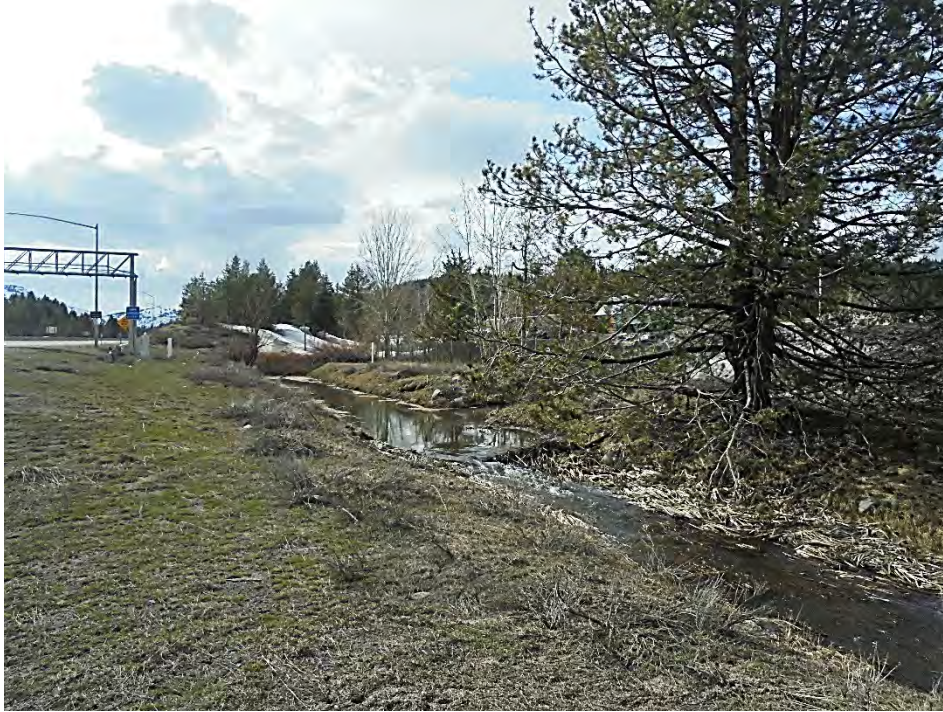
Western grading area, approximately Section B-B. Excavate as shown per field direct to expand floodplain area. Check location clay layer prior to excavating to 5887' depth. Photo taken looking West (3/29/2017)

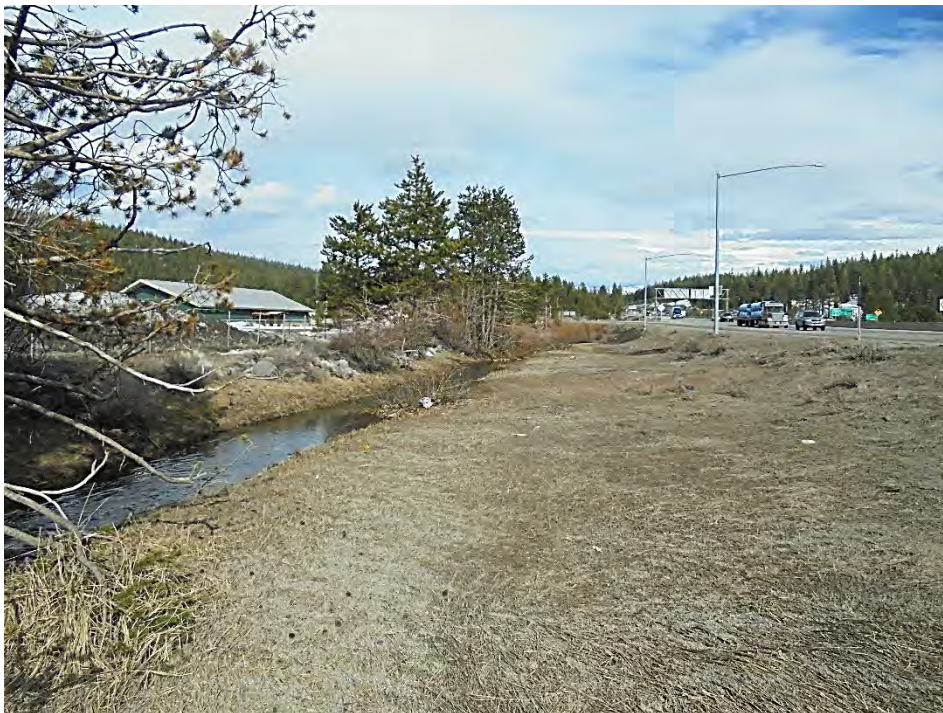
Western grading area, approximately Section B-B. Install (n) grass-lined swale/infiltration trench w/check dams at 100' O.C. (right of photo). Photo taken looking East (3/29/2017)

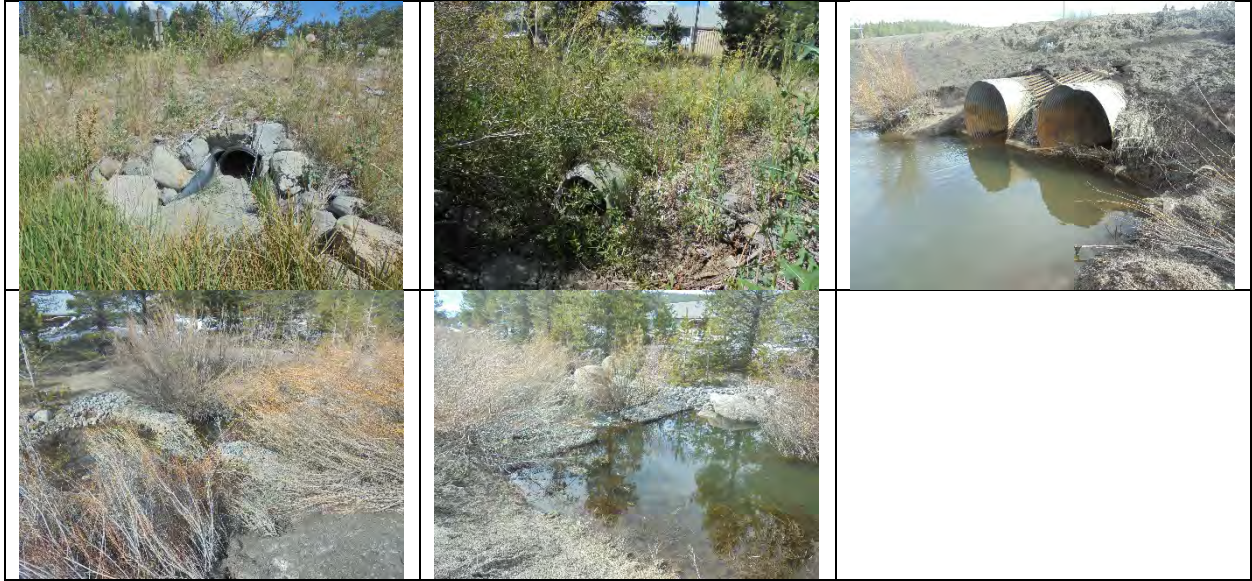
Preserve (E) rock gabion weirs and all (E) culverts. (7/27/2017)

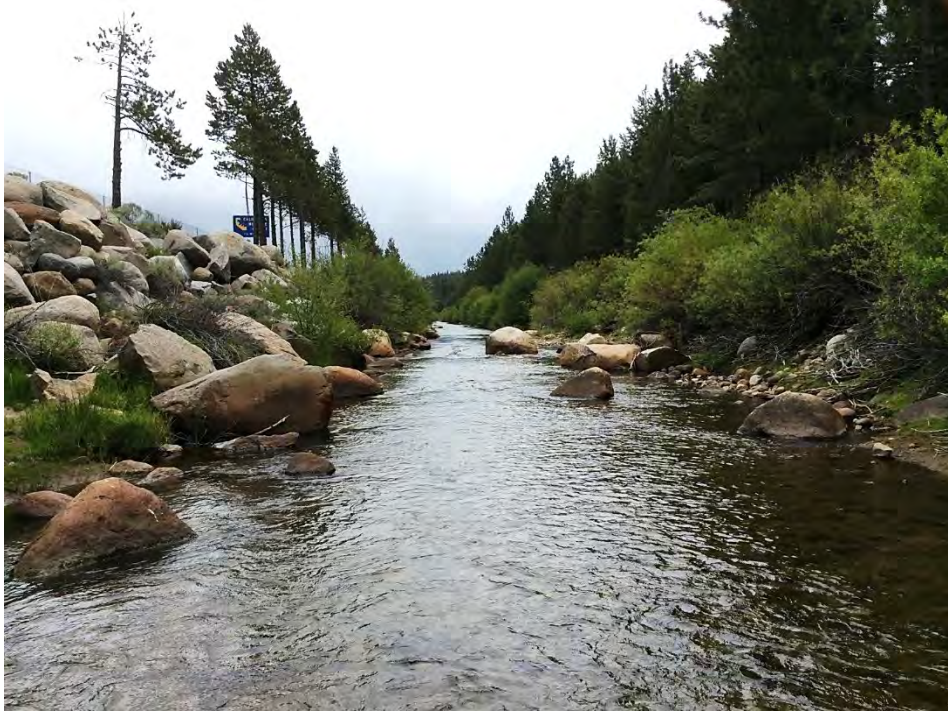
Upper Site 4 straightened channel, approximately Match Line 1. Install rootwad bendway weirs at 260'-320' OC spacing alternating from north to south bank as shown on plans. Photo taken looking East (8/7/2017)

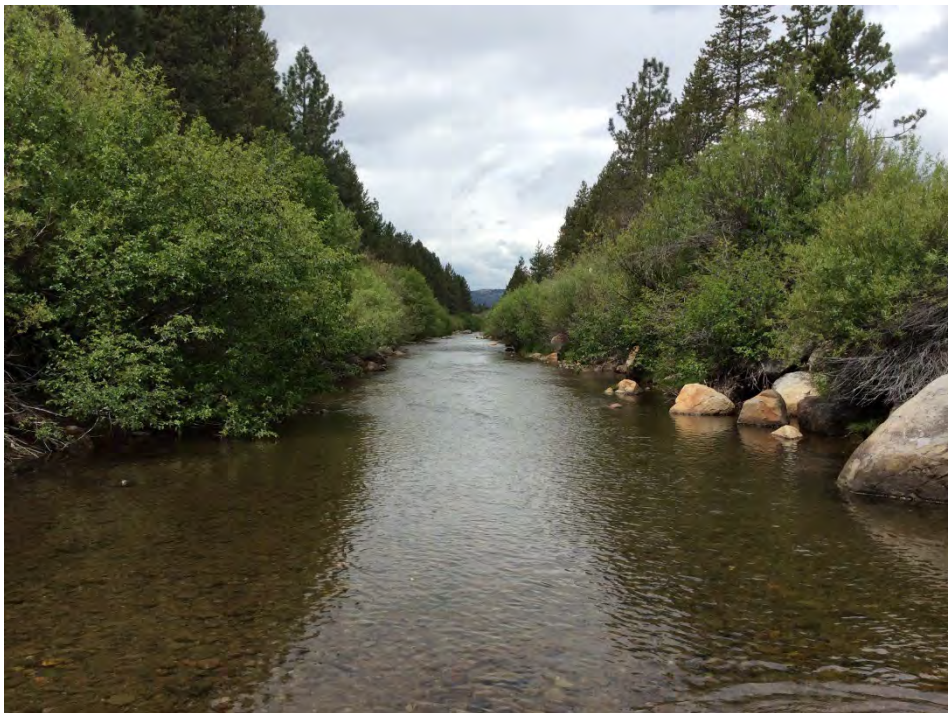
Middle Site 4 straightened channel. Install rootwad bendway weirs at 260'-320' OC spacing alternating from north to south bank as shown on plans. Photo taken looking East (8/7/2017)

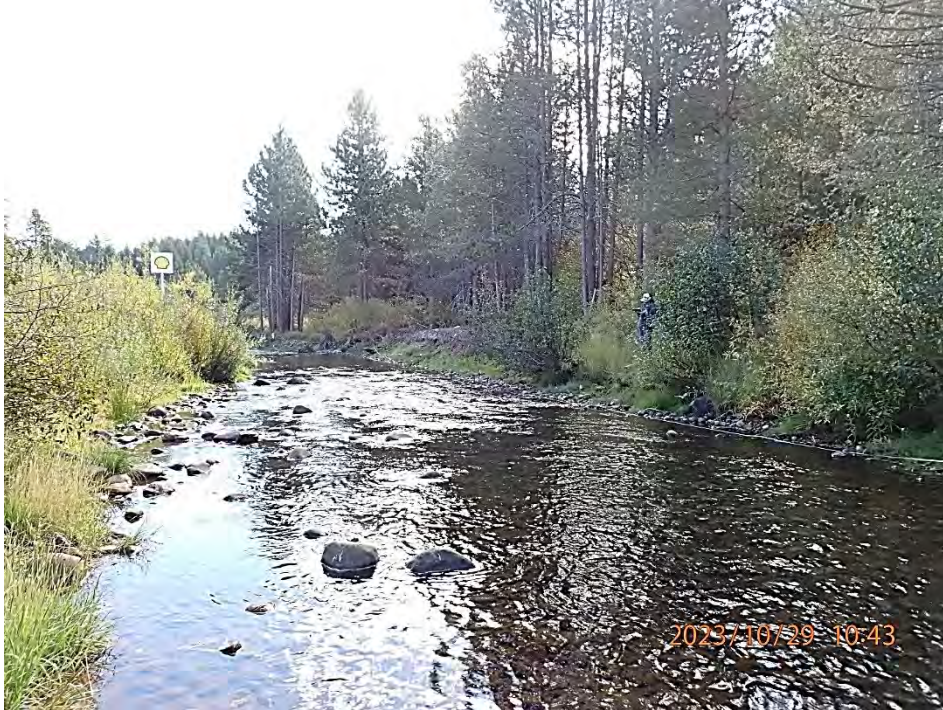
Lower Site 4, approximately from Match Line 3. Install rootwad bendway weir see note 4 (right of photo). Photo taken looking East (10/29/2023)

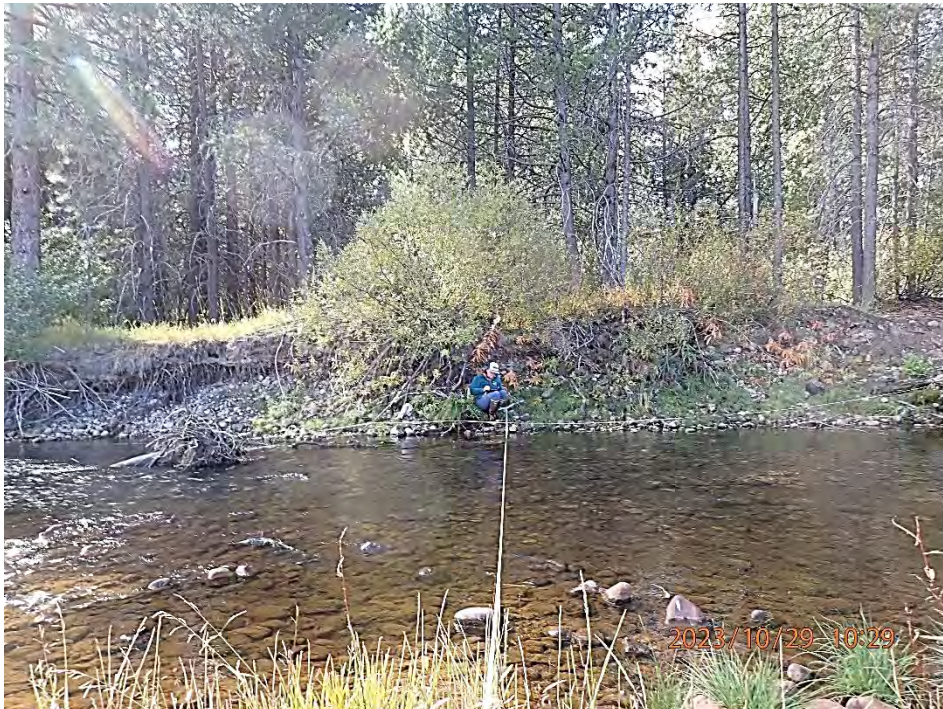
Lower Site 4, approximately Section A-A South bank. Install RSP with willows. Photo taken looking South (10/29/2023)

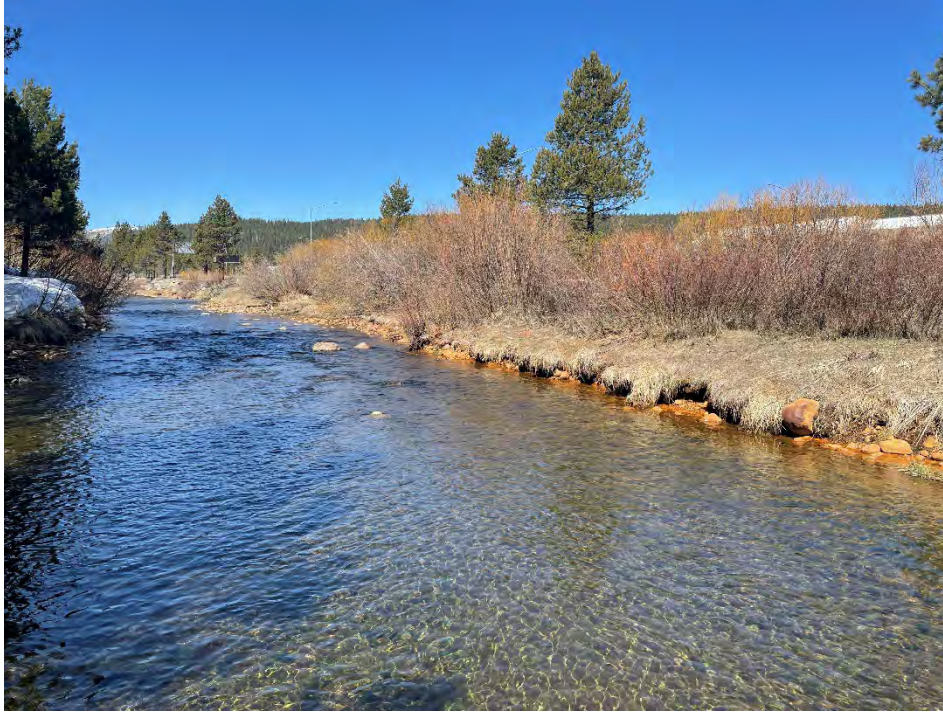
Lower Site 4, approximately Section A-A north bank. Salvage sod and willow and lower floodplain bench up to 1' per field direction. Photo taken looking West (March 2021)
