Donner Creek Restoration
Figure 1. Regional Location Map
Truckee, CA

Donner Creek Restoration Project Request for Bid Attachment 2 – Project Photos

Photos include access and staging areas, followed by restoration areas from upstream to downstream.

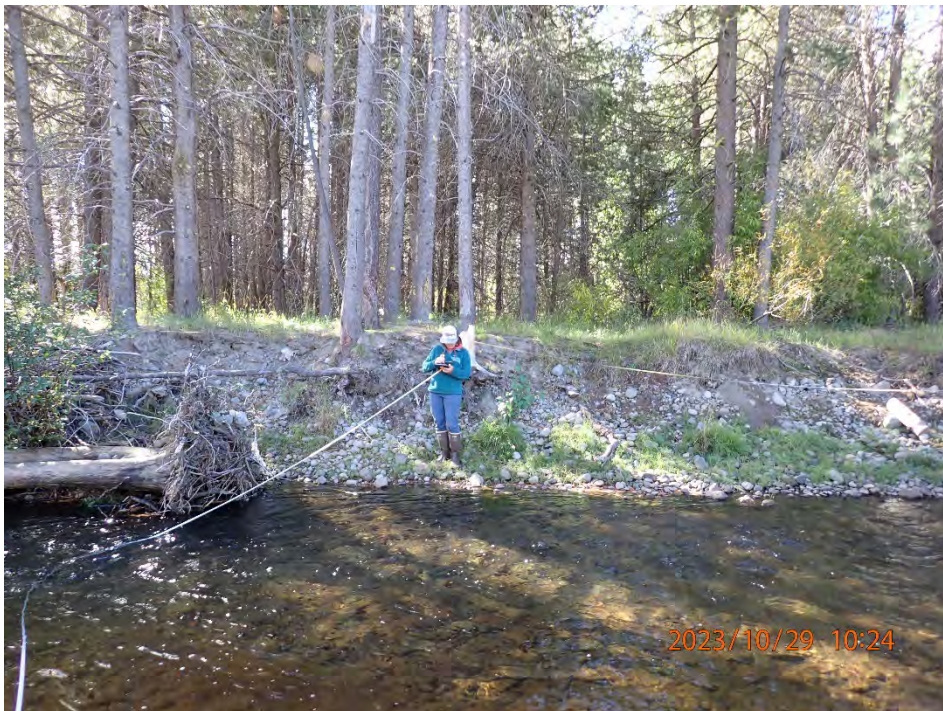
Lower Site 4. Remove downed logs/deposited material and incorporate into u/s RSP with willows per field direction. Photo taken looking South (10/29/2023)

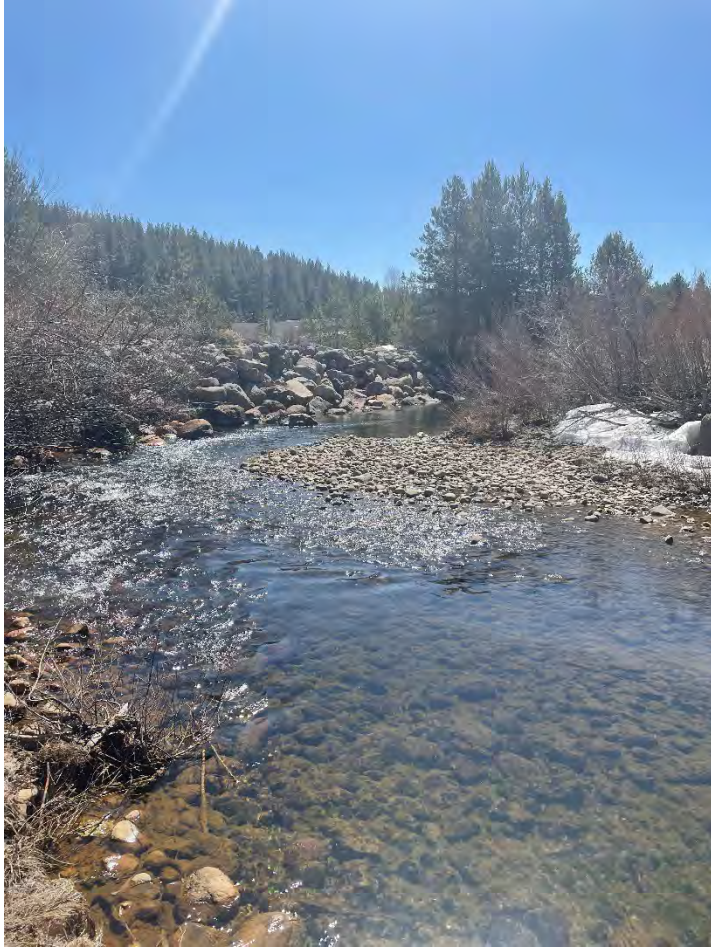
Lower Site 4, approximately Section B-B. Extend (E) RSP w/willows per field direction and Note 3. Photo taken looking East (March 2021)
