DONNER LAKE
INTERAGENCY
PARTNERSHIP FOR
STEWARDSHIP

STATE OF

DONNER LAKE

MARCH 2024 – DRAFT

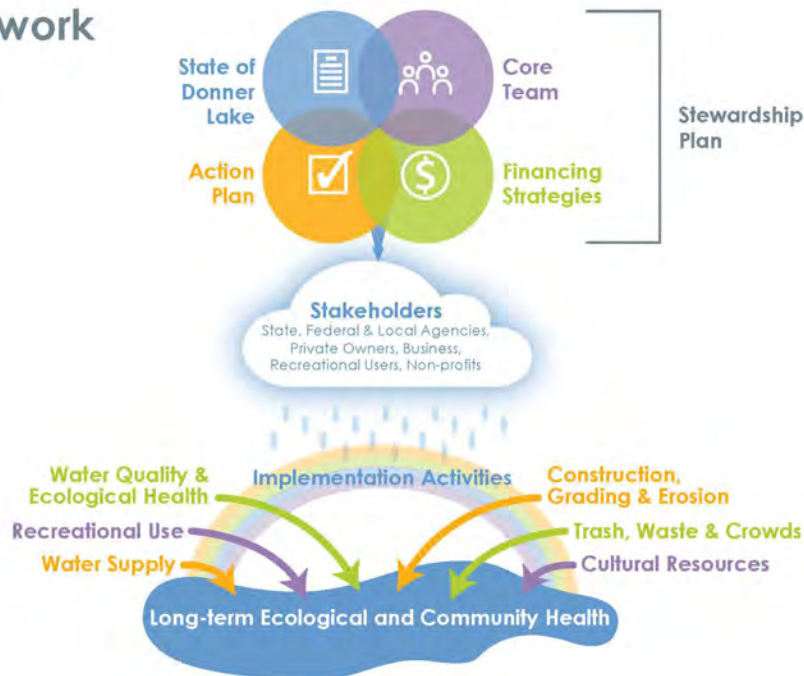
Figure 2. DIPS framework for developing the Stewardship Plan, engaging stakeholders, and implementing activities for the long-term ecological and community health of Donner Lake.

Figure 2 shows the relationships between the DIPS Core team, the State of Donner Lake, the Stewardship Plan, and additional stakeholders playing key roles in the lake and watershed.

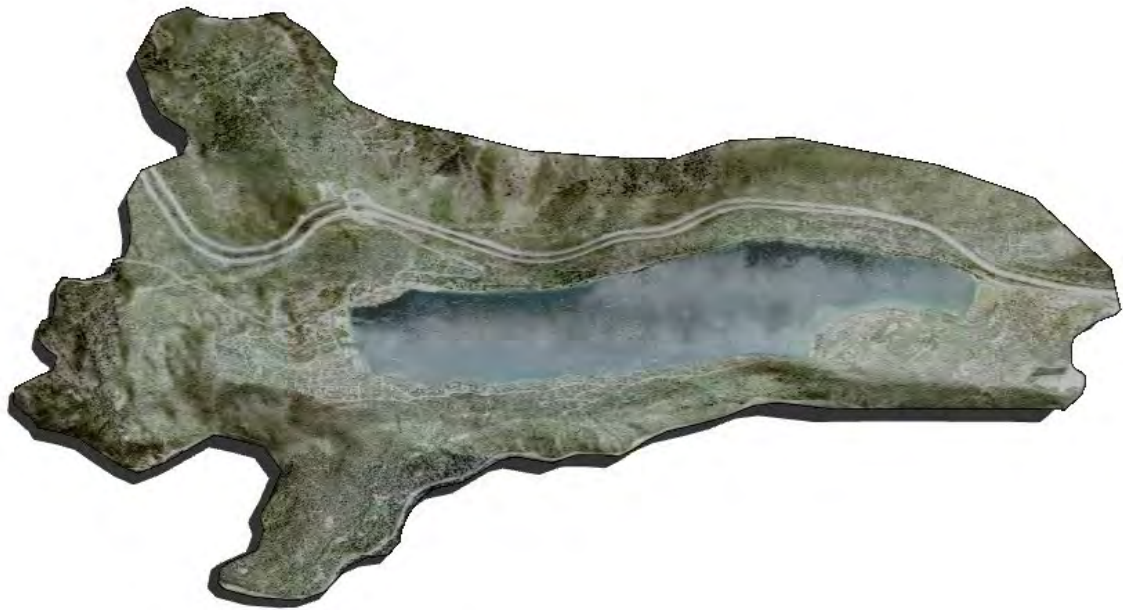
Figure 3. DIPS geographic area of interest.

Donner Lake is a freshwater mountain lake located just east of the Sierra Nevada crest within the Town of Truckee, California. The DIPS area of interest, shown in **Figure 3**, is bordered on the north by Interstate 80 and unincorporated Nevada County, on the south by the Union Pacific Railroad and unincorporated Placer County, on the east by the Town of Truckee, and on the west by Donner Summit and the Sierra Crest. The lake is at an elevation of approximately 6,000 feet and has a depth of 328 feet at its deepest point formed through a mix of glacial action and faulting. It is approximately 3 miles long, $\frac{3}{4}$ mile wide and 7 miles around. The water surface covers approximately 960 acres.

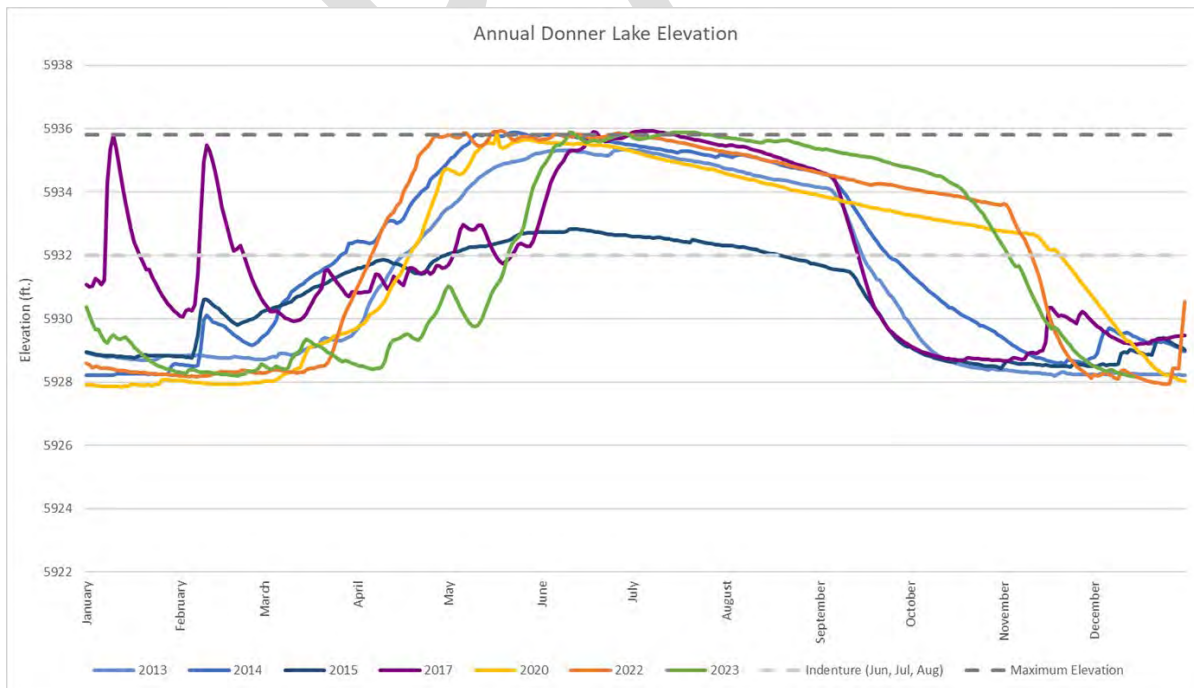
Figure 5. Donner Lake water surface elevations for select years. Credit: Truckee Meadows Water Authority

Furthermore, the lake is regulated by the 1943 Donner Lake Indenture Agreement which prohibits any releases above minimum flows during June, July, and August if the lake level falls below 5,932 feet. TMWA typically maintains high lake levels through the end of the summer for the benefit of local residents and recreational purposes. From the time of peak storage (usually late-May to early July) to the end of the summer (typically end of August or early September), lake levels are typically affected only by releases for ecological flows, incoming runoff from precipitation and evaporation. In early fall, typically between September and November, lake levels are drawn down for water supply (a combination of agricultural, municipal, industrial and hydropower) purposes and in preparation for meeting flood control requirements. See **Figure 5** for Donner Lake water surface elevations for select years.

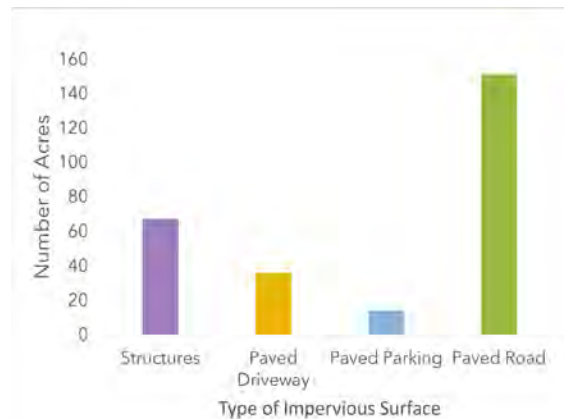
Figure 14. Acres of impervious surface by type of surface.

As noted in **Table 3** and **Figure 14**, there are just over 200 acres of impervious surfaces around Donner Lake, with paved roads and structures making up the majority. With up to date, well maintained low impact storm water treatment infrastructure (e.g. bio-swales, retention areas, rain/snow gardens), water quality and sediment impacts can be substantially reduced, but much of Donner’s infrastructure and construction dates back to an earlier era when storm water facilities were not as well regulated, designed or built.

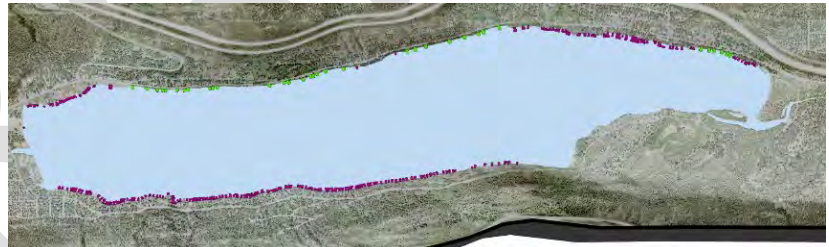
Figure 16. Private and public docks within the Donner Lake study area.

Figure 16 shows the locations of 37 public piers all located on the lake's north side and 225 permitted private piers scattered around the lake. The public piers are managed by the Truckee Donner Recreation and Park District. TDRPD repairs and replaces selected docks each year based on need and resource availability.

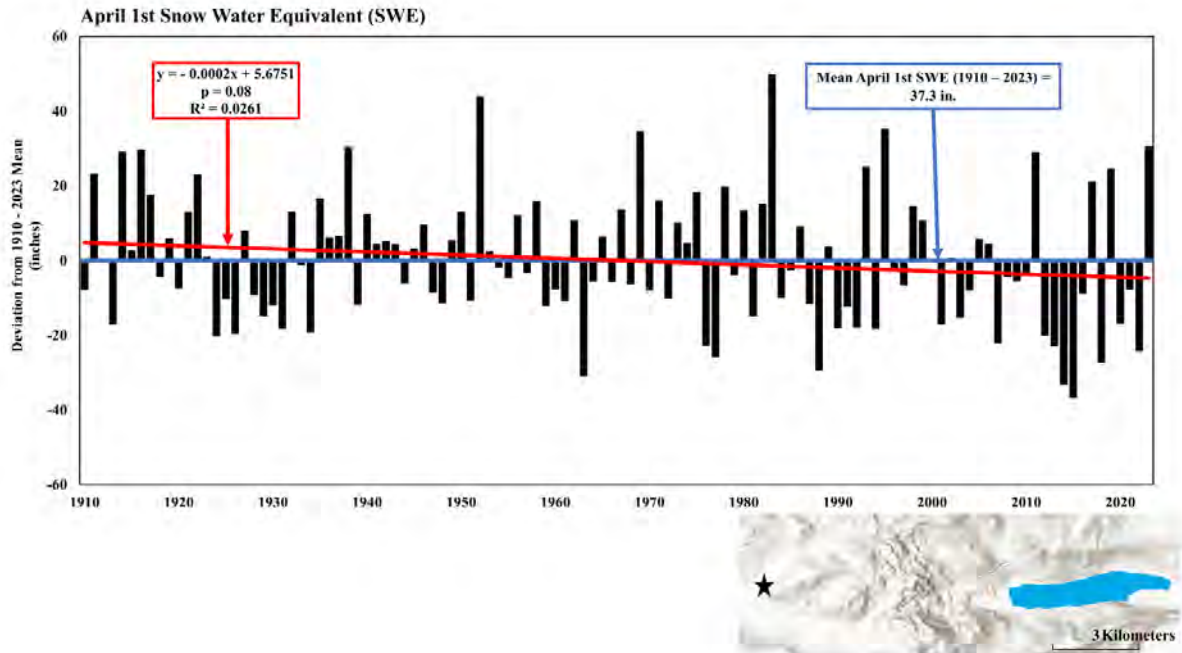
Figure 17. Snow Water Equivalent at Donner Pass, CA as measured on April 1st, 1910 to present. Source: UC Berkeley Central-Sierra Snow Laboratory.

Regional climate has a large influence on the ecology of Donner Lake. Snowpack (measured as snow water equivalent (SWE), or the amount of water within snow) governs the lake's water level, the timing of lake mixing, summertime thermal structure of the lake, the length of the growing season for algae, and nutrient loading to the lake. A record of SWE allows us to understand the influence of climate on the lake. UC Berkeley's Central Sierra Snow Laboratory near Donner Pass has collected one of the longest records of snowpack in the Sierra Nevada, measuring annual SWE since the early 1900s (**Figure 17**). Historic April 1st SWE measurements fall into 3 categories: 1) above-average (above the blue line) SWE, average SWE (37.3 inches), and below-average SWE (below the blue line) snow water content observed on April 1st. Due to the high elevation of the watershed, the snowpack shows no major long-term decline, indicating the potential throughput of water in the Donner Lake watershed. However, in recent decades and especially since 2010, SWE has generally been below average, indicating the potential for the watershed and its vegetation to be drier compared to in previous decades.

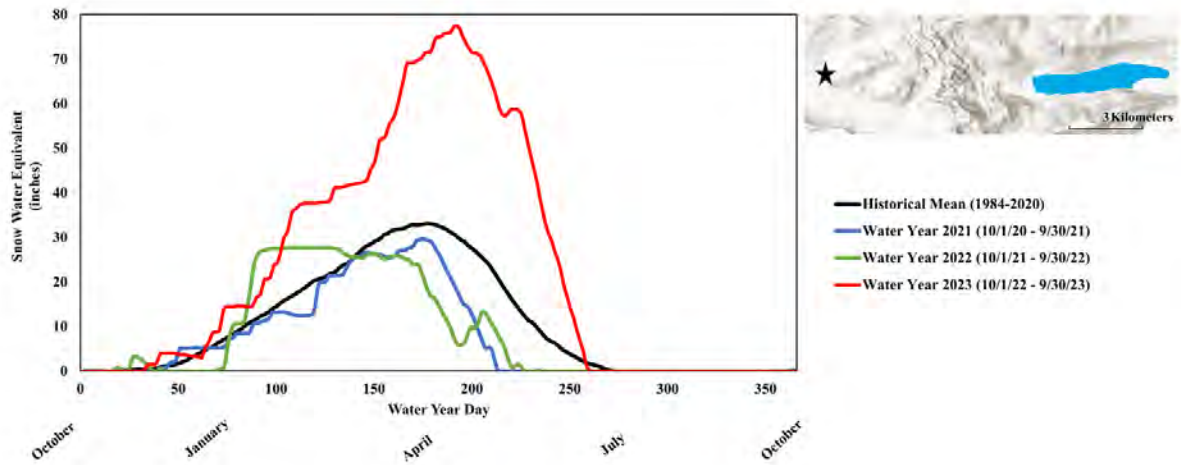
Figure 18. Snow Water Equivalent by month at Donner Pass, CA, Water Years 2021-2023 compared to historical mean (1984-2020). Source: UC Berkeley Central-Sierra Snow Laboratory.

The Sierra Nevada receives its precipitation most often as snow from Fall to Spring. Hydrologists measure the amount of snow that falls throughout the Water Year, starting on October 1 and ending on September 30th. Historically, snowpack SWE values are generally greatest from March to April, and the mean maximum SWE from 1984 to 2020 was approximately 30 inches (black line). The contemporary studies undertaken to evaluate the condition of Donner Lake occurred in 2021 to 2023. The first two years of this study (**Figure 18**; 2021 in blue and 2022 in green) had SWE values from January to April that were similar to the historical average. However, the water year 2023 (red) had a snowpack that was much greater than both the historical mean and 2021-2022.

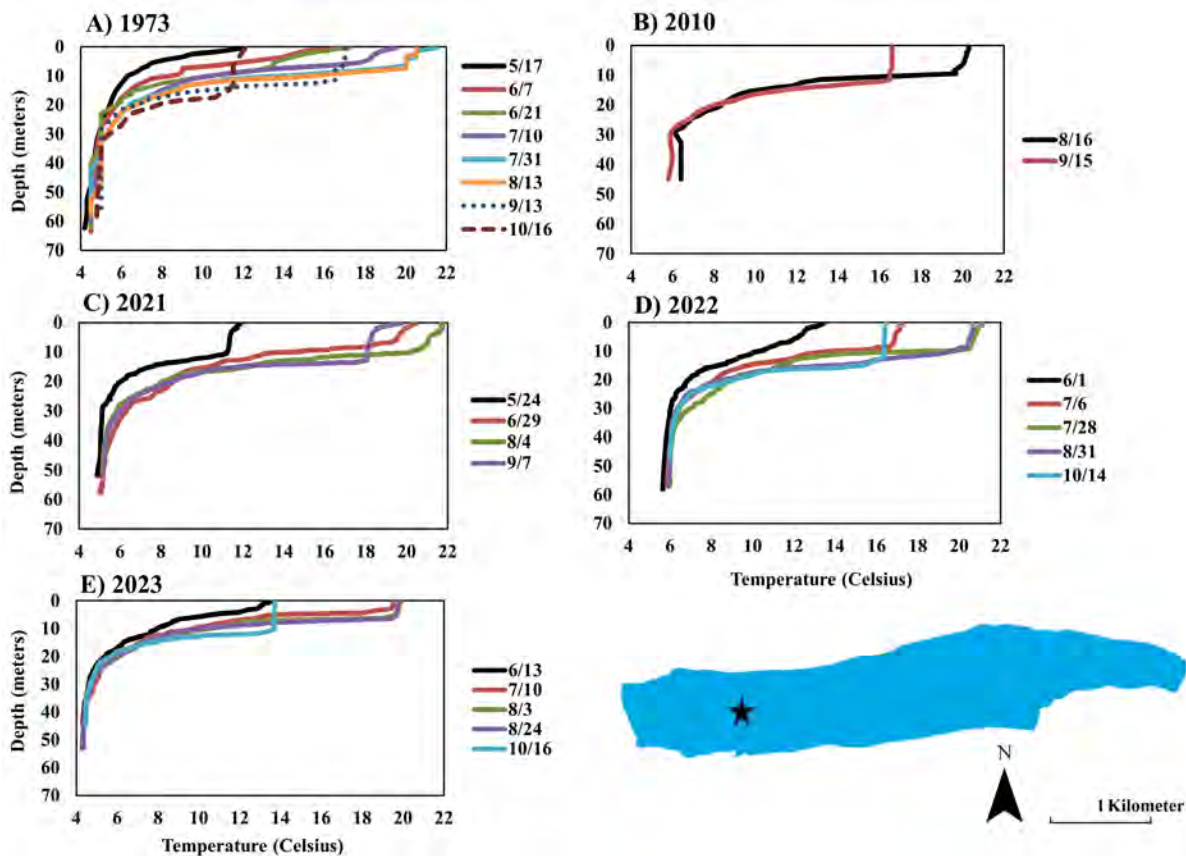
Figure 20 (A-E). Offshore water temperature at Donner Lake, select years 1973-2023. Source: Global Water Center, UNR.

Historical (1973 and 2010) and contemporary (2021-2023) water profiles in Donner Lake indicate a typical pattern for mountain lakes in our region. The lake is most stratified in mid-summer and less stratified in spring and fall. In mid-summer, the mixed upper layer can reach 10 to 11 meters depth. In the fall, the mixed upper layer is gradually eroded by deeper mixing. Near-surface, mixed-layer water temperatures can reach 20 to 22 degrees Celsius in the summer, typical for mountain lakes in this region. Below the transitional thermocline, water can reach temperatures as low as 4 degrees Celsius, especially in years with high SWE and spring inflows. Long-term monitoring of temperature profiles will be important for understanding the connections between climate (air temperature, precipitation) and lake conditions.

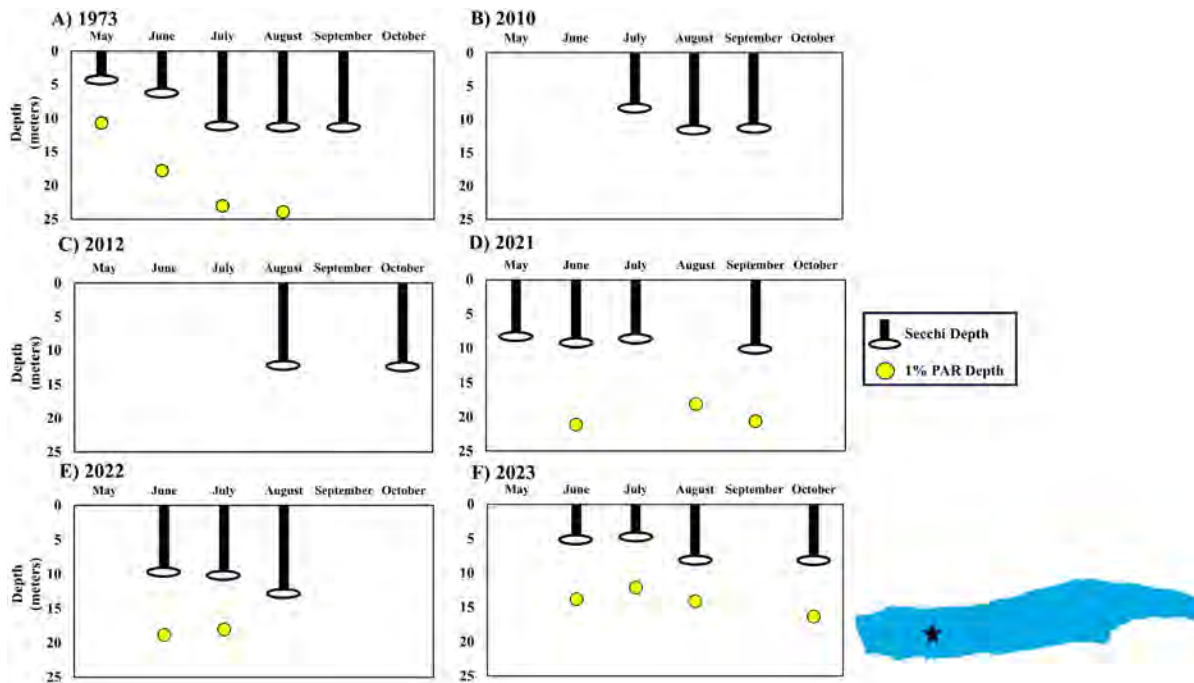
Figure 21. Water clarity at Donner Lake, select years 1973-2023. Source: Global Water Center, UNR.

Historical measurements of Donner Lake's clarity from 1973 indicate seasonal changes in clarity as measured by a Secchi disk (**Figure 21**). A white Secchi disk can be seen to depths of generally 5 to 7 meters in spring and early summer. However, clarity increases throughout the summer such that the Secchi disk can be seen at a depth of 12 meters from July to August. The deepest Secchi depth ever observed in Donner Lake was in August 2022 (13.5 meters) while the shallowest was in May 1973 (5.0 meters). Decreases in transparency can be caused by a variety of factors such as high snowpack runoff (2023), or increased runoff of nutrients and sediment or smoke from wildfires (summer 2022). One percent PAR depths at Donner Lake suggest that plant production may have been as deep as 23.9 meters in August 1973 and as deep as 21.1 and 18.8 meters in 2021 and 2022, respectively. However, the maximum 1% PAR depth observed in water year 2023 was only 16.3. These measurements indicate that both clarity and light transmission are highly variable in the lake, likely driven by the particles delivered to the lake during spring inflow and algal production in the lake. Longer-term monitoring of clarity using both Secchi disk and more precise light instrumentation can provide a robust understanding of water quality conditions in the lake over time.

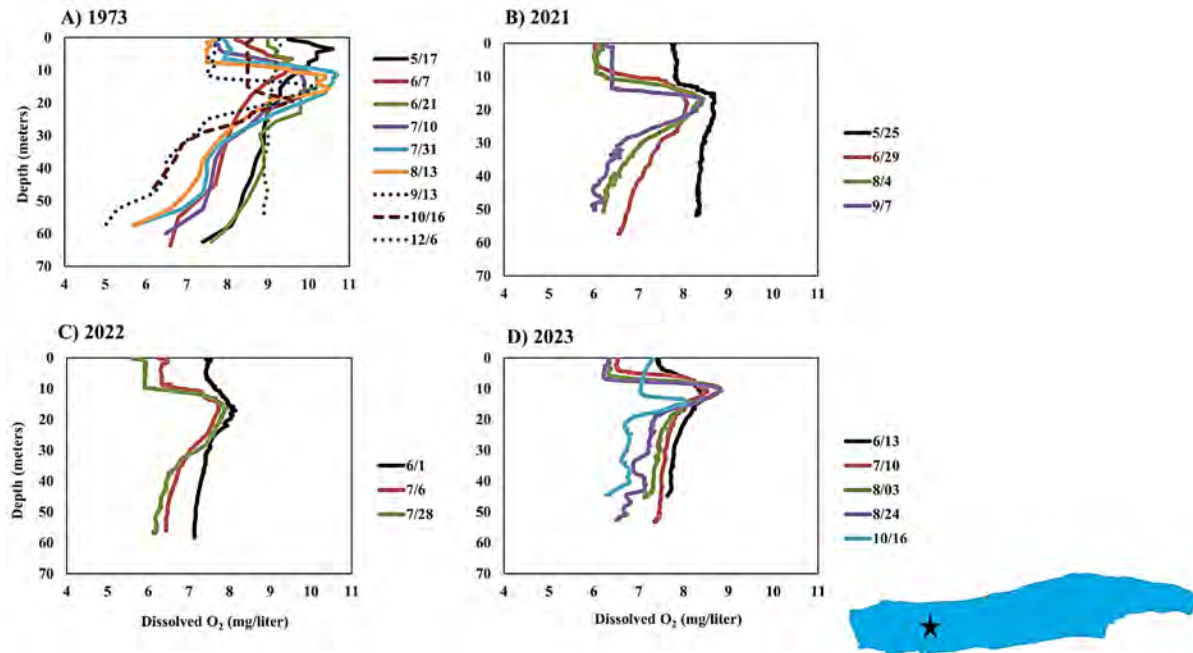
Figure 22. Dissolved Oxygen at depth at Donner Lake, select years 1973-2023. Source: Global Water Center, UNR.

Historic (1973) and present (2021-2023) dissolved oxygen profiles show well-oxygenated conditions (**Figure 22**). There are strong, seasonal oxygen dynamics similar to what is observed in other transparent, deep mountain lakes in the region. Oxygen concentrations are highest in the surface mixed layers during spring runoff in May to early June and decrease throughout the summer. At moderate depths (15-20 meters), oxygen increases, suggesting an area of maximum algal biomass but also a zone of temperatures that transitions to colder waters.

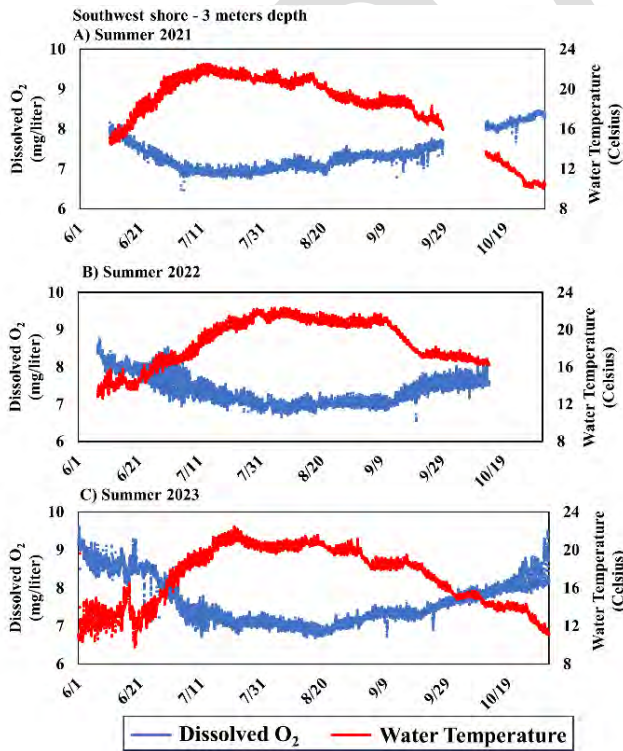
Figure 24. Dissolved Oxygen and Water Temperature on the South Shore of Donner Lake, 2021-2023. Source: Global Water Center, UNR.

Using automated probes, we collected high-frequency measurements of oxygen concentration and water temperature in two shallow areas of the lake (**Figure 23** and **Figure 24**). In general, nearshore water temperature is highest in July and August. In 2021, however, summer water temperatures cooled in mid to late summer, presumably due to increased wildfire smoke in the basin (see 6.2 Air Quality and Wildfire Smoke). Nearshore oxygen concentrations reflect daily shifts in oxygen with higher concentrations during the day when sunlight drives photosynthesis and nearshore algal growth. In 2021, on the northeast shore of the lake, there were more variable oxygen concentrations while the lake was cooling, and smoke conditions increased in the airshed. Continued monitoring of nearshore oxygen and calculations of algal and bacterial production is valuable for understanding how climate or introduced species influence water quality and nearshore algal and bacterial growth. Recent evidence from other clear water lakes suggests that nearshore water quality is degrading but the exact reasons are multifold.

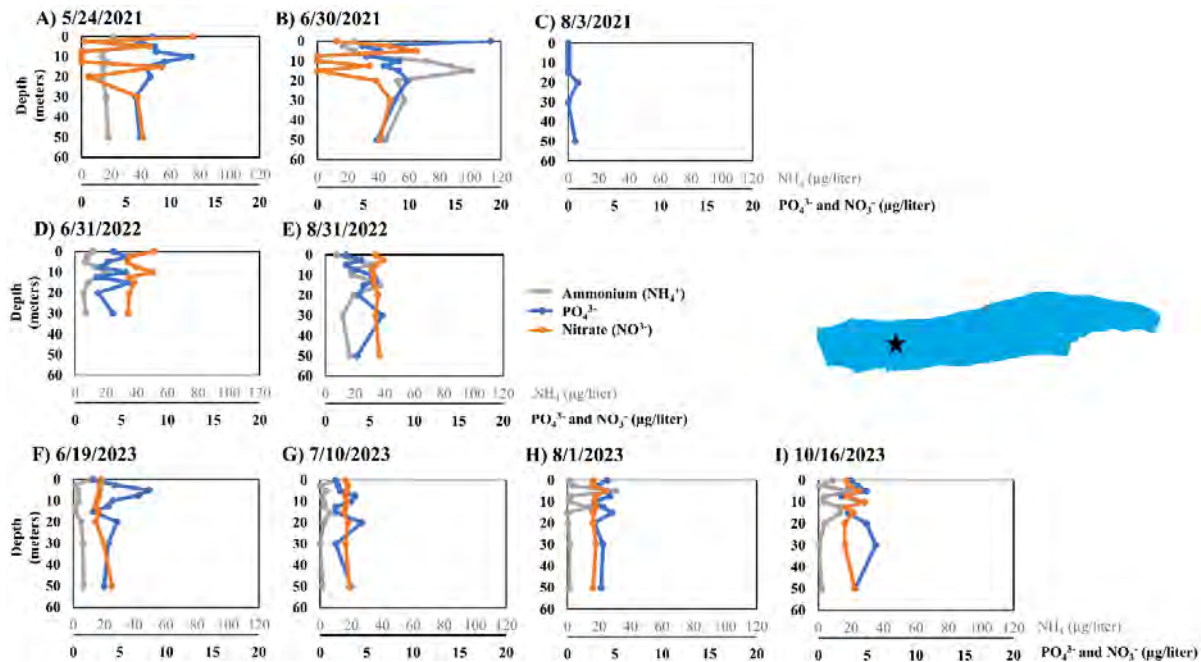
Figure 25 (A-I). Nutrients at depth at Donner Lake, 2021-2023. Source: Global Water Center, UNR.

In **Figure 25**, several patterns can be observed with regard to the nutrients. Each of these patterns reflects the fact that summertime oxygen concentrations are relatively high in Donner Lake. For instance, ammonium concentrations are generally low as would be expected in high-elevation lakes such as Donner Lake where oxygen concentrations are generally high. The high concentration of oxygen allows for organisms to take up the ammonium as a nutrient throughout the water column, leaving behind only trace amounts of ammonium. The concentrations of both phosphorus and nitrate are likewise reflective of the oxygen profile throughout the water column. Specifically, the high concentrations of oxygen in the upper water column allow for nitrifying bacteria to produce nitrate while slightly lower oxygen concentrations deeper in the water column lead to relatively lower nitrate concentrations. Likewise, the availability of oxygen keeps phosphate concentrations low by reacting with the phosphate to produce precipitated phosphorus that sinks into the sediment.

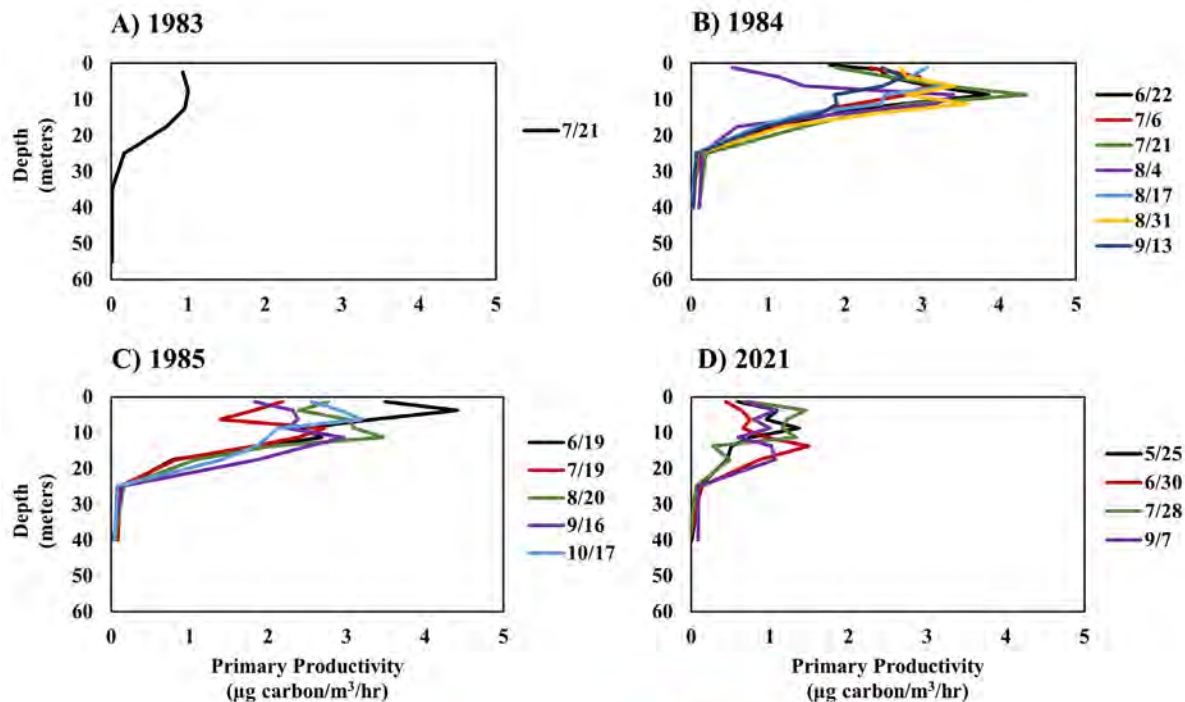
Figure 27. Primary Productivity at Donner Lake, 1983-1985 and 2021. Source: Global Water Center, UNR.

Measurements of open-water productivity using carbon tracing were historically performed at Donner Lake and again in 2021. These measurements are obtained by conducting experiments with tracers in the cells of phytoplankton. As seen in **Figure 27**, historical experiments (1983-85) showed higher phytoplankton (open water algae) production compared to recent times (2021). Production is typically maximized in the top 10 meters and develops during the summer growing season.

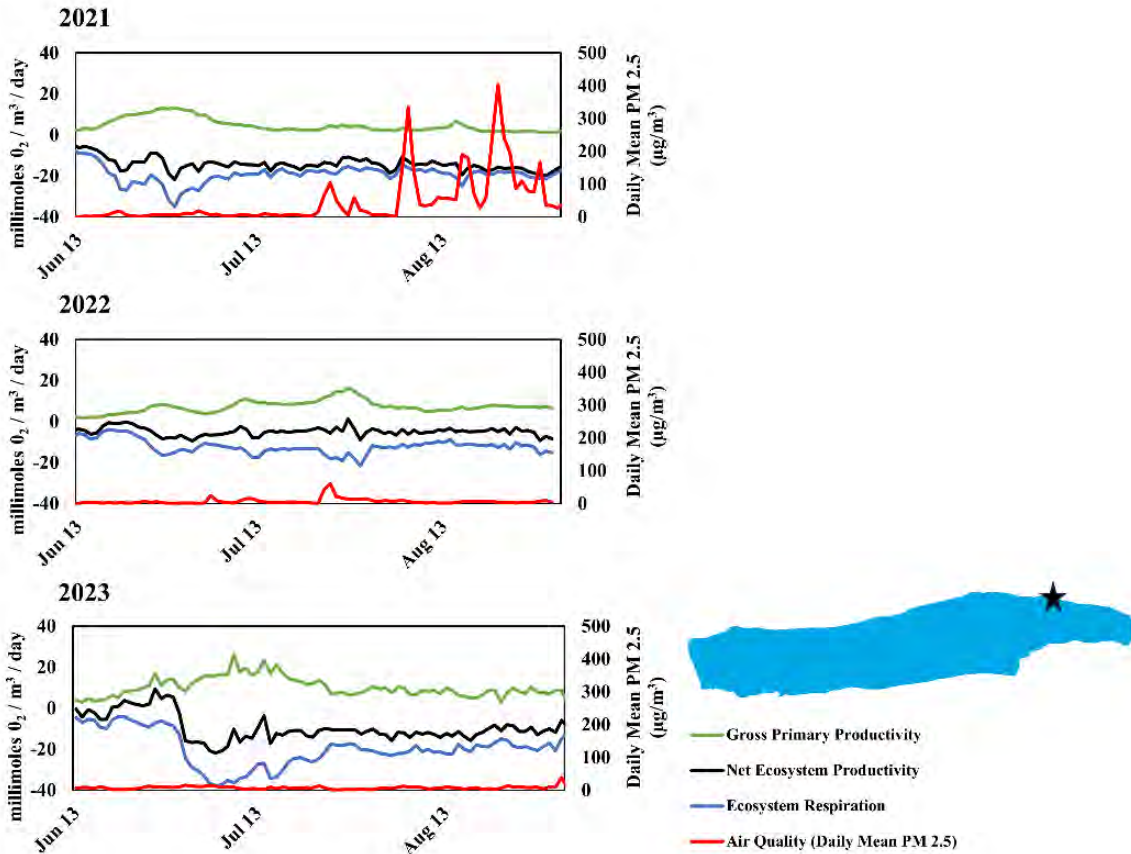
Figure 28. Gross Primary Productivity (GPP), Net Ecosystem Productivity (NEP), Ecosystem Respiration (ER), and Air Quality at Donner Lake, 2021-2023. Source: Global Water Center, UNR.

respiration are not influenced by the presence of smoke in the atmosphere (the red line in **Figure 28**).

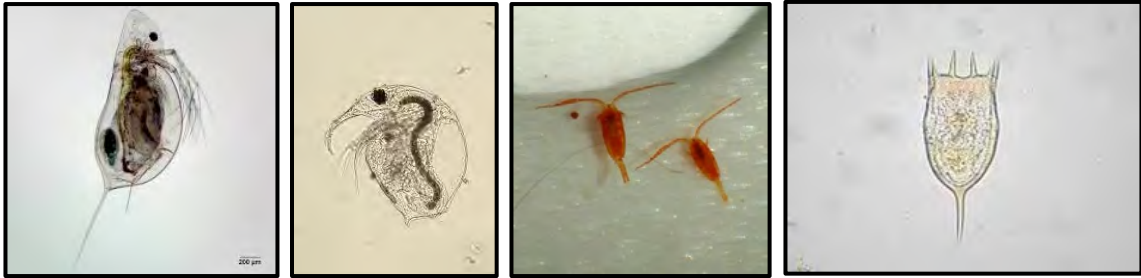
Bosmina

Daphnia

Figure 29. Native and non-native zooplankton in Donner Lake.

The native zooplankton in Donner Lake are *Daphnia*, *Bosmina*, copepods (*Diaptomus*, cyclopoids), *Kellicotia*, *Keratella*, and *Polyarthra* (**Figure 29**). Their densities are highest in late summer (August), but highly variable over years (**Figure 30**). Sometimes, lower densities are observed at the beginning of the growing season (e.g., June and July 2023)

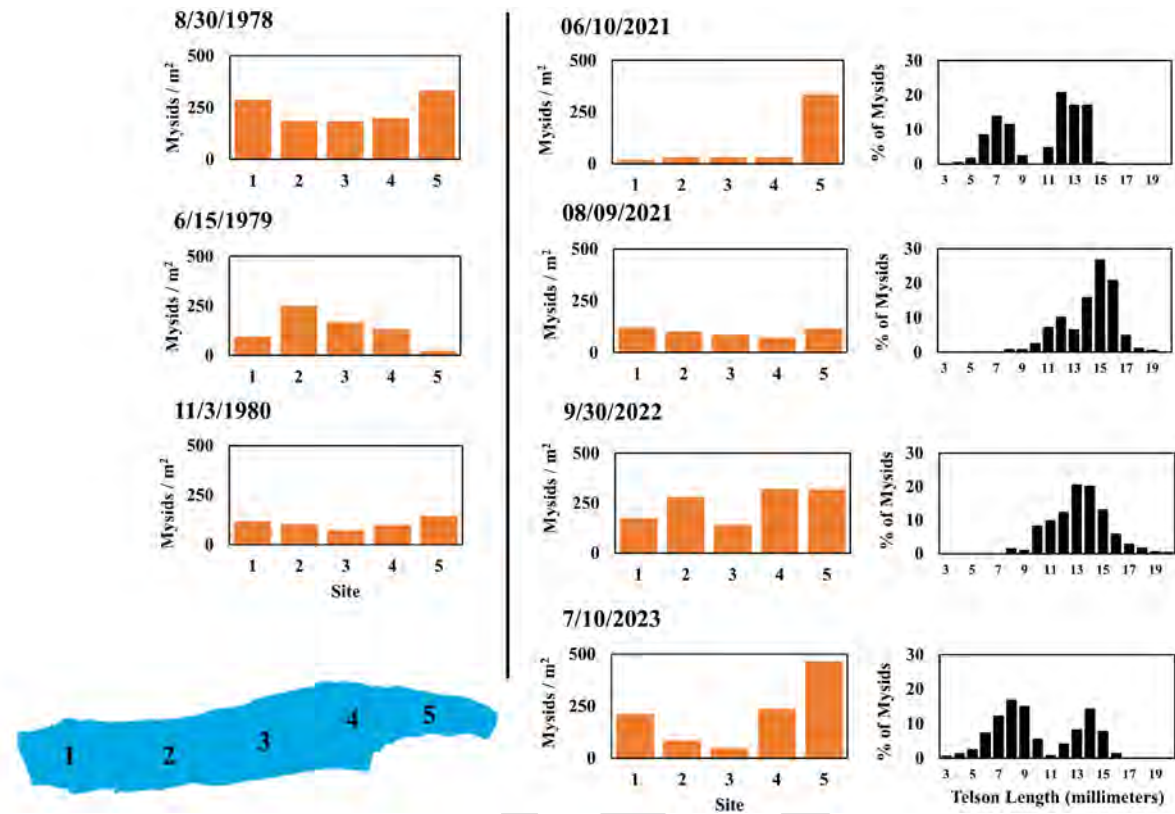
Figure 31. Mysis shrimp density at various location, 1978-1980, 2021-2023, and Telson length, 2021-2023. Source: Global Water Center, UNR.

The non-native mysids can migrate vertically and horizontally. Therefore, we sampled these mysids across the lake at 5 locations during the nighttime when they have migrated out of the deep bottom waters (**Figure 31**). The length of a mysid is approximately the diameter of a quarter. Despite their small size, they are excellent visual predators, feeding on other zooplankton and serving a food item for fishes like kokanee salmon, juvenile trout, and forage fishes. They can live for more than 2 years. Recent densities of mysids (2021-2023) in Donner Lake are similar to what was observed historically (1978-1980). In early summer, measurements of telson lengths show the presence of two cohorts (small juveniles and large adults). By fall, these two cohorts become indistinguishable due to the growth that the juveniles experience throughout the summer.

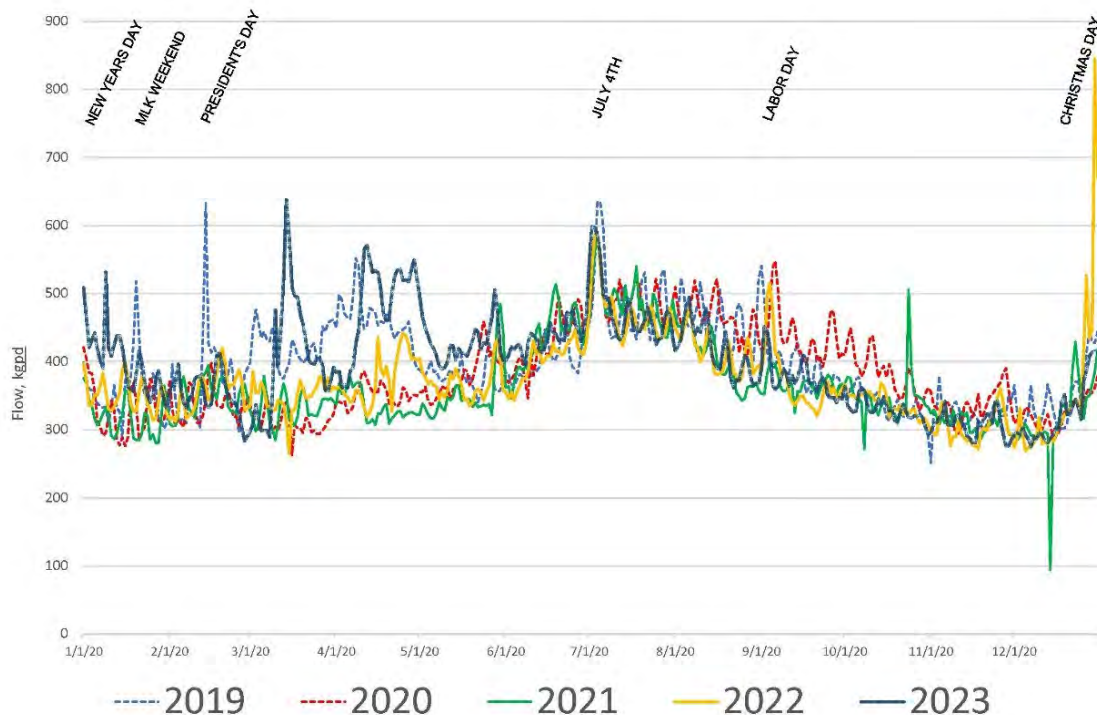
Figure 44. TSD daily sewage flows within the Donner Lake study area. Source: TSD as of 3/6/2024.

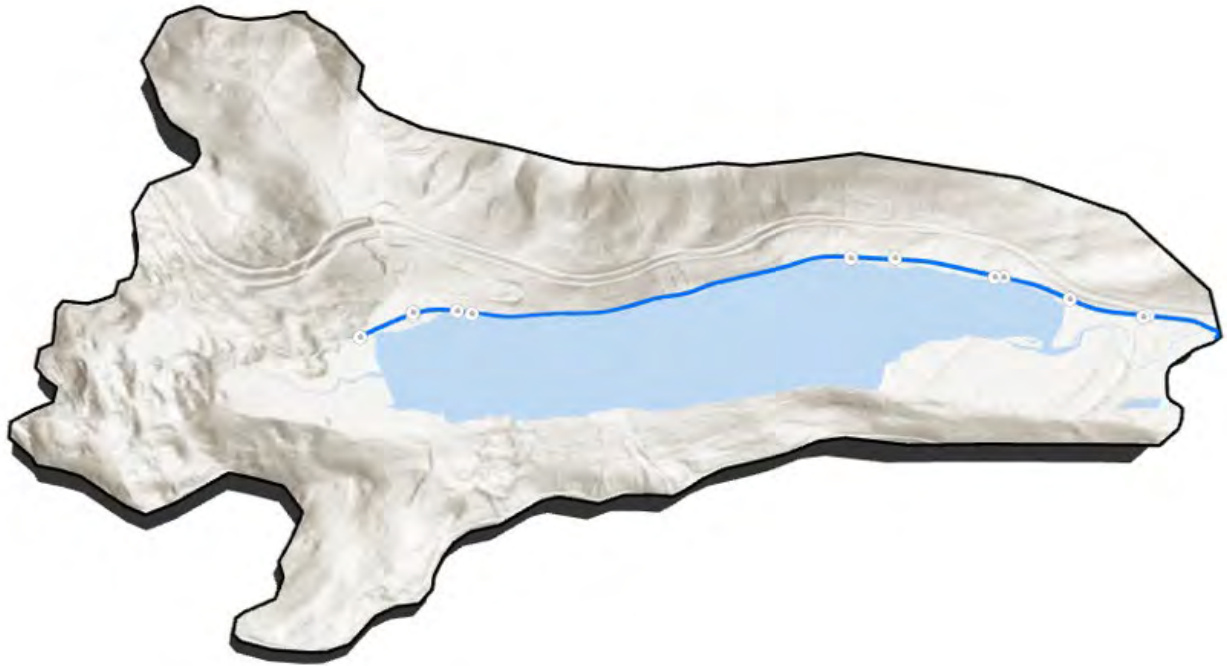
Figure 46. Map of public bus route with points indicating bus stops. Source: Town of Truckee as of 3/3/2022.

Traffic and parking are consistent concerns at Donner Lake driven by concerns about safety, overcrowding, pollution, and excess erosion. Truckee Area Rapid Transit operates a single route to serve Donner Lake along Donner Pass Road from West End Beach to Donner Memorial State Park and points east (**Figure 46**). **Table 15** and **Figure 47** depict the ridership of public transit service at the lake. In 2022 in partnership with the Town of Truckee, TART began providing the new point to point, on-demand TART Connect Also in 2022, the Tahoe Donner Association began offering a shuttle service from the Truckee High School parking lot to the Beach Club Marina July-September. Other potential transportation initiatives include launching an e-bike share for the east end of Donner Lake and a shuttle for the 4th of July. Since 2020, ridership has been increasing consistently.
