Conceptual Design and Feasibility Study Mainstem Martis Creek Placer County, California

August 2016

**Balance
Hydrologics, Inc.®**

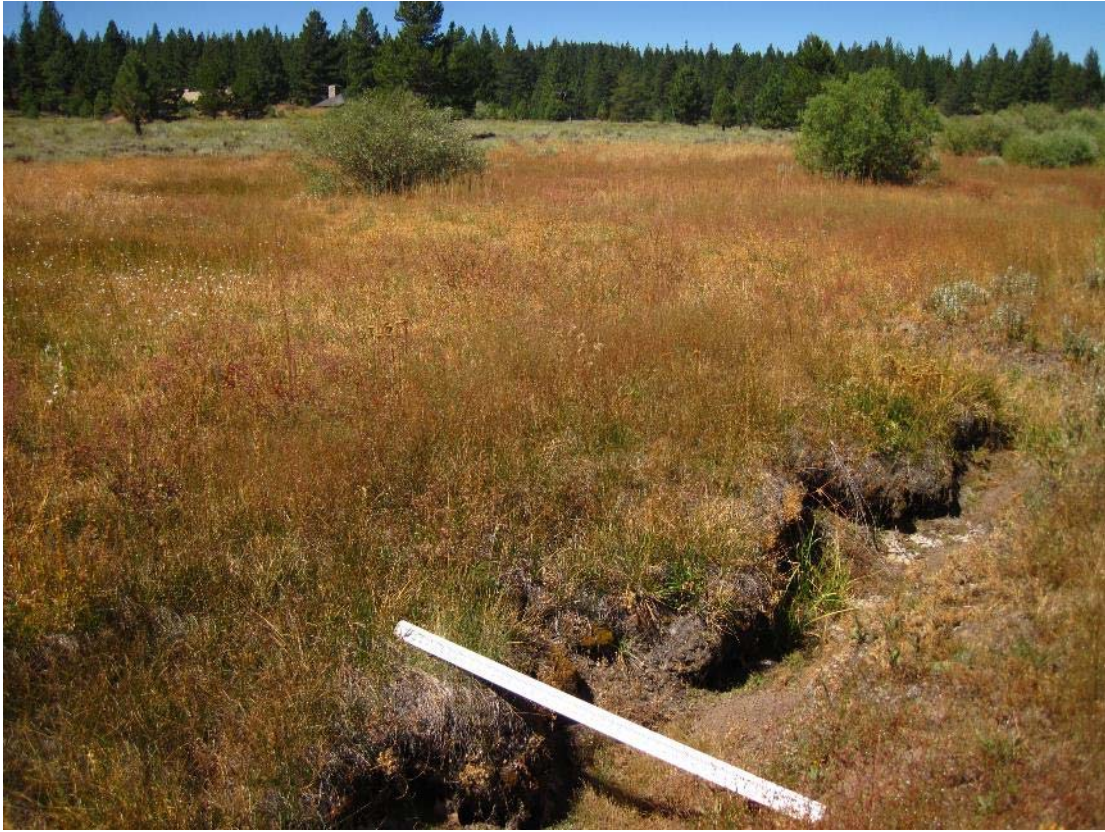
Abandoned irrigation ditch, Mainstem Martis Creek, Reach 1

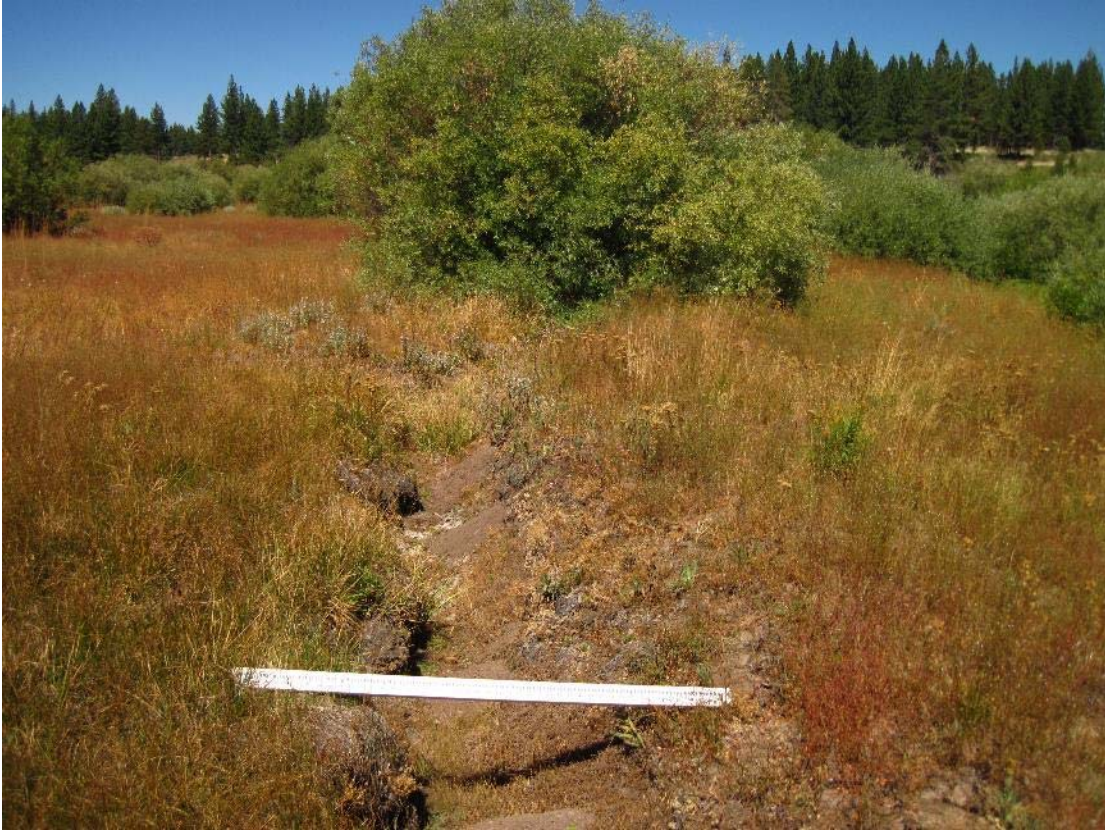
Abandoned irrigation ditch, Mainstem Martis Creek, Reach 1

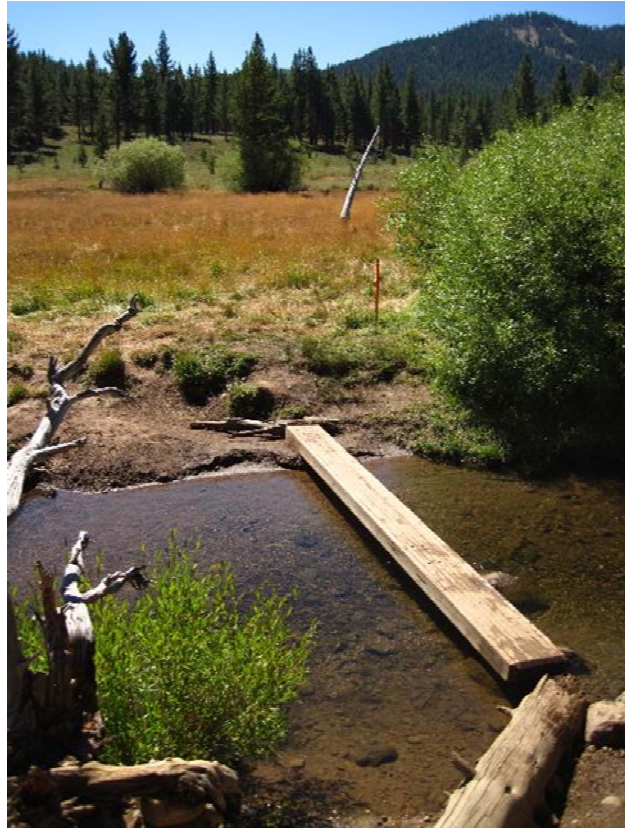
Unofficial footbridge/trail and bank erosion, Mainstem Martis Creek, Reach 1

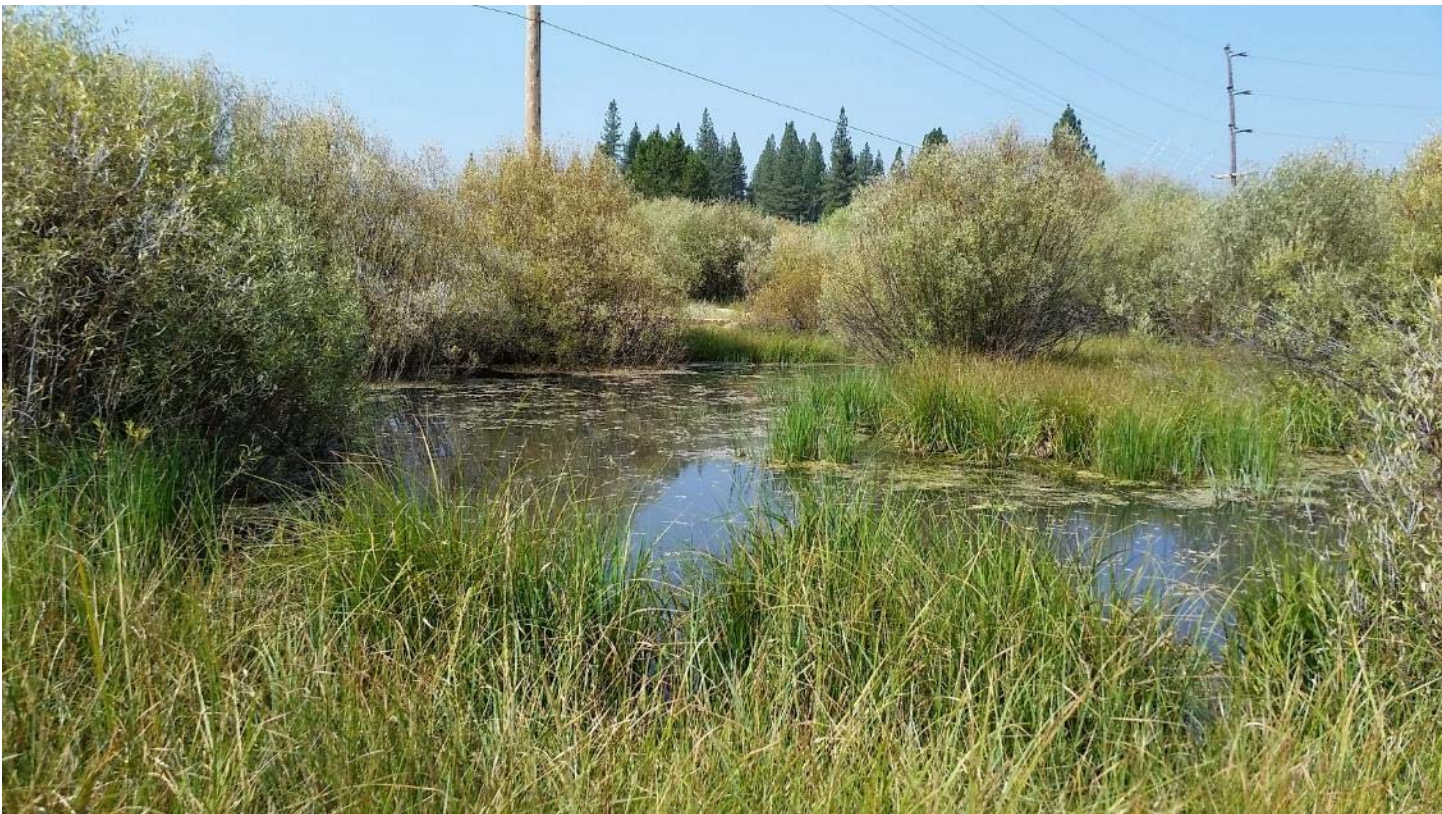
Inundation from active beaver dam, Mainstem Martis Creek, Reach 2

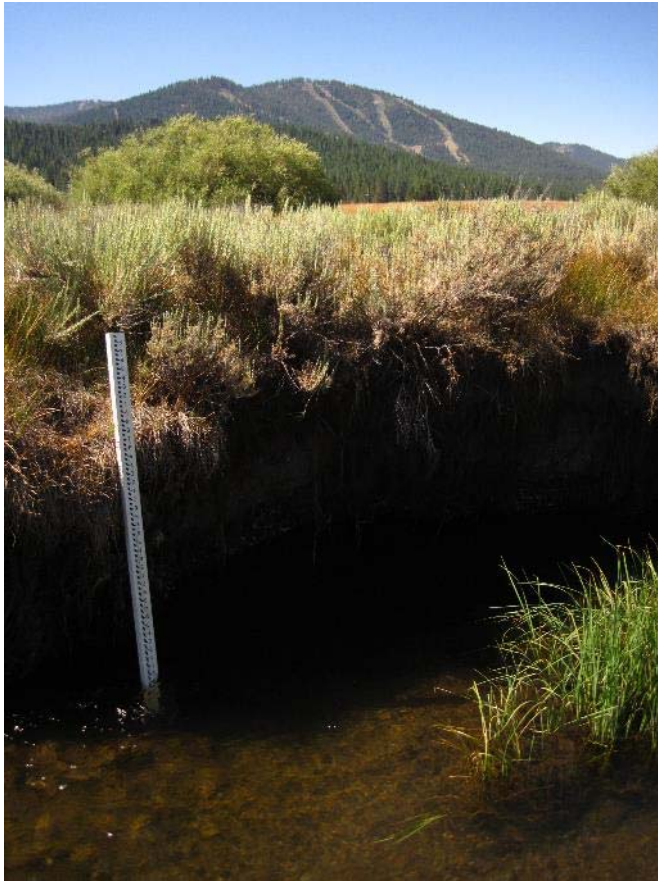
Incised channel with active bank erosion, Mainstem Martis Creek, Reach 4

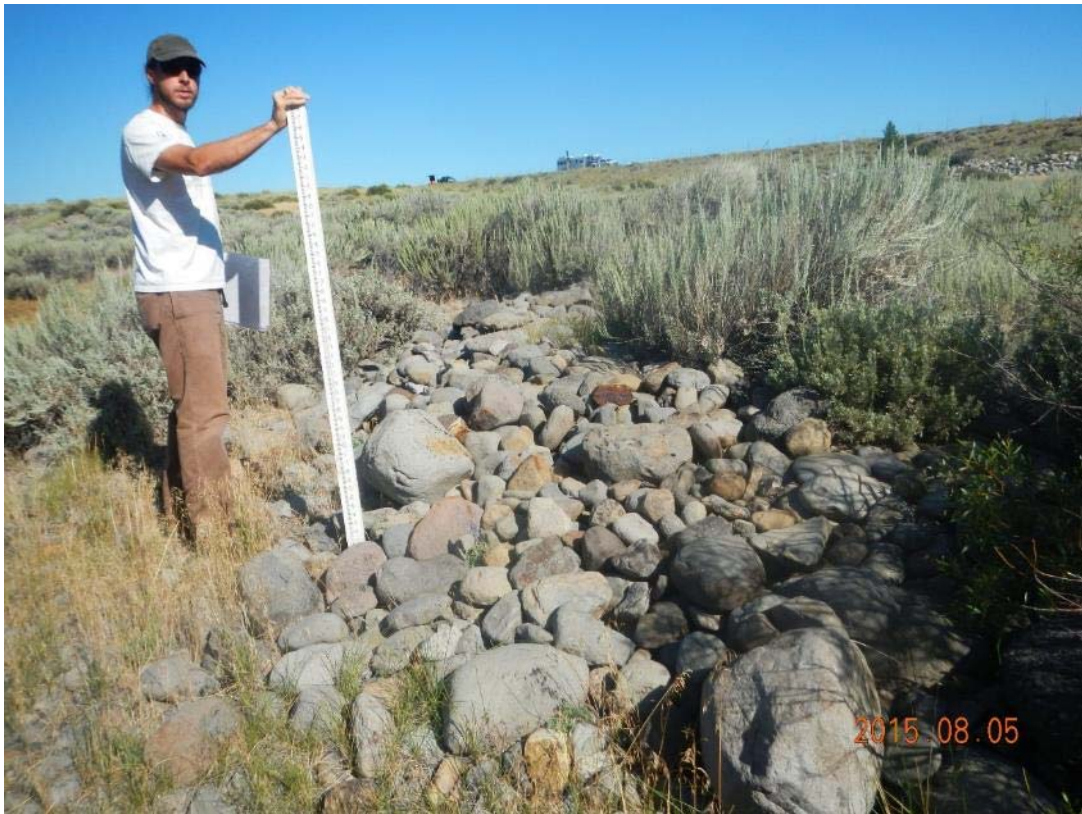
Former channel crossing, Mainstem Martis Creek, Reach 5

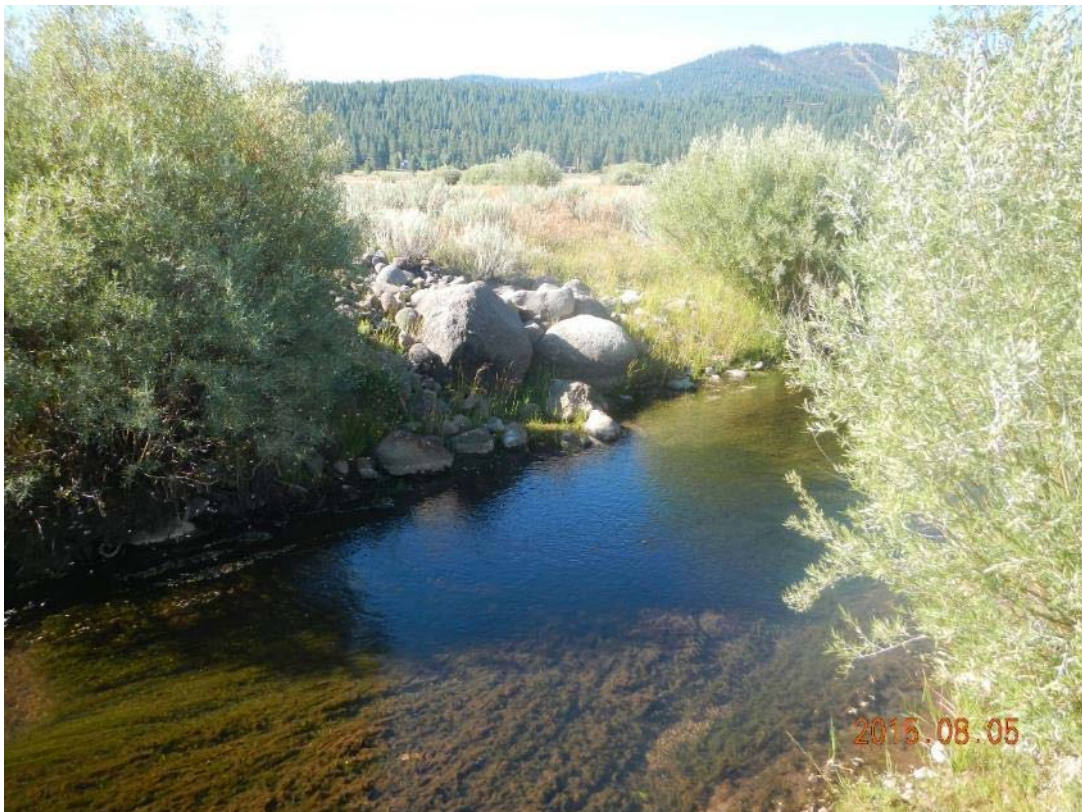
Former channel crossing, Mainstem Martis Creek, Reach 5

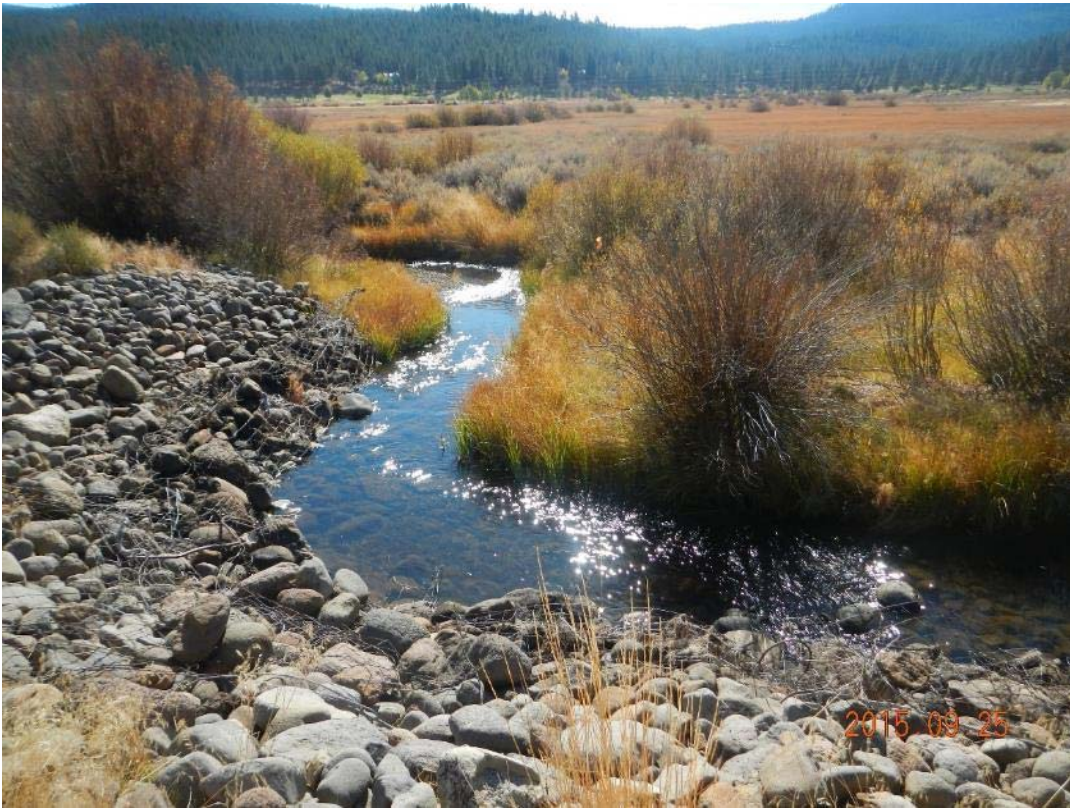
Rip-rap bank protection, Mainstem Martis Creek, Reach 5

- Reach 5 (Upper; Sheet 2.8): a) Log grade-control features will be strategically located across existing intermittent channels currently undergoing headcutting; log grade-control features will be augmented with live willow plantings and willow fascines to enhance long-term stability; b) removal of rip-rap banks and replace with sod mats and other revegetation strategies;
