# **Middle Truckee River Tributaries Sediment Source Assessment Prescription Plan**

**Truckee River Watershed Council  
USDA Forest Service, Tahoe National Forest, Truckee Ranger District  
August 2016**

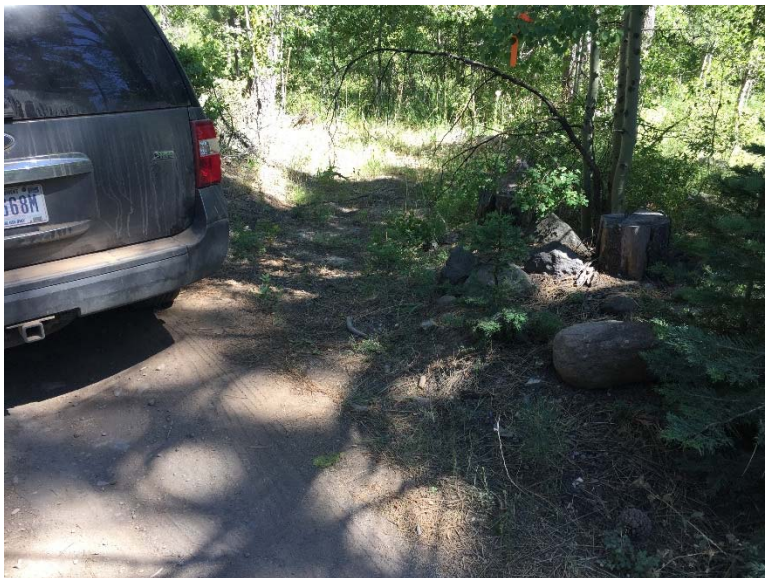
J1: Road segment of Jackass Point Spur road. Waterbars/dips are installed on the length of road on average 200 ft apart on a 5% gradient. Road surface runoff on this length is large enough for leadouts for these road surface drainages to transport sediment through a small buffer and directly into the channel.

J1. Leadout filled with sediment heading towards channel.

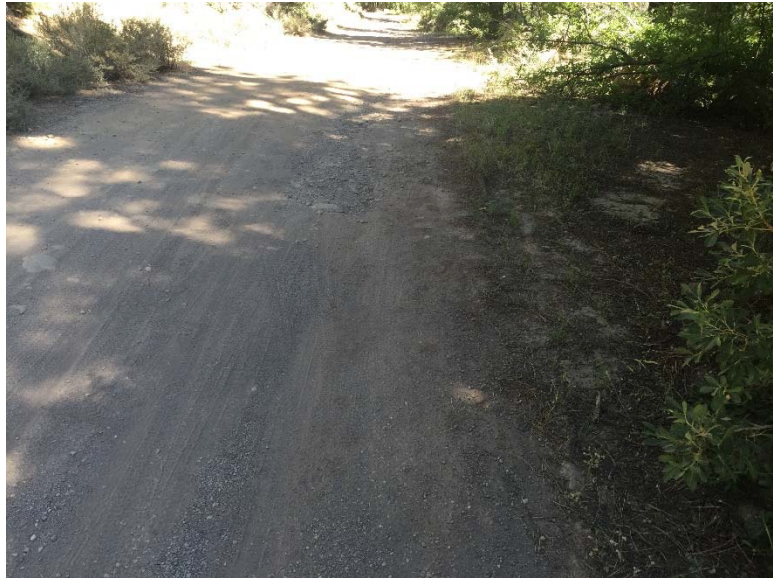
J2: Road surface runoff accumulates on this length of Jackass Point spur road and Jackass Point road due to a lack of surface drainage structures. It eventually exits at J13, transporting sediment into channel.

J2. Leadout filled with sediment from runoff from J2 heading towards channel.

J13: Leadout where runoff and sediment from J2 flows into. This leadout is filled with sediment and continues towards Jackass Creek.

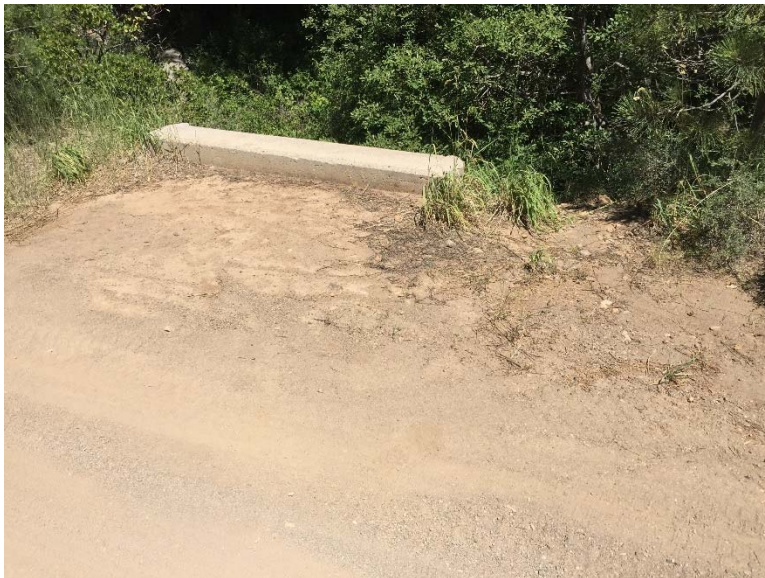
J3: Road surface runoff accumulates on this length of Jackass Point road. Nearby landing also contributes the accumulated surface runoff. Runoff and sediment flows over the outlet of this crossing.

J3. Accumulated sediment on runoff flowing over and around outlet of crossing.

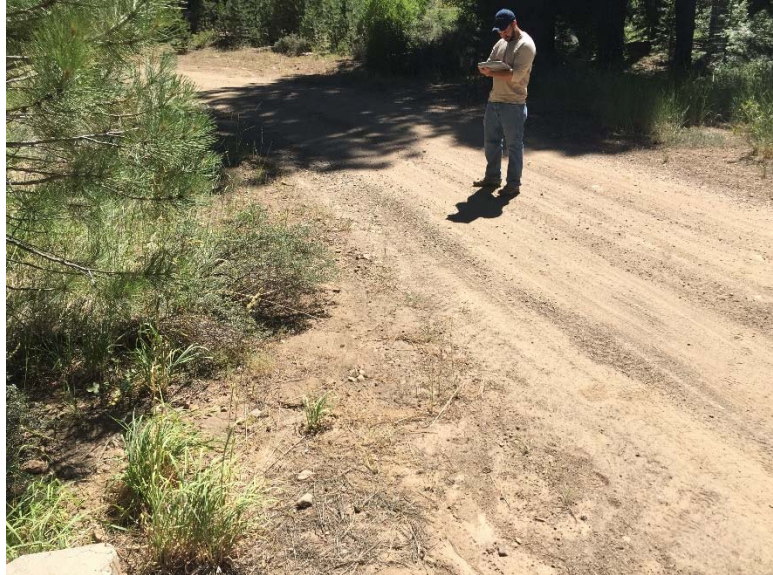
J3. Accumulated sediment on runoff flowing from road and nearby landing.

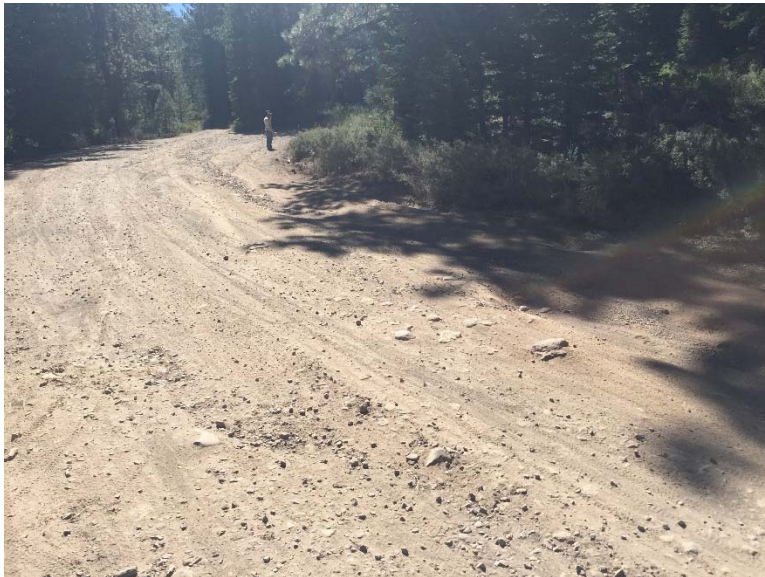
J6: Road surface runoff on this length of Jackass Point spur road has accumulated to large amounts due to a lack of functional waterbars/dips and has created multiple rills and ruts. This length also captures runoff from J5. Multiple leadouts do capture some runoff and direct it downslope towards Jackass Creek. The remaining runoff exits the road via leadout J18 before reaching the next crossing.

J6. Accumulated surface runoff forming rills and ruts.

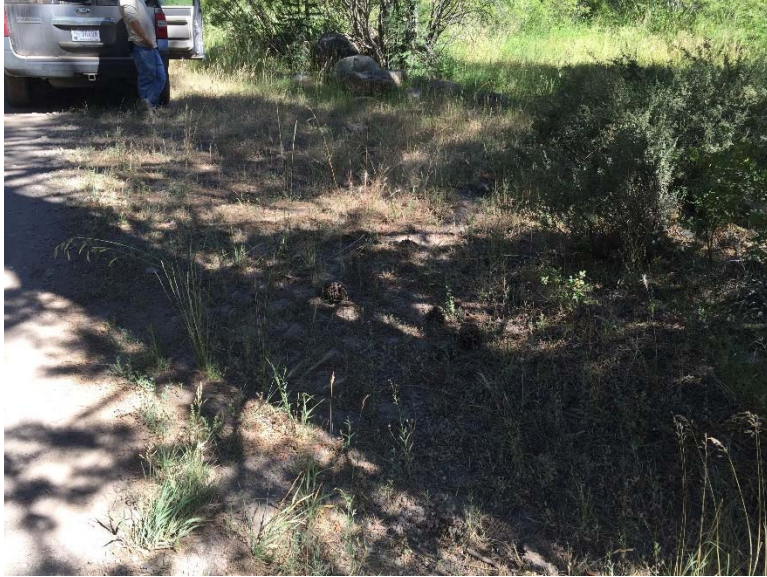
J14: Leadout where runoff and sediment from J4 flows into. This leadout is filled with sediment and continues towards Jackass Creek.

J14. Leadout for runoff from J4. Leadout is filled with sediment and continues into Jackass Creek.

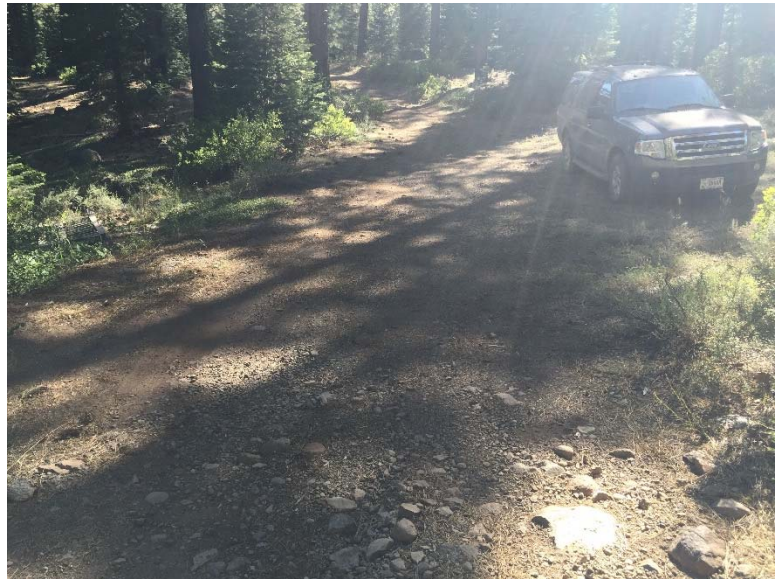
J17: Stream crossing where surface runoff from J7 and J8 enter the tributary channel. No crossing structure exists for this ephemeral channel.

J17. At crossing looking south where runoff of J7 flows from.

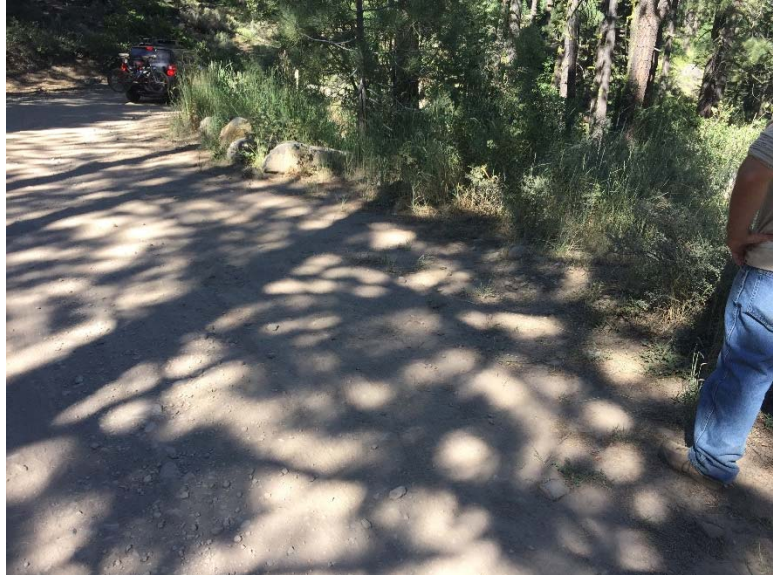
J18: Road begins to outslope before reaching crossing J19: Runoff from J6 leaves road before passing over culvert and enters Jackass Creek.

J18. Runoff from J6 leaving road before flowing over crossing J19. The road outslopes sediment off road and into the creek.

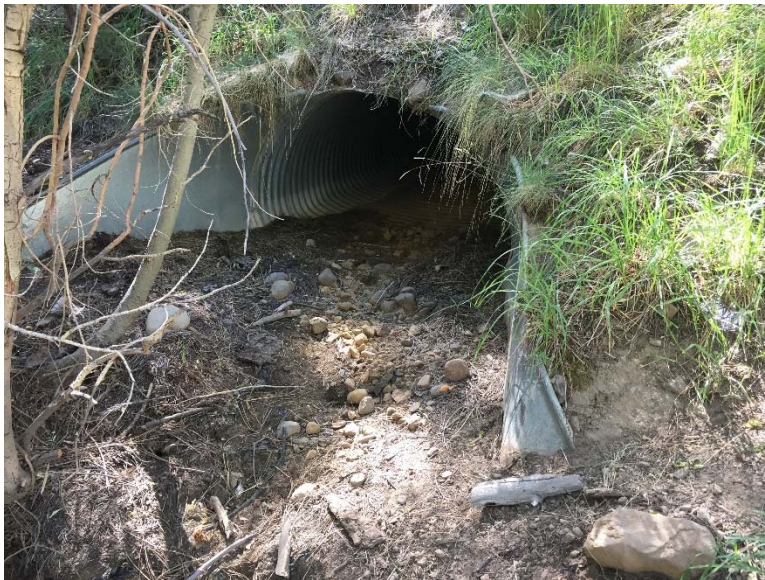
J19: Culvert crossing. Sediment can be seen at the outlet.

J19: Looking at outlet of culvert crossing. Sediment is starting to fill outlet.

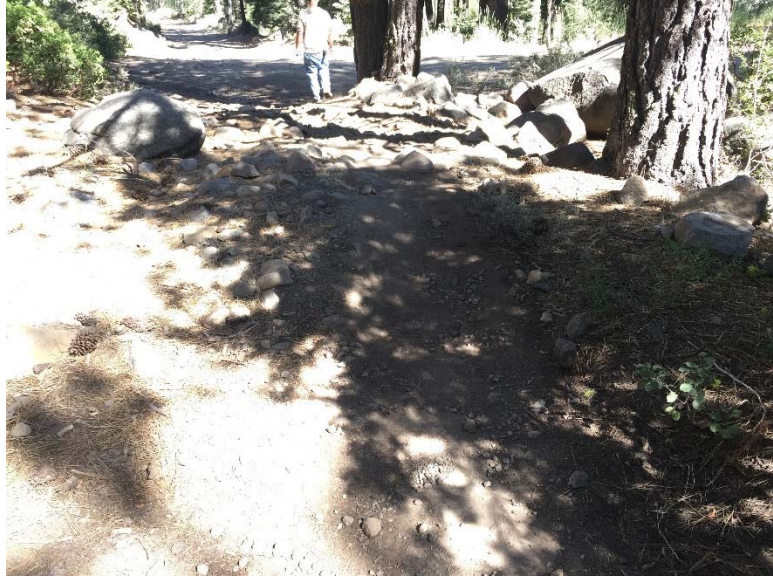
J20: A depression that can turn into a sediment pond has developed on a bike trail. This may have been a waterbar to divert runoff from the bike trail, but now appears to pool runoff and sediment.

J20. Looking at a depression on a bike trail heading towards Jackass Point road.

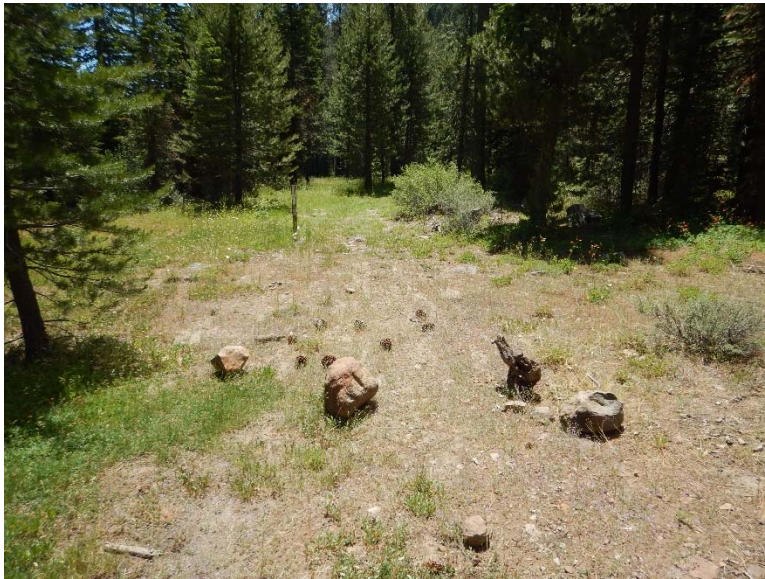
J21: Motor vehicles have access to the meadow south of this point. A sign is posted prohibiting vehicle access. Ruts for tires have developed here and into the meadow.

J21. Looking south at user created trail to access meadow. Tires have created ruts towards the meadow.

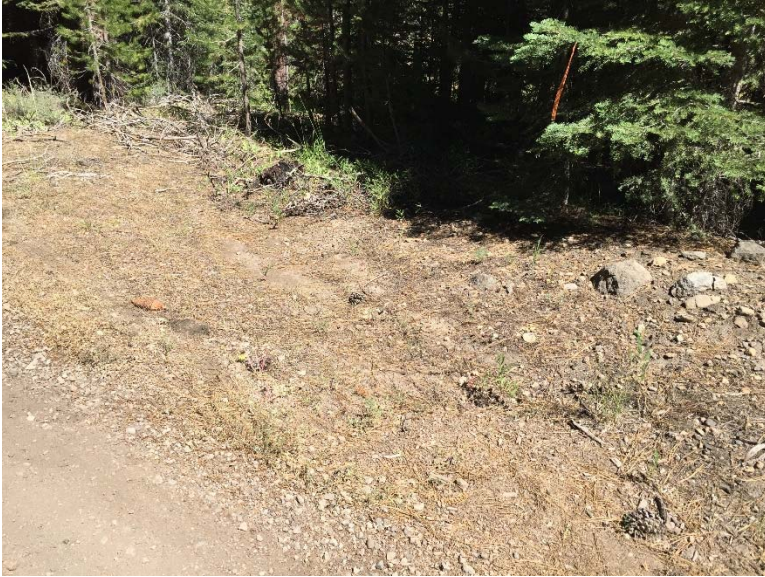
J22: Leadout for runoff from J10. Runoff is accumulating enough to fill this leadout and transport sediment further into the meadow.

J22. Leadout filled with sediment from runoff of J10. Sediment continues into a meadow.

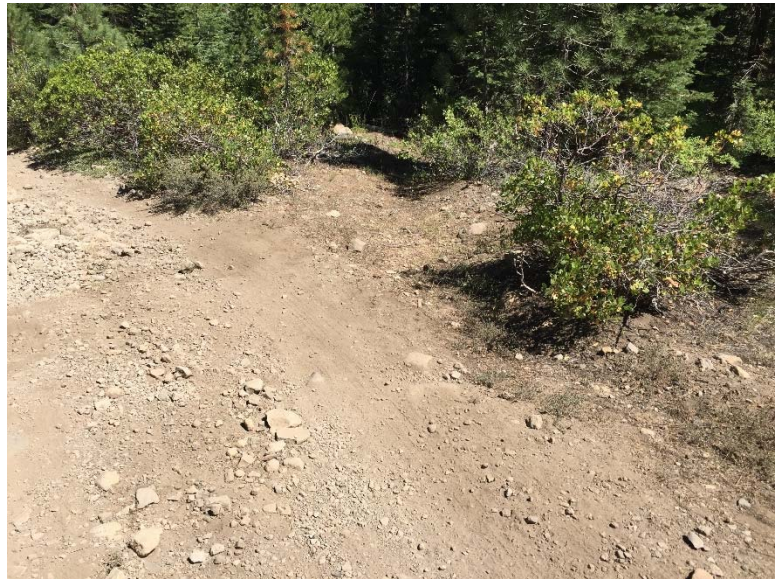
J23: Leadout the captures surface runoff from skid trail J11. On private property. Sediment is seen in the leadout and beyond towards Jackass Creek.

J23. Leadout catching runoff from J11.

**Proposed Action:** Fixing the roads and installing more road surface drainage structures is the best remedy for this subwatershed. The road shape for J1, J4, J9, and J10 should be reshaped to be outsloped. These segments of road do have the proper number of waterbars at the proper distance apart installed for this road design, but the road consist of native surface that is highly susceptible to erosion. Removing surface runoff immediately would be the best way to prevent any amount of runoff accumulation that would start surface erosion. J2, J3, J5, J6, J7, and J8 should have more waterbars/dips installed and current ones maintained. These road segments lack the proper number of waterbars/dips or have poorly maintain waterbars/dips for their road design. Installing new and maintaining current waterbars/dips will prevent flow to accumulate to a capacity that will transport large amounts of sediment. A proper crossing structure such as a culvert should be installed at J17. This will prevent any runoff from road segments J7 and J8 to enter the channel. Skid trail J11 should be obliterated. This trail does not have a functional use and is provided a vector for road surface runoff to accumulate and transport sediment.

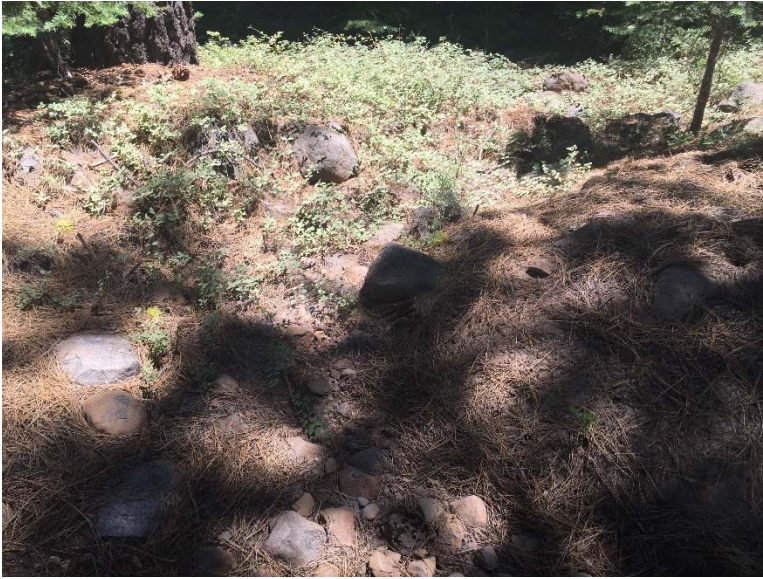
L1: Road surface runoff on this length of skid trail enters the ephemeral channel at crossing L2.

L2: Incision at crossing outlet. There is no crossing structure installed here. Surface runoff from skid trail L2 flows directly into this channel at this crossing.

The skid trail L1 can be obliterated as the trail is not a Forest Service system trail or road. Removal of the trail will prevent any surface runoff from the trail to flow into the channel. Removal of this vector of surface runoff will allow the channel to stabilize and no longer incise. Additional waterbars/dips to the length of road L3 will reduce the amount of accumulated flow leaving the turnout L4. A lower amount of flow will lower the capacity for the sediment to be transported to the channel.

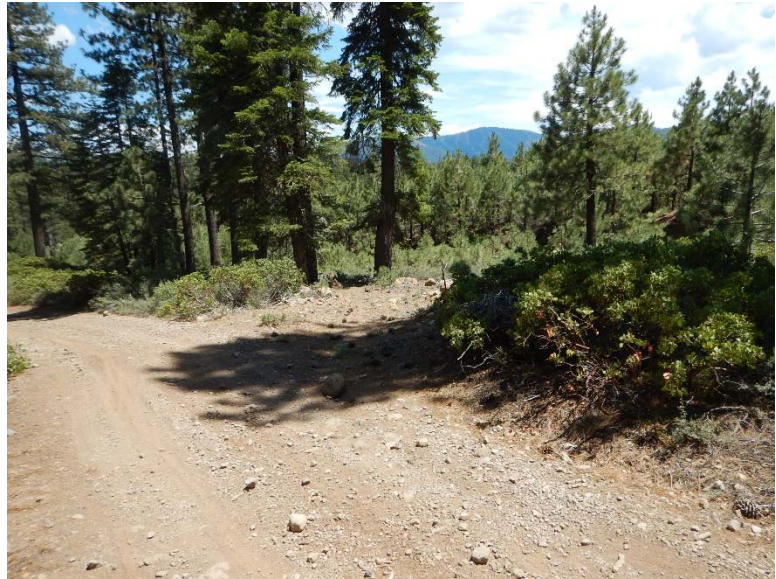
L3: Road surface runoff from this length of Jackass Point road is accumulating enough runoff to transport sediment to turnout L4.

L4: Turnout off Jackass Point road is diverting road runoff from length of road L3.

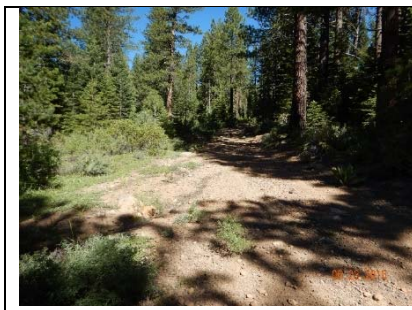
**Photo A**  
Heading: 300

300 ft. of road drainage and 500 ft. of skid trail drainage meet here and is diverted south. Flow remains channeled to downslope stream.

**Proposed Action** - Ultimately the preferred remediation would be to obliterate both E-W trending roads in this section. Sheetflow is being channeled along both, increasing velocity and turbidity of the stream once both drain into the channel, and rilling and scouring of the road and trail adds to sediment influx into Cabin Creek. Because Skid Trail 2 is no longer in use, we recommend full obliteration; however proper drainage structures will probably alleviate most of the problem provided action is taken on the downslope ML-2 road, Road 1. While full obliteration of the ML-2 road would be ideal, the road can be left in its present location provided it is ripped and proper drainage structures such as waterbars are emplaced along this section. The N-S skid trail at the southwest of this area catches drainage and should also be removed.

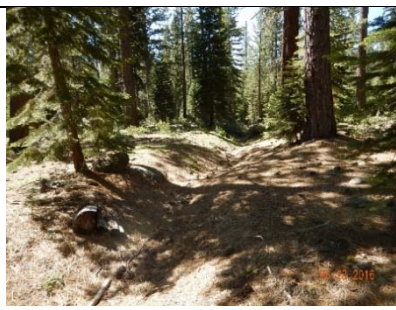
**Photo B**  
Heading: 135

Skid Trail 3 catches overflow from roads 1 and 2 (above) and this captured flow has incised approximately 4 ft.

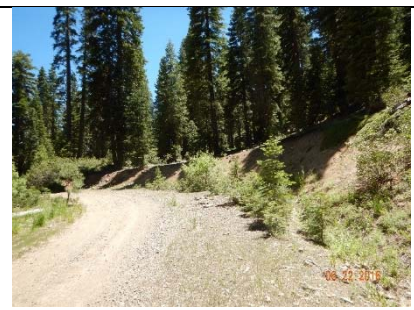
**Photo C**  
Heading: 245

Cutslope of road exposes loose sediment that is captured along inslope and dumped directly into stream channel.

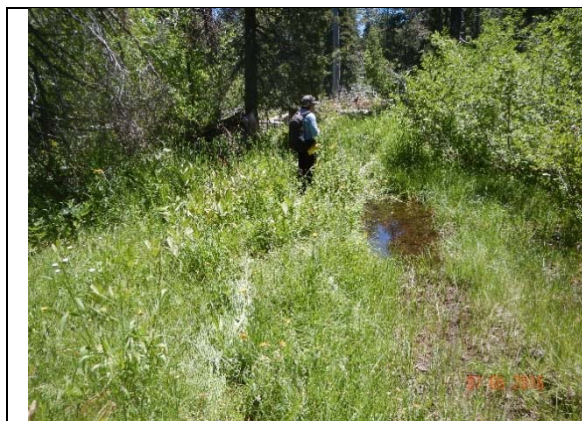
**Photo A**

Road through meadow causes normally dispersed shallow lateral flow to surface and concentrate, beginning channel that is captured by skid road to east

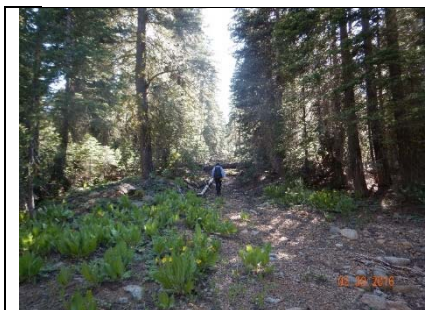
**Photo A**  
Heading: 225

Skid trail is capturing drainage. Trail is moderately eroded. Drainage continues into trail of Photo B

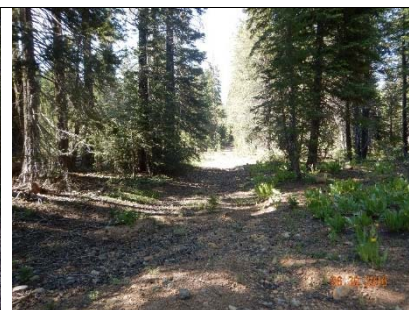
**Photo B**  
Heading: 000

Skid trail is capturing drainage and creating channel. Trail is moderately eroded. Sparse vegetation.

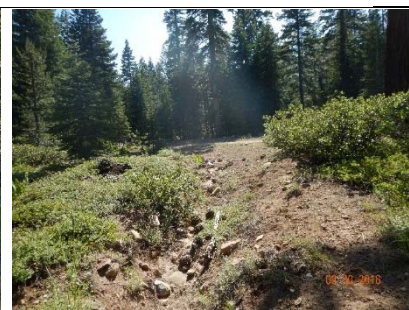
**Photo C**  
Heading: 90

Incised channel created by skid trail and road channeling. This begins headwaters for this drainage.

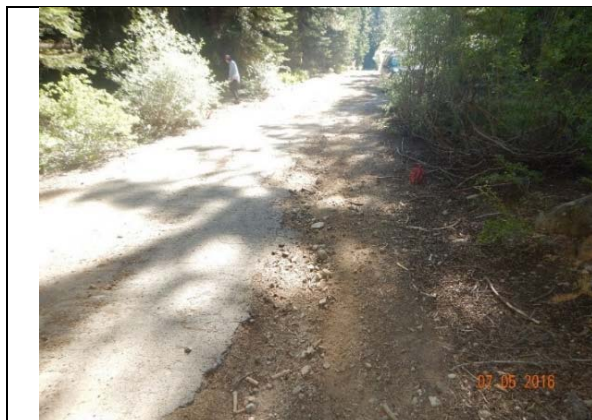
**Photo A**  
**Heading: 250**

The road in this area is heavily rilled and scoured. It was previously paved, but almost 50% of the pavement has been eroded away.

500 ft. of east travelling road captures and channels southerly directed sheetflow. Road is significantly rilled and rutted. The only drainage structure present is one waterbar that empties <10ft above the channel.

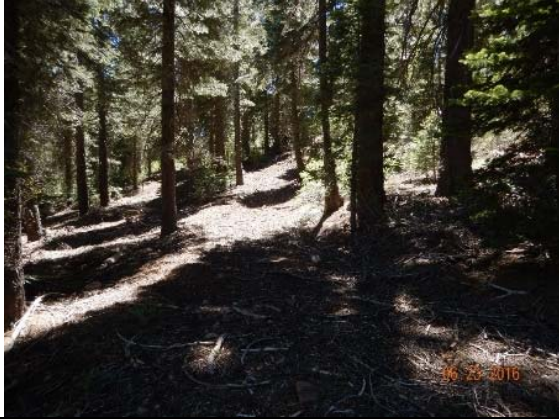
**Photo A**  
**Heading: 250**

Erosion of skid spur at Skid Trail 1

**Proposed Action** – Because practices employed are unsuccessful, we recommend obliterating this road and recontouring the slope to reduce erosion off this trail and the road downslope. Adding proper waterbars along the road every ~100 ft. should significantly reduce any other sediment influx from this site into the creek.

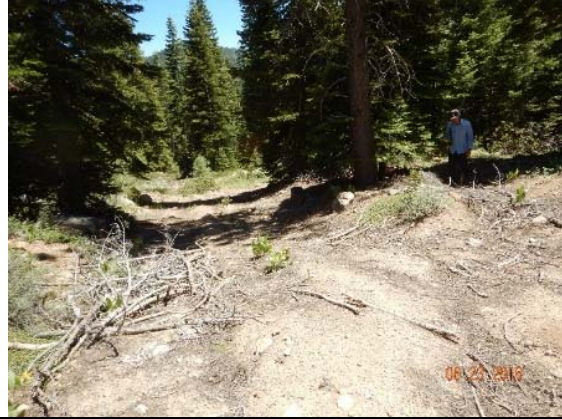
**Photo B**  
**Heading: 135**

Skid Trail 4 erosion controls have failed, channels maintain on road

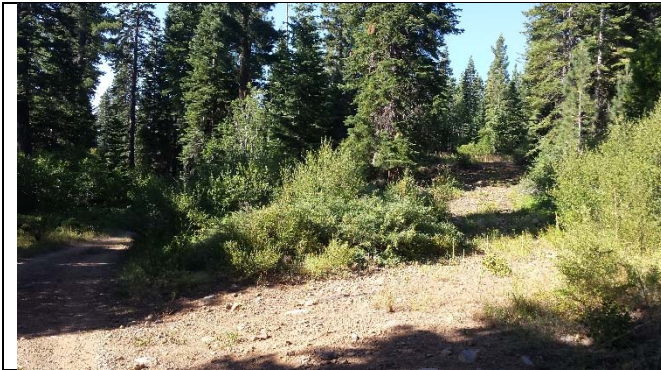
**Photo 3**

Several skid trails in this area divert upslope from the main road. These skid trails are not hydrologically remediated; they are poorly vegetated, have a lot of loose sediment, and drain directly into the road below as can be evidenced by rilling. The road itself shows signs of water transport and erosion and requires proper drainage structures to alleviate channeling along the road.

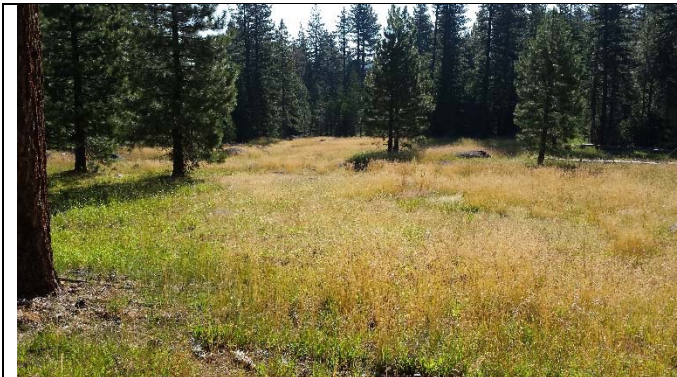
**Photo 4**

An access road runs east from the 'main' road and crosscuts the natural drainage of a small meadow. This allows the access road to divert water from the meadow along the road. This drainage leads to a small cut in the hillslope to the east that can be clearly identified on LiDAR (see map above). This access road needs obliterated to restore the natural dispersed flow.

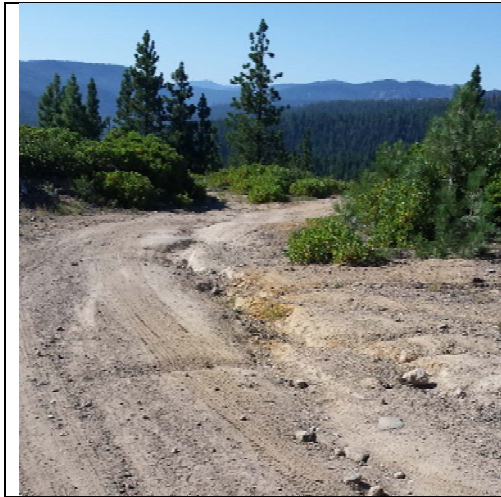
Road is heavily rilled and rutted. It carries a significant amount of water south for several hundred feet before diverting into the spot where the E-W access road and N-S main road intersect. The spot of intersection is very well vegetated and seems to be functioning properly. Coarse sediment from road erosion is no doubt deposited in the vegetation; fines may still remain in channel during high precipitation events.

**Photo 5**  
**Heading: 180**  
 Substantial road erosion at this location; however this drains into a very well-vegetated channel that probably works to significantly reduce the amount of sediment in the water.

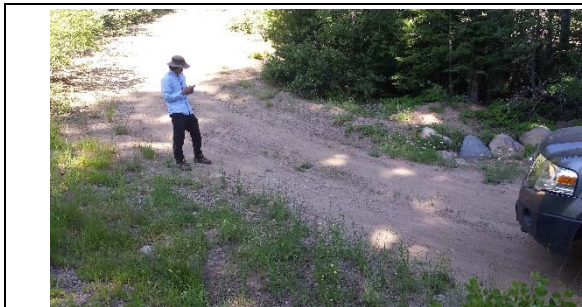
Two abandoned access roads come from upslope to the south and southwest of this point. These roads carry water in presumed high velocity channels as evidenced by size of boulders left in drainage. The present day road is itself carrying water from the northwest. All three combine and drain in a channel towards the north-northwest. The abandoned access roads need demolished and the present road corrected with proper drainage structures to reduce channel velocity in the NNW drainage.

**Photo 6a**  
**Heading: 285**  
 Access road channels and main road channels converge at this point. Velocity of flow is evidenced by size of boulders in drainage (right side of photo).

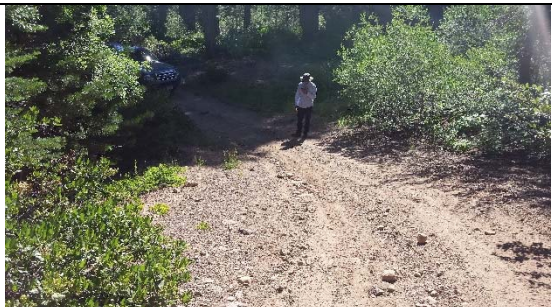
**Photo 6b**  
**Heading: 180**  
 Access road channels and main road channels converge at this point. Main channel is moderately rilled and eroded at this point.

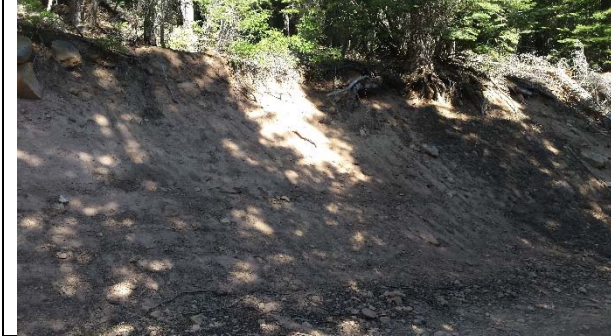
Massive cutslope at this hairpin turn is actively eroding. Road is entrenched on upslope side and is eroding both sides. Road itself is rilled and rutted adding more sediment to runoff.

**Photo 7a**  
**Heading: 270**  
Massive cutslope is actively eroding. Vegetation is sparsely holding on at top

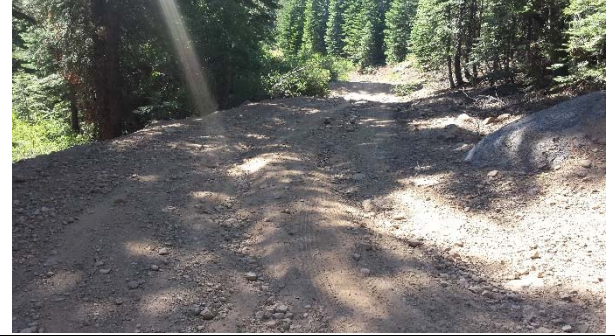
**Photo 7b**  
**Heading: 135**  
Road is eroding as well. It is rilled and rutted. Size of transported clasts can be seen in photo.

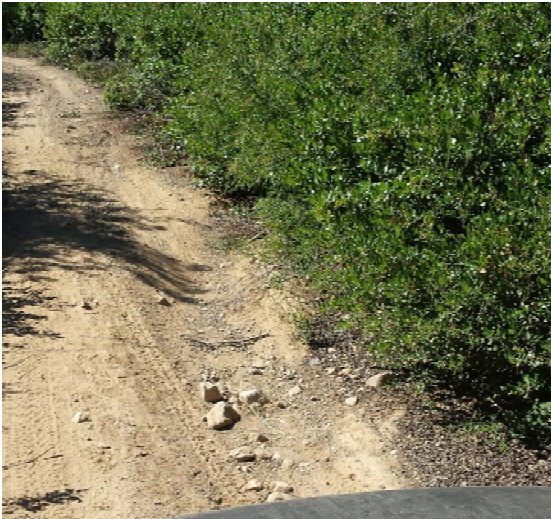
Small channel is diverted by road and begins stream that is caught again further downslope to NE by abandoned roads. Suggest properly draining this this road and the downslope abandoned roads.

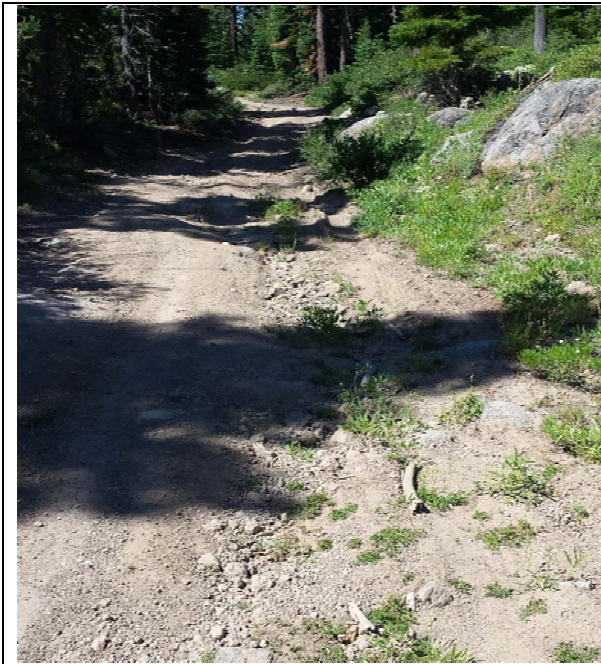
**Photo 8**

Road in this area carries a lot of water and is significantly rilled. Some water comes from the abandoned road upslope that parallels this road. The one outlet from road diverts flow downslope but because it is already channeled it begins to incise. Downslope, an old road from a landing also carries water and contributes to the headwaters of this channel. Suggest obliterating old abandoned roads and properly draining this road.

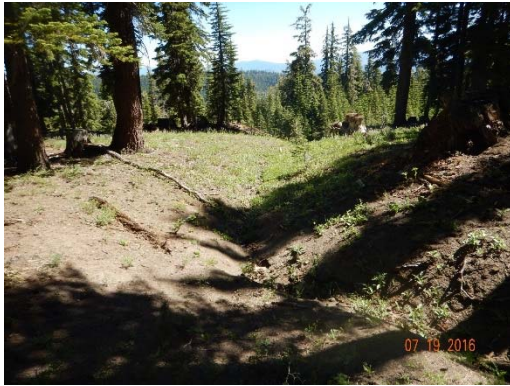
**Photo A**  
**Heading: 015**

Access road and skid trails have led to channeled flow from the upper hillslope into a landing just south of photo point A. Water and sediment pools on this landing until it spills over into either the NNE directed now 'natural' drainage at photo A or the NW impaired access road shown by the orange line. At the northern point of connection of the two another road that diverts to the northwest captures overflow from this channel and diverts it to the northwest.

Channel leading from landing is actively incising.

**Proposed Action:** Obliterate landing and all impaired roads. Stabilize the slope along impaired road at B to reduce sediment influx into headwaters of channel.

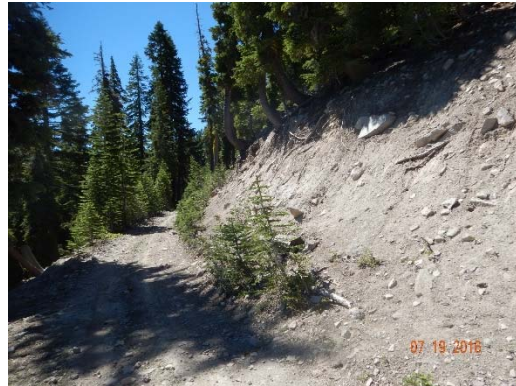
**Photo B**  
**Heading: 165**

On the western side of Sub-Area C\_1 the cutslope of 16E84 is very unstable and is eroding onto the road, where high precipitation/runoff flow channels this sediment north until it drains, still channeled, near where the road passes the ridge of the hill.

Cutslope is unstable and actively eroding onto road to be carried directly into drainage to NE.

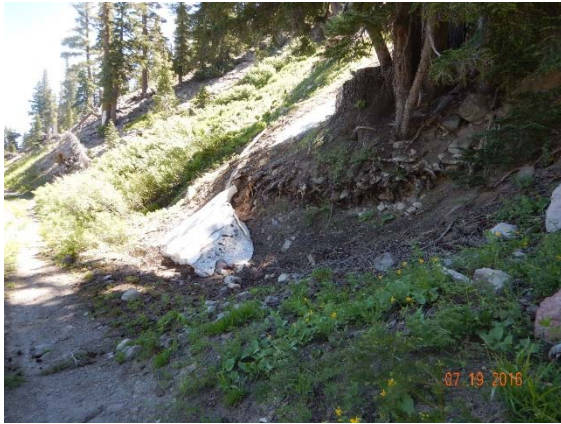
**Photo A**  
**Heading: 110**

Loose sediment from landslide erodes directly into channel. Sediment covers old road, current road can be seen on left side of photo.

**Proposed Action:** Stabilize cutslope and fillslope of road at point A and east of point B. Stabilize and revegetate banks of channel at Point C. Add waterbars along road between points C and D to allow exposed subsurface flow to infiltrate back into subsurface; rockfill the channel cut north of D to reduce incision of this channel.

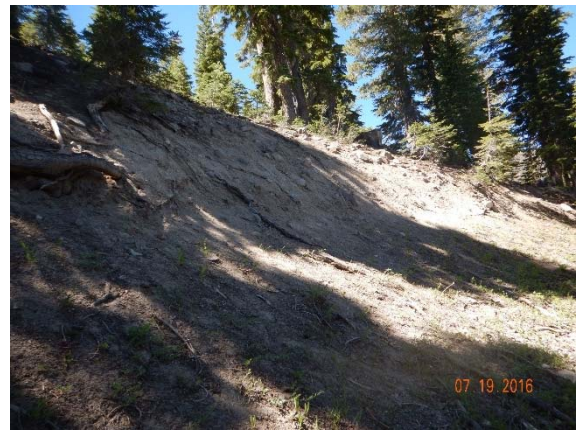
**Photo B**  
**Heading: 200**

Cutslope is unstable and erodes directly into headwaters of channel.

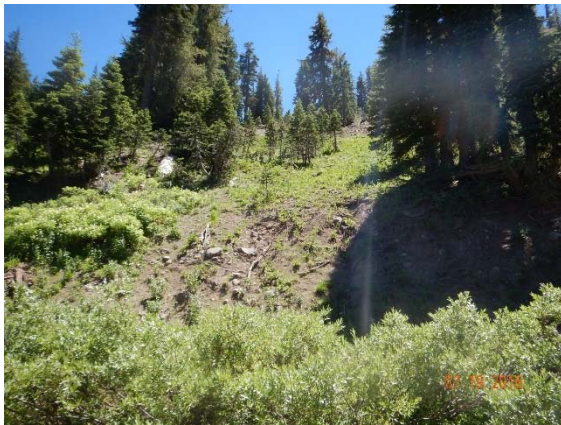
**Photo C**  
**Heading: 090**

Channel deeply incises in close proximity to headwaters. Banks are unstable and require revegetation.

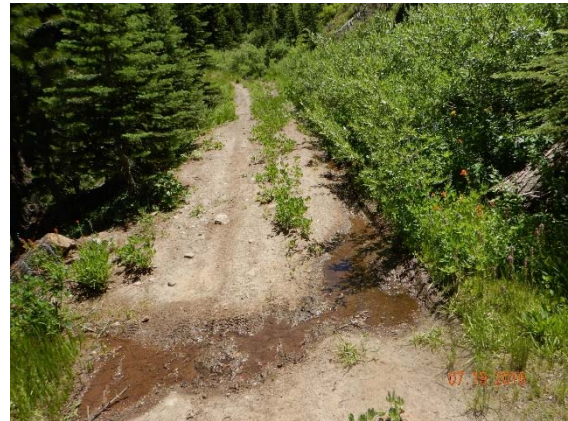
**Photo D**  
**Heading: 080**

Road cuts expose shallow subsurface lateral flow. Flow is channeled alongside of road ~100ft before crossing.

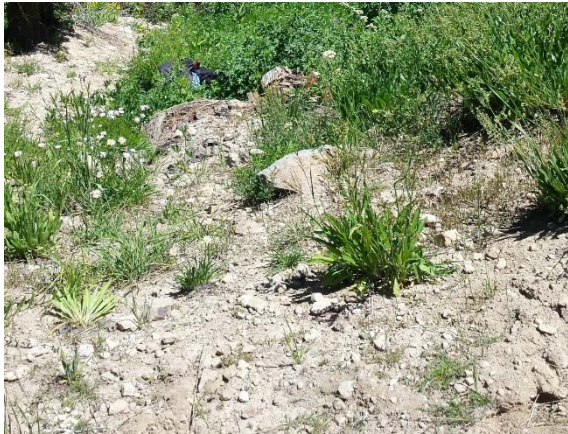
**Photo A**  
**Heading: 000**

Log acts as culvert under road, risking sediment dump into channel when log eventually decomposes. Road crosses left to right while log 'outlet' is in center.

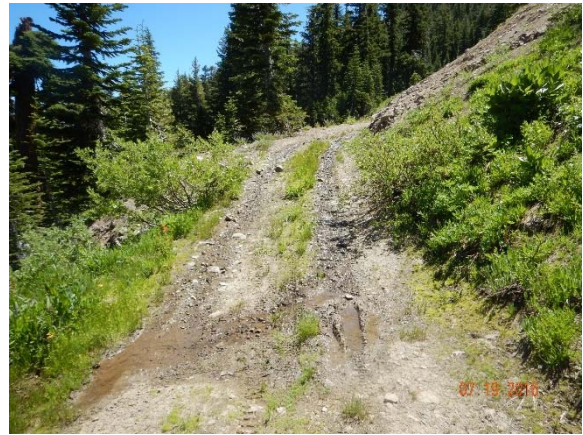
**Photo B**  
**Heading: 090**

Roadcut allows subsurface flow to reach surface, channel and become headwaters for subsidiary stream

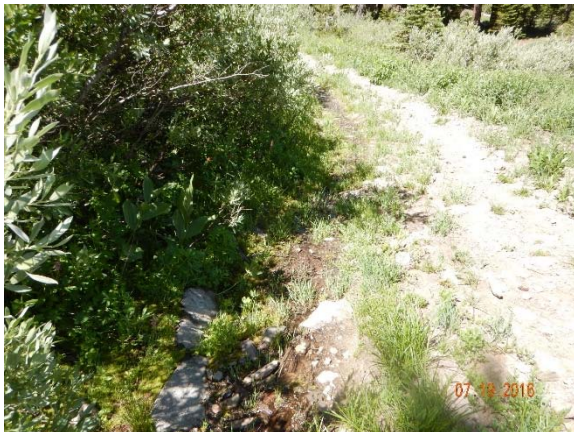
**Photo C**  
**Heading: 290**

Stream diverted east (parallel to road) empties onto road and immediately follows road for ~50 ft before diverting off into NW channel

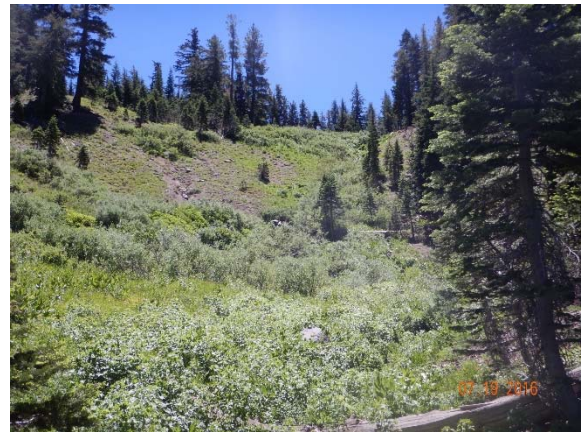
**Photo D**  
**Heading: 180**

Two paths of runoff from top of road can be seen. The left path has left mud deposits on the slope, suggesting it carries significant fine sediment loads..

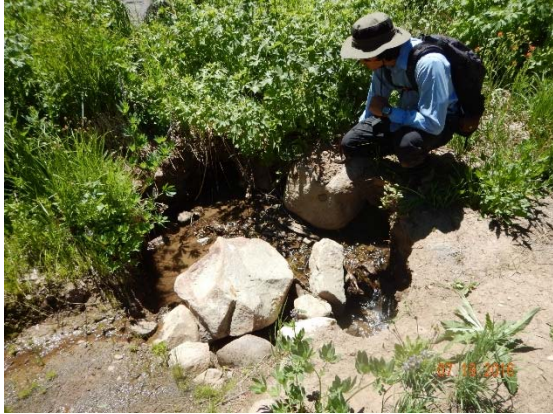
**Photo E**  
**Heading: 335**

No obvious drainage structure, but channel does flow under road. Road is actively eroding and near failure; when it fails that portion of road will immediately enter the channel

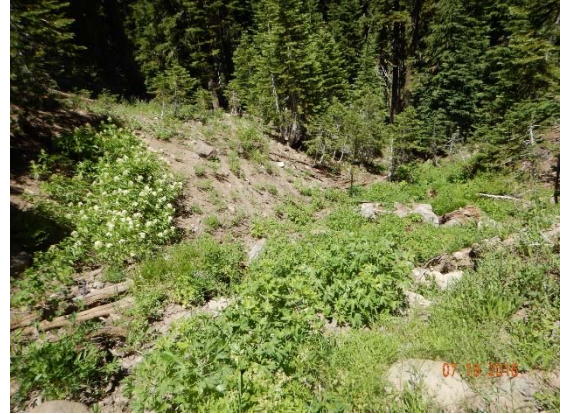
**Photo F**  
**Heading: 345**

Channel incision downslope. Bank is thinly vegetated and actively erodes into channel.

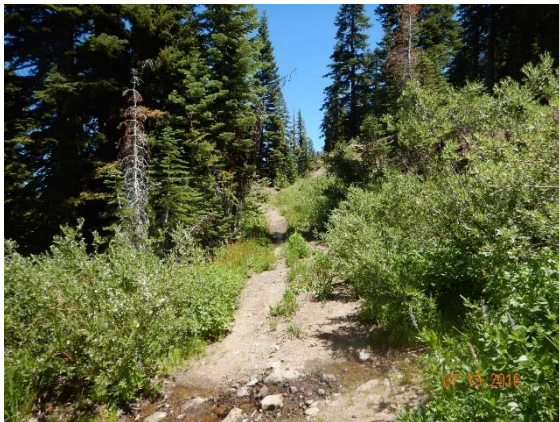
**Photo G**  
**Heading: 90**

Channel from upslope runs on road ~50 ft, moderately incising and picking up more sediment.

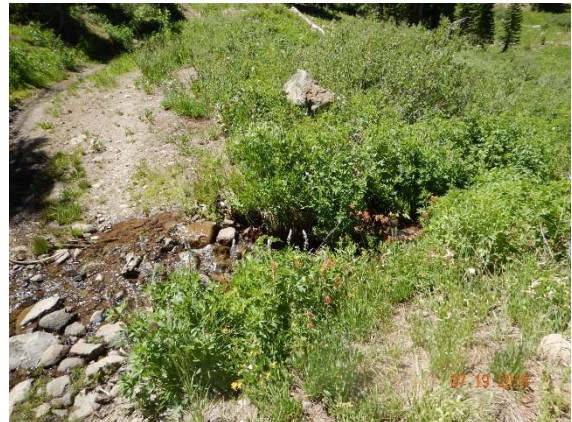
**Photo H**  
**Heading: 270**

Channel from upslope runs on road ~50 ft, moderately incising and picking up more sediment.

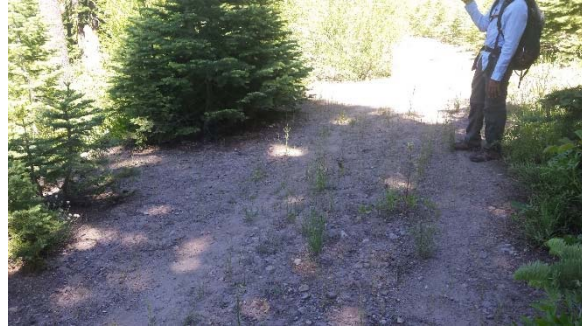
<b>Location:</b>	<b>A_1</b>
<b>Latitude:</b>	<b>120 16'06.102 W</b>
<b>Longitude:</b>	<b>39 15'49.794 N</b>
<b>Heading:</b>	<b>090</b>
<b>Map Datum:</b>	<b>WGS 84</b>

Culvert to allow northeast drainage under road has loose sediment pooled atop the culvert, indicating the road is carrying runoff and sediment and depositing directly into the channel. Recommend removing the culvert, obliterating the road within 100 feet of the crossing and recontouring the landscape to reduce influx of sediment from road. 76.5 tons of dirt removed from this site can be used as fill for other sites within this watershed and the rest of the 89 Corridor.

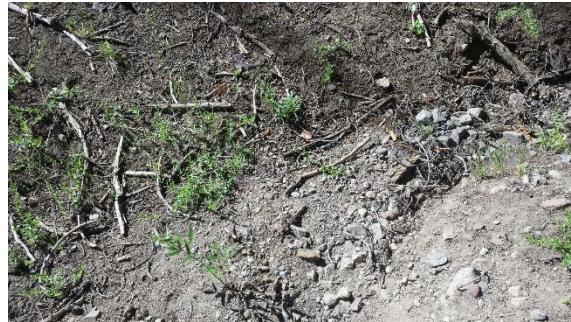
<b>Location:</b>	<b>A_2</b>
<b>Latitude:</b>	<b>120 16'15.742 W</b>
<b>Longitude:</b>	<b>39 15'01.161 N</b>
<b>Heading:</b>	<b>010</b>
<b>Map Datum:</b>	<b>WGS 84</b>

Another channel that crosses RTE 89-15 through a culvert carries a lot of sediment, as evidenced by deposit piles within the stream channel within 100 yards of the culvert. Recommend removing culvert, obliterating road within 100 feet of the crossing and recontouring landscape to reduce influx of sediment from road channel. 56 tons of dirt will be removed from this site.

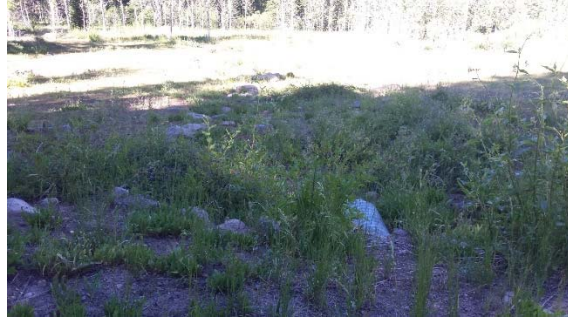
**Location:** A\_3  
**Latitude:** 120 15'25.462 W  
**Longitude:** 39 15'02.525 N  
**Heading:** 060  
**Map Datum:** WGS 84

Three stream crossings initiated by skid trails to SW are further concentrated through 3 separate culverts as the channels enter the meadow. These culverts are not allowing the water to disperse through the meadow and instead remain channeled, allowing for incision and subsequent draining of the meadow. We suggest removing the 3 culverts and recontour RTE 89-15. The lack of significant incision through the meadow suggests obliteration of skid trails is unnecessary; once the culverts are removed flow should disperse properly throughout the meadow. A cumulative 79.3 tons of dirt will be available for use at other remediation sites.

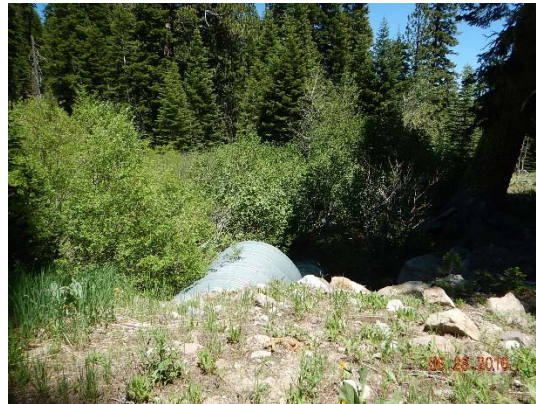
**Location:** A\_4  
**Latitude:** 120 15'27.342 W  
**Longitude:** 39 15'05.273 N  
**Heading:** 090  
**Map Datum:** WGS 84

Massive culvert at main channel crossing adding to channel concentration immediately as it enters the meadowed area. We recommend removing the culvert and recontouring the landscape within the drainage to allow for more dispersed flow during high precipitation events. Revegetate to reduce short term high sediment influx from landscape activities. Culvert removal and road obliteration of this site will result in 175 tons of dirt that can be used at other sites.

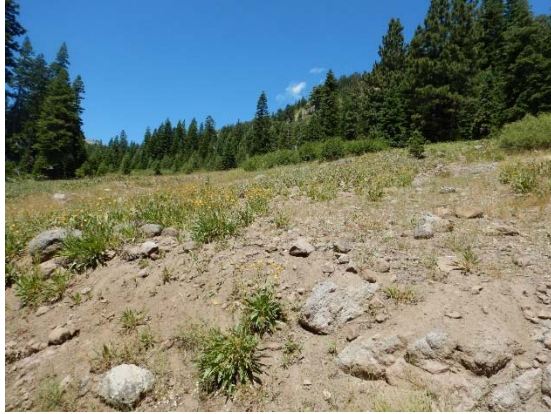
**Location:** A\_5  
**Latitude:** 120 15'28.755 W  
**Longitude:** 39 15'07.237 N  
**Heading:** 335  
**Map Datum:** WGS 84

Exposed soils near RTE 89-15 that can be picked up by surface flow and carried to road and dumped directly into main channel of Deep Creek. Recommend revegetating this area to reduce sediment pickup during storm events.

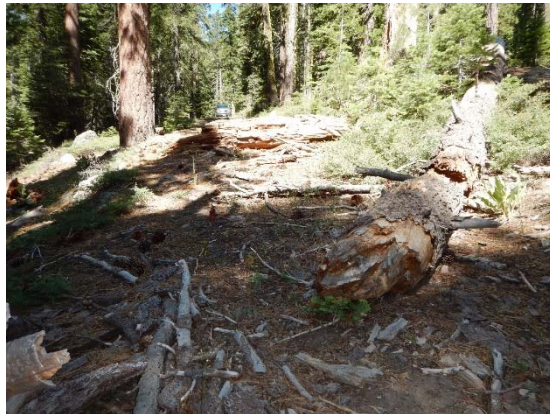
**Location:** A\_6  
**Latitude:** 120 15'20.440 W  
**Longitude:** 39 15'08.199 N  
**Heading:** 270  
**Map Datum:** WGS 84

Felled trees disallow vehicle passage beyond this point. Suggests road is entirely unused in this area, supporting request to decommission road.

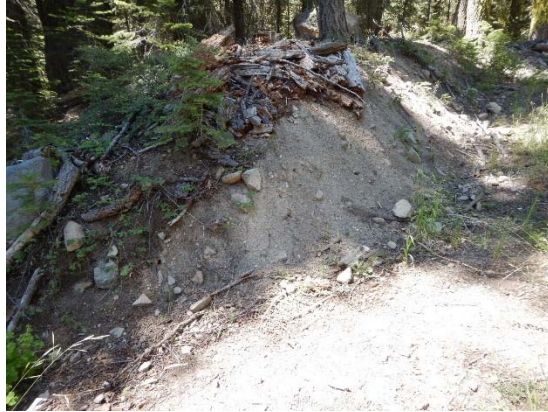
**Location:** A\_7  
**Latitude:** 120 15'04.813 W  
**Longitude:** 39 15'05.642 N  
**Heading:** 220  
**Map Datum:** WGS 84

Large mounds of loose sediment left during creation of road are in close proximity to main channel of Deep Creek. During high precipitation events mound can erode directly into channel. Suggest leveling and revegetating this mounds. Pile consists of ~10 tons of dirt.

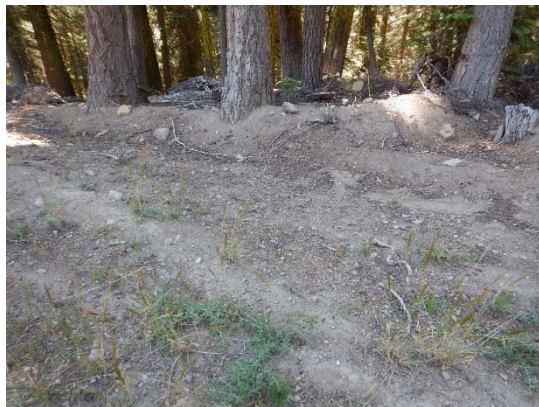
**Location:** A\_8  
**Latitude:** 120 14'59.581 W  
**Longitude:** 39 15'06.429 N  
**Heading:** 135  
**Map Datum:** WGS 84

More loose sediment along road needs leveled and revegetated during obliteration of RTE 89-15. Removed sediment mounds combine to ~5 tons of dirt that can be used at other sites requiring fill.

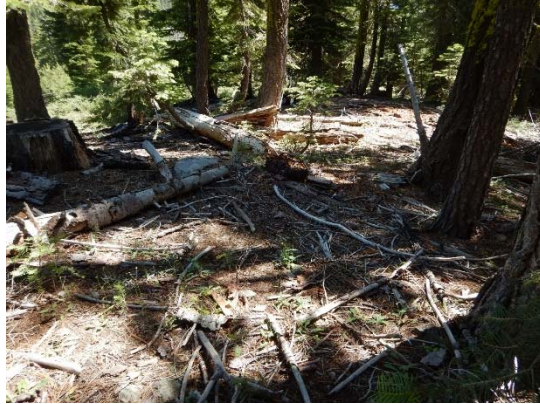
**Location:** A\_9  
**Latitude:** 120 14'56.463 W  
**Longitude:** 39 15'07.504 N  
**Heading:** 000  
**Map Datum:** WGS 84

Bare soil disturbance between road and stream. Further support for obliterating road, as this will reduce surface flow and help to allow proper infiltration.

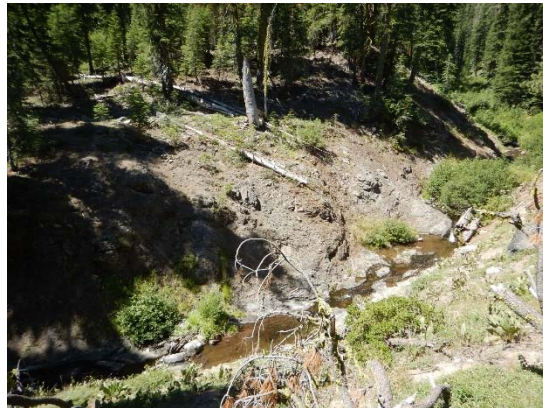
**Location:** A\_10  
**Latitude:** 120 14'55.236 W  
**Longitude:** 39 15'06.466 N  
**Heading:** 225  
**Map Datum:** WGS 84

Bare bank exposes soil that dumps directly into creek. Creek is cut to bedrock so erosion is along banks. Suggest bank stabilization measures to reduce sediment dumping into creek. 8000 m<sup>2</sup> of banks are identified for remediation at this site.

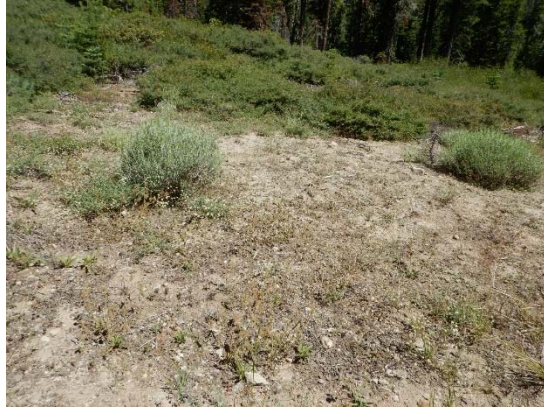
**Location:** A\_11  
**Latitude:** 120 14'51.657 W  
**Longitude:** 39 15'10.501 N  
**Heading:** 060  
**Map Datum:** WGS 84

Old landing site exposes soil upslope from road. Runoff brings sediment directly into stream channel. Obliterate old landing site.
