# **Middle Truckee River Tributaries Sediment Source Assessment Prescription Plan**

**Truckee River Watershed Council  
USDA Forest Service, Tahoe National Forest, Truckee Ranger District  
August 2016**

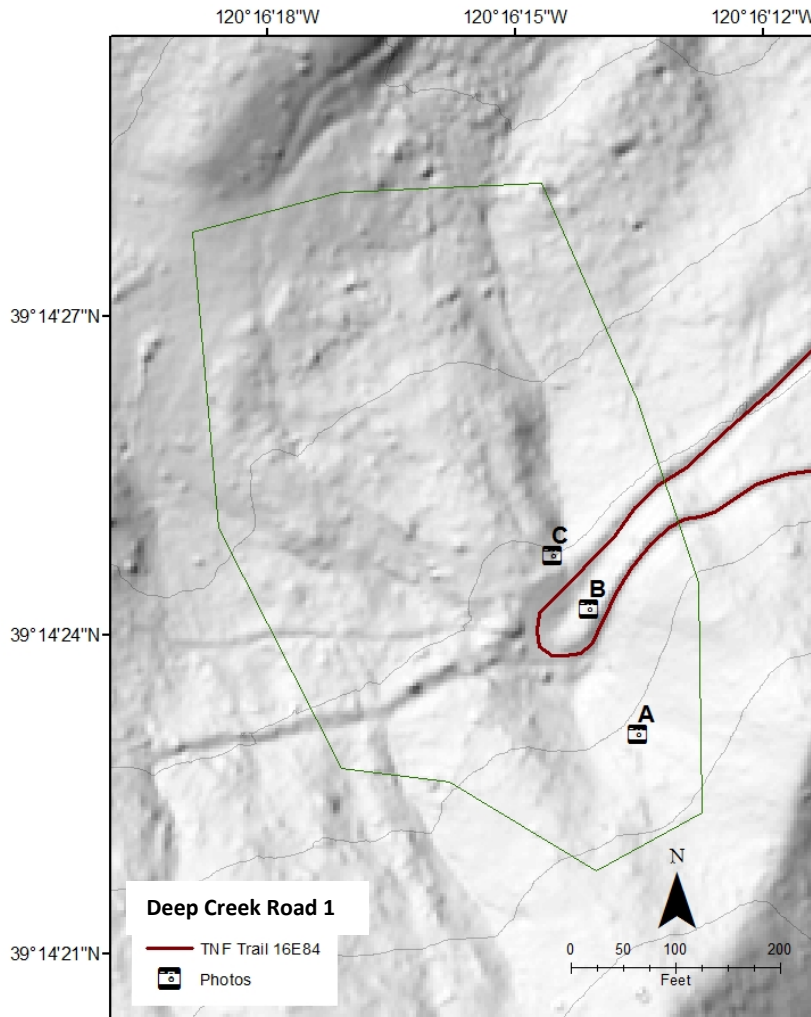
### **Road 1:**

This hairpin turn is the site of an old landing that has numerous access roads leading to and away from it; some of them are near parallel the slope of the hillside. The site is particularly problematic because it is a sharp redirection of the road after it has channeled overland flow for over 300 feet. The road is cut deep into the slope, such that it is actively eroding. The skid trails have waterbars and leadouts and are functional at present. All erosion from the road and cutslope immediately enters the channel leading north.

**Proposed Actions:** We recommend installing gravel on the road through this section, and rockfilling the leadout at point C. We also suggest a thorough geo-technical assessment to identify practical and efficient methods of stabilization and revegetation of the exposed hillslopes both upslope and downslope of the road through this section.

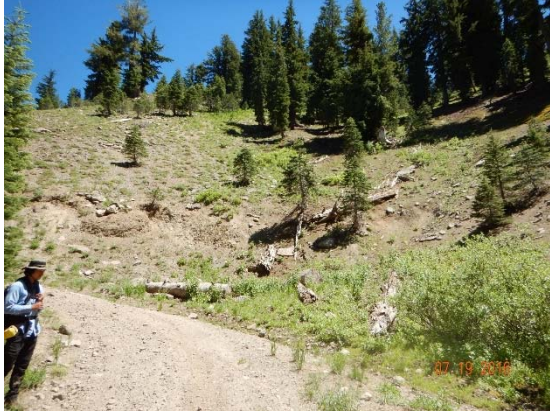
**Photo A**  
**Heading: 130**

Cutslope shows evidence of erosion at its base. Eroded sediment is delivered directly to channel to the south. Slope needs revegetated.

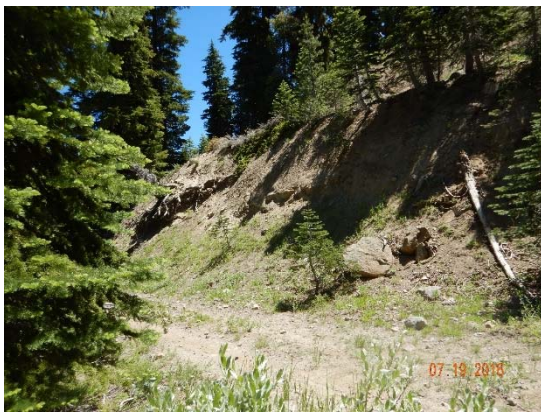
**Photo B**  
**Heading: 130**

Cutslope shows major evidence of erosion at its base. Eroded sediment is delivered directly to channel to the south.

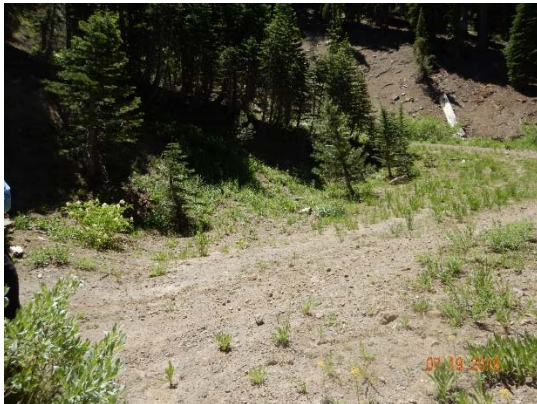
**Photo C**  
**Heading: 130**

Leadout in road helps to channel flow. Recommend deepening the leadout and rockfilling to reduce current turbidity during high stormflow events.

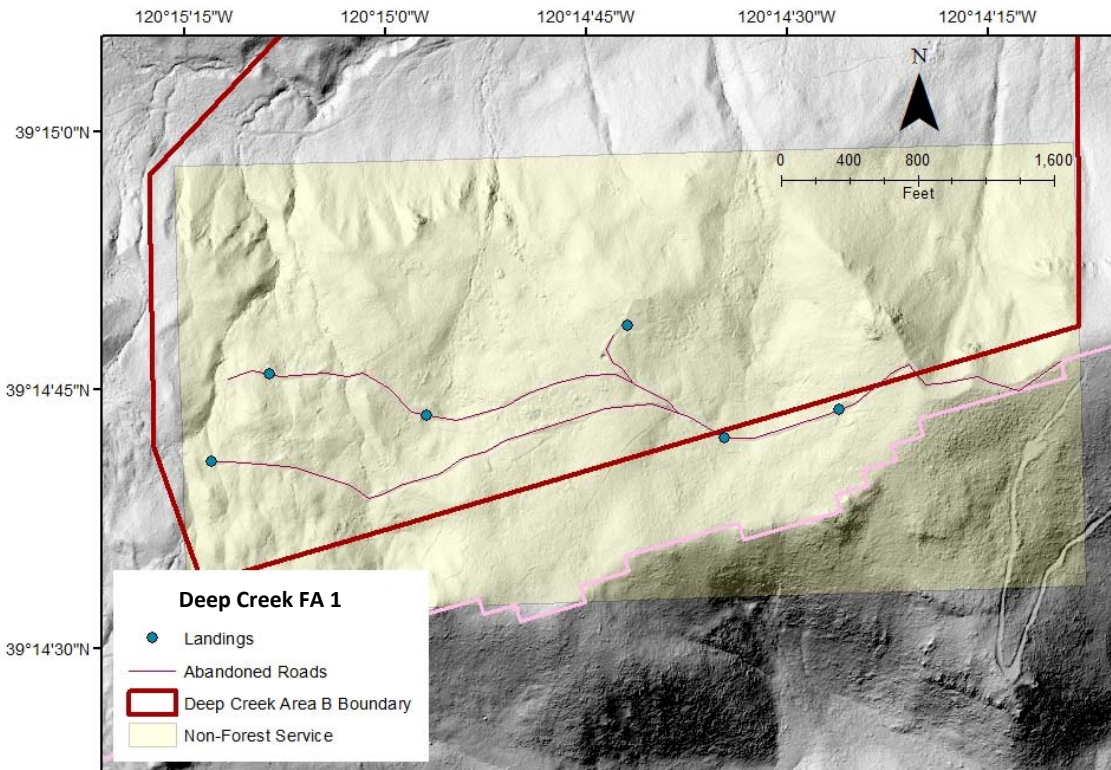
Abandoned logging roads and landings have had significant impact on drainage of the hillslope in this area. LiDAR images suggest drainage cuts begin at the sites of old landings. These drainages then incise down the hillslope and deposit directly into Deep Creek. Because these landings and roads are located on private, Non-Forest Service land, we suggest contact be made with landowners to discuss potential for remedial actions prior to a full ground assessment of Area B.

**Recommendations:** Make initial field assessment to identify problems and potential remedies. Begin discussion with landowners to determine feasibility of remedies.

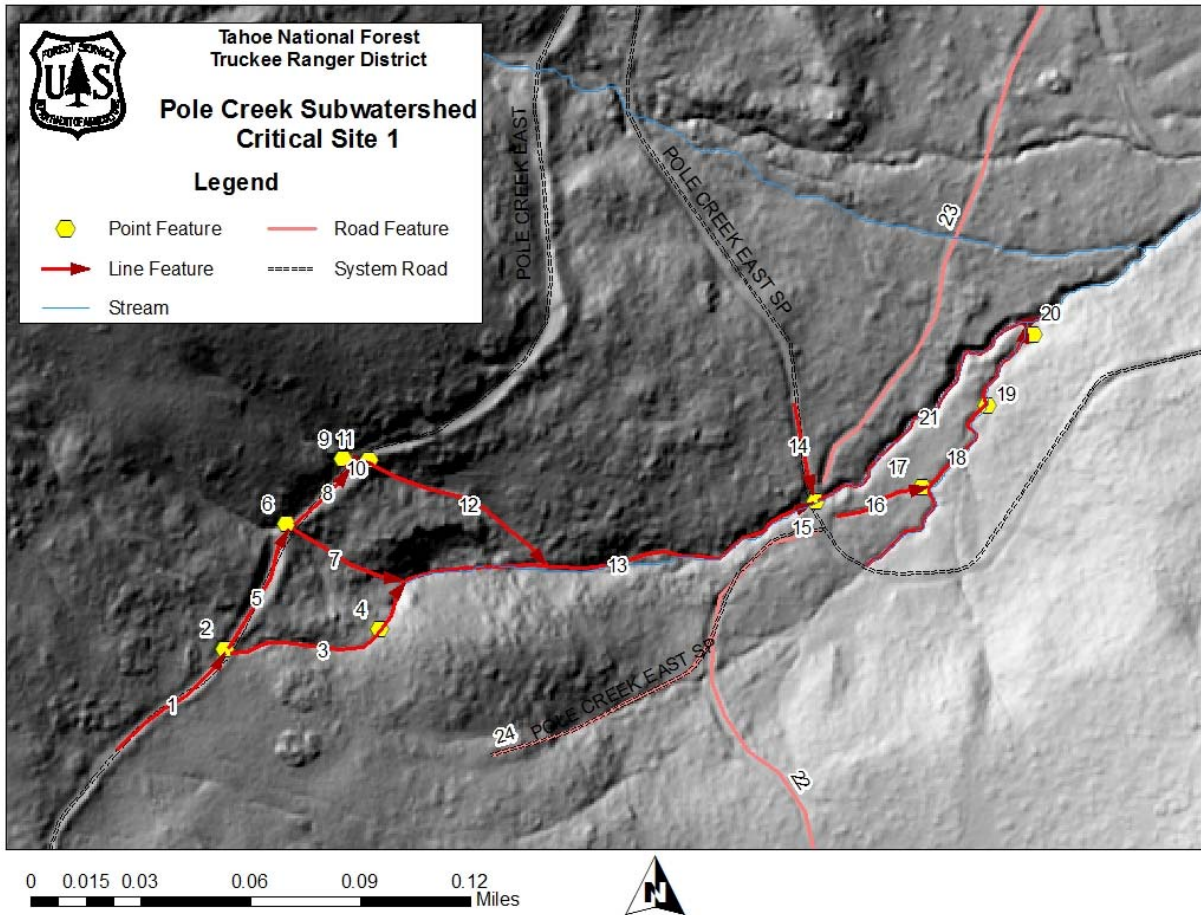
### Area/Critical Site 1

The main feature of this site is a deeply incised channel downstream of a crossing with Pole Creek East Spur Road. Average incision depth is 6ft. Geomorphology suggest this channel is unnatural as it is not the low point in the valley. Another, more stable, channel is found southeast at a lower elevation. There are signs of what may be the original flow path of the incised channel, but the development of the spur roads to the southwest and northeast of the crossing may have caused the relocation of the channel. Discharge in this incised channel has also increased due to the large amounts of road surface runoff entering the channel from the Pole Creek East road found uphill from the crossing. Poor maintenance and placement of road surface drainages have allowed road runoff to accumulate to amounts high enough to incise leadout outlets and adjacent fillslopes. This has allowed unnatural flow paths to lead into the headwaters of the incised channel downstream. Sediment from the erosion of the road and fillslopes enter the channel.

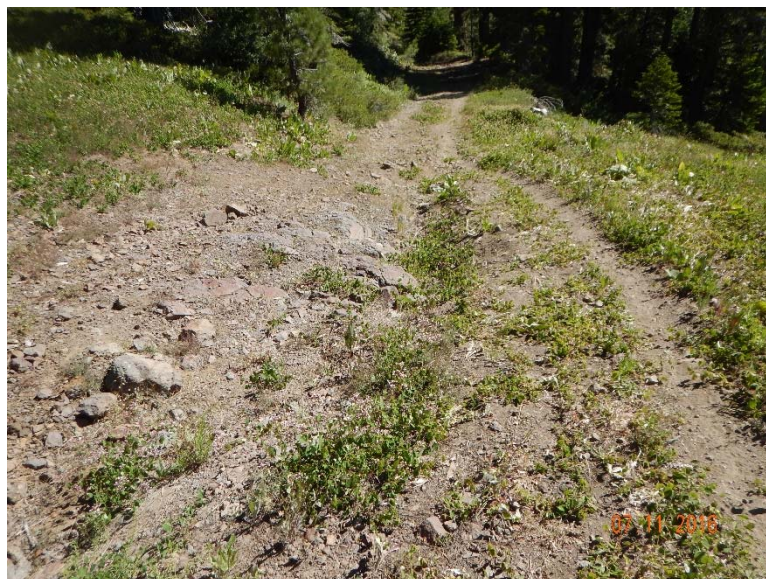
1.1: Road surface runoff from this length of Pole Creek East road accumulates and exits at leadout 1.2.

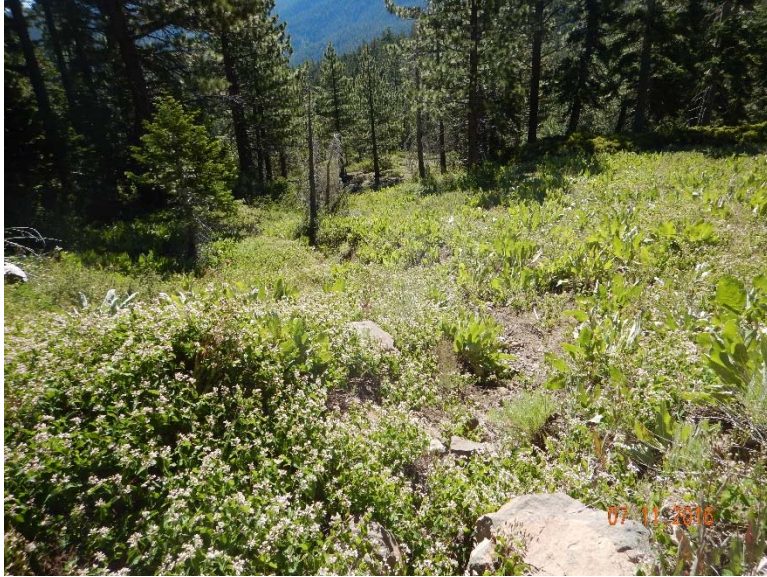
1.2: Leadout for road surface runoff from 1.1. Runoff is high enough that it has incised the outlet and fillslope, forming a flow path (1.3).

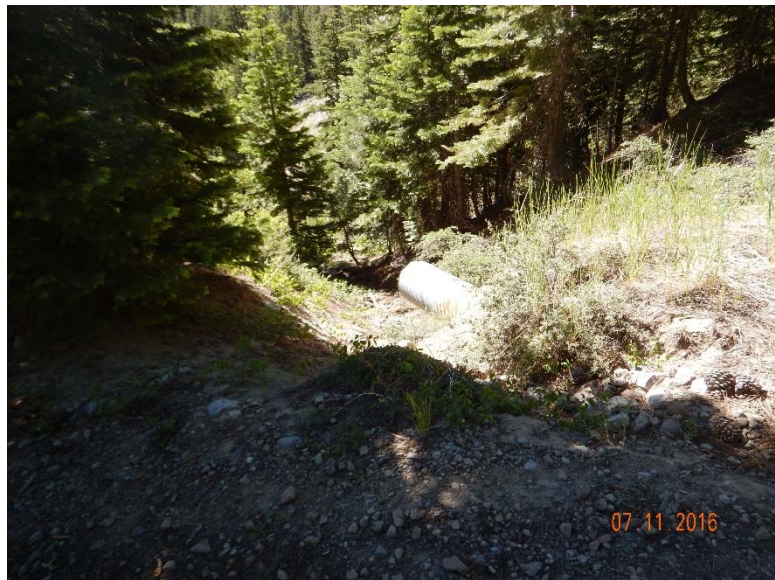
1.6: Stream crossing culvert. Surface runoff from the Pole Creek East road flows over the outlet of this culvert, and has been eroding the surrounding fillslope. The outlet now shotguns, giving discharge from the stream more potential energy to scour the channel downstream.

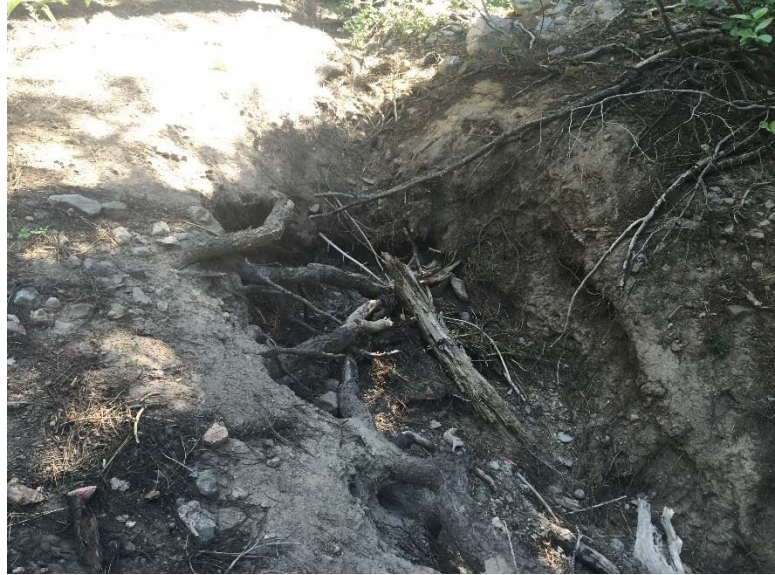
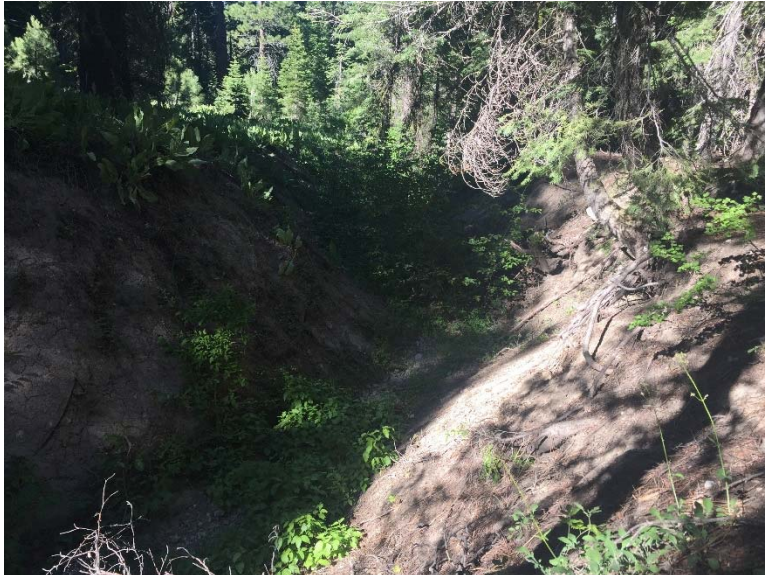
1.19 and 1.20: Headcuts in the natural channel 1.18 south of the main incised channel.

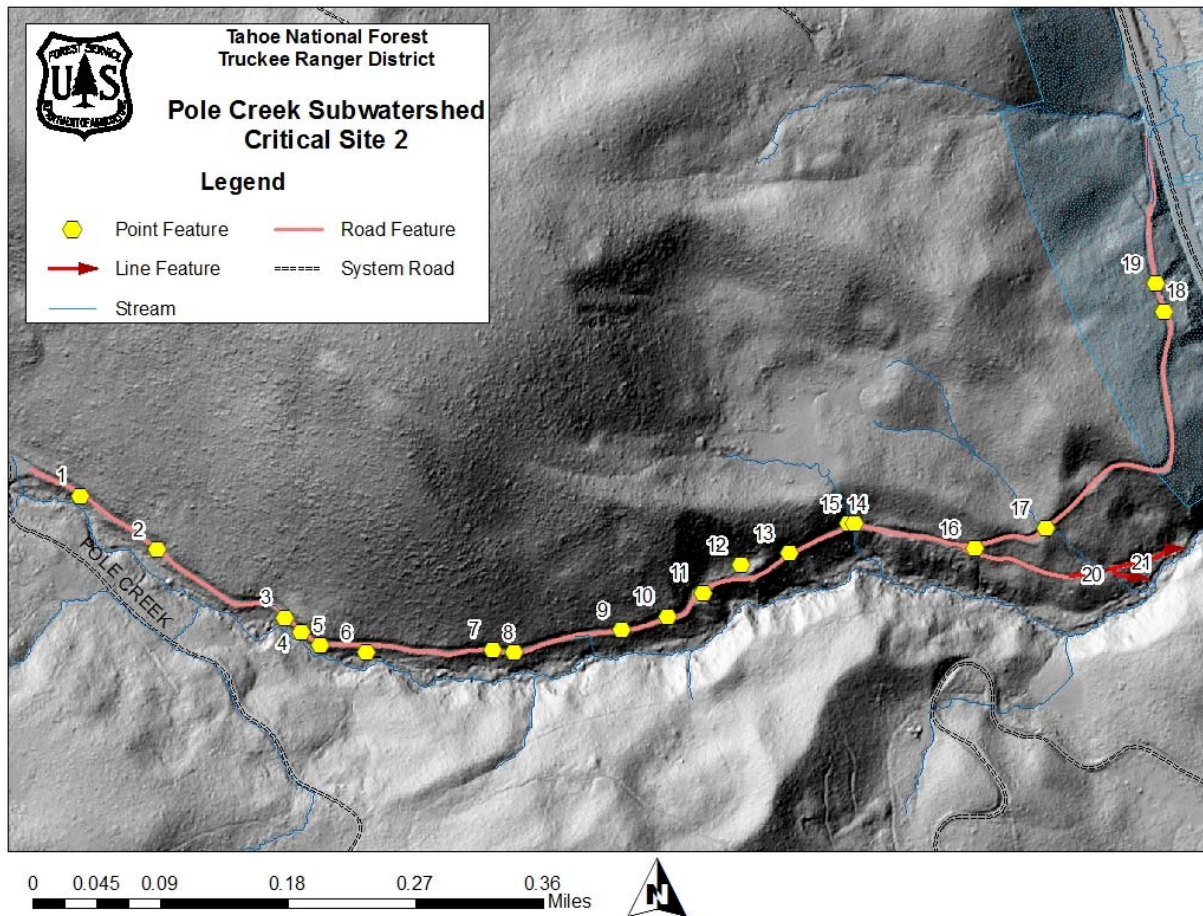
## Area/Critical Site 2

This site consists of a decommissioned road found directly north of Pole Creek. This road likely served as another way to access the Pole Creek watershed from Highway 89. The entire length of the road parallels Pole Creek before turning north and running semi parallel to the highway. This road sees no usage from any motor vehicles as access on the west and east end of the road is barricaded by multiple boulders. Due to its status as a decommissioned and unauthorized road, maintenance for its drainage features is nonexistent. Many waterbars and dips are no longer functional, and allow for runoff to accumulate to high amounts. This has allowed the formation of rillings on the road, and incision at leadouts and fillslopes. The eroded sediment from the roads and fillslope are allowed to flow directly into Pole Creek due the short length of buffer. A portion of the road appears have been built on the toe of a landslide, with the fillslope consisting of the moved mass. The road may have allowed for a washout event, causing a large amount of the fillslope to fail and deposit into the channel.

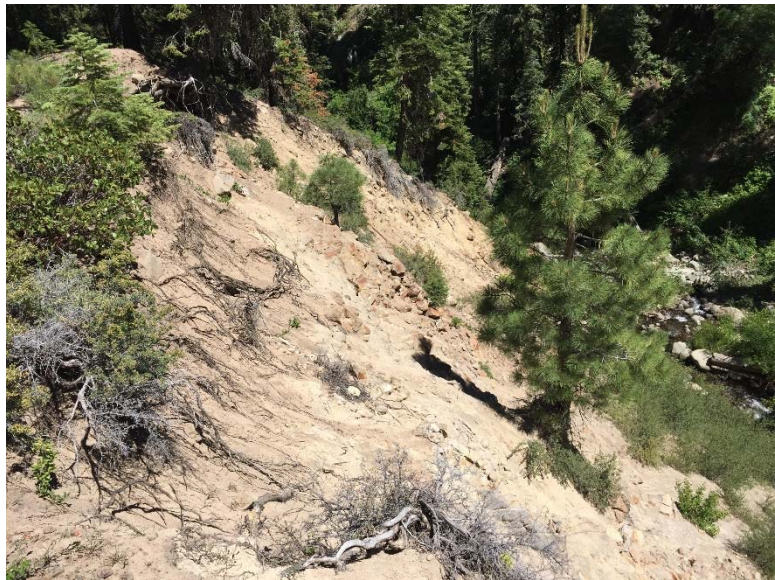
2.11 (cont.)

2.11: Segment of road built on toe of a landslide. A washout event may have allowed mass failure of the fillslope. Mass amounts of fillslope is no longer present and has left the remaining fillslope with low vegetation and bare soils.

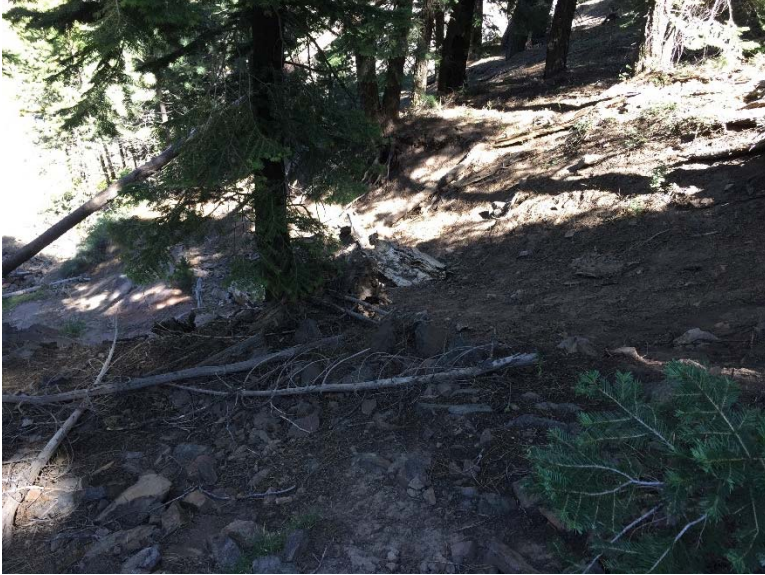
2.18: On private property. Leadout is catching excessive amounts of runoff from the upslope portion of road. Incision at the outlet of the leadout and fillslope occurs.

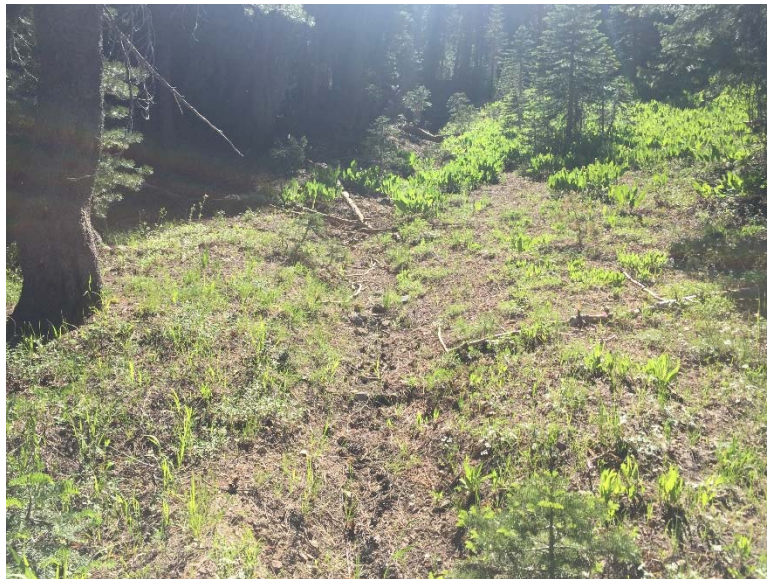
3.3: Leadout that collects road surface runoff from Pole Creek road. The runoff collected here has created a small channel that flows into the meadow.

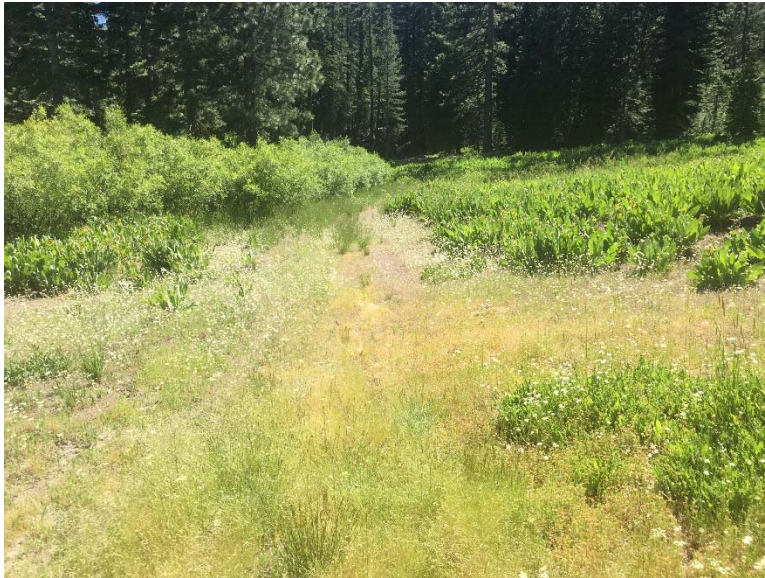
3.13: Unnatural runoff diversion for surface runoff from the Pole Creek Spur road. Runoff from Pole Creek road that reaches the spur road flows out into the meadow here as well.

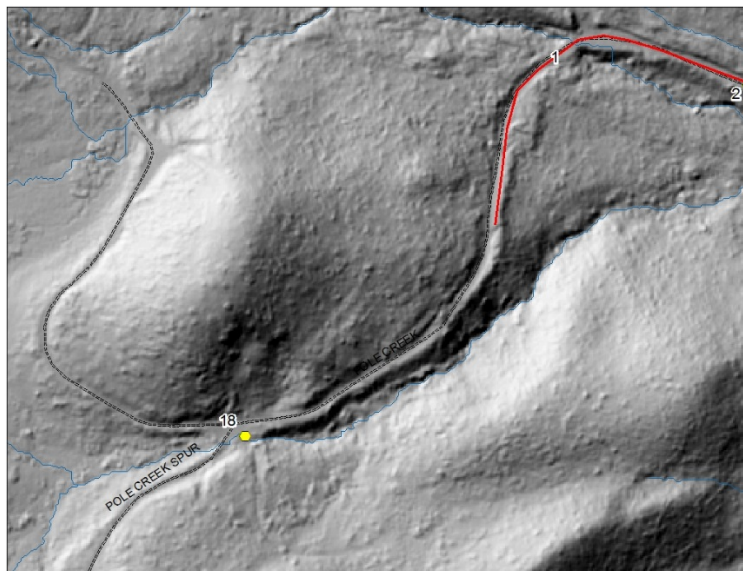
Further west on Pole Creek road, the road again crosses the same channel incising the fill of feature 3.17. A similar problem exists where fill was placed into the channel to allow for a road crossing. Currently, the fill appears to be stable due to the large amount of established vegetation here. There are currently no proposed action for this feature as remediation might be more detrimental than leaving it in its current condition. Further monitoring will continue to ensure its stability and/or determine a proposed action when it is deemed beneficial.

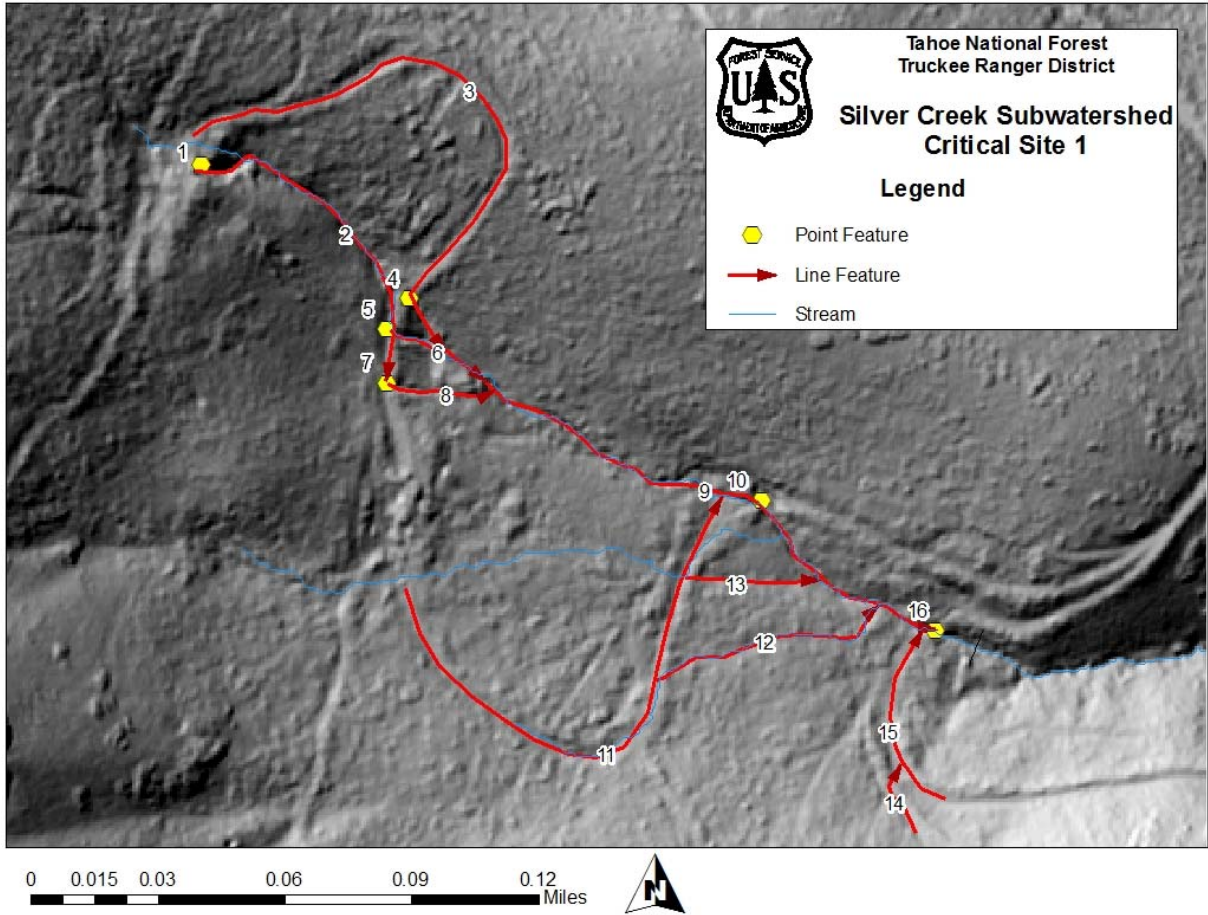
### Area/Critical Site 1

This area of Silver Creek has had a series of very old road development/bench cut following logging in the late 50's or 60's. Road fill crosses the drainage in multiple locations and there is no evidence that at any point in time these fills have either had culverts or any other structured drainage. These fills have since failed and resulted in transport of sediments transported through the fluvial system. There continue to be raw areas of fill remaining along the crossings and on roads that have potential for future sediment transport. Much of the road fill was developed over glacial till formed under the foot of the glacier.

It is recommended that the road fill and cut slopes that have potential to carry more sediment through the system be removed and natural slope contours be restored, while using out-sloping topography where the potential to collect and transport water over in-sloped road cuts exists. Use of road cuts previously developed but, found in more stable locations (not a product of glacial till) could be used to restore the glacial alpine soils in two locations. This glacial till has the capacity to respond as a high alpine sloping meadow as is evidenced by remnant vegetation. This site will require additional investigations to attain the final remedy.

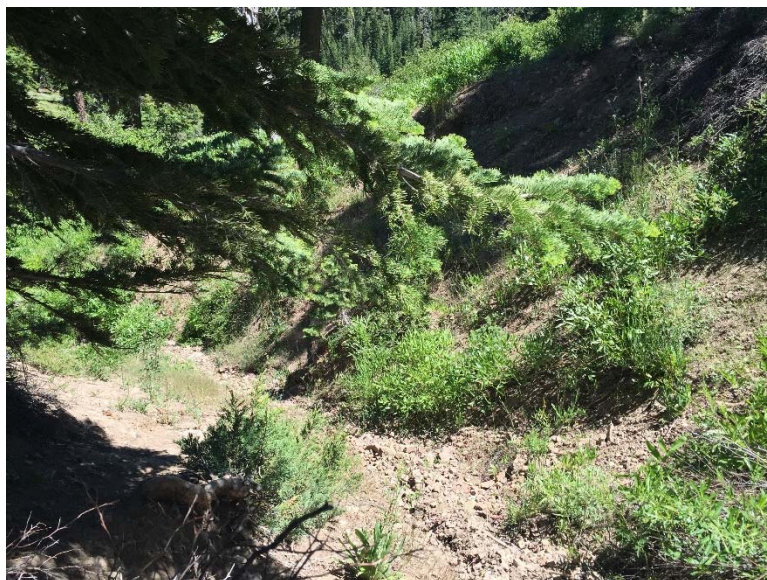
Looking downstream at channel 1.2 from left bank at leadout 1.1.

1.1 Accumulative runoff from the upland slope incises this leadout and fillslope.

1.2 Channel formed by the incision of the runoff flowing into leadout 1.1. Channel is incised approximately 3 ft. Runoff from this channel flows onto the road downstream and captured by leadouts 1.5 and 1.7.

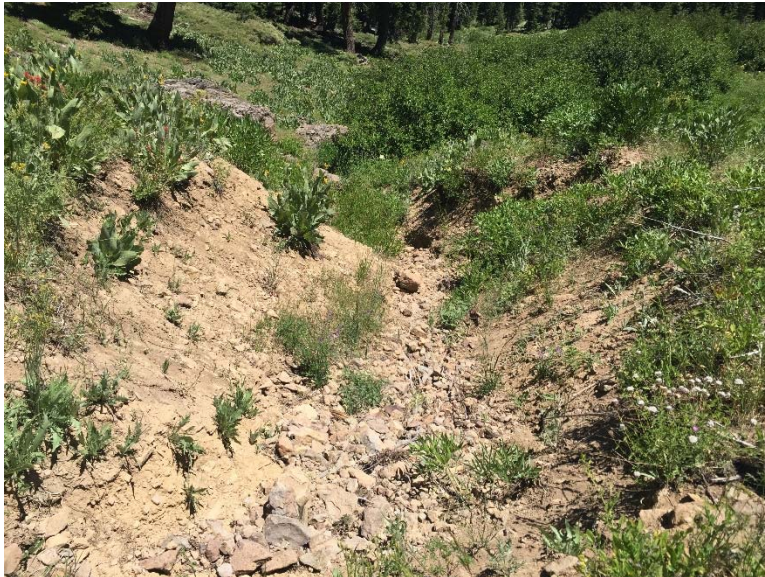
Looking downstream at channel 1.6 from leadout 1.5.

1.5 Leadout is capturing some runoff from channel 1.2. Runoff is still large enough to deeply incise the leadout and fillslope.

1.6 Channel formed from the large amount of runoff flowing into 1.5 and incising fillslope. Channel is incised approximately 4 ft. This channel feeds into channel 1.9.

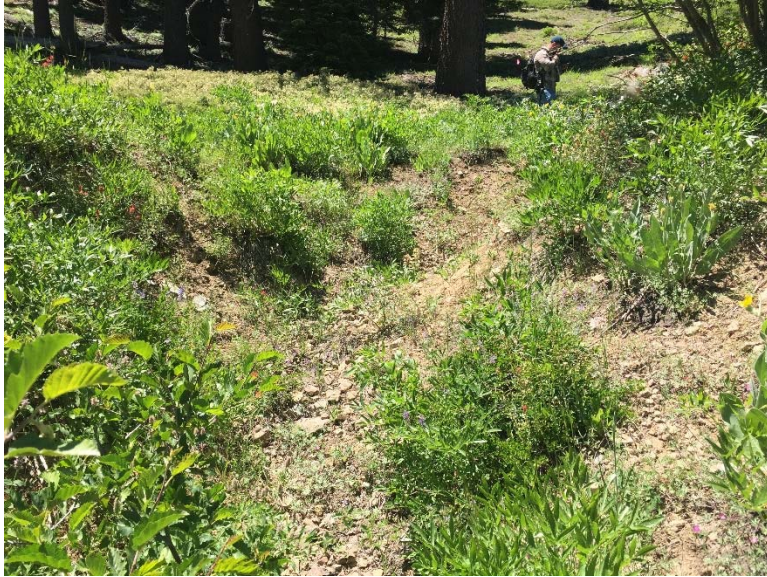
Looking upstream in channel 1.8 at leadout 1.7.

1.7 Leadout that is capturing some runoff from channel 1.2 and upslope runoff. Runoff is large enough to deeply incise the leadout and fillslope. Leadout discharges into channel 1.8.

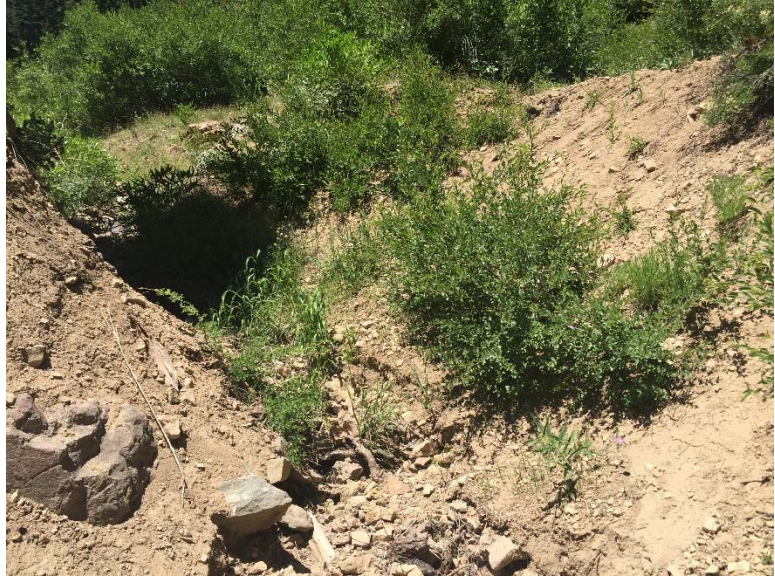
Looking upstream in channel 1.9 at crossing 1.10.

1.10 Road crossing that has been deeply incised and eroded away. The V-shape of this channel at this crossing is high angled. Incision at this channel is approximately 6ft deep. Fill material used for this crossing was highly erodible as seen by the deep incision.

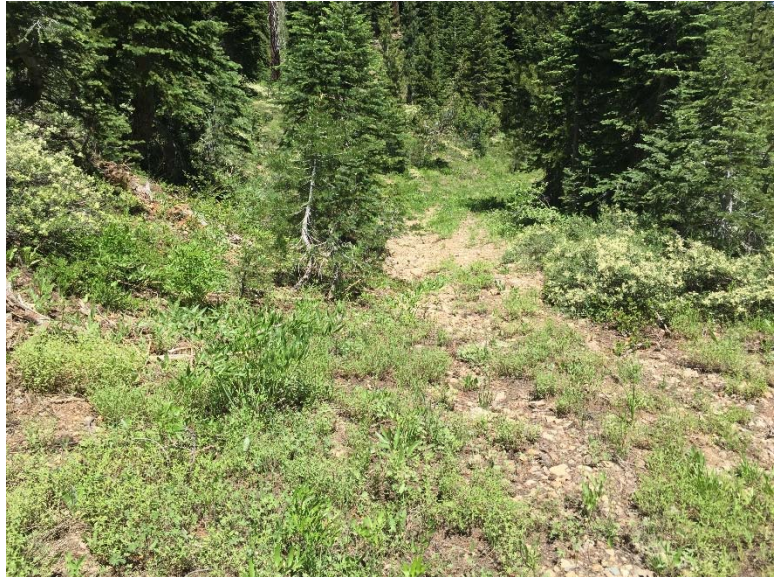
1.15 Road surface runoff accumulates along this length of road and skid trail runoff from 1.14 before flowing into channel 1.9 at the road crossing at 1.16.

Looking downslope at road surface runoff 1.15 sloped towards channel 1.9 and crossing 1.16.

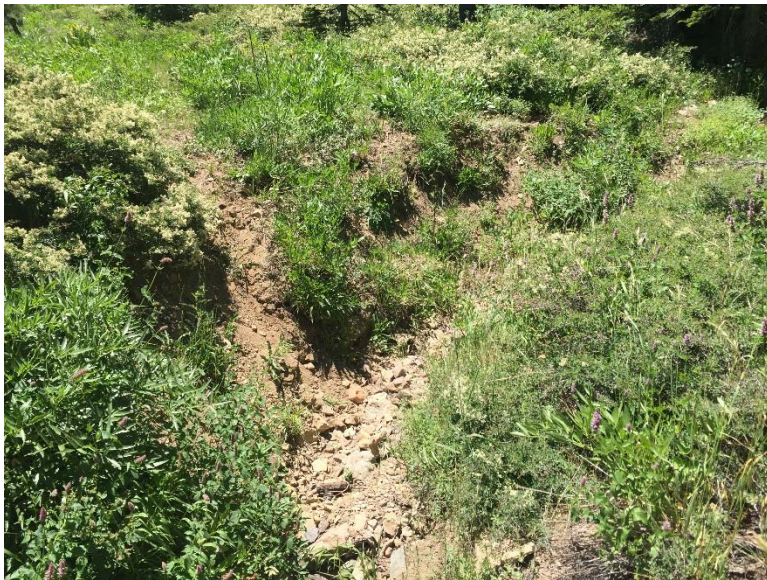
1.16 Crossing with the Pole Creek East Spur road. Channel 1.9 has incised and eroded the fill material used to make this crossing. Incision at this crossing is approximately 4 ft deep. Incision continues before channel turn slightly north. Its turn to the north is likely due to channel flowing over a different substrate, and may represent the original flow path prior to the landslide.

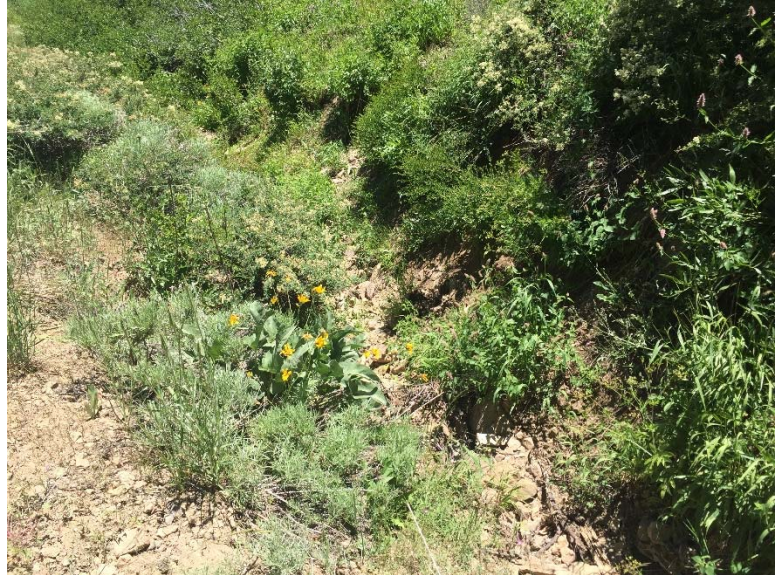
Looking upstream along channel 1.9 downstream of crossing 1.16.

Looking downstream along channel 1.9 on the left bank at crossing 1.16.

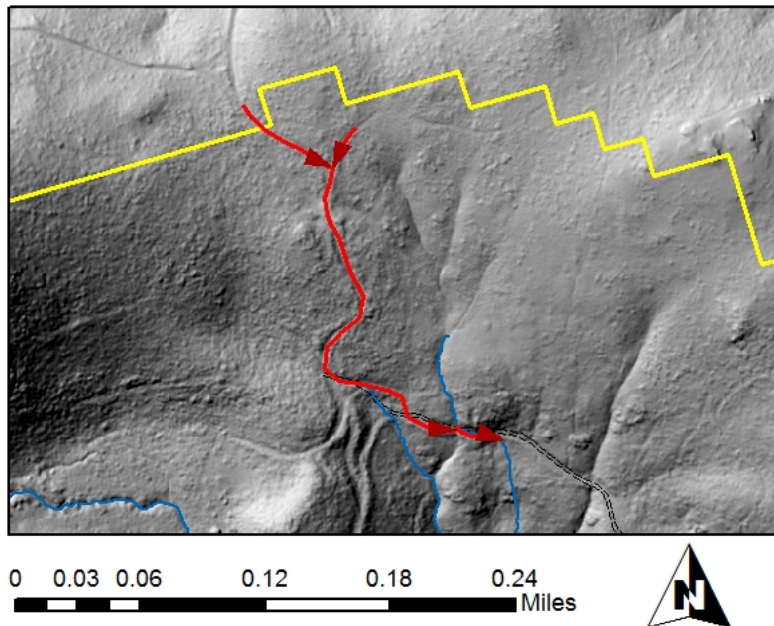
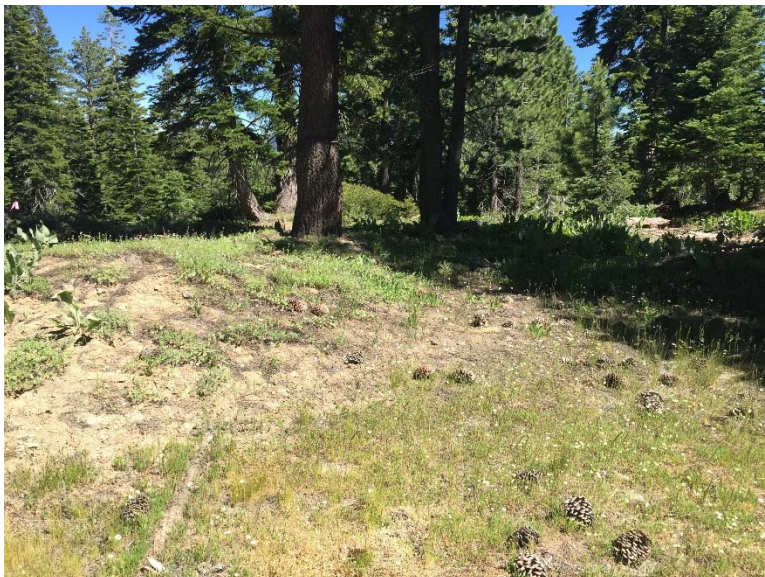
**R1:** A spur road for the Pole Creek East road is accumulating road surface runoff due to the lack of road surface drainage structures. Runoff begins collecting at this road's extent at the top of the subwatershed. A small segment of a skid trail intersects with this spur road, and contributes its own surface runoff. South of the skid trail intersection, the road has a higher grade and bisects a small meadow. Runoff from the west meadow flows onto the road. Runoff continues to accumulate along down the road and turns to the east and onto Pole Creek East road. Some road runoff exits the road via leadout, however some continues to stay on the road. An ephemeral channel flows onto the road and collects the accumulated runoff from the spur road and continues for approximately 35 feet before exiting Pole Creek East road through a leadout.

Road grade is elevated (at base of tree) compared to the meadow (grass at bottom of picture)

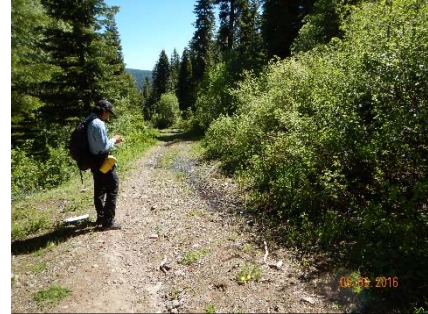
**SEGMENT 1A:** This private land road is insloped and moderately rutted in places. The road catches stream subsurface and surface runoff from the cutslope and diverts flow as much as 125 ft. in places before allowing runoff. Prior attempts to mitigate runoff have been made to alleviate this flow with culverts spaced approximately 75 ft. apart through some of the segment.

Remediation of This segment is divided into 5 sections: Section (a) improve the number of water diversions to approximately every 75 ft.; (b) needs no restoration; (c) improved with additional culverts through the segment; (d) improved with additional water diversions to approximately every 60 ft.

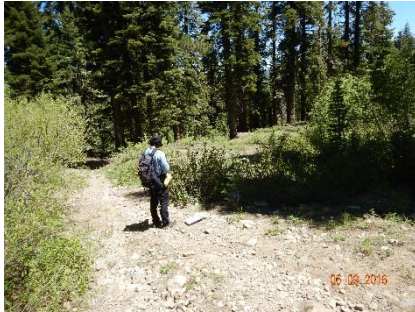
### SEGMENT 1B:

This section of Forest Service Road has not been maintained for some time and significant remediation is required in this section. Overflow from upslope streams is channeled along the road in this section. This overflow has led to heavy rutting of the road and formation of gullies on the inside edge of the road at the bottom of this section. Tightly spaced waterbars are needed along the upper section and culverts on the lower section to alleviate concentrated flows.

**Suggested Remediation:** We recommend emplacing waterbars through this entire segment every 50 feet.

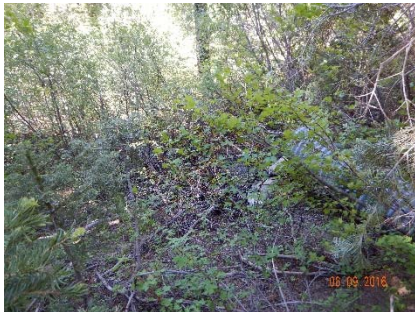
**SEGMENT 2A:** This road segment needs increased water diversions spaced at approximately 50 ft. apart between the existing culverts. Culverts need to be cleaned out (at right). Some culverts overhang and water drops 2-3 ft. causing significant erosion beneath the culvert. Improve outlet designs to alleviate some of this erosive effect.

**Suggested Remediation:** We recommend cleaning out existing culverts, cutting back overhanging culverts, and adding water diversions through entire segment evenly spaced at 50 ft.

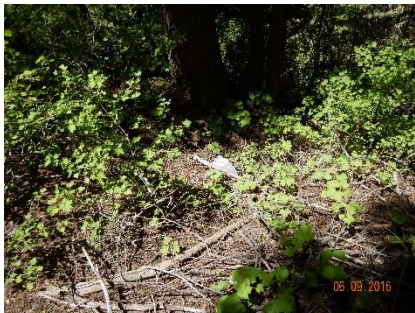
**SEGMENT 2B:** Road exhibits little to no signs of rilling suggesting road has little effect on water flow. Several culverts exist to allow normal drainage of streams under the road. Some of these culverts need maintenance of vegetation and clearing debris.

**Suggested remediation:** Clear existing culverts

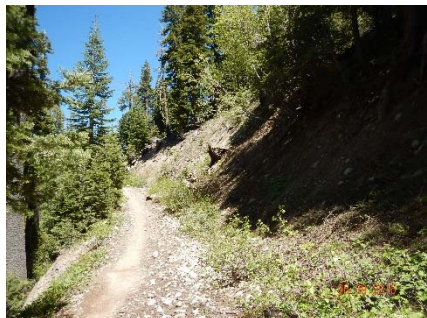
**SEGMENT 2C:** Road is generally in good condition. One overhanging culvert outlet needs improvement to reduce impact from falling water. The existing cutslope is actively eroding in some locations and could use vegetative stabilization to reduce erosive effects. An area with standing water on the road may require a designed sub-drain.

**Suggested remediation:** Vegetate high angle cutslopes.

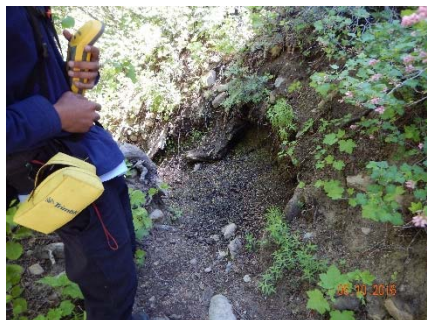
**SEGMENT 3A:** The foot trail between main throughways diverts channel flow, exposes subsurface flow, and concentrates flow. An old skid trail crosses the foot trail just due south of the locked gate but, does not interrupt natural hydrology.

**Suggested Remediation:** Obliterate foot trail

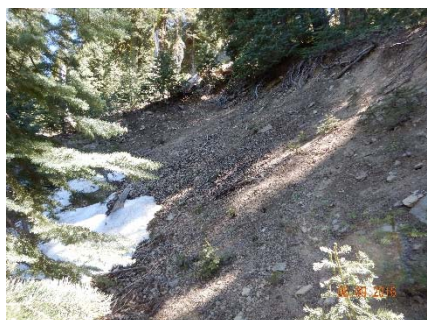
**SEGMENT 4A:** Numerous waterbars exist and are functioning; vegetative growth has made the road nearly impassable in multiple places. At one point the cutslope has failed and filled the road. The disturbance required to get machinery to this location make mechanical remediation unreasonable.

**Suggested Remediation:** None

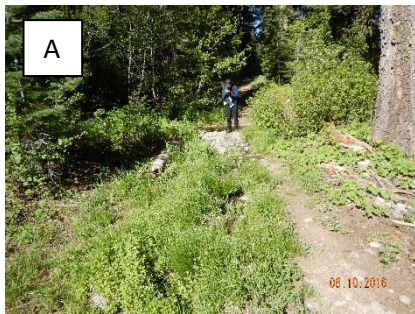
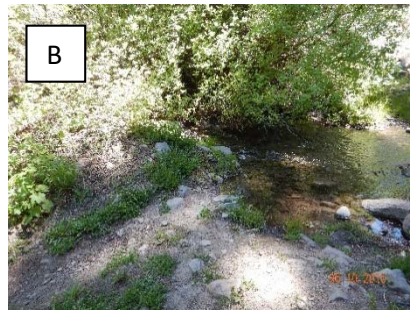
**SEGMENT 5A:** Significant remediation measures are needed in this area. Two streams cross the trail but overflow is not captured. Diversions were placed to maintain flow along the stream’s present day pathway, but traffic has caused the raised topography to be worn down. During times of high runoff overflow the road now captures this runoff and allows significant erosion off the road. The high mound where the drainages split show signs of deposition and over time water has coursed on one side or the other; flow has since been controlled to allow for timber harvesting and housing development downstream.

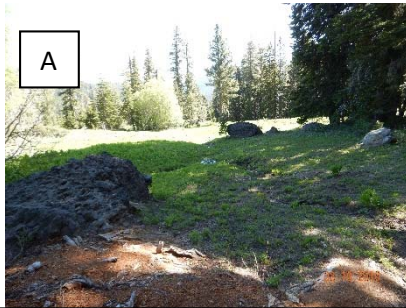
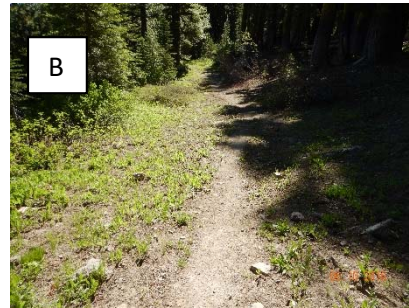
**SEGMENT 5C (east):** Road has captured and channelized drainage (photo B). Channel empties into meadow on fillslope and has channeled flow through the meadow (photo A).

**Suggested Remediation:** Add water diversions along the road approximately every 55 ft. Restore meadow hydrology by reconnecting hydrologic flows across meadow surface.

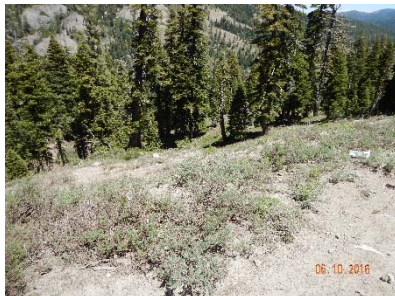
**SEGMENT 5C (west):** Road captures runoff and channels into preexisting channel paths. Along hilltop runoff has mounded sediment on the fillslope that allows runoff to channel around the mound.

**Suggested Remediation:** Remove mounded sediment below road.

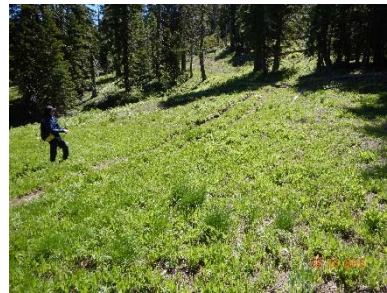
**SEGMENT 5D:** Overall road 5D is in good shape. However, at point 38 a meadow is incised from trail use. This cut catches all water flow through the meadow and channelizes it. To the SE, topographically above road 5D in this section, the road appears to be channelizing runoff in several areas. We suggest further review of this southern road.

**Suggested Remediation:** Repair trail and road to promote dispersed flow through meadows and assess need for access through segment over forest service lands.

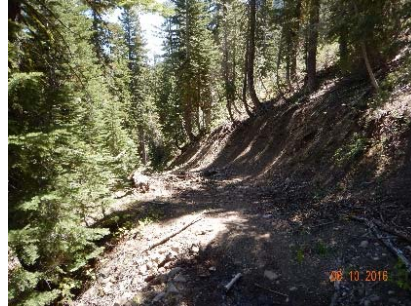
**SEGMENT 5E:** Road channels significant flow in both sections. Numerous felled trees parallel the road on the fillslope of 5E and help to contain water flow onto road. Felled trees need removed and waterbars need emplaced to reduce flow rate. Cutslope adds to sediment erosion at places.

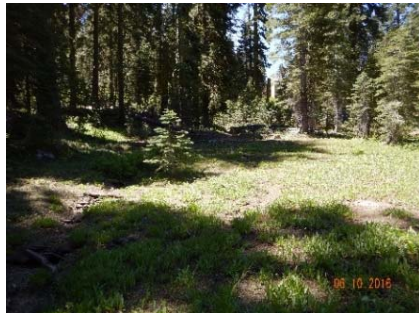
**SEGMENT 5G:** Road catches a lot of flow and diverts into meadow to the NW. Due to downstream infrastructure a detailed study may be needed to determine. Recommend waterbars to slow down channeling of water into meadow. The meadow the road crosses to the NW (in photo) shows signs of previous studies as it is flagged and at least one well is present. No sign of previous study or remediation in Segment 5G however.

**Suggested Remediation:** Install culvert at stream crossing. Add water diversions every 50 ft. on west sloping road west of stream crossing.

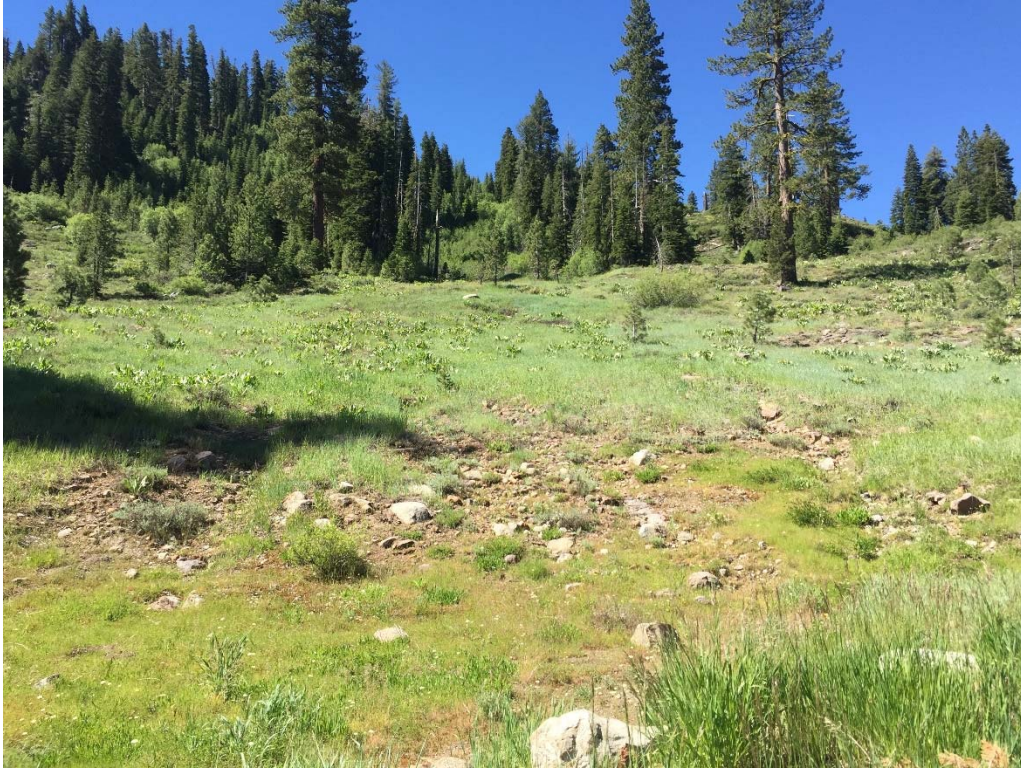
The slope regrading removed natural roughness features, removed the rock fragments from the top soil surface, and removed tree and shrub vegetation replacing the site with a smooth monoculture of grass. While erosion control structures as low profile slope diversions were constructed on the graded slopes, these erosion control features have failed. These modifications from the natural slope conditions now create a long flow path down the fall line of the ski slope. As the years progressed since abandonment of the facilities, the unnatural drainages have worsen, creating rilling and incisional features. Because of a lack of roughness and vegetative changes, the site has directed an unnatural amount of discharge to the northern slope base of this area (See the general flow patterns on Map 1: Deer Park Legacy: Existing Conditions and the positively affected areas on Map 2: Deer Park Legacy: Remediation). The existing conditions include rill and gully formation as shown on the map and in the site photos (Figure 1). There is evidence of transport of water and sediment to drainage structures that are found in the adjacent parking lot and road to the north. The creation of ski slopes by grading reduces ecosystem function and decreases the predictability of soil and vegetation recovery. The documentation suggest the existing graded ski slopes may benefit from restoration of soils and vegetation (Burt and Clary, 2016). Approximately 4.85 acres are disturbed from development of this ski area.

Figure 1. Looking upslope at the hillside from the parking lot directly north of Deer Park.

- Restore infiltration through reincorporating rock and roughness to the ski slope surface areas
- Restore natural flow patterns through re-grading to approximate original slope where feasible and effective
- Restore natural vegetation types to increase rainfall interception, reduce raindrop splash and increase infiltration rates.
- Provide water control measures (waterbars-to support re-graded site conditions).
- Bust up burry/and or remove cement lift infrastructure and other infrastructure as identified.

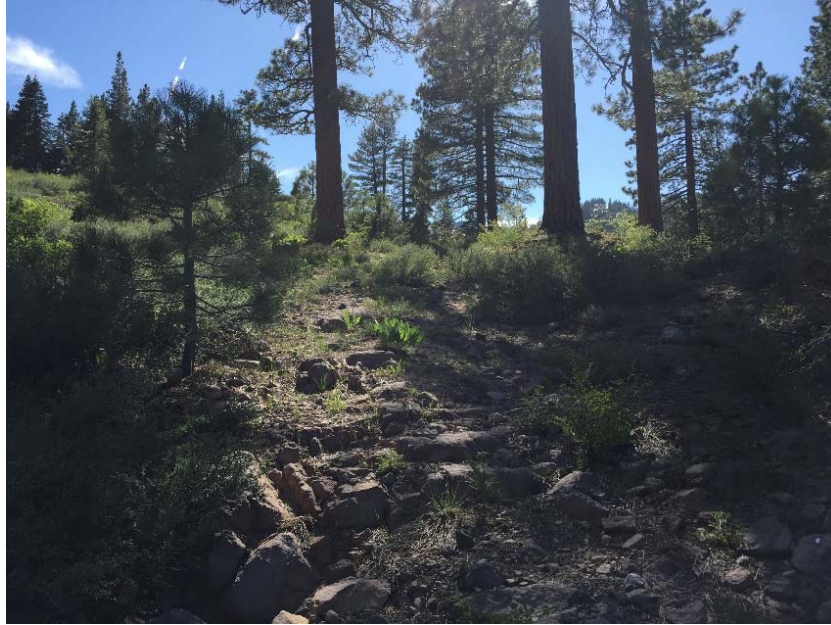
Figure 2. Looking upslope of feature R2. This feature cuts into substrate that consist of bedrock.

R2: Recontour/Waterbar. Material nearby fill feature F3 can be used. This segment's material consist of a large amount of rock, importing rock maybe required (Figure 2).
