# **Middle Truckee River Tributaries Sediment Source Assessment Prescription Plan**

**Truckee River Watershed Council  
USDA Forest Service, Tahoe National Forest, Truckee Ranger District  
August 2016**

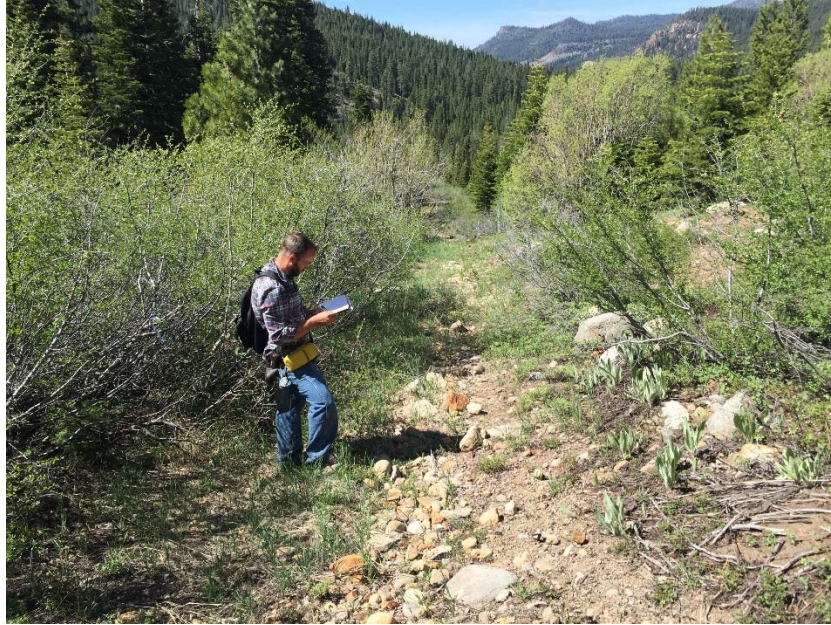
Figure 3. Looking downslope along feature R5. Slope drops down to the left (west) past vegetation.

R5: Recontour/Waterbar. Segment of road is nearly outslope shaped. Waterbars would allow for effective diversion of water down the west slope (Figure 3). Once upstream flows are disconnected this slope would have a large reduction in channelized flows.

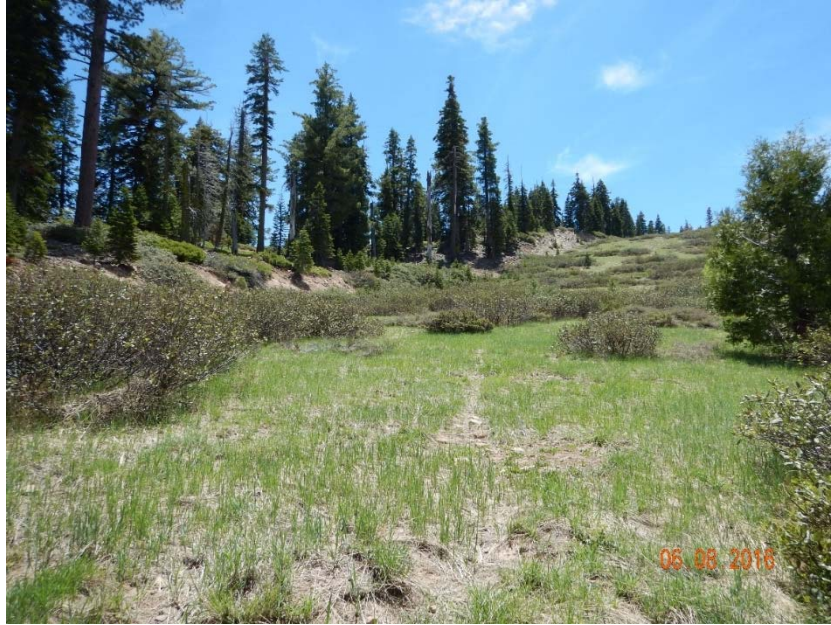
C3: The largest and the highest elevated graded slope in the area (Figure 6). Vegetation is found on the graded slope, and consists of mainly grass with some shrubs. The cutslope is poorly vegetated and exposed. Waterbars were constructed on this slope, but most have failed due to lack of maintenance. Rilling occurs and gully erosion is present due to the lack of functioning erosional control. The flow continues down to the northwest end of this feature and connects with rilling found in C2. A portion of the flow is directed to an adjacent channel. Flow then continues through the majority of features found at this site and ends at the base, next to the parking lot and connecting with the drainage system there. As this area of disturbance is the highest in the site, its contribution to unnatural discharge and flow paths is the highest priority. Its remediation would positively affect the rest of the features. Enlarging, reinforcing and increasing the number of existing waterbars will help in dispersing water flow properly, however lack of continued maintenance would eventually result in enlarged gully erosion and increased delivery to the stream channel and drainage ways. Recontouring provides a long-term solution. Revegetation and surface roughening will allow the water to infiltrate, increase vegetative interception and transpiration and slow down flow velocities to reduce future erosion processes. The fillslope and its adjacent parts of the graded slope can be pulled back and reconnected to cutslope. More material can be acquired from fill feature F7.

Figure 6. Looking upslope (south) at the base of feature C3.

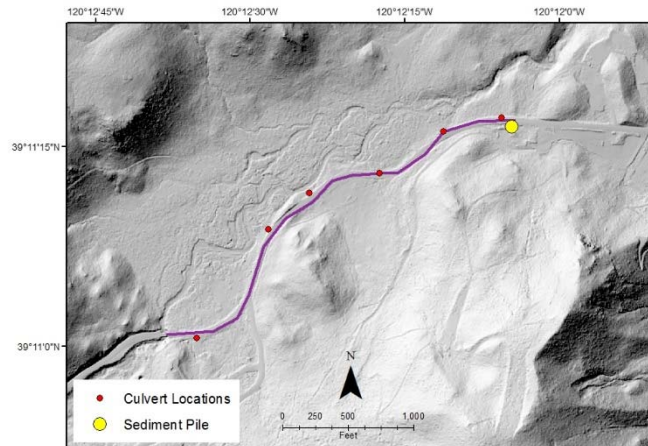
Sediment buildup at culvert outlet indicates amount of energy channeled flow has during high precipitation/runoff events

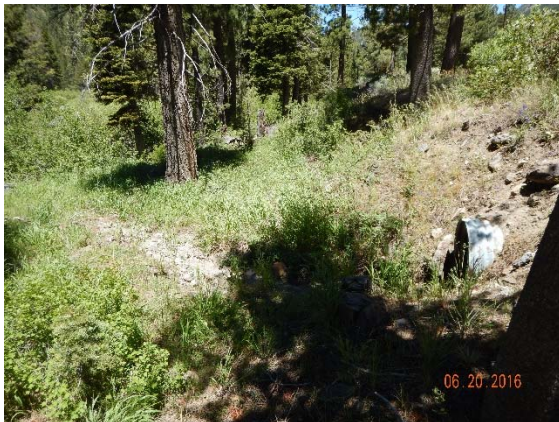
This channeled flow can have high enough energy to cut paths from culvert to Bear Creek

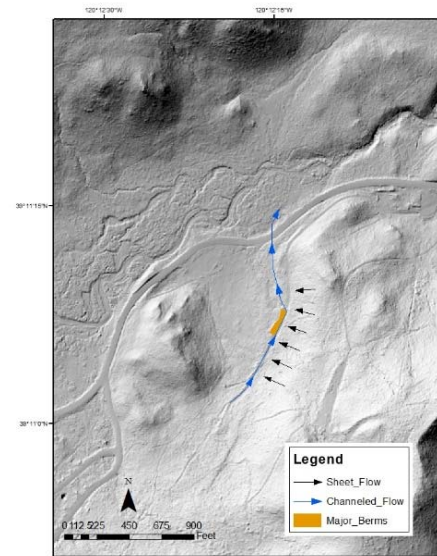
Scouring of old road picks up sediment later drained into Bear Creek.

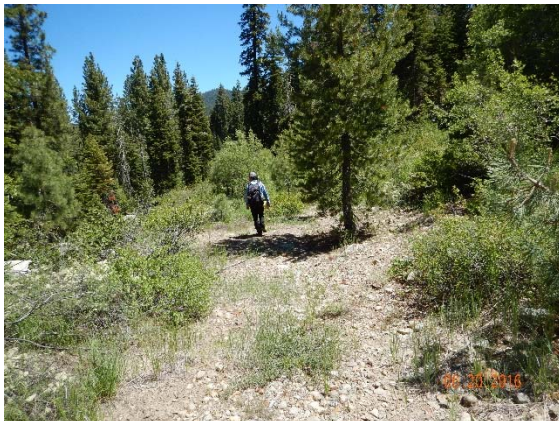
Old road cuts through hillside with fillslope higher than old road, allowing for heavy capture and channeling of runoff.

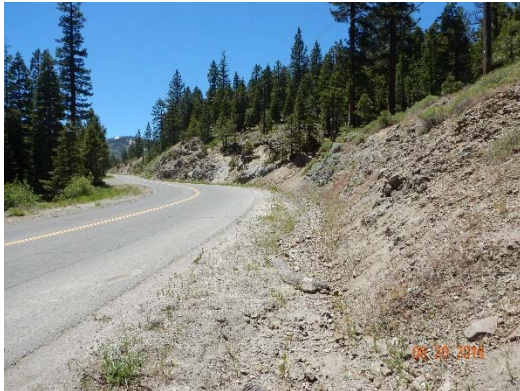
High angle cutslope with inside ditch is catching and channeling erosion and runoff

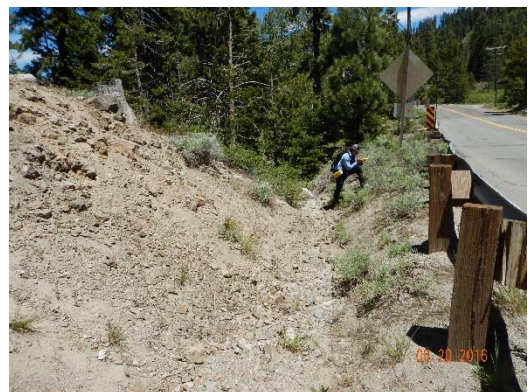
View downstream of ditch showing it feed directly into river.

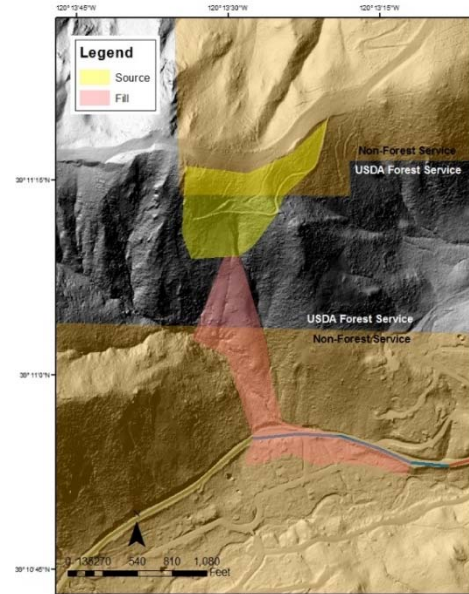
Sediment accumulation within this rut does not appear natural; however, there are some geologically instable lands upstream and it is in an avalanche runout zone. While this sediment accumulation could be primarily from those sources there may be a connection to the source from the road that runs parallel to slope above the accumulation. At the time of this survey, the crew was not able to gain access and the road manager typically checks this road. Additional review of the need for this road due to the associated risk from the location should be assessed.

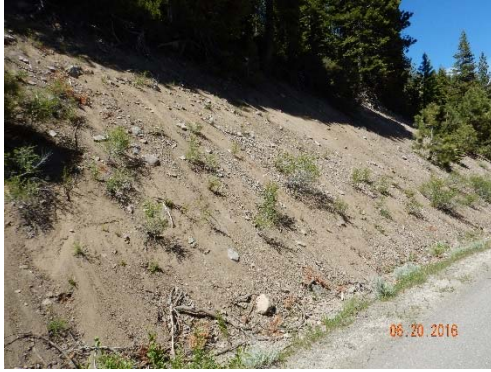
Along the eastern half of this segment the cutslope is heavily eroding, being captured in the inside ditch and eventually channeled through a culvert into Bear Creek. A thorough geo-technical assessment to identify practical and efficient methods of stabilization and revegetation of the exposed hillslopes both upslope and downslope of the northern side of the road may provide beneficial reductions in sediment through this section. Drainage along the western half is functional, however; there could be some flood flow constriction influencing downstream capacity due to encroachment within the near stream zone.

Cutslope along eastern half of road segment needs covered and revegetated.

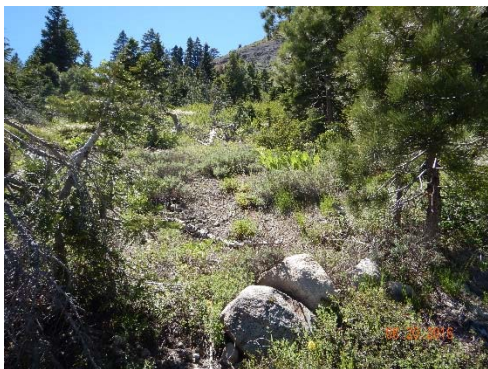
Older access route is well vegetated and shows no sign of interrupting or channeling flow.

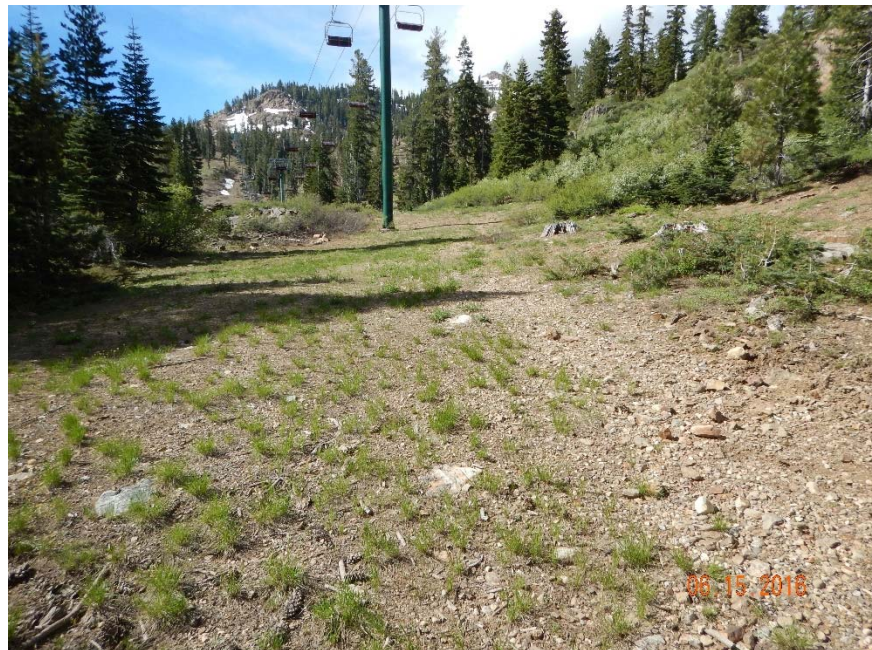
- The hillside is poorly vegetated, providing poor cover and exposing soils (Figure 2 and Figure 3). Water from rain and snowpack does not have proper infiltration time and immediately leaves the hillslope and flows into the road. The waterbars and leadouts are collecting this discharge.

Figure 2. Poorly vegetated hillslopes. The lack of vegetation allows for exposed soils. Rain and overland flow are allowed to erode the surface and carry sediment downslope into adjacent roads, eventually flowing into nearby streams.

It is recommended that the hillslopes have their surfaces roughen and revegetated to slow down overland flow and allow more time for infiltration. Armoring of the leadouts will prevent further incision.

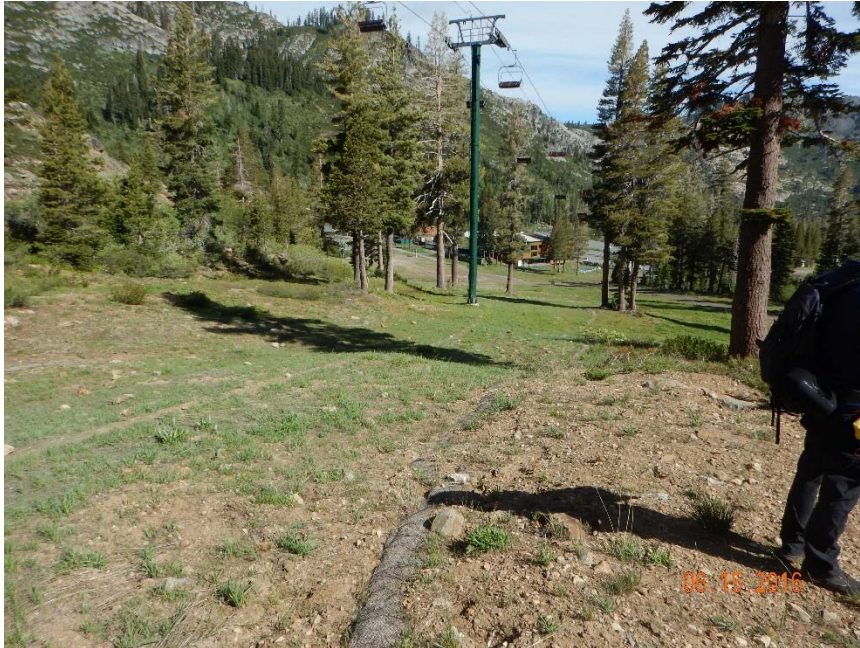
Figure 3. Poorly vegetated hillslopes. Poor vegetation is allowing for exposed soils, becoming more susceptible to erosion from rain and overland flow.

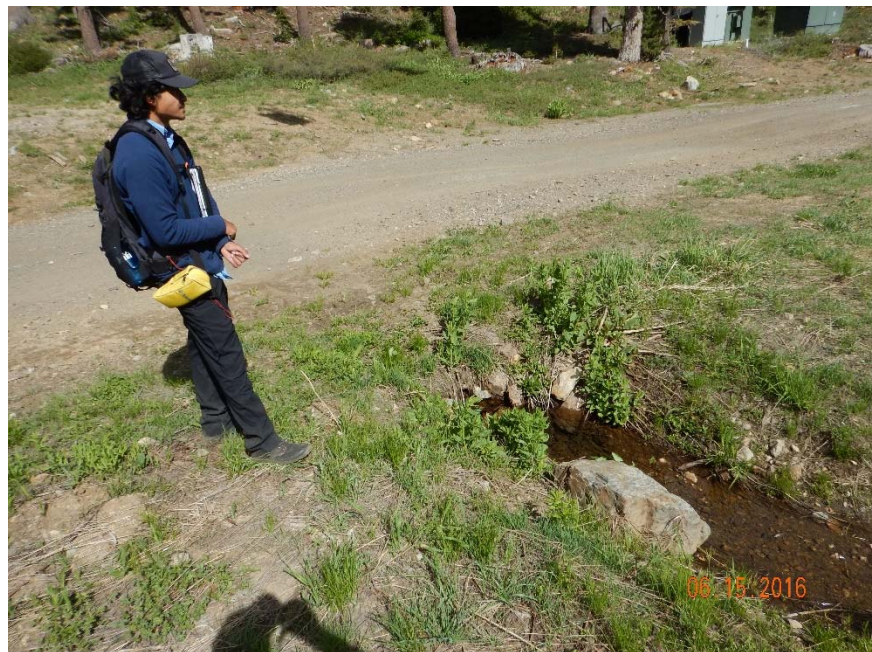
- The hillslope of the road is entering the stream and allowing outslope runoff from the road to flow over the hillslope and into the stream (Figure 4). There is also a culvert with a damaged outlet that requires repair (Figure 5).

Figure 4. Fillslope of road placed directly into channel.

Recommended actions consist of the following. Hillslope surfaces are roughen and vegetated. This will allow slower overland flow and greater infiltration time, effectively lowering the amount of hillslope runoff from entering the roads and drainage structures. The hillslope material placed in the channel along this road segment should be removed and the remaining stream bank should be

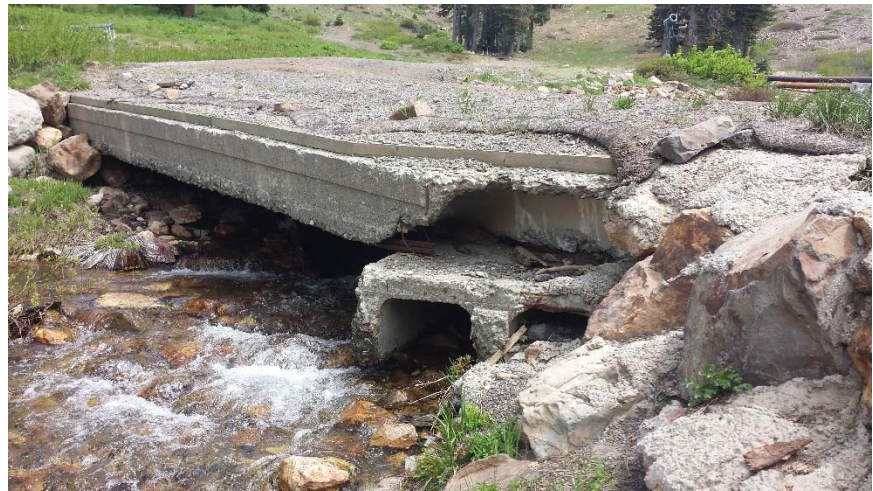
- This road segment has a bridge crossing over a perennial channel (Figure 6 and Figure 7). The bridge does not have any railing or raised lip, so any runoff that flows over the bridge can flow over the top and into the stream. Straw waddles were installed on the sides of the bridge to prevent road runoff to top over, but have failed.

Figure 6. Bridge crossing over perennial channel. Straw waddles installed to prevent water from flowing over the top of the bridge and into the channel have failed.

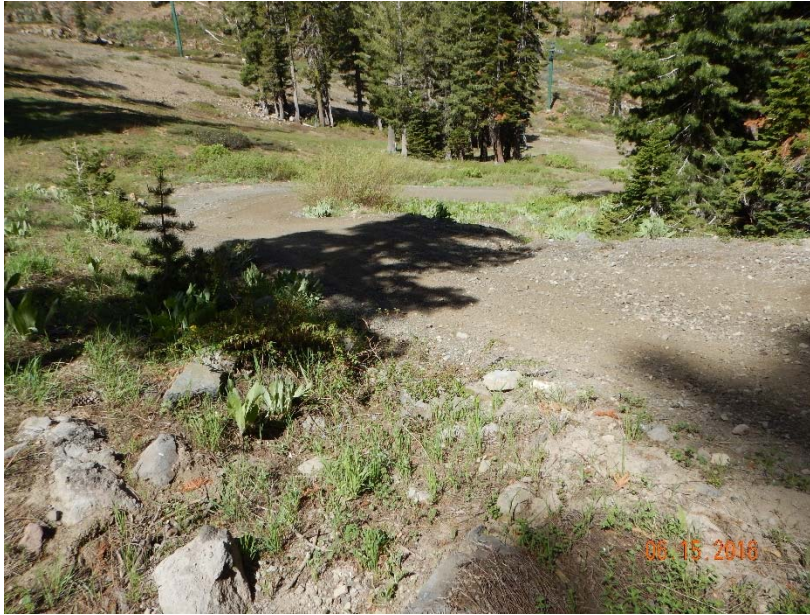
Figure 10. Poorly vegetated slope looking uphill where Figure 9 was taken.

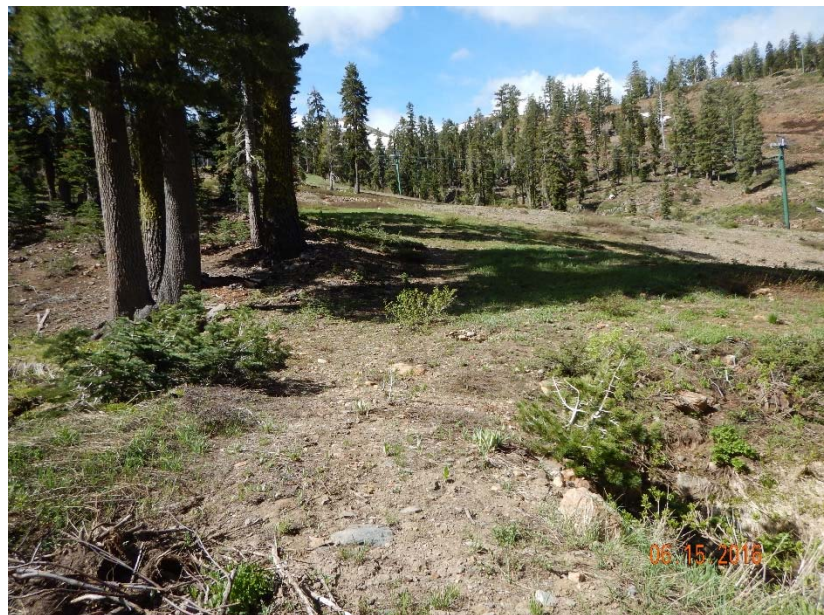
Figure 11. Ephemeral channel crossing road through trough of rolling dip.

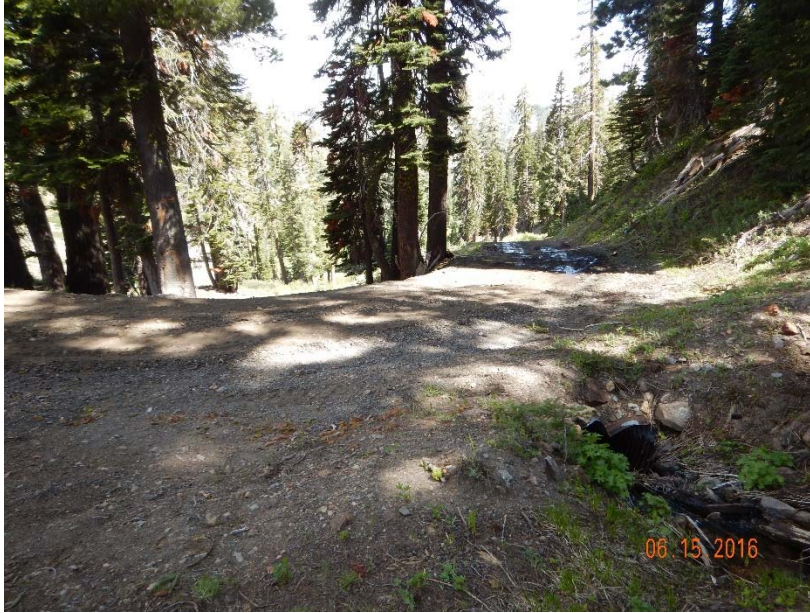
**Road Segment 5:** Outslope graveled road. Road gradient of 15%. Average hillslope gradient of 40%. No major concerns with this road except for possible old skid trail crossing into the main road may be bringing water down and onto road (Figure 12). The skid trail crossing is ~5 ft north of culvert crossing on main road. Recontour and/or addition of waterbars to skid road should divert water back to overland sheet flow.

Figure 12. Old road passing over culvert crossing. Runoff from old road flows over top of the culvert outlet and into the stream.

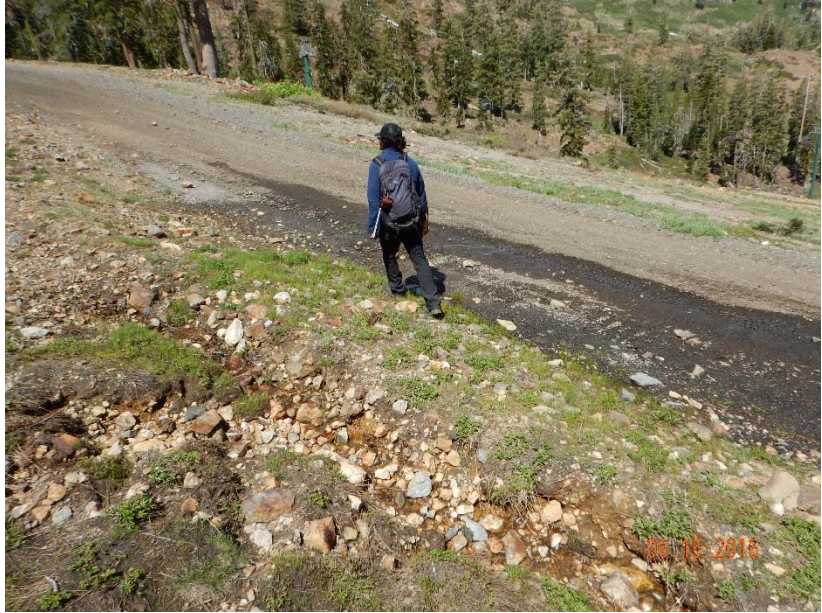
- Culvert drainage is buried due to large amounts of slope runoff.
- Water maybe flowing subsurface due to rocky slope. Water flows out of surface and into a small channel parallel to road (Figure 13). It flows out and onto the road for ~20ft (Figure 14). Water may be being transported by rills that formed on the slope from road drainages uphill.

Figure 13. Small channel/ditch forming parallel to road. Water maybe permeating through small berm between road and channel.

The main contributor to the concerns of this segment is heavy overland flow from uphill. The hillslope is barren and consist mainly of rock with exposed soils, allowing for rainfall and snowpack runoff to flow downhill quickly without a large amount of infiltration. Increasing cover and vegetation on this slope will increase infiltration rates and lower the amount of runoff reaching the road. Reinforcing the rolling dips/waterbars will ensure proper drainage and less accumulate flow for drainage structures downhill. Armoring the outlets with rocks will lower the erosion to the outlets and the amount of sediment leaving them.

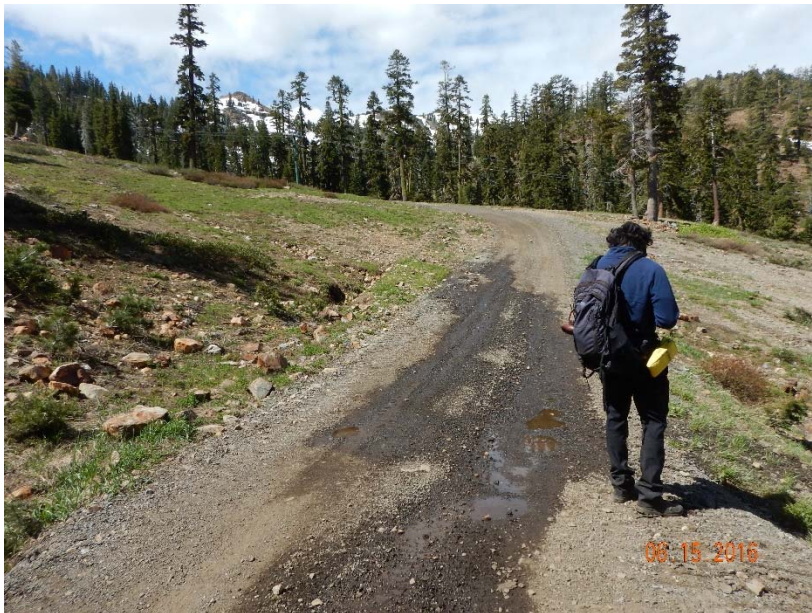
Figure 14. Extent of runoff from small channel/ditch onto road. Runoff travels ~20ft on road.

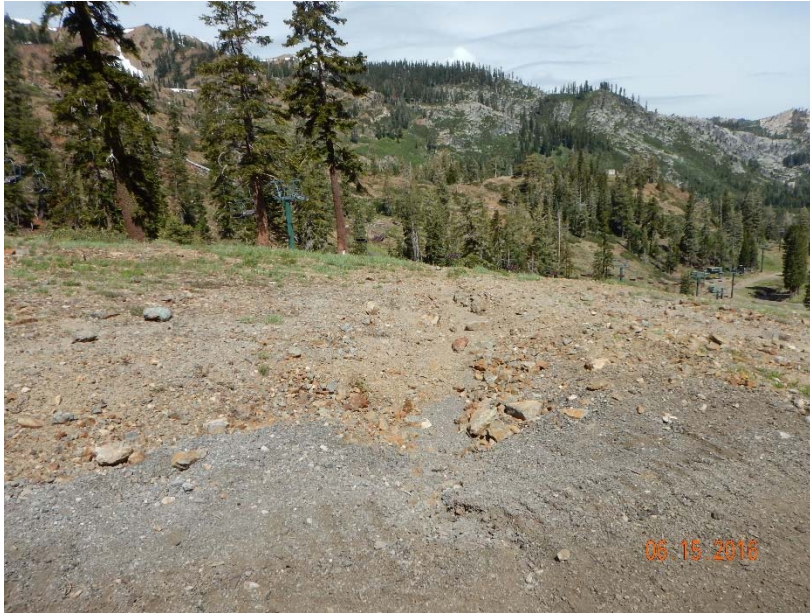
- Rolling dips/waterbars are accumulating large amounts of flow (Figure 15, 16, and 17). A majority of the water is likely coming from overland sheet flow uphill. Hillslope is rocky with poor cover and vegetation, allowing water from rainfall and snowpack to flow downhill with low infiltration rates. The large accumulated flow from the hillslope and road is scouring and incising the drainage outlets, flowing downslope and into nearby stream.

Figure 15. Rolling dip/waterbar transporting large amounts of runoff off the road. Outlet is filled with road material and sediment, and is flowing past the outlet, downslope, towards stream.

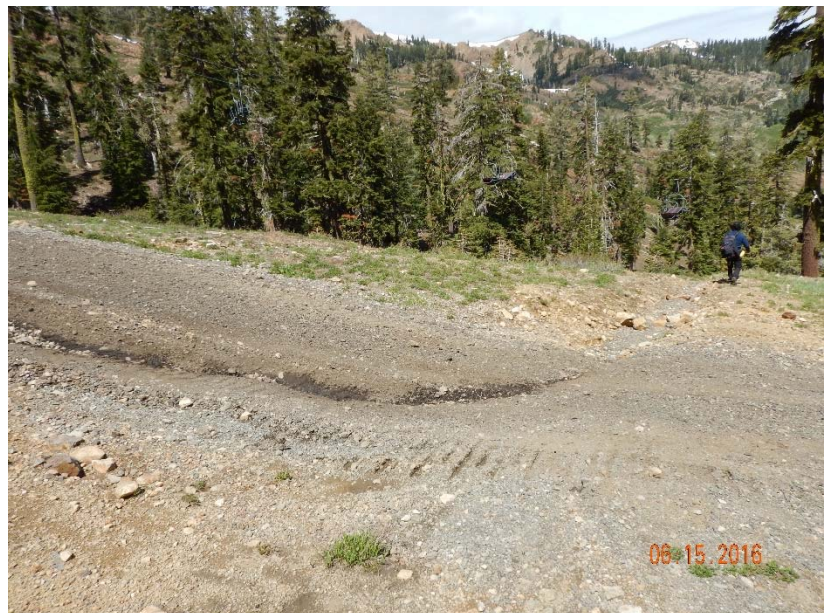
- Rilling is occurring on parts of the road, creating an inside ditch on an outslope road (Figure 16 and 17). The unnatural inside ditch accumulates more discharge and transports it to drainage outlet, scouring and incising the outlet.

Figure 16. Riling creating inside ditch on outslope road. Rolling dip transporting larger than normal runoff off road. Outlet is being scoured and incised due to large amount of flow.

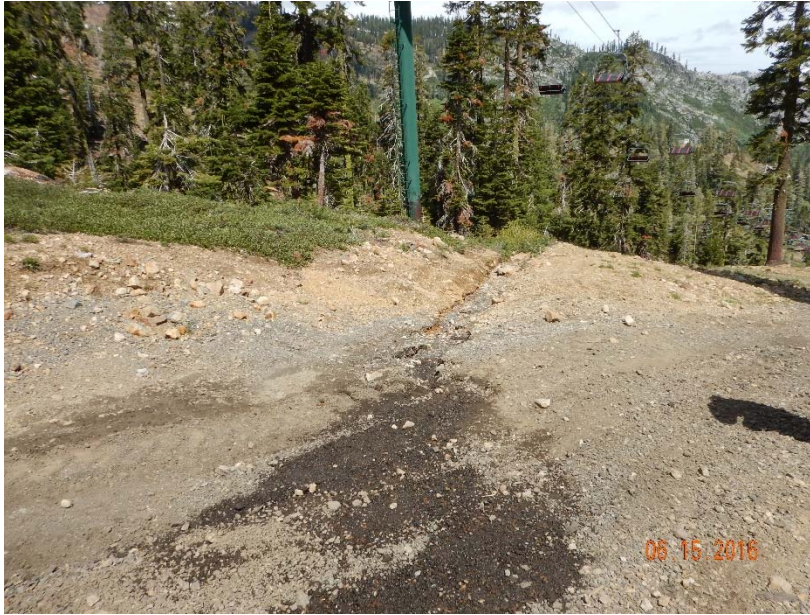
Figure 17. Rilling creating inside ditch on outslope road. Rolling dip transporting larger than normal runoff off road. Outlet is being scoured and incised due to large amount of flow.

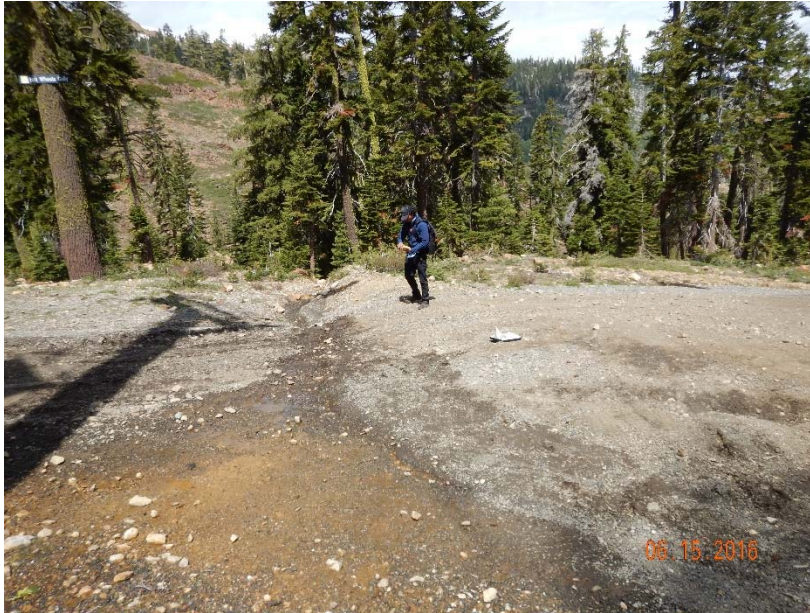
- Rolling Dip/Waterbar at the junction of two roads (one going uphill to the south, the other going uphill to the east) is catching large amounts of runoff (Figure 18). Both roads appear to allow runoff to accumulate at this point. Due to this, the outlet is being scoured and incised, with large amounts of sediment in and leaving the outlet.

Figure 18. Looking at rolling dip at the base of a junction for two roads. This rolling dip is catching runoff from both roads. The excess flow is incising and scouring the leadout outlet, transport

The waterbars installed on the segment of road before the road turns south/southwest into forest canopy are not fully functioning. They allow some runoff to bypass them and continue down the road, accumulating at the junction. They should be reinforced so that road runoff can be properly dispersed on the hillslope. The possible intermittent channel flowing across the road seen in Figure 19 has multiple resolutions. A proper stream crossing structure, such as a culvert, could be installed to prevent further incision of the road. This will also prevent road runoff and sediment from entering the channel. Another possibility is to recontour, roughen, and revegetate the hillslope that is being incised by the possible intermittent channel. If this is done, the accumulated runoff that serves as the headwaters will disperse to overland sheet flow. It will not be concentrated and should not cross the road in Figure 19 as a channel. Further up the road from Figure 20, snowpack melt is flowing along the road before collecting at the trough in the road. This is likely the headwaters for the intermittent channel that is rilling forming

on the downslope and incises the road below at its crossing. between Waterbars installed up the road more can disperse the snowpack melt and prevent it from collection at the trough. Water will not accumulate large enough to create a concentrated flow path that continues to where it crosses the road downhill.

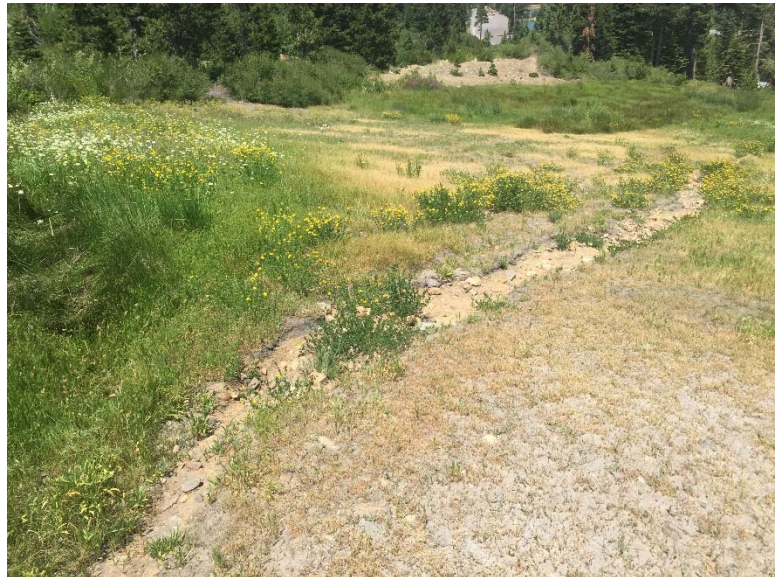
**W1:** A graded slope for a ski run. This slope is more vegetated compared to the major graded slope on the east side. However, multiple waterbars were built running across almost the entire width of the slope. They catch large amounts of runoff (Figure 1). On the northern end of the waterbars, density in vegetation increases due to larger soil moisture. Due to the large amount of captured runoff, a channel has formed on the north edge of the slope. This unnatural channel runs parallel to a natural channel, but is separated by a berm. At the southwest end of this graded slope, a road captures runoff and directs it into what may have been an ephemeral channel, but now is the headwaters for the unnatural channel. The waterbars however do not capture and slow down all surface runoff during higher flows, and excess surface runoff have created rills that are widening and removing top soil from the slope (Figure 2 and 3). There's a water tower used for storing water on this graded slope. However, it is leaking water and flowing down into the northern most water bar (Figure 4). This furthers the formation of the unnatural channel.

Figure 2. Rillings that have formed from large amounts of surface runoff that have bypassed waterbars.

Remediation: Possible resurface and roughening of graded slope to remove existing rills and reestablish a viable top soil to provide more vegetation and increase infiltration time for surface runoff. Waterbars should be reinforced and added to prevent future rills to form. The berm separating the unnatural channel with the natural channel north of this area should be removed to allow runoff to drain into a natural channel. With the other improvements, the water quality of the surface runoff should be better and create a minimal impact on overall water quality of the natural channel. This will also prevent the unnatural drainage to flow into the parking lot. The water tower should be reinforced to prevent future water leaks at the base.

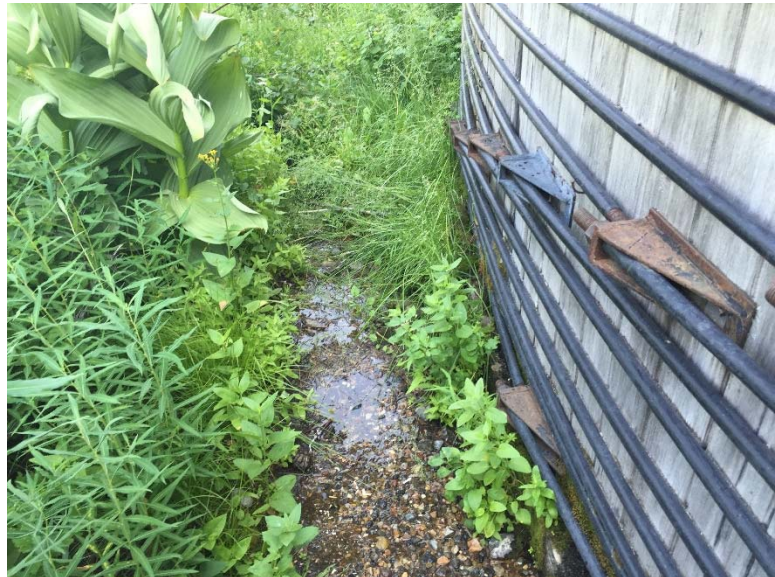
Figure 3. Another photo of rillings that are removing top soil exposing rocky substrate.

Figure 4. Water leaking out of the base of the water tower.

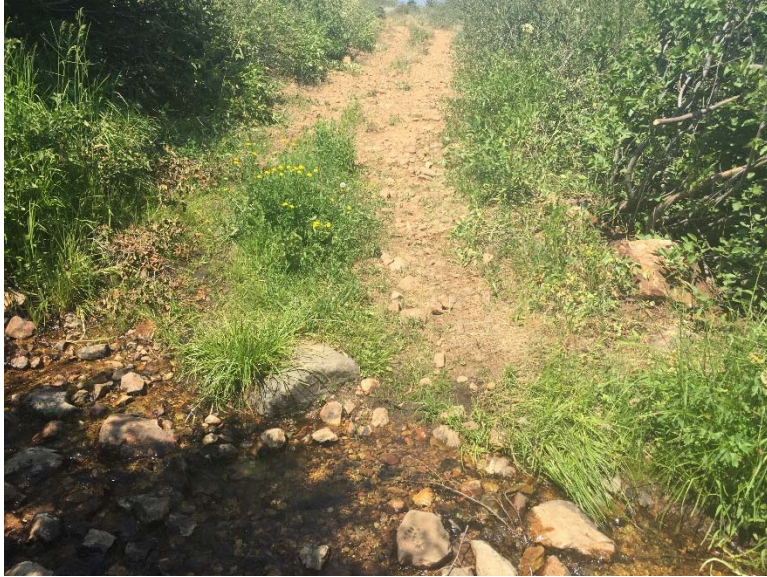
**W2:** This length of road crosses multiple ephemeral and intermittent channels without any proper stream crossing structures (Figure 5 and 6). This has allowed road runoff to directly drain into these channels and on multiple occasions allow to road to capture and redirect the stream, degrading their water quality. This road also lacks a sufficient number of road surface drainage structures to prevent large accumulations of runoff.

Figure 5. Road crossing into an intermittent channel.

Remediation: Install proper crossing structures such as culverts at crossings to prevent road surface runoff connectivity to the channel. This will also prevent the road from capturing the channel and redirecting it. Maintaining existing waterbars and installing more will help prevent excess accumulation of road surface runoff which could erode the road and harm nearby water quality.

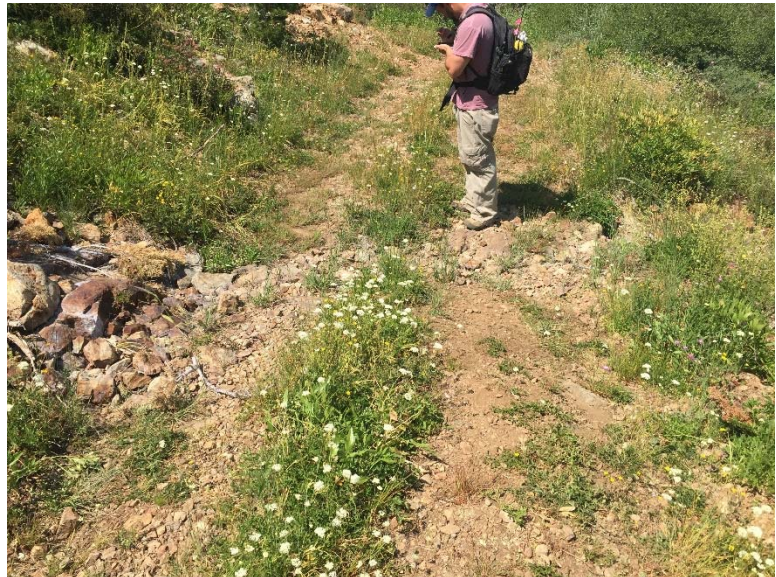
Figure 6. Road crossing into an ephemeral channel.

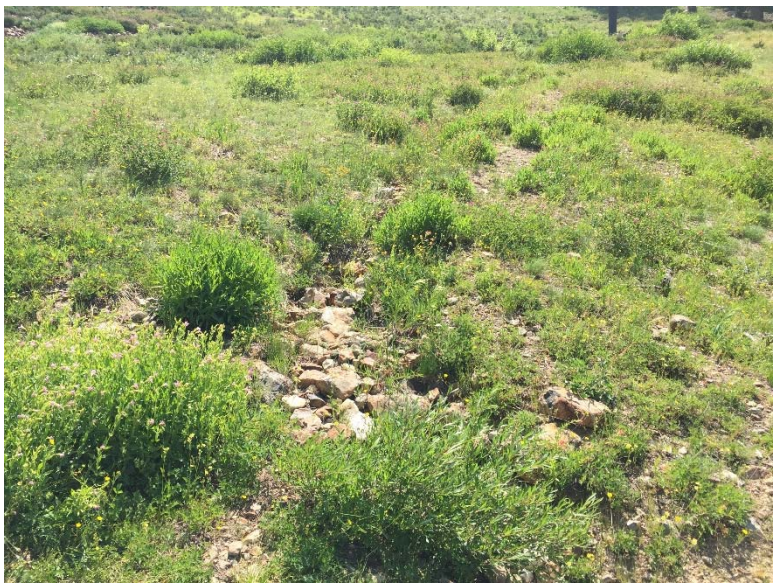
**W3, W4, and W5:** These areas are similar in the nature of having the same source issue. These areas are portions of the road that switch back to prevent high road gradients. However, they were poorly designed in regards to their surface drainage systems, which directs surface runoff away from the road only to be directed back to the road at a lower elevation. Similar to W2, there are multiple points where a channel would cross road without a proper crossing structure, allowing road surface runoff the flow directly into the channel.

Figure 7. Diverted road surface runoff has created a channel that goes downslope to a lower portion of this switchback.

Figure 8. Road surface runoff leaving a leadout only to flow back onto road downslope.

Remediation: Redesign of the road and drainage structures could remediate the existing problems. Altering the road design to be insloped with a rock lined inside ditch will prevent surface runoff from flowing down slope through an outsloped manner. Leadouts for the inside ditch should be placed at the hairpin turns and directed at an angle that provides the furthest distance from the road and allows runoff to flow downslope. Crossing culverts should be installed at crossings to prevent road surface runoff from entering the channel.

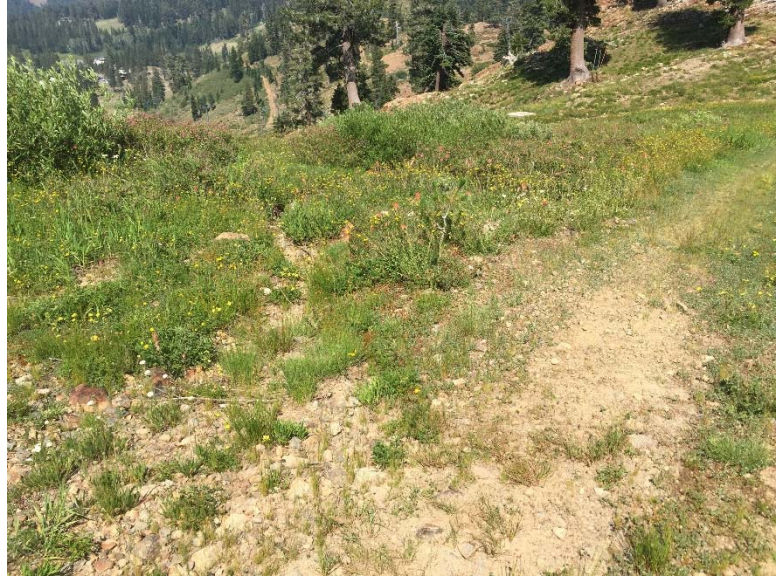
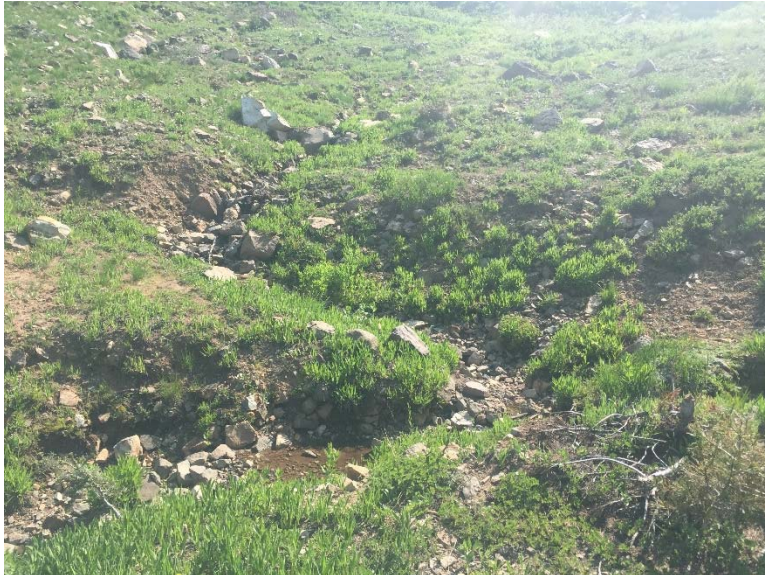
Figure 9. Runoff from road directed downslope to another segment of the road.

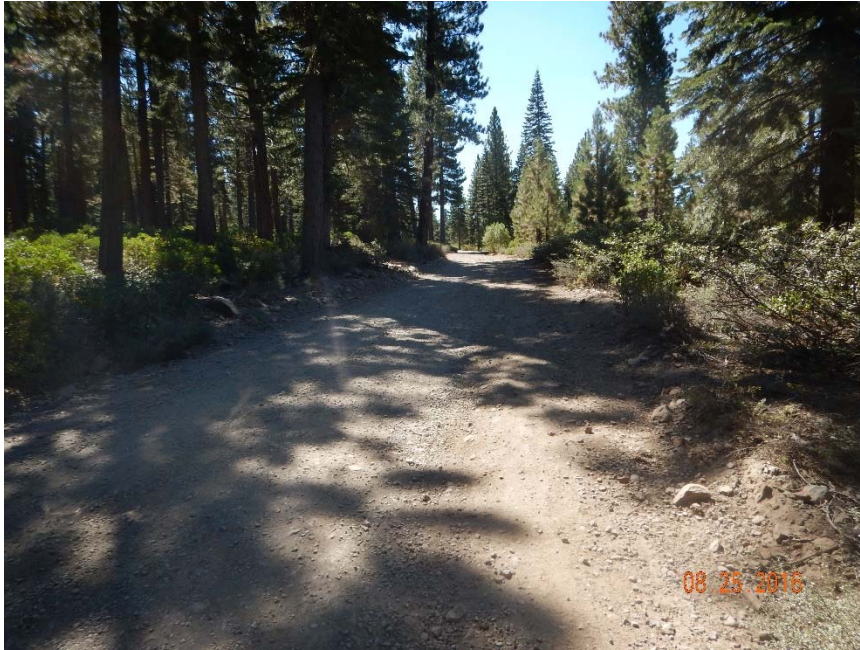
Looking down main Sawtooth 06 road with gravel road surface. The 06 road mainly consists of gravel road surfaces.

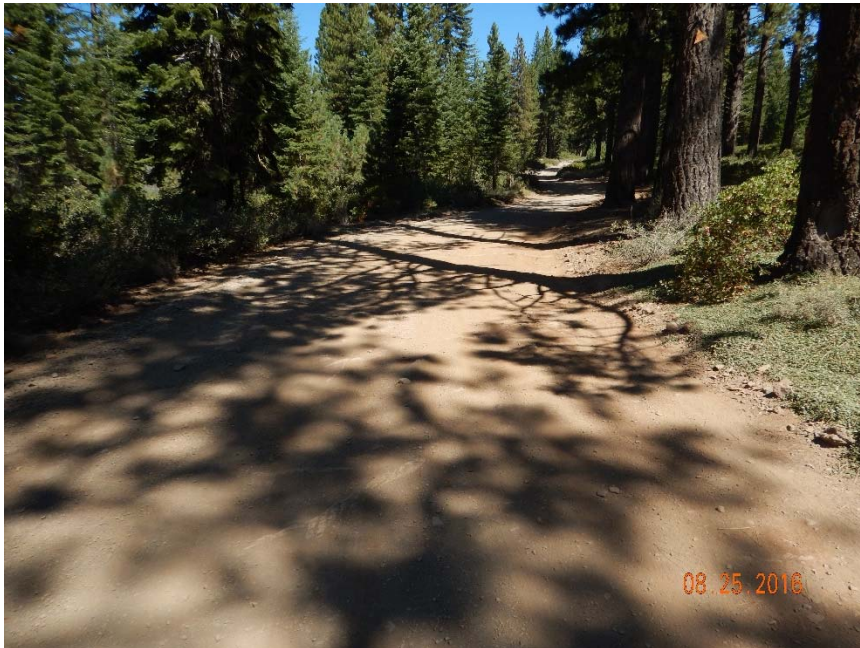
Looking down main Sawtooth 06 road with native road surface.

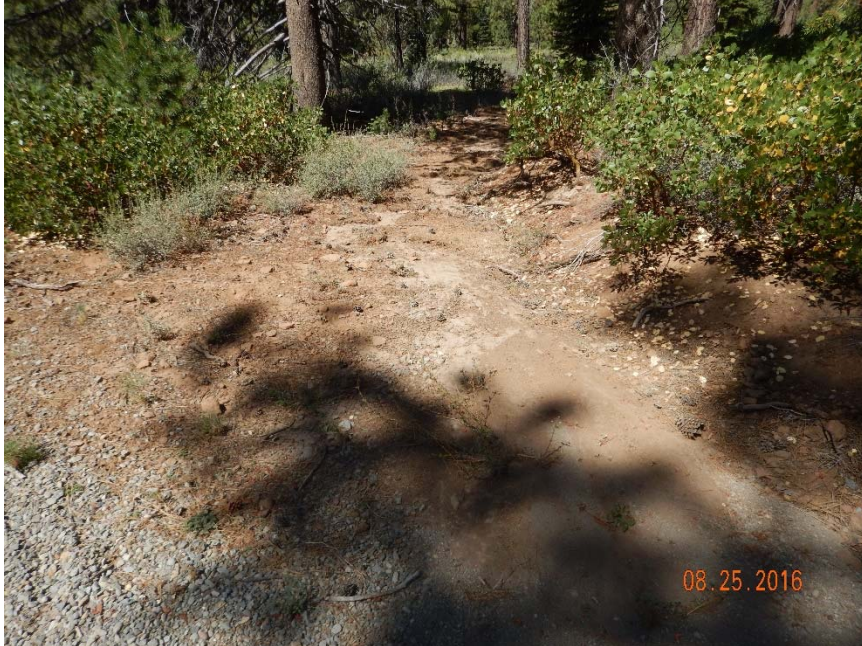
Leadout from road that has collected large amounts of sediment.

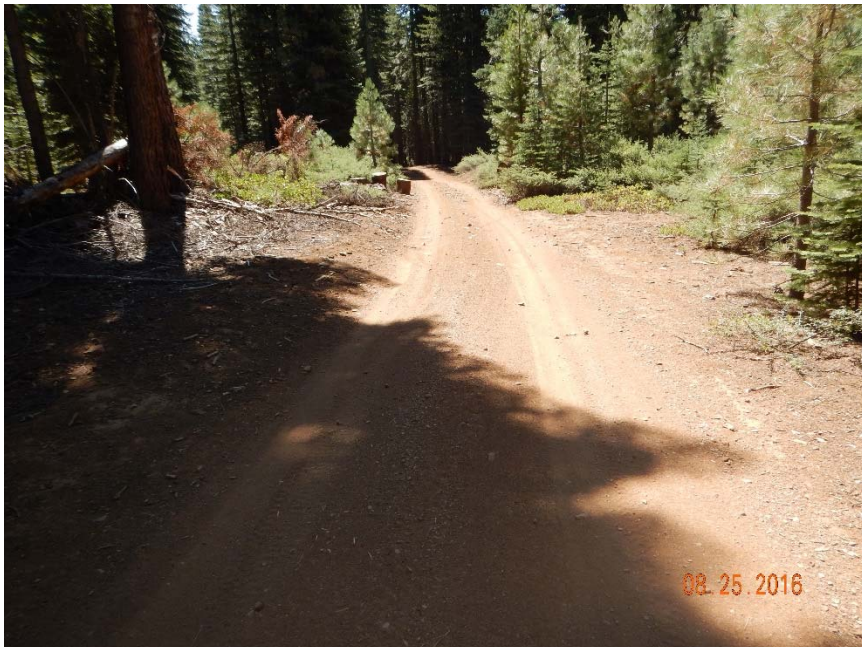
Spur road with native road surface.
