Johnson Canyon West Watershed Assessment

Truckee River Watershed Council
PO Box 8568
Truckee, CA 96161

Wildscape Engineering, Inc.
3079 Harrison Ave., Suite 5
South Lake Tahoe, CA 96150

January 30, 2017

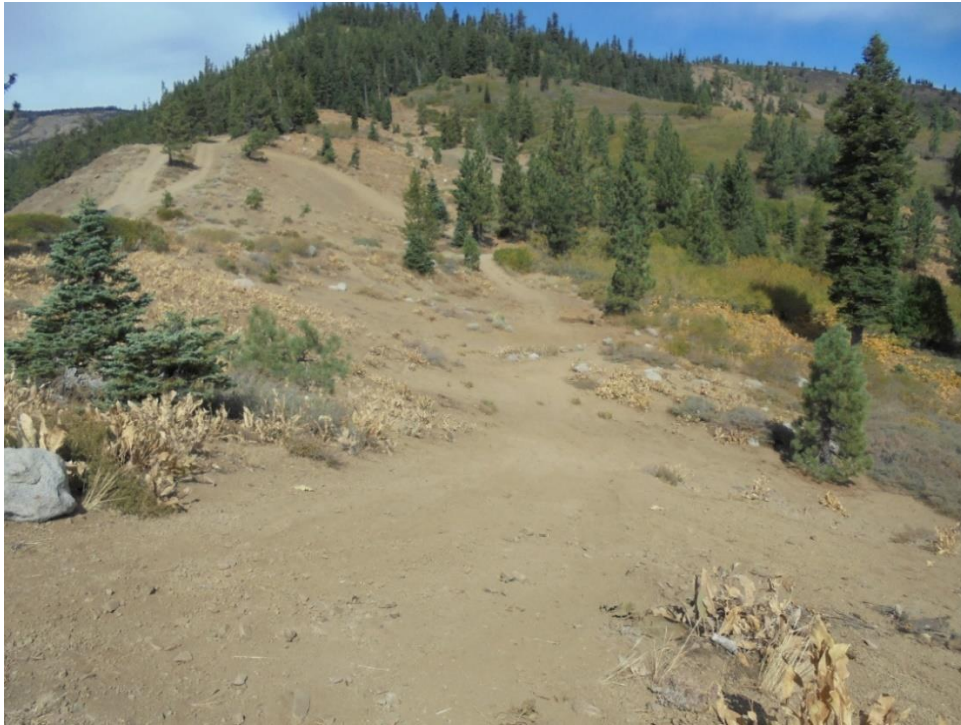
At the location where Billy Mack Road (USFS Rd West) gains the ridge that defines the western watershed boundary, the slope is steep, vegetation is sparse, and numerous OHV trails have been developed. Figure 4 of Appendix A shows an aerial view of the site. Photos B1-B12 of Appendix B display field photos of the location. Signs of erosion vary among OHV routes and along Billy Mack Road, ranging from mild to severe. This site is broken into several sub-sites for more detailed description and assessment, which is included in Appendix C – Field Log.

Photo 1. #1 – Four Corners Site (looking northwest from #1f – OHV South Loop).

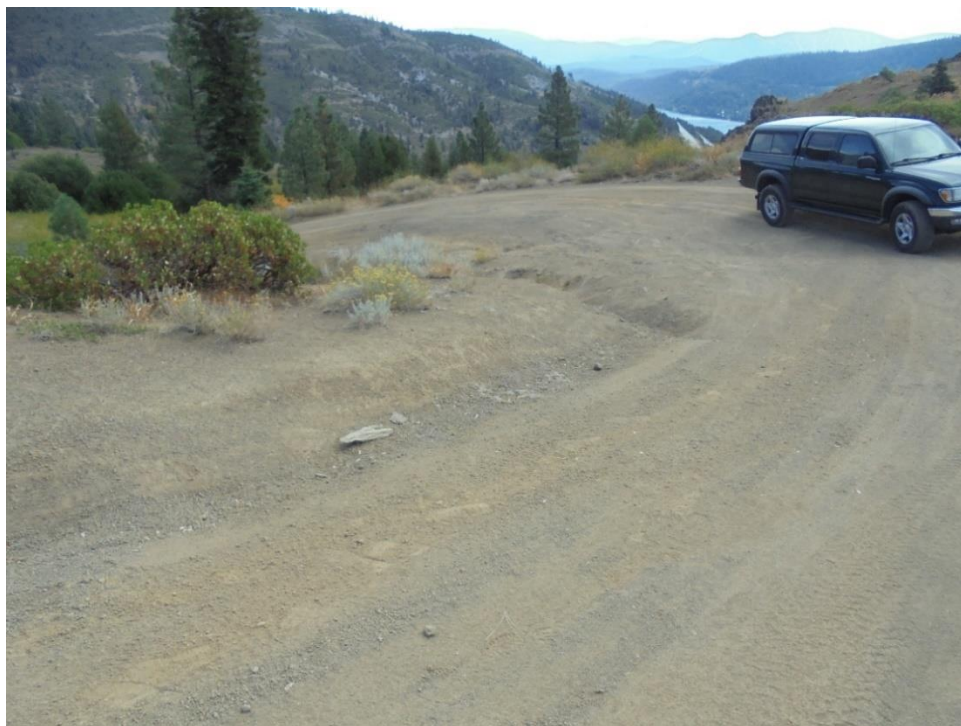
Photo 2. Inside bend of #1a – Billy Mack Road Ascent to Ridge (looking southeast).

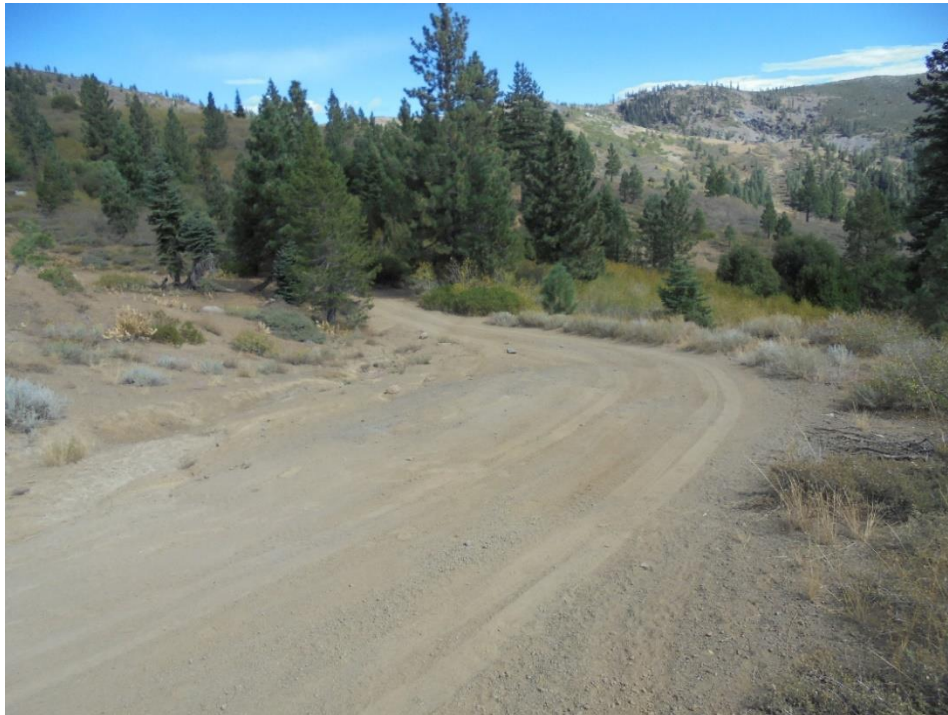
Photo 3. Gullying along northern edge of #1a – Billy Mack Road Ascent to Ridge (looking northeast down road from start of #1f – OHV South Loop).

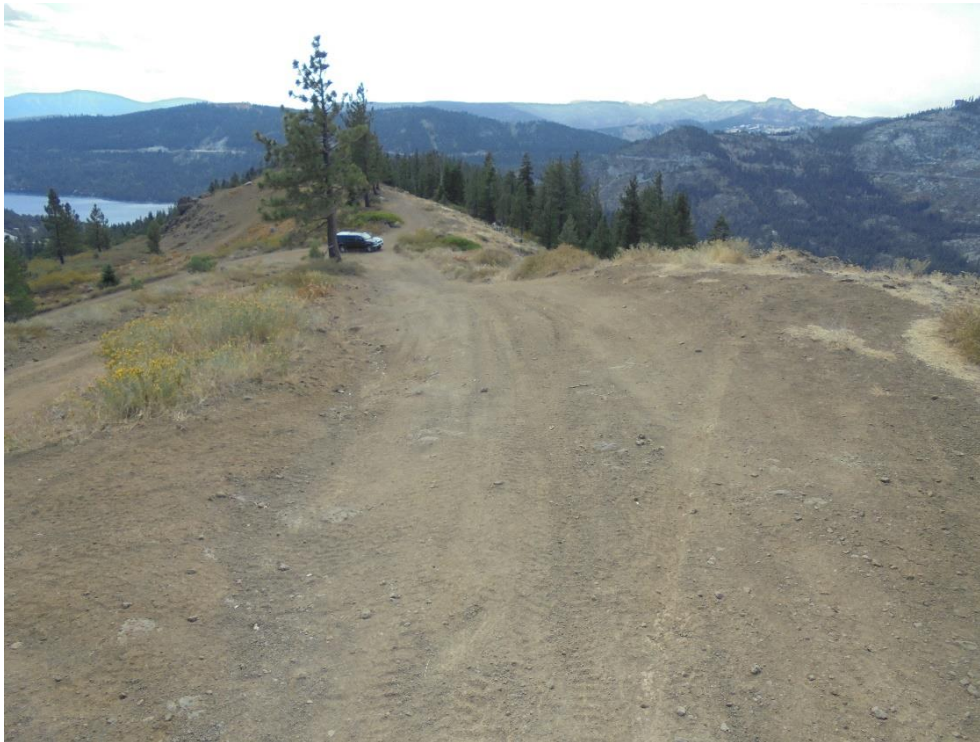
Photo 4. #1b – Main Route of Billy Mack Road along ridge (looking south down road from intersection of Main Route, Alternative Route, OHV Center Route; #1f – OHV South Route visible in background).

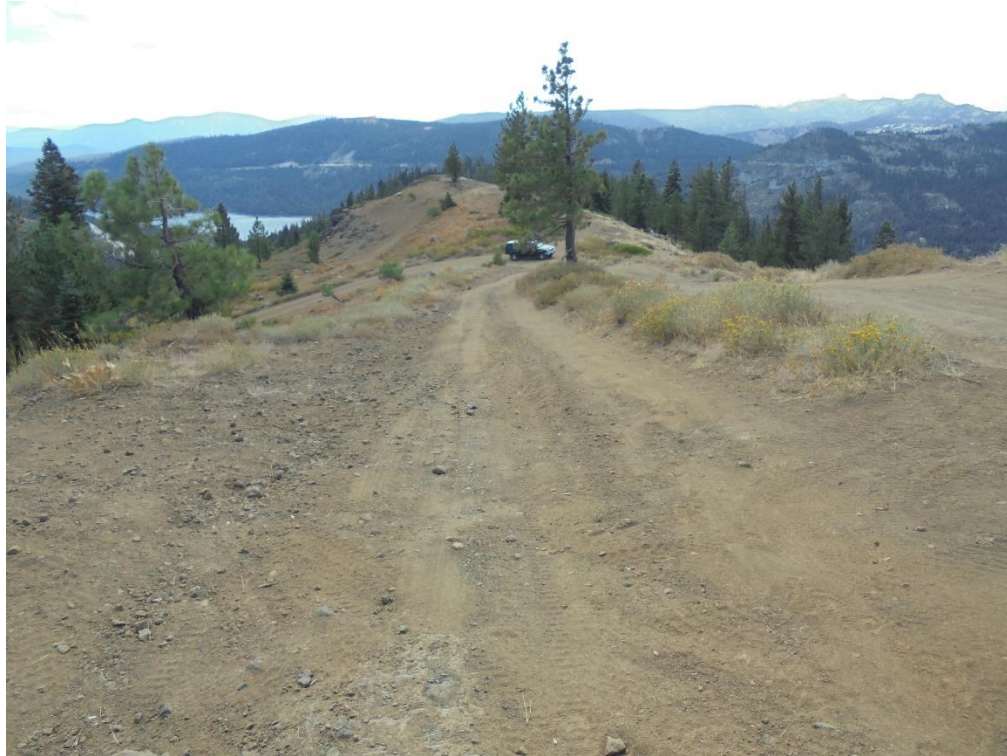
Photo 5. #1c – Alternative Route of Billy Mack Road along ridge (looking south down road from intersection of Main Route, Alternative Route, and OHV Center Route).

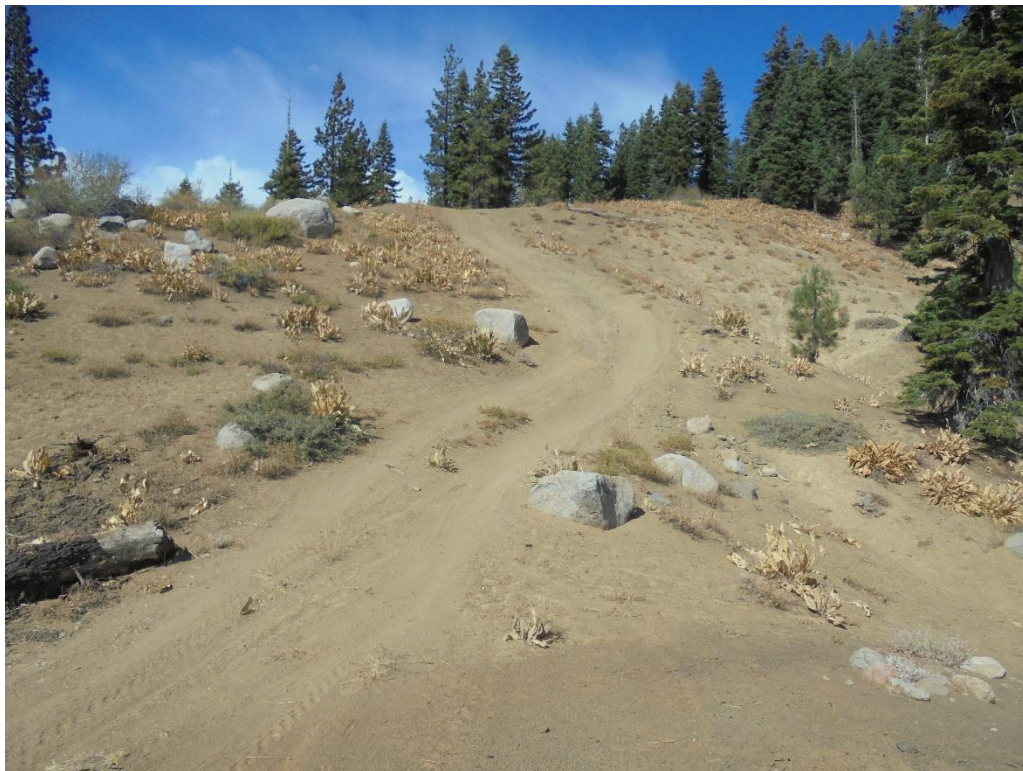
Photo 6. #1d – OHV North Route ascent to Billy Mack Road (looking northwest from rock outcrop).

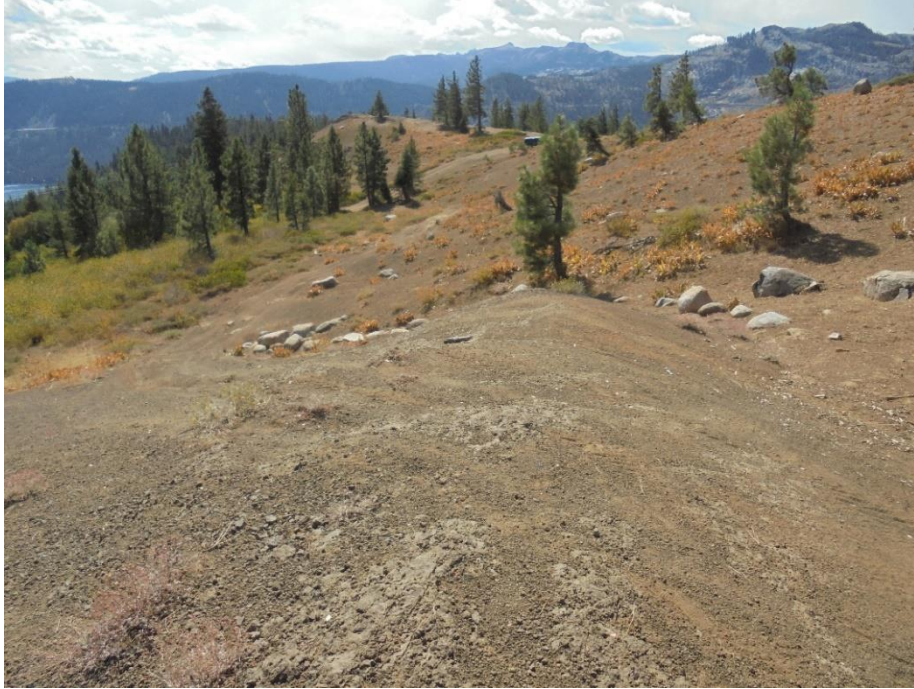
Photo 7. #1d – OHV North Route descent to Billy Mack Road (looking south from rock outcrop).

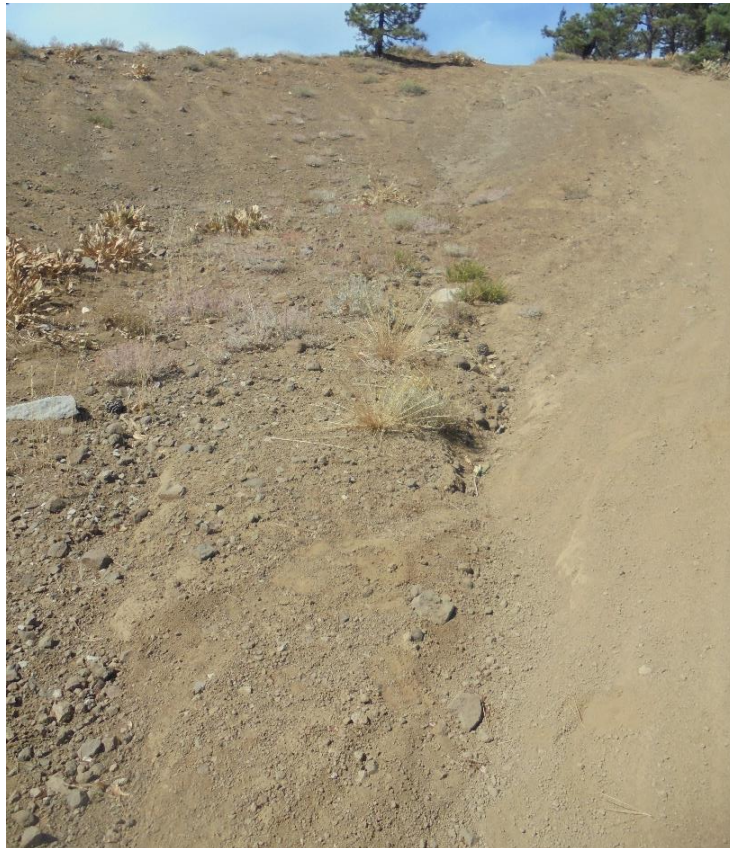
Photo 8. #1e – OHV Center Route ascent to Billy Mack Road and runoff flowline (looking northwest from location where OHV North Route forks from Center Route).

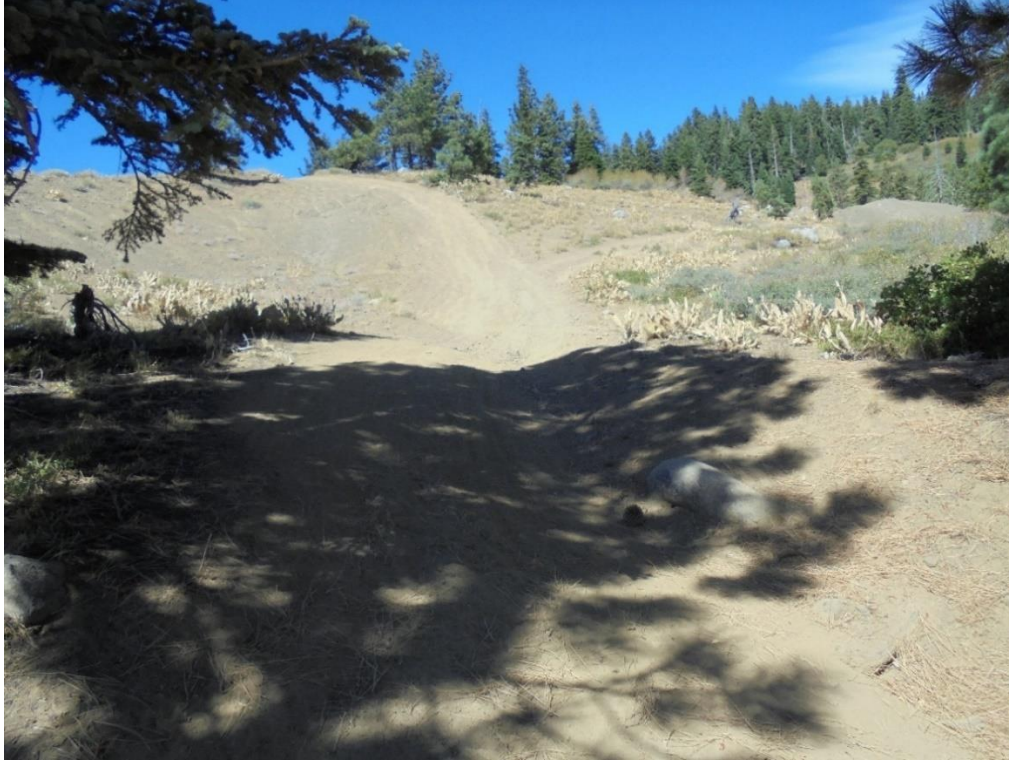
Photo 9. #1e – OHV Center Route (looking northwest from Billy Mack Road, #1d – OHV North Route forks to the right at center of frame).

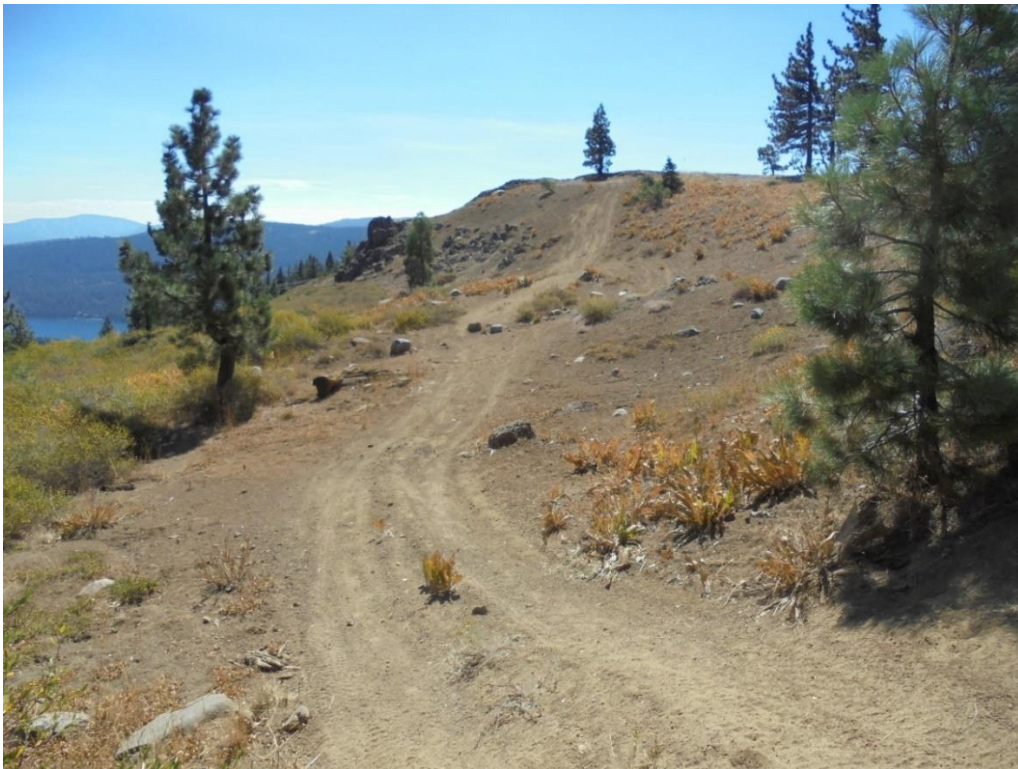
Photo 10. #1f – OHV South Loop to scenic viewpoint (looking south from Billy Mack Road).

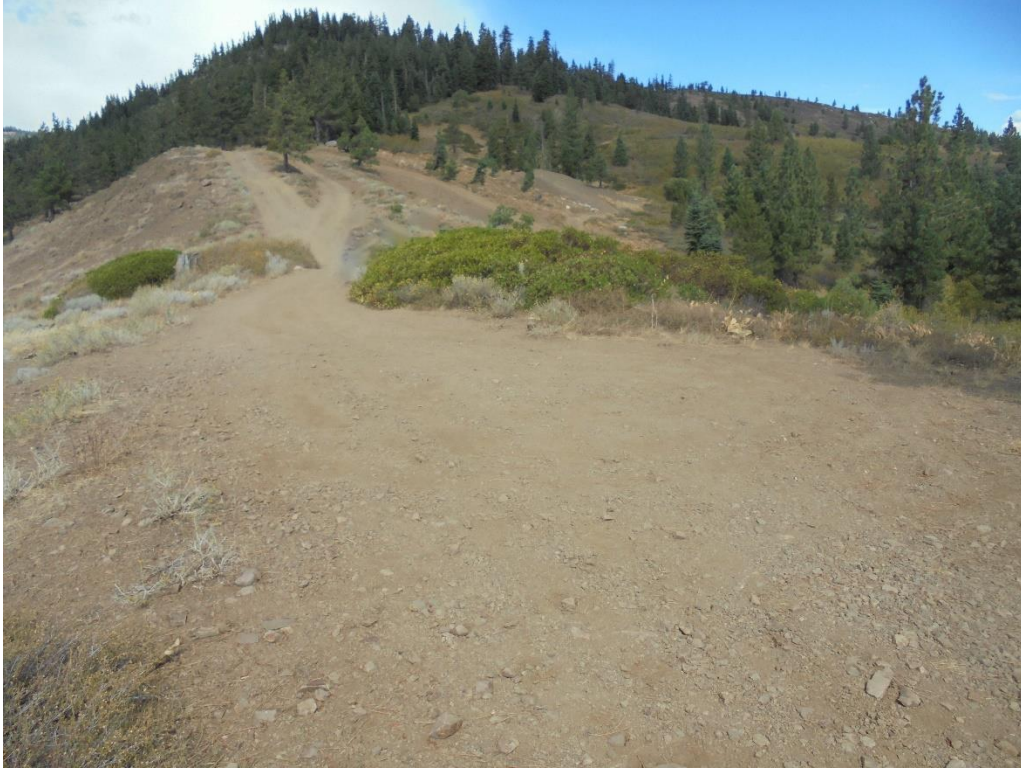
Photo 11. #1f – OHV South Loop possible turn-around location (looking north).

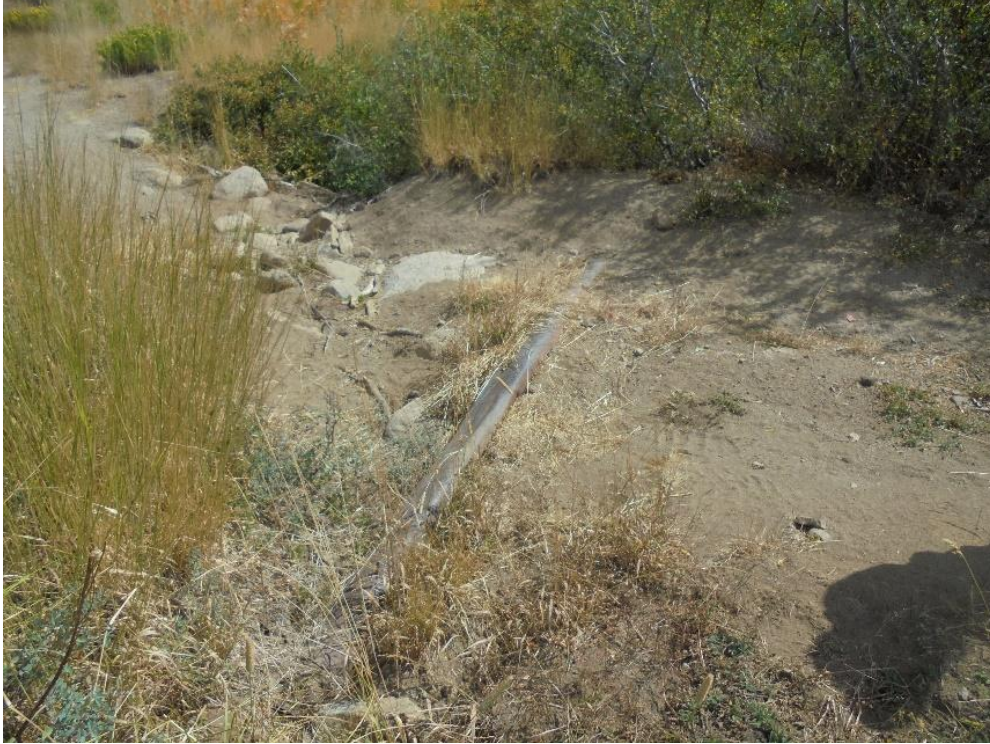
The southwest fork of USFS Rd 0676-088 has mild slope and minimal erosion. No rolling dips or waterbars exist on the road. A small (approximately 6-inch diameter) iron culvert exists approximately 0.1 miles from the fork where an intermittent stream crosses the road (Crossing #1; Photo 13). The culvert is exposed, partially collapsed, and poorly aligned and flow regularly overtops the road. Some rock lining exists along the culvert within the developed flow path. The upstream and downstream reaches of the intermittent stream are well vegetated and erosion is mild. Photo 14 displays the road beyond the culvert crossing and Photo 15 shows the road as it enters the densely forested USFS land.

Photo 13. #2 – Southwest Fork USFS Rd 6-inch iron culvert at Crossing #1 (looking southeast in downstream direction).

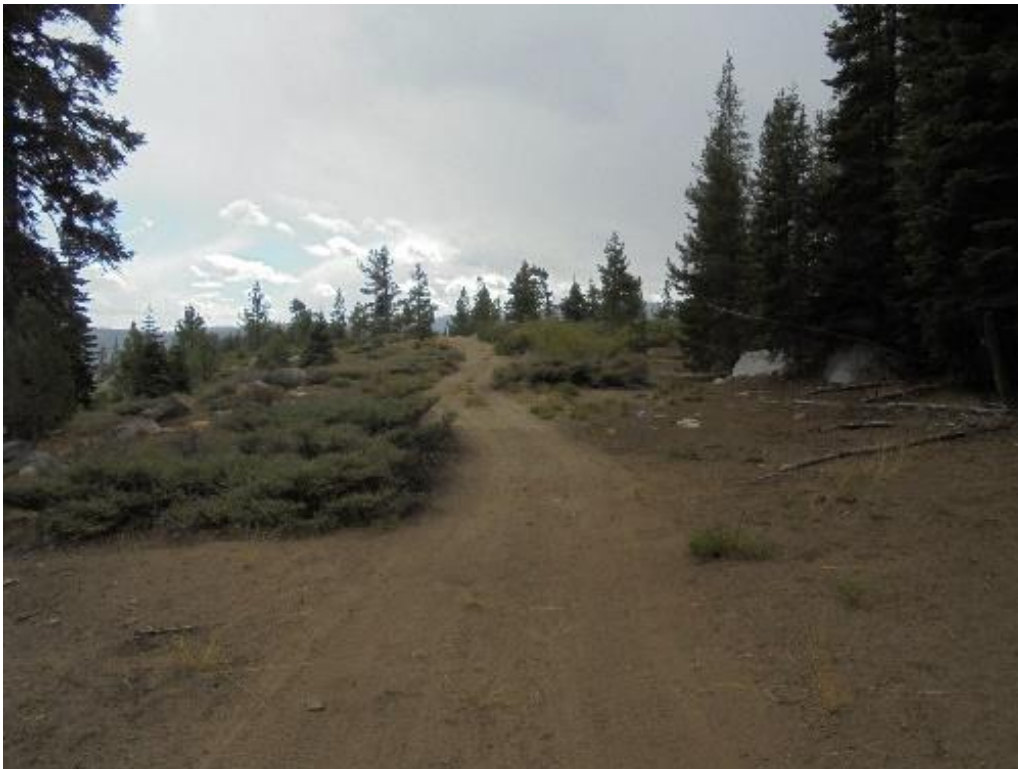
Photo 14. #2 – Southwest Fork of USFS Rd beyond culvert crossing (looking southwest).

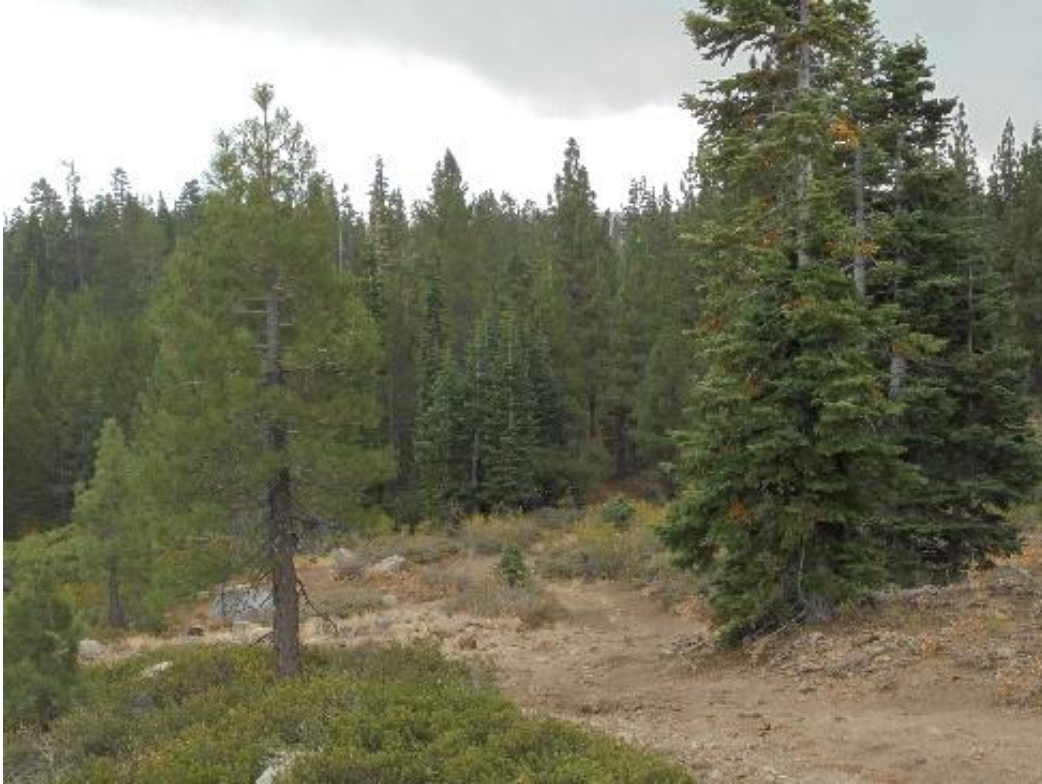
Photo 15. #2 – Southwest Fork of USFS Rd entering forested USFS land (looking south).

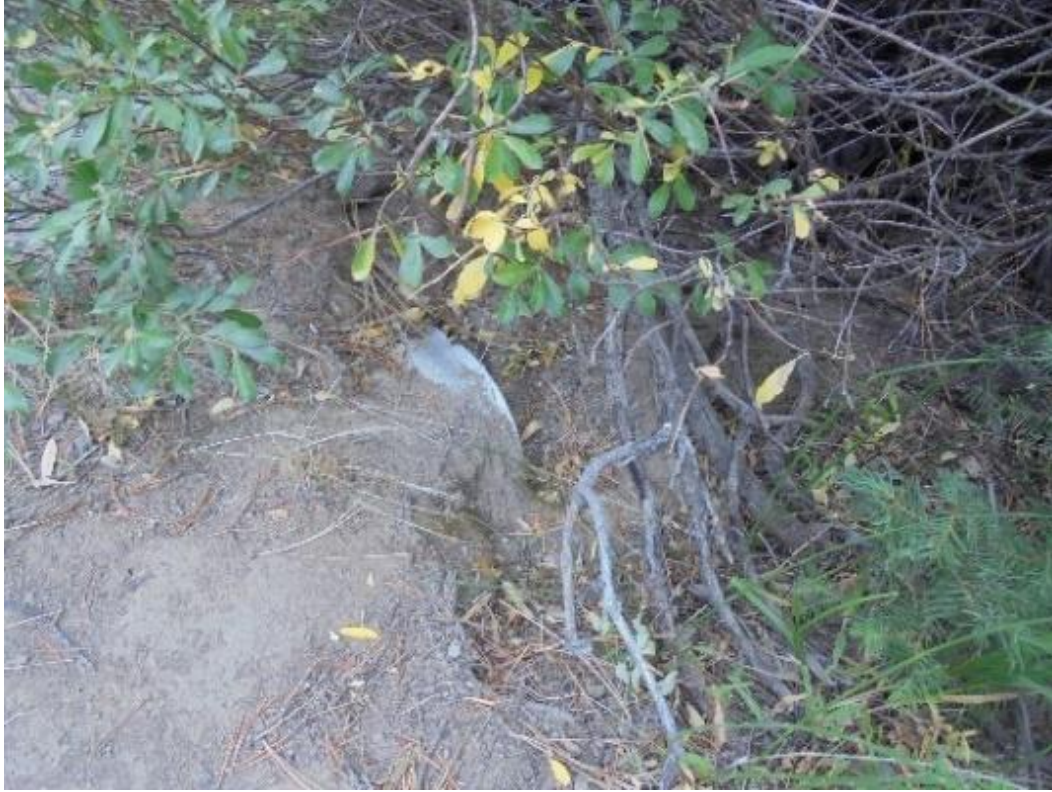
An abandoned quarry approximately 1.1 acres in size exists on the west side of Billy Mack Road approximately one mile from the Parking Area. Runoff from the steep quarry slopes flows into a contained basin with dense riparian and upland vegetation. A 16-inch diameter culvert exists to convey overflows from the basin to the down-gradient east side of the road. The culvert is approximately 50% full of sediment and some minimal sediment accumulation exists at the outlet, which discharges flows into a densely vegetated, mildly sloped drainage with no visible erosion. Photo 16 shows the north side of the Quarry site as viewed from the road and Photo 17 shows the south side as viewed from the top of the Quarry. Photo 18 shows the culvert crossing, Photo 19 shows the inlet, and Photo 20 shows the outlet area.

Photo 19. #3 – Quarry culvert inlet (looking southwest).

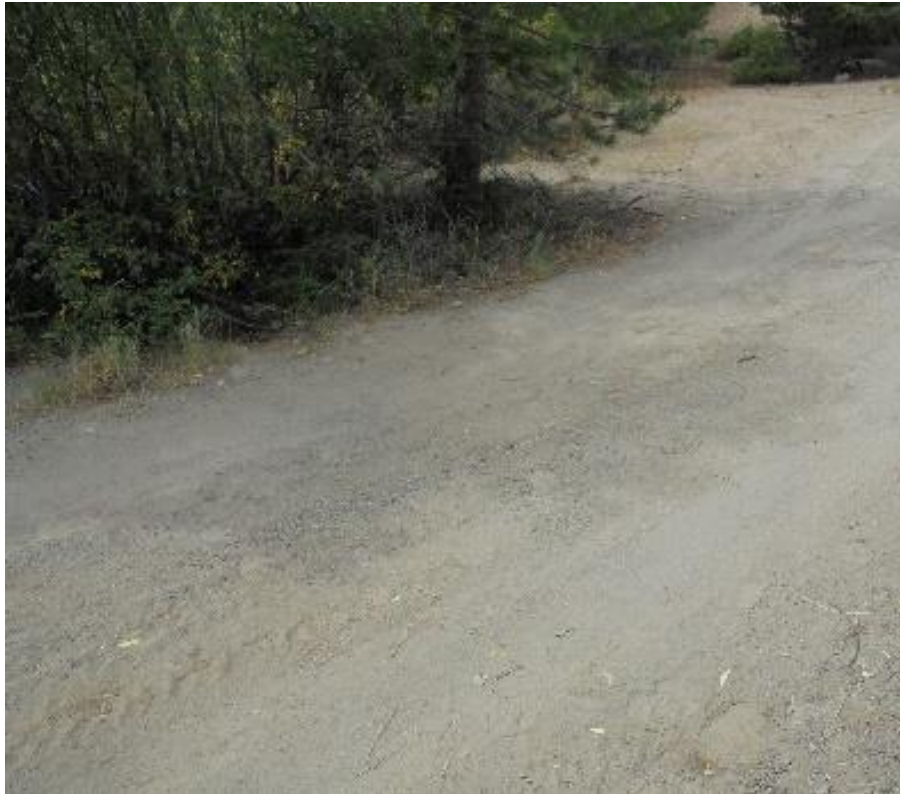
Photo 20. #3 – Quarry culvert outlet area (looking southeast).

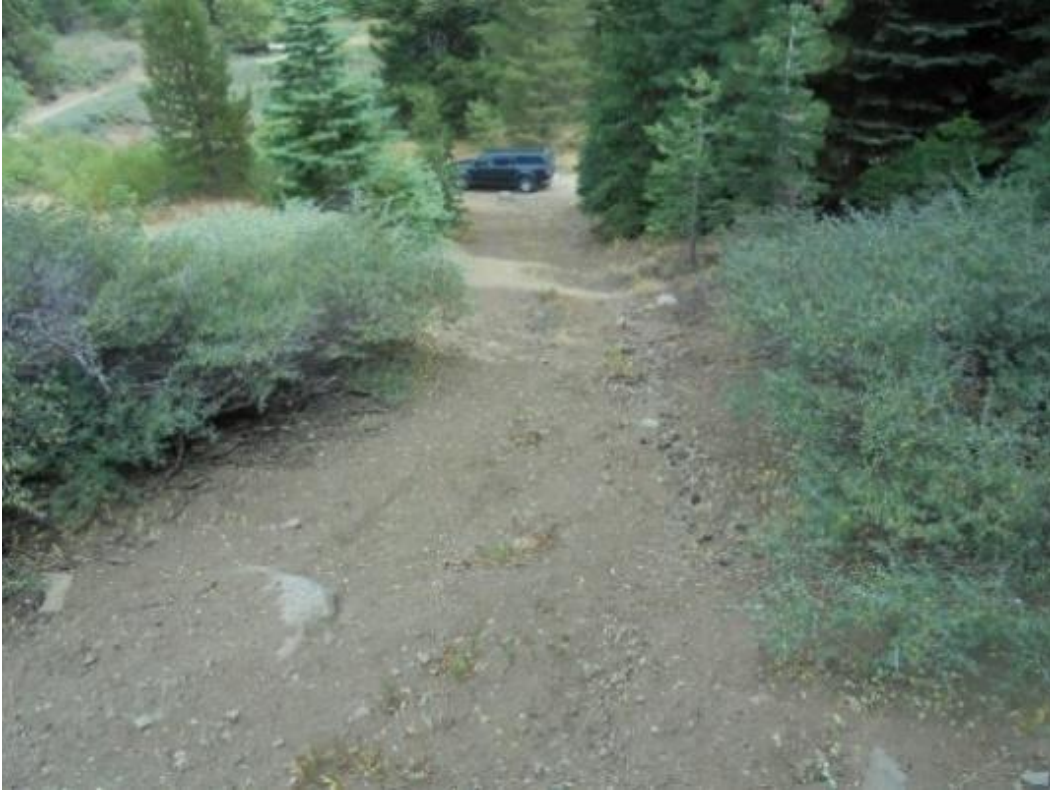
A steep OHV trail forks west from Billy Mack Rod (USFS Rd West) approximately 0.95 miles from the parking area (250 northwest of the Quarry described above). The trail climbs straight up the slope for approximately 115 feet then terminates. Erosion along the trail is minor. Photo 21 shows the trail from the top down toward the road.

Photo 21. #4 – OHV Climb
(looking east from top looking down to Billy Mack Road).

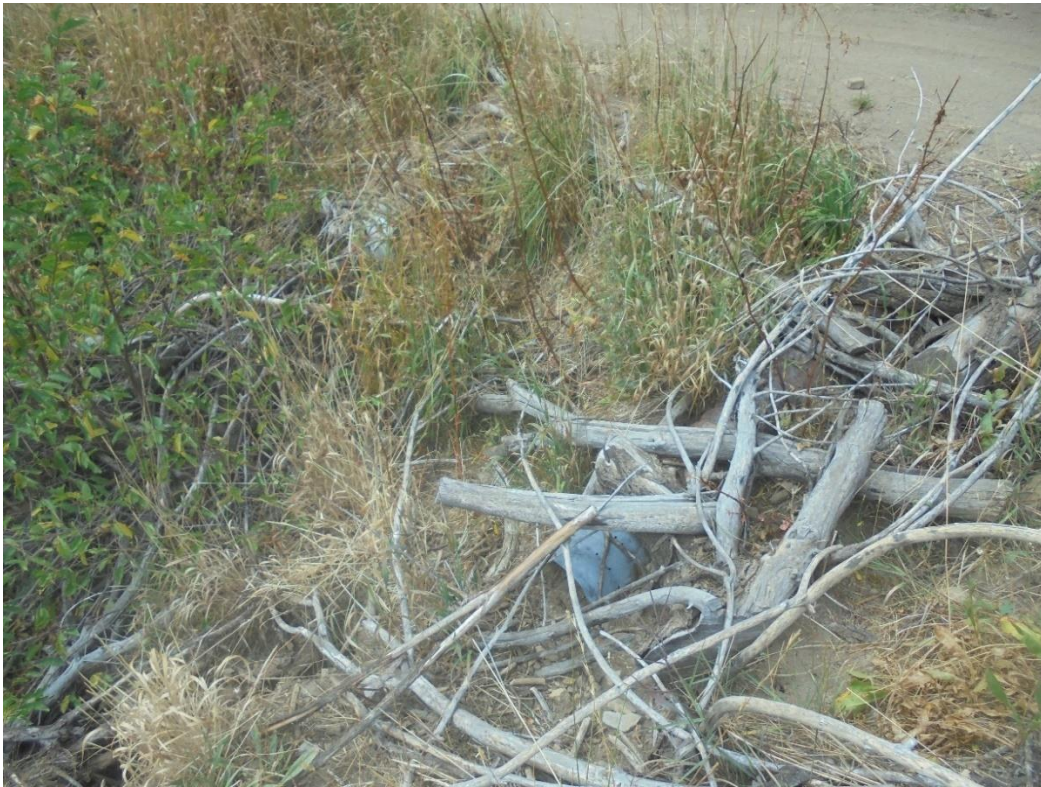
An intermittent stream crossing under Billy Mack Road exists approximately 0.91 miles from the Parking Area (130 feet north of the OHV trail described above). The crossing comprises two culverts (Photo 22): the primary culvert is approximately 20-inches in diameter and free of sediment and the overflow culvert is approximately 10-inches in diameter and is approximately 50% full of sediment. No sign of overtopping is evident. The upstream channel (Photo 23) is wide and well-vegetated, but has minor incision. The downstream channel (Photo 24) is slightly more narrow and steep. A large pool has formed at the outfall from the primary culvert and minor erosion is evident continuing downstream.

Photo 22. #5 – Crossing #2 culvert outlets (looking west).

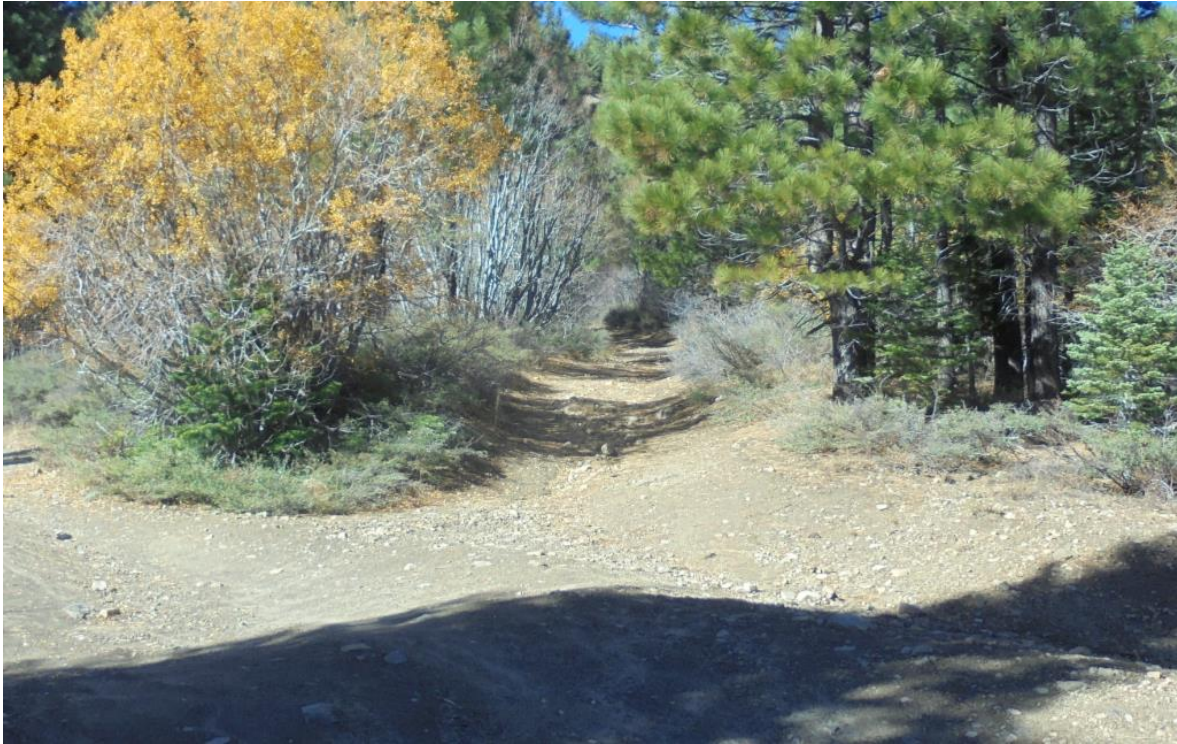
A steep spur road/OHV trail exists approximately 0.88 miles from the Parking Area (160 feet east of Crossing #2). The road forks northwest from Billy Mack Road (Photo 25) and continues up the moderate slope for approximately 0.1 miles before terminating at the intersection with the Donner Lake Rim Trail (Photo 26). Minor erosion is evident from roadway runoff (Photo 27).

Photo 25. #6 – Billy Mack Road/DLRT Connector (looking northwest from Billy Mack Road West Fork, waterbars present in foreground).

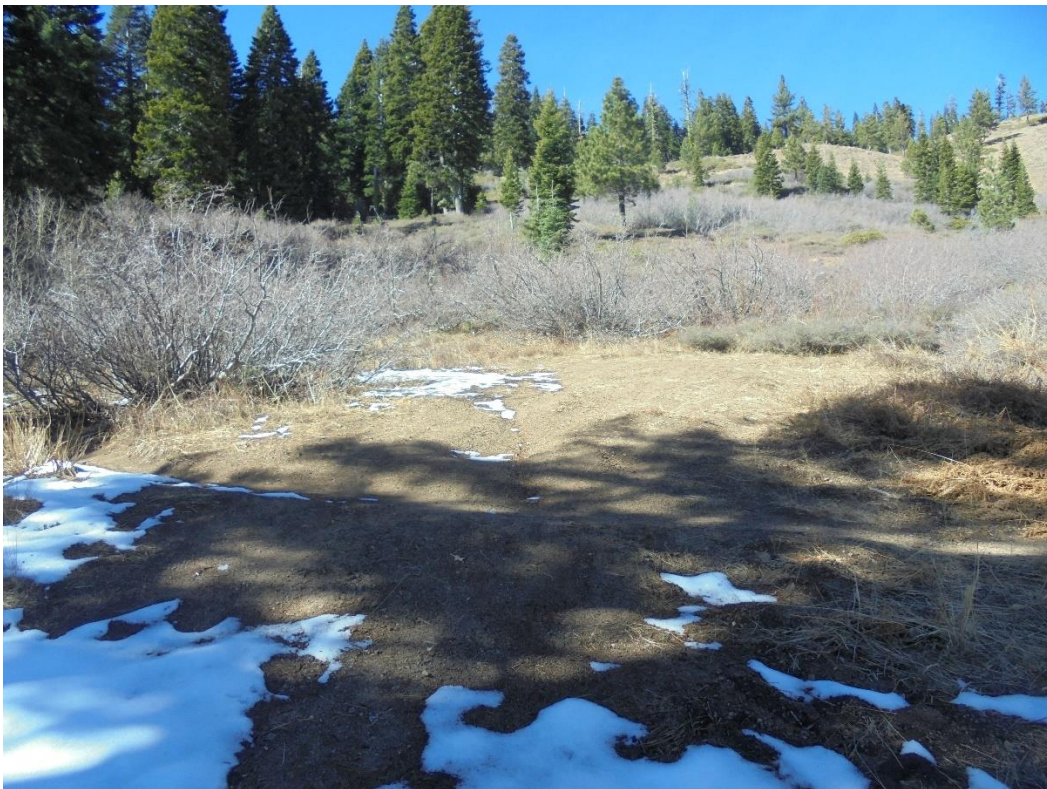
Photo 26. #6 – Billy Mack Road/DLRT Connector terminus just beyond intersection with DLRT (looking north, DLRT crosses through center of frame).

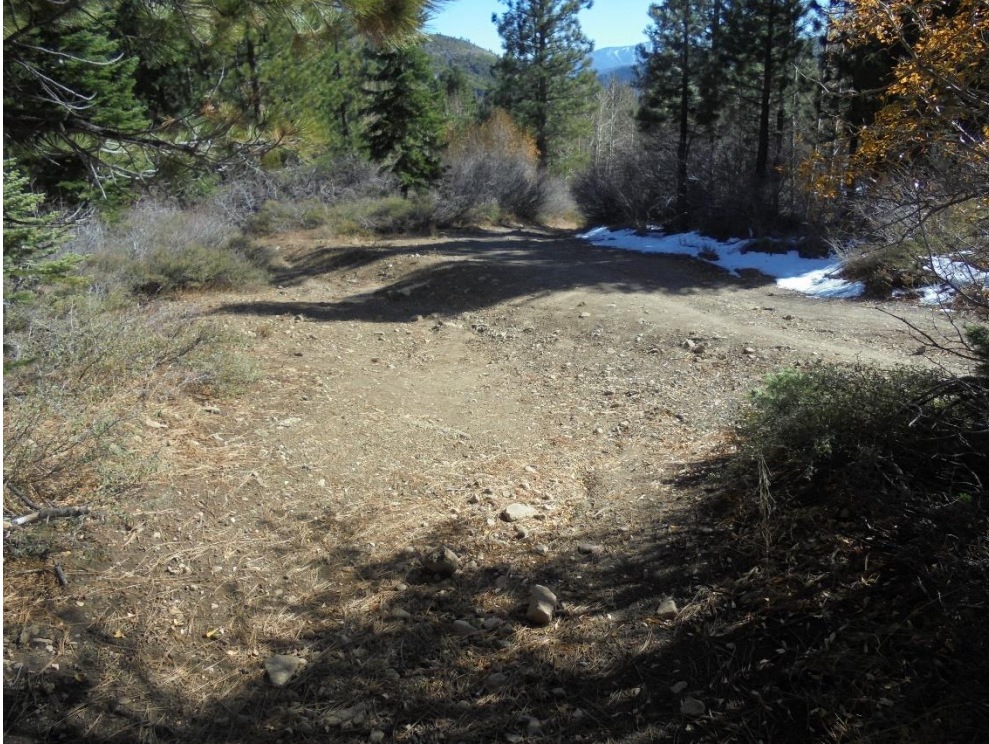
Photo 27. Looking southeast from #6 – Billy Mack Road/DLRT Connector toward Billy Mack Road, waterbar diverts runoff to the left where minor erosion is evident.

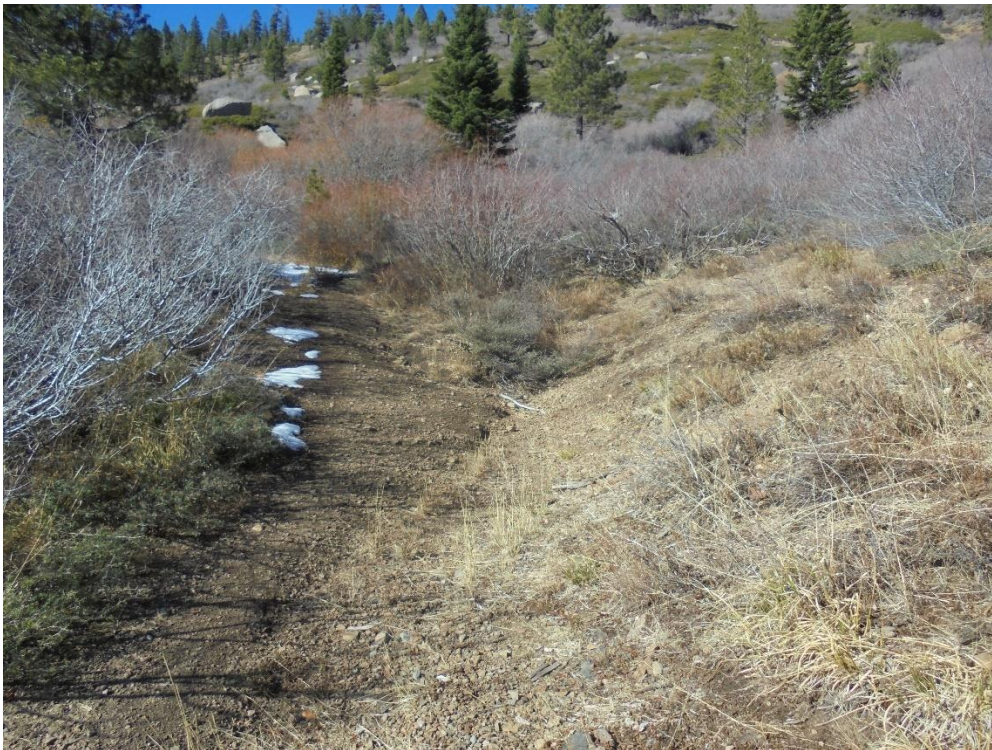
Photo 28. #7 – Project Area C Spur Road capturing drainage causing minor erosion (looking northwest).

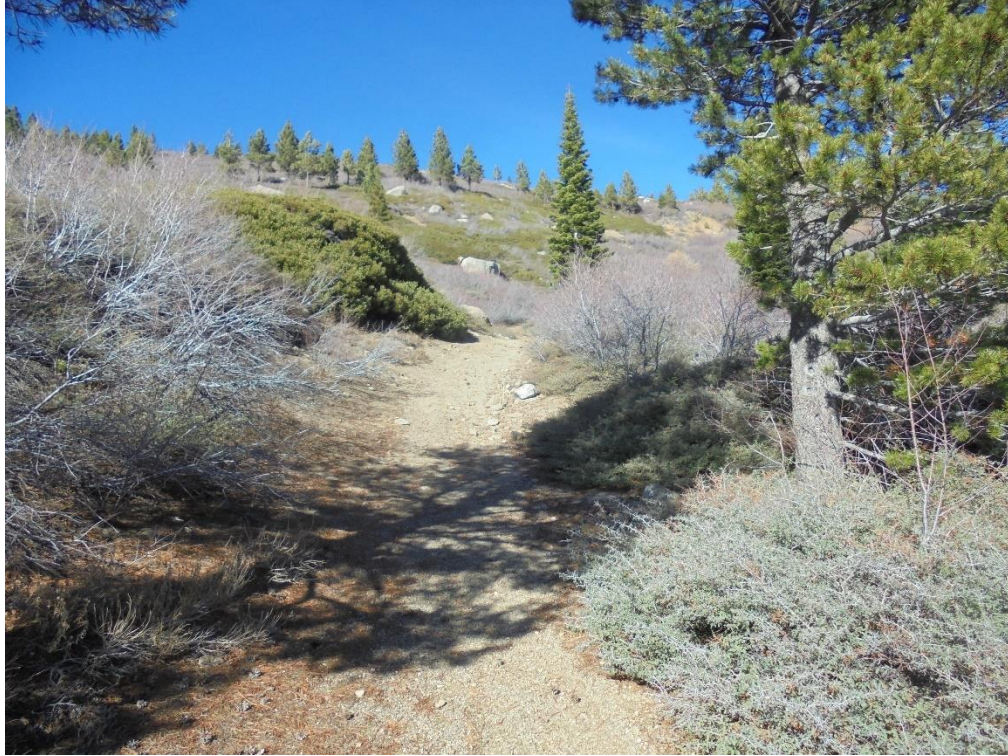
Photo 29. #7 – Project Area C Spur Road capturing drainage causing minor erosion (looking northeast).

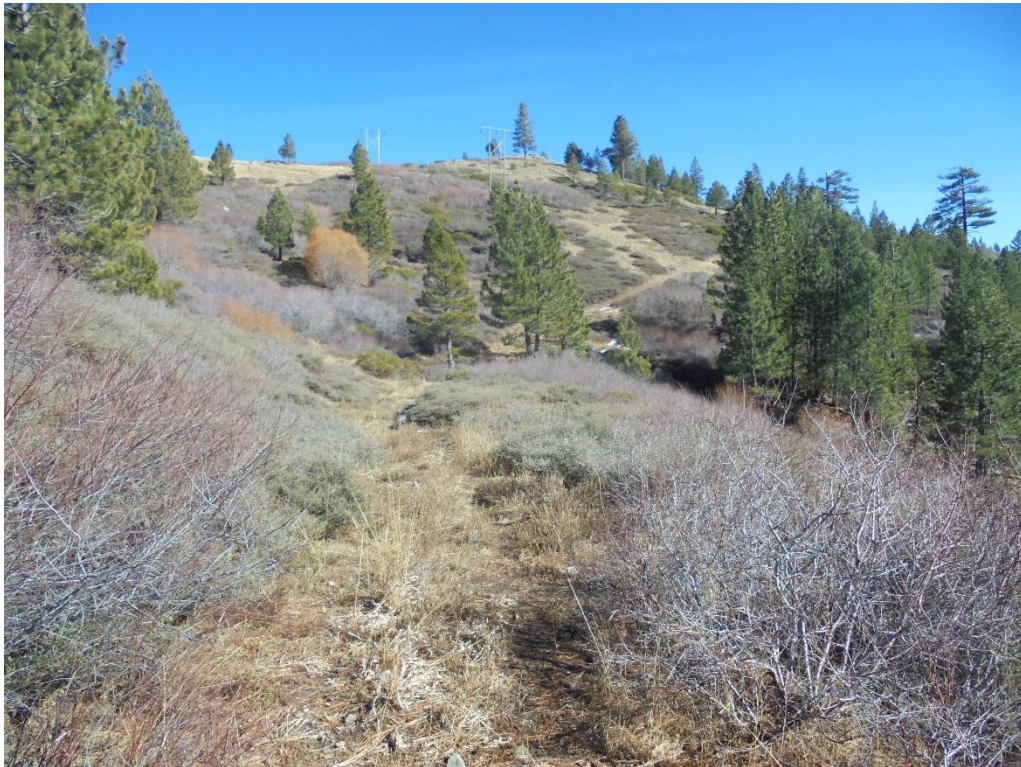
Vegetation has encroached and covered a large portion of the spur roads and both of the logging landings (Photo 30). A number of remnant trails which appear to be mountain biking trails were identified along and in the vicinity of the spur roads. The spur roads and logging landings altered drainage patterns in several small drainages in the headwaters of the watershed. Several areas of mild erosion were identified, but appeared to be relatively stable. Moderate to severe erosion was identified (Photo 31) at the larger of the two logging landings (the western landing; #40 from the 2010 Assessment), but signs of active erosion were generally minimal.

Photo 30. #7 – Project Area C Spur Road partially grown over near East Logging Landing (looking northeast).

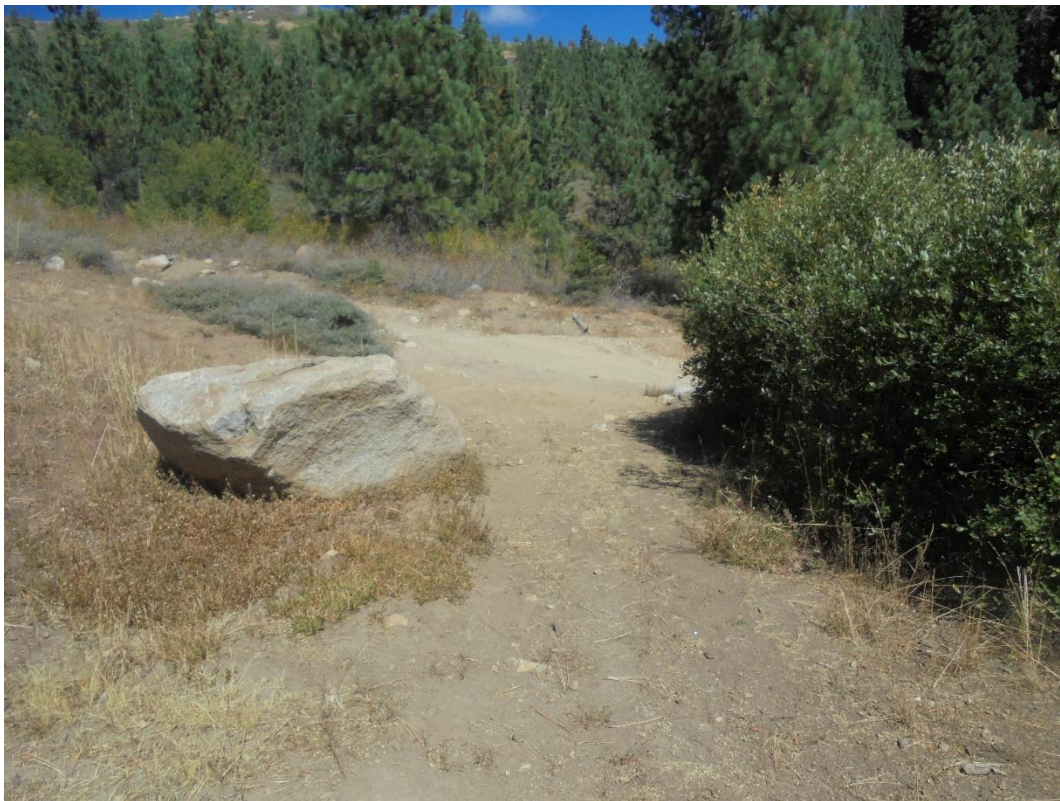
Photo 38. #9 – Logging Landing #1 blocked entrance (looking northeast).

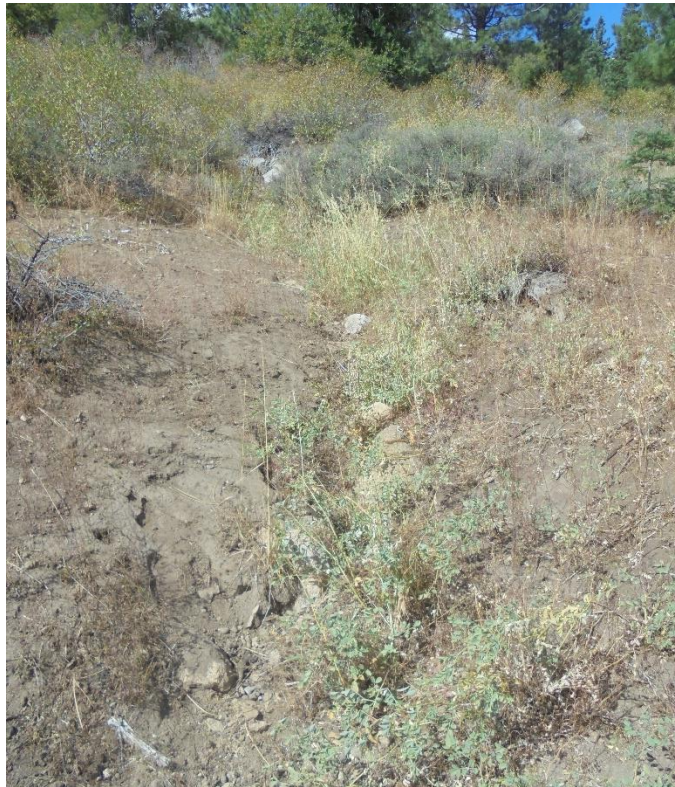
An abandoned logging landing (Photo 37), approximately 0.4 acres in size, exists on the west side of Billy Mack Road approximately 0.67 miles from the Parking Area (approximately 0.2 miles southwest of the spur road described above). The landing is flat, well vegetated, and blocked to vehicle traffic by large rocks placed at the entrance (Photo 38). OHV traffic, however, can bypass the rocks to enter the landing. An ephemeral drainage runs southwest onto (Photo 39) and through the landing. The drainage channel is mildly incised. Signs of sediment mobilization are minimal.

Photo 39. #9 – Logging Landing #1 intermittent drainage running onto landing (looking northwest).

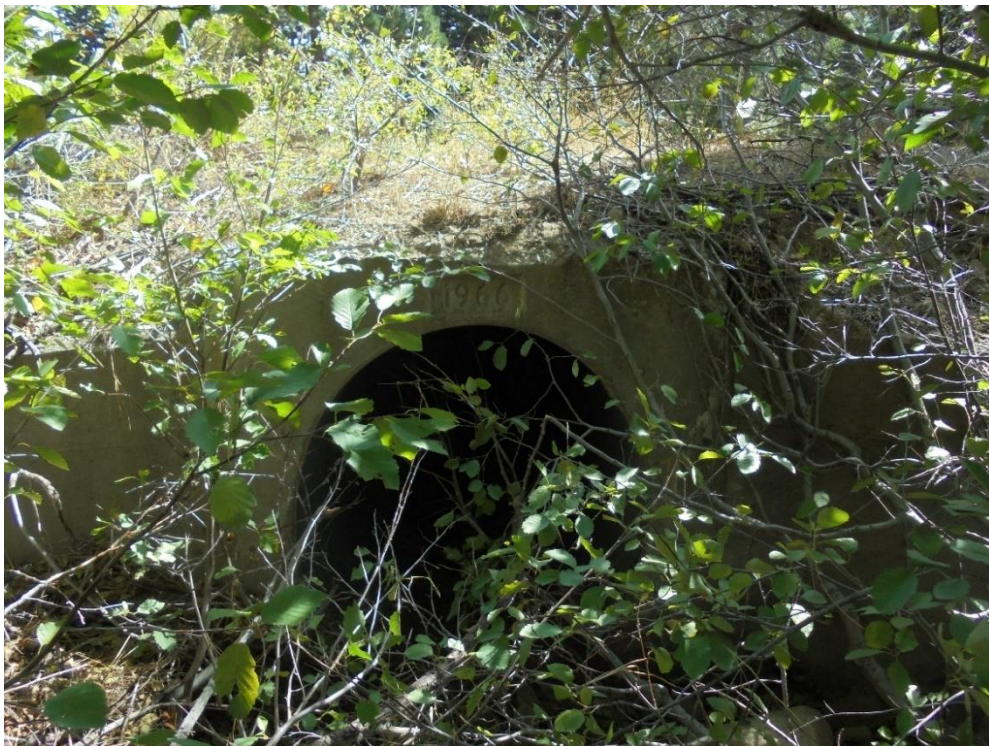
A large intermittent drainage (west fork Gregory Creek) crossing under Billy Mack Road exists approximately 0.63 miles from the parking area (240 feet southeast of Logging Landing #1 described above). The crossing consists of one 60-inch culvert (Photo 40) with a headwall at the inlet (with "1966" engraved across the top) in good condition with no sediment or debris accumulation. The upstream reach has moderately steep banks, but minimal erosion. The downstream reach (Photos 41-43), however, is severely incised and eroded from the culvert outlet to approximately 150 feet downstream. The banks are steep and the reach has high sinuosity, with tight, narrow turns.

Photo 40. #10 – Crossing #4 culvert inlet (looking south).
