Johnson Canyon West Watershed Assessment

Truckee River Watershed Council
PO Box 8568
Truckee, CA 96161

Wildscape Engineering, Inc.
3079 Harrison Ave., Suite 5
South Lake Tahoe, CA 96150

January 30, 2017

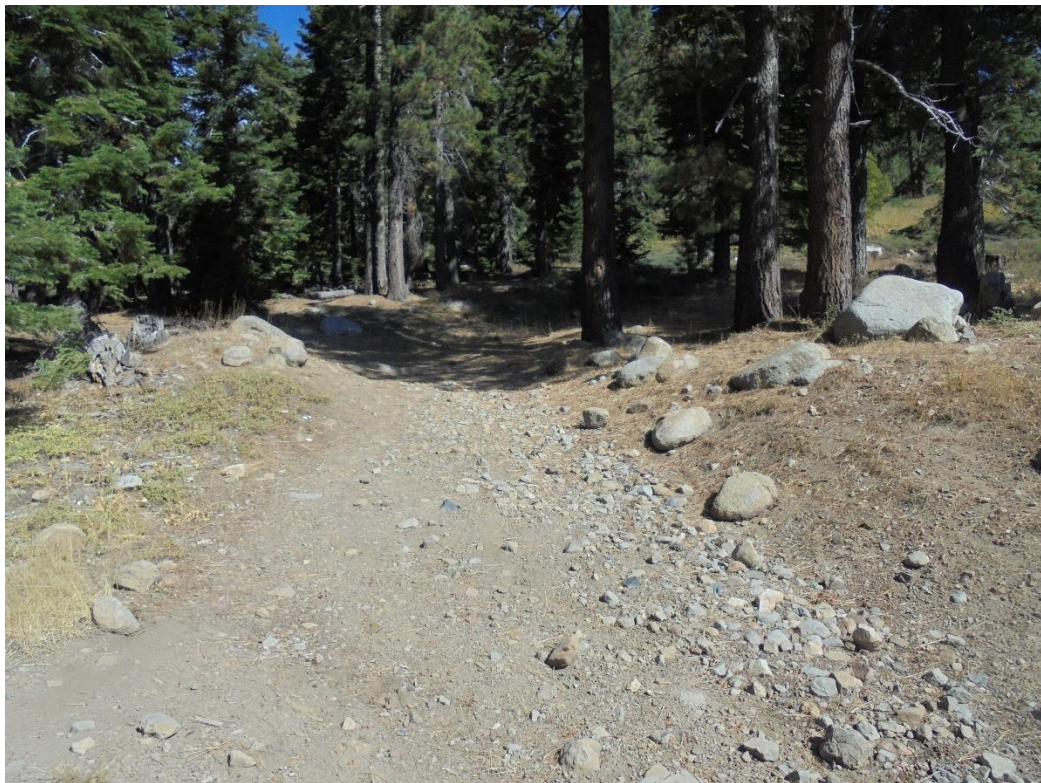
11a. USFS Road East Fork (Photo 45)

Photo 45. #11a – USFS Rd East Fork (looking east)

The portion of the east fork of the USFS Road that is within the study area is approximately 0.15 miles in length, spanning from the fork to the approximate divide between the Gregory Creek east and west sub-watersheds. This east-west stretch of roadway is moderately sloped at approximately 10% throughout the stretch (drops from elevation 6,835 feet at the east study area boundary to 6,755 feet at the roadway fork over approximately 800 feet) and captures runoff from the hillside to the north. The runoff currently runs the length of the road and discharges to the previously described degraded intermittent stream reach via the diversion channel at the fork.

Three waterbars exist along the stretch (Figure 6 of Appendix A), spaced at approximately 75 feet apart, with the first located approximately 500 feet from the eastern boundary of the Gregory Creek west fork sub-watershed and the last approximately 150 feet from the roadway fork. Minor erosion is evident along the slope south of the road at the outfall of the waterbars, although it is clear that runoff no longer discharges via the waterbar outfalls as intended, due to the failure of the waterbars along the northern edge of the road. The lack of waterbars to divert roadway runoff along the first 500 feet is the likely cause of failure of the existing waterbars (first waterbar overloaded, leading to failure followed by subsequent failure of downstream waterbars). The failed waterbars have resulted in severe gulying along the north edge of the road (Photo 45), substantial sediment transport and added drainage area and runoff entering the degraded reach, which in turn has contributed to the observed downstream erosion.

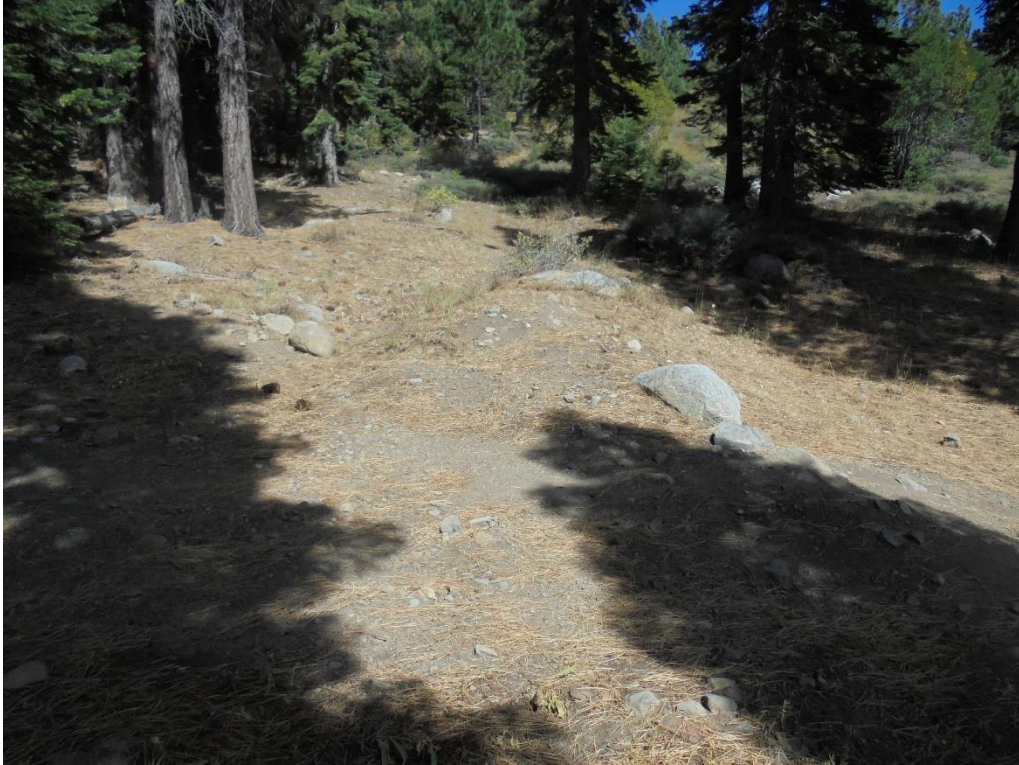
Photo 46. #11b – Logging Landing #2
(looking northwest from #11c – Logging Landing #2 East Access Road).

An abandoned logging landing, approximately 0.3 acres in size, exists north of the USFS Rd fork, approximately 0.6 miles from the Parking Area. The logging landing is relatively flat and well vegetated (Photo 46). A small ephemeral drainage channel runs onto the landing (Photo 47) and continues along the east side of the landing onto the road at the fork. Two areas within the northwest and north portions of the landing have rock campfire rings and some trash (Photos 48 and 49), indicating that the site has been used as a camp in the past. Signs of erosion in the area of the landing are minimal. However, it was noted that invasive Cheat Grass is present in the area.

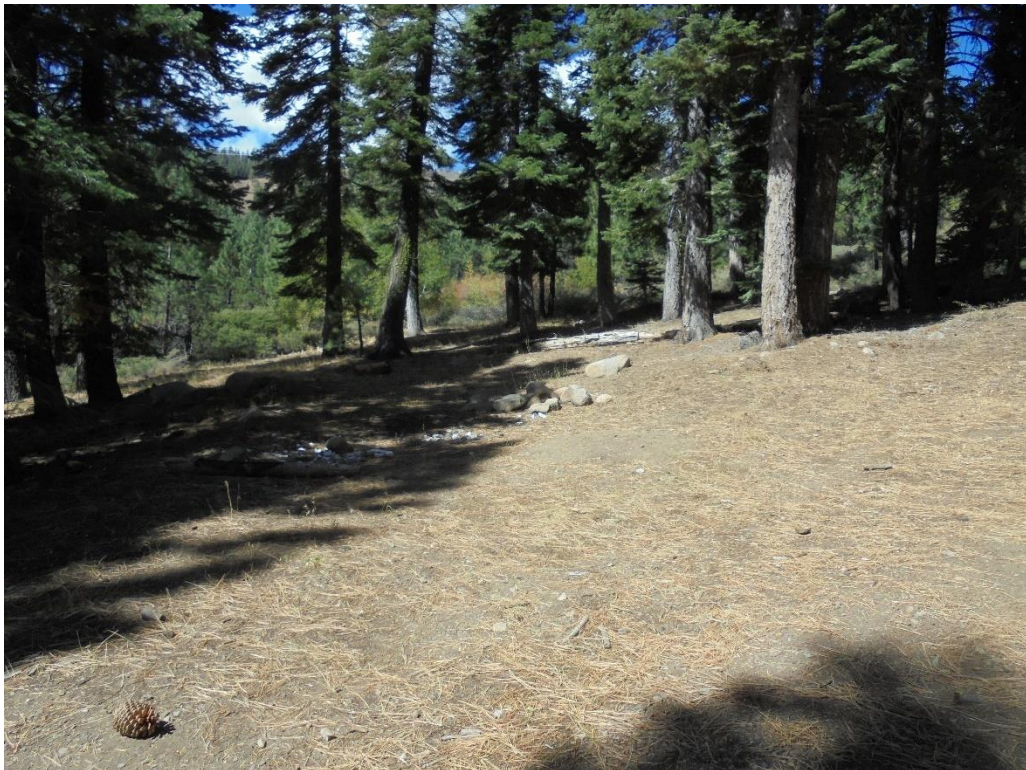
Photo 47. Ephemeral drainage channel running onto #11b – Logging Landing #2 (looking northeast from #11b – Logging Landing #2).

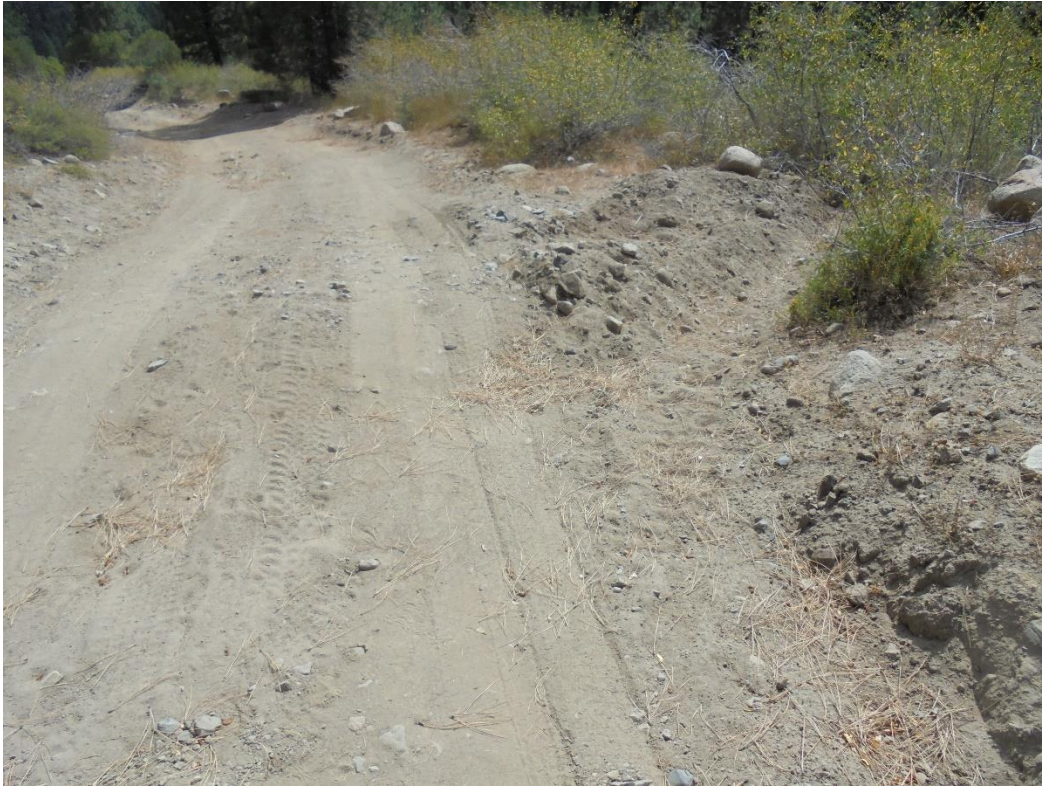
11f. Rolling Dip and Diversion Channel (Photo 56)

Photo 56. #11f – Billy Mack Road Fork Rolling Dip and Diversion Channel (looking southwest from USFS Road 0676-088 fork).

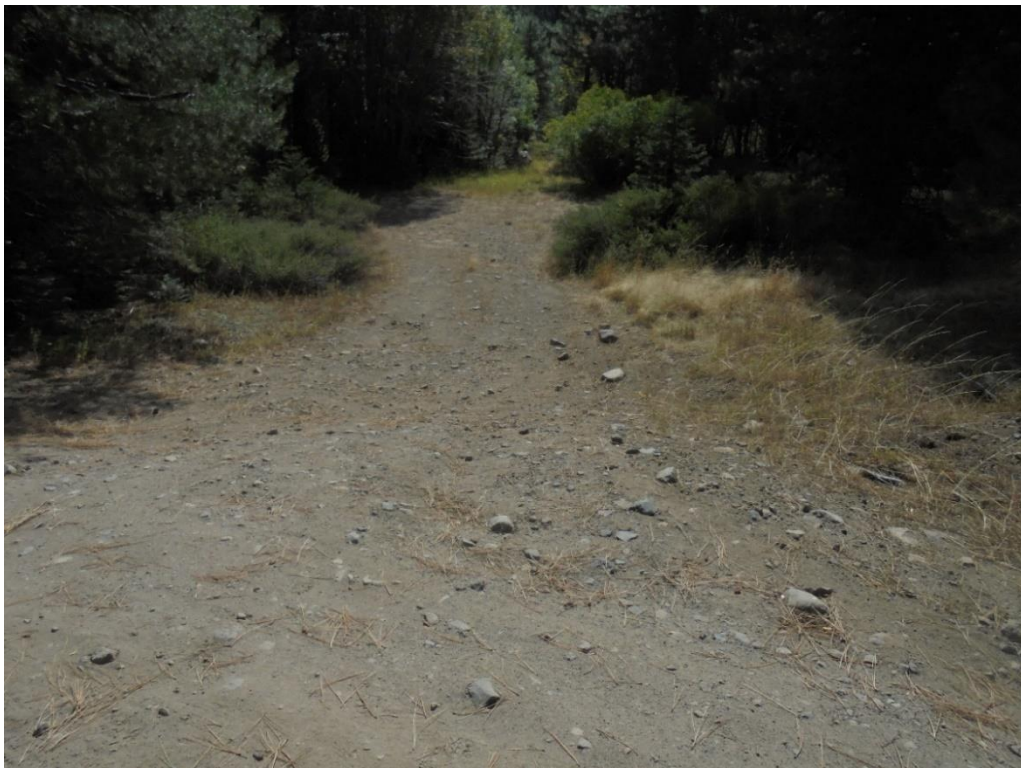
This stretch of roadway, approximately 1.2 miles in length, maintains a moderate to steep slope of approximately 7-13% throughout its length, with the upper portion generally running steeper than the lower portion. The road runs parallel to the west fork of Gregory Creek, crosses the creek, and then runs above the creek up and out of the watershed. Numerous existing waterbars (Photo 57-68) divert road runoff toward the creek and in many cases, directly into the creek. The waterbars appear to be functional and had received minor maintenance shortly before the field reconnaissance. Erosion at the waterbar outfall ranges from minor at the lower waterbars to severe at the upper waterbars where the road is directly adjacent to the deep Gregory Creek West Fork channel. Photo 69 shows an example of moderate erosive rilling and gullying at the outfall of an upper waterbar (above The "T") where waterbar spacing is insufficient for preventing erosion.

Photo 69. Example of erosive rilling and gullying from inadequate waterbar spacing on Billy Mack Road (taken in November 2016 after large October 2016 storms).

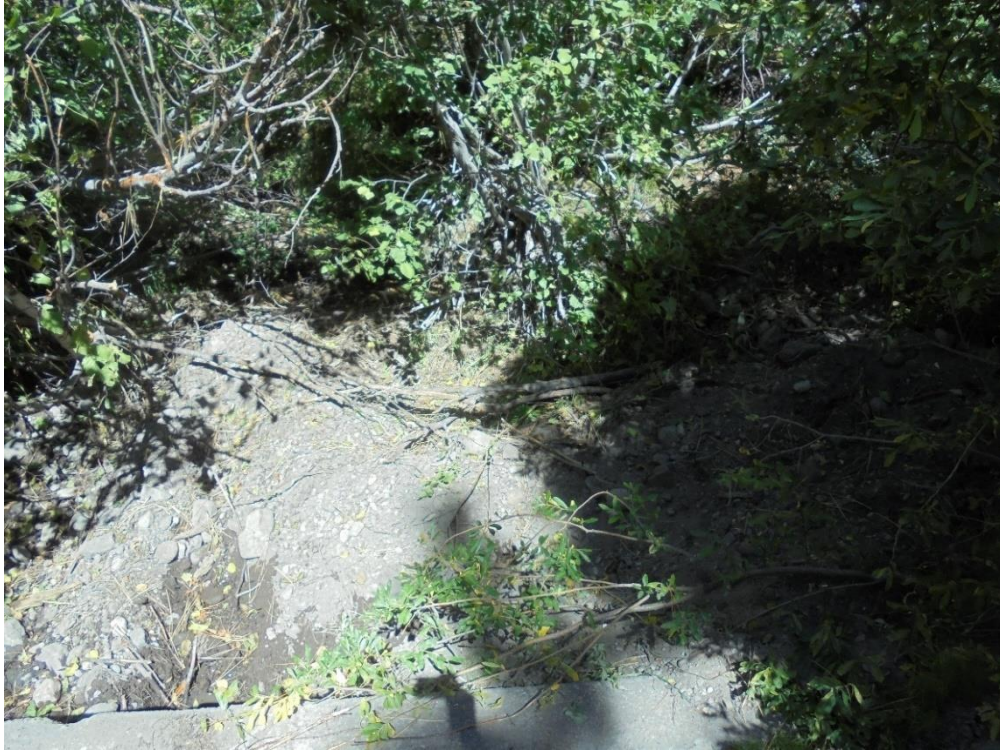
Gregory Creek East Fork crosses under Billy Mack Road approximately 0.1 miles from the Parking Area. The crossing consists of two 16-inch diameter culverts with headwalls constructed at both the inlets (Photo 72) and outlets. Mild erosion is evident within the upstream and downstream reaches, which are relatively low slope and well vegetated through the reach (Photos 73-74). An overflow channel exists along the west side of the main channel (Photos 75-76). The overflow channel displays signs of moderate erosion upstream from the road and severe erosion downstream of the road where the overflow channel turns slightly south to reconnect with the main channel. It is apparent that the

Photo 72. #14 – Crossing #5 Gregory Creek east fork culvert inlet (looking southwest).

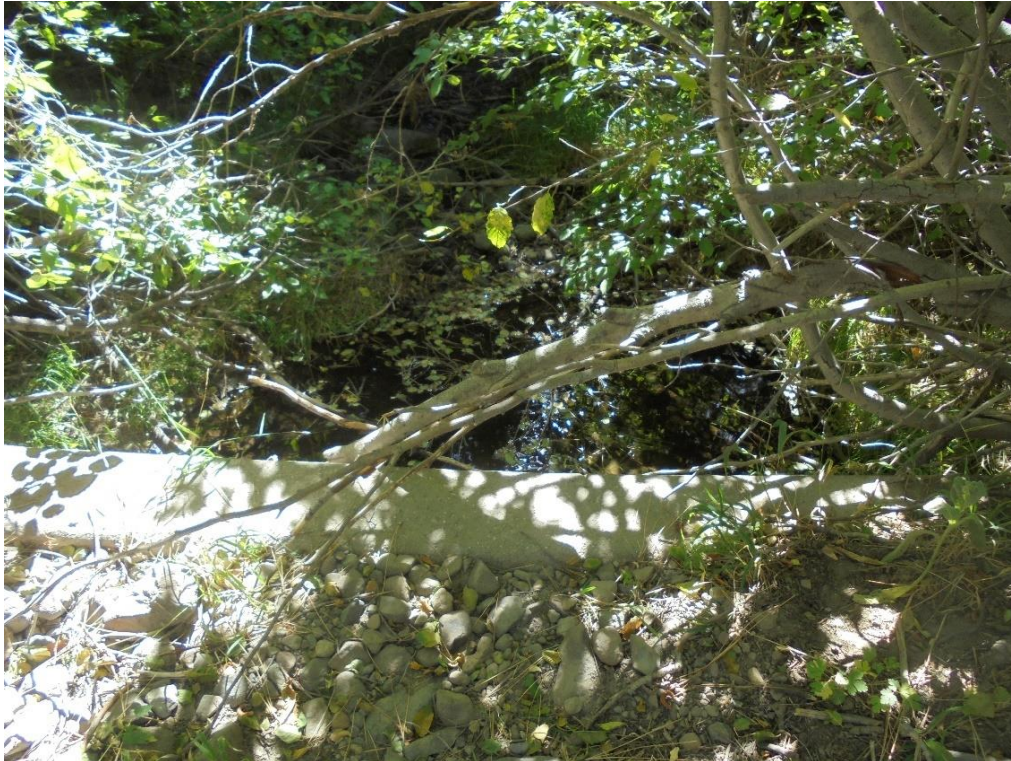
Photo 73. #14 – Crossing #5 Gregory Creek east fork (looking north upstream from Billy Mack Road; lose dirt in channel, possibly from road maintenance crew).

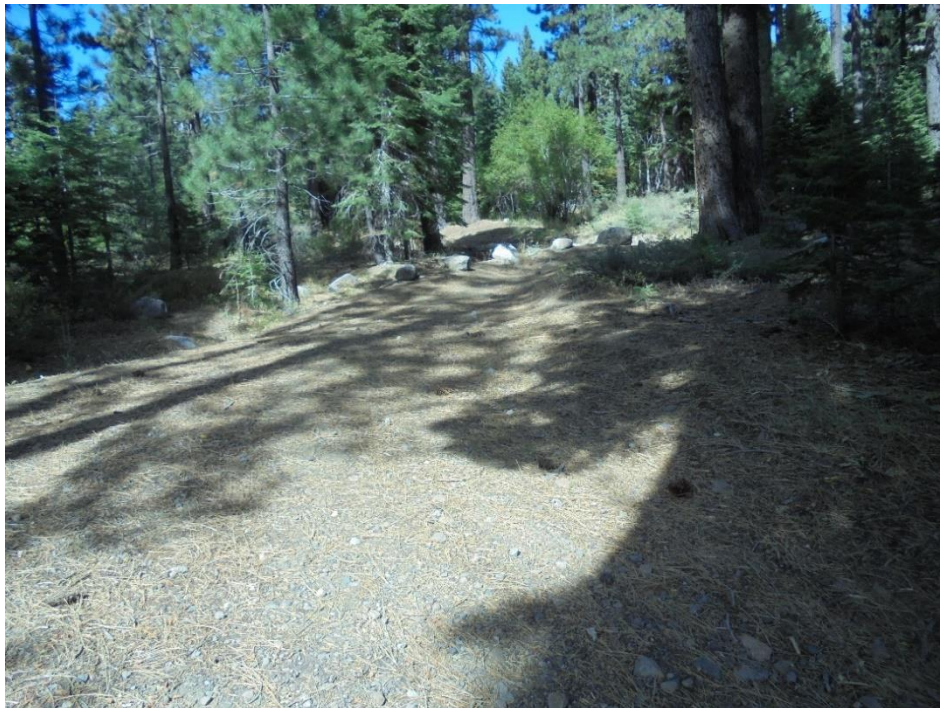
15a. Ephemeral Drainage (Photo 77)

Photo 77. #15a – Ephemeral Drainage that runs onto #15 – Former Staging Area (looking southwest from Billy Mack Road; staging area visible through trees center-left of frame).

A small ephemeral drainage crosses Billy Mack Road approximately 300 feet north of the Staging Area and runs down along the west side of a partially decommissioned road (described below), where the drainage channel is well defined and well vegetated. The drainage channel diverges to the west from the partially decommissioned road and fans out. The flowline(s) of the drainage beyond this point are no longer visible and the terrain is relatively flat, but the majority of runoff from the channel likely continues south to the Staging Area. The entrenched flow path that forms at the northeast corner of the concrete pad (Photo 81) is likely the ultimate discharge location of the majority of the flow from the ephemeral drainage onto the Staging Area.

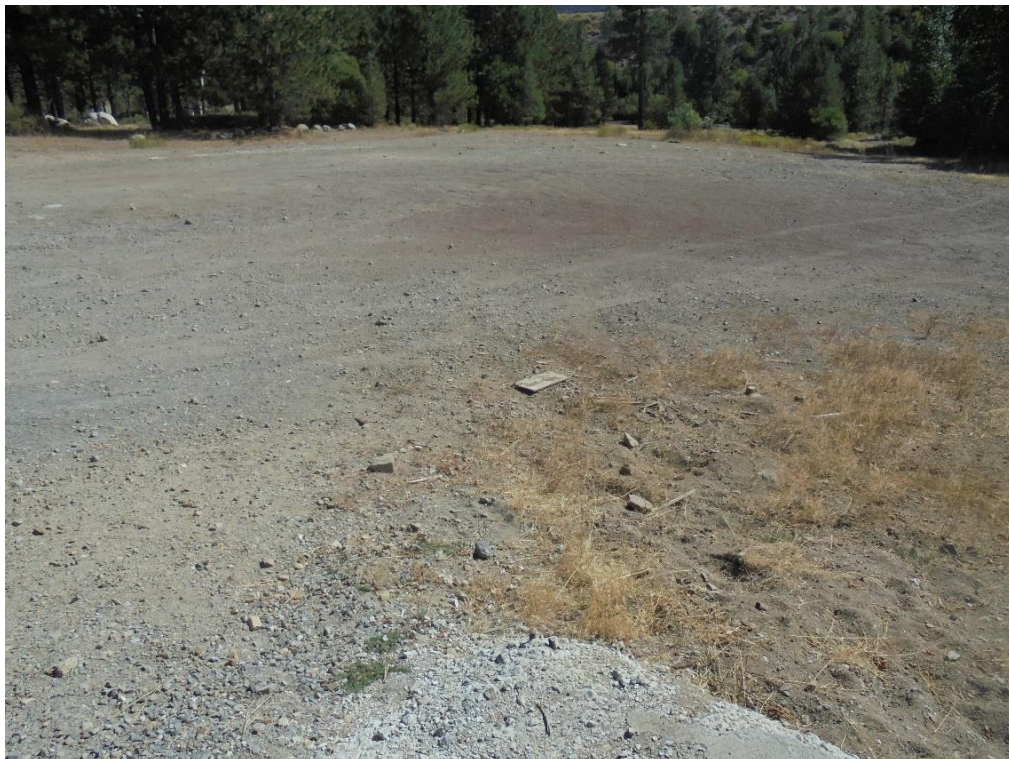
Photo 81. Eroded flowline from northeast corner of #15c – Concrete Pad (looking northwest).

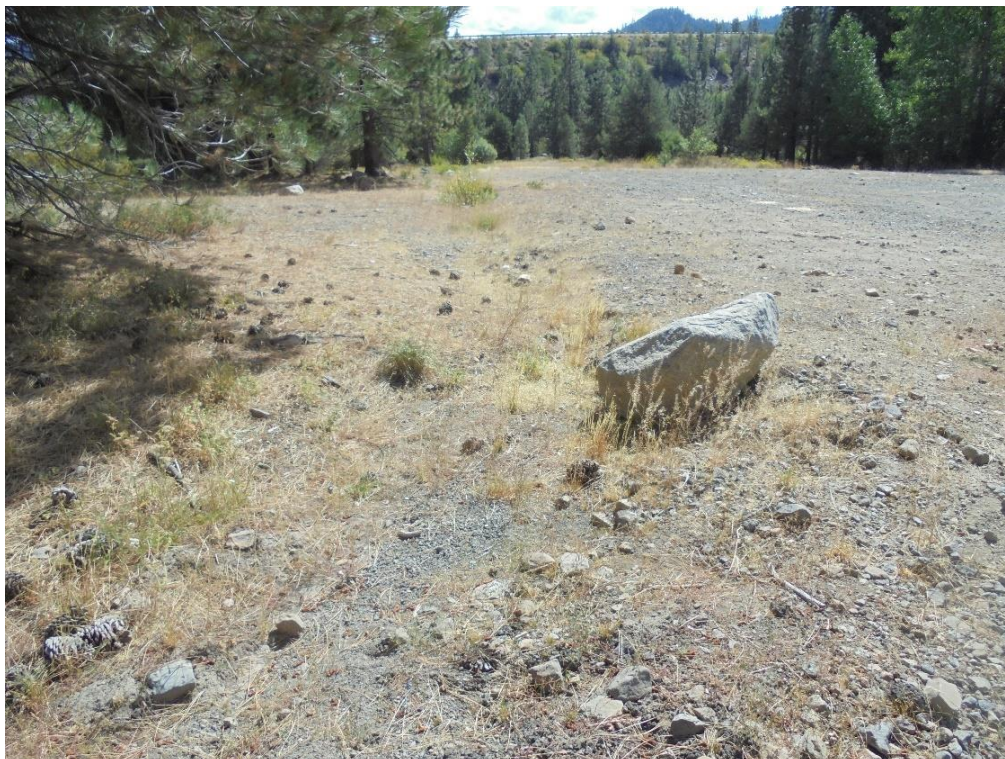
15d. Compacted Subbase (Photos 82, 91, 92)

Photo 82. #15d – Compacted Subbase portion of #15 Former Staging Area (looking southeast from southeast corner of #14c – Concrete Pad).

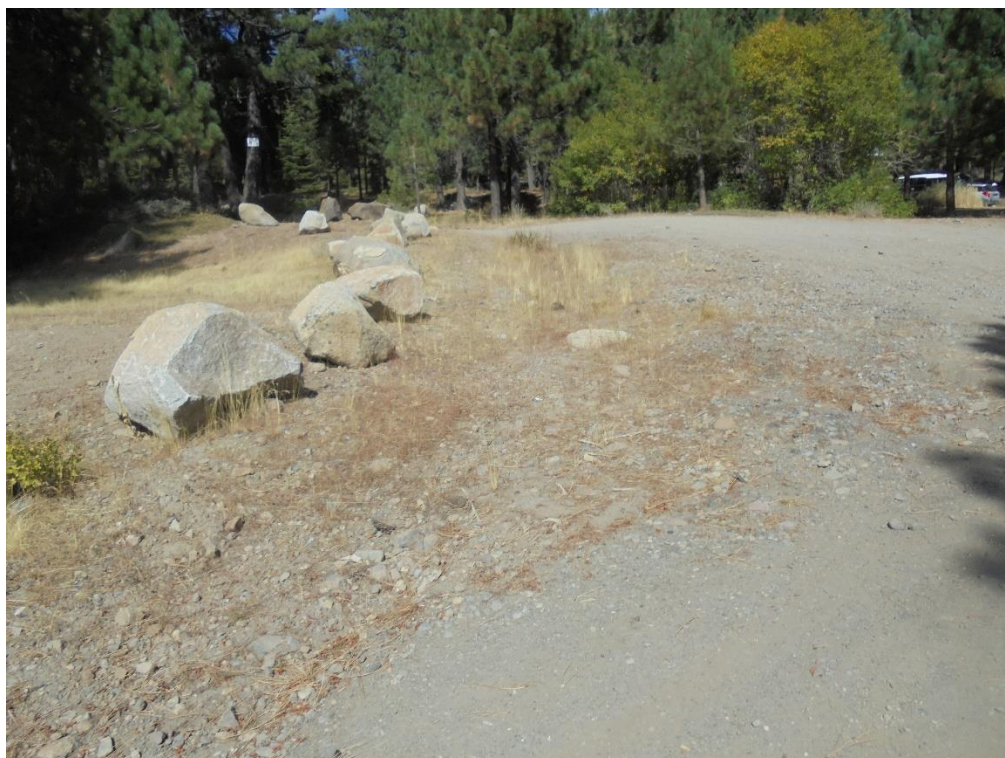
Photo 84. #15e East Drainage along #15 Former Staging Area (looking north upstream from Staging Area access road).

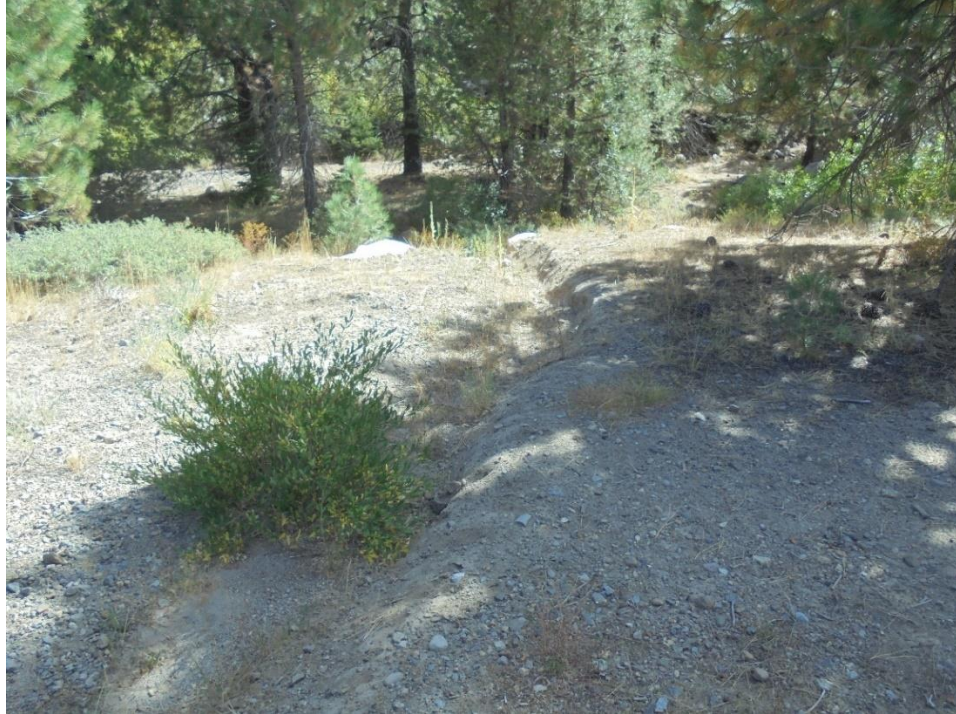
15f. Runoff Outlet (Photo 85)

Photo 85. #15f Outlet from #15 Former Staging Area to Caltrans drainage ditch along I-80 (looking southwest).

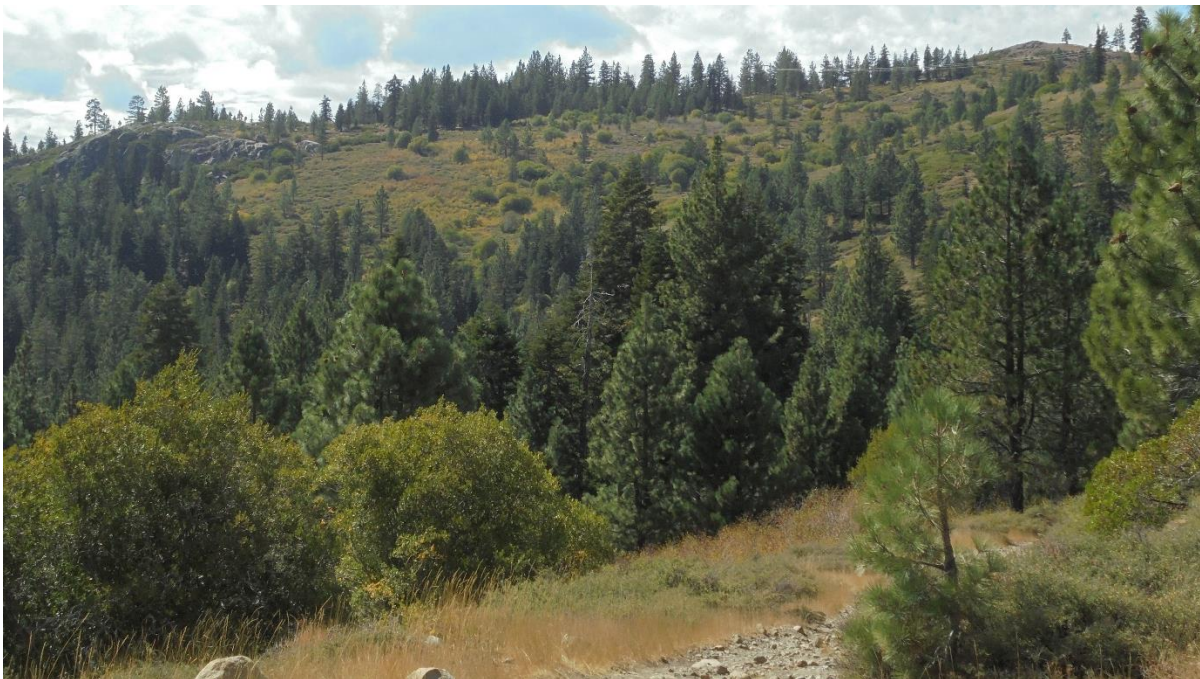
Photo 86. Central portion of eastern slope within study area (looking west from USFS Rd 0676-088 East Fork near the Gregory Creek West Fork sub-watershed east boundary; the previously referenced scenic viewpoint is visible at top-right of frame; the powerlines are visible passing beneath the scenic viewpoint; USFS Road Southwest Fork gains the ridge and leaves the study area behind the rock knoll at top-left of frame).

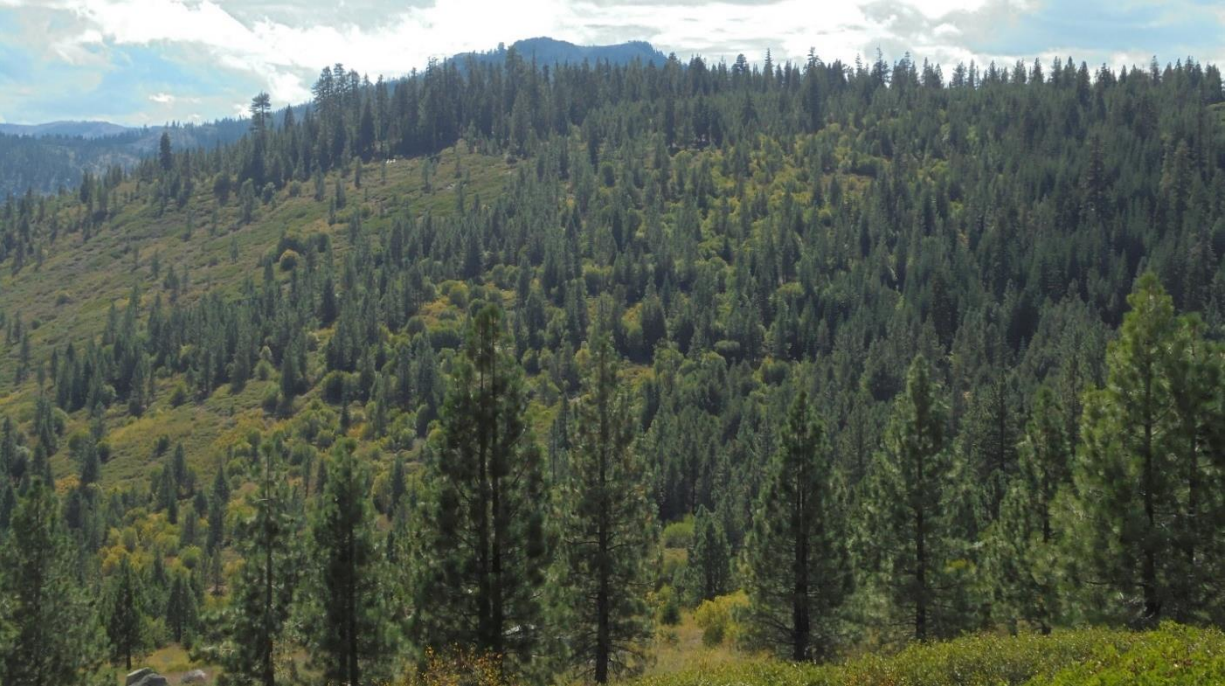
Photo 87. South portion of eastern slope within study area (looking southwest from USFS Rd 0676-088 East Fork near the Gregory Creek West Fork sub-watershed east boundary).

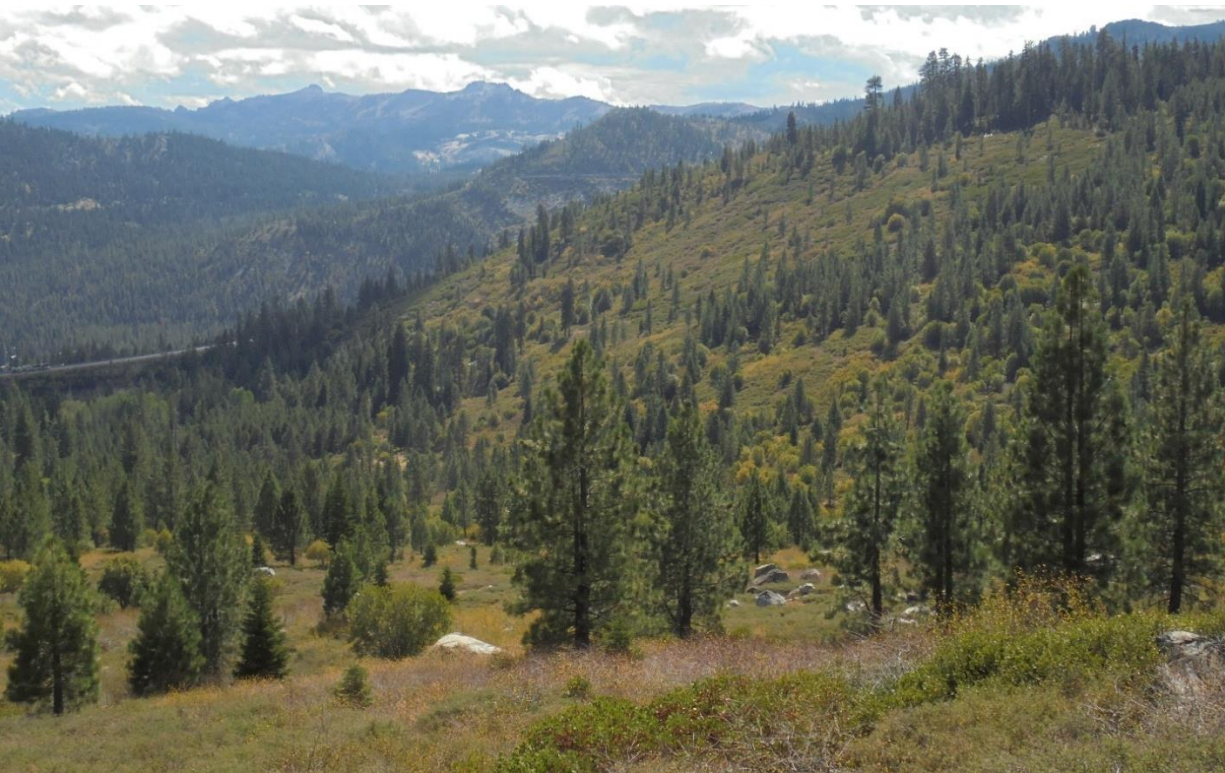
Photo 88. View of the lower portion of the Gregory Creek West Fork sub-watershed (looking southwest from USFS Rd 0676-088 East Fork at the sub-watershed east boundary).

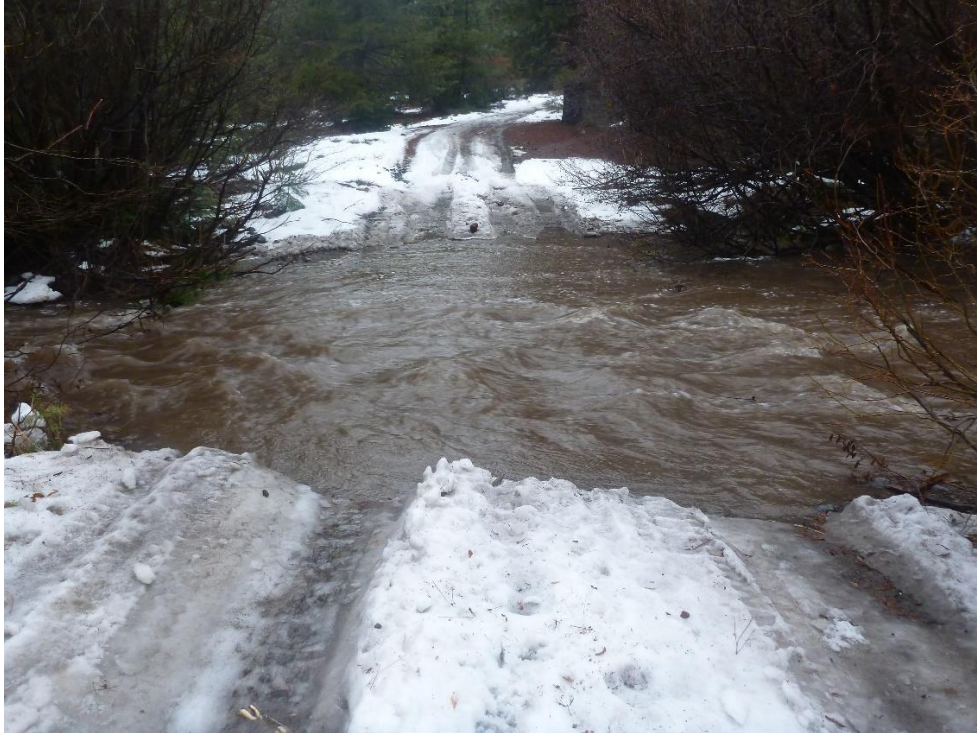
overflow channel is activated periodically during normal water years and the large rocked low water crossing that was recently installed for the overflow channel road crossing suggests that overflow has partially washed out the road in the past. Photos 88 and 89 show Billy Mack Road being overtopped at the location in fall 2016.

Photo 89. #14 – Crossing #5 Gregory Creek east fork flowing over Billy Mack Road due to high flows during storm in fall 2016 (looking northwest, up Billy Mack Road).

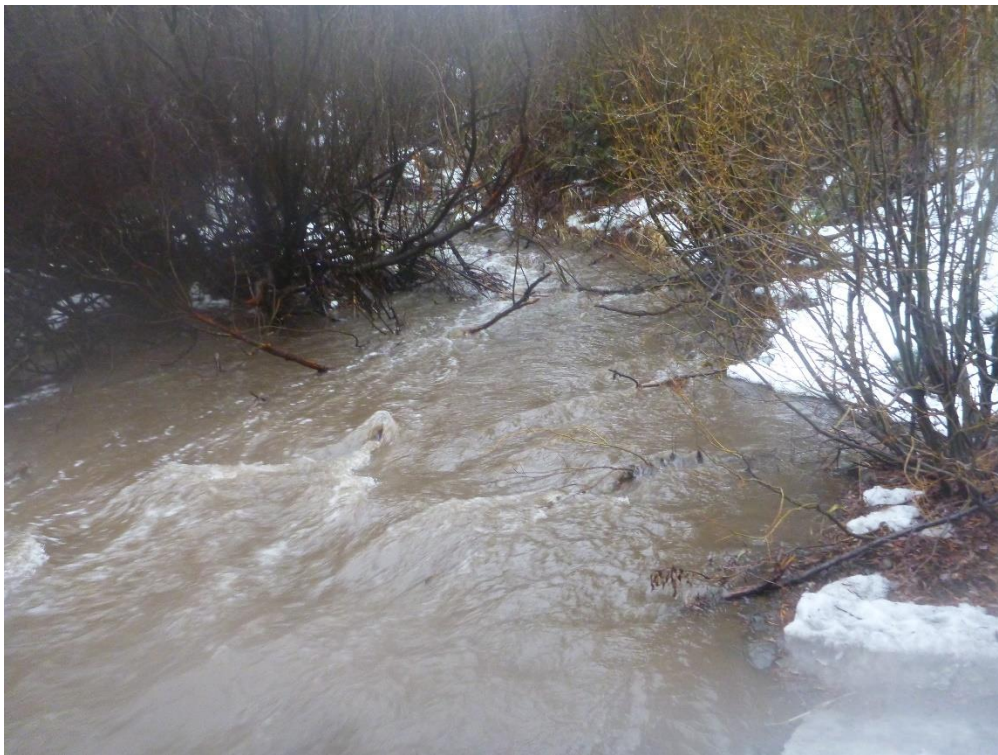
Photo 90. #14 – Crossing #5 Gregory Creek east fork during storm in fall 2016 (looking northeast, upstream).

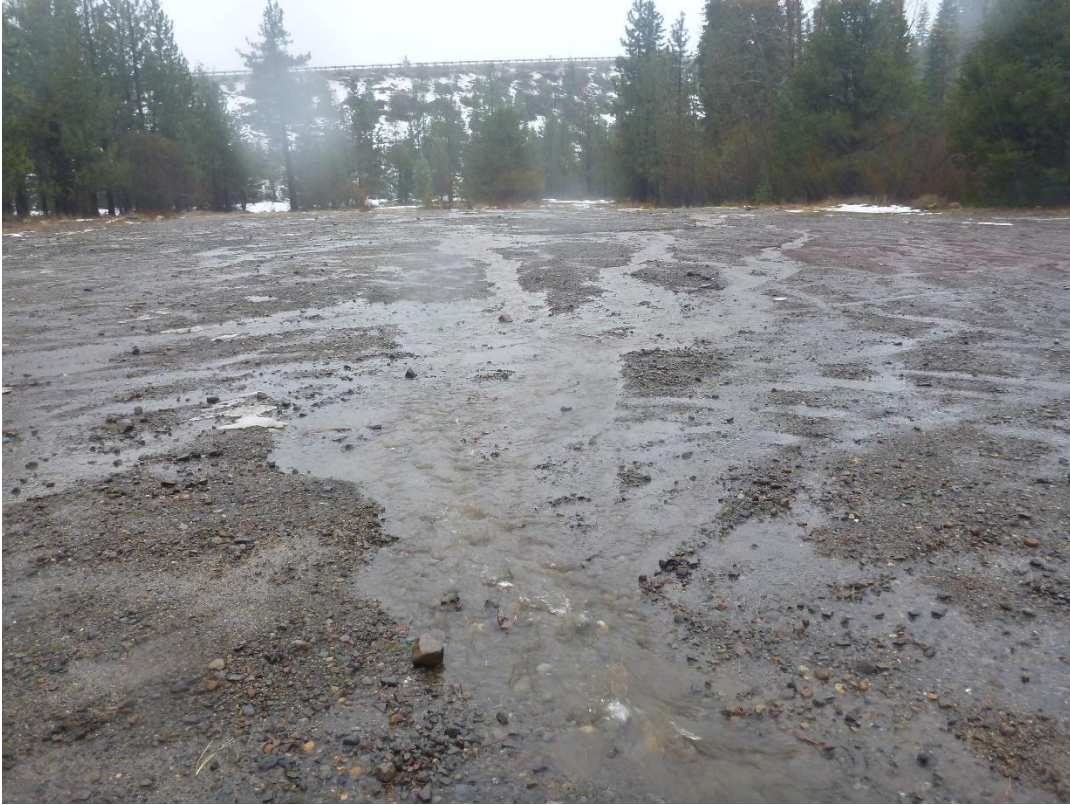
Photo 91. #15d – Compacted Subbase during storm in fall 2016 (looking southwest).

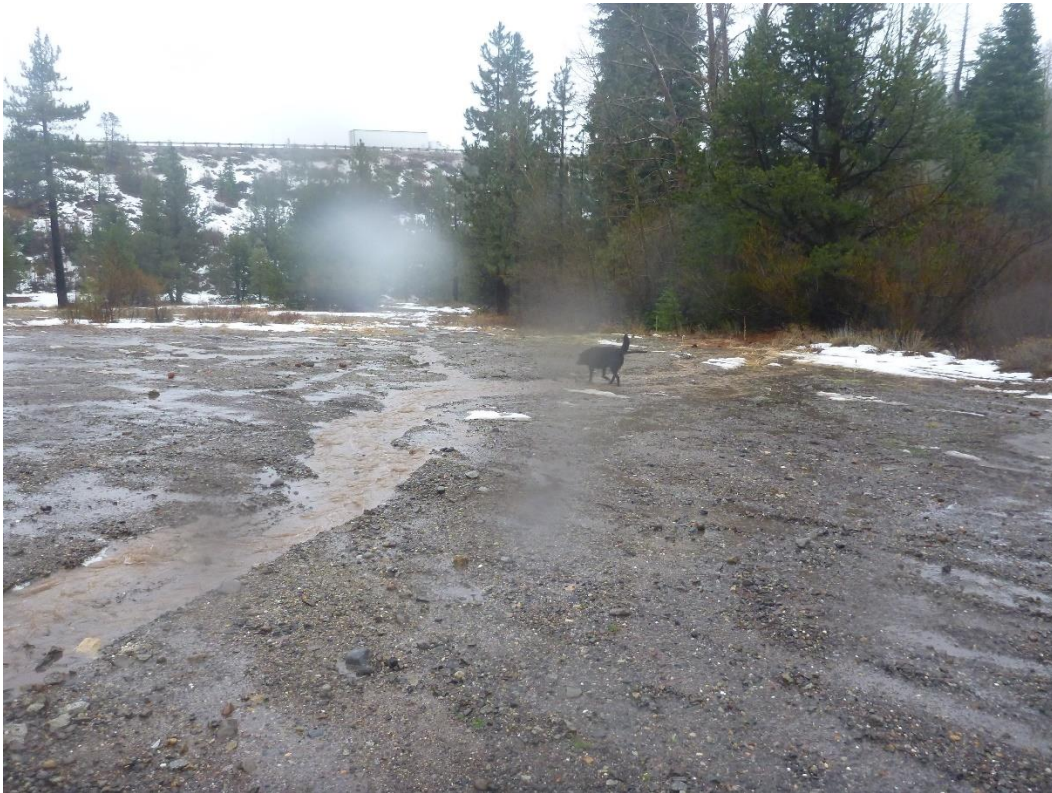
Photo 92. #15d – Compacted Subbase during storm in fall 2016 (looking southwest).

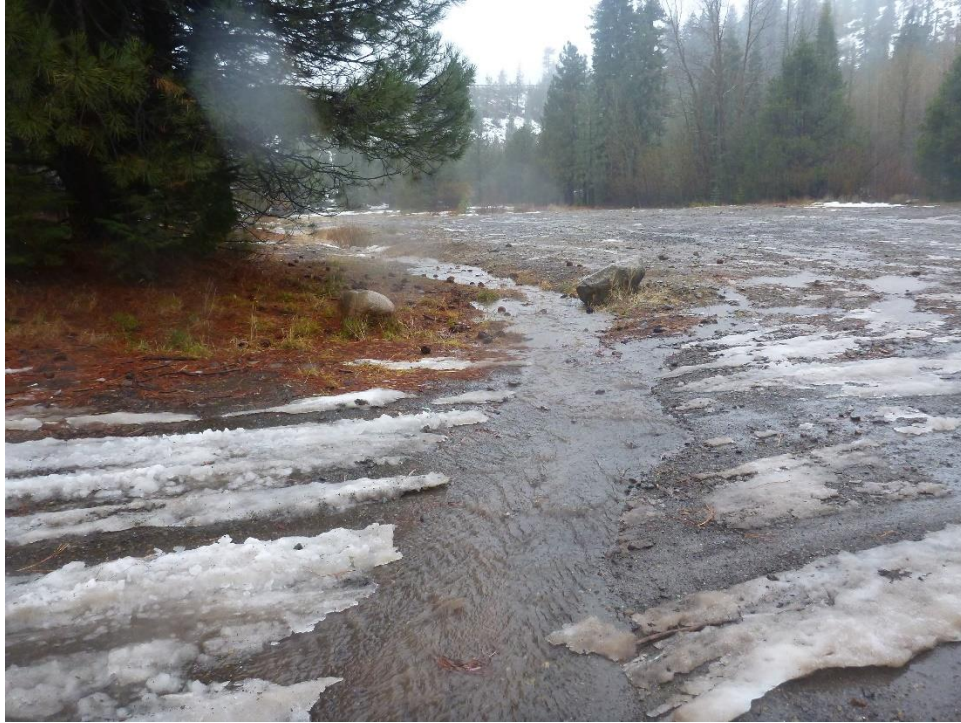
Photo 93. #15e – East ephemeral drainage along Former Staging Area east boundary during storm in fall 2016 (looking southwest).

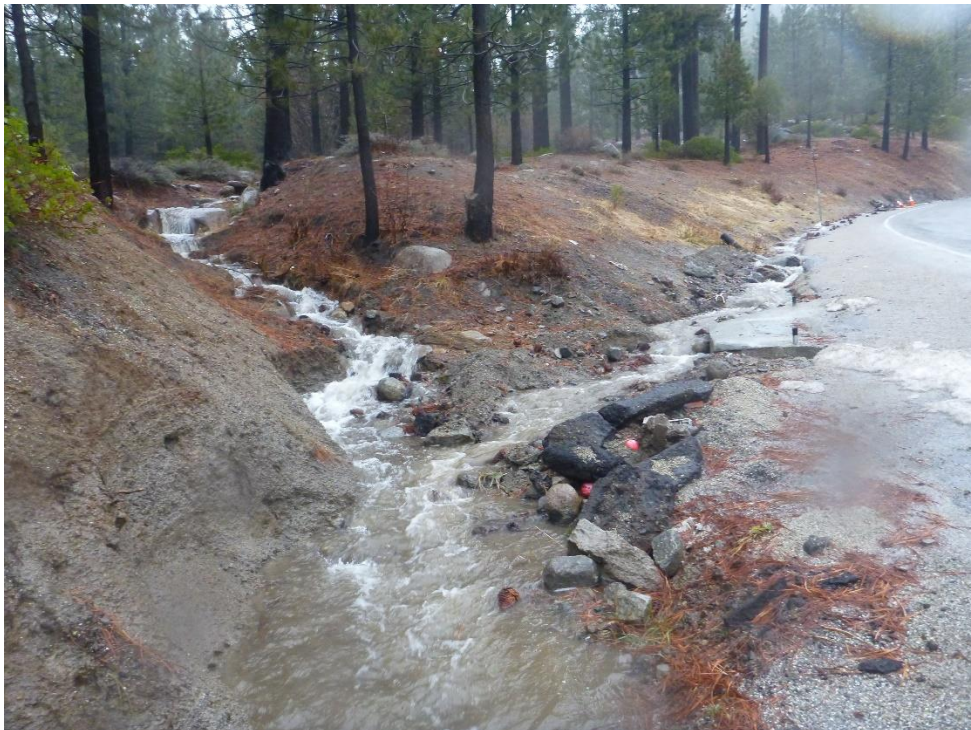
Photo 94. #15 – Confluence of runoff from I-80 West Exit 180 off-ramp and ephemeral drainage from the lower eastern portion of Johnson Canyon (looking north); these flows drain through the Caltrans drainage ditch and join runoff flows from the Former Staging Area before entering Gregory Creek.
