# Boca Watershed Assessment

**USDA Forest Service  
Tahoe National Forest  
Truckee Ranger District  
2020**

**Prepared by**  
Sharon Falvey, Lindsay Ryan, and Rachel Hutchinson

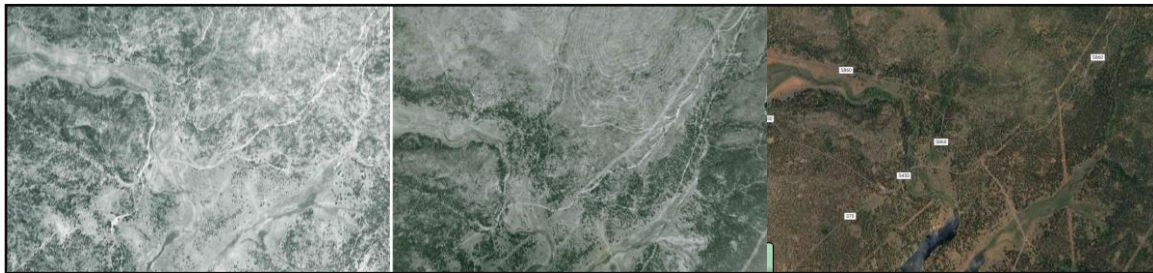
**Figure 1. Hoke Valley area within the Boca watershed. 1939 (left) and 1966 (middle), 2019 (right). Information gleaned from these records are discussed in Chapter 3.**

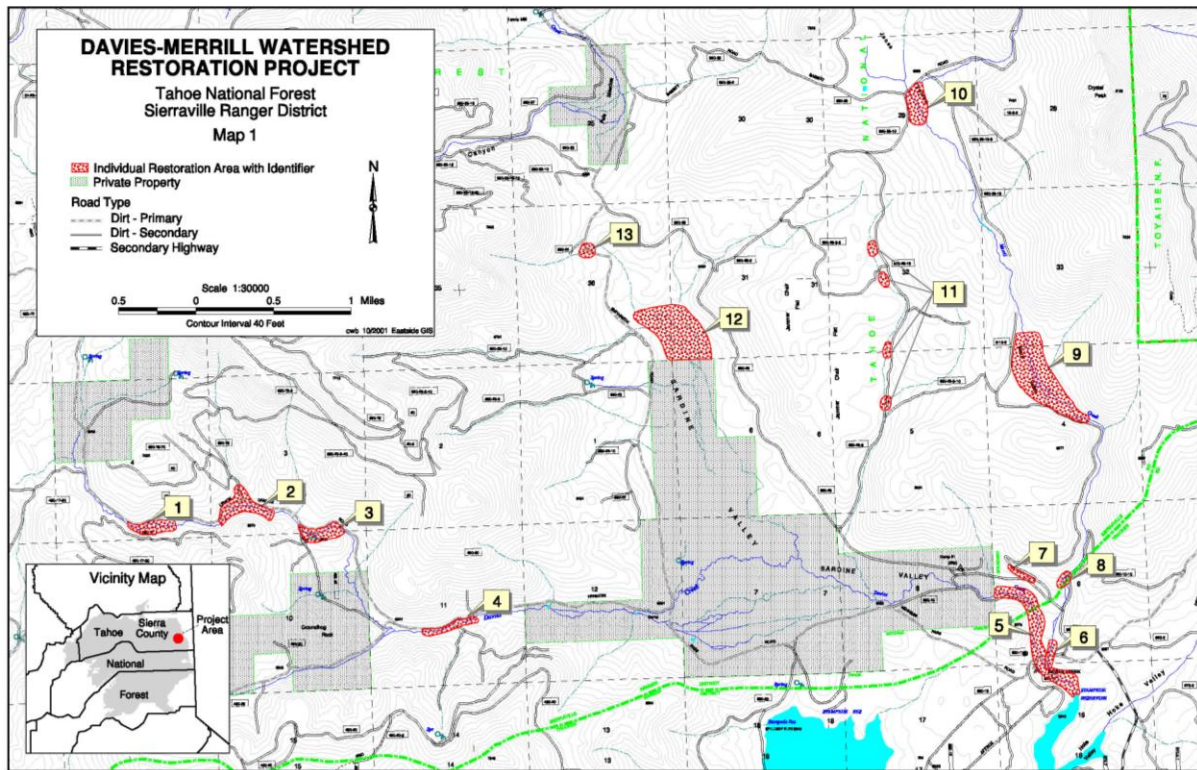
**Figure 8. Davies- Merrill Watershed Restoration Project: Sites 5-8 are within the Boca Watershed Assessment Area and have been completed.**

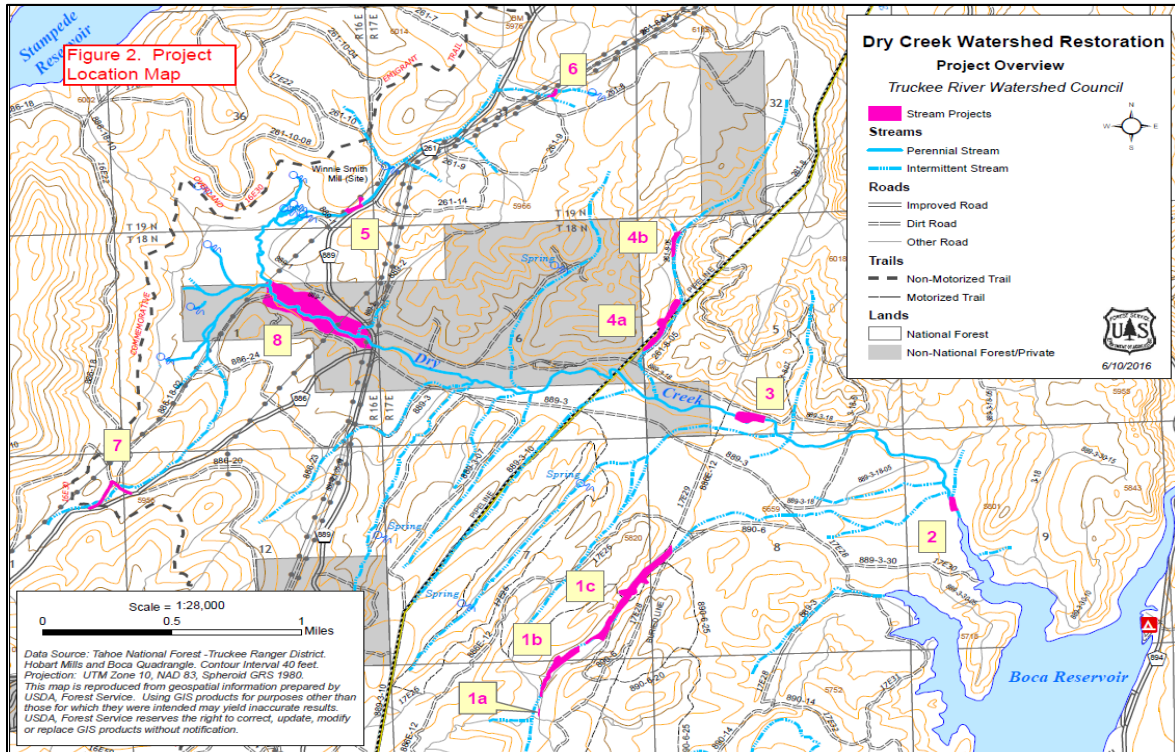
The Dry Creek Watershed Assessment was completed in 2013 (Figure 12). The assessment found that hydrologic function of the watershed was heavily impacted by past activities including clear cut logging, roads, railroads, and intensive grazing. Sites 1 through 8 were identified as good opportunities for restoration to improve overall watershed function. Since the assessment was completed, several projects have been completed in the Dry Creek watershed.

Between 2015 and 2017, Phase 1 of the Dry Creek Restoration Project was completed. This first phase included the restoration of two intermittent tributaries by decommissioning roads that diverted flows and filling in gullies so flows can access remnant channels in the meadows. Phase 2 of the project was completed in 2019. A large meadow on the main stem of Dry Creek was restored, roads were removed or relocated on two tributaries, and an eroding gully and headcut were repaired. Sites 1 and 4 were completed between 2015 and 2017. Sites 5, 6, 7, and 8 were completed in 2019 (Figure 12). Sites 2 and 3 have not been completed.

**Figure 12. Dry Creek Watershed Restoration projects. Sites 1 and 4 were completed between 2015 and 2017. Sites 5, 6, 7, and 8 were completed in 2019. Sites 2 and 3 have not been completed.**

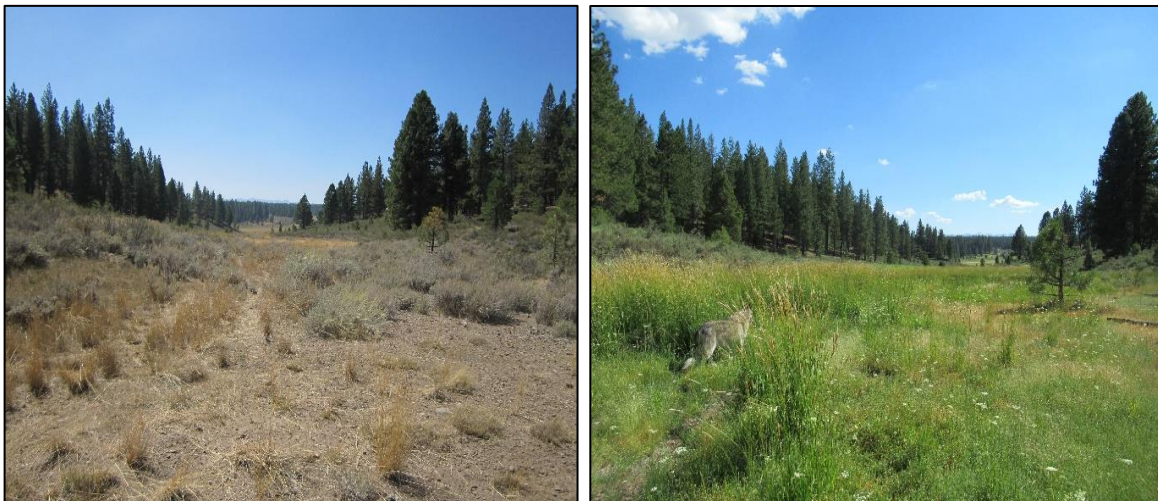
**Figure 13. Site 4 of the Dry Creek Restoration project was completed in 2016. Before (left) the meadow was dominated by sagebrush. In 2019 (right), wet vegetation had taken over the meadow.**

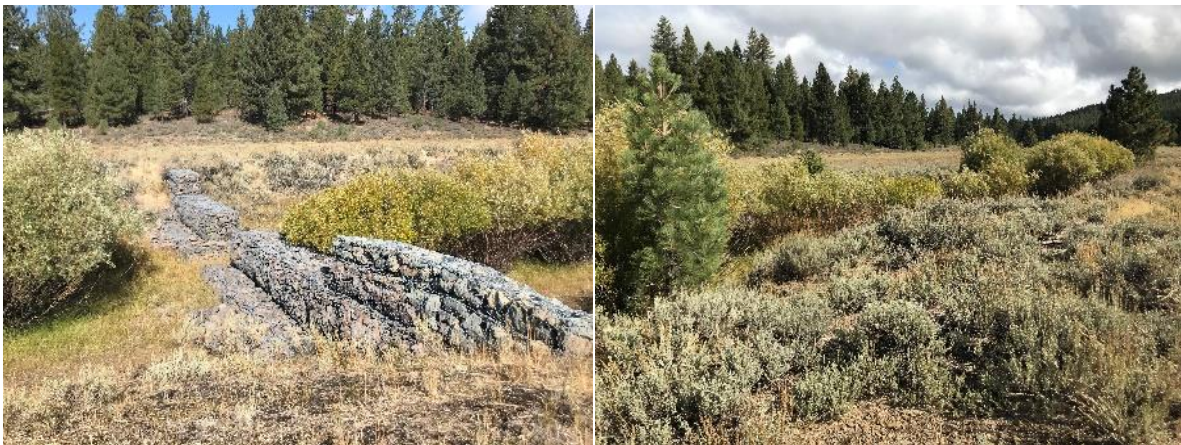
The Hoke Valley Restoration Project HV-D is currently in the design phase (Figure 11). The meadow has been impacted by historic railroad grades and logging, in addition to an underground fiber-optic cable and petroleum pipeline that run across the meadow. This project will restore the meadow and main channel between County Road 270 and Forest

Service road 860-5. The project will address meadow incision and reconnect meadow soil hydrology.

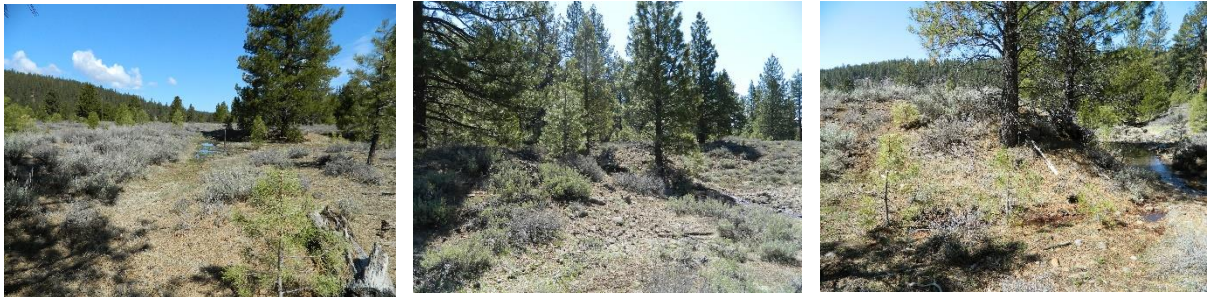
This site will improve hydrologic connection of 21 meadow acres, 750 feet of stream channel, and improve hydrology for 4.5 acres of aspen habitat. Implementation actions at this site may include protecting and expanding existing meadow habitat by re-routing a road that bisects the upper edge of a meadow and reconnects hydrology across the restored road surface. Restoration actions will include importing material to restore topography and soil conditions in decommissioned road segments and compacted sites. Additional measures include the development of a re-routed road segment outside of sensitive areas, restoring the decommissioned segment of the existing roadbed and re-contouring to match adjoining grades, reconnection of historic drainage paths to restore hydrology to a degraded meadow, and seed and mulch disturbed areas with native materials.

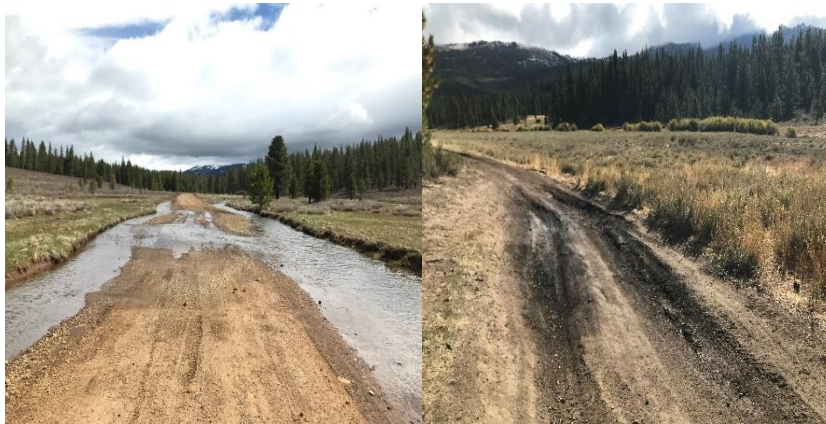
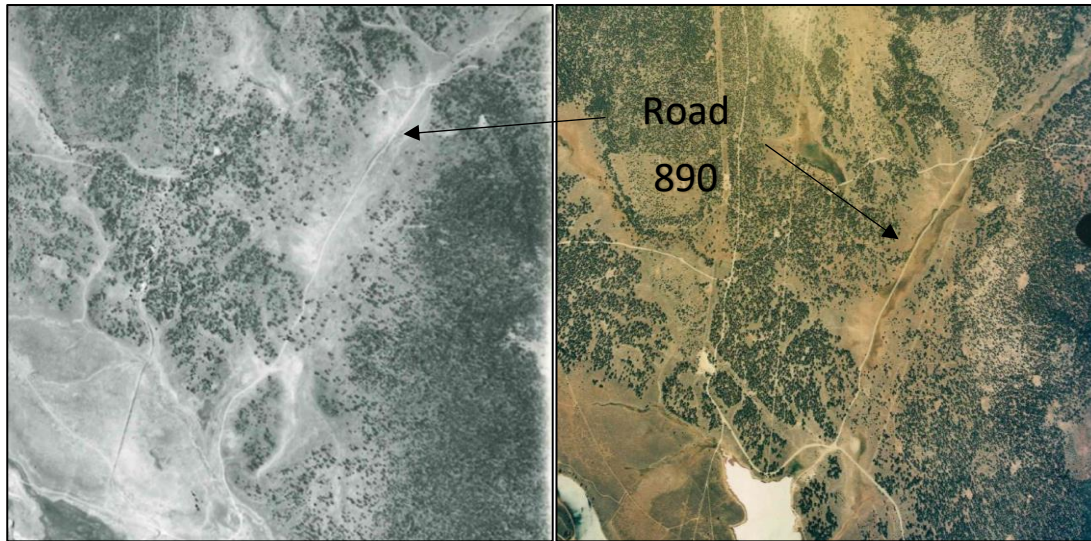
This area is proposed for stream and meadow restoration. The existing county road bisects the meadow and intercepts the west drainage that contributes spring flow down this drainage to the reservoir (Figure 14). It is a seasonal meadow that supports spring blooms of Camas lily, *Camassia quamash*. This meadow is often accessed during the wet season and results in unauthorized OHV trailing the remaining adjacent meadow system.

**Figure 14. Since before 1939, County Road 890 has run through this meadow on the west side of Boca Reservoir, just north of Prosser Reservoir. To help restore the meadow, this road could be rerouted.**
