Excerpt from Tributaries Assessment - Pole Creek

Area/Critical Site 1

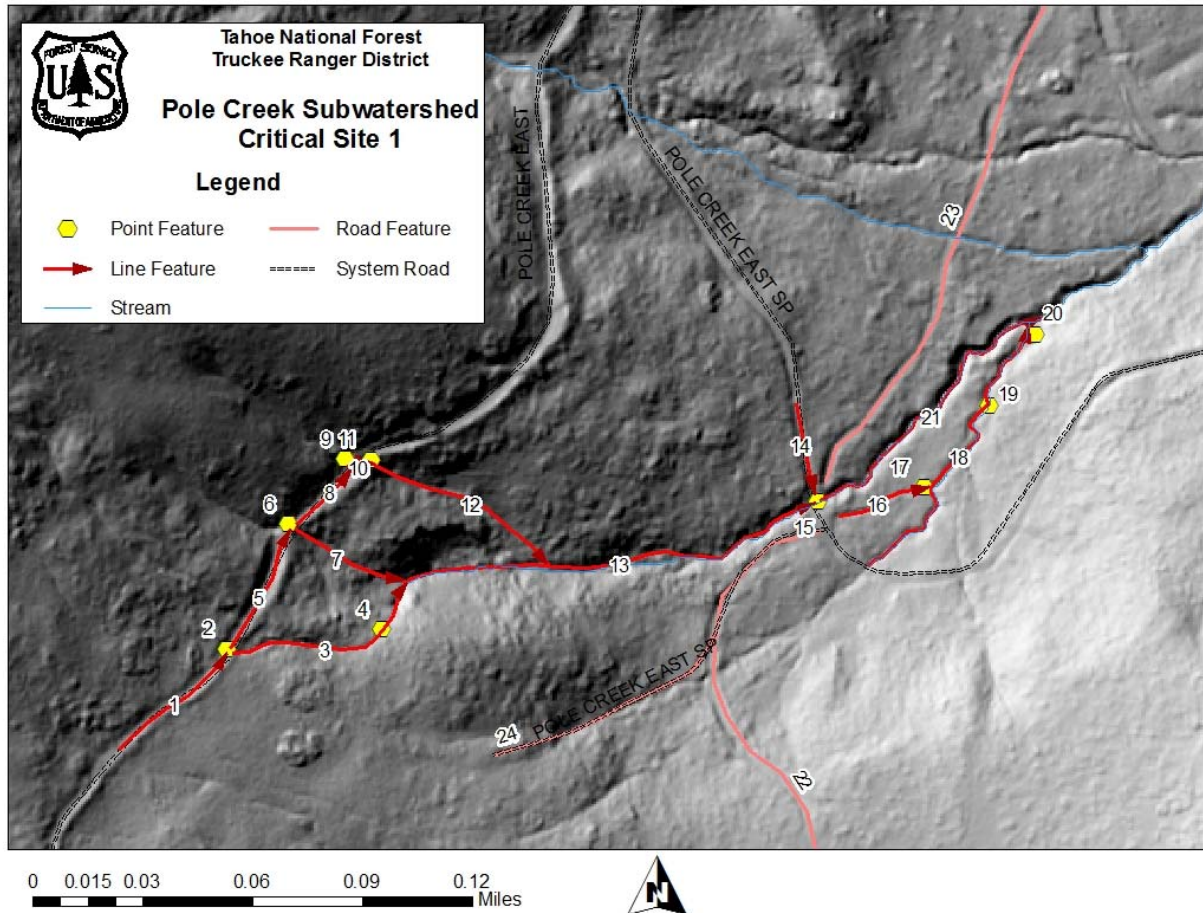
The main feature of this site is a deeply incised channel downstream of a crossing with Pole Creek East Spur Road. Average incision depth is 6ft. Geomorphology suggest this channel is unnatural as it is not the low point in the valley. Another, more stable, channel is found southeast at a lower elevation. There are signs of what may be the original flow path of the incised channel, but the development of the spur roads to the southwest and northeast of the crossing may have caused the relocation of the channel. Discharge in this incised channel has also increased due to the large amounts of road surface runoff entering the channel from the Pole Creek East road found uphill from the crossing. Poor maintenance and placement of road surface drainages have allowed road runoff to accumulate to amounts high enough to incise leadout outlets and adjacent fillslopes. This has allowed unnatural flow paths to lead into the headwaters of the incised channel downstream. Sediment from the erosion of the road and fillslopes enter the channel.

1.1: Road surface runoff from this length of Pole Creek East road accumulates and exits at leadout 1.2.

1.2: Leadout for road surface runoff from 1.1. Runoff is high enough that it has incised the outlet and fillslope, forming a flow path (1.3).

1.3: A flow path in a meadow from accumulated runoff from the Pole Creek East road. This flow path has incised enough to expose bedrock at 1.4. This flow path ultimately feeds the headwaters of the incised channel downstream.

1.4: Bedrock is exposed at this point due to scouring from flow path 1.3.

1.5: Length of Pole Creek East road where runoff accumulates. The runoff drains above the outlet of a stream crossing culvert (1.6), incising around the culvert and fillslope.

1.6: Stream crossing culvert. Surface runoff from the Pole Creek East road flows over the outlet of this culvert, and has been eroding the surrounding fillslope. The outlet now shotguns, giving discharge from the stream more potential energy to scour the channel downstream.

1.7: Flow path of an ephemeral channel with surface runoff from Pole Creek East road. This channel flows into the main incised channel downstream.

1.8: Segment of Pole Creek road that accumulates surface runoff. This runoff flows into a stream that has flowed onto the road.

1.9: Ephemeral channel flows along Pole Creek East road for ~20ft (1.10). The channel and road surface runoff exits at leadout 1.11 and flows into the headwaters of the incised channel downstream.

1.10: Segment of Pole Creek East road where an ephemeral channel flows onto. The channel leaves the road at leadout 1.11.

1.11: Leadout where surface runoff from Pole Creek East road and an ephemeral channel leave the road.

1.12: This channel formed from combined runoff from an ephemeral channel and the Pole Creek East road.

1.13: This channel accumulates flow from multiple flow paths coming off of the Pole Creek East road. Due to the unnatural nature of these flow paths, that amount of water in this channel is above natural. This channel is crossed by the Pole Creek East Spur road downstream at feature 1.15, and becomes heavily incised after crossing the road.

1.14: Surface runoff from this length of Pole Creek East Spur road flows into the channel crossing 1.15, contributing to the discharge of the incised channel.

1.15: Channel crossing for Pole Creek East Spur road. The crossing is a ford that is lined with rocks as armor. Downstream of this crossing, the channel becomes deeply incised. The installation of this crossing may have diverted this channel to create an unnatural flow path, indicated by the high amounts of incision and lack to bank stability.

1.16: Possible channel in which water from the incised channel use to flow naturally in. This channel is topographically lower than the current incised channel. Water would have preferred this flow path, but the installation of the Pole Creek East Spur roads may have forced the diversion of this channel.

1.17: Headcut on the old channel 1.16.

1.18: This natural channel is topographically the lowest point in this valley, indicating it may be the overall preferred flow path.

1.19 and 1.20: Headcuts in the natural channel 1.18 south of the main incised channel.

1.21: The current channel downstream of crossing 1.15. This channel is highly incised with average depths of 6 ft. The slope banks are bare and allow for mass movement into the channel. This channel is unnatural and may have formed due to the installation of the Pole Creek East Spur road crossing and the spur roads to the north and south.

Similarly at the downstream end of the site, waterbars/dips should be installed on the road north of the crossing with the main incised channel to mitigate road surface discharge into the channel. This crossing should be reinstalled to allow the flow path to follow its original natural channel, 1.16. Afterwards, the incised channel should be buried. Multiple headcuts were identified on the original channel and an adjacent tributary to the south. They should be repaired to prevent further erosion.

Spur roads 1.22 and 1.23 should be obliterated. Both spur roads are not listed as Forest Service system roads and have poor access and development for motor vehicle use. The roads have poorly maintained road surface drainages, which is allowing runoff to accumulate on roads, creating erosional features such as rills and incisions at the outlets. The removal of both roads would remediate these issues and return proper overland sheet flow, providing more infiltration time of sediments before entering the nearest channel.

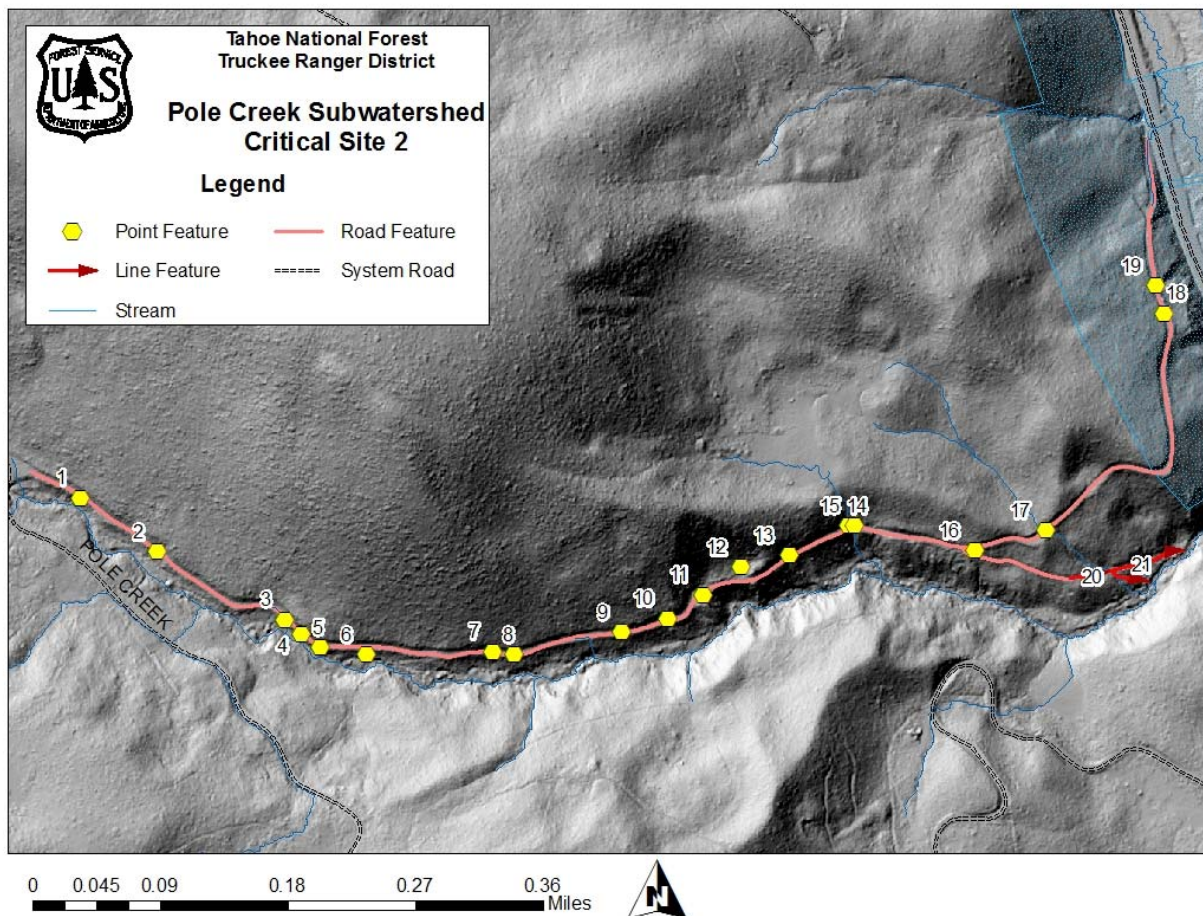
Area/Critical Site 2

This site consists of a decommissioned road found directly north of Pole Creek. This road likely served as another way to access the Pole Creek watershed from Highway 89. The entire length of the road parallels Pole Creek before turning north and running semi parallel to the highway. This road sees no usage from any motor vehicles as access on the west and east end of the road is barricaded by multiple boulders. Due to its status as a decommissioned and unauthorized road, maintenance for its drainage features is nonexistent. Many waterbars and dips are no longer functional, and allow for runoff to accumulate to high amounts. This has allowed the formation of rillings on the road, and incision at leadouts and fillslopes. The eroded sediment from the roads and fillslope are allowed to flow directly into Pole Creek due the short length of buffer. A portion of the road appears have been built on the toe of a landslide, with the fillslope consisting of the moved mass. The road may have allowed for a washout event, causing a large amount of the fillslope to fail and deposit into the channel.

2.1 and 2.2: Leadout catching excessive amounts of runoff from road. Incision at the outlet and fillslope occurs.

2.3: Fillslope is failing and has exposed and bare soils.

2.5: Fillslope is failing and has exposed and bare soils.

2.6: Fillslope material appears to have failed and collected at the slope base and in the channel.

2.7-2.10: Leadout catching excessive amounts of runoff from road. Incision at the outlet and fillslope occurs. Fillslope is failing.

2.11: Segment of road built on toe of a landslide. A washout event may have allowed mass failure of the fillslope. Mass amounts of fillslope is no longer present and has left the remaining fillslope with low vegetation and bare soils.

2.13: Failing cutslope. Mass movement is collecting on road.

2.19: On private property. Fillslope is failing and exposing bare soils.

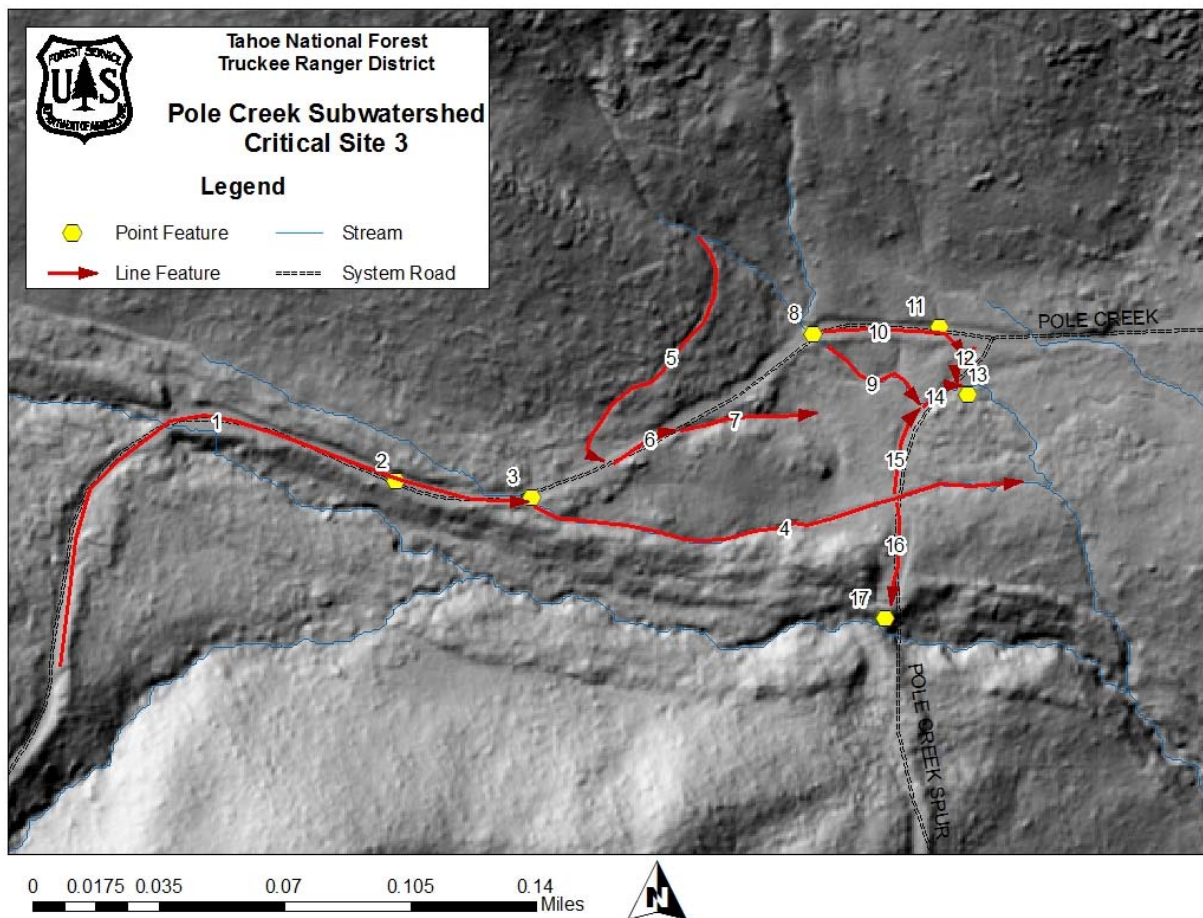
Area/Critical Site 3

This site is found off Pole Creek road, in the northwest section of the watershed. It exists due to an old spur road built across the western end of the meadow in this area. The road is no longer used, but has caused the diversion of natural flow paths in this meadow. Pole Creek road connects to this spur road and contains poorly placed or failing drainage structures. These poor drainage structures have allowed excessive runoff to enter the vicinity of the spur road, furthering the development of unnatural flow paths here. The spur road continues south to a crossing. At another point in time, this crossing was functional and allowed the spur road to continue south. That crossing has been removed since, and now is being incised by the natural channel flowing here. The banks at this crossing are bare and exposed. A section of the spur road slopes toward the channel, allowing road runoff to enter the channel at this crossing. Continued existence of these problems will allow further incision of the channel at the crossing, erosion and formation of nick points in the meadow, and sediment to deposit in the meadow and in the channel.

3.1: Length of Pole Creek road where runoff is not drained off properly. Road runoff accumulates due to the lack of functioning waterbars or dips. The accumulated runoff exits out through dip 3.3, where it has created an unnatural drainage (3.4).

3.2: Location of a failed dip along the length of 3.1.

3.18: Fill placed in channel to provide for road crossing at west end of the Pole Creek Spur road. 3.18 is found further west on Pole Creek road from the rest of the features.

Further west on Pole Creek road, the road again crosses the same channel incising the fill of feature 3.17. A similar problem exists where fill was placed into the channel to allow for a road crossing. Currently, the fill appears to be stable due to the large amount of established vegetation here. There are currently no proposed action for this feature as remediation might be more detrimental than leaving it in its current condition. Further monitoring will continue to ensure its stability and/or determine a proposed action when it is deemed beneficial.
