Boca Watershed Assessment

**USDA Forest Service
Tahoe National Forest
Truckee Ranger District
2020**

Prepared by
Sharon Falvey, Lindsay Ryan, and Rachel Hutchinson

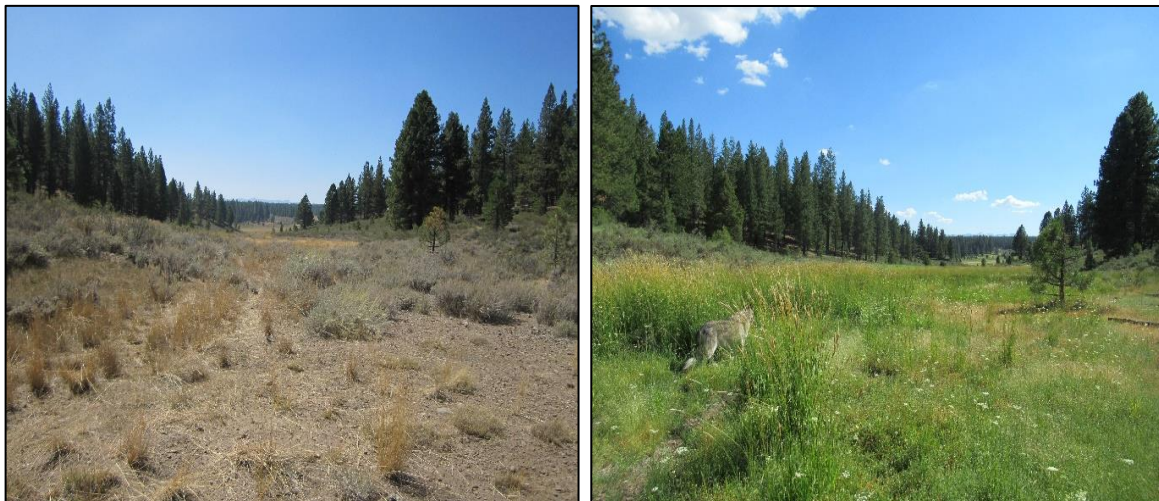
Figure 13. Site 4 of the Dry Creek Restoration project was completed in 2016. Before (left) the meadow was dominated by sagebrush. In 2019 (right), wet vegetation had taken over the meadow.

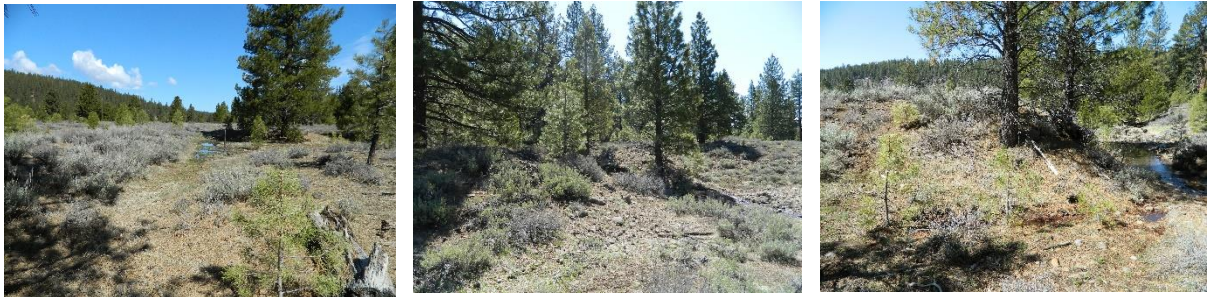
Sunrise Meadow Restoration HV-A

This site will improve hydrologic connection of 21 meadow acres, 750 feet of stream channel, and improve hydrology for 4.5 acres of aspen habitat. Implementation actions at this site may include protecting and expanding existing meadow habitat by re-routing a road that bisects the upper edge of a meadow and reconnects hydrology across the restored road surface. Restoration actions will include importing material to restore topography and soil conditions in decommissioned road segments and compacted sites. Additional measures include the development of a re-routed road segment outside of sensitive areas, restoring the decommissioned segment of the existing roadbed and re-contouring to match adjoining grades, reconnection of historic drainage paths to restore hydrology to a degraded meadow, and seed and mulch disturbed areas with native materials.
