Euer Valley Meadow

Baseline Stream Condition Inventory Summer 2020

Report prepared by: Sabra Purdy, Trout Unlimited
On Behalf of the Truckee River Watershed Council
May 15, 2021

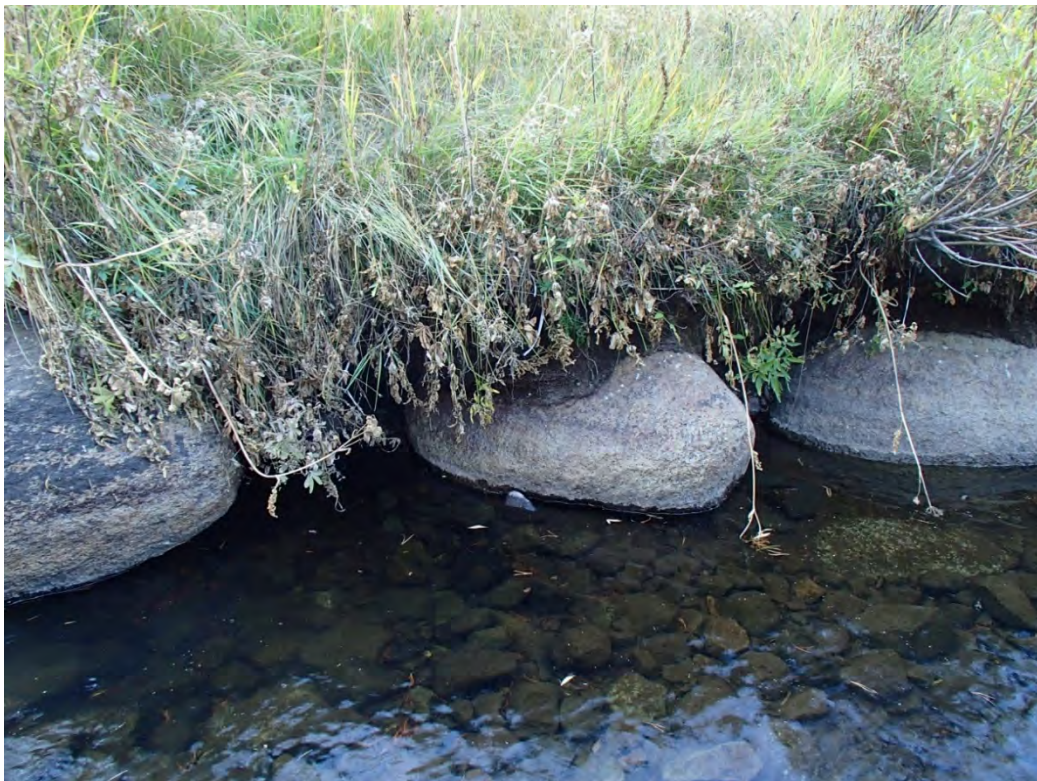
Figure 13. Remnants of the glacial history at Euer Valley provide structure and stability for vegetation to get a foothold as well as providing excellent cover and velocity refuge for fishes at higher flows

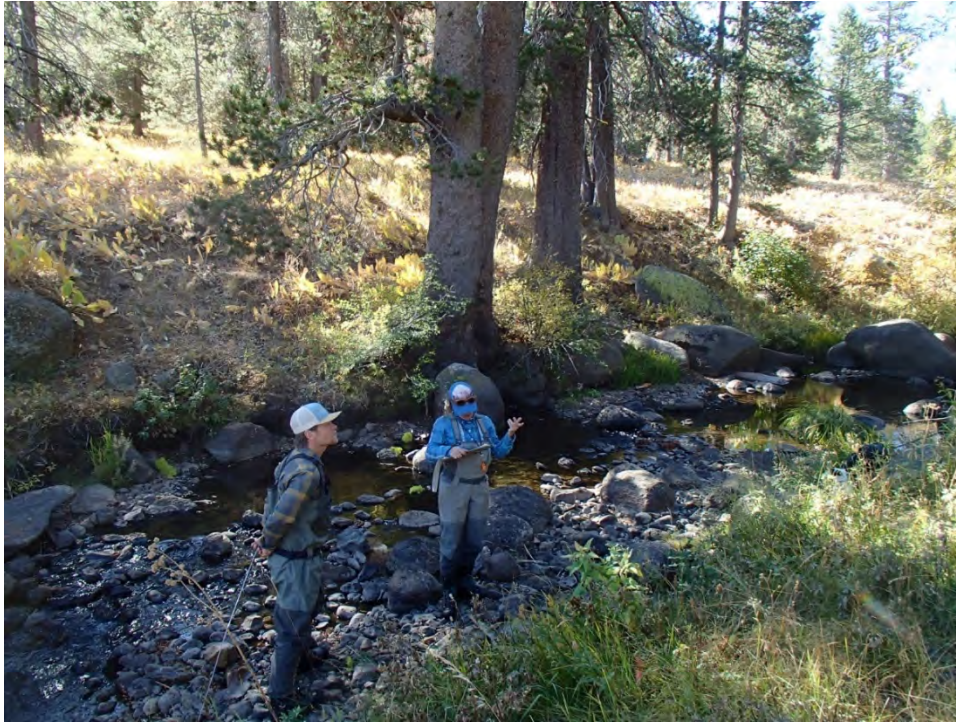
Figure 14. The channel cuts into the moraine on the right bank. Conifers shade the stream and provide potential for large wood recruitment in the future.

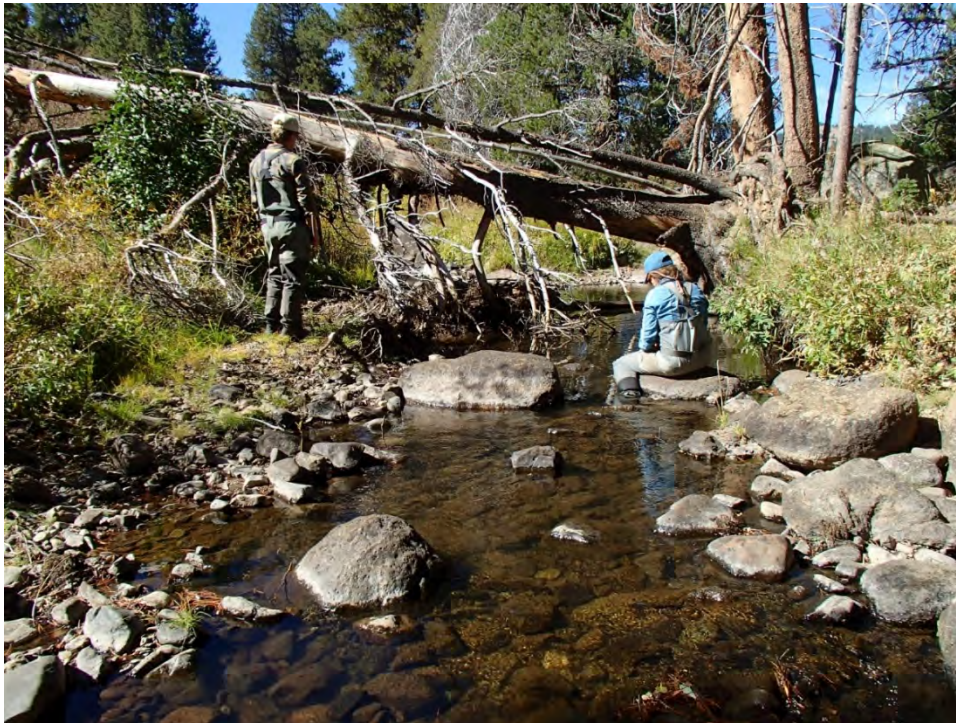
Figure 15. Large wood falling into the channel provides essential structure, hydraulic diversity, and scour and deposition.

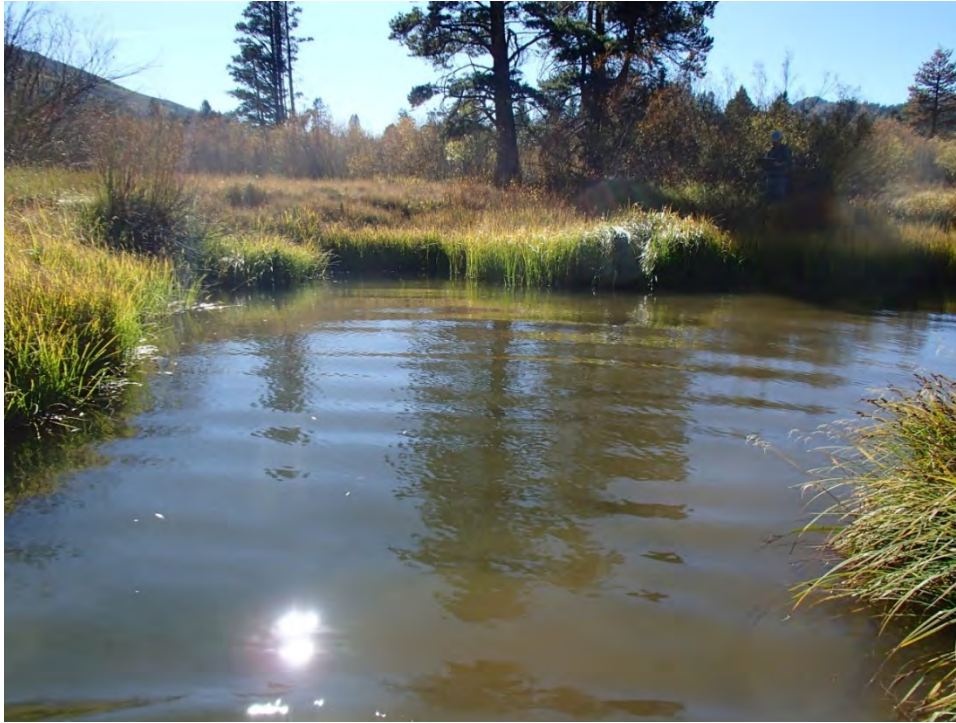
Figure 18. An area of complex habitat formed upstream of a now-breached beaver dam with lush sedges and emergent vegetation, side channels and backwater habitats, and well-developed undercut banks.

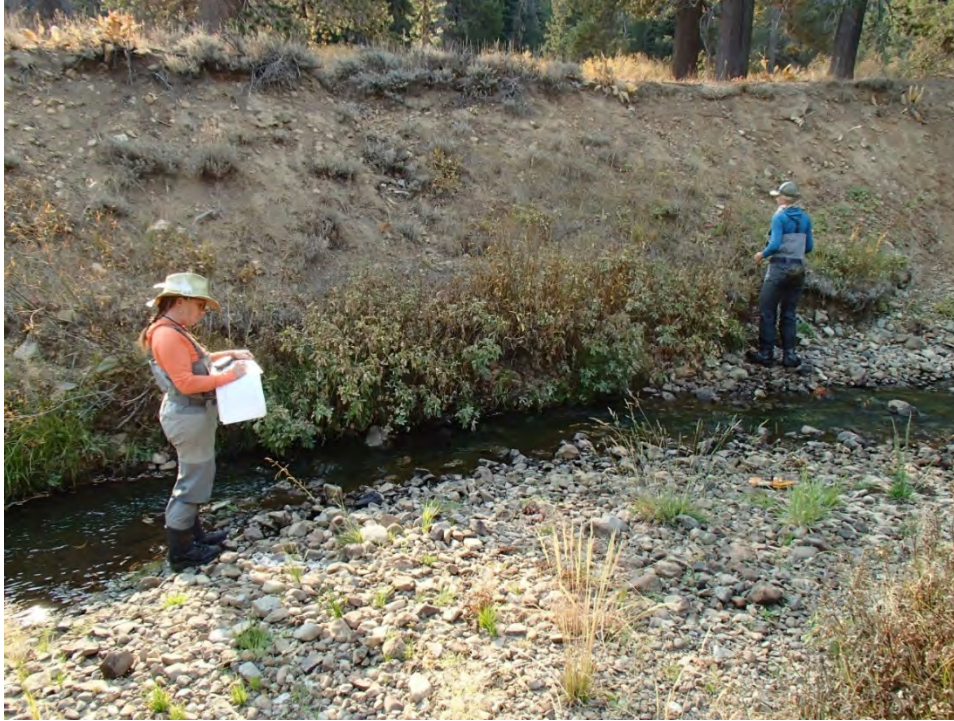
Figure 20. The channel cutting into the toe slope confines the stream on the right bank but provides opportunities for wood and sediment recruitment.

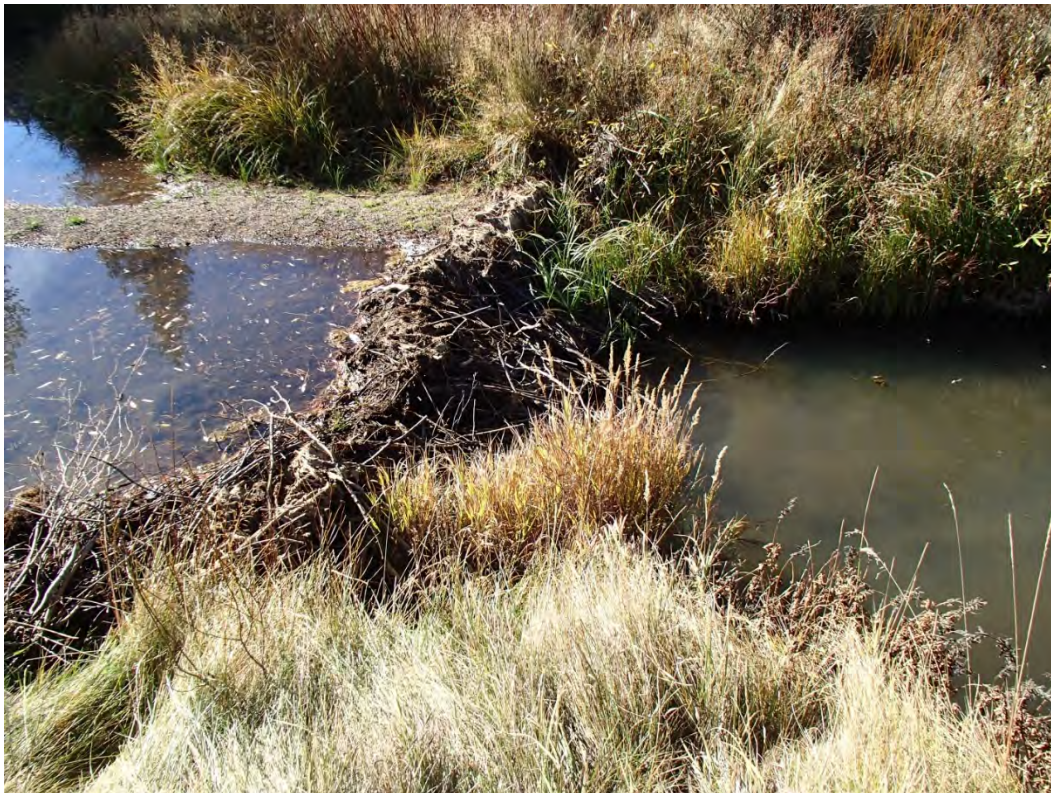
Figure 21. A small beaver dam on a side channel aggrades sediment and raises the water table. Fine sediment deposition encourages obligate and facultative wetland plant recruitment.

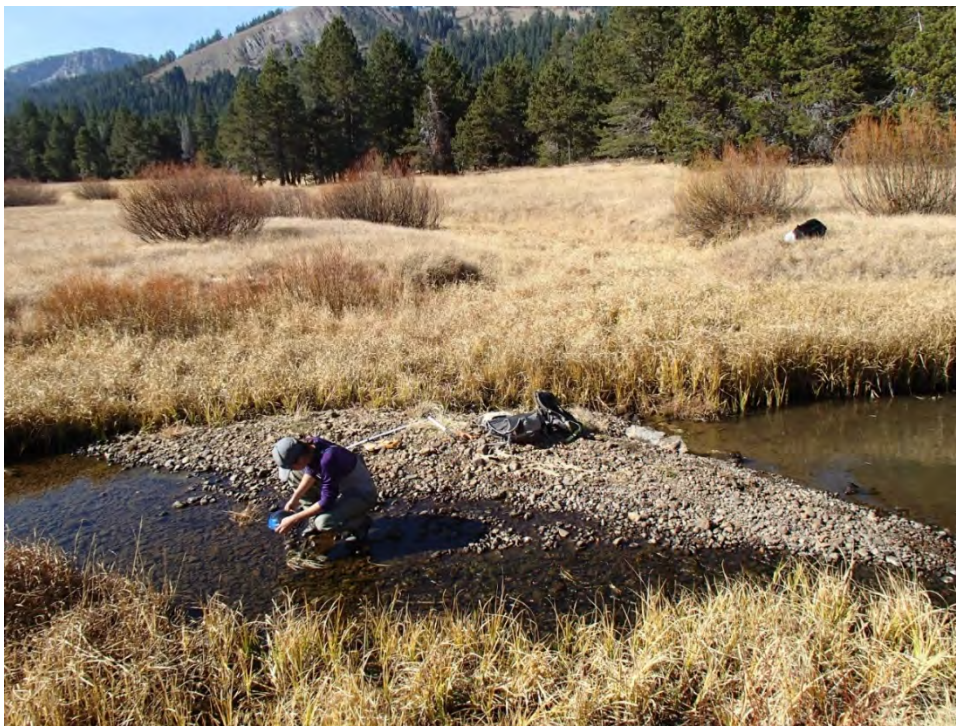
Figure 33. A gravel bar formed at the location of an old beaver dam with long established emergent marsh and relic channel in the background.

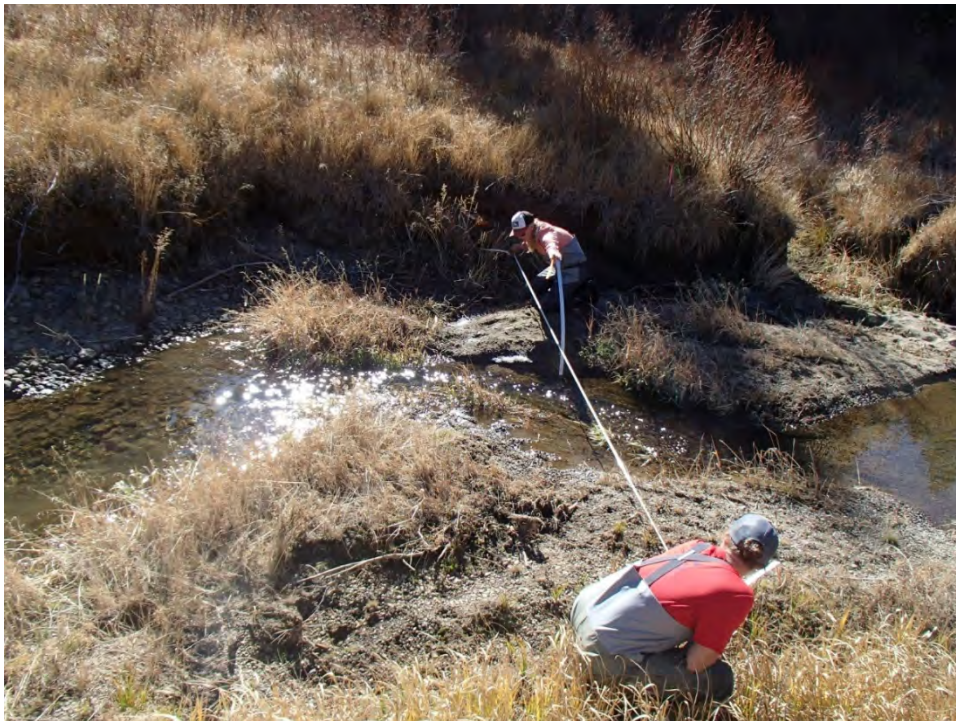
Figure 35. Riffle formation over old beaver dam remnants.
