Euer Valley Restoration Project

90% DRAFT Design Basis Memorandum

Revised November 29, 2022

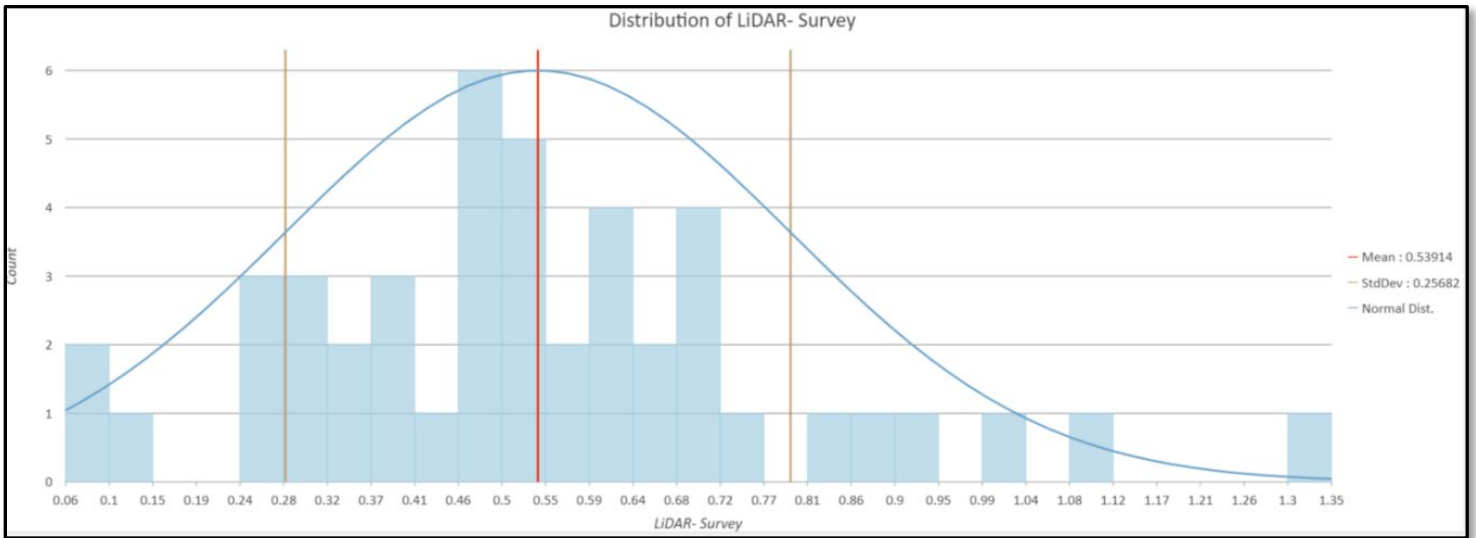
Figure 3. Distribution of the difference between the LiDAR and RTK Field Survey for 45 points collected on the trail.

Differences were observed between the field survey data and the LiDAR data where they overlapped. To determine the cause of these discrepancies Wildscape staff confirmed the field data collected and the OPUS solution for final coordinates, and then compared the field survey topography to the LiDAR topography for areas with no vegetative cover. These areas of bare ground allowed Wildscape to compare survey elevations to LiDAR elevations without the interference of vegetation. Vegetation can cause considerable error in LiDAR data collection since the airborne laser will intercept the vegetation never reaching the ground surface. This is especially true in areas of thick cover such as the dense meadow graminoids (dominated by species of *Carex*) encountered at the project site. The technical report for the 2014 USDA Tahoe National Forest LiDAR data was also reviewed and it was learned that the 2014 collection was not compared to field collected survey elevations but was compared to the previous LiDAR collection where the two data collections overlapped, with the resulting reported "accuracy" in the range of 0.16 to 1.15 ft. Given this range, a mean difference of approximately 0.5 ft on trail edge and center (Figure 3) is well within the error of the LiDAR. In summary the LiDAR data is not necessarily more accurate than the field survey data and the differences can be rectified by either adjusting the survey data to match the LiDAR data or adjusting the LiDAR data to match the survey data.

This adjustment step was not taken during the initial hydraulic model set up in order to expedite results using the LiDAR topographic data set only. It may be a beneficial exercise to merge the two data sets, however given the dense meadow vegetation had skewed the LiDAR data to be inconsistently higher in elevation than the field survey data and the LiDAR data set was reported to have a fairly wide range in "accuracy" from 0.16 to 1.15 ft per the technical report, it would likely be a challenging and time consuming effort. This combined with the lesser need to design for increased channel overbanking per reasons described in later sections and budget limitations the field survey data was not merged with the LiDAR and instead used in design development and as a "check" on the channel size, shape, and slope. Modeled water surface and overbanking may be slightly higher and sooner respectively given the LiDAR data did not always show the full depth of the channel and velocity and shear in the channel may be slightly lower than actual given containment in the

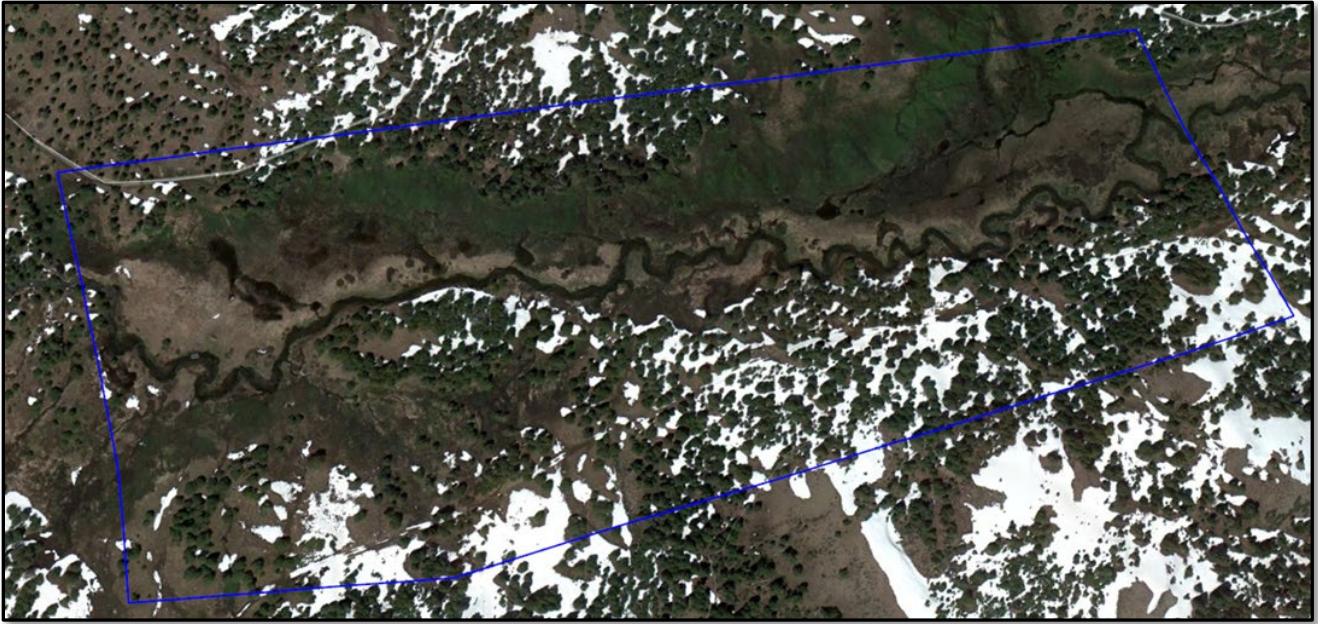
Figure 6: Euer Valley meadow June 2011 aerial image (Source: Google Earth). Note the surface water in the swales likely fed by springs while the immediate area along the creek does not appear to have any sustained saturation by an overbanking event.

The valley floor in the study area consists of a meadow floodplain. The meadow receives abundant hydrologic support from groundwater migration from the valley sides, although this appears to be primarily associated with the north side of the valley. **This level of inflow is so substantial that there are a number of seeps and small spring-fed ponds that persist well into the growing season (Figure 5). This groundwater inflow provides for a remarkably high level of vigor in the meadow vegetation.** Aerial photographs taken during the end of the snowmelt period show the “greening up” of the meadow while the immediate vicinity of the creek has not yet responded. This

indicates that the primary hydrologic support of the meadow is lateral subsurface inflows, as opposed to overbank flooding from the creek. However, aerial photographs taken later in the growing season, July, and August, does show uniform green conditions, even along the stream itself indicating that the condition of the stream is not adversely affecting the vigor of the meadow (Figures 6 and 7). In fact, groundwater migration toward the creek may indicate that the stream is a gaining reach within the study area, i.e., the meadow may be supporting the stream as opposed to the stream supporting the meadow.

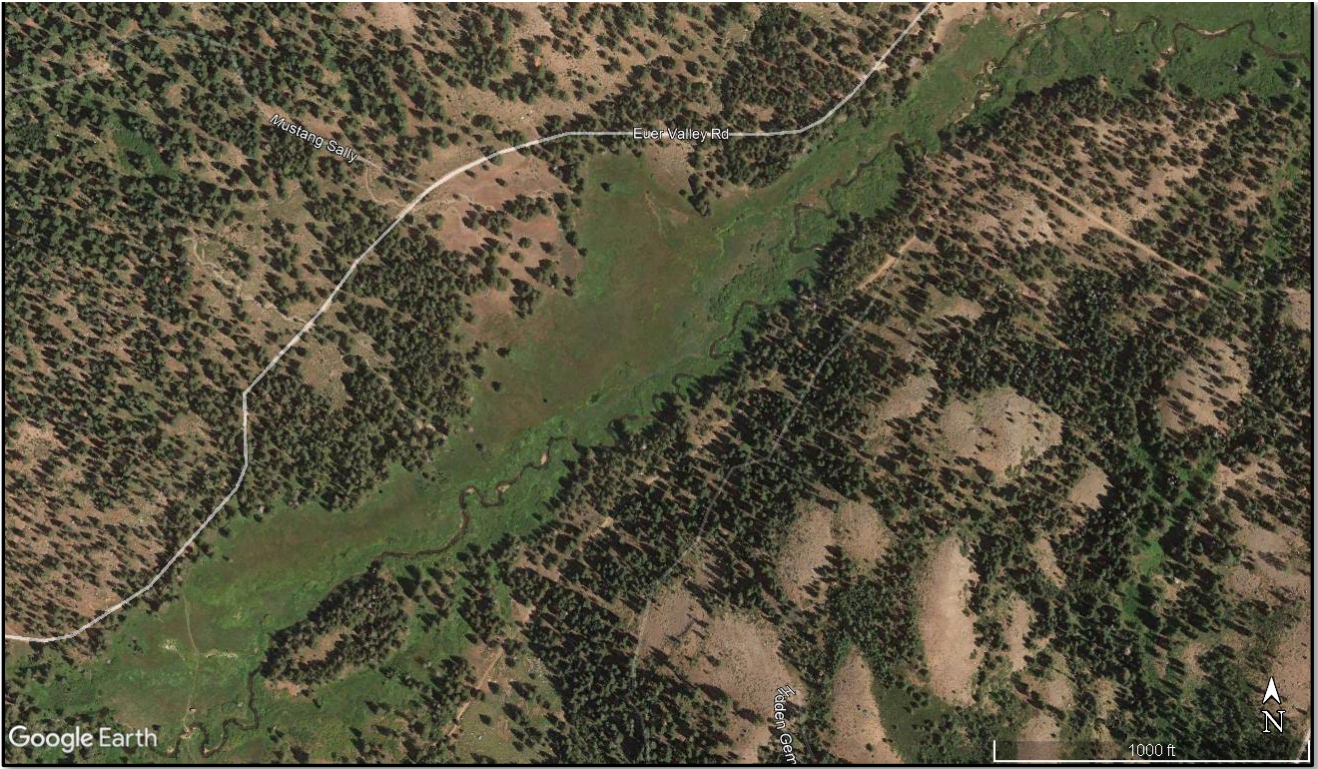
Figure 7. Euer Valley meadow August 11, 2017, showing actively growing vegetation throughout the meadow.

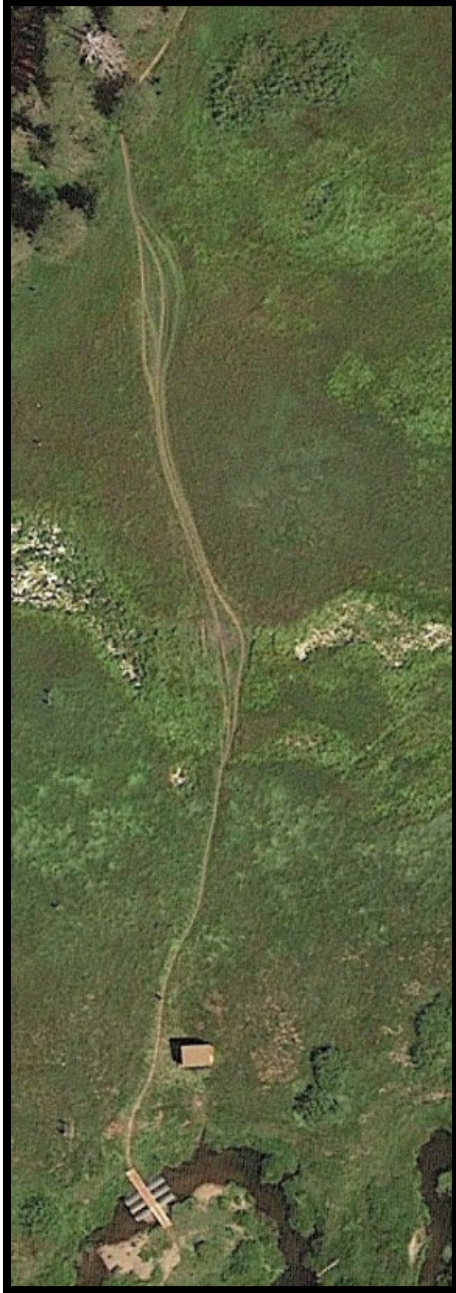
Figure 10. North side of Coyote Crossing Trail showing clear signs of braiding at locations of spring fed swales, August 2017 (Google Earth)

Due to the persistent standing water well into peak recreation months, multiple volunteer trails are formed (Figure 10). This is especially apparent where it crosses the spring fed swales as recreationists avoid getting their feet wet. This behavior likely exacerbates erosion in the saturated meadow area, compacts soil, and stunts vegetation growth within the vicinity of the existing trail alignment. TDA has indicated disturbance by equestrians is especially concerning and would like to discourage equestrians from fording the river at locations other than a developed crossing. Coyote Crossing is a key part of TDA's existing trail system because it is the only crossing on the South Fork Prosser Creek until the access road, Alder Creek Road over 2 miles to the East. There is a warming hut, i.e., Coyote Hut, just northwest of Coyote Crossing that is primarily used by cross-country skiers in the winter season.

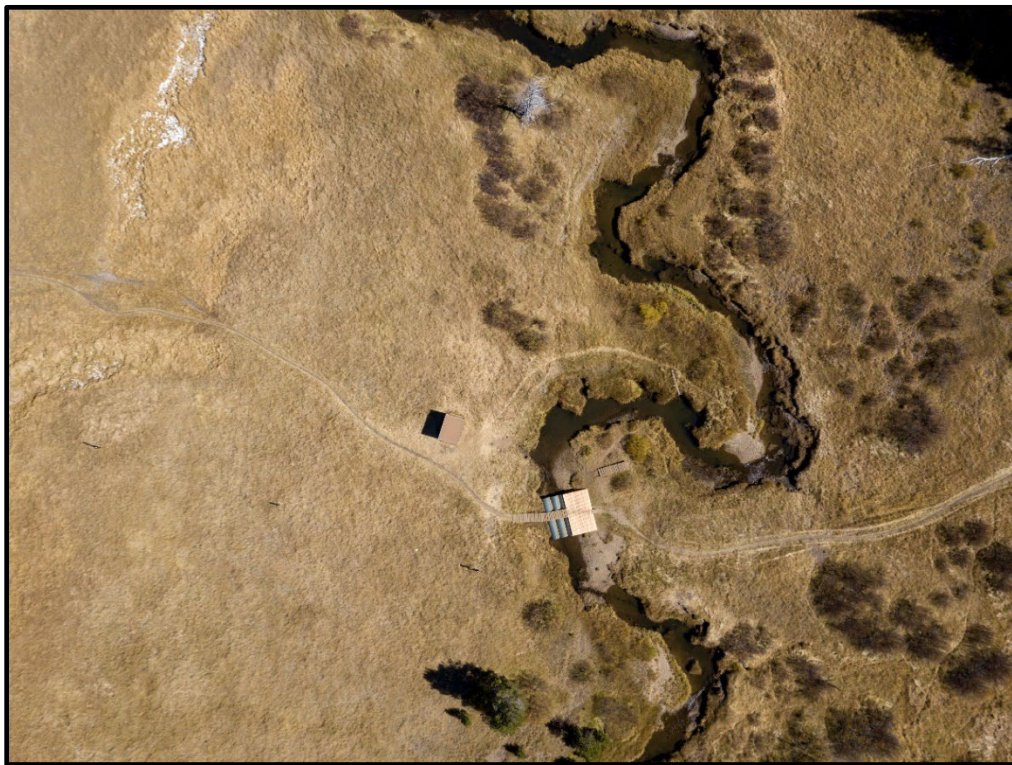
Figure 12. View of existing culverted crossing (Coyote Crossing). (Source: TDA Drone Footage)

The existing creek crossing (Coyote Crossing) consists of 3 CMP culverts covered by an anchored wooden walkway and a constructed access ramp which allows summer and winter recreationists and groomers to cross (Figure 12). As a result of the spring fed swales, the north trail approach to the culverted crossing remains saturated with persistent standing water often into July making access difficult and detrimental to the wetland surface.

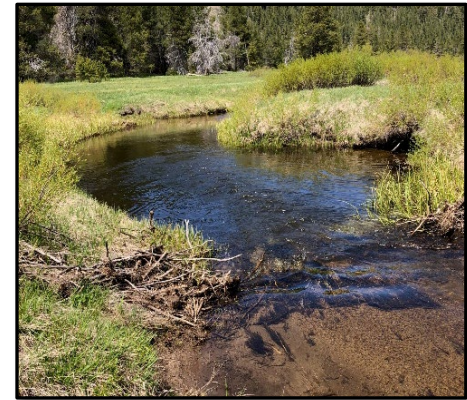
Relic Beaver Dam Grade Control

2-year event

STA	WSE	LEFT FP VELOCITY	RIGHT FP VELOCITY	CHANNEL VELOCITY	LEFT FP SHEAR	RIGHT FP SHEAR	CHANNEL SHEAR
48+05	6521.93	0.5-0.75	0.3-0.6	0.45-0.65	0.01-0.03	0.01-0.03	0.01-0.03
48+65	6521.21	1.5-2.7	0.4-1.1	0.1-0.5	0.1-0.4	0.01-0.04	0.01-0.10
49+67	6521.16	1.6-2.0	1.0-1.8	1.8-2.1	0.09-0.12	0.04-0.1	0.10-0.14
50+24	6521.11	1.5-1.7	0.7-1.3	1.3-1.7	0.09-0.12	0.01-0.07	0.07-0.12

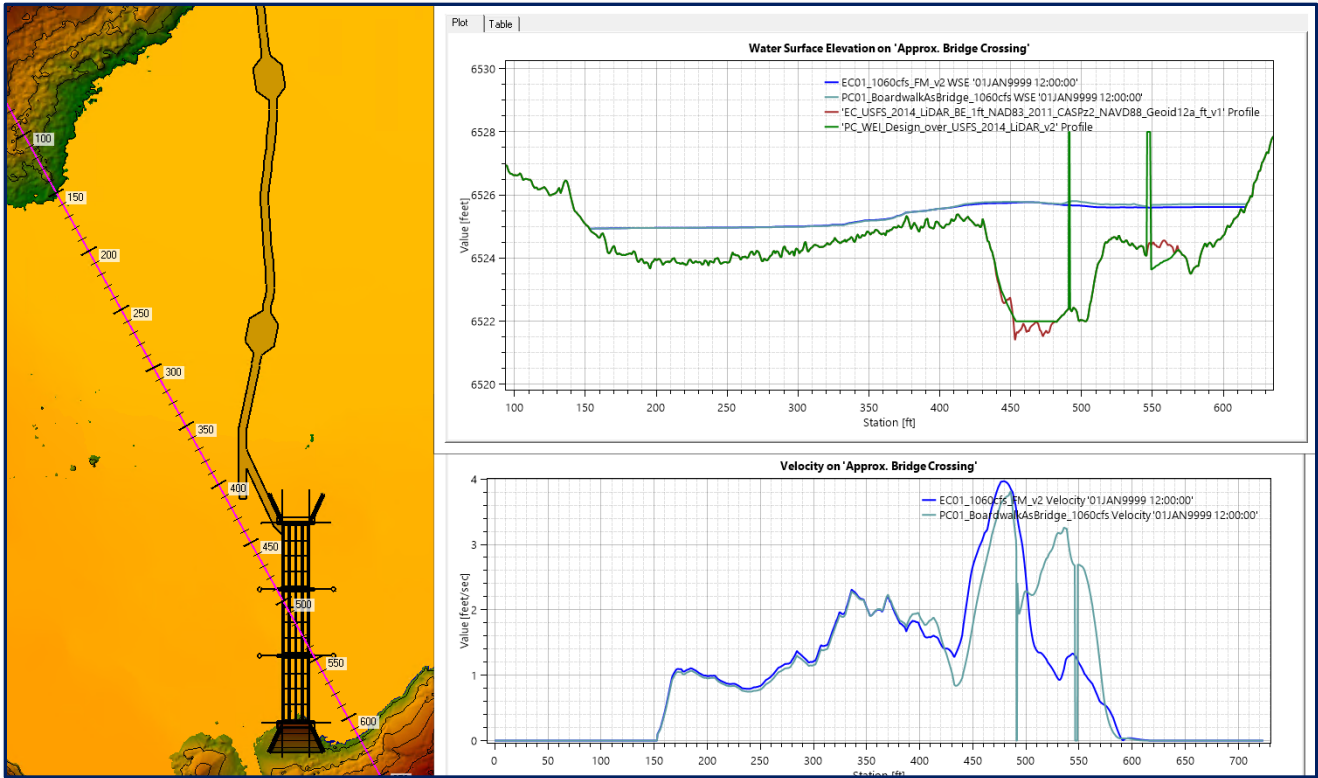
Figure 20. Cross-Valley Profile 100-year Water Surface Elevation and Velocities

The higher velocities in the vicinity of the bridge remain 4 fps or less for proposed. There is a noticeable shift in higher velocity values in the area of the lowered right bank floodplain of up to 3.2 fps between existing and proposed.

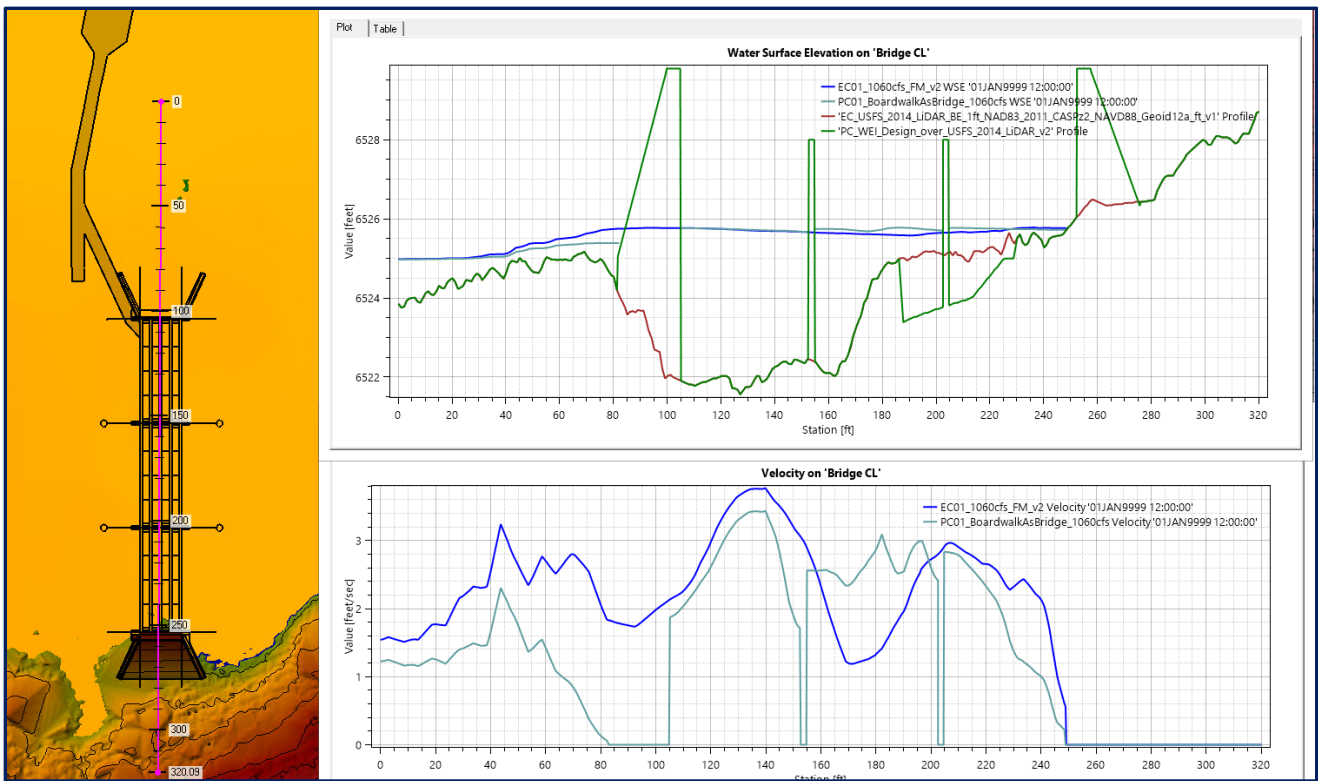
Figure 21. Bridge Centerline Profile 100-year Water Surface Elevation and Velocities
