# Boca Unit Restoration

## 90% Design Basis Memorandum

Wildscape Engineering, Inc.  
1901 Lisa Maloff Way, Suite 108  
South Lake Tahoe, CA 96150

Revised January 13, 2022

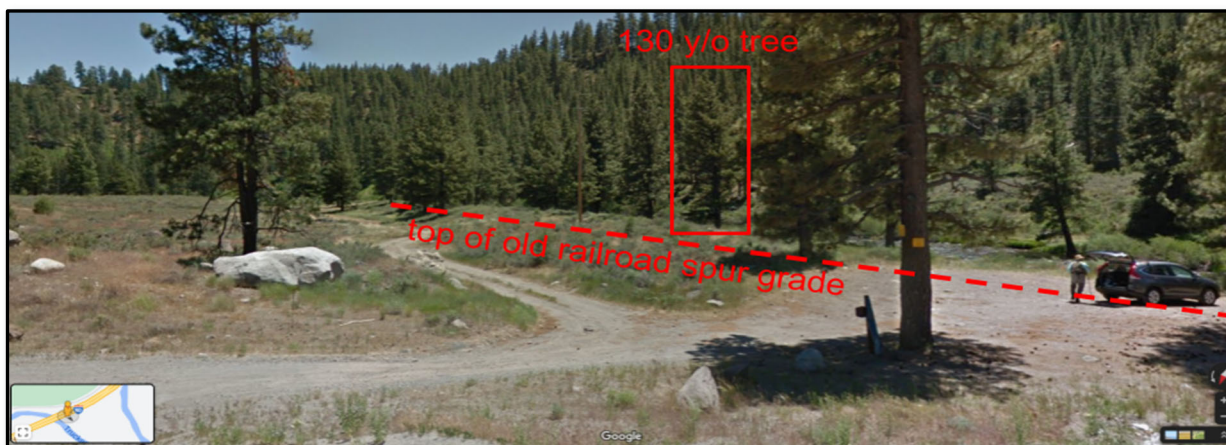
**Figure 3.** June 2018 photo showing former railroad spur and approximate size of ring dated tree (Google Street View, 2020)

operation of the Nevada Ice Company from 1872 to 1875. And the third was The Pacific Shingles Company in 1874 (Balance Hydrologics, Inc. et al 2018). The general location of these facilities is shown in Figure 2. The most significant land manipulation during this time was construction of the railroad spur extending south along the left bank (looking downstream) of the Truckee River. The spur was most likely constructed during the operational years of the Nevada Ice Company, from 1872 to 1875 (Balance Hydrologics, Inc. et al 2018). The railroad spur grade (Figure 3) can still be observed today where conifers

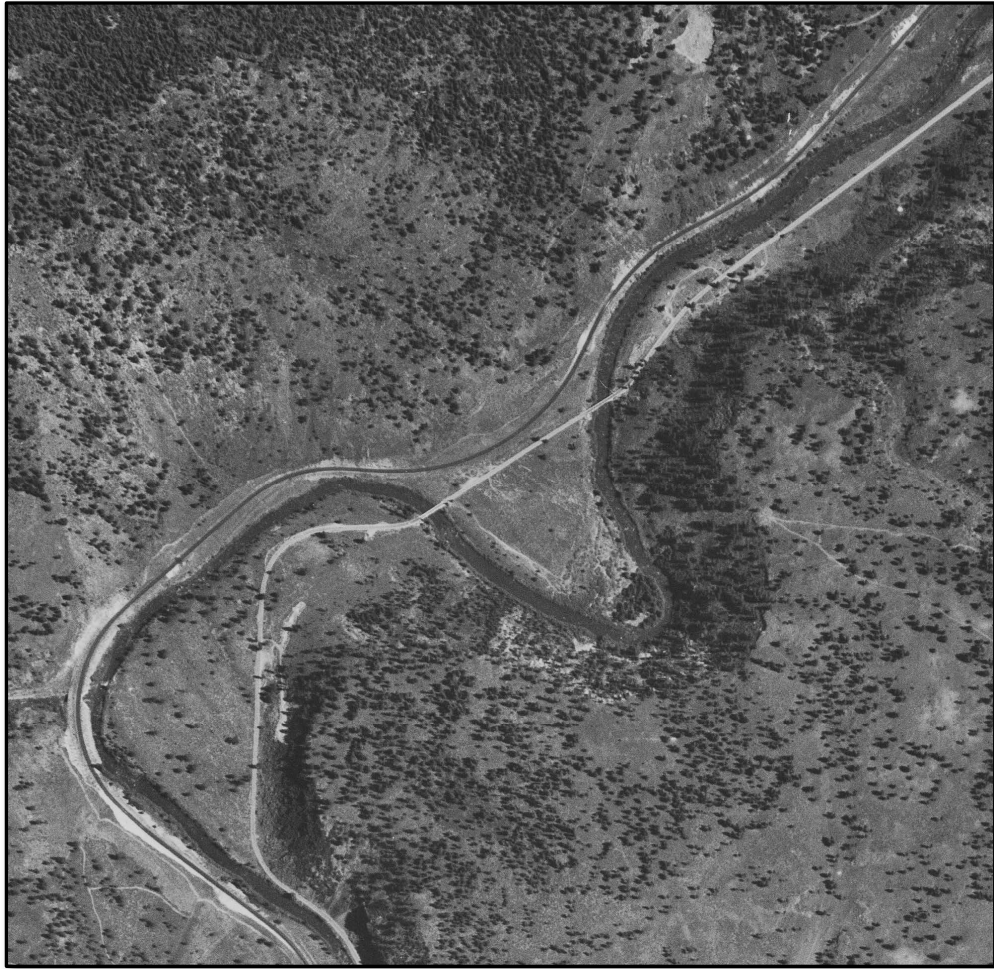
**Figure 5.** June 1, 1948, photo image showing Victory Highway and railway infrastructure at Boca Site (*Source: USGS Photo Aerial Single Frames*)

Major roads transecting this site also impacted local topography and sediment inputs to the Truckee River. In and around the Boca site it started with the Dutch Flat Wagon Road in 1864, the Lincoln Highway in 1913 (later named the Victory Highway in 1921), and present day Interstate 80 completed in 1964 (Figures 5 and 6). Interstate 80 and its precursors impacted the site by straightening the channel upstream from the bend, likely leading to higher shear forces on the bank (Balance Hydrologics, Inc., 2018). Today, vehicle access (Figure 7) to the river, which remains a popular fishing spot, compacts soils and limits vegetation growth thereby producing direct sediment loads to the Truckee River (Balance Hydrologics, Inc., 2018). The most recent structural changes to the river channel at Boca were constructed by Trout Unlimited in the fall of 2018 to improve available habitat for large adult fish and fishing opportunities. Three separate boulder structures configured in a 'W' pattern were installed across the river channel on the west side of the bend staggered evenly between the I-80 crossing and the beginning of the bend (Figure 8). The channel habitat structures installed at Boca by Trout Unlimited was part of a larger project, the Glenshire Drive Project. Coincidentally, the second phase of this project installed habitat improvement structures just downstream of the other TRWA site, Polaris, in the fall of 2020.

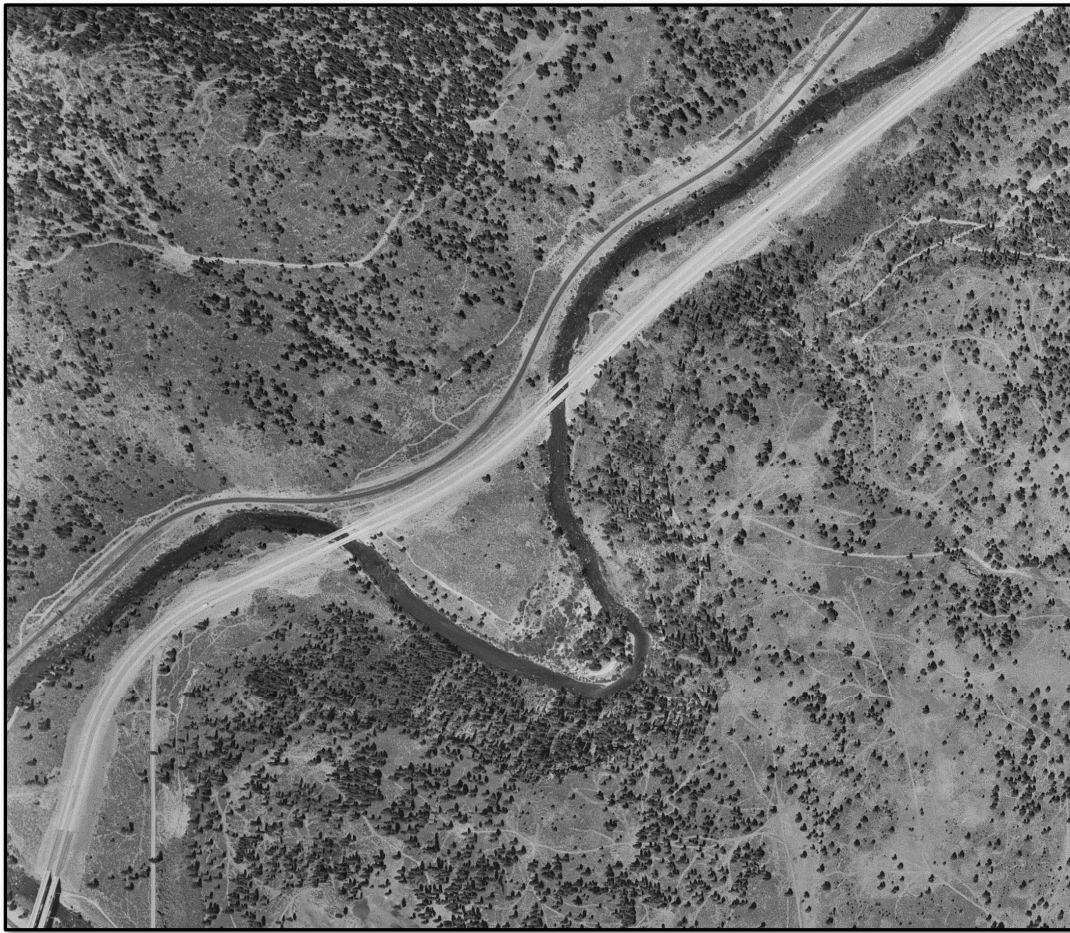
**Figure 6.** August 16, 1969, photo image showing Interstate 80 construction completed at Boca Site (*Source: USGS Photo Aerial Single Frames*)

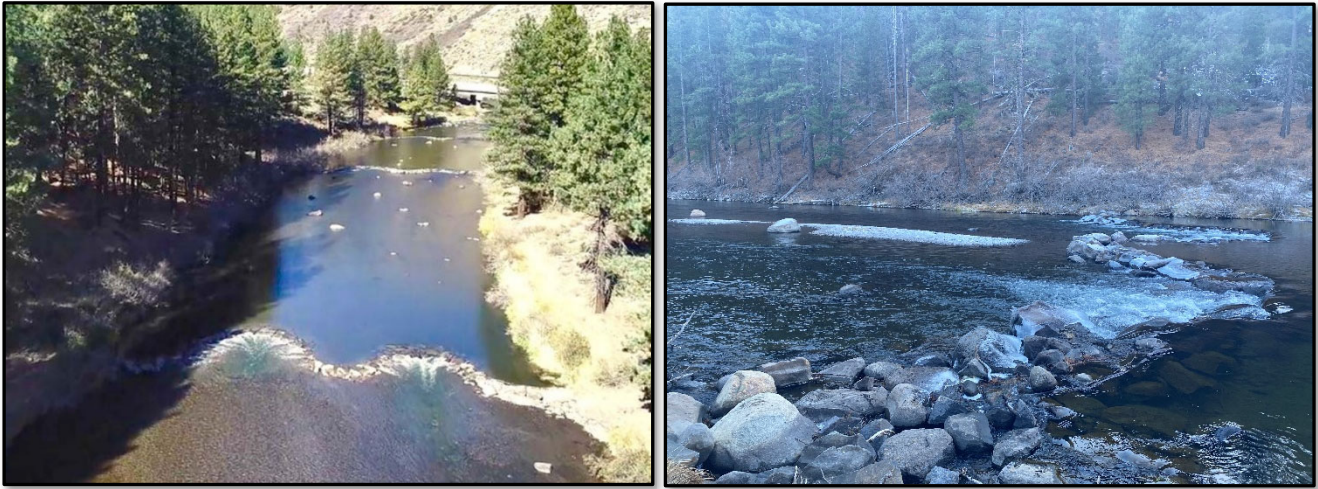
**Figure 8.** (Image left) Drone footage of series of three W-weirs looking upstream (Trout Unlimited). (Image right) Photo of W-weir taken from left bank looking S/W taken December 2020.

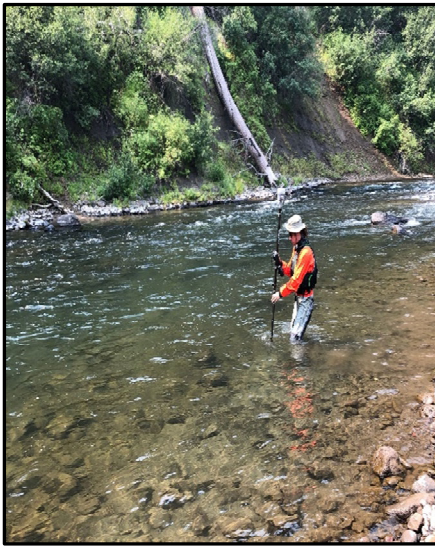
**Figure 9.** Collecting additional bathymetric data in deep water areas August 12, 2021.

hydraulic modeling and design. Flows during the 2020 field survey were too high to safely collect data in the deeper pools, therefore additional bathymetric data was collected in those areas in late summer 2021 when flows were reduced. The data processing just described was repeated and the newly updated surface is being used to further refine the hydraulic model (Figure 9). This result is considered best available data.

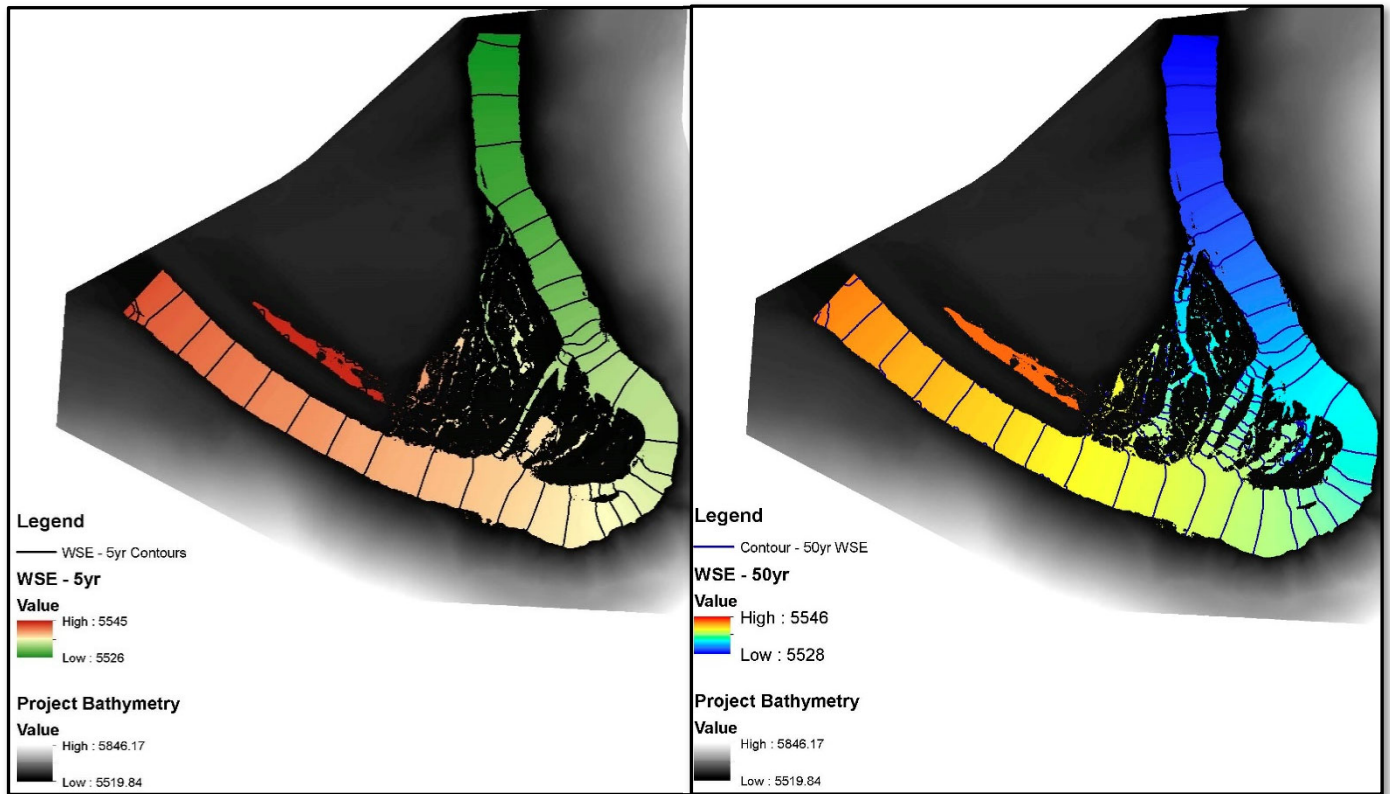
**Figure 11.** (Left image) Existing conditions 5-yr recurrence event water surface elevation (Right image) 50-yr recurrence event water surface elevation.

Preliminary (30%) results of existing conditions showed flows from the 2-year event are generally contained entirely within the main channel. At a 5-yr recurrence event beyond the artificial berm the lower floodplain overflow channels are beginning to be activated (Figure 11). During the rarer larger flood events, unsurprisingly the entire suite of secondary channels within the inside bar are inundated. The upper terrace and berm/borrow area are not inundated even at the more extreme flood events, including the 100-yr recurrence event. It should be noted the water surface that shows up in the borrow area in Figure 11 is simply residual from the model set up showing a draining phenomenon rather than an overbank occurrence.

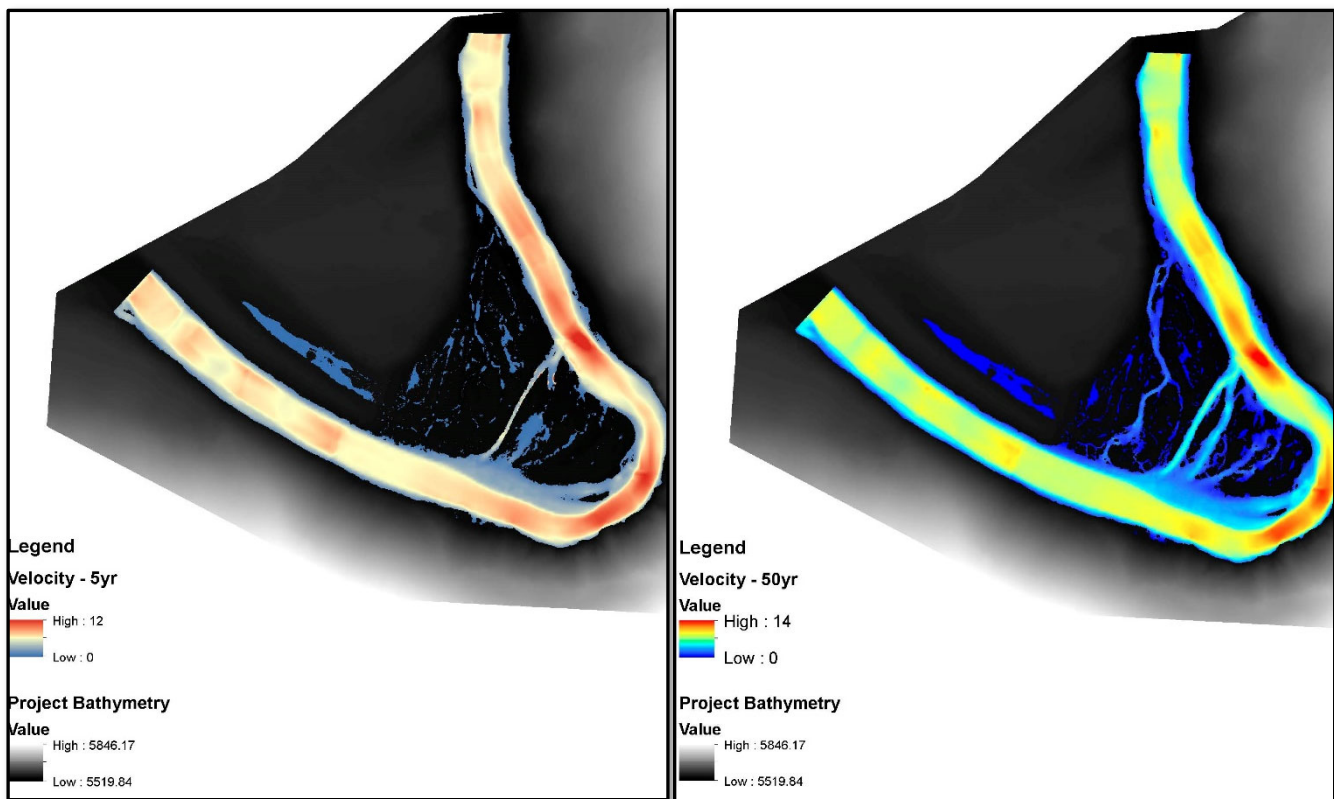
**Figure 12.** Existing conditions, velocities under a 5-yr (image left) and 50-year (image right) recurrence

Also notable are the high velocities which equate to high shear forces within portions of the channel (Figure 12). During the 5-yr and 50-yr events mid to high velocities appear throughout the channel reach with the highest values, 12 to 14 feet per second (fps) within and downstream of the outermost bend. Under the 5-yr event the floodplain secondary channel along the toe of the terrace slope starts to undergo increased velocities while the other secondary overflow channels remain low. Under a 50-yr event the same floodplain channel plus the one adjacent start to see increased velocities while the other overflow channels remain low.

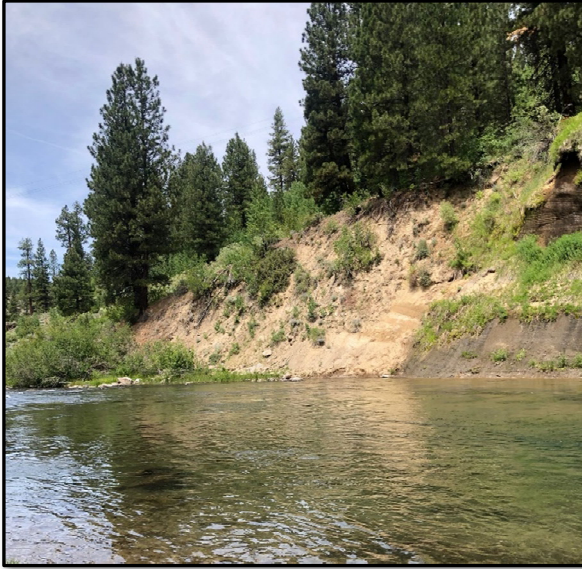
**Figure 13.** Right bank section with erodible layer (lighter colored material) still intact bordered by stable hardpan section upstream and protected by vegetated floodplain bench downstream.

- Given the height and steepness of the right banks in the erosional areas there is risk of causing further instability during installation.
- In the downstream location only a short bank segment remains with the more friable material still vulnerable to future erosion (Figure 13). The amount of erosion and sediment production prevented by installing a bendway weir upstream of this area may not be much more than the amount of sediment disturbed during installation of the temporary river diversion and the bendway weirs.

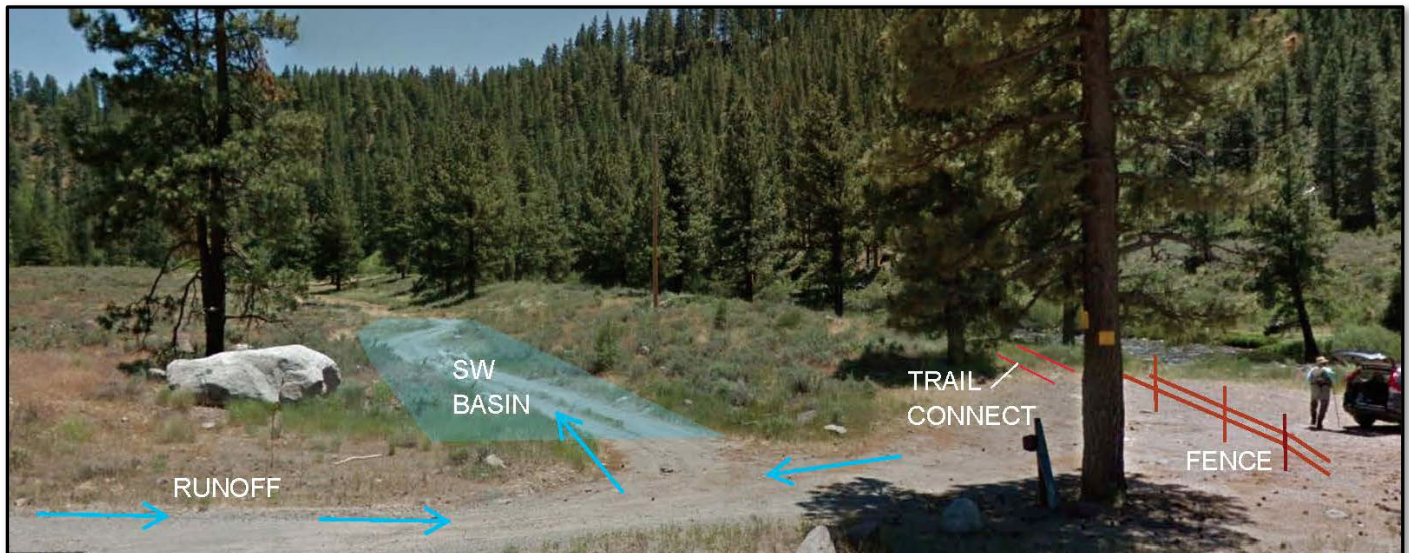
**Figure 14.** Illustration of maintaining drainage to stormwater basin and restoring northwest corner of project area.

Stormwater Basin: A 3300-sq ft stormwater basin was added within the footprint of the former borrow site of which the majority of the disturbed highway access area should still drain to (Figure 14). The 65% plans include a spillway and outflow swale which will rarely, if at all, see outflow given the capacity of the basin relative to the area draining to it is more than adequate. The size and configuration of the basin and the need to armor the swale where it crosses the trail and heads down the slope will be further examined and refined moving to 90%.

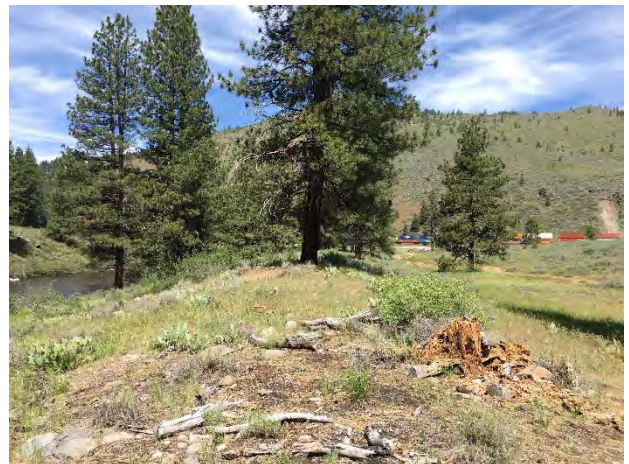
*Railroad spur grade channelizes river and limits floodplain inundation*

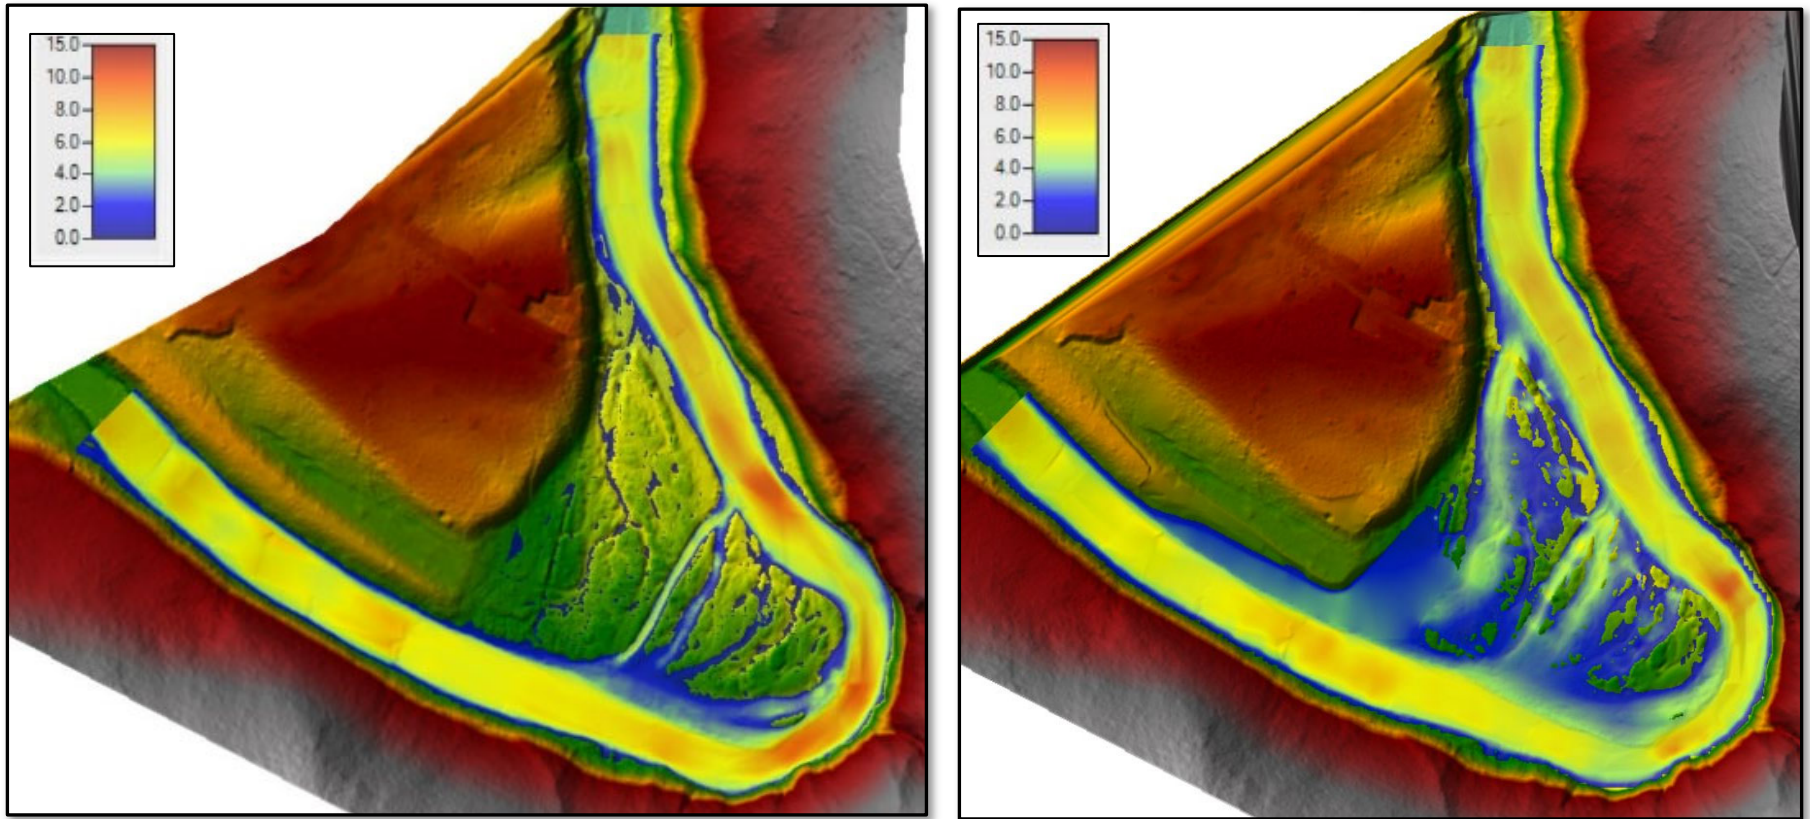
***Figure 2b. Existing vs Proposed 5 Year Velocity***

Velocities in the floodplain range from 2 to 4 feet per second (fps) with the higher velocity on the downstream end of the overflow channels.
