SARDINE MEADOW RESTORATION PROJECT: CEQA PREPARATION

Attachment 1. Draft Conceptual Restoration Design – Sardine Meadow.

Sardine Valley Restoration

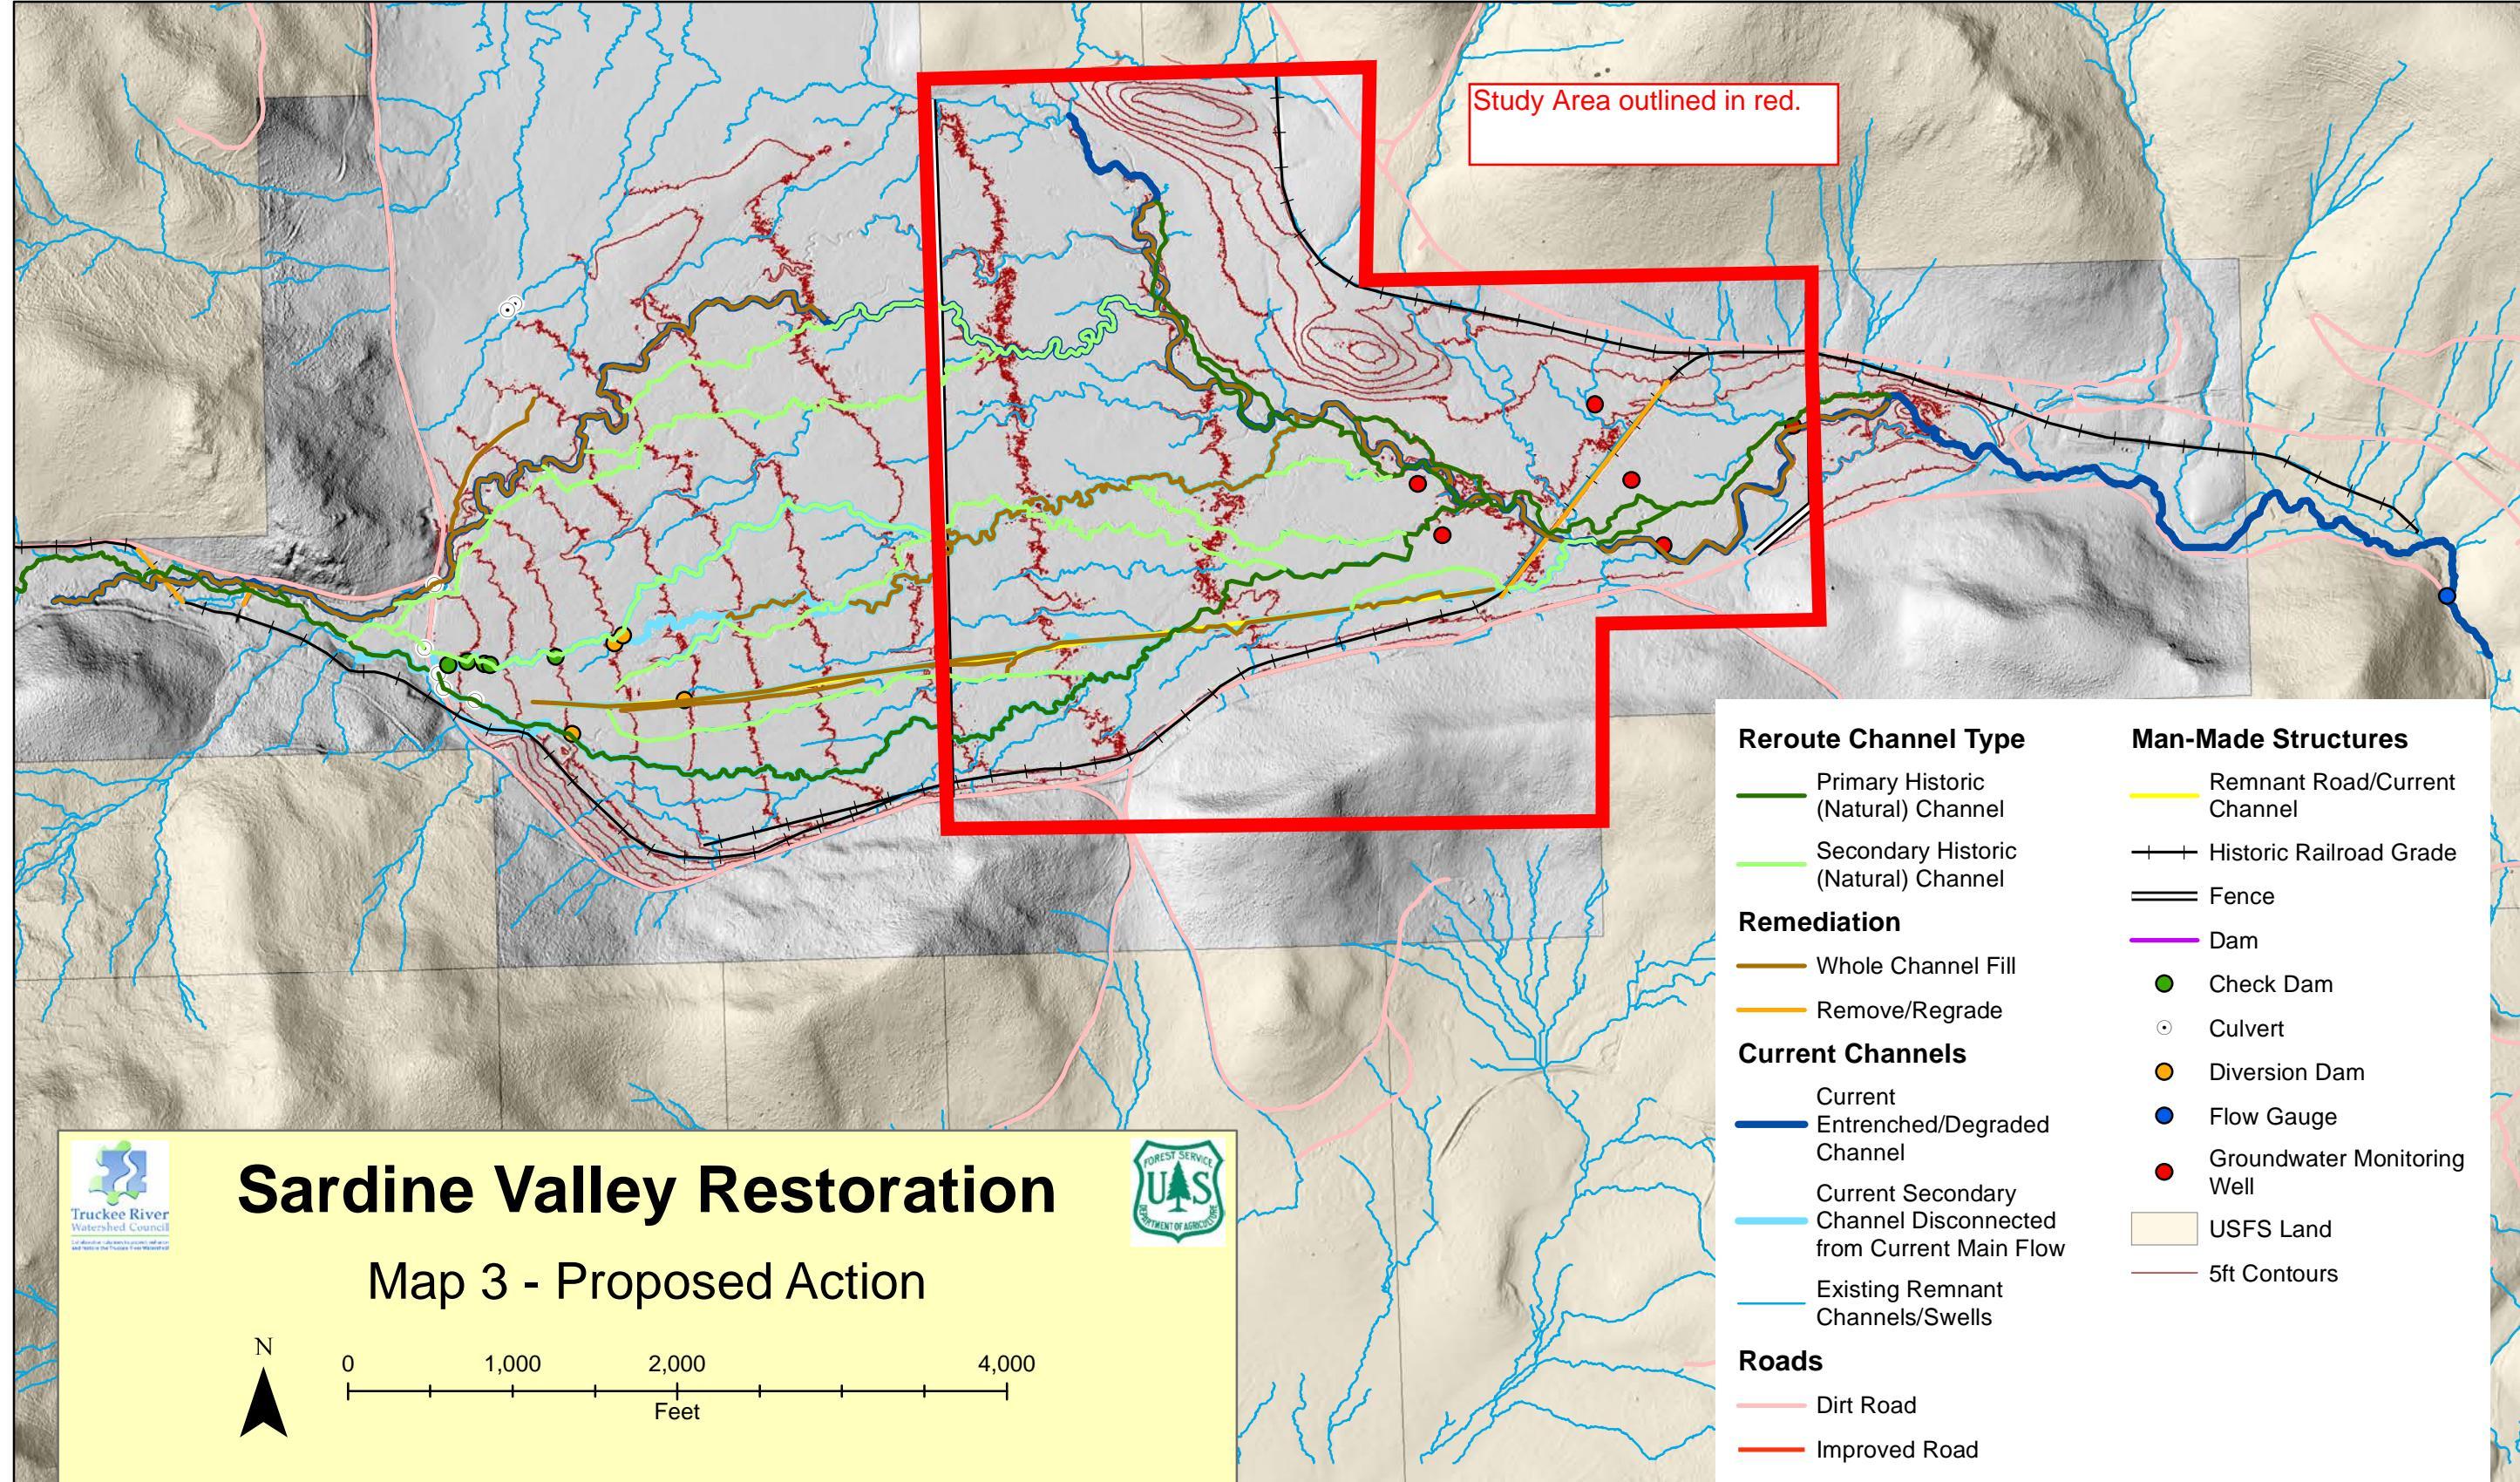
Man-I	Made Structures	
	Remnant Road/Current Channel	1000
+	Historic Railroad Grade	1
	Fence	7
	Dam	22
•	Check Dam	5
\odot	Culvert	
0	Diversion Dam	242
•	Flow Gauge	1
•	Groundwater Monitoring Well	
	USFS Land	2
	5ft Contours	
		1
		1
	Man-I	Man-Wade StructuresRemnant Road/Current ChannelHistoric Railroad GradeFenceDamCheck DamCulvertDiversion DamFlow GaugeGroundwater Monitoring WellUSFS LandSft Contours

We have also included a topographic map of the project area to further outline the project boundary.

1. Size of study area has been changed. Please see the map on the following page for clarification of the study area. Only the parcel held by the Trust for Public Land will be included in this phase of CEQA assessment.
