**PERAZZO MEADOWS RESTORATION
HYDROLOGIC MONITORING DATA
REPORT: UPPER AND MIDDLE
PERAZZO MEADOWS
SIERRA COUNTY, CALIFORNIA

WATER YEAR 2013**

Report prepared for:
Truckee River Watershed Council

Balance Hydrologics, Inc.

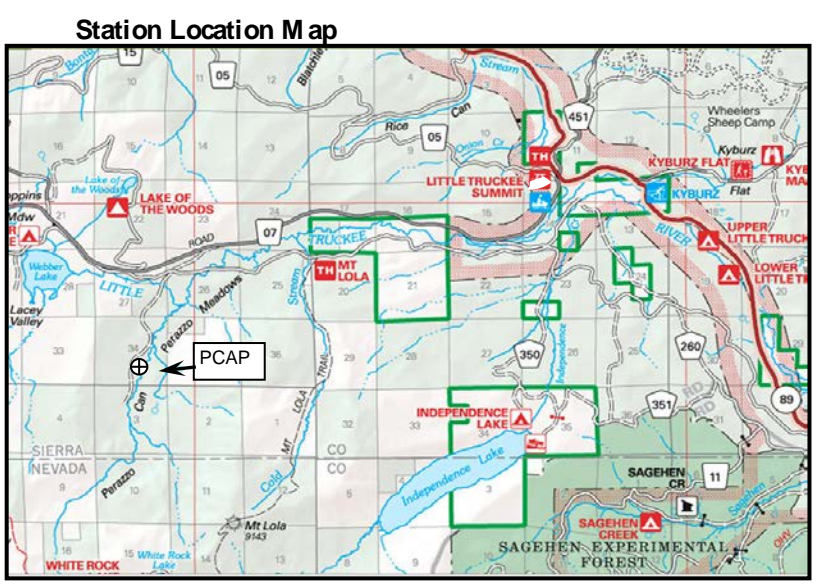
Extreme for period of record (WY2011-WY2013) is 268 cfs on December 2, 2012.

Period of Record
 Staff plate and water level recorder were installed on November 17, 2010.
 Gaging is sponsored by the Truckee River Watershed Council and USFS

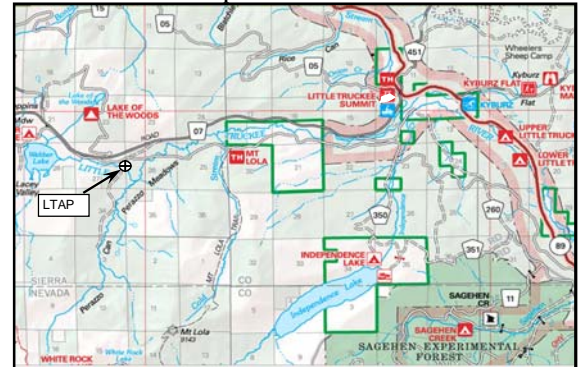
Station Location Map

Staff plate and water level recorder were installed on November 18, 2010.
 Gaging is sponsored by the Truckee River Watershed Council and USFS

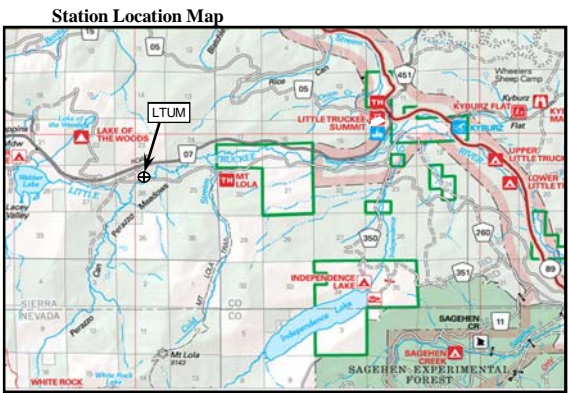
Extreme for period of record (WY2011-WY2013) is 801 cfs on June 29, 2011.

Staff plate and water level recorder were installed on November 19, 2010.
 Gaging is sponsored by the Truckee River Watershed Council and USFS

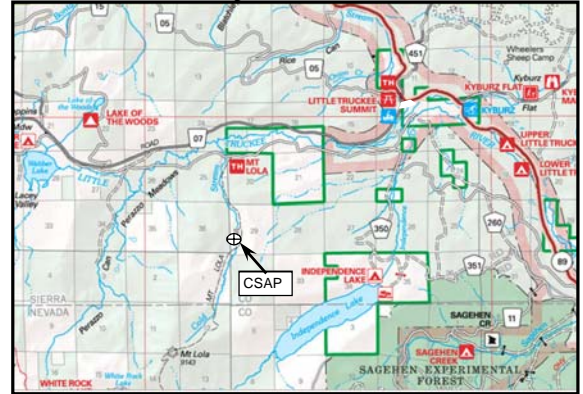
Station Location Map

Staff plate and water level recorder were installed August 18, 2011.
 Gaging sponsored by the Truckee River Watershed Council and USFS.

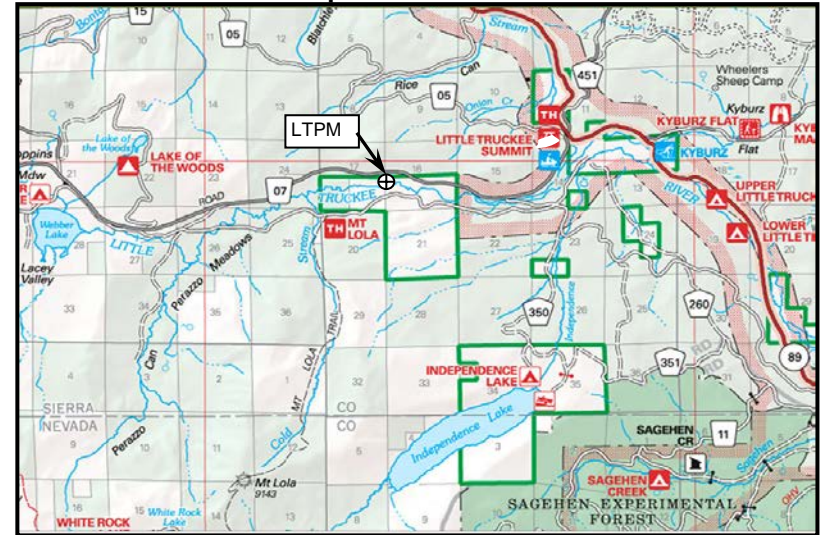
Station Location Map

Staff plate #1 installed Sep 23, 2010. Datalogger installed on Oct 1, 2009.
 Staff plate #2 installed Sep 28, 2010.
 Staff plate #3 installed Jun 8, 2011.
 Gaging is sponsored by the Truckee River Watershed Council and USFS

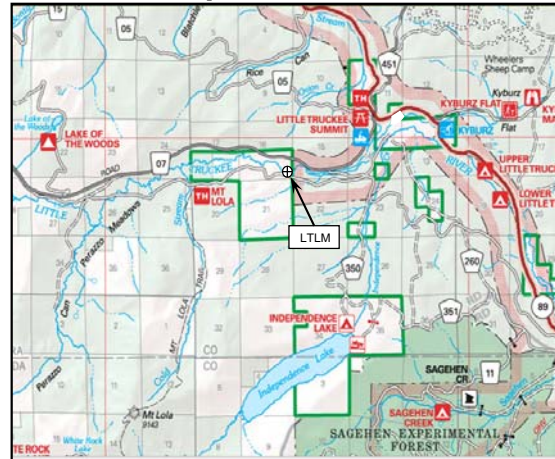
Station Location Map

Staff plate and water level recorder were installed August 18, 2011.
 Gaging is sponsored by the Truckee River Watershed Council

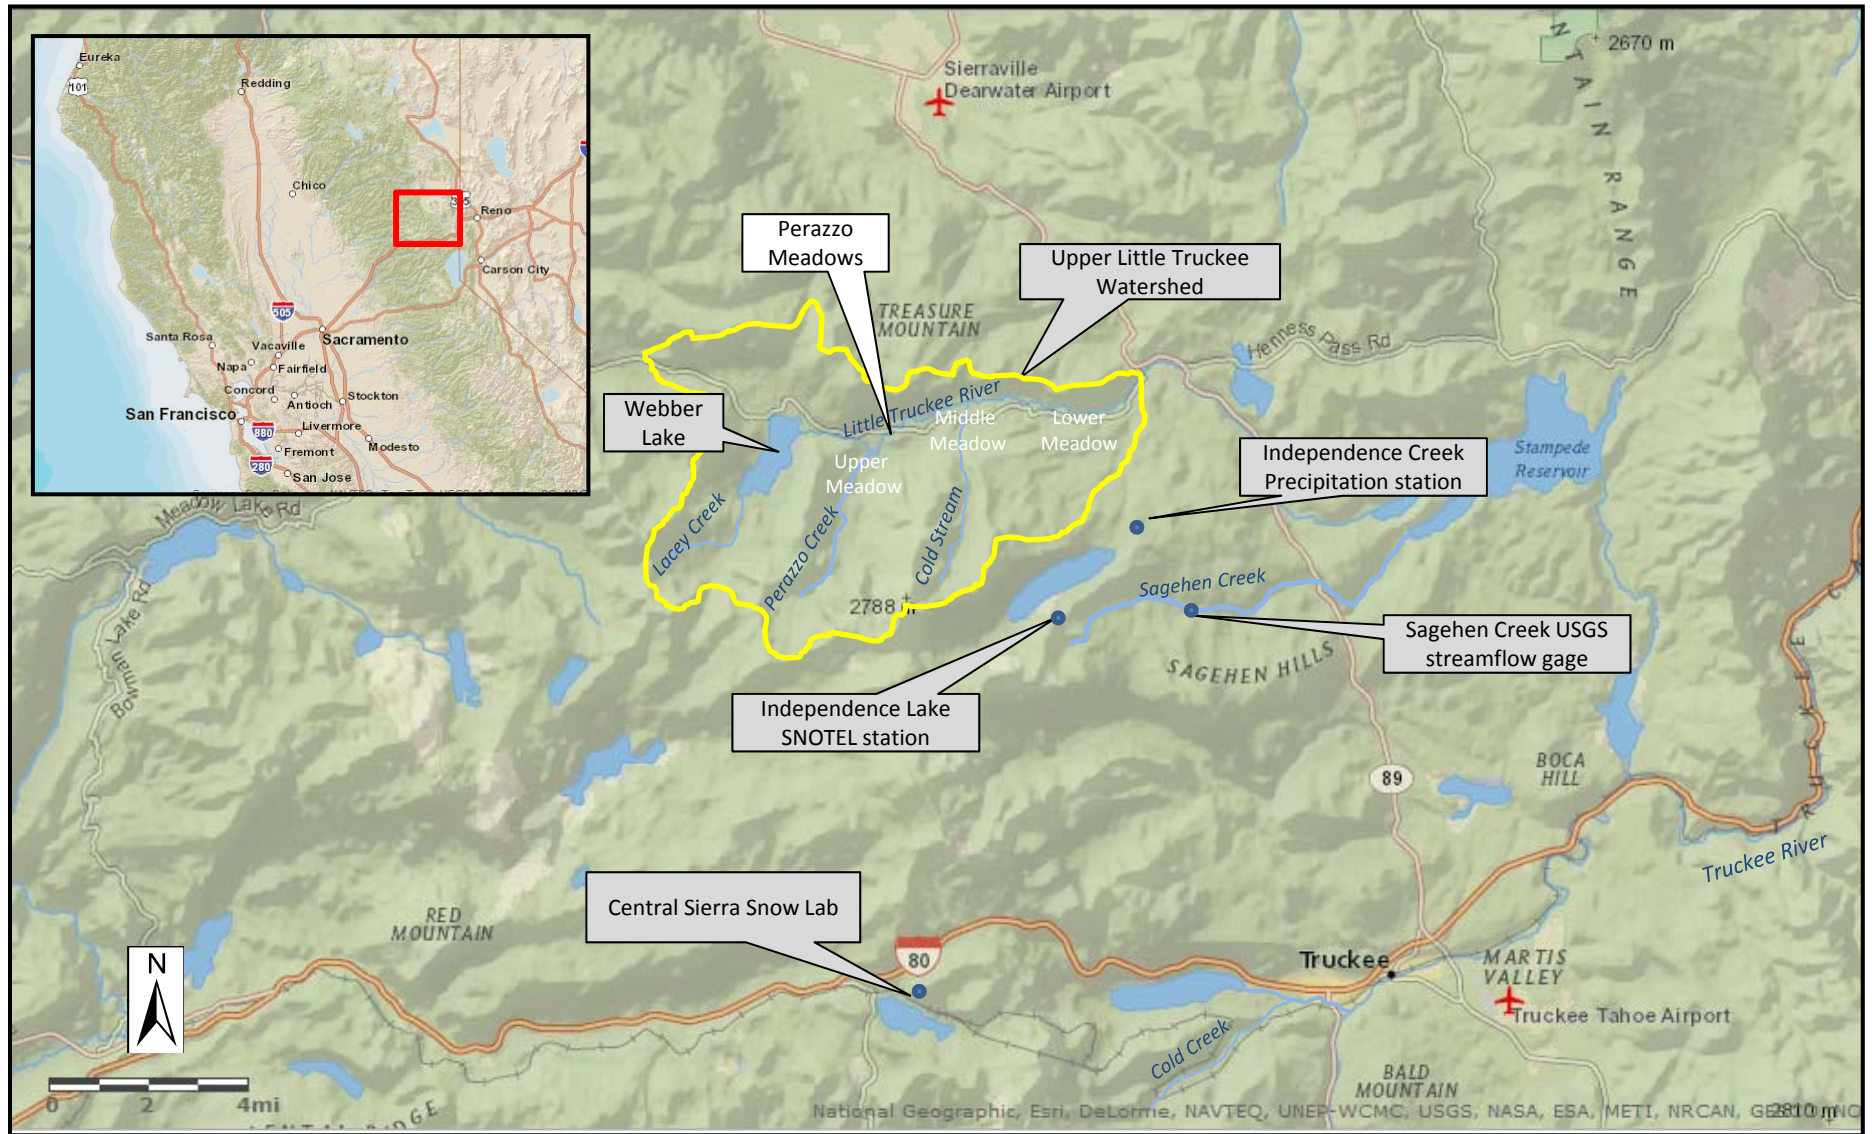
Figure 1. Perazzo Meadows, Sierra County, California

Perazzo Meadows is part of the Upper Little Truckee watershed, in the headwaters of the Truckee River. Other locations discussed in this report are identified on this map.

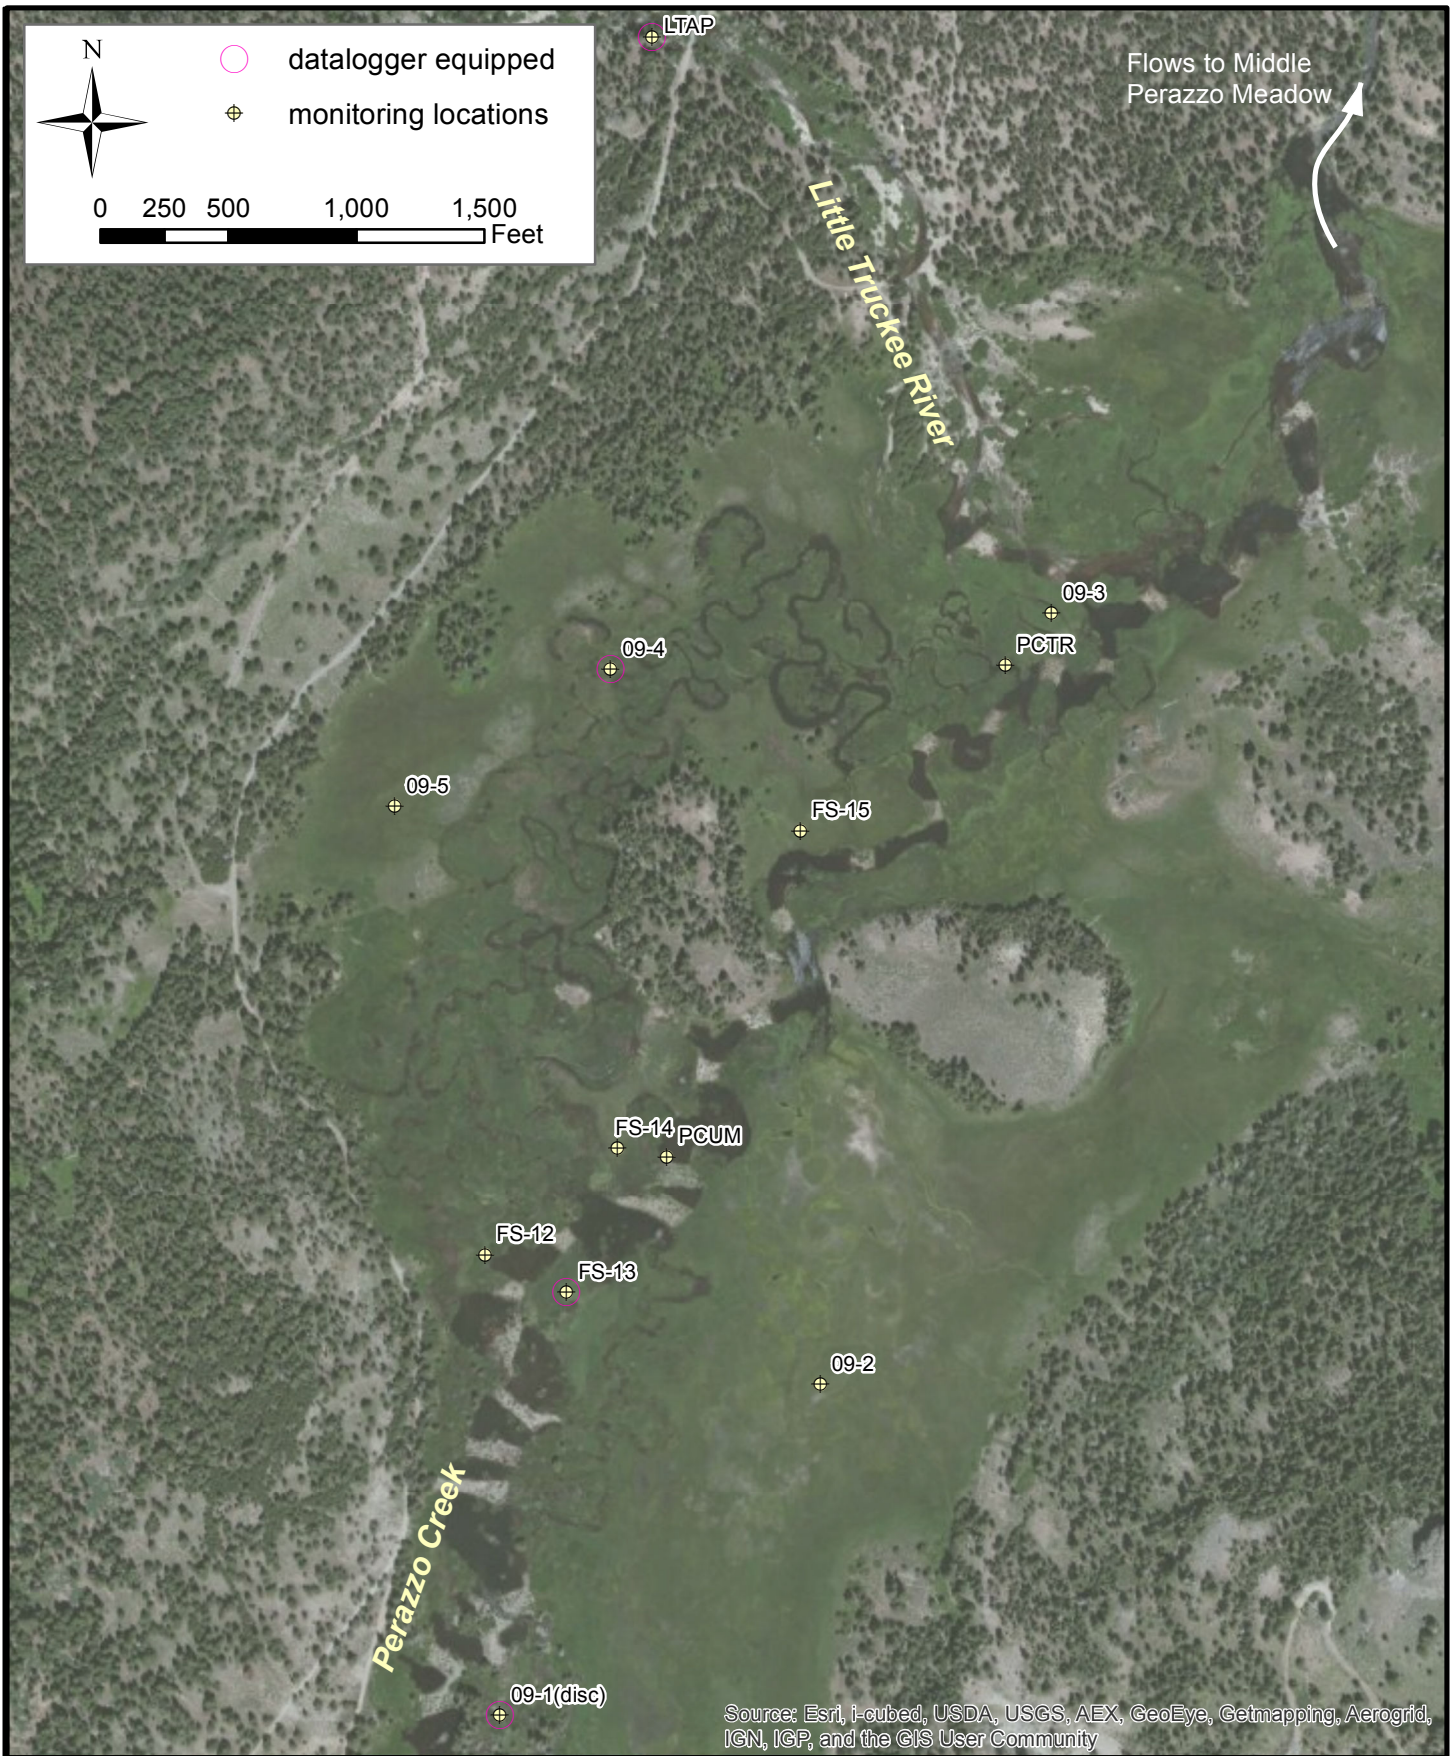
Figure 2. Location of groundwater and surface water monitoring stations
 Upper Perazzo Meadow, Sierra County, California

Piezometers were designed with the aim of measuring seasonal water-table fluctuations, and range in depth from 4.1 to 8.0 feet below the meadow surface. Piezometer locations were chosen to represent a range of geomorphic and hydrologic conditions, including spring-fed areas with perennial saturation (e.g. Piezometers 09-02, 09-06), upland surfaces (e.g. 09-05, FS-14, 09-11), and areas adjacent to the main channel (e.g. 09-03, 09-09), as shown in **Figures 2 and 3**.

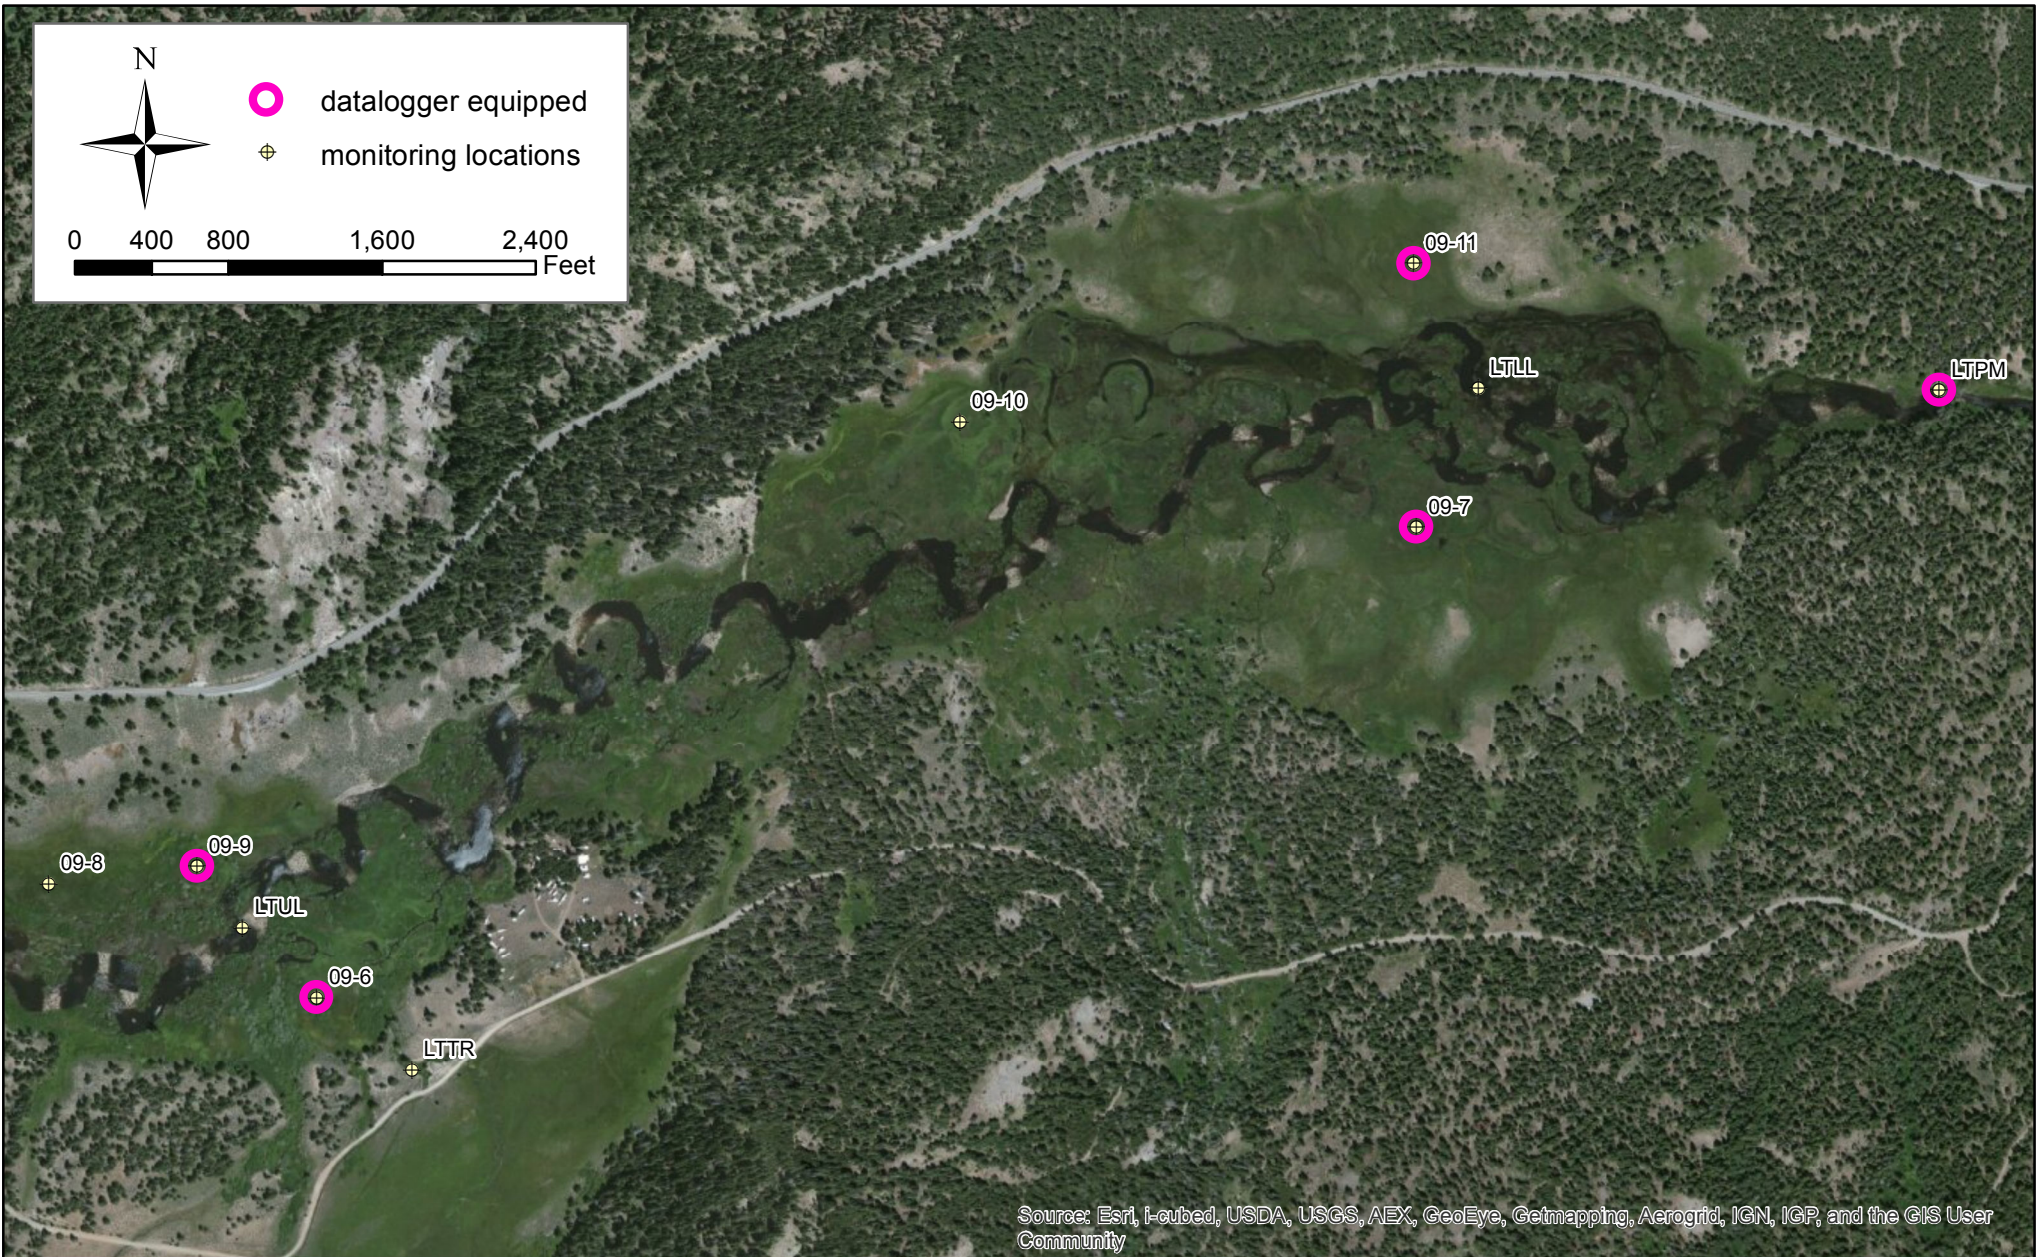
Figure 3. Location of groundwater and surface water monitoring stations
 Middle Perazzo Meadow, Sierra County, California

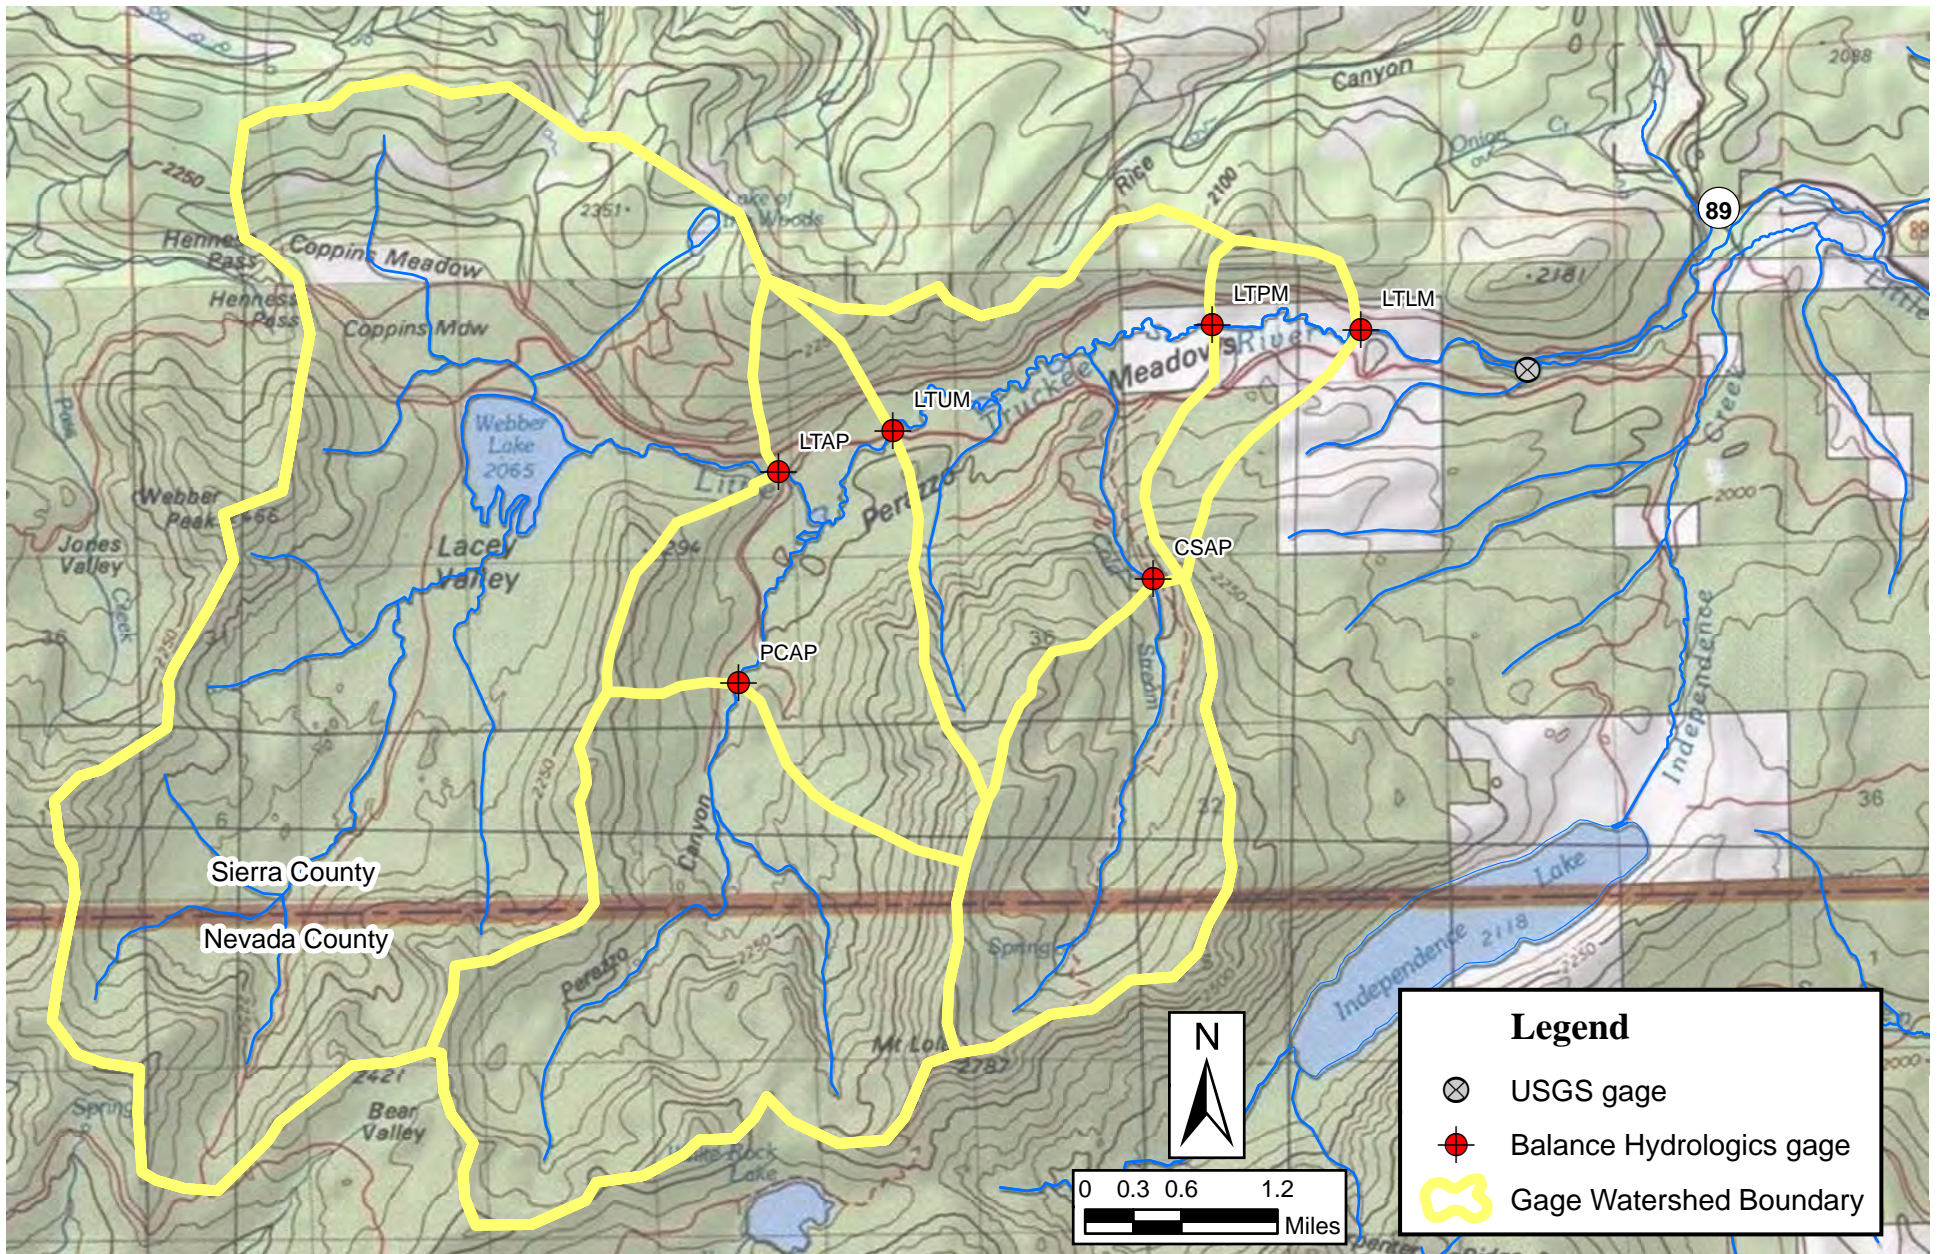
Figure 4. Stream gaging locations and contributing watersheds, Perazzo Meadows, Sierra and Nevada Counties, California

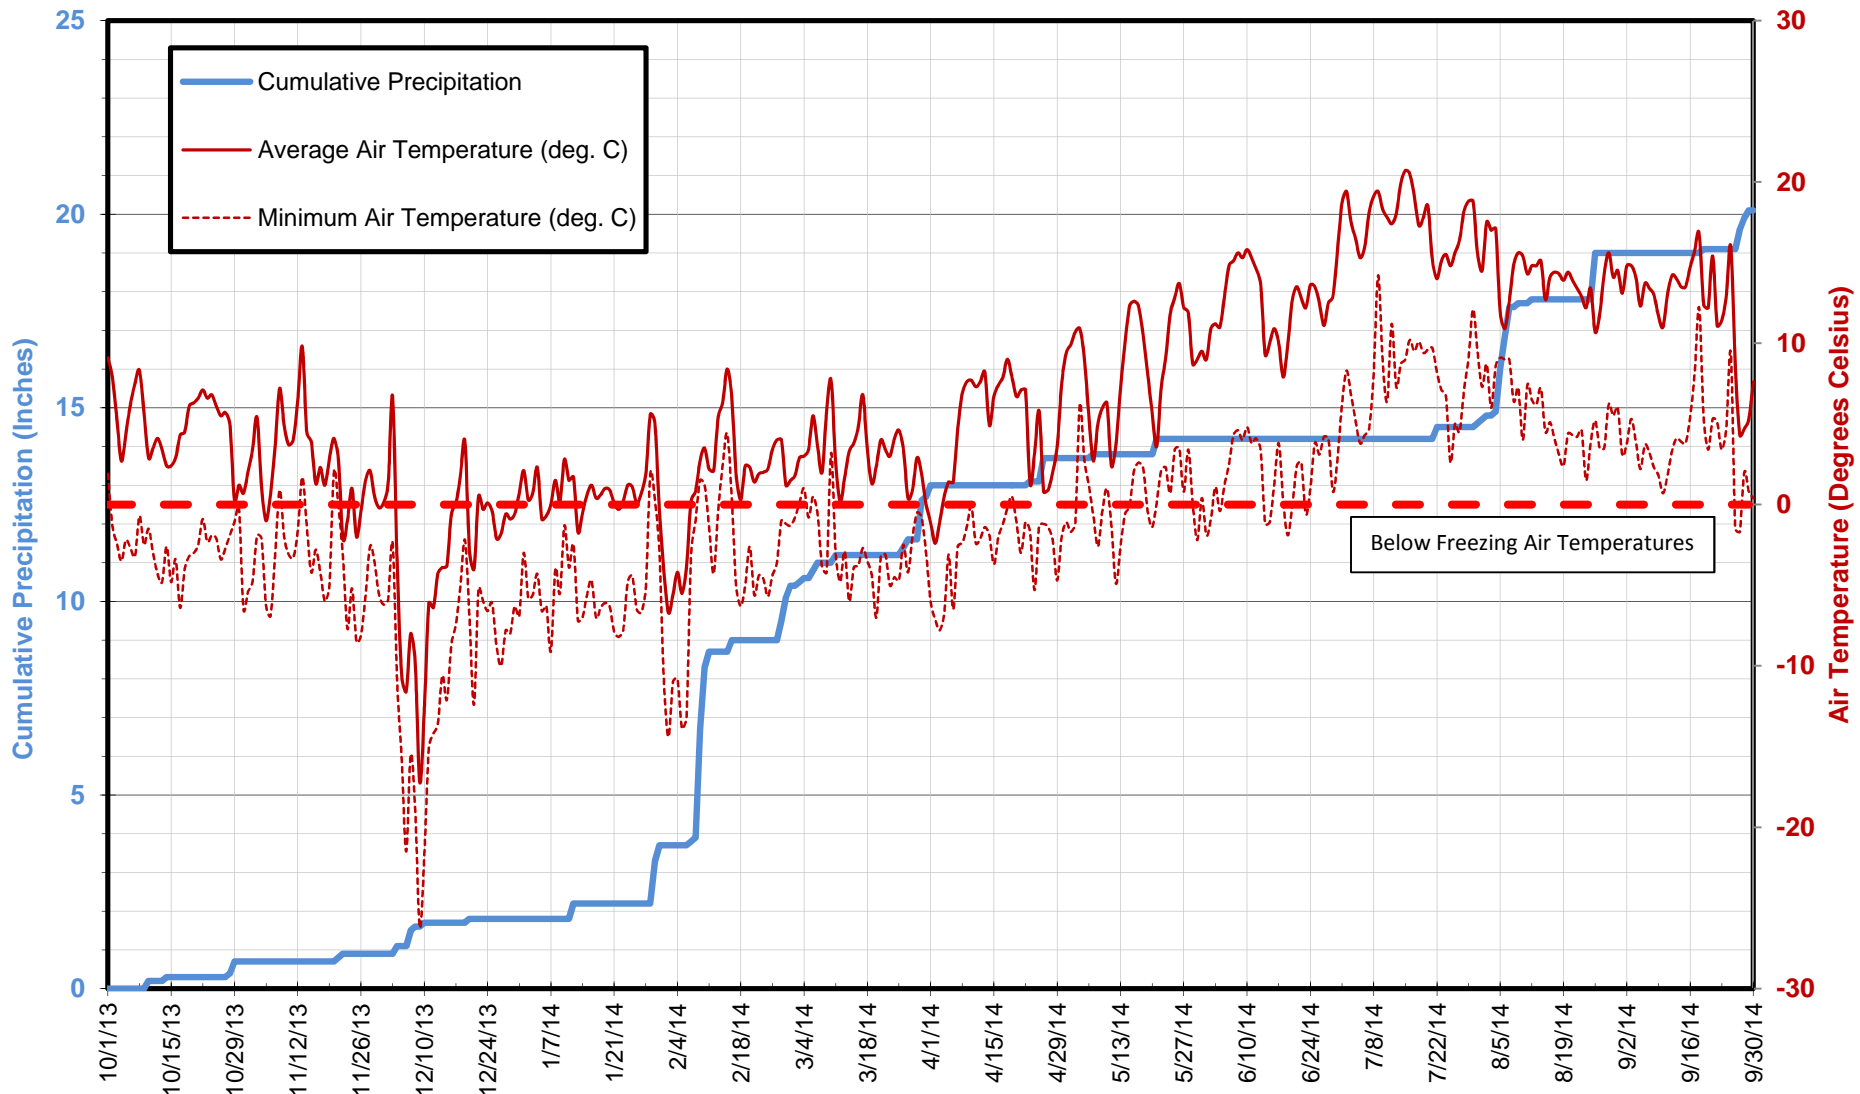
Figure 5. Cumulative precipitation and daily minimum and mean temperatures, Independence Creek, Sierra County, California, Water Year 2014. Weather station located approximately 3.5 miles southeast of Perazzo Meadows at 6,500 feet elevation.

Annual precipitation for Perazzo Meadows is evaluated from daily data collected at Independence Creek (California Data Exchange Center Station INN) located at similar elevation (6,500 feet) and approximately 3.5 miles southeast of Perazzo Meadows. Annual and long-term average snow-water equivalent is reported from Central Sierra Snow Lab, located near Donner Pass at 6,950 feet elevation and about 11 miles south-southwest. The Snow Lab has over 100-years of record and serves as a good reference for comparison to WY2013 observed conditions at Perazzo Meadows.

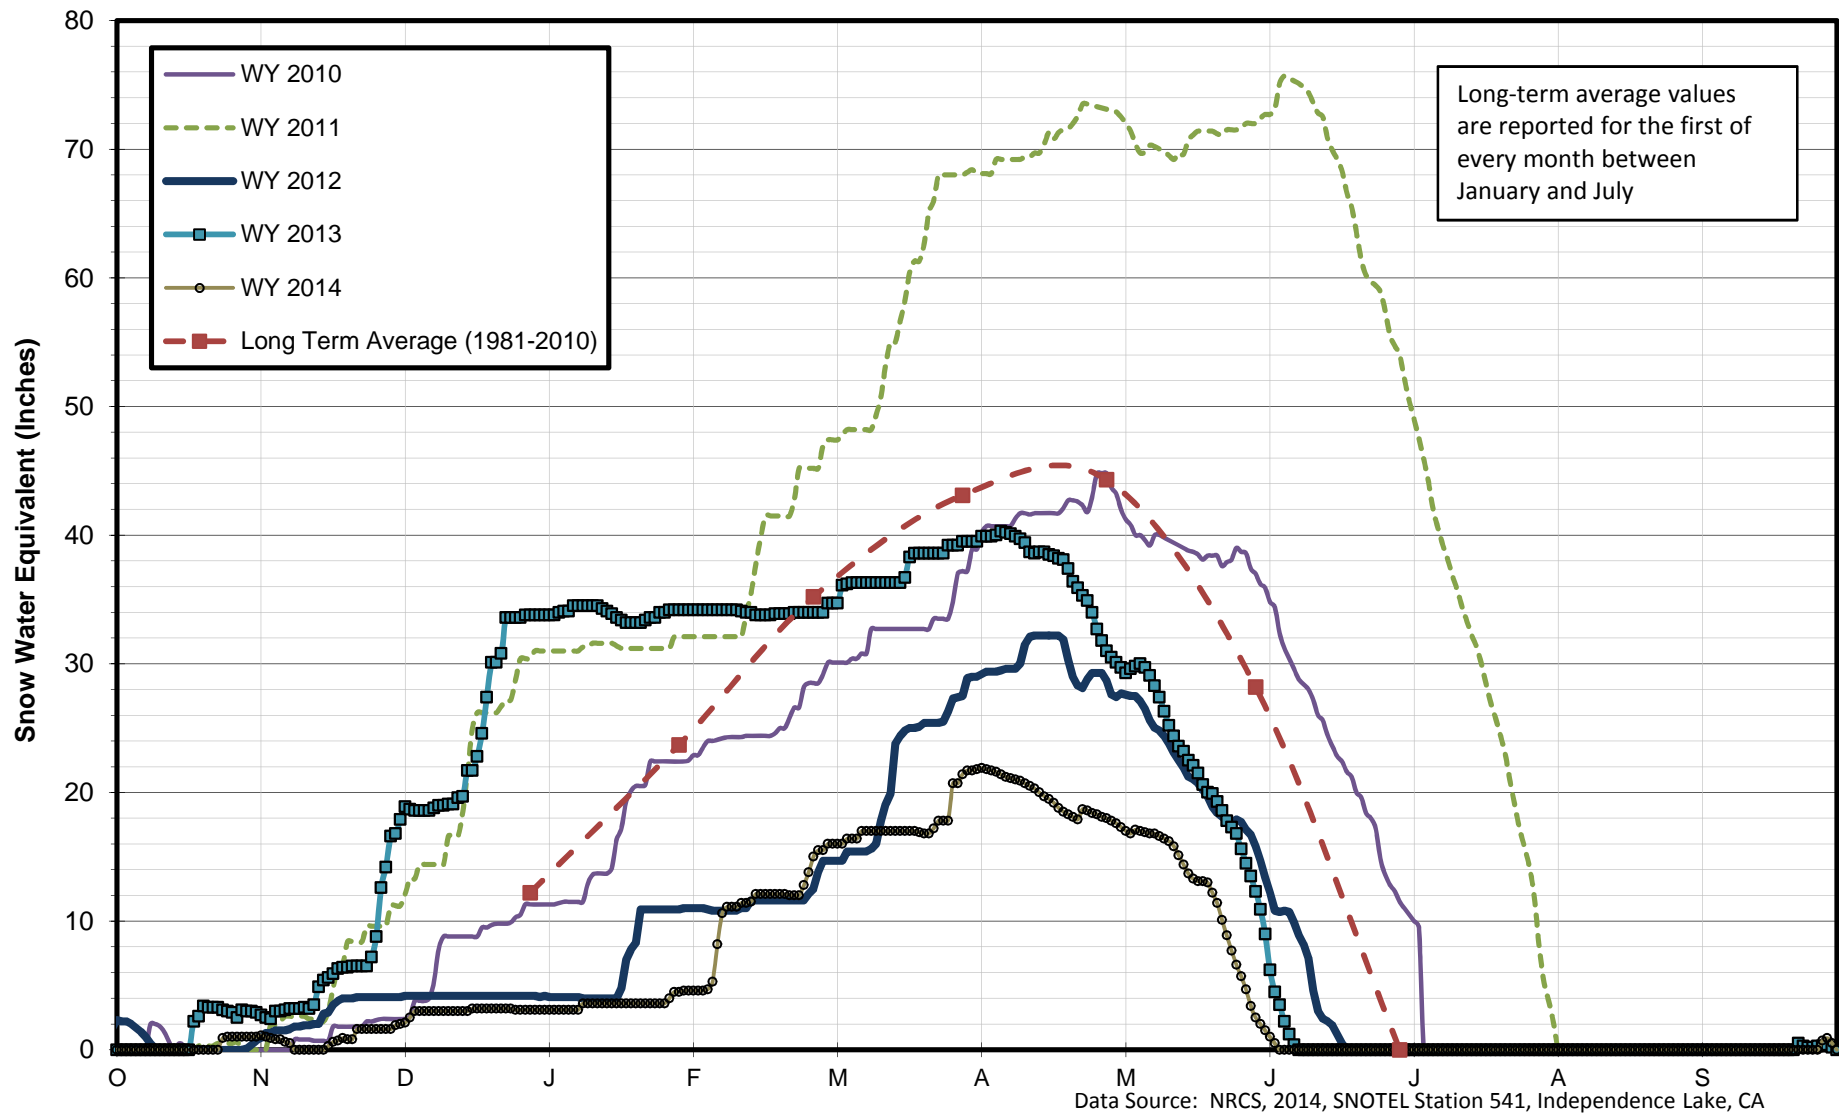
Figure 6. Snow water equivalent, Independence Lake, Nevada County, California, water years 2010, 2011, 2012, 2013, and 2014 as compared to long-term average. SNOTEL station is located approximately 3.5 miles south-southwest of Perazzo Meadows at 8,352 feet elevation. WY 2010 was average, WY 2011 was wet, while WY 2012, WY 2013, and WY 2014 were dry.

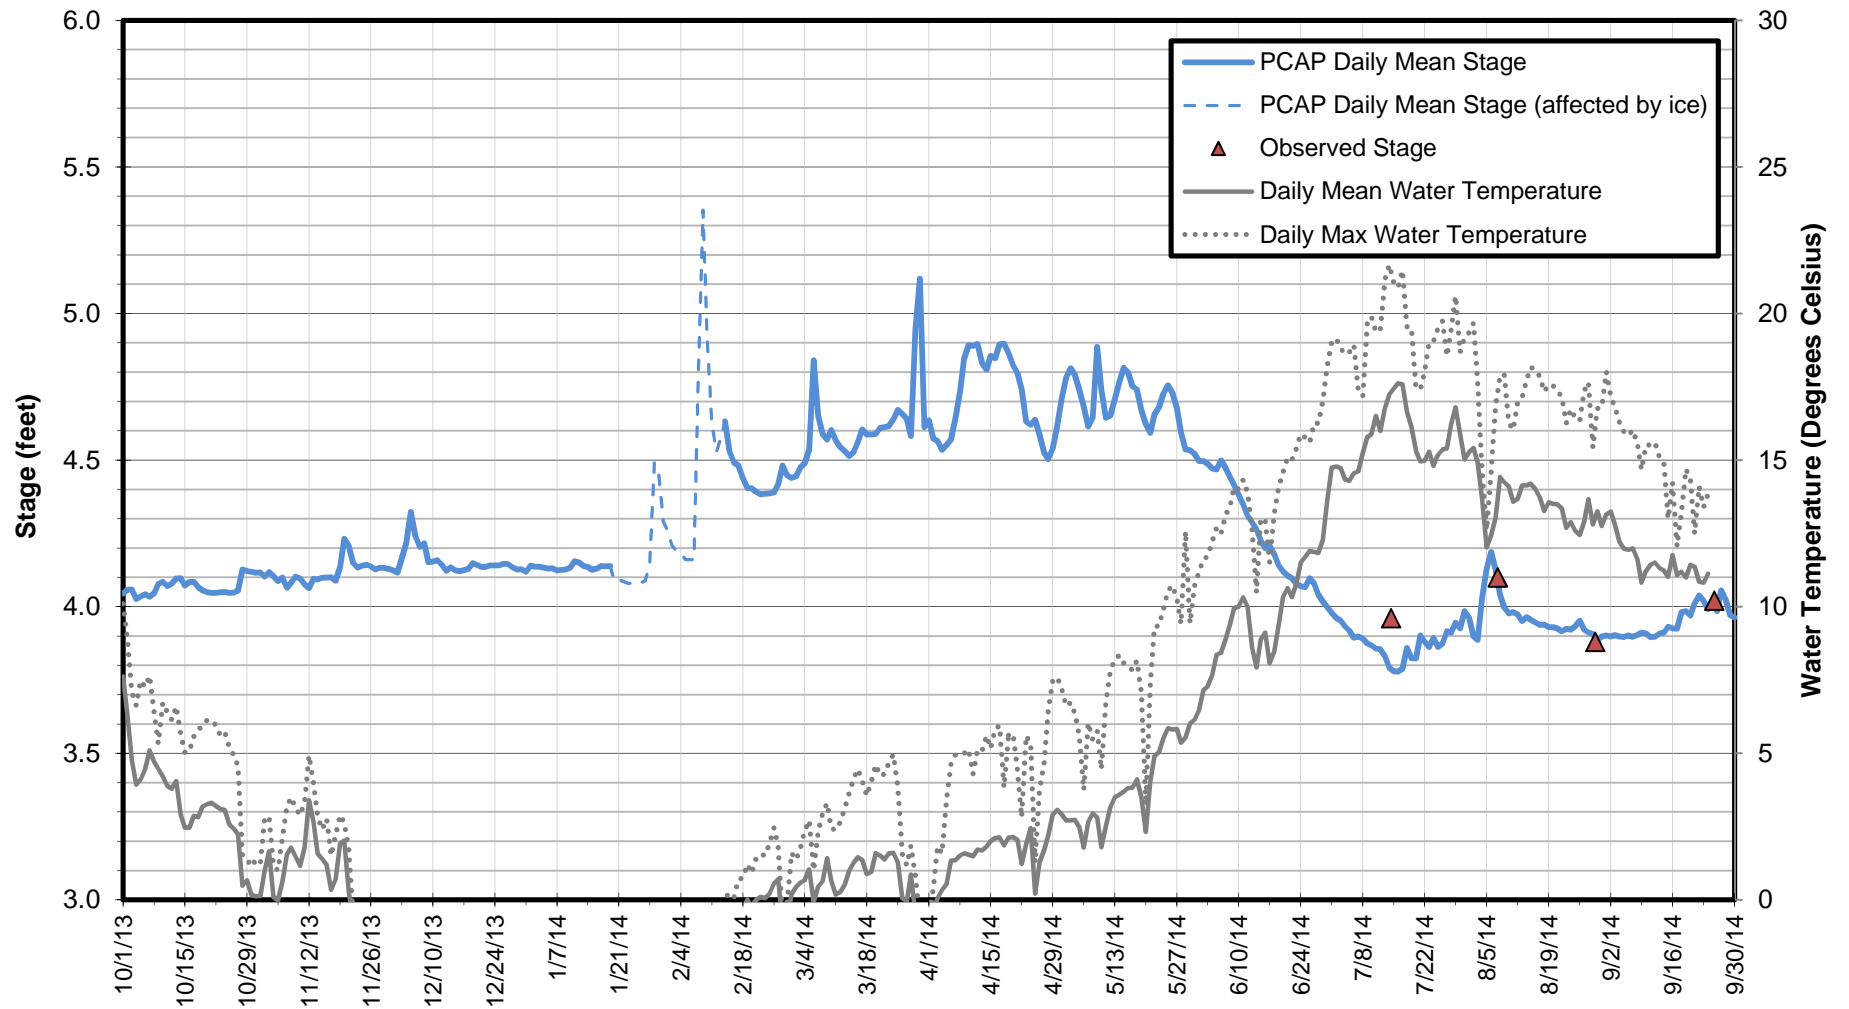
Figure 7. Daily stage and water temperature: Perazzo Creek above Perazzo Meadows (PCAP), Sierra County, California, water year 2014.

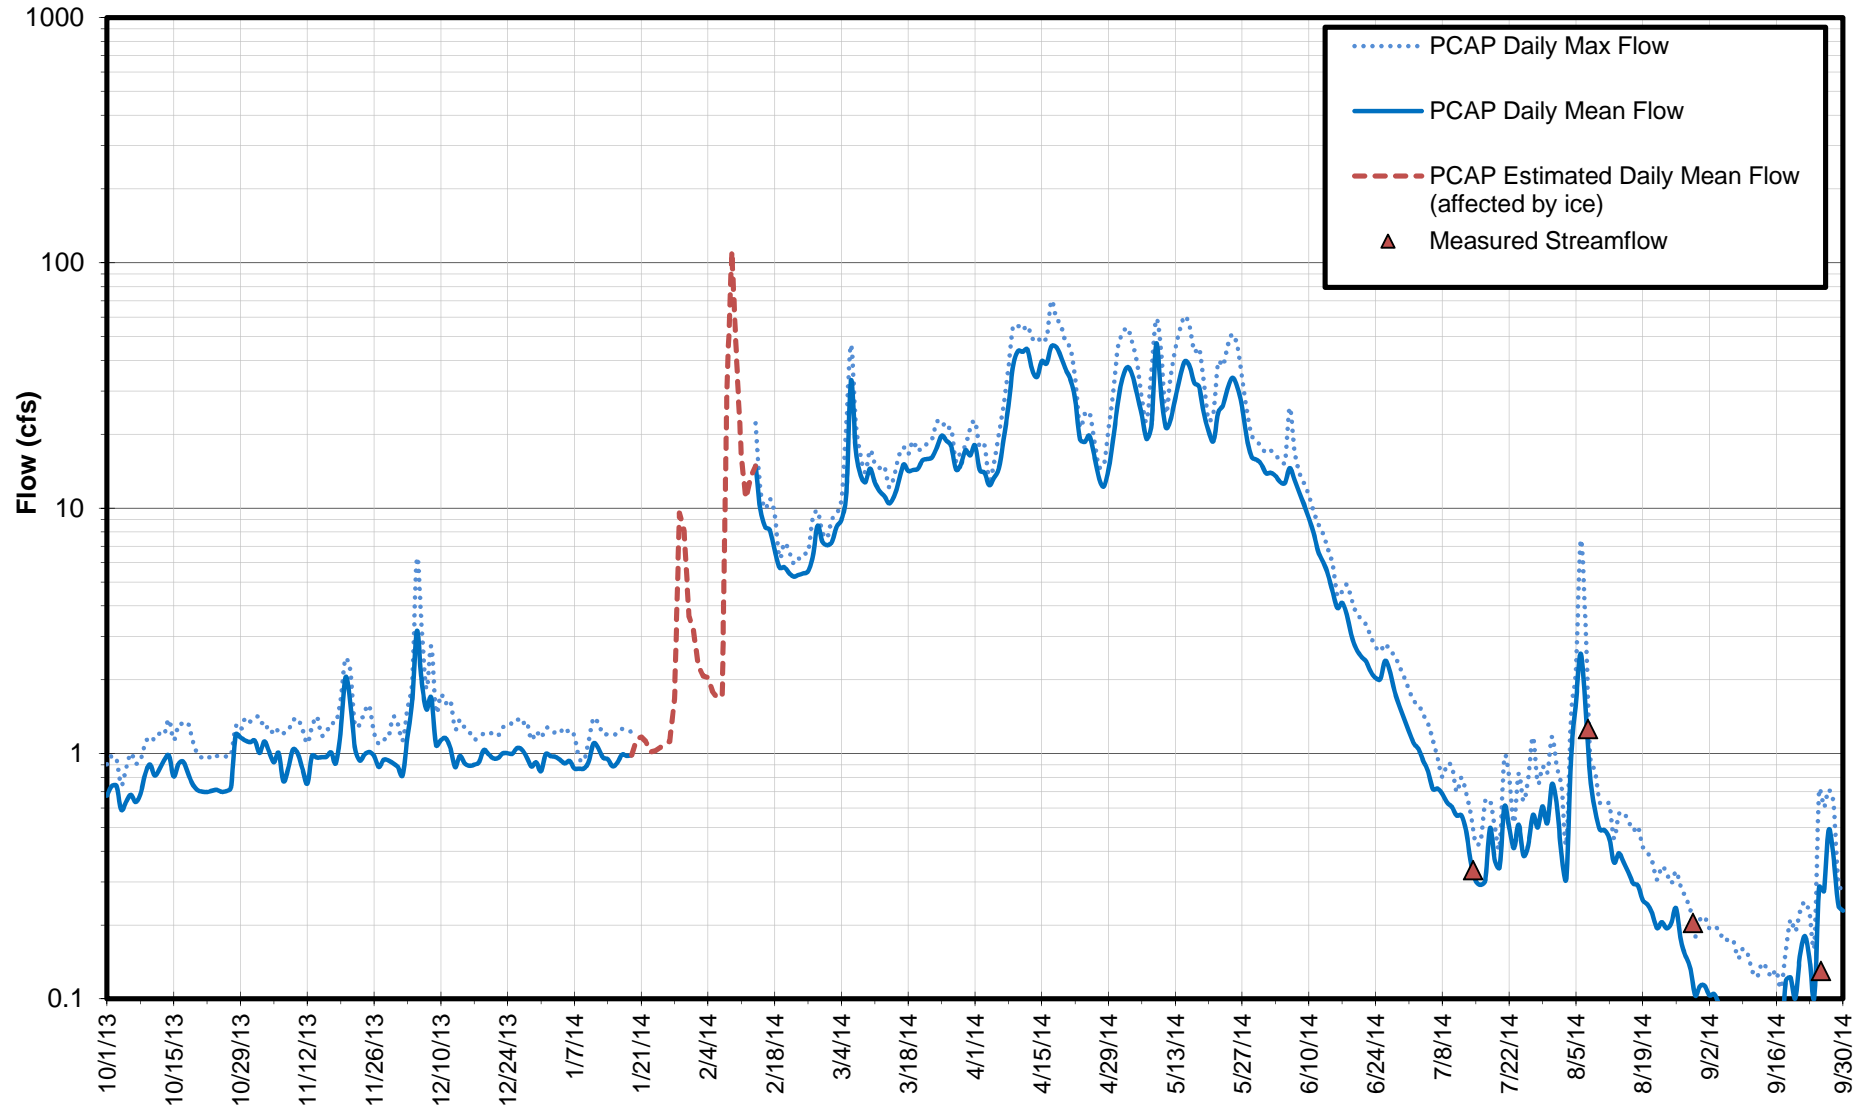
Note that the flow axis is logarithmic.

Figure 8. Daily flow hydrograph, Perazzo Creek above Perazzo Meadows (PCAP), Sierra County, California, water year 2014.

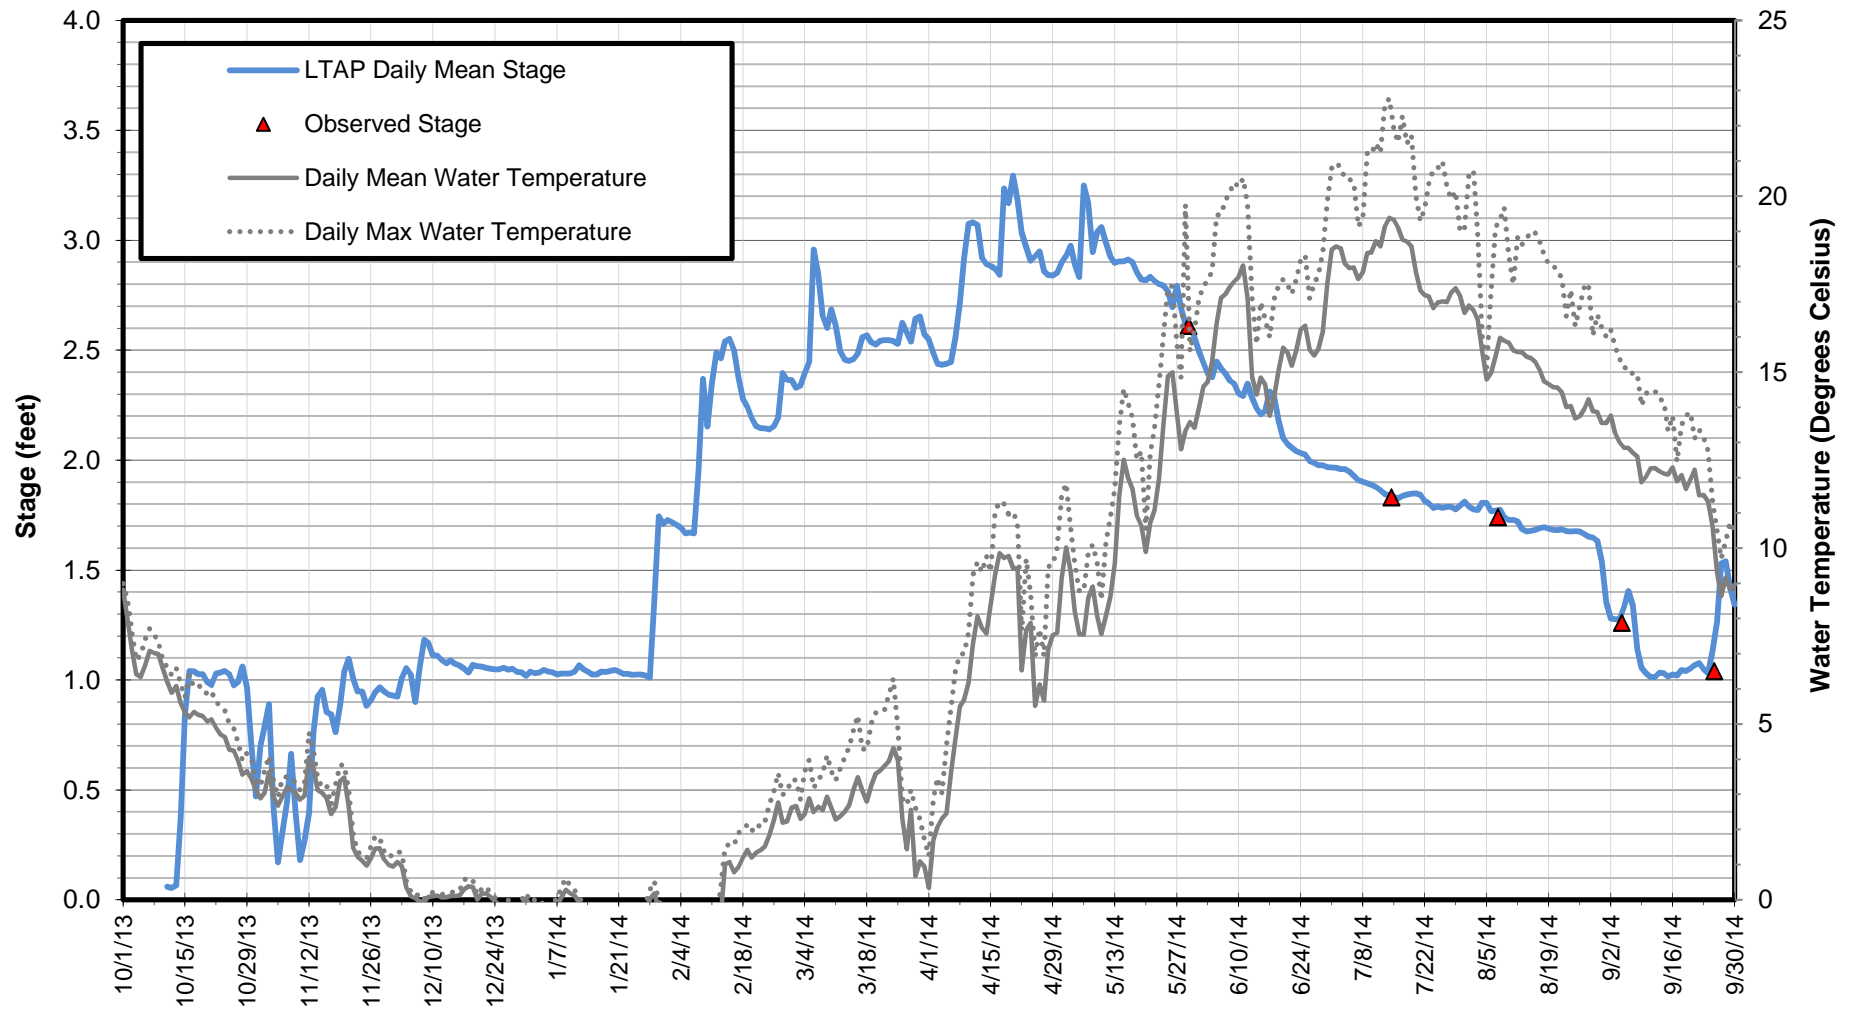
Figure 9. Daily stage and water temperature: Little Truckee above Perazzo Meadows (LTAP), Sierra County, California, water year 2014. No flow is associated with a stage less than approximately 1.26 feet.

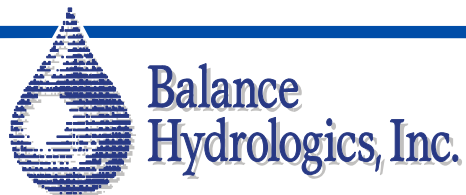
Note that the flow axis is logarithmic.

Table 4 provides information and observations from site visits and manual measurements of flow. An annual streamflow summary, including peak flows, monthly, and annual statistics is provided in **Form 2**. Daily mean stage and flow are graphically illustrated in **Figures 9 and 10**, respectively.
