**PERAZZO MEADOWS RESTORATION
HYDROLOGIC MONITORING DATA
REPORT: UPPER AND MIDDLE
PERAZZO MEADOWS
SIERRA COUNTY, CALIFORNIA

WATER YEAR 2013**

Report prepared for:
Truckee River Watershed Council

Balance Hydrologics, Inc.

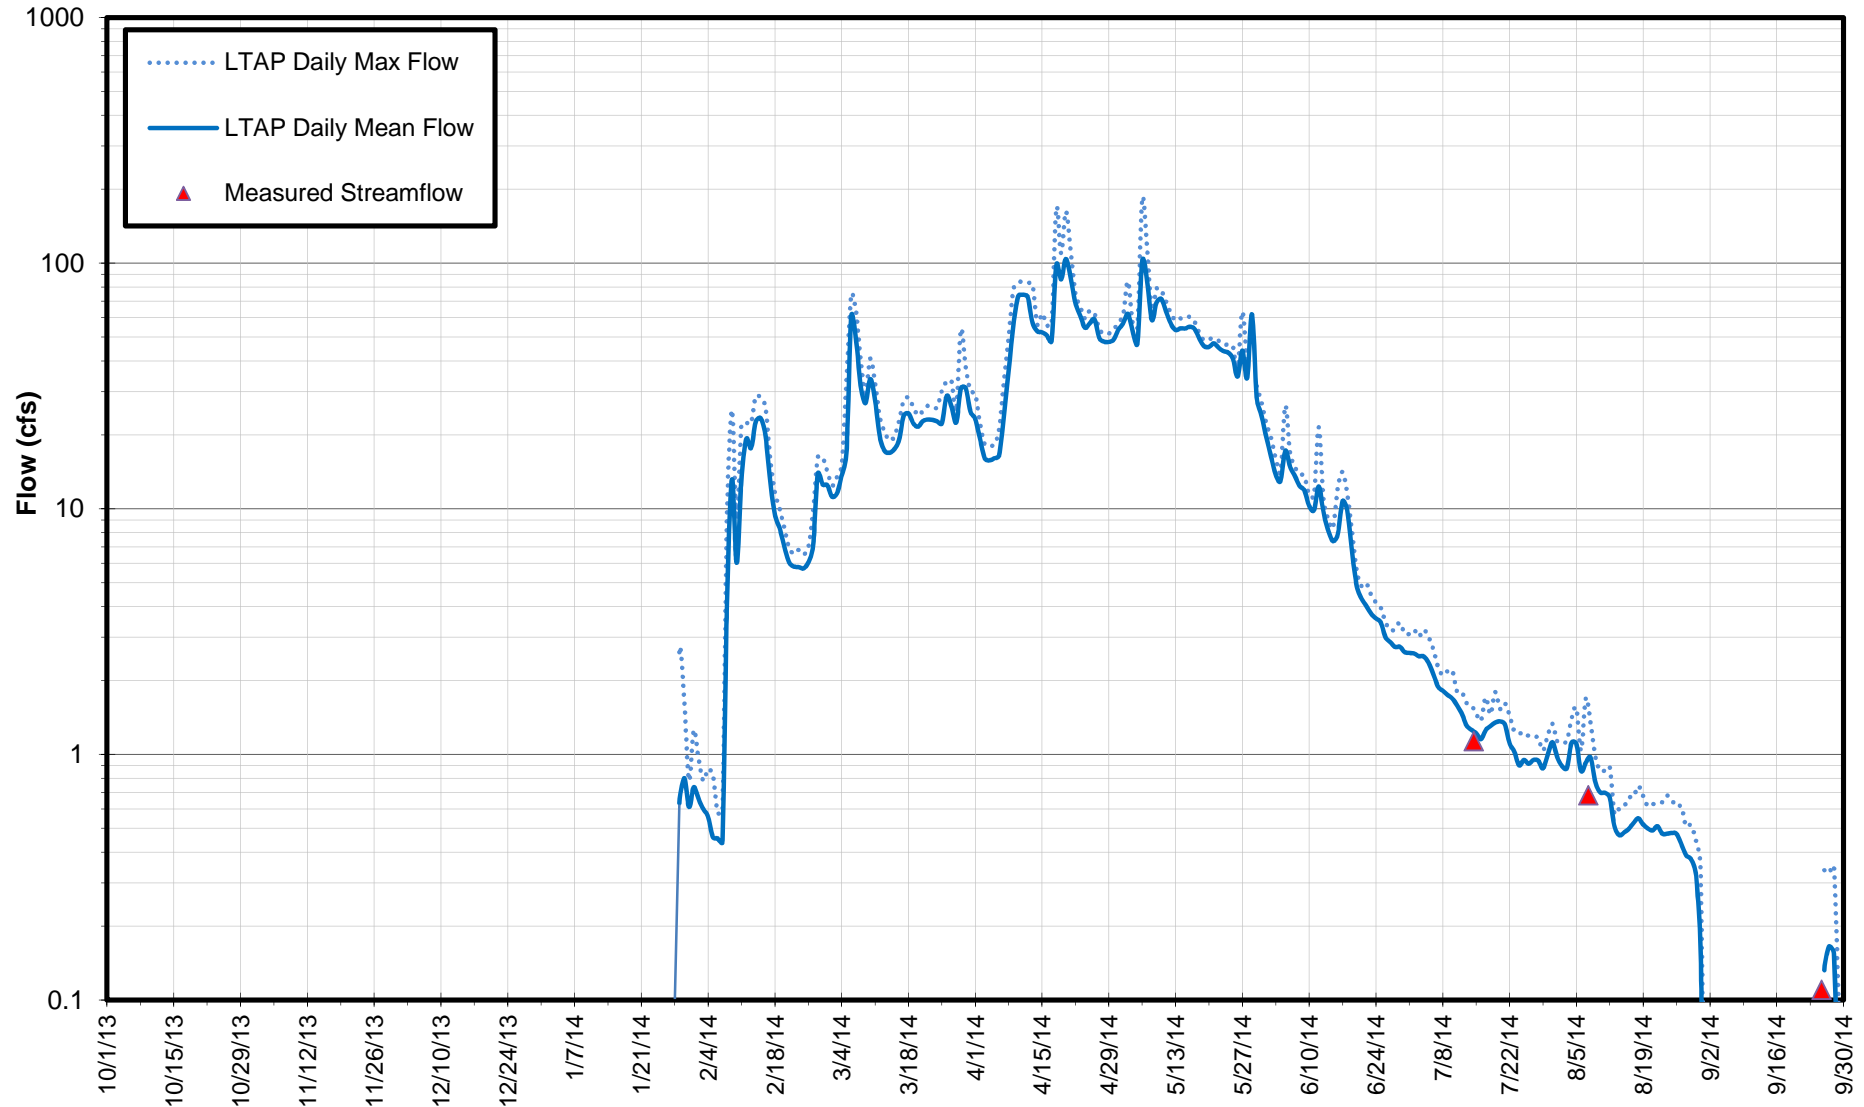
Note that the flow axis is logarithmic.

Figure 10. Daily flow hydrograph, Little Truckee River above Perazzo Meadows (LTAP), Sierra County, California, water year 2014. Little Truckee River was dry for much of the beginning of the 2014 water year. A rain-on-snow event on February 8, 2014 initiated flow at the gaging station. Annual peak flow of 182 cfs occurred on May 6, 2014 as the result of snowmelt runoff.

The water year began with no surface flow in the Truckee River above Perazzo Meadow, likely attributable to the below average precipitation year during WY2012. Baseflow increased marginally as a result of early season rains in late October and early November, fluctuating between less than 0.1 cfs and 1 cfs. The high winds and high flows of November 28 caused a significant tree fall and destruction of the stream gage. Peak flow for the year likely occurred on December 2, 2012, the magnitude of which has been estimated by way of correlation to other streamflow gages in the watershed at approximately 490 cfs. The gage was inoperable between November 28, 2012 and January 30, 2013, when it was repaired. With the exception of one peak flow of approximately 116 cfs on March 6, streamflow held steady through the winter between 10 and 20 cfs. Spring snowmelt began in mid-March and peaked at approximately 189 cfs on April 29. Peak snowmelt runoff was followed by dry and warm conditions, resulting in quickly receding streamflow punctuated by ephemeral increases associated with summer thunderstorms, and to an unknown extent, management of the Webber Lake dam. Aside from these events, baseflow receded fairly steadily until August 24, 2013, when outflow from the gaging pool ceased.

In total, The Little Truckee River contributed approximately 15,075 acre-feet of surface water to the Upper Meadow during WY2013. It should be noted, however, that this estimate is based on 2 months of estimated flow during the period when the gage was not in operation. Readers should also be aware that during periods when no flow was occurring at the gaging station, minor flows were observed in the bedrock-controlled channel upstream approximately 500 to 1000 feet upstream of the gage.

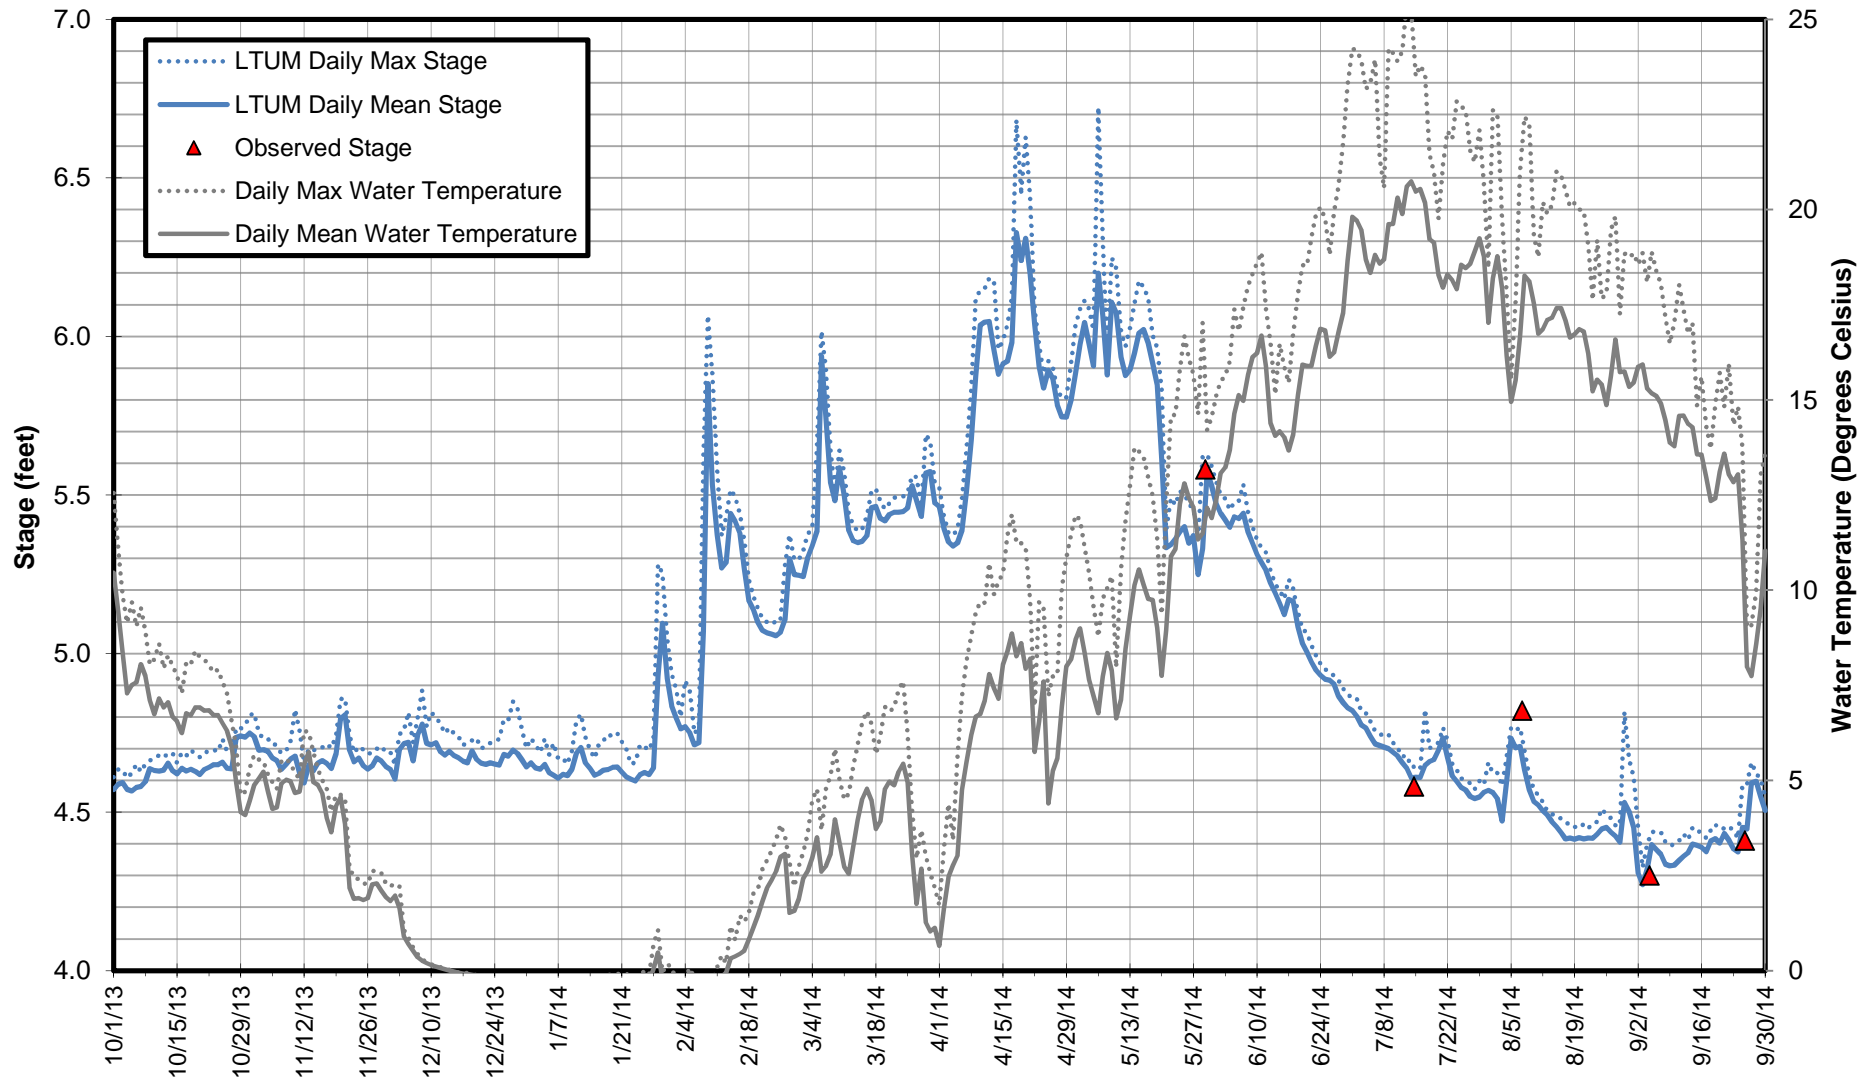
Figure 11. Daily stage and water temperature, Little Truckee River, below Upper Perazzo Meadows (LTUM), Sierra County, California, water year 2014.

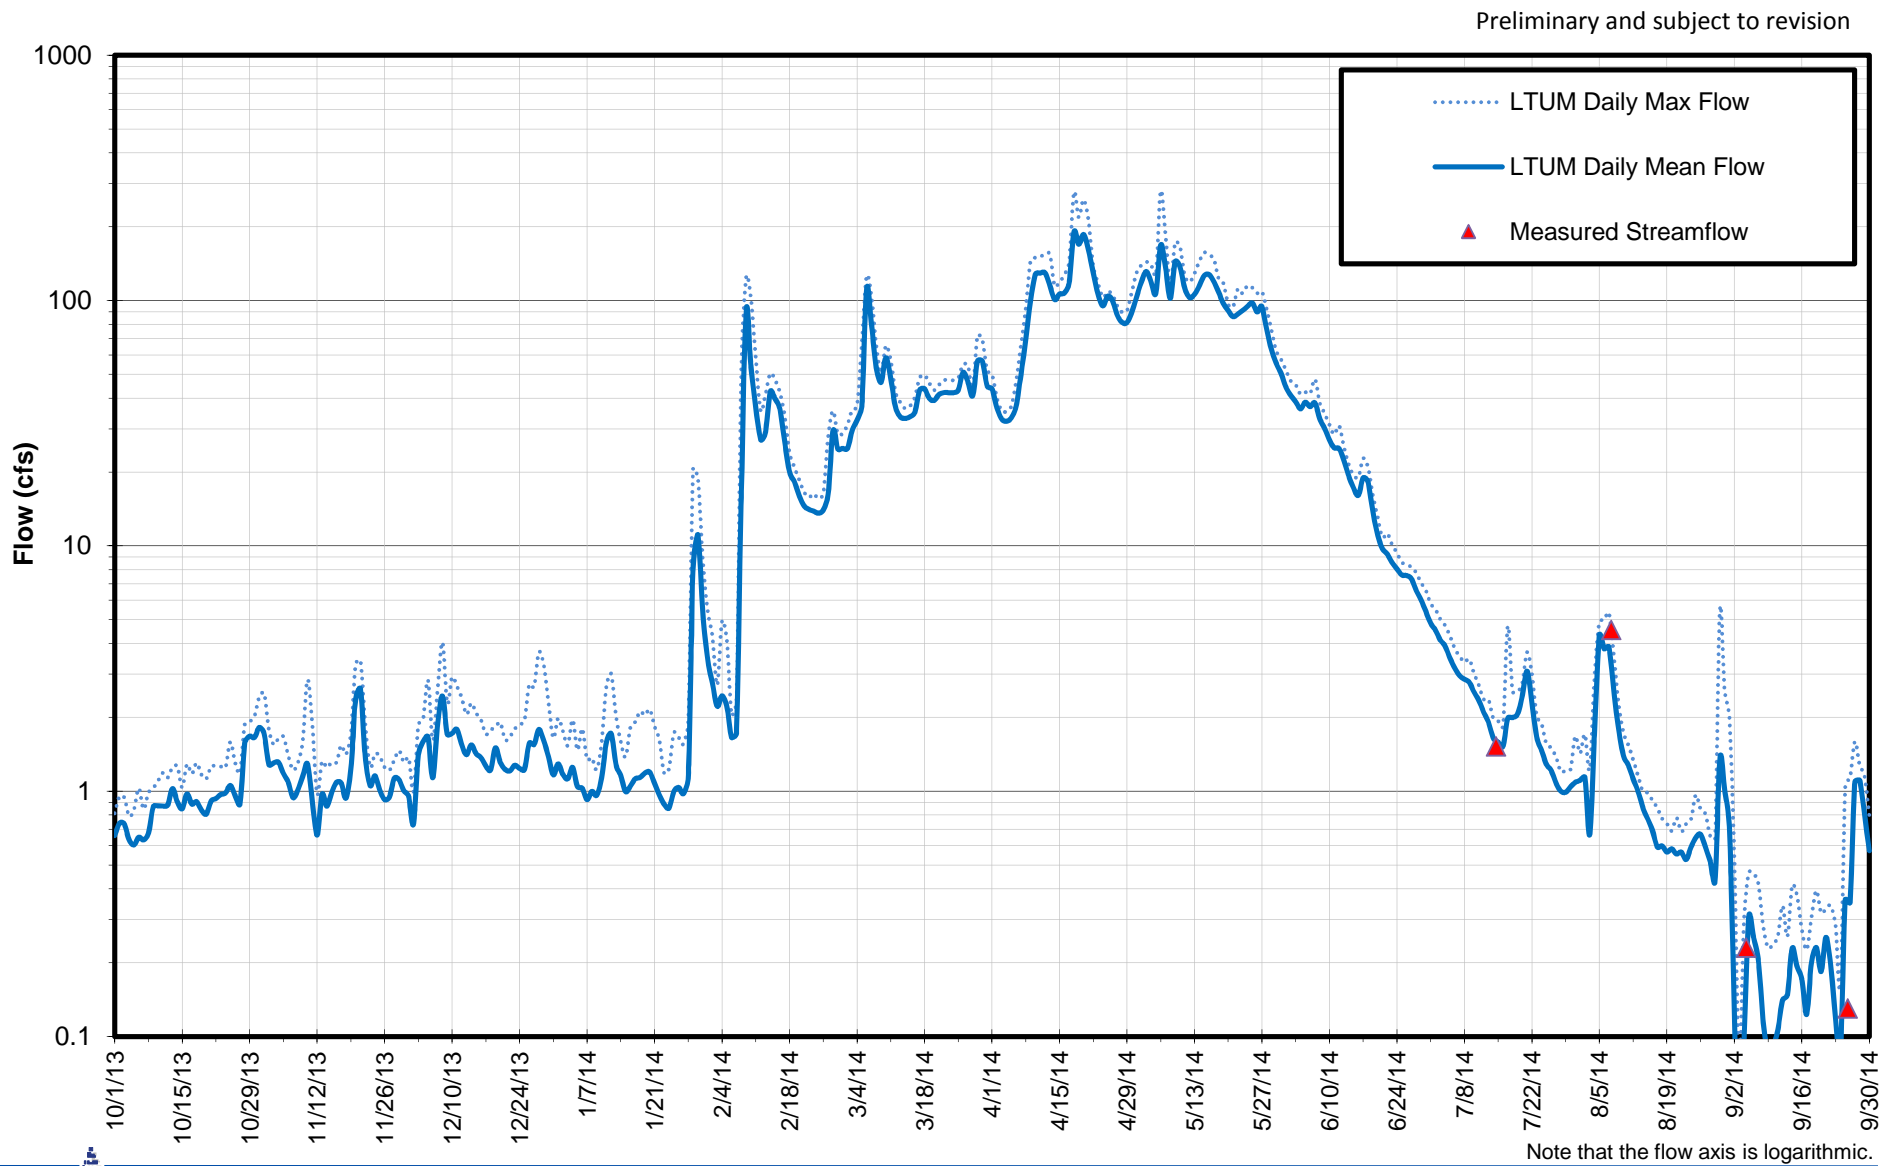
Figure 12. Daily flow hydrograph, Little Truckee River, below Upper Perazzo Meadow (LTUM), Sierra County, California, water year 2014.

Mean daily flow at the beginning of the water year was approximately 0.3 to 0.5 cfs, significantly lower than observed after WY2011, a wetter than average year. Similar to upstream gages, streamflow responded to fall rainstorms and the storm period between November 28 and December 2, 2012. The annual peak flow of 792 occurred on December 2, and was just shy of the maximum flow for the period of record (801 cfs during spring snowmelt in June 2011). Peak snowmelt runoff of 302 cfs occurred on April 28, 2013. Streamflow then receded steadily during an early dry and hot summer with small responses to a few summer thunderstorms, levelling off at a baseflow of approximately 0.3 to 0.5 cfs, similar to baseflow observed at the beginning of the water year. In the absence of snowmelt, baseflow was likely sustained by groundwater discharge to the channel that originates from Perazzo Creek and groundwater storage in Upper Perazzo Meadow.

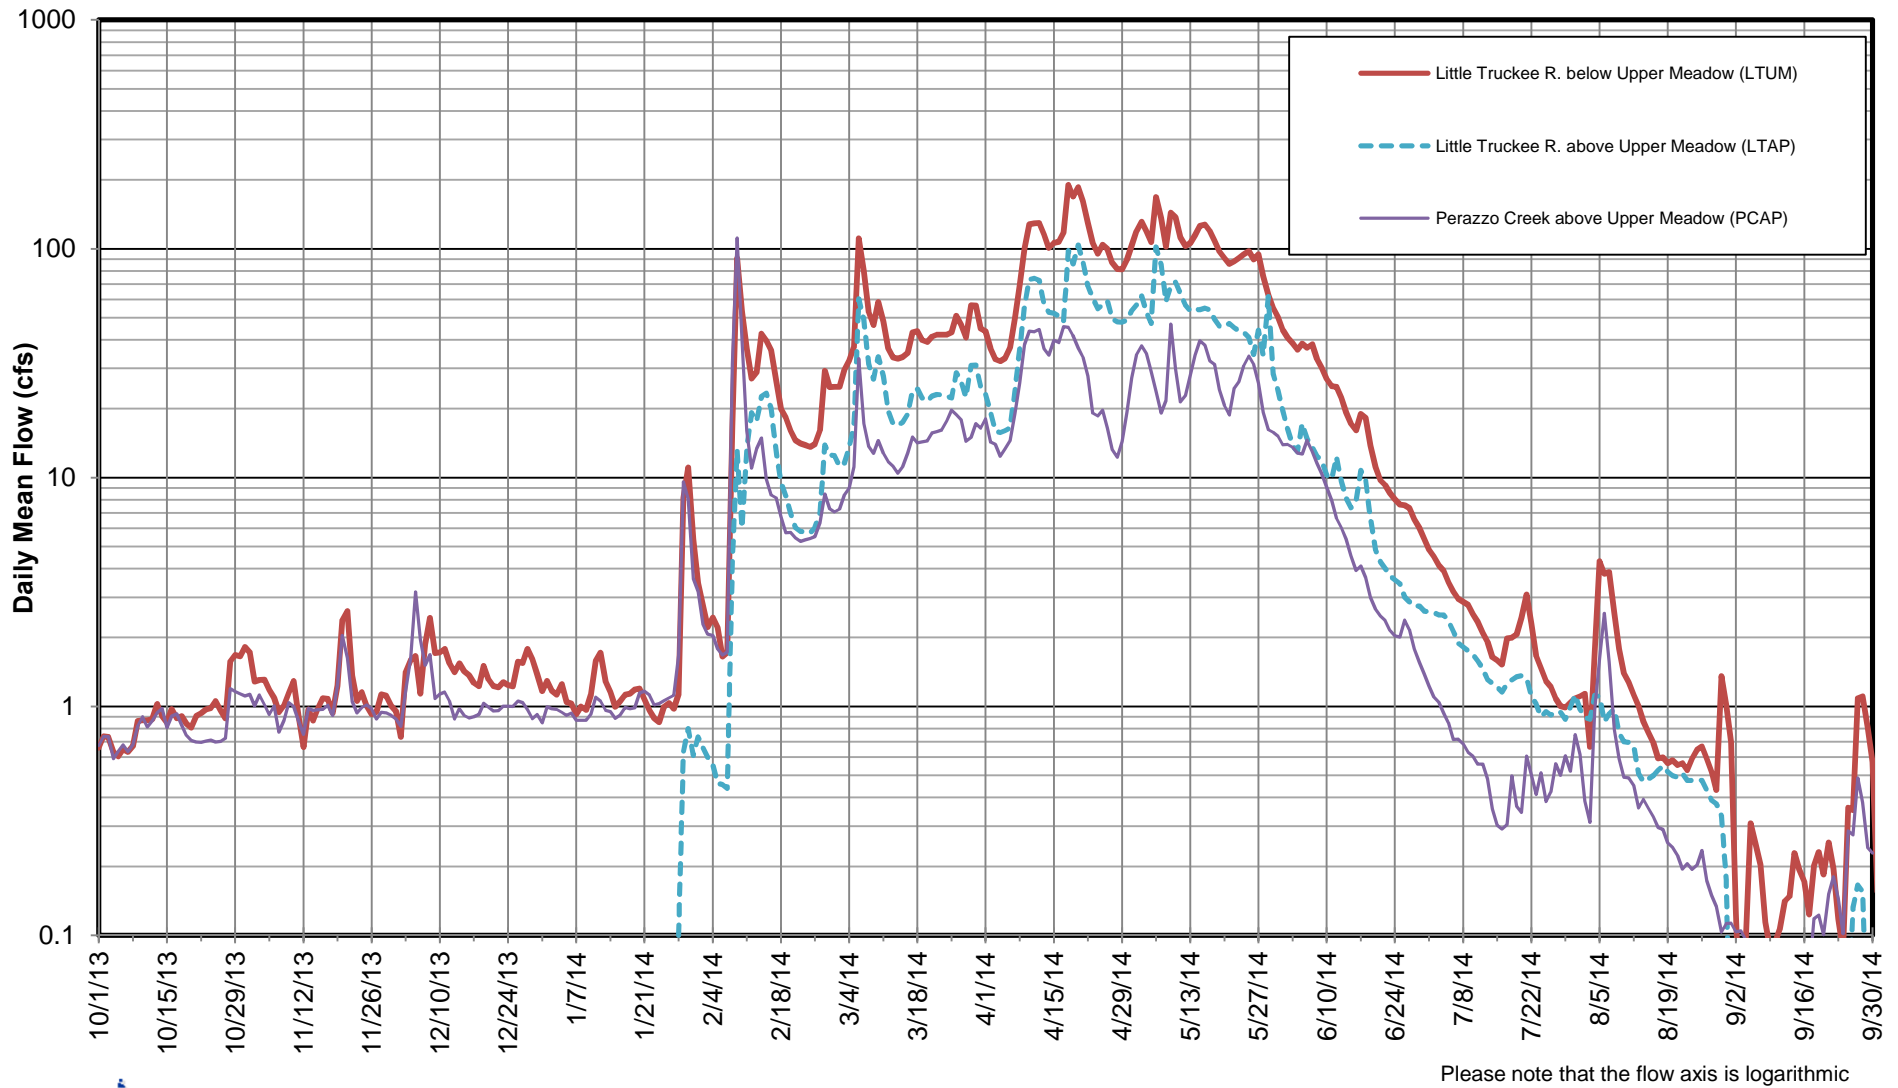
**Figure 13. Daily flow hydrographs:
Upper Perazzo Meadow Inflow and Outflow, Sierra County, California,
water year 2014.**

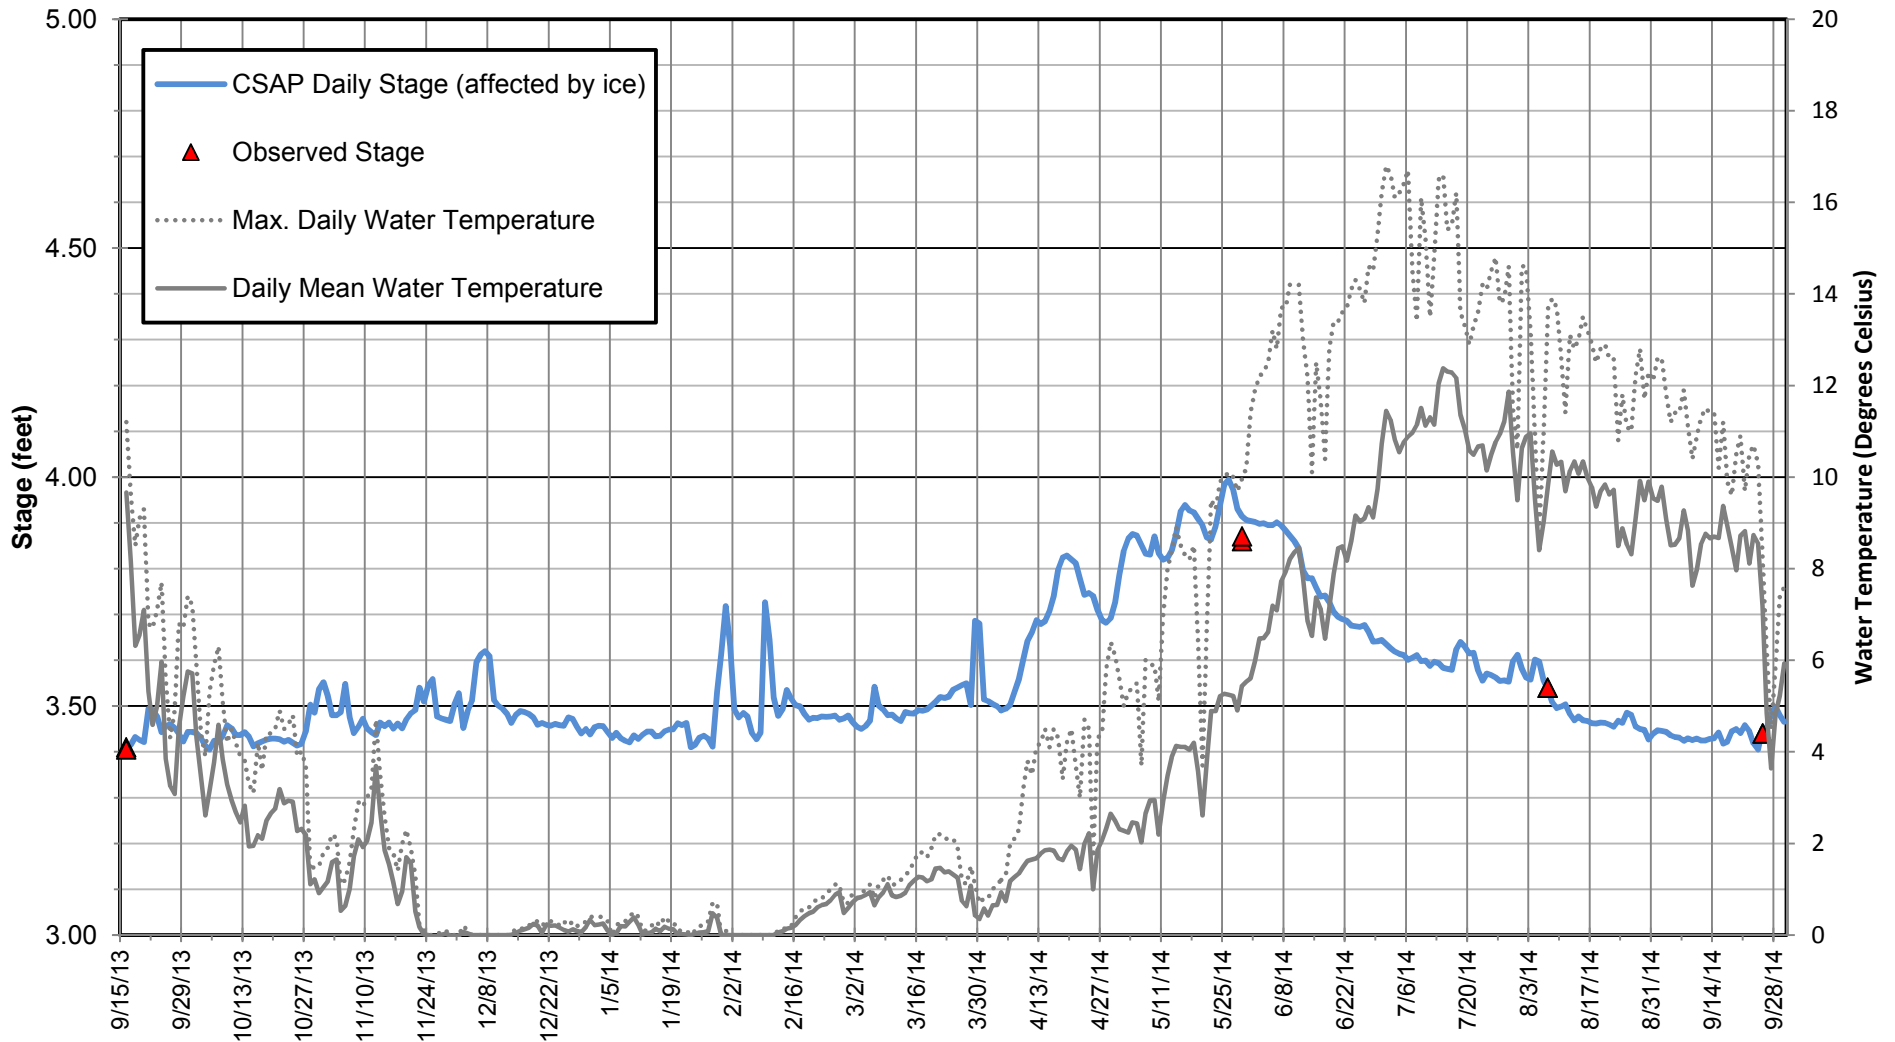
Figure 14. Daily stage and water temperature, Cold Stream above Perazzo Meadows (CSAP), Sierra County, California, water year 2014.

Ice jam during the January 20-21, 2012 rain-on-snow event likely attributed to a super-elevated stage reading.

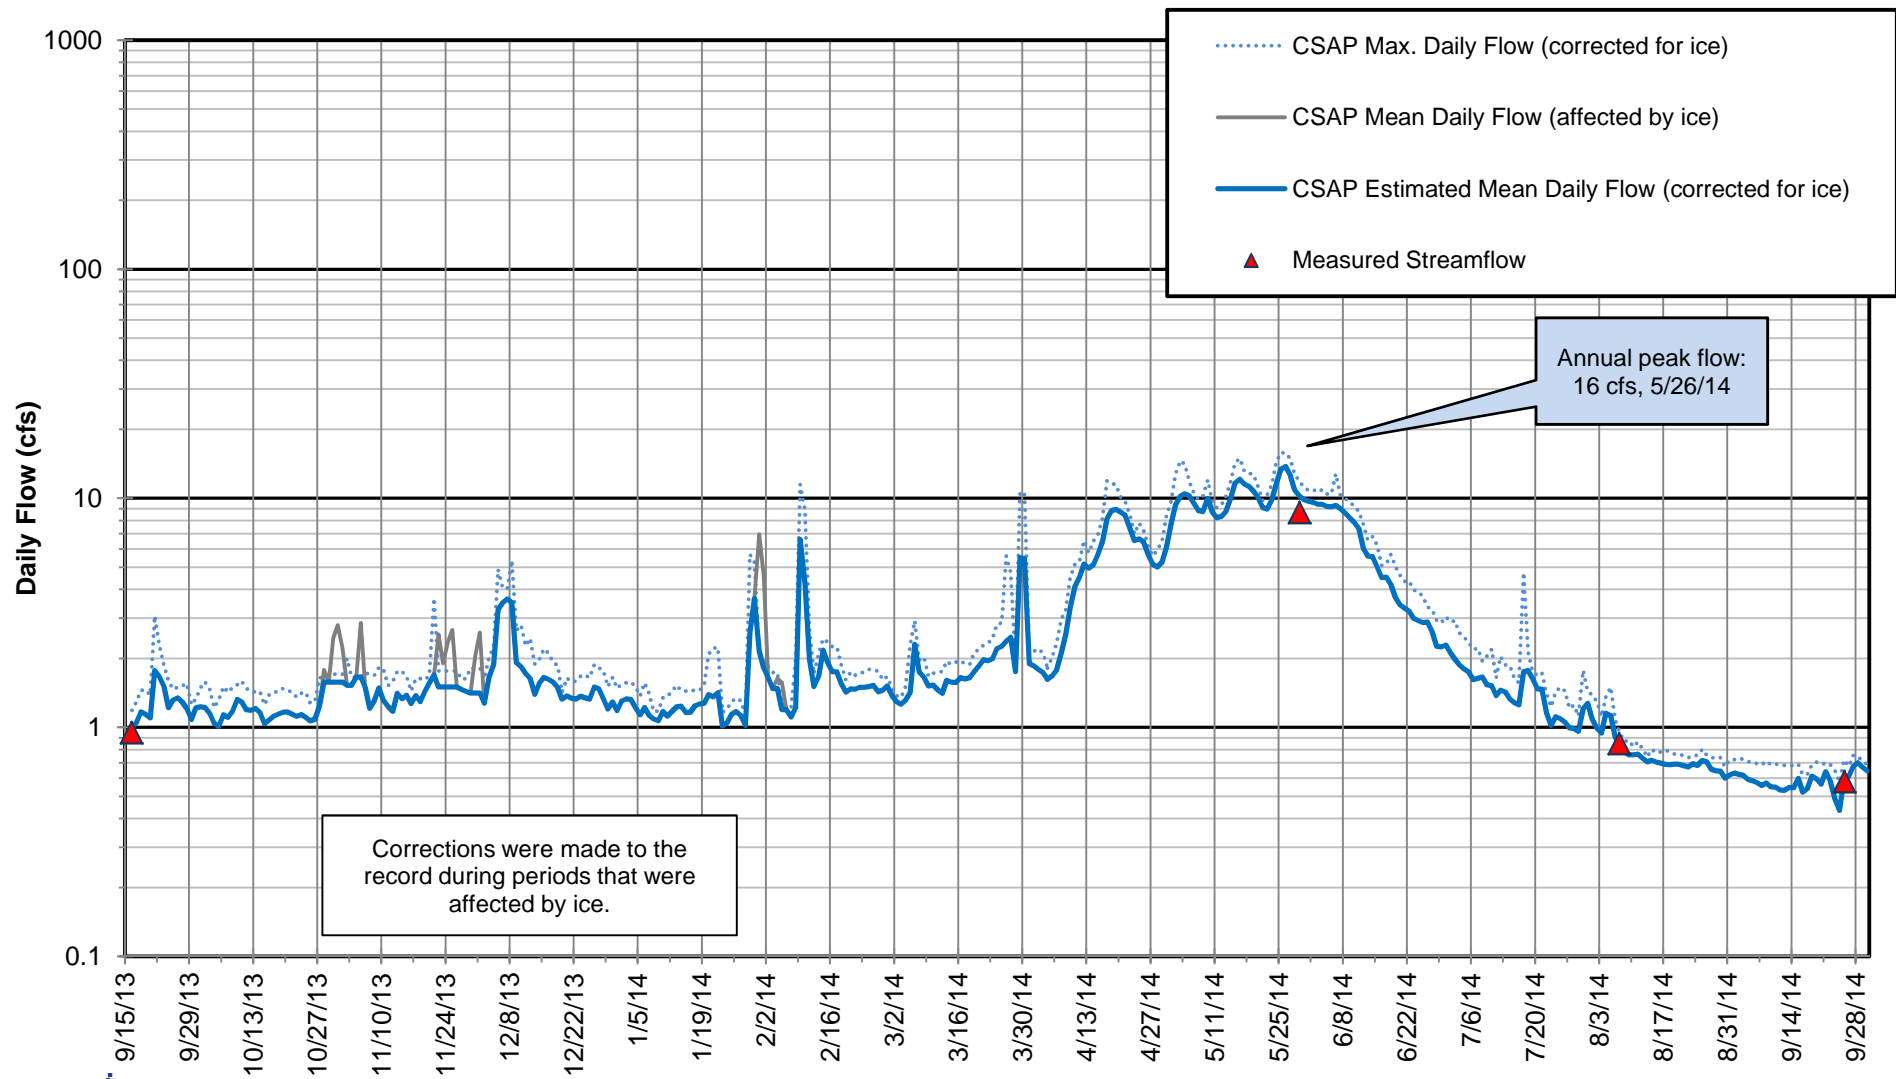
Figure 15. Daily flow hydrograph, Cold Stream above Perazzo Meadows (CSAP), Sierra County, California, water year 2014. Annual peak flow of 16 cfs occurred on May 26, 2014. Baseflow was lower at the end of the water year than at the beginning, which reflects water year 2014 being a low-precipitation year.

May 13, 2013. As has been observed in other years, the peak snowmelt flow on Cold Stream occurred slightly later than at the other stations, due to the high-elevation, north-facing nature of the watershed. The gage was affected by ice during in mid-February, when flows remained fairly steady at approximately the same baseflow as in late fall, 0.7 cfs. Following the peak snowmelt, flows receded steadily, but stabilized at a baseflow of 0.9 cfs, slightly higher than the previous fall. In total, Cold Stream contributed approximately 3,006 acre-feet of surface water to the Middle Meadow in WY2013. As consistent with previous years, Cold Stream appears to provide only a small fraction (roughly 8 percent) of the total annual runoff to the Middle Meadow, but accounts for 65- to 70-percent of the baseflow entering the Middle Meadow during the late summer and fall months.

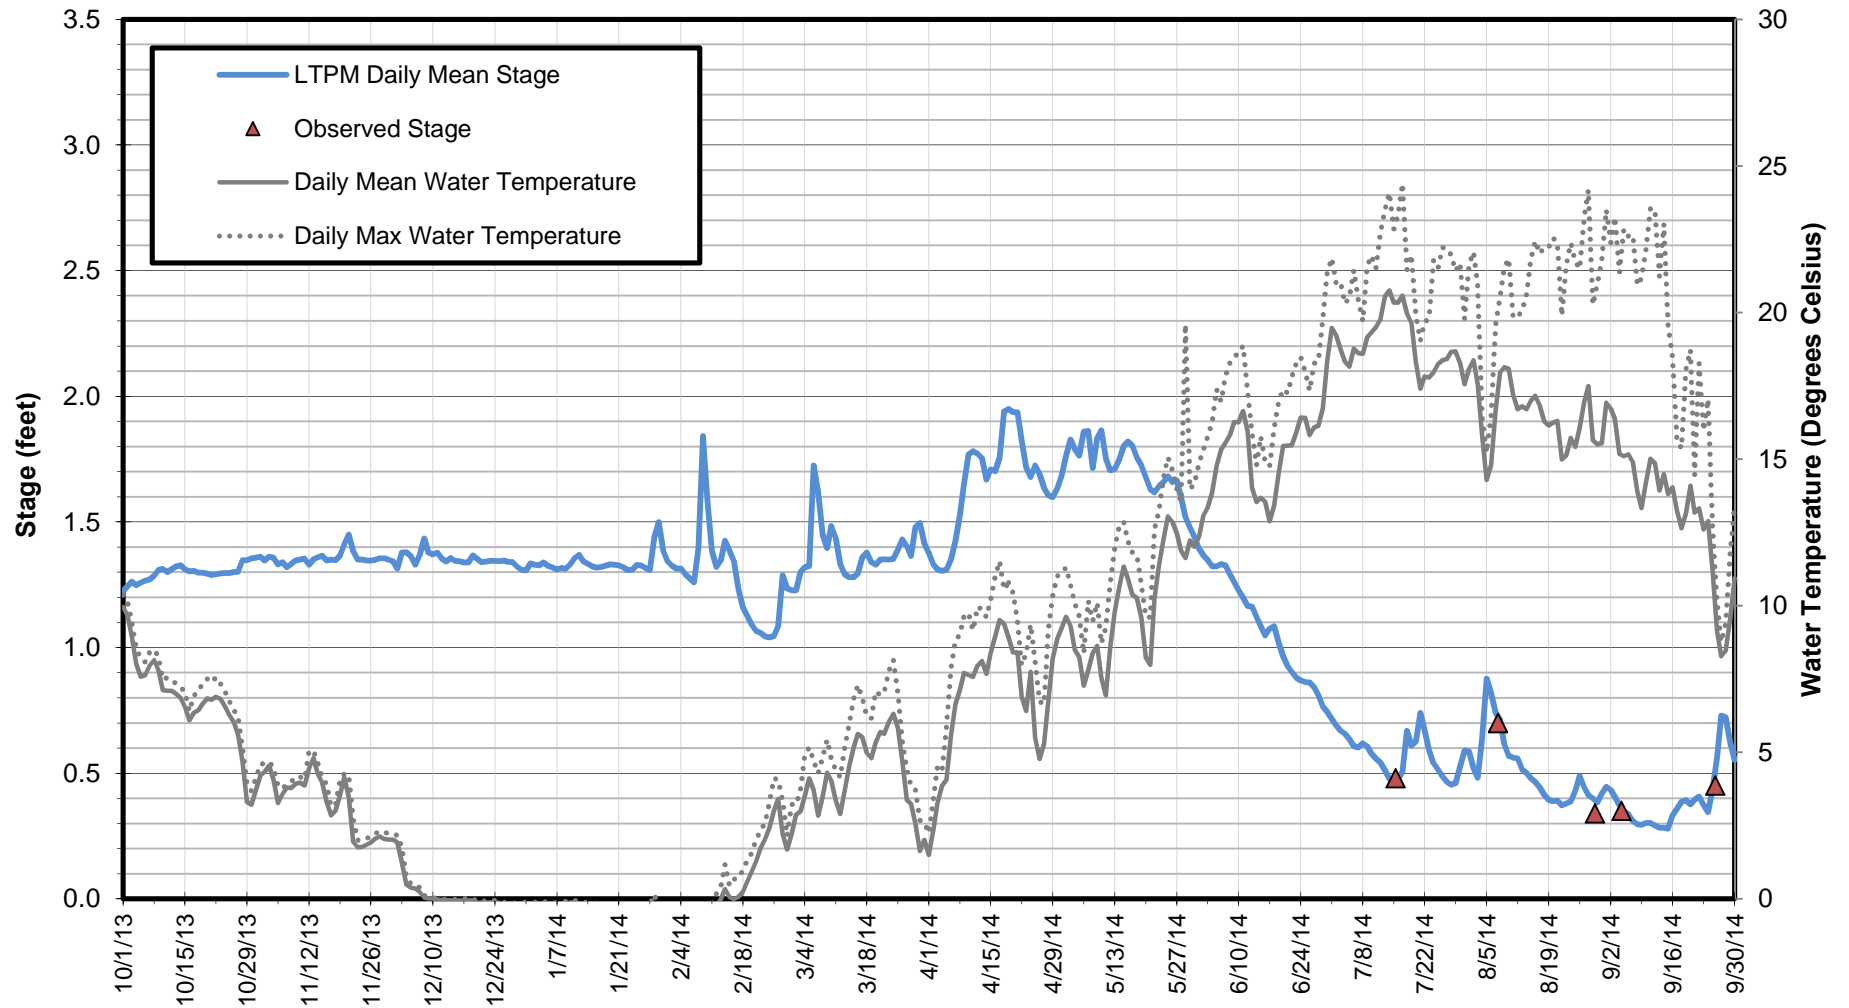
Figure 16. Daily stage and water temperature: Little Truckee River below Middle Perazzo Meadow (LTPM), Sierra County, California, water year 2014.

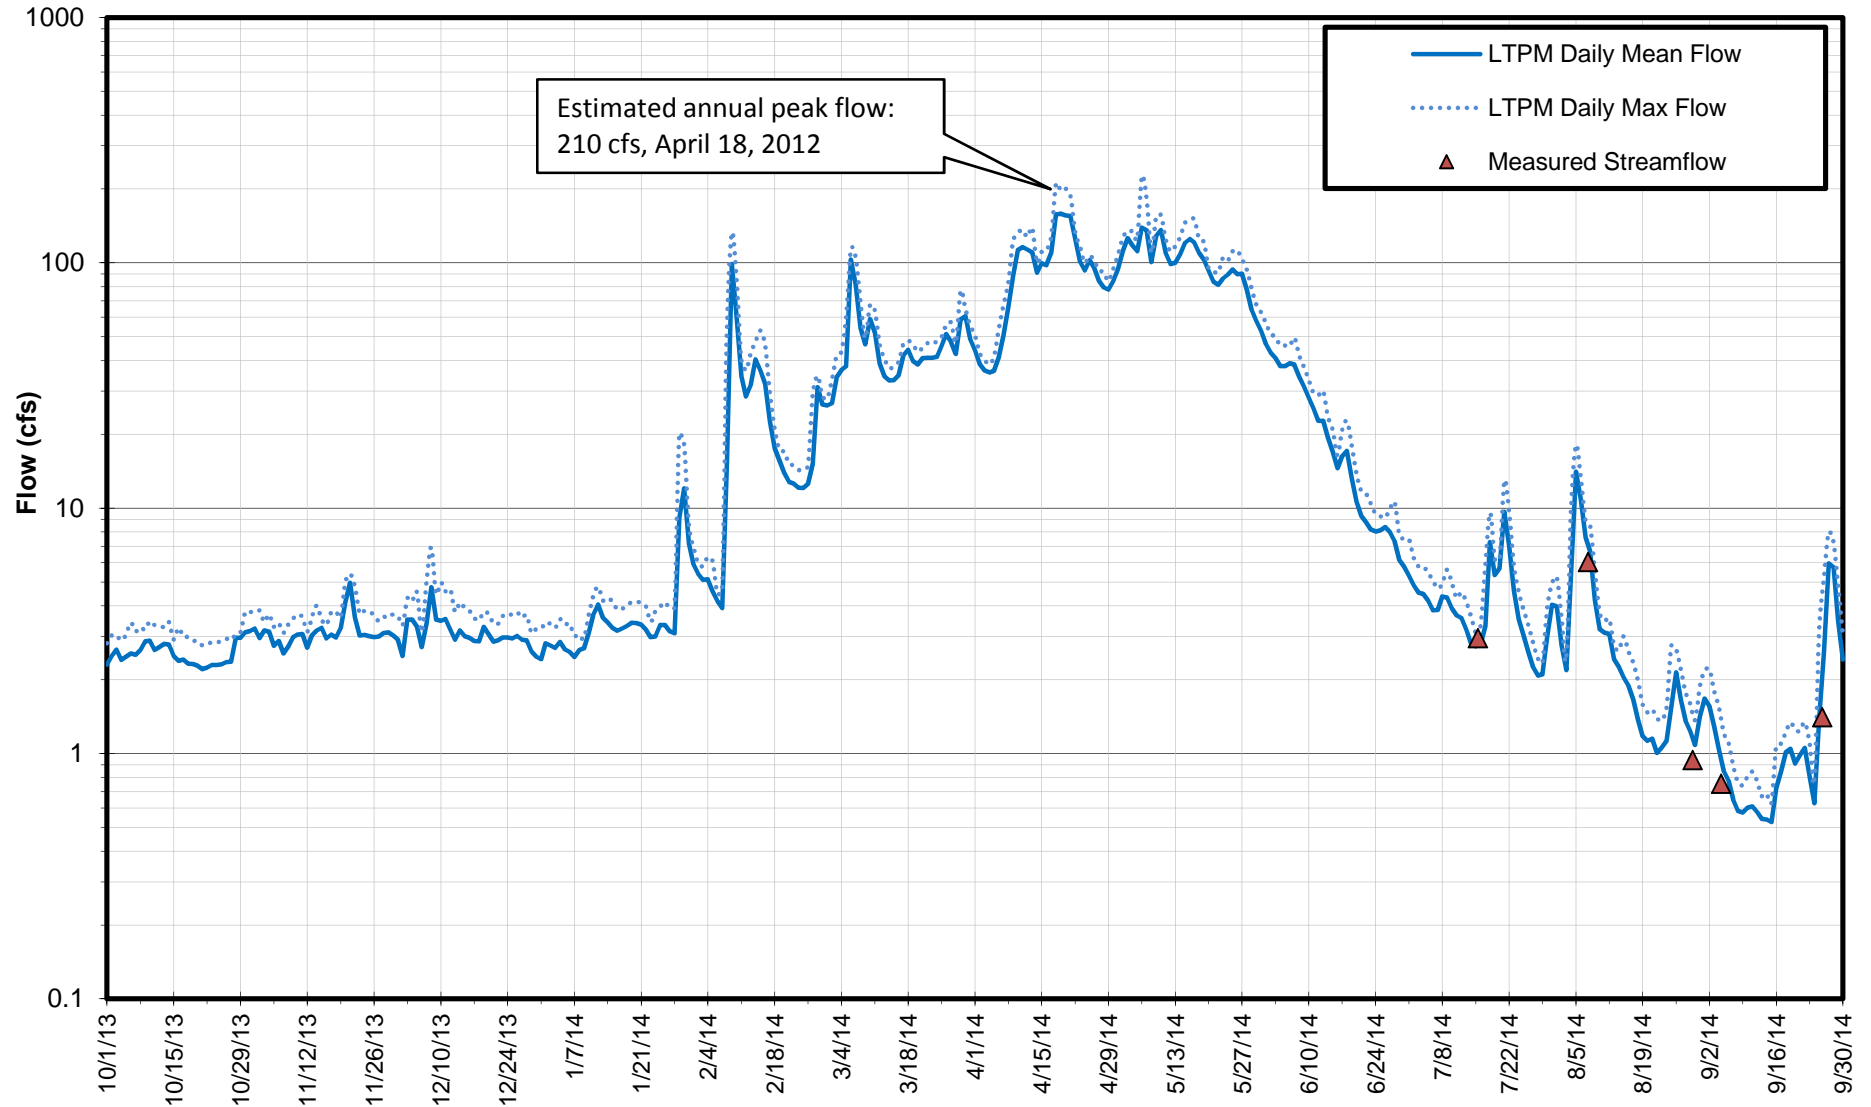
Note that the flow axis is logarithmic.

Figure 17. Daily flow hydrograph, Little Truckee River below Middle Perazzo Meadow (LTPM), Sierra County, California, water year 2014.

At the beginning of the water year baseflow was approximately 0.8 cfs. Similar to upstream gages, streamflow responded to autumn rainstorms, and rose steadily through October and into November. Ice was observed at the gaging station during this period and in January; with minimal apparent effects on stage and flow, ice has been accounted for by applying rating curve shifts. As with the other stations, high flows were caused by the rain on snow events of late November and early December, and culminated with the annual peak of approximately 1,166 cfs on December 2, 2012. Flows receded steadily after this storm, but winter baseflow of 30 to 60 cfs was maintained through January and February until spring snowmelt began in early March. Peak snowmelt of 341 cfs occurred on May 11, slightly higher than the peak of 328 cfs on April 30. Summer baseflow stabilized at approximately 2 cfs in August and September. Beaver dam construction at the gage pool outlet caused the water level in the pool to rise beginning on July 30, 2013, and required a significant rating curve shift to be applied for calculation of the streamflow record during this period, when baseflow appears to have held steady. In total, the Little Truckee River, at the outlet of Middle Perazzo Meadow discharged approximately 46,334 acre-feet of water during WY2013.

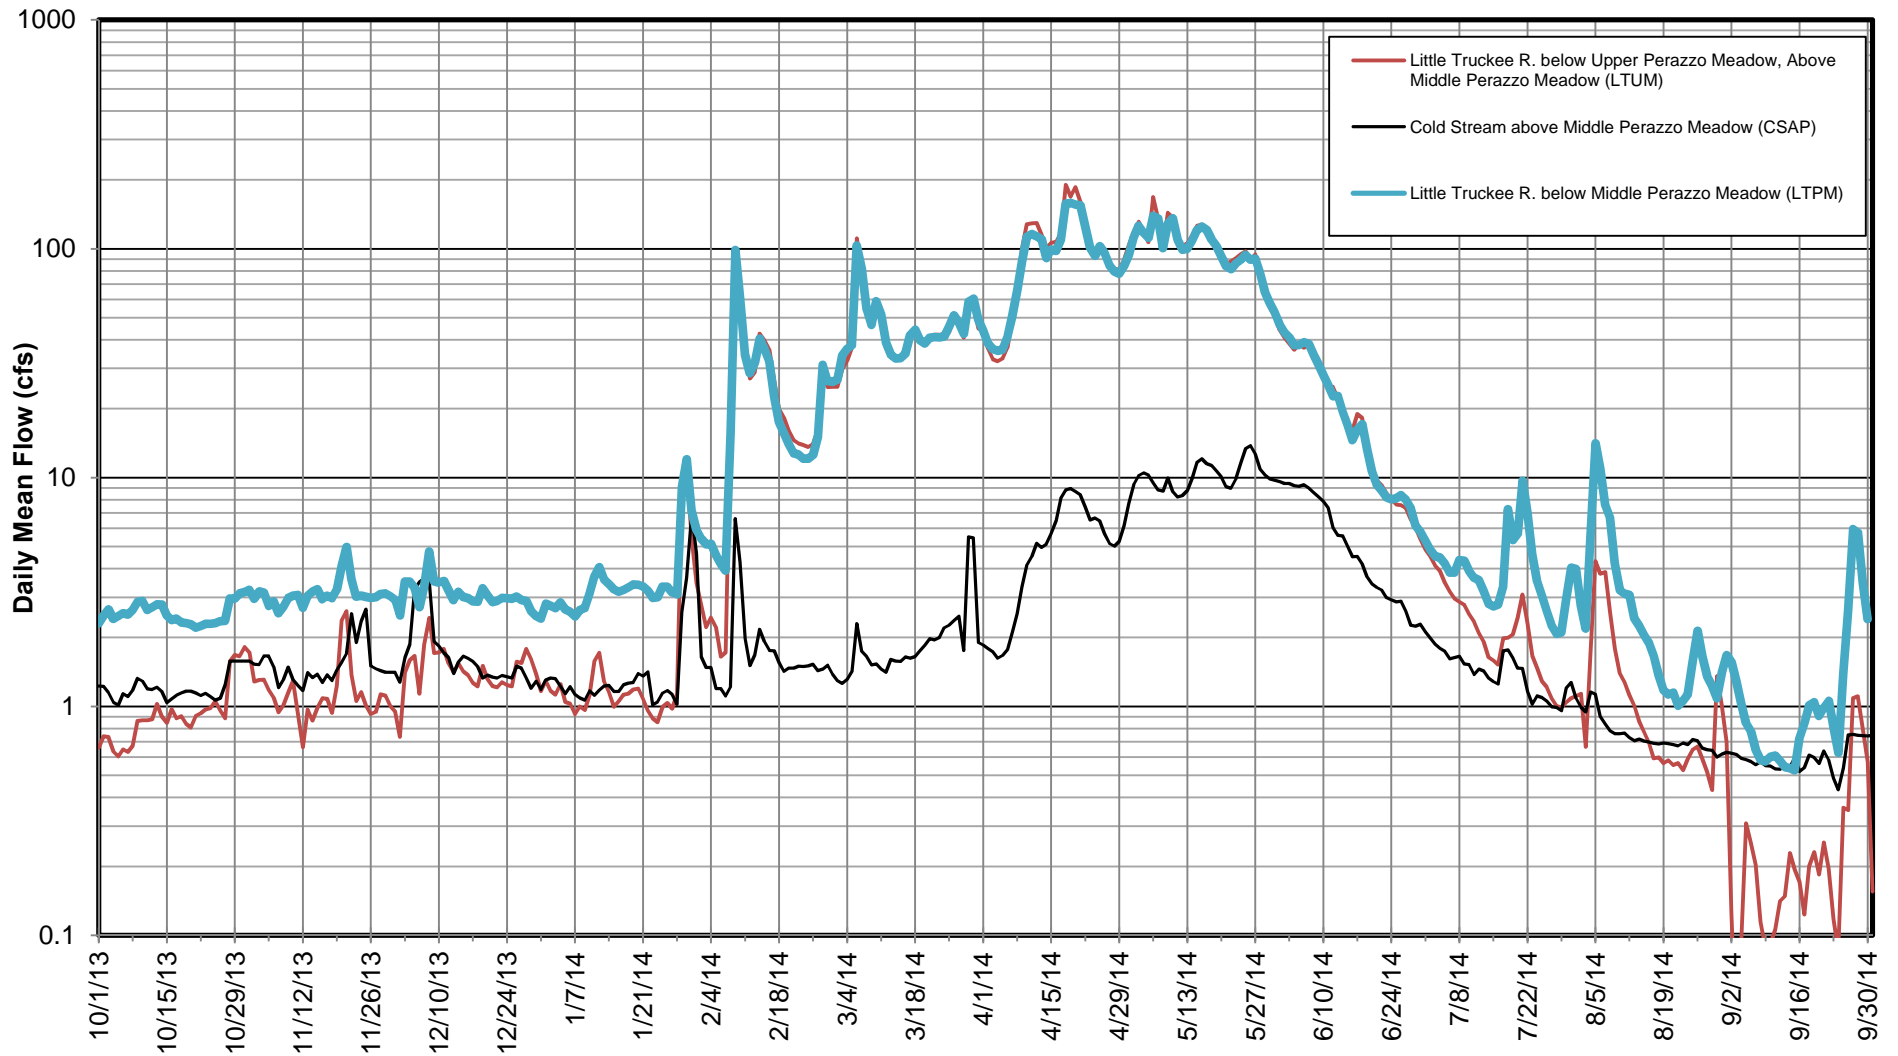
Please note that the flow axis is logarithmic

**Figure 18. Daily flow hydrographs:
Middle Perazzo Meadow Inflow and Outflow, Sierra County, California,
water year 2014.**

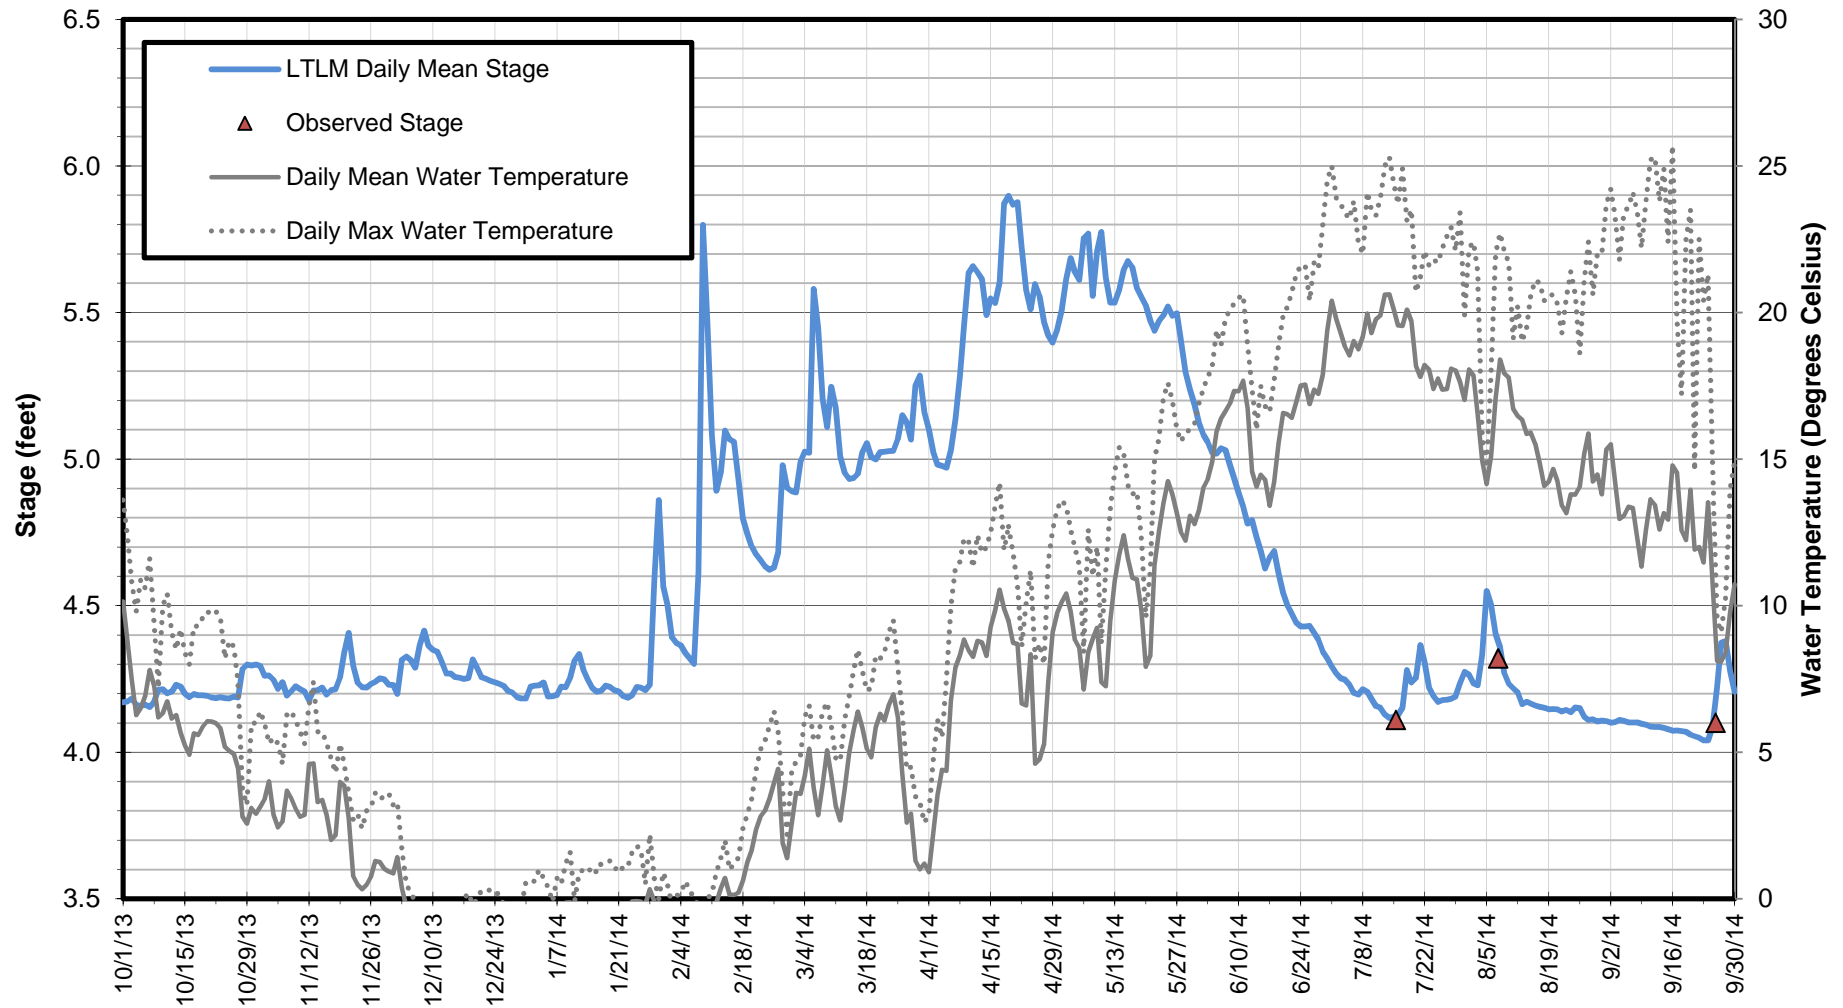
Figure 19. Daily stage and water temperature: Perazzo Creek below Middle Perazzo Meadow (LTLM), Sierra County, California, water year 2014.
