**PERAZZO MEADOWS RESTORATION
HYDROLOGIC MONITORING DATA
REPORT: UPPER AND MIDDLE
PERAZZO MEADOWS
SIERRA COUNTY, CALIFORNIA

WATER YEAR 2013**

Report prepared for:
Truckee River Watershed Council

Balance Hydrologics, Inc.

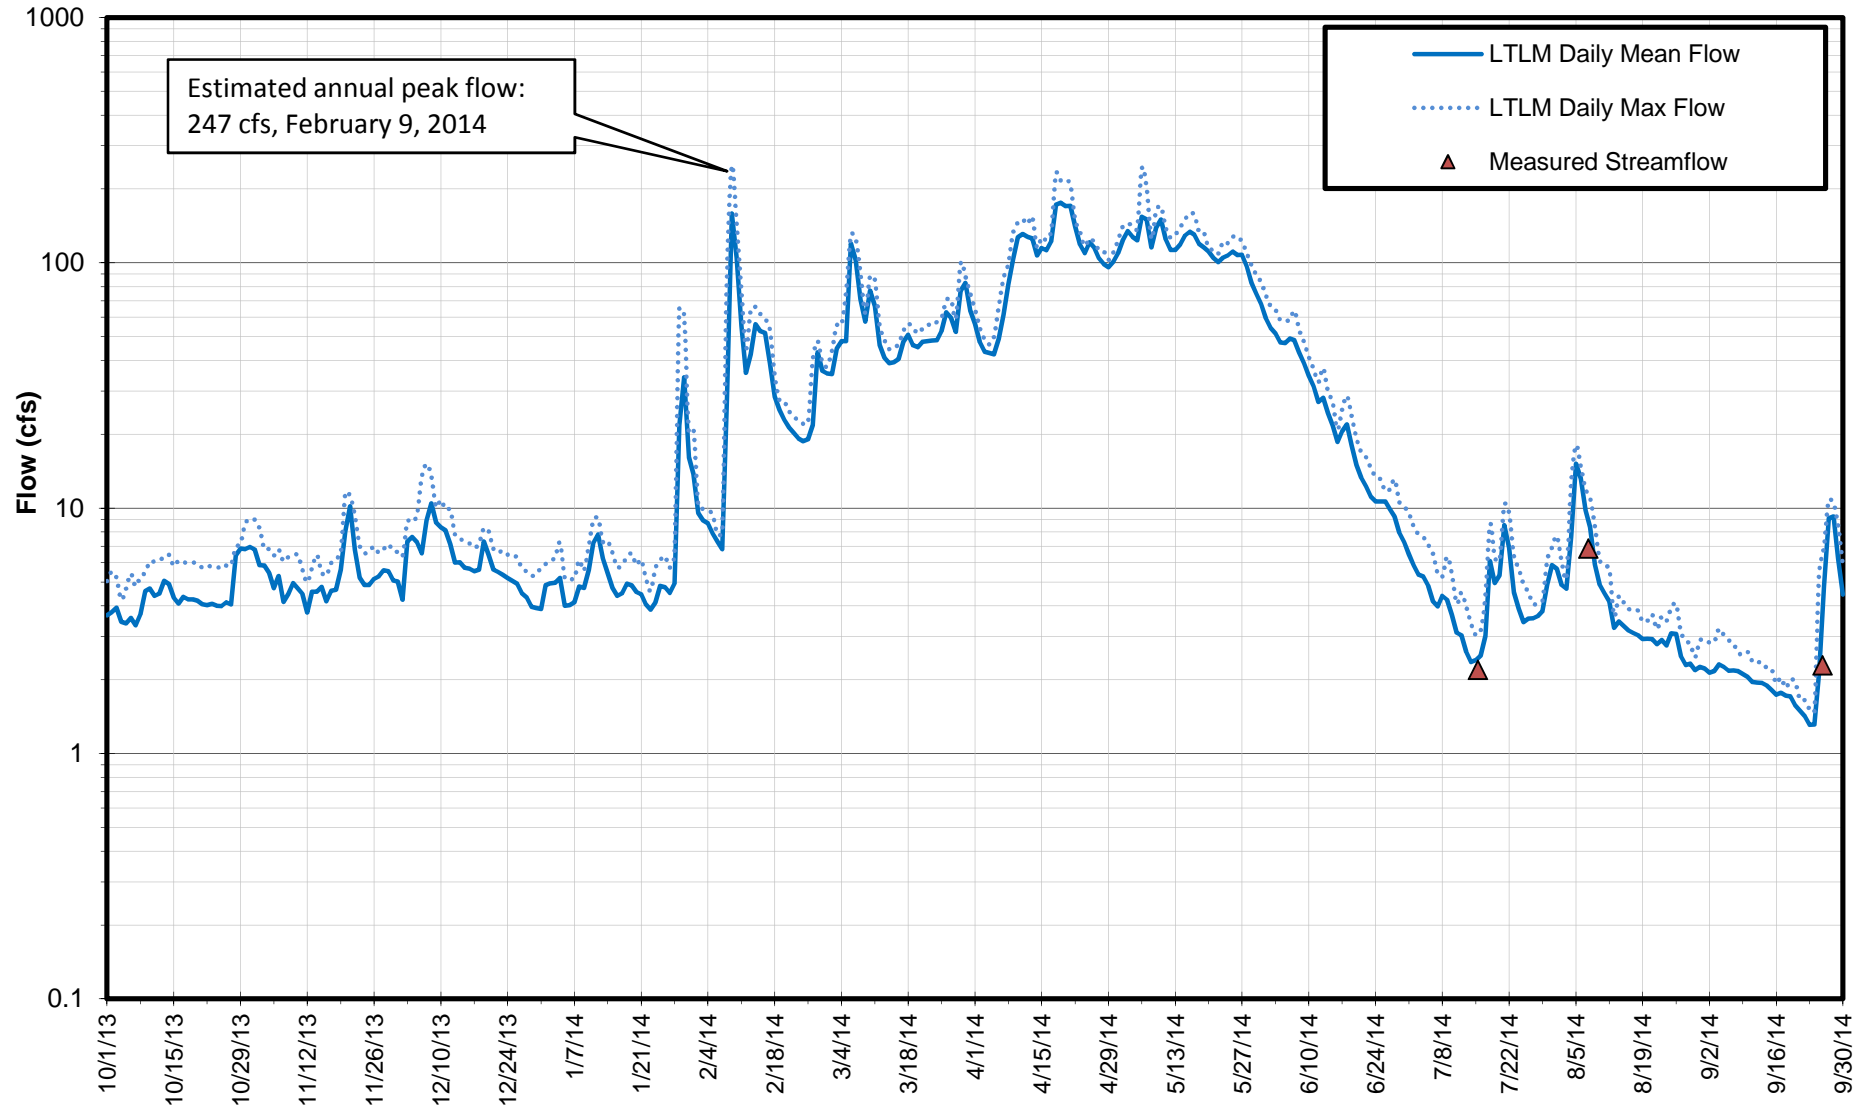
Figure 20. Daily flow hydrograph, Perazzo Creek below Middle Perazzo Meadow (LTLM), Sierra County, California, water year 2014.

Lower Perazzo Meadow, downstream from LTPM, has not yet been restored. Beginning in August 2011, Balance began coordinating with UC Merced researchers to develop a continuous record of flow at the Lower Meadow outlet (LTLM) to characterize baseline conditions in preparation for future restoration activities. This gage is the downstream-most gaging station in Perazzo Meadows, located approximately 0.85 river miles upstream of the Sierra Valley Diversion Ditch. Ongoing collection of baseline data prior to restoration of the meadow will provide a valuable data set against which to compare post-restoration conditions. Under current conditions, data at this station can be used to evaluate differences in meadow storage between a restored meadow (Middle or Upper Meadow) and an unrestored meadow (Lower Meadow).

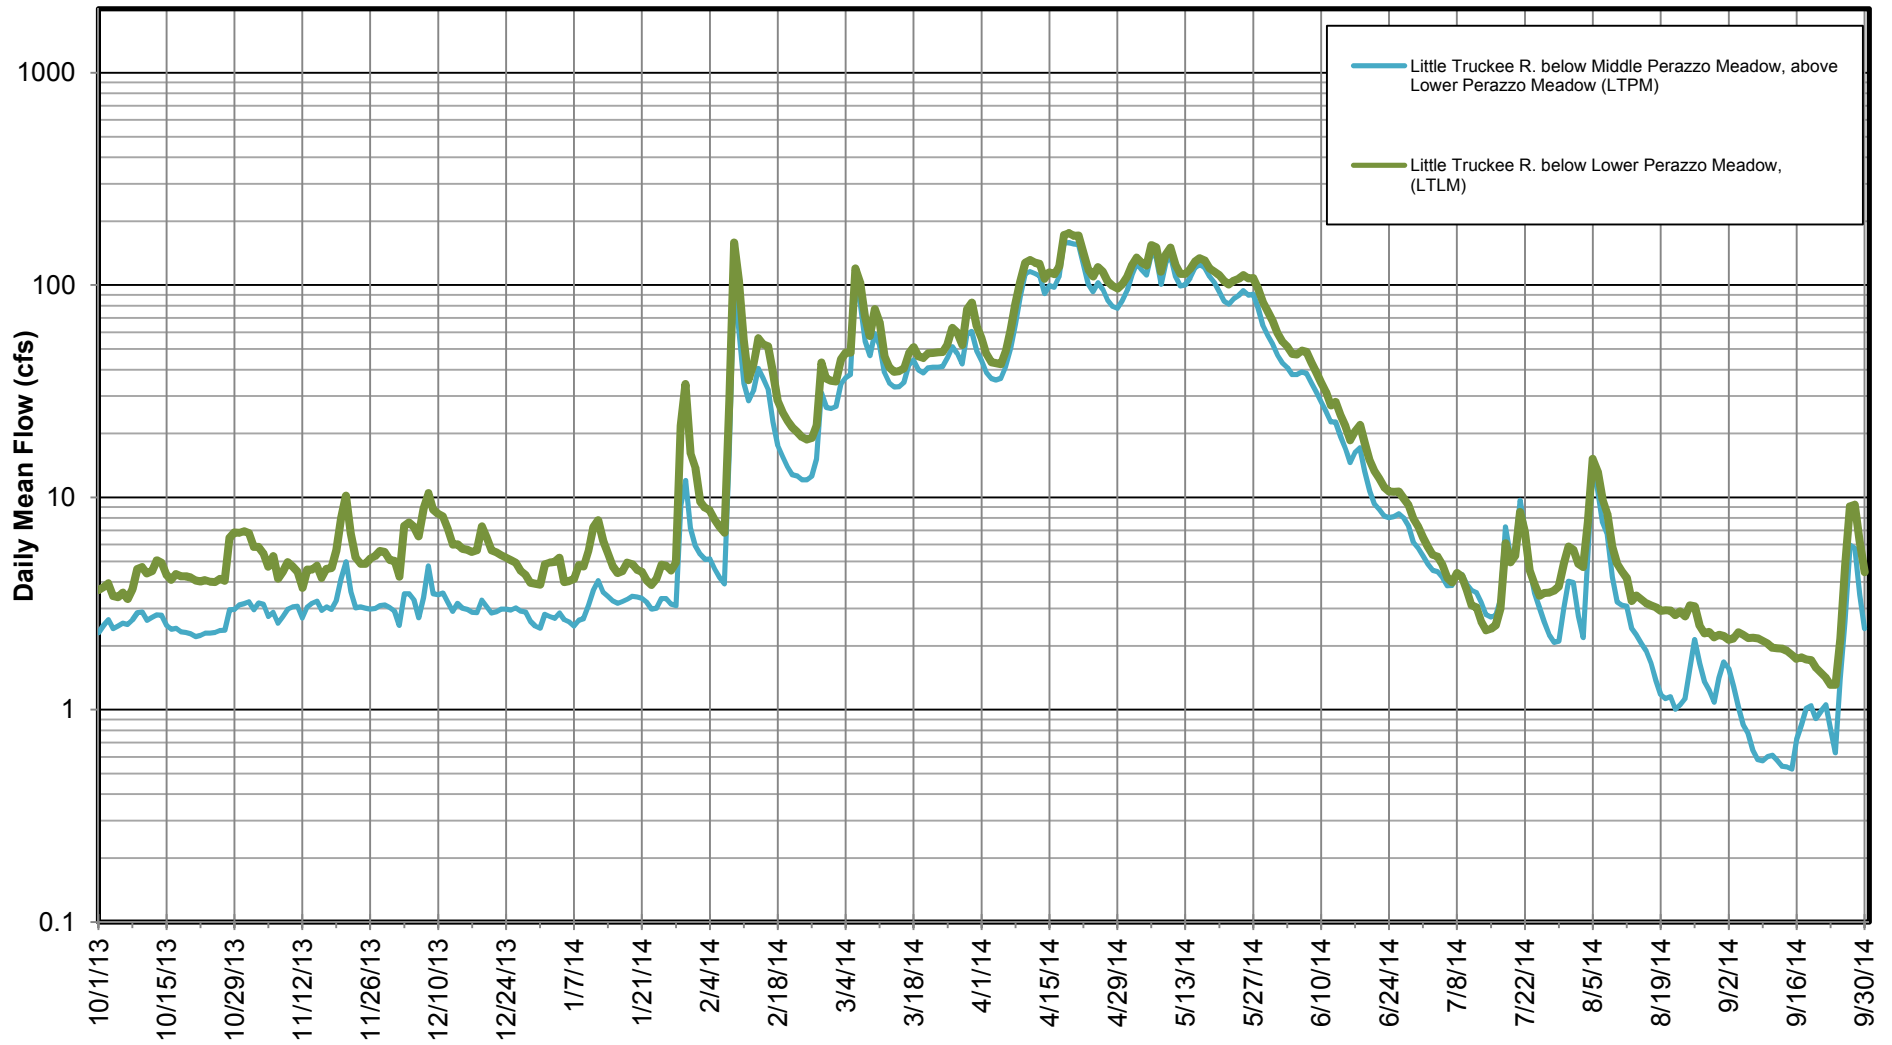
Please note that the flow axis is logarithmic

Figure 21. Daily flow hydrographs: Lower Perazzo Meadow inflow and outflow stations, Sierra County, California, water year 2014.

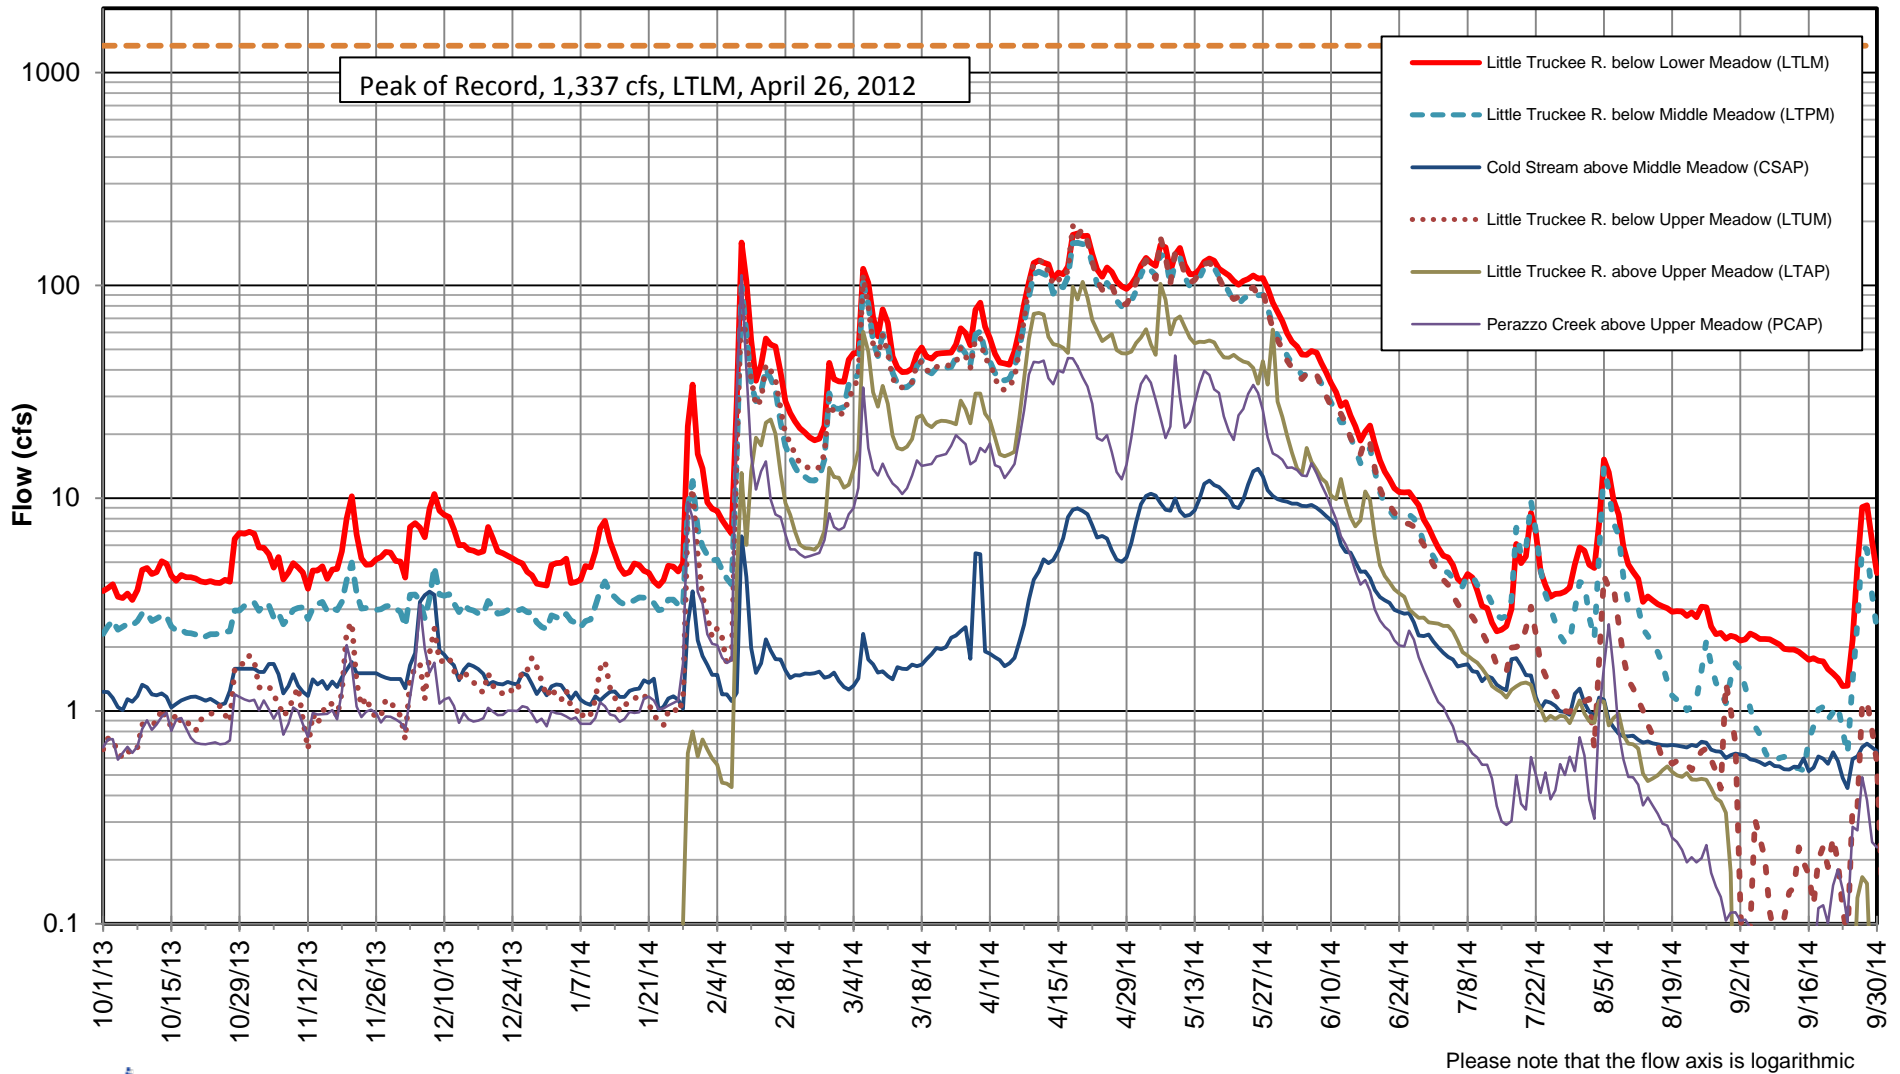
Figure 22.

Flow hydrographs for all stations, Perazzo Meadows, Sierra County, California, water year 2014. Peak flows in WY2014 were an order of magnitude less than the peak of record. At the outlet of Lower Perazzo Meadow (Station LTLM), peak flow in WY2014 was 247 cfs, compared to peak flow in WY2012 of 1,337 cfs.

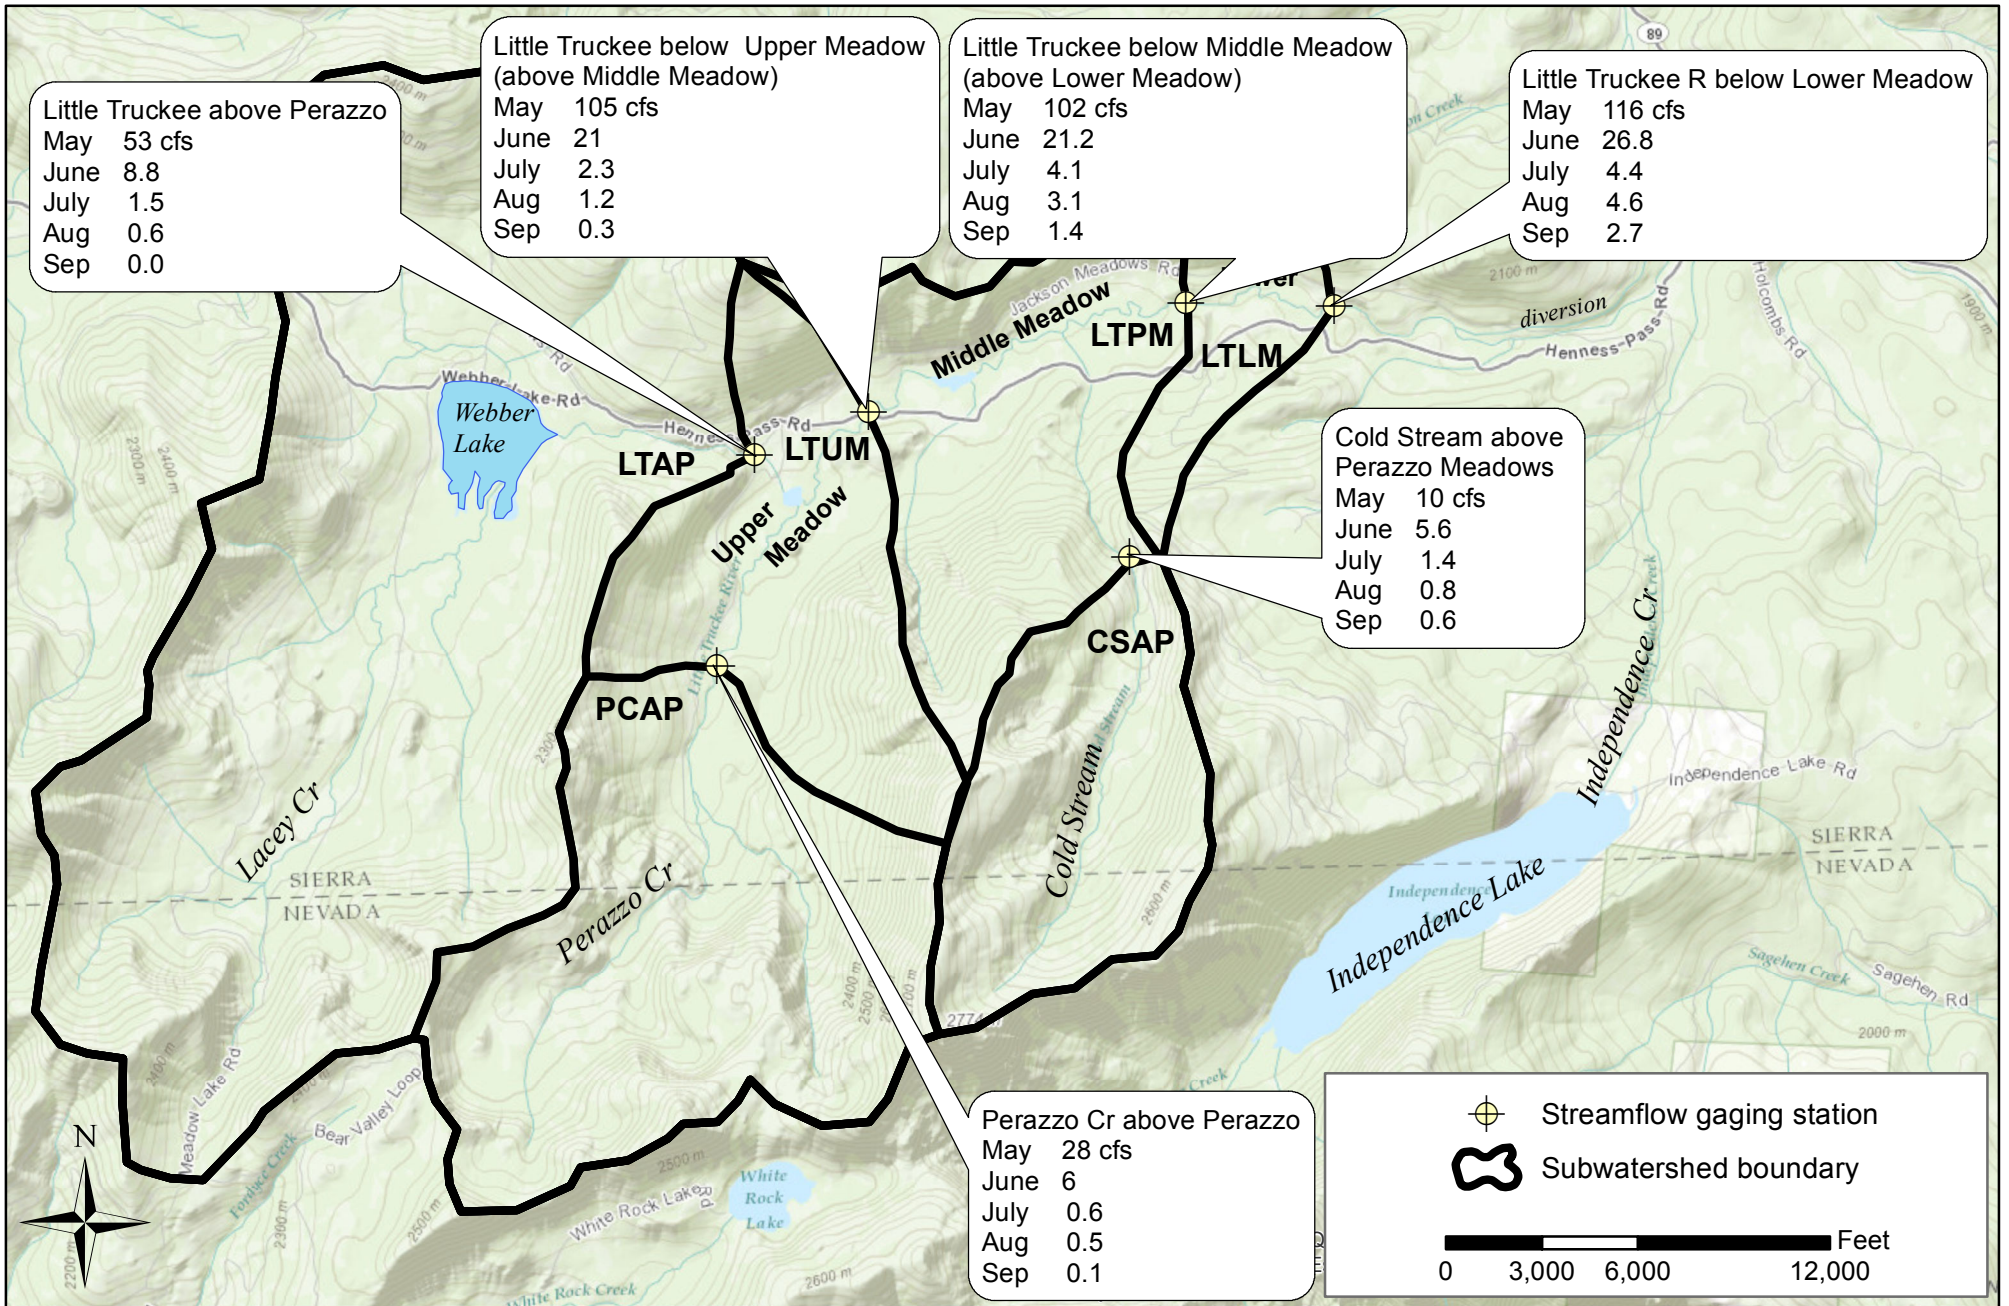
Figure 23. Monthly streamflow during the snowmelt recession period, WY2014, Perazzo Meadows, Sierra County, California

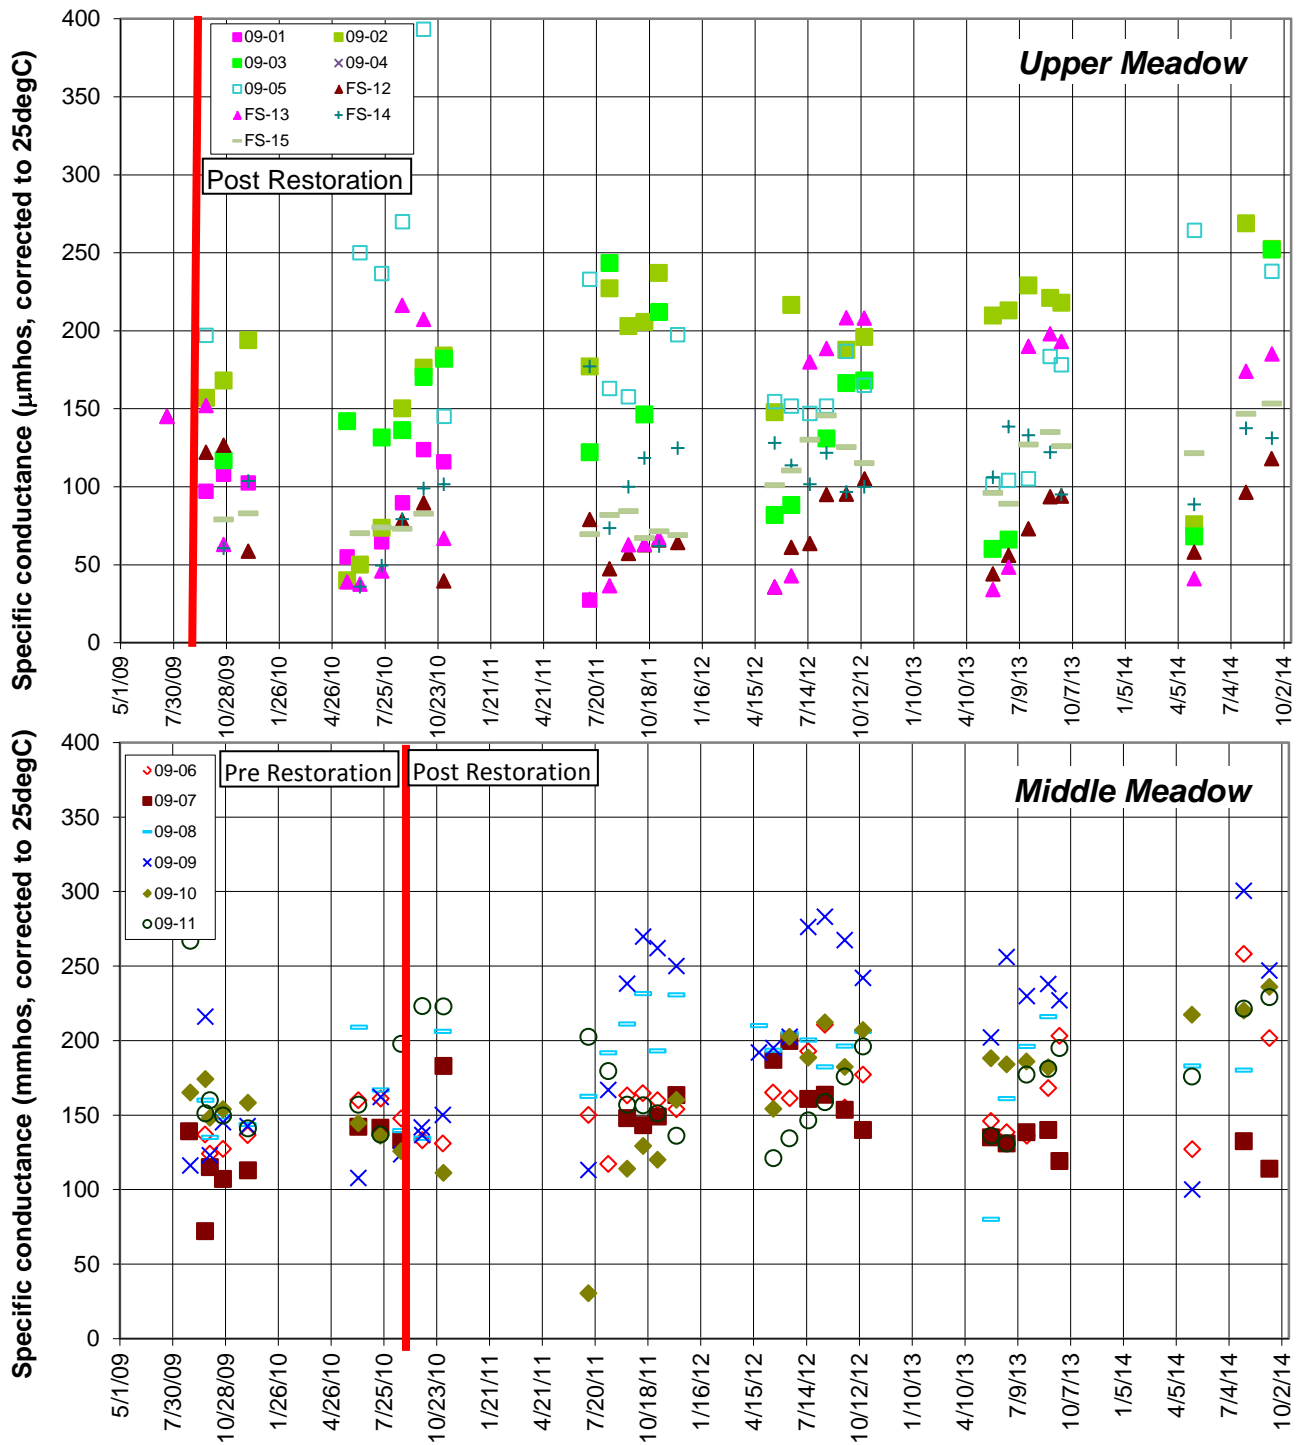
Figure 24. Specific conductance of groundwater, Upper and Middle Perazzo Meadows, Sierra County, California, June 2009 to September 2014
See Figures 2 and 3 for piezometer locations.

Figure 24 shows groundwater specific conductance in piezometers groundwater in the Middle Meadow prior to restoration (WY2010) and following restoration activities (WY2011 through WY2013). Piezometer 09-09 exhibited some of the highest specific conductance both prior to restoration and during the drier than normal conditions of WY2012 and WY2013, an indication that this area is supported by deeper groundwater discharge in all but the wettest years. Specific conductance in 09-07, 09-08 and 09-10, and to a limited degree, 09-06, appear to rely more heavily on deeper groundwater support during this second year of drought.

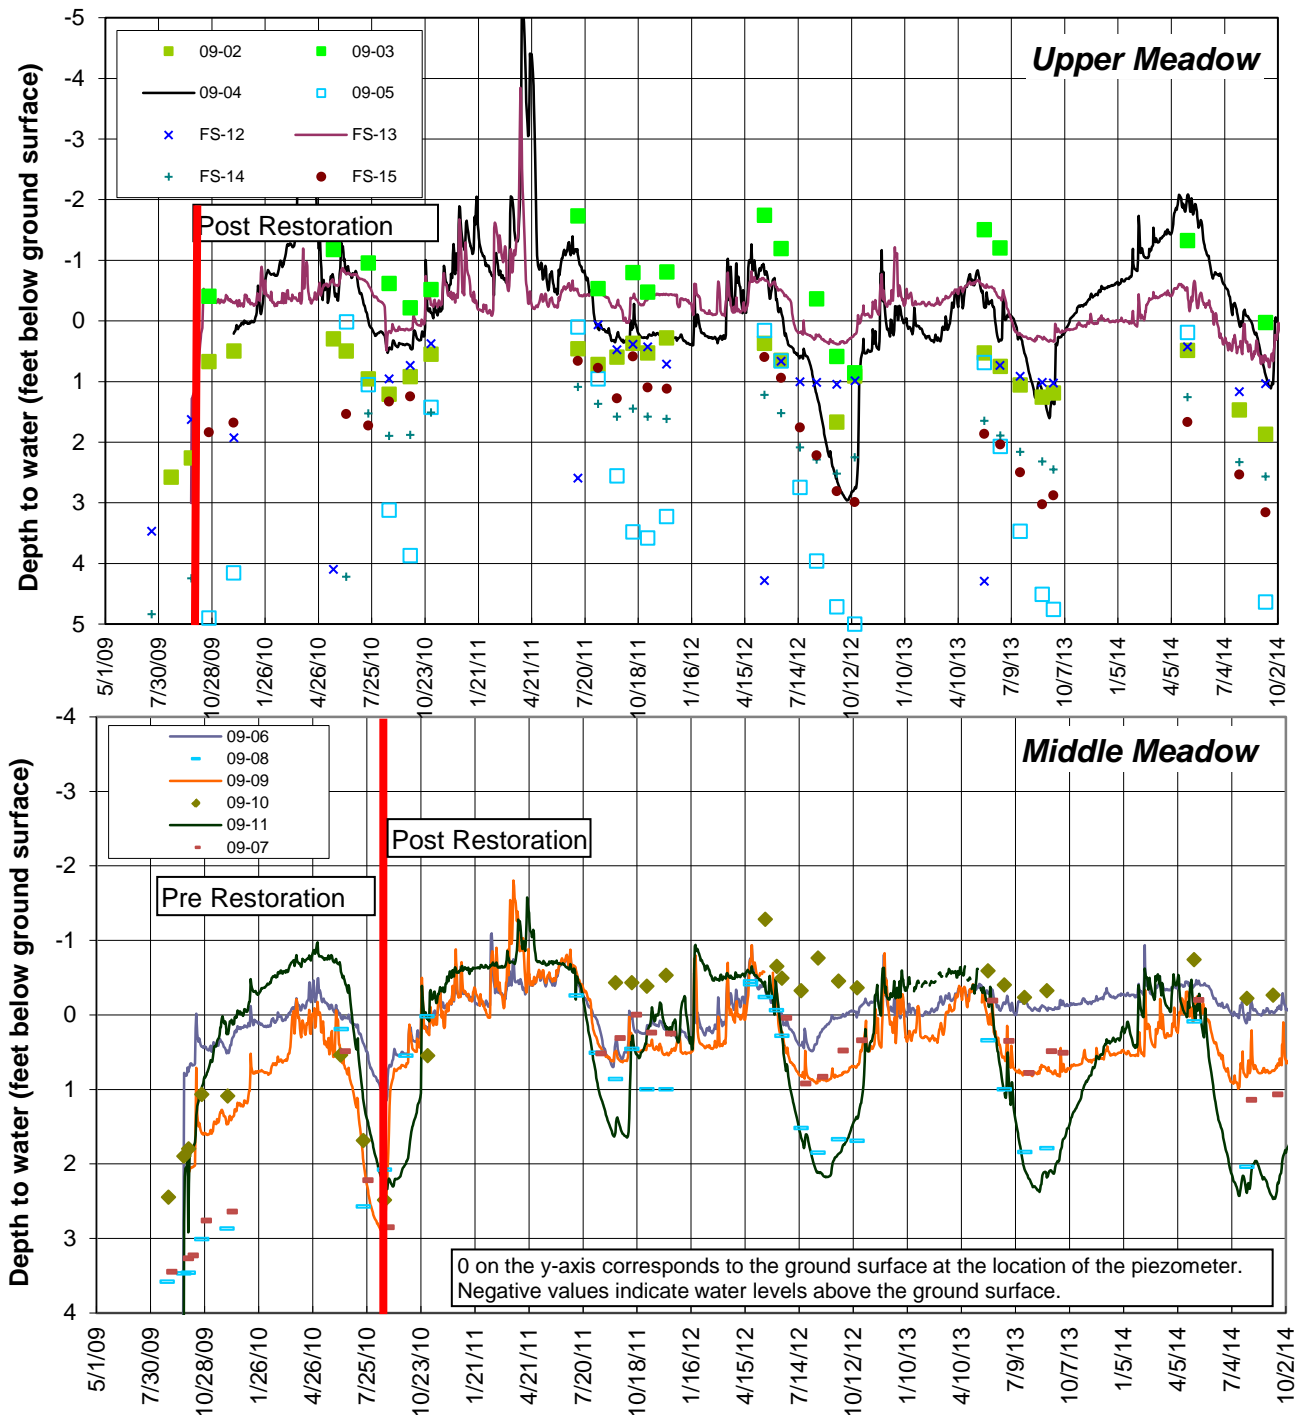
Figure 25. Depth to groundwater for the monitoring period, Upper and Middle Perazzo Meadows, Sierra County, California, June 2009 to September 2014.

Groundwater in the Upper Meadow responded similarly to below average precipitation in WY2013 as in WY2012 (**Figure 25**). Under very dry conditions, groundwater levels fell to the lowest recorded since the restoration was implemented, and in some cases, lower than observed under pre-restoration conditions observed in Summer 2009, primarily in the vicinity of FS-12 and FS-5. Piezometers FS-15, FS-14, fell to levels very similar to WY2012, establishing a hydraulic floor at approximately 2 to 3 feet below the ground surface.

Groundwater conditions in the vicinity of Piezometer 09-04 and 09-02 behaved slightly differently in WY2013 than WY2012, even though ambient hydrologic conditions like snowpack and streamflow were very similar between the two years. Piezometer 09-04 is located in an area where surface flow was re-introduced by restoration activities. WY2012 saw this area become drier than in previous years, with groundwater levels falling to 3 feet below the meadow surface when beavers directed flows away from the restored meadow. Surface flow conditions in WY2012 allowed this area to remain wetter through the summer, with groundwater levels only falling to 1.25 feet below the meadow surface.
