Conceptual Design and Feasibility Study Mainstem Martis Creek Placer County, California

August 2016

**Balance
Hydrologics, Inc.®**

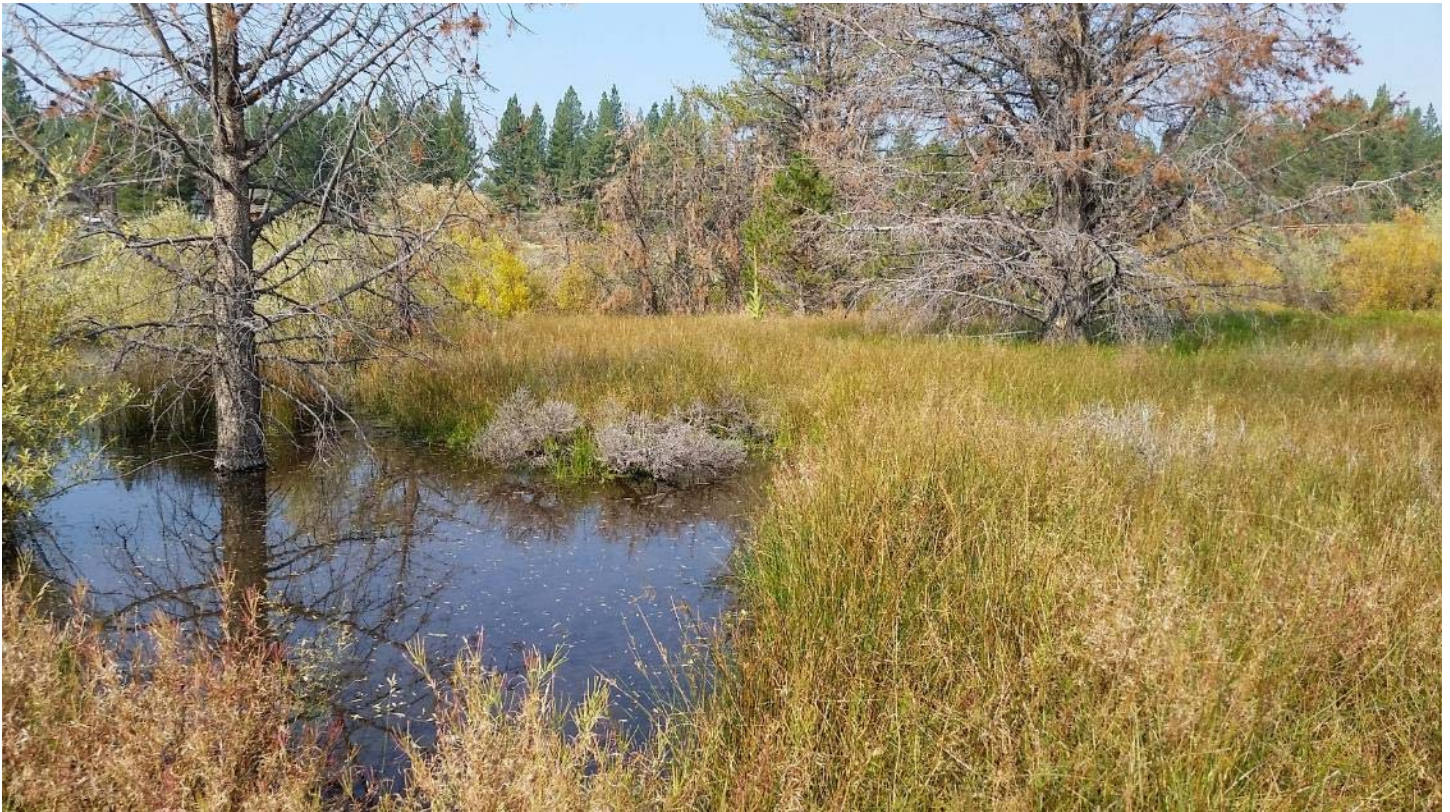
Beaver-influenced meadow inundation, Lahontan Golf Club and Community (upstream of project reach)

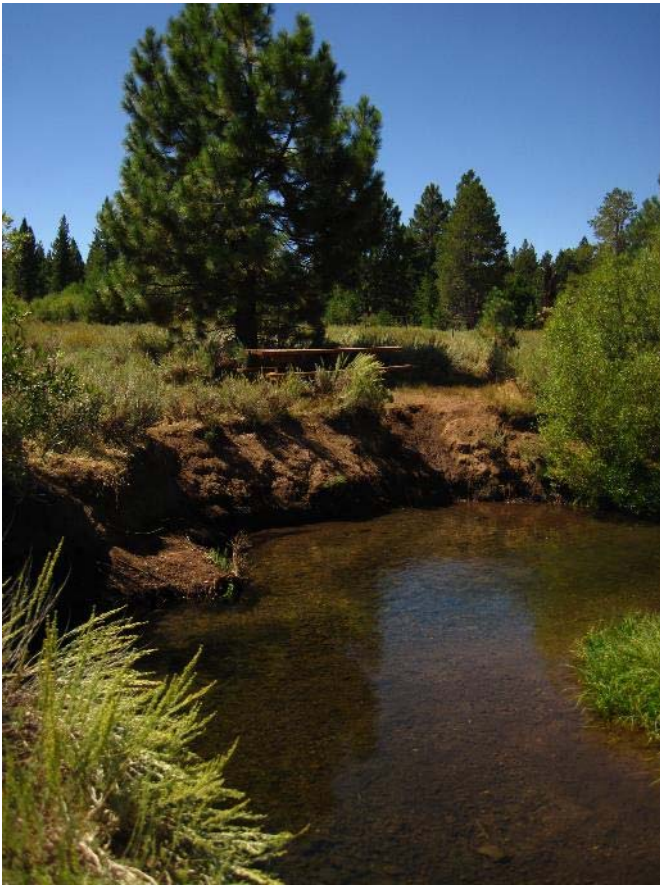
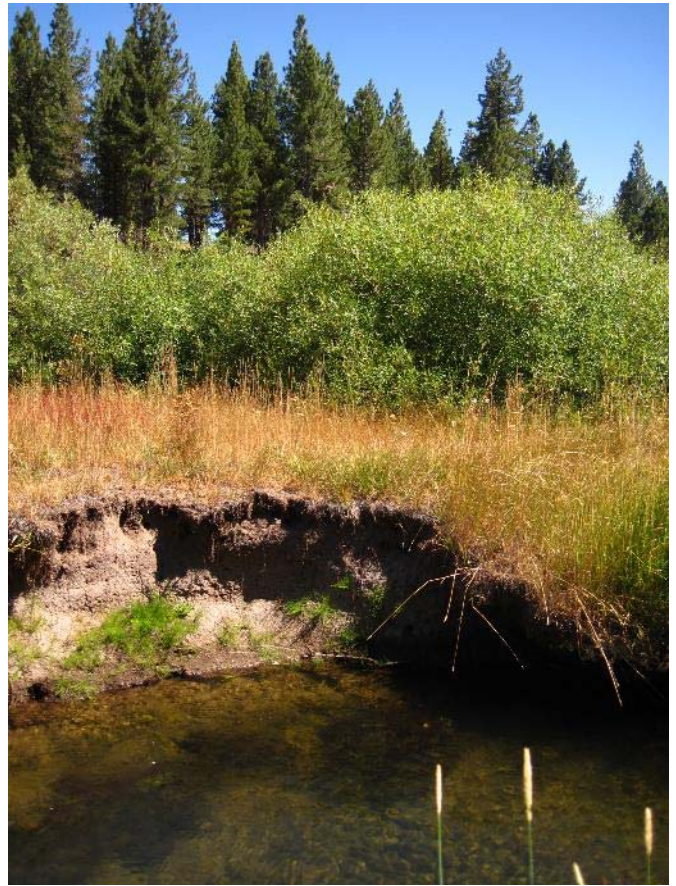
Incised channel with active bank widening and erosion, Mainstem Martis Creek, Reach 1

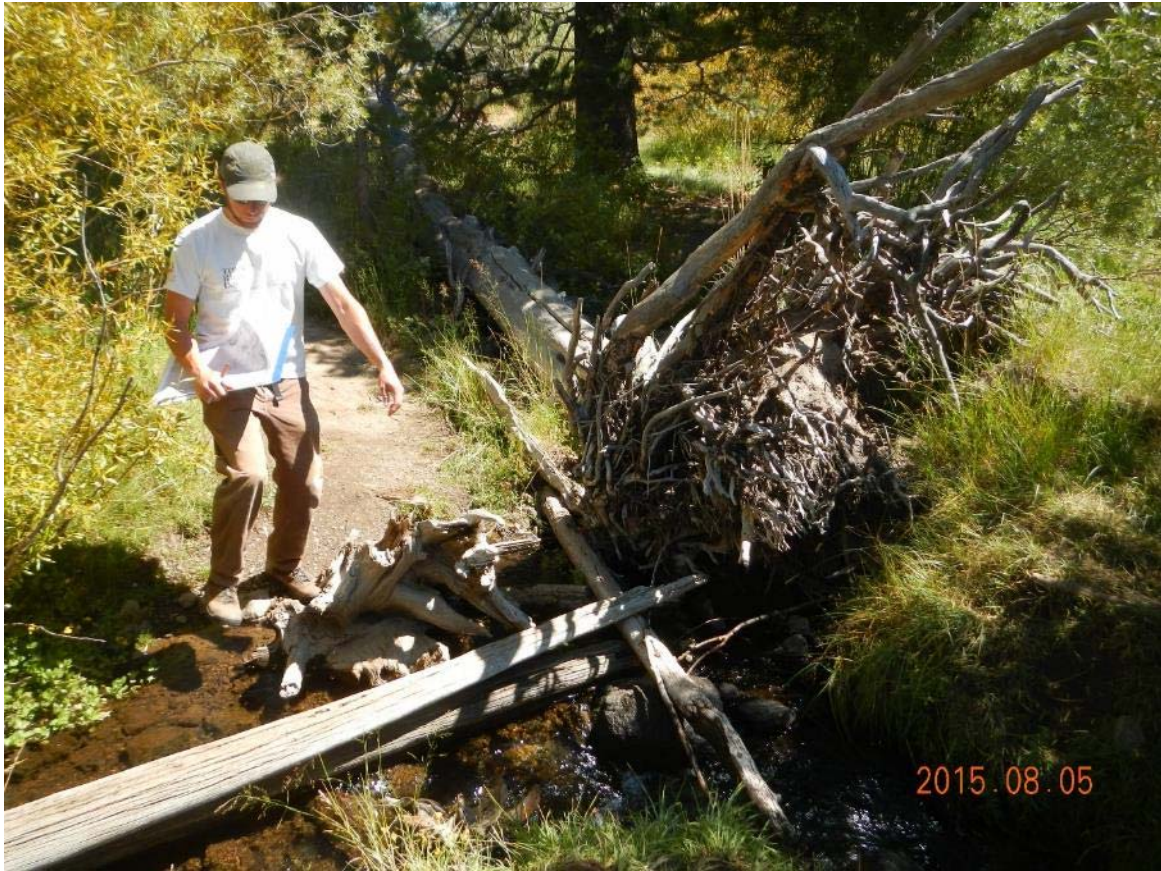
Instream wood recruitment, Mainstem Martis Creek, Reach 1

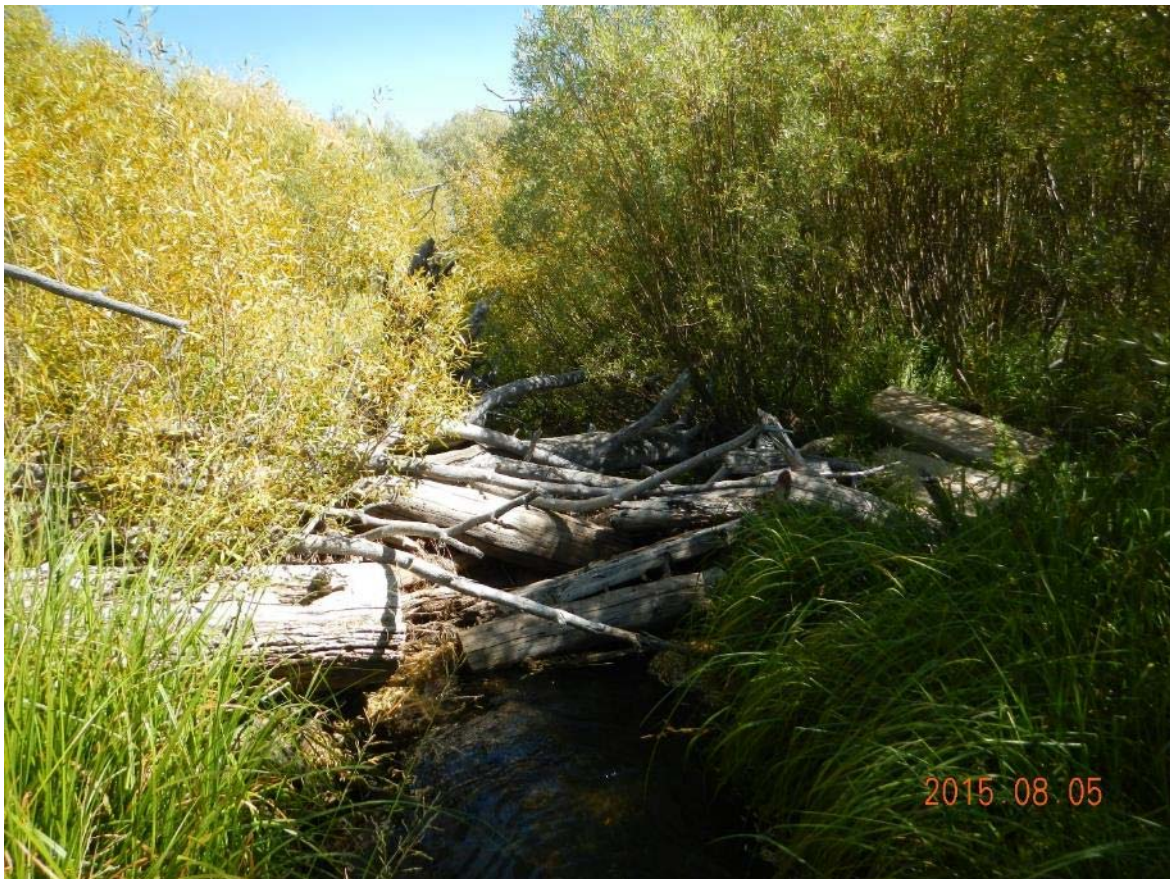
Instream wood jam, Mainstem Martis Creek, Reach 2

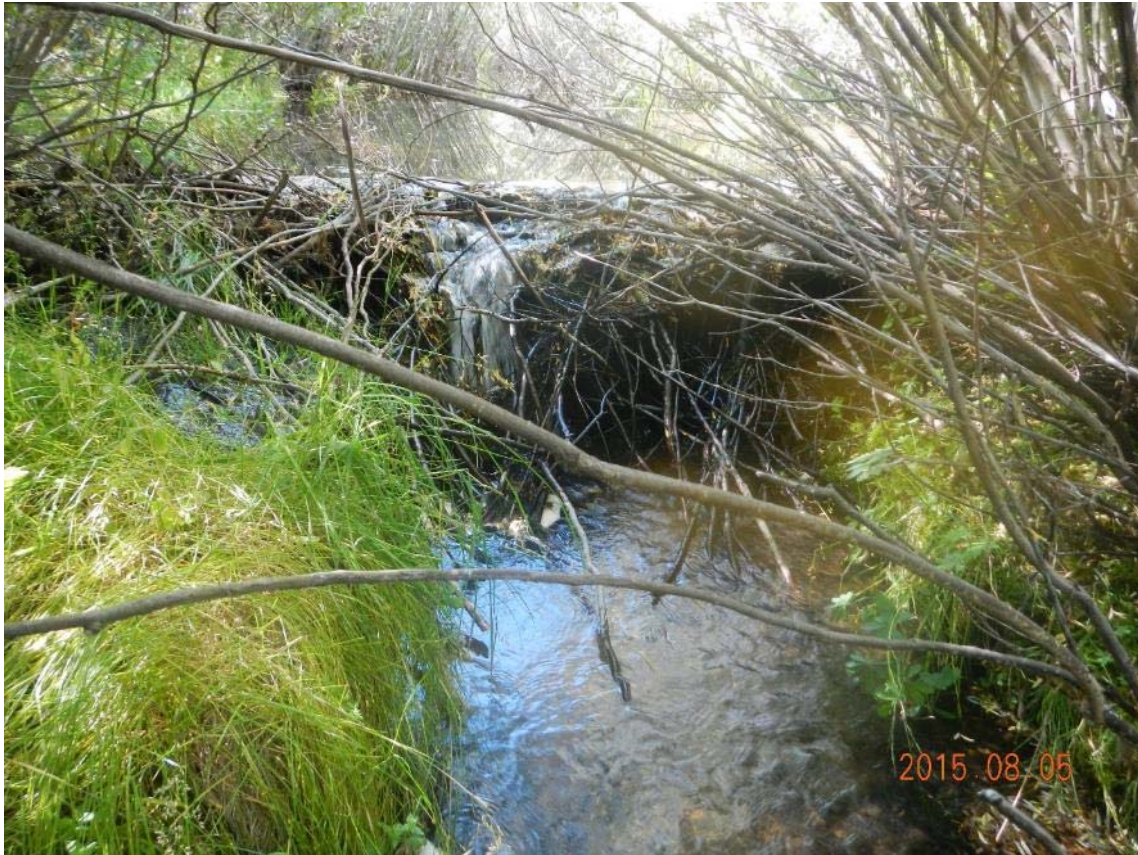
Active beaver dam, Mainstem Martis Creek, Reach 2

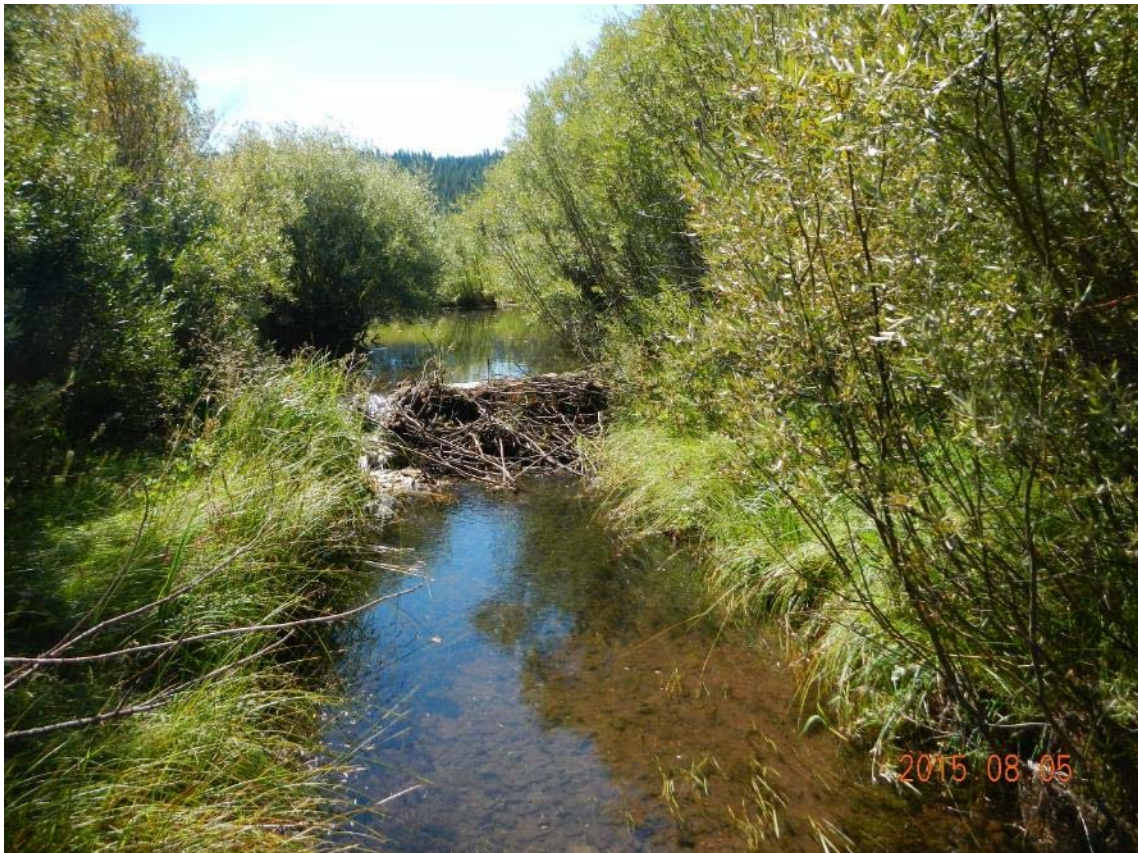
Active beaver dam, Mainstem Martis Creek, Reach 2

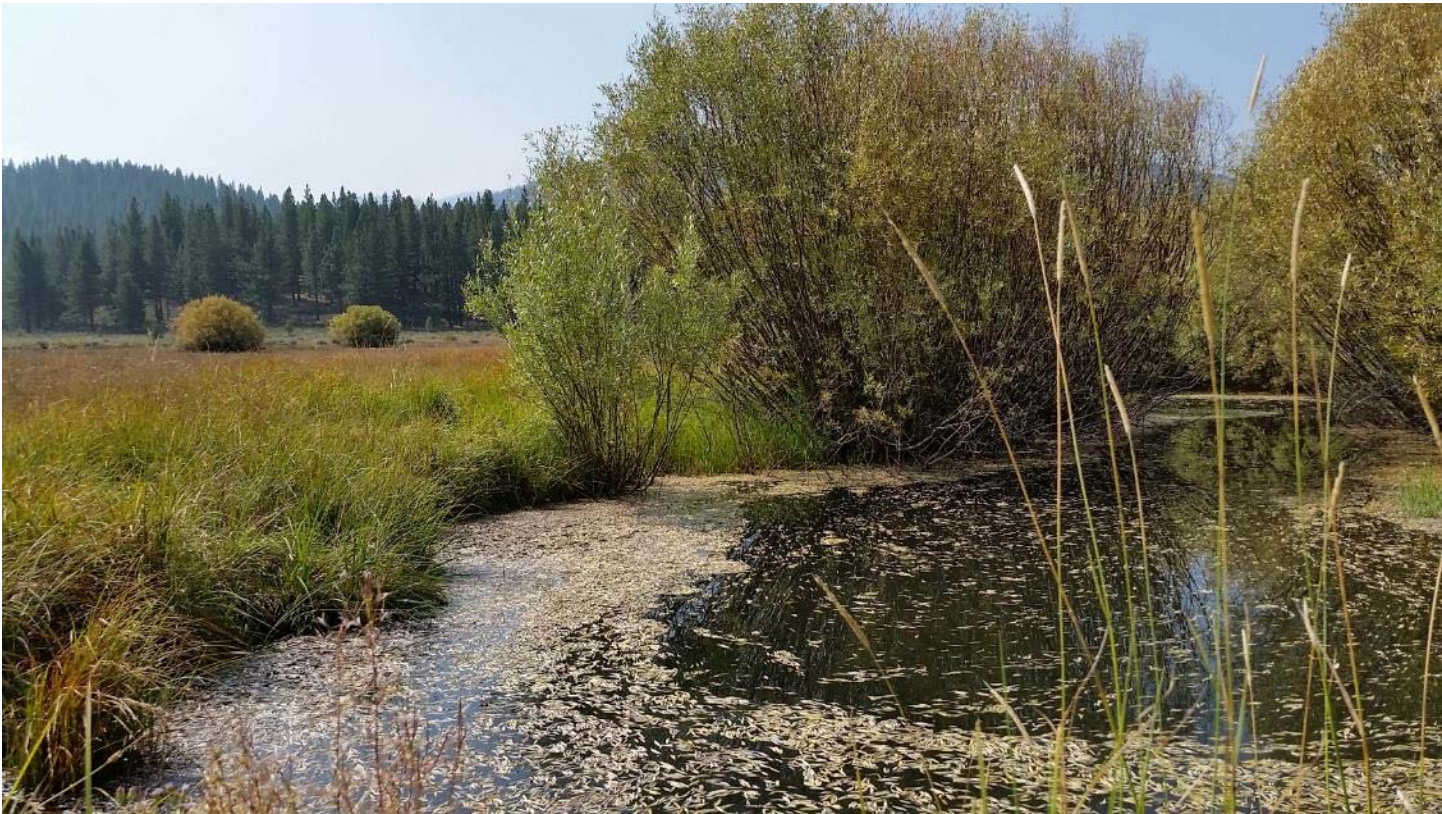
Inundation from active beaver dam, Mainstem Martis Creek, Reach 2

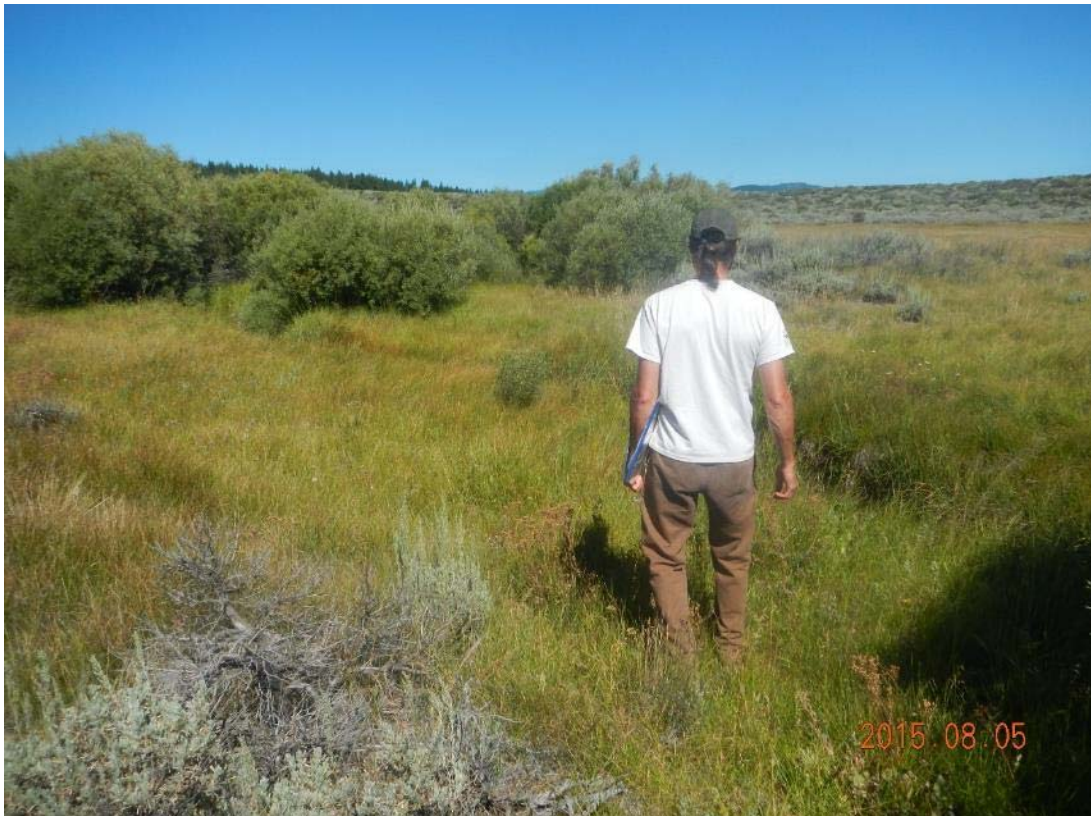
Secondary channel/swale, Mainstem Martis Creek, Reach 3

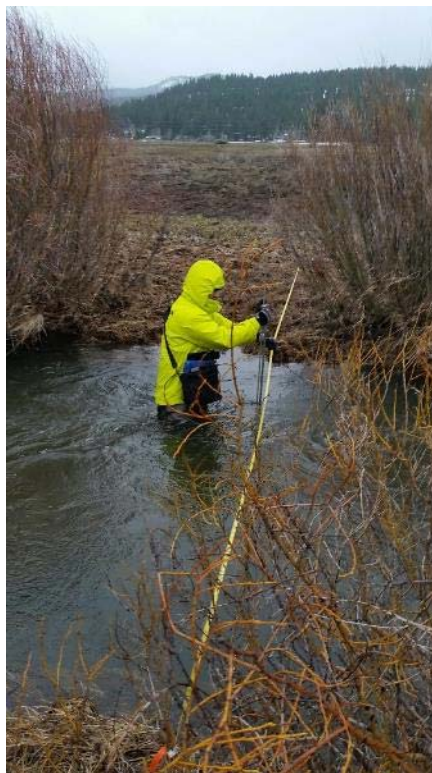
50 cfs, flow confined to a single channel, Mainstem Martis Creek, Reach 3

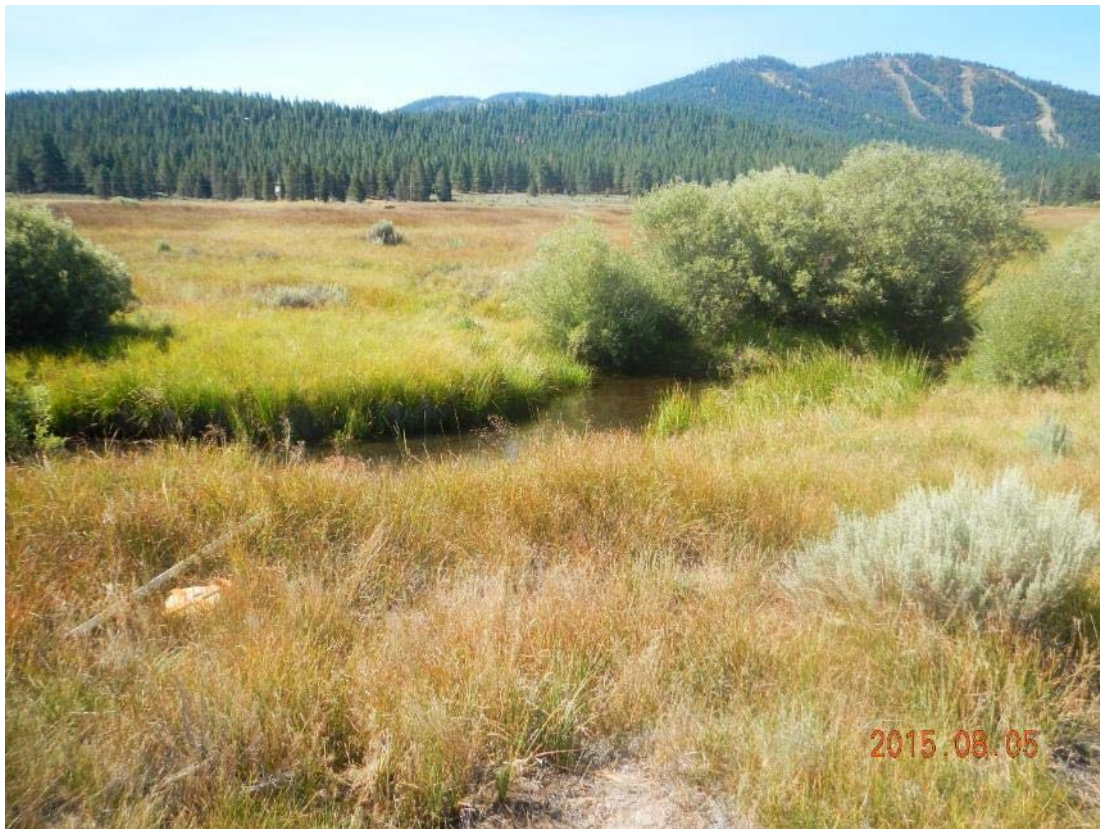
Inset floodplain, Mainstem Martis Creek, Reach 4

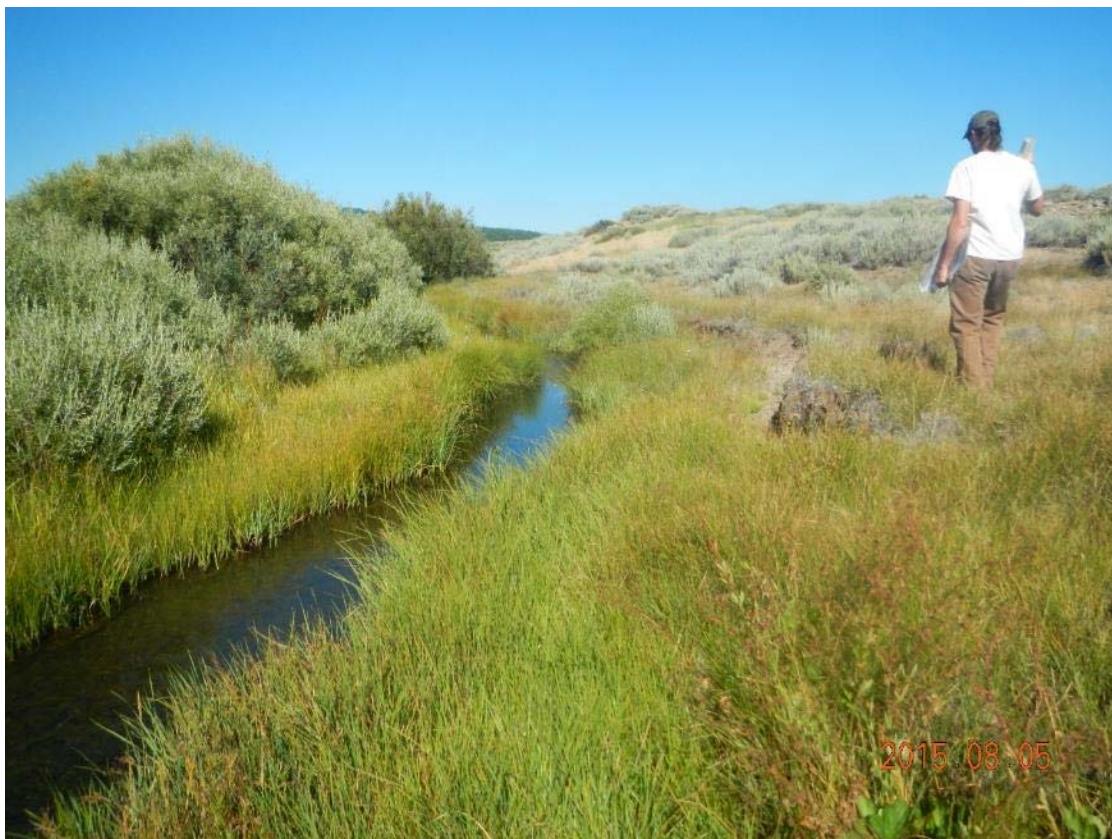
Inset floodplain, Mainstem Martis Creek, Reach 4

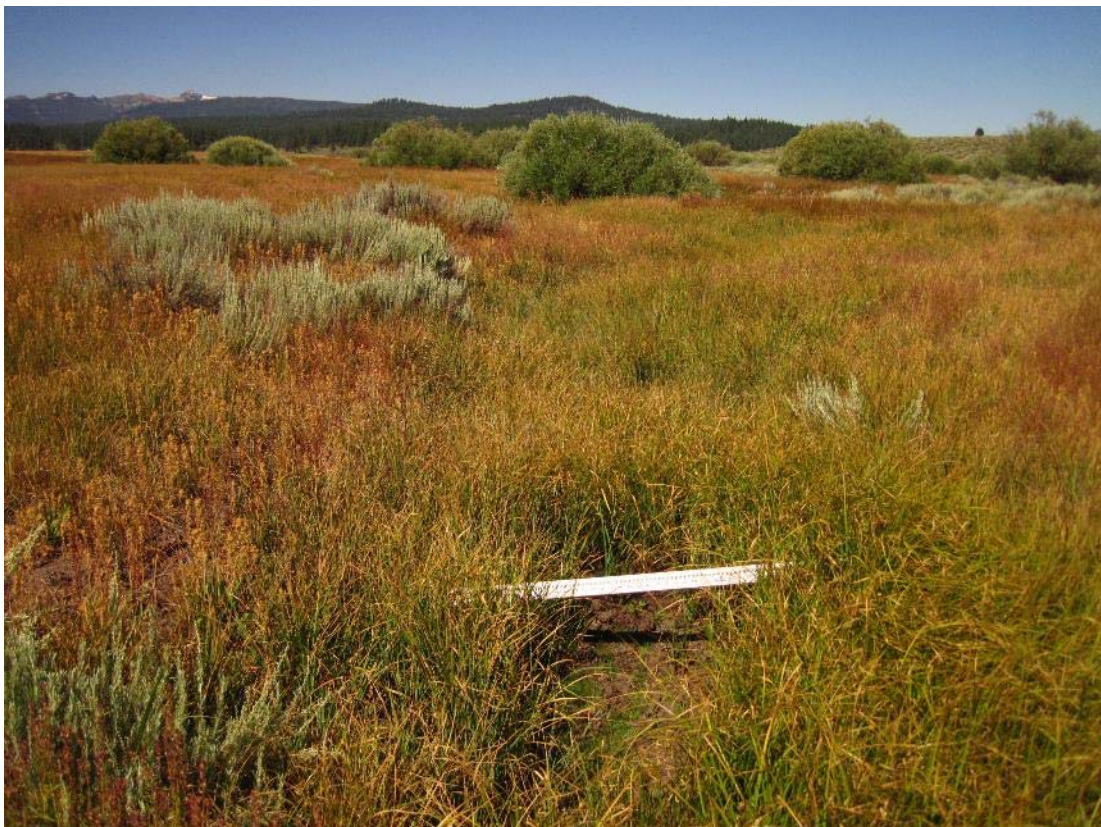
High-flow meadow swale, Mainstem Martis Creek, Reach 4

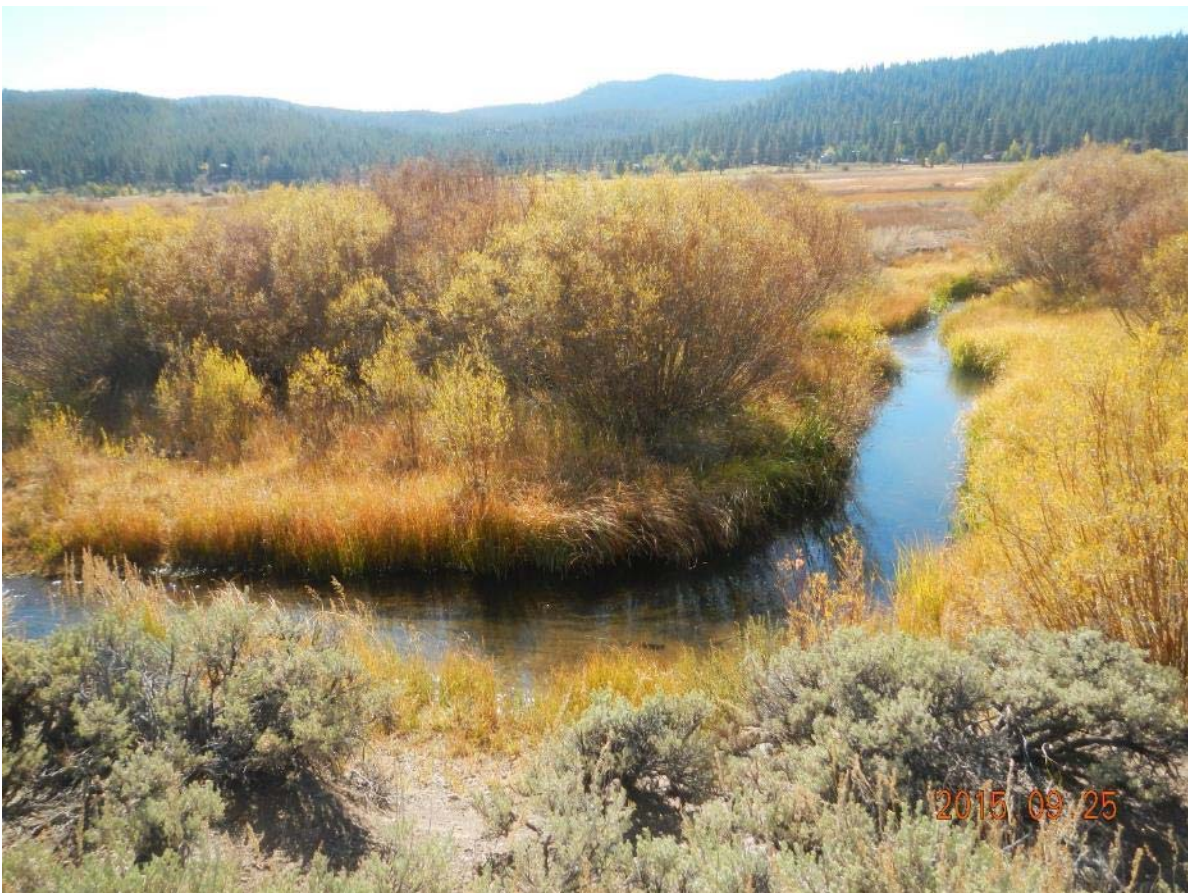
Inset floodplain, Mainstem Martis Creek, Reach 5

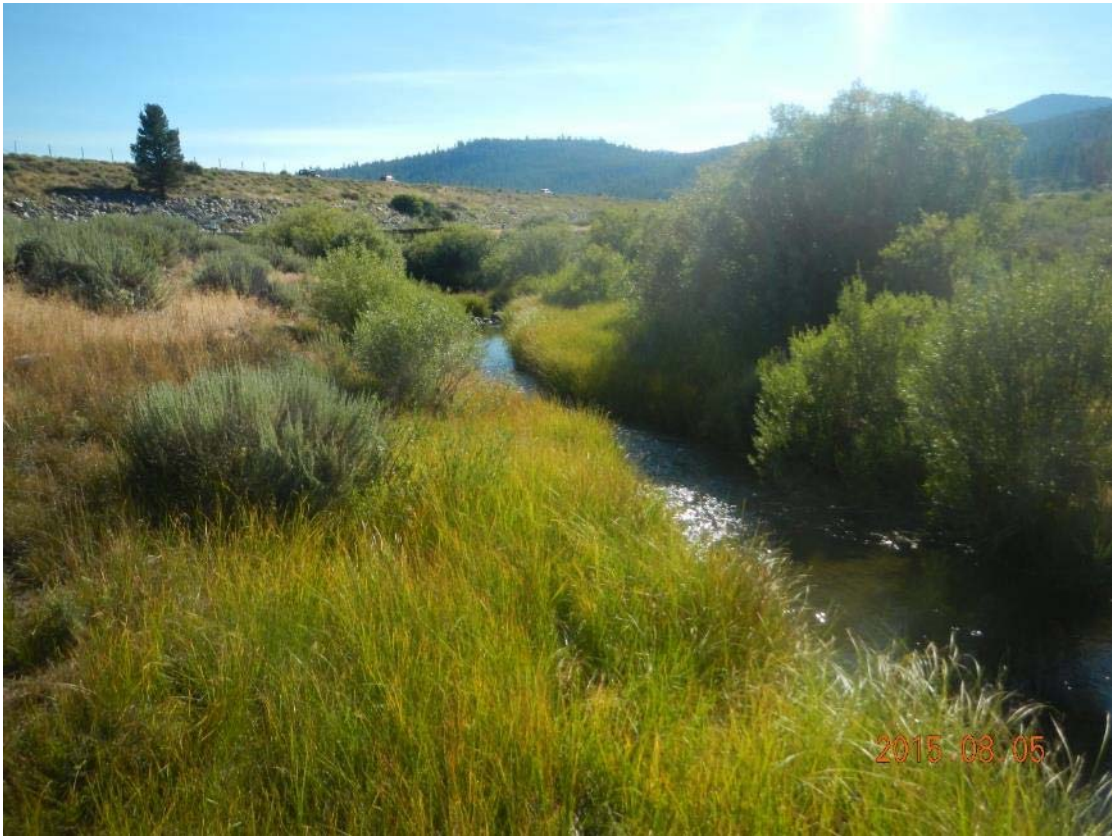
Inset floodplain, Mainstem Martis Creek, Reach 5

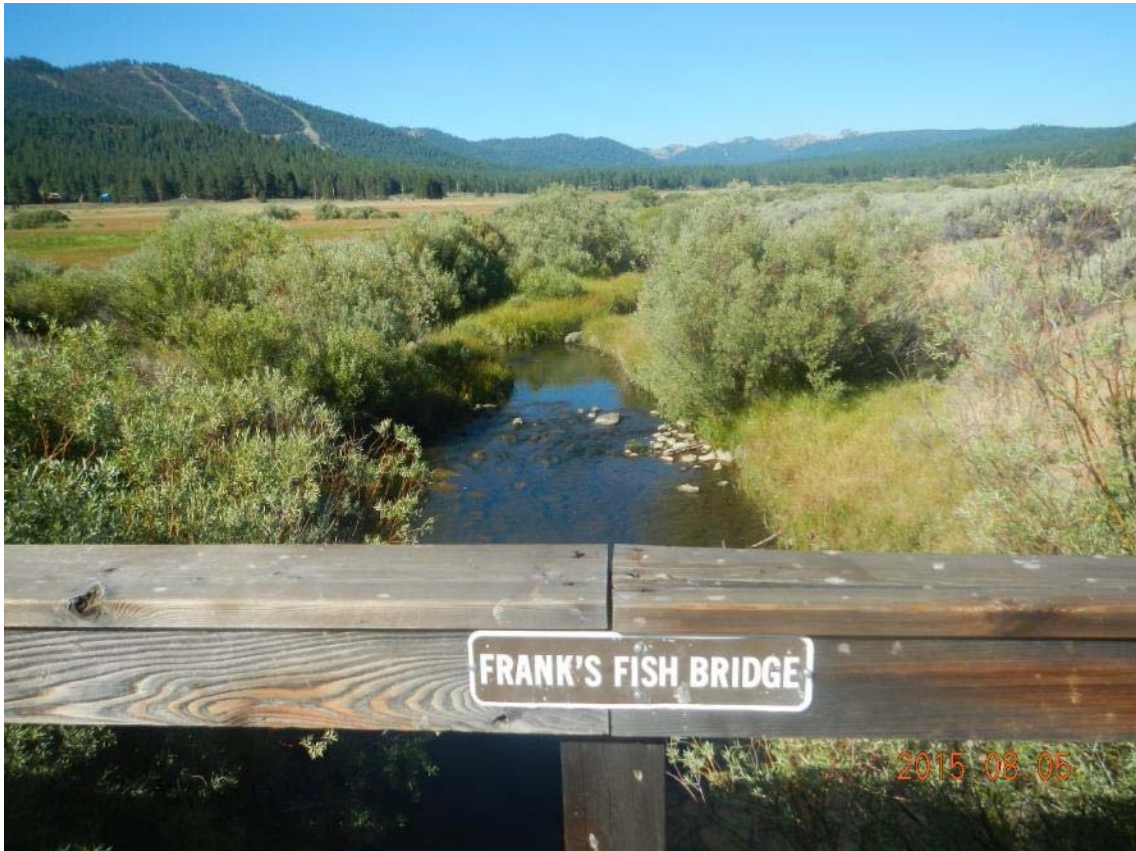
Future Martis Trail crossing, Mainstem Martis Creek, Reach 5
